Visual Site Inspection Report

Project Name	H-600 Pipeline Spread I	AFE	124300139	Spread	H-600 Pipeline Spread I
Contractor	Precision			Report #	11647
Inspector	Ben Davenport			Date/Time	6/8/2020 5:00 PM
Permit #	TBD	Inspection Type	VA SWPP	Station Begin	14928+52
State	VA	Inspection Area	Partial	Station End	15296+00
County	Franklin/Pittsylvania	Ground	Dry	Temperature (°F)	85.00
Municipality	Chatham	Weather	Sunny	Rain Gauge (in)	0.00
				Rain Accumulation Time (days)	4.00

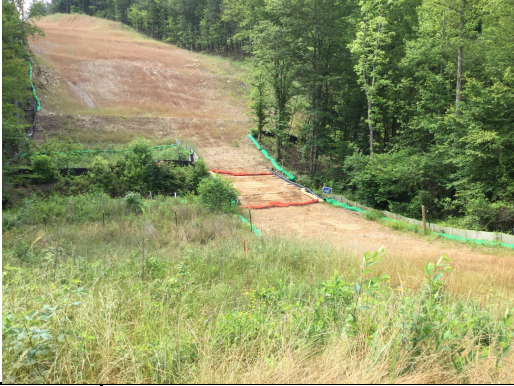
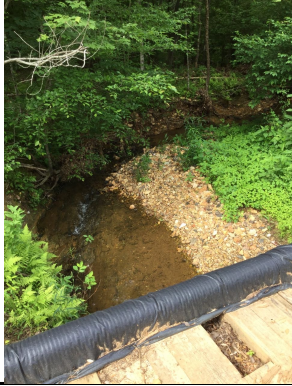
GPS Location	1	GPS Location	2		
Field Station#	14950+47	Field Station#	14950+47		
Pic 1 Desc.	Bridge crossing of stream S-G13. ECD's on bridge and surrounding streams and buffer areas in good condition.		Pic 2 Desc.	Downstream view of S-G13.

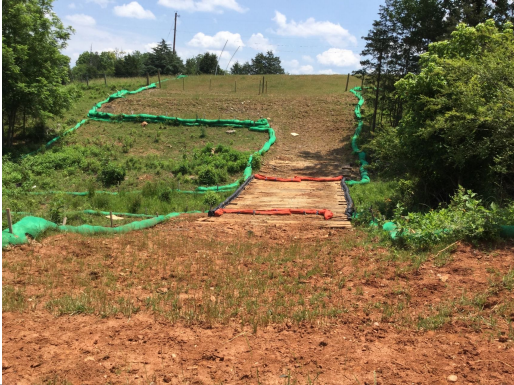
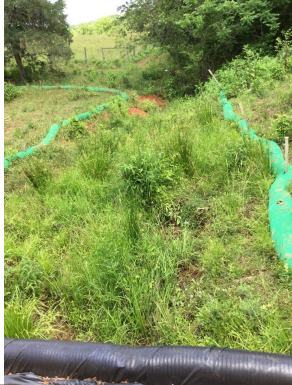
GPS Location	3	GPS Location	4		
Field Station#	14991+62	Field Station#	14991+62		
Pic 3 Desc.	Bridge crossing of stream S-D7. ECD's on bridge and surrounding streams and buffer areas in good condition.		Pic 4 Desc.	Downstream view of S-D7.

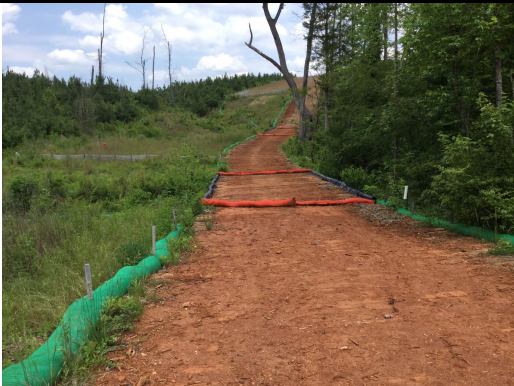
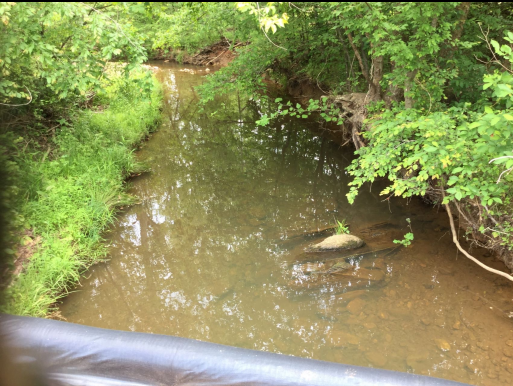
GPS Location	5	GPS Location	6		
Field Station#	15026+04	Field Station#	15026+04		
Pic 5 Desc.	Bridge crossing of streams S-D3 and S-D4. ECD's on bridge and surrounding streams and buffer areas in good condition.		Pic 6 Desc.	Downstream view of S-D3.

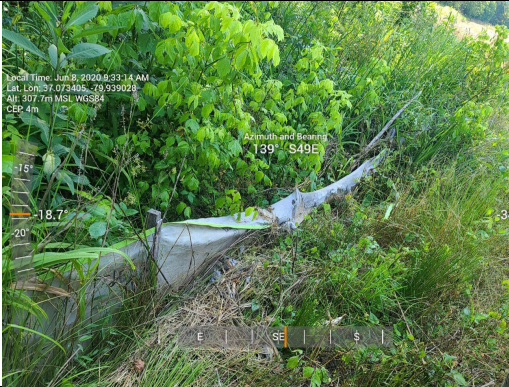
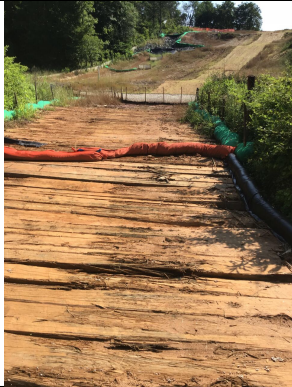
GPS Location	0000	GPS Location	0000		
Field Station#	13756+60	Field Station#	13781+62		
Pic 1 Desc.	P1 requires maintenance, added to the punch list	Pic 2 Desc.	Bridge protection in place and functioning

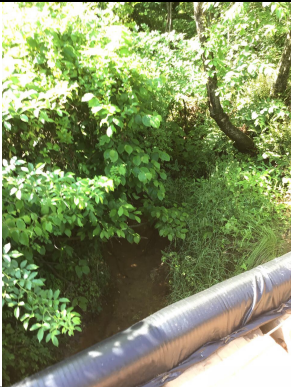
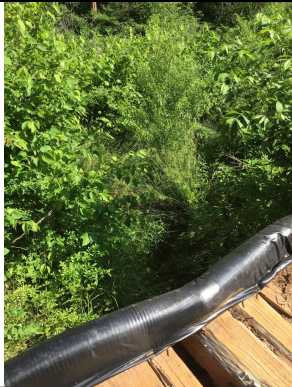
GPS Location	0000	GPS Location	0000		
Field Station#	13781+62	Field Station#	13781+62		
Pic 3 Desc.	Stream photo facing downstream	Pic 4 Desc.	Stream crossing photo facing upstream		
Insert image here			Insert image here		
GPS Location		GPS Location			
Field Station#		Field Station#			
Pic 5 Desc.		Pic 6 Desc.

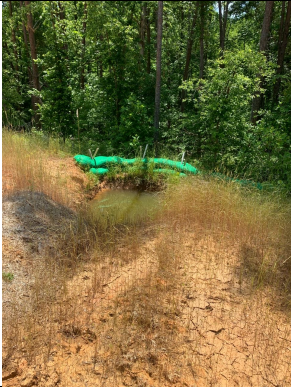
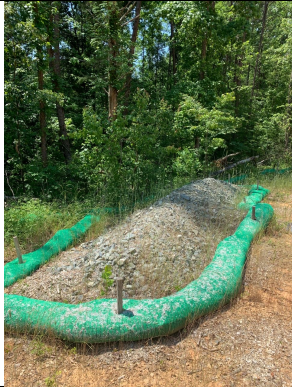
GPS Location	O	GPS Location	O		
Field Station#	16010+00	Field Station#	16013+00		
Pic 1 Desc.	Observing water bar, sump and end treatment performing as they should.	Pic 2 Desc.	Observing CWD outlet and ECD's performing as they should.

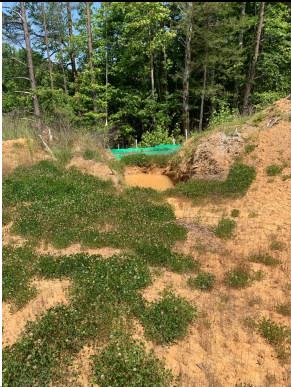
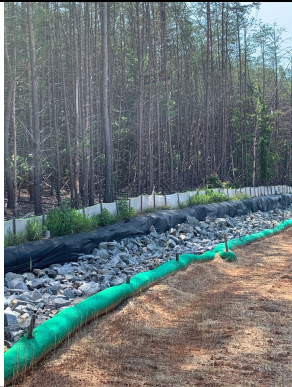
GPS Location	O	GPS Location	O		
Field Station#	16008+00	Field Station#	15837+00		
Pic 3 Desc.	Observing sump and end treatment performing as they should.	Pic 4 Desc.	Observing ECD's performing as they should.		
Insert image here			Insert image here		
GPS Location		GPS Location			
Field Station#		Field Station#			
Pic 5 Desc.		Pic 6 Desc.

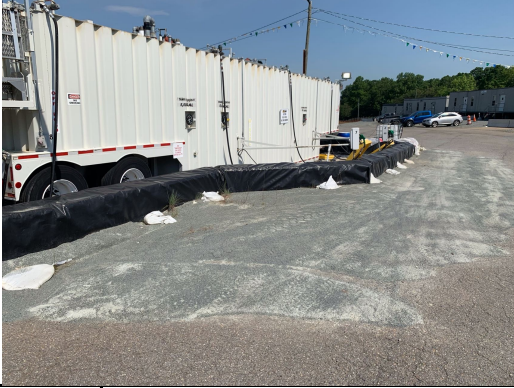
GPS Location	000000000000	GPS Location	000000000000		
Field Station#	0000+00	Field Station#	0000+00		
Pic 1 Desc.	Secondary containment structure for the fuel cell in compliance.	Pic 2 Desc.	General Construction permits and contact information are posted at the entrance of the paved yard.

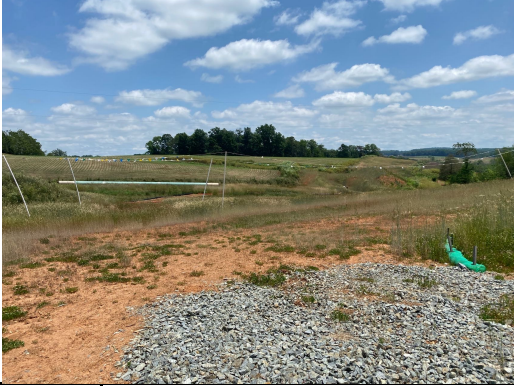
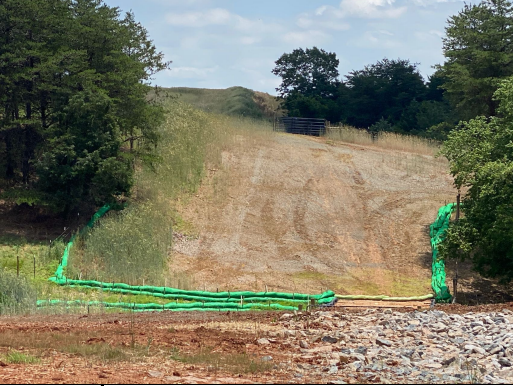
GPS Location	0	GPS Location	0		
Field Station#	15297+00	Field Station#	15338+00		
Pic 1 Desc.	Temporary vegetation is present but is beginning to die out due to warm temperatures.		Pic 2 Desc.	No temporary vegetation present along row.

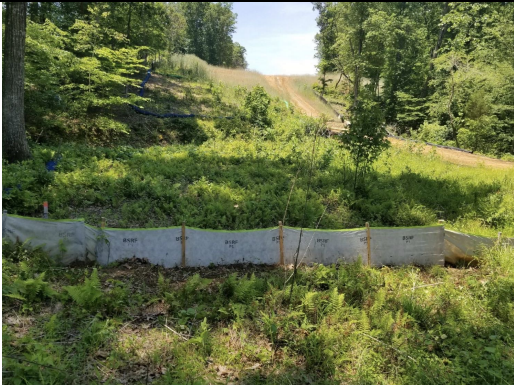
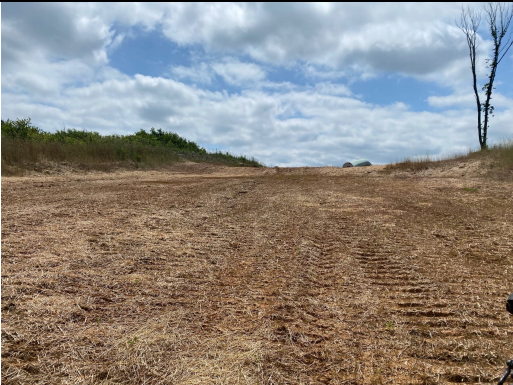
GPS Location	0	GPS Location	0		
Field Station#	15427+50	Field Station#	15510+00		
Pic 3 Desc.	New P1 fence installed during maintenance process.		Pic 4 Desc.	No temporary vegetation present along row.

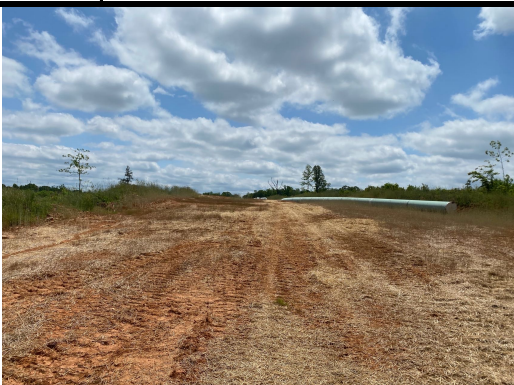
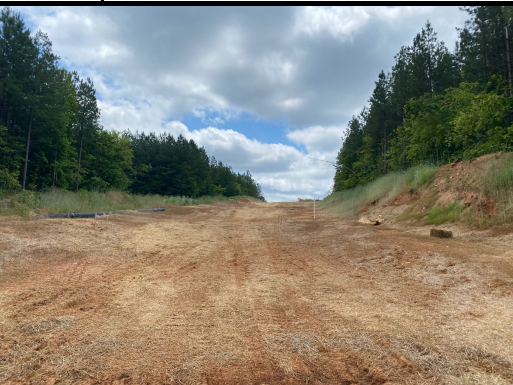
GPS Location	0	GPS Location	0		
Field Station#	15529+00	Field Station#	15578+00		
Pic 5 Desc.	No temporary vegetation present along row.		Pic 6 Desc.	No temporary vegetation present along row.

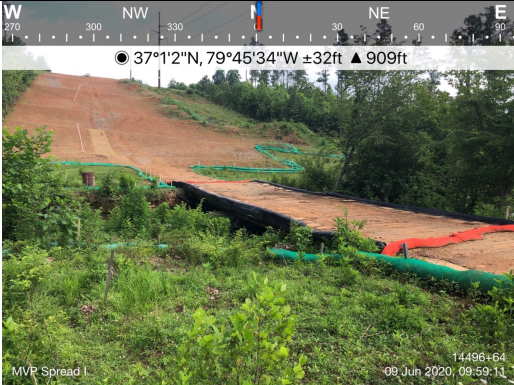
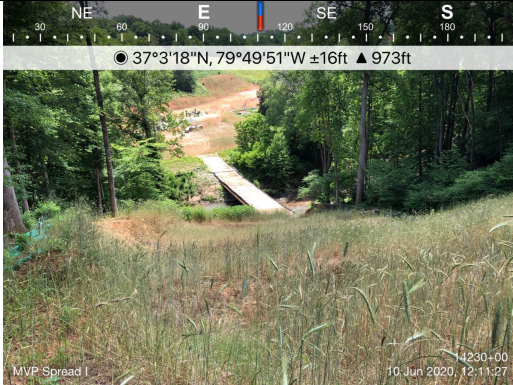
GPS Location	0	GPS Location	0		
Field Station#	14496+64	Field Station#	14230+00		
Pic 1 Desc.	Equipment bridge in acceptable condition		Pic 2 Desc.	Temporary vegetative stabilization in acceptable condition

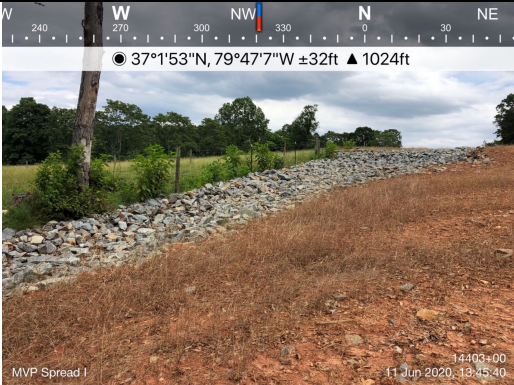
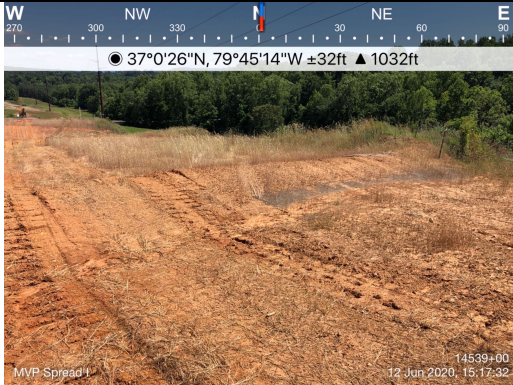
GPS Location	0	GPS Location	0		
Field Station#	14403+00	Field Station#	14539+00		
Pic 3 Desc.	Rock lined channel in acceptable condition		Pic 4 Desc.	Waterbar in acceptable condition	
Insert image here			Insert image here		
GPS Location		GPS Location			
Field Station#		Field Station#			
Pic 5 Desc.			Pic 6 Desc.

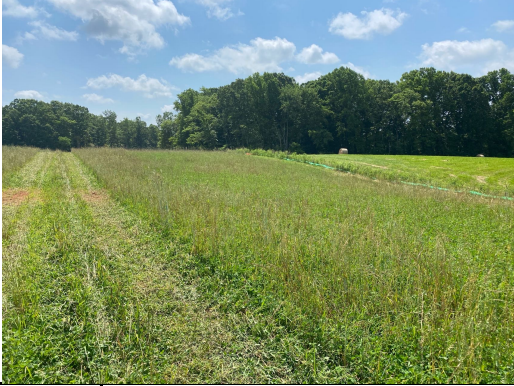
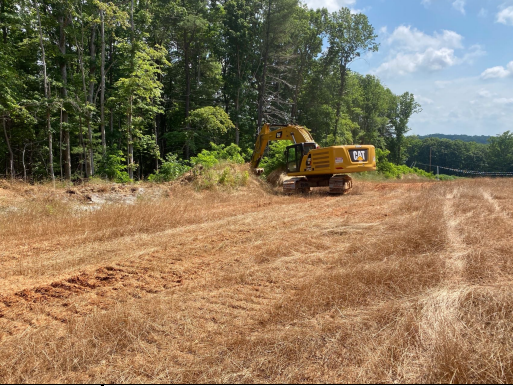
GPS Location	0	GPS Location	0		
Field Station#	14115+00	Field Station#	14080+00		
Pic 1 Desc.	Approximately 14115+00. Overview of ROW. ROW temporarily stabilized and has temporary and permanent vegetation growing.		Pic 2 Desc.	Approximately 14080+00. Contractor cleaning sumps.

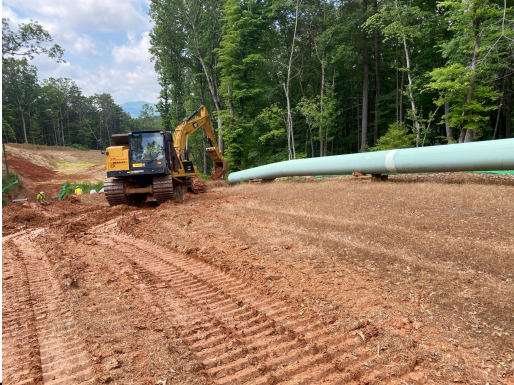
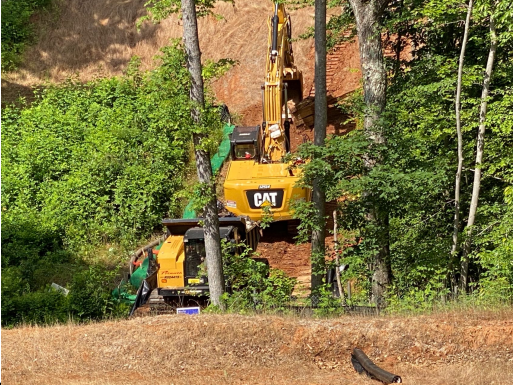
GPS Location	0	GPS Location	0		
Field Station#	14047+00	Field Station#	14105+26		
Pic 3 Desc.	Approximately 14047+00. Contractor cleaning sumps, removing and replacing old ECDs.		Pic 4 Desc.	Approximately 14105+26. Contractor replacing Geotextile fabric under equipment bridge cap.	
Insert image here			Insert image here		
GPS Location		GPS Location			
Field Station#		Field Station#			
Pic 5 Desc.		Pic 6 Desc.

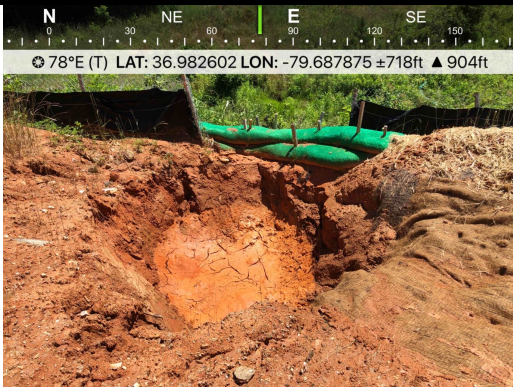
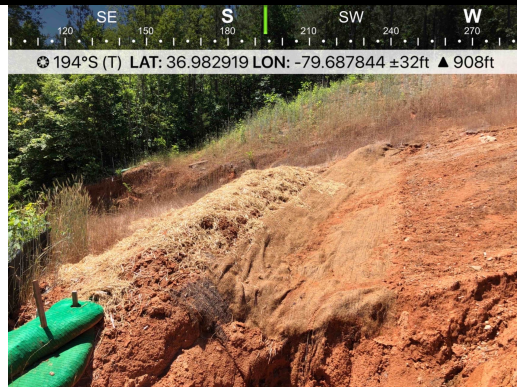
<p>194°S (T) LAT: 36.982919 LON: -79.687844 ±32ft ▲ 908ft</p>			
GPS Location	0	GPS Location	0		
Field Station#	14765+50	Field Station#	14765+50		
Pic 1 Desc.	Sump pit cleaned out that was over 50% full	Pic 2 Desc.	Water bar built up to spec, seeded, and mulched

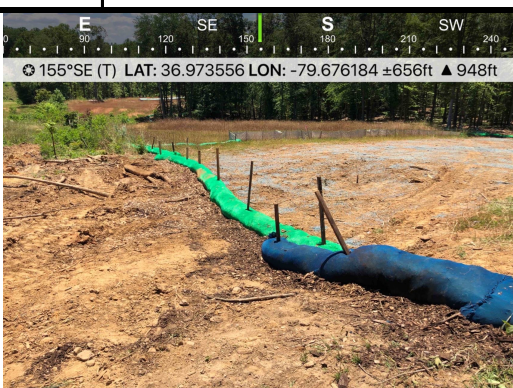
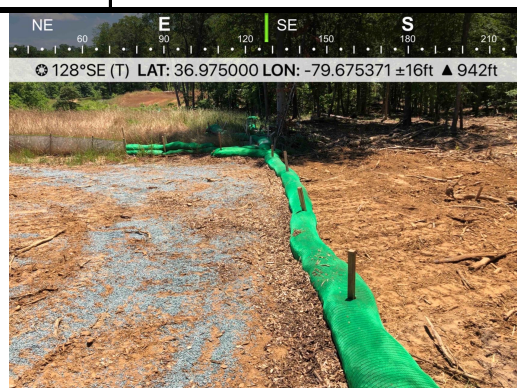
<p>128°SE (T) LAT: 36.975000 LON: -79.675371 ±16ft ▲ 942ft</p>			
GPS Location	0	GPS Location	0		
Field Station#	14812+00	Field Station#	14812+00		
Pic 3 Desc.	Perimeter ECDs installed, area seeded, and earthguard edge applied to the area where third party logging company crossed ROW	Pic 4 Desc.	Perimeter ECDs installed, area seeded, and earthguard edge applied to the area where third party logging company crossed ROW

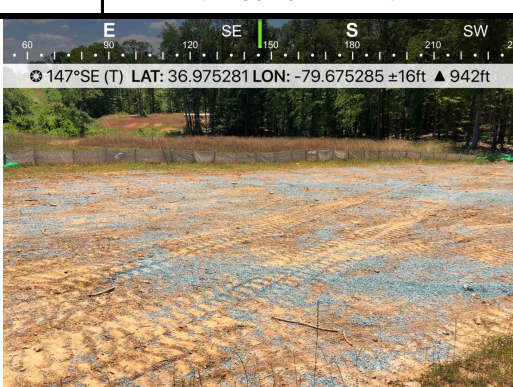
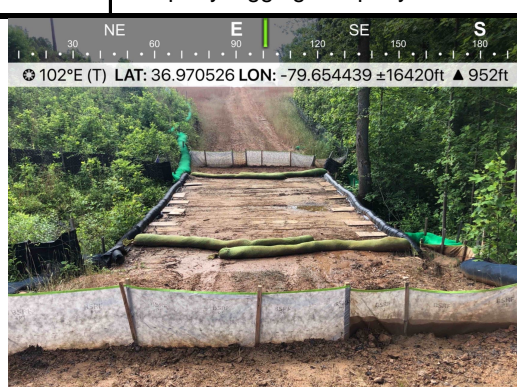
GPS Location	0	GPS Location	0		
Field Station#	14812+00	Field Station#	14870+43		
Pic 5 Desc.	Perimeter ECDs installed, area seeded, and earthguard edge applied to the area where third party logging company crossed ROW	Pic 6 Desc.	P1 silt fence repaired on both sides of stream S-SS8

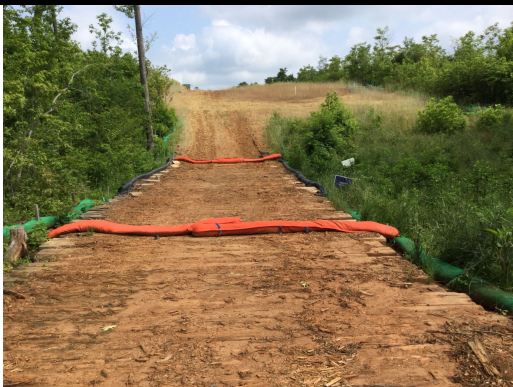
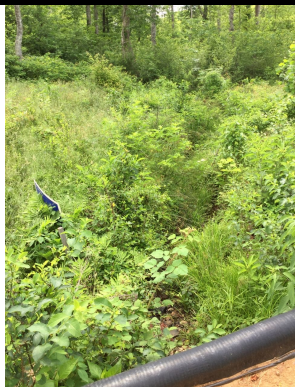
GPS Location	1	GPS Location	2		
Field Station#	15126+40	Field Station#	15126+40		
Pic 1 Desc.	Equipment bridge and surrounding ECD's functional and in good condition at stream S-A6.		Pic 2 Desc.	Downstream view of stream S-A6.

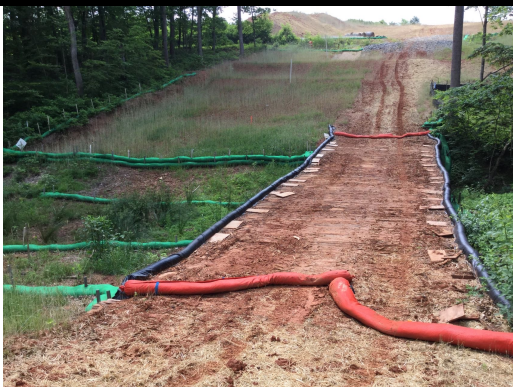
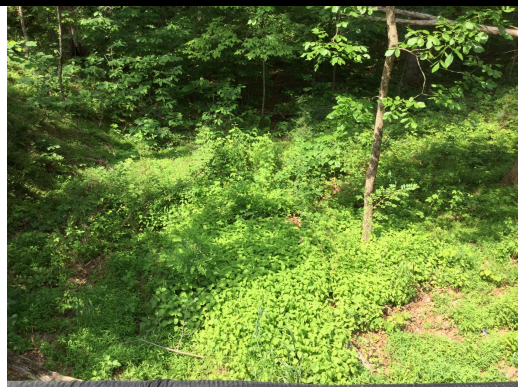
GPS Location	3	GPS Location	4		
Field Station#	15141+00	Field Station#	15141+00		
Pic 3 Desc.	Equipment bridge and ECD's functional and in good condition CIS Rock Creek Rd near streams S-H09 and S-H10.		Pic 4 Desc.	Downstream look at start of S-H09.

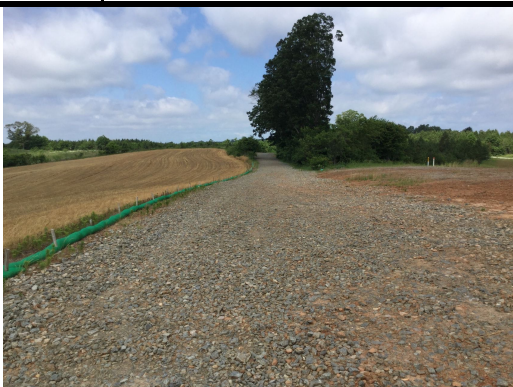
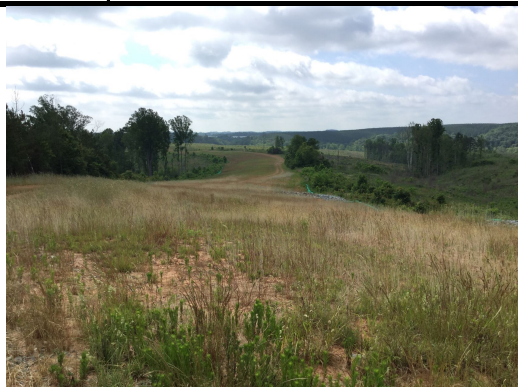
GPS Location	5	GPS Location	6		
Field Station#	15227+00	Field Station#	15240+00		
Pic 5 Desc.	RCE at MVP-PI-328 in good condition.		Pic 6 Desc.	View of permanent vegetation growing along ROW. Permanent ECD's and perimeter controls functional and in good condition.

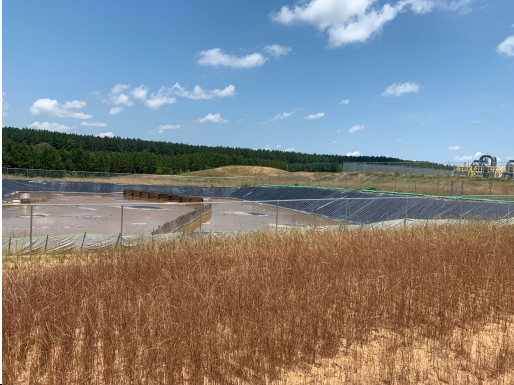
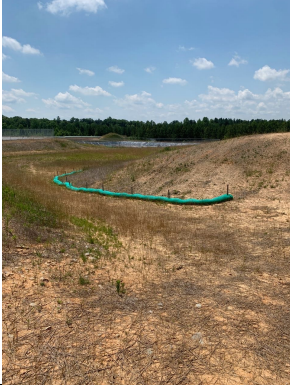
GPS Location	O	GPS Location	O		
Field Station#	00+00	Field Station#	00+00		
Pic 1 Desc.	Observing storm water pond.	Pic 2 Desc.	Observing ECD's performing as they should.

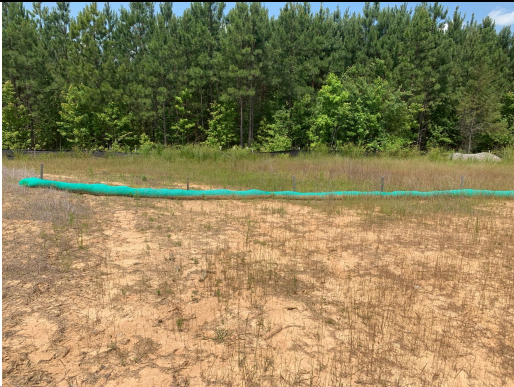
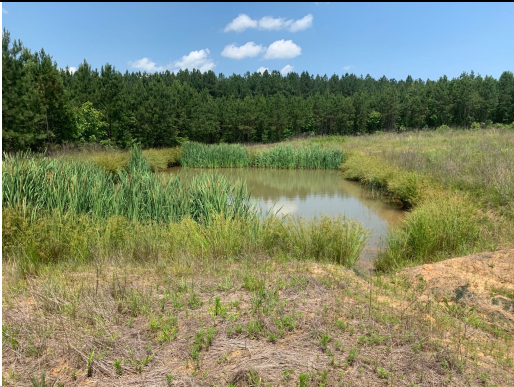
GPS Location	O	GPS Location	O		
Field Station#	00+00	Field Station#	00+00		
Pic 3 Desc.	Observing ECD's performing as they should.	Pic 4 Desc.	Observing sediment basin.		
Insert image here			Insert image here		
GPS Location		GPS Location			
Field Station#		Field Station#			
Pic 5 Desc.		Pic 6 Desc.

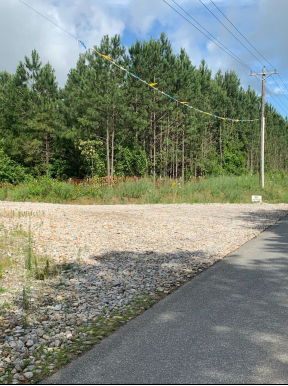
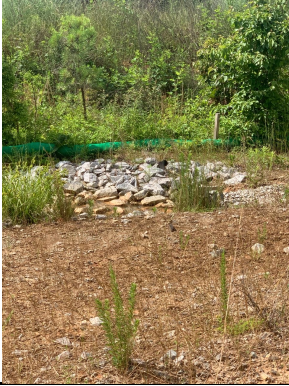
GPS Location	O	GPS Location	O		
Field Station#	00+00	Field Station#	00+00		
Pic 1 Desc.	Observing RCE.	Pic 2 Desc.	Observing outlet and outlet protection.

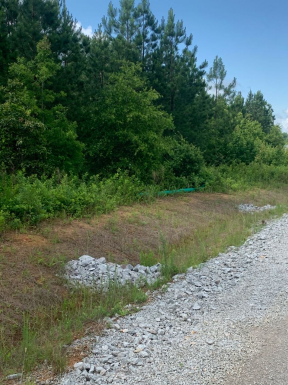
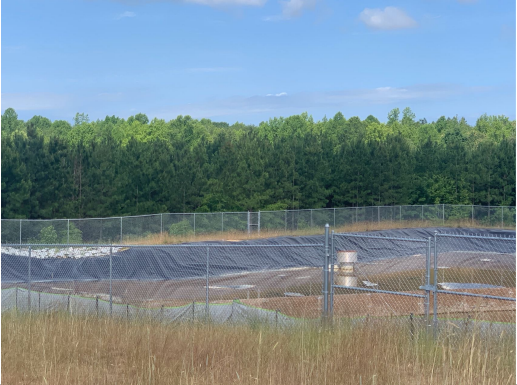
GPS Location	O	GPS Location	O		
Field Station#	00+00	Field Station#	00+00		
Pic 3 Desc.	Observing rock check dams.	Pic 4 Desc.	Observing storm water pond.		
Insert image here			Insert image here		
GPS Location		GPS Location			
Field Station#		Field Station#			
Pic 5 Desc.		Pic 6 Desc.
