# Visual Site Inspection Report

<b>Project Name</b>	H-600 Pipeline Spread I	<b>AFE</b>	124300139	<b>Spread</b>	H-600 Pipeline Spread I
<b>Contractor</b>	Precision			<b>Report #</b>	12721
<b>Inspector</b>	Logan Box			<b>Date/Time</b>	7/16/2020 4:24 PM
<b>Permit #</b>	TBD	<b>Inspection Type</b>	VA SWPP	<b>Station Begin</b>	13670+00
<b>State</b>	VA	<b>Inspection Area</b>	Partial	<b>Station End</b>	13853+45
<b>County</b>	Franklin	<b>Ground</b>	Dry	<b>Temperature (°F)</b>	90.00
<b>Municipality</b>	N/A	<b>Weather</b>	Cloudy	<b>Rain Gauge (in)</b>	0.00
				<b>Rain Accumulation Time (days)</b>	6.00

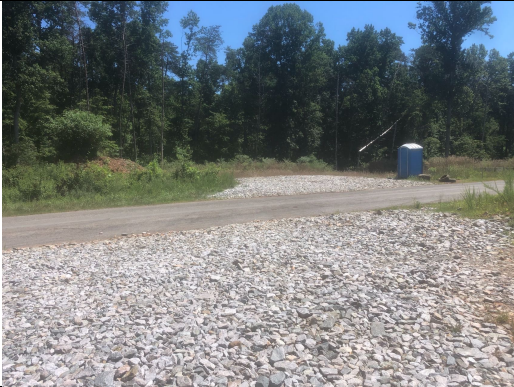
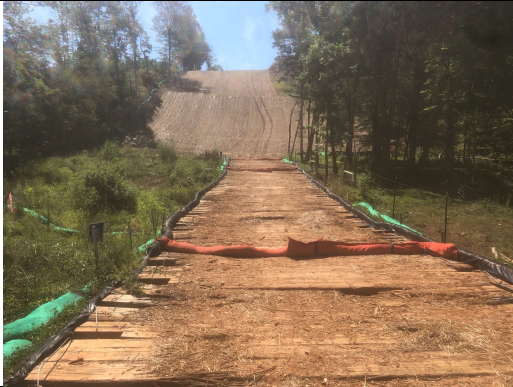
<b>GPS Location</b>	1	<b>GPS Location</b>	2		
<b>Field Station#</b>	15370+62	<b>Field Station#</b>	15168+59		
<b>Pic 1 Desc.</b>	RCE at Snowberry Rd in good condition. No issues observed.		<b>Pic 2 Desc.</b>	Equipment bridge and surrounding ECD's at stream and resource buffer in place and functional.

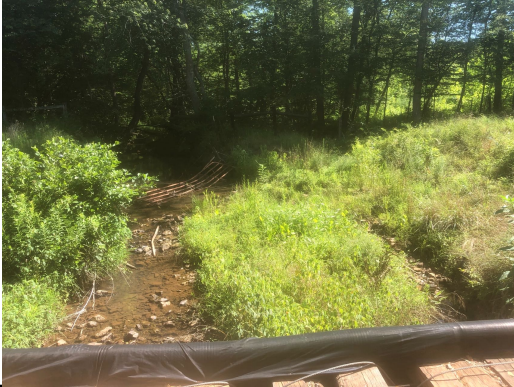
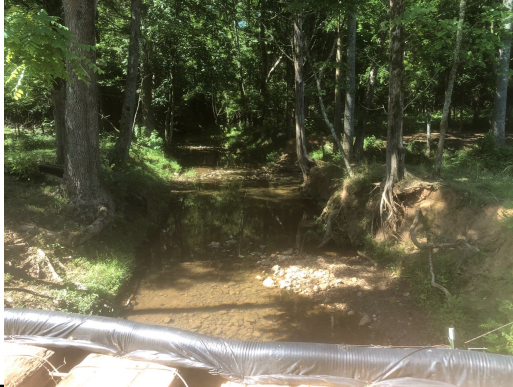
<b>GPS Location</b>	3	<b>GPS Location</b>	4		
<b>Field Station#</b>	15168+59	<b>Field Station#</b>	15168+59		
<b>Pic 3 Desc.</b>	Upstream view of S-C7. No issues observed.		<b>Pic 4 Desc.</b>	Downstream view of S-C7. No issues observed.

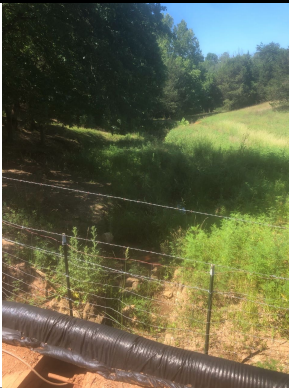
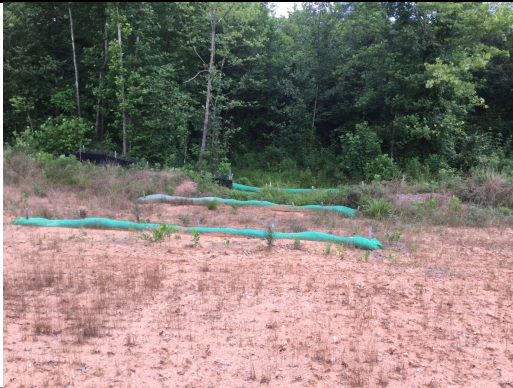
<b>GPS Location</b>	5	<b>GPS Location</b>	6		
<b>Field Station#</b>	15327+25	<b>Field Station#</b>	15452+00		
<b>Pic 5 Desc.</b>	Downstream view of the start of S-H15/H16 at ROW crossing. No issues observed.		<b>Pic 6 Desc.</b>	CFS check dams performing intended function and ROW showing no signs of erosion in this area currently. Limited to no temporary vegetation growing.

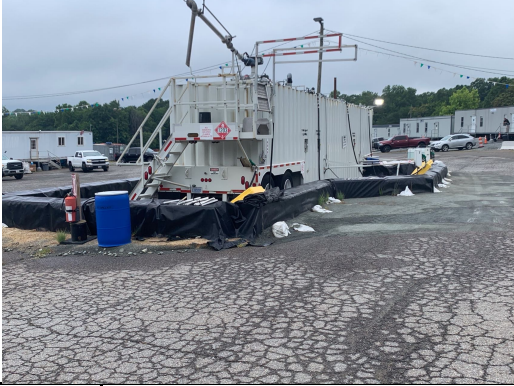
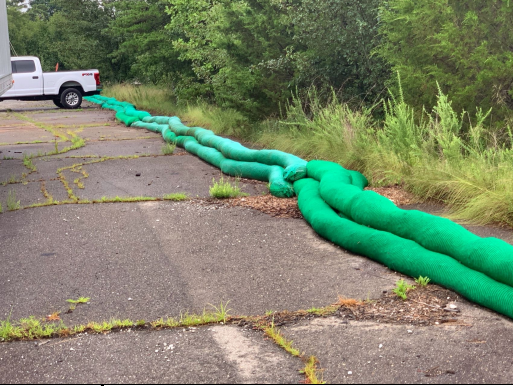
<b>GPS Location</b> 000000000000		<b>GPS Location</b> 000000000000			
<b>Field Station#</b> 0000+00		<b>Field Station#</b> 0000+00			
<b>Pic 1 Desc.</b> Secondary containment structure for fuel cell in compliance		<b>Pic 2 Desc.</b> Perimeter ECD's on south end of paved yard in good condition.

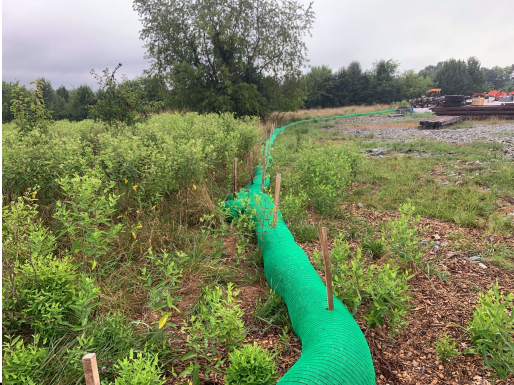
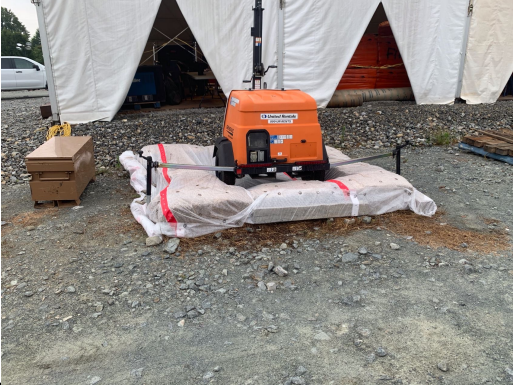
<b>GPS Location</b> 000000000000		<b>GPS Location</b> 000000000000			
<b>Field Station#</b> 0000+00		<b>Field Station#</b> 0000+00			
<b>Pic 3 Desc.</b> Perimeter ECD's on north end of gravel yard in good condition		<b>Pic 4 Desc.</b> Secondary containment structure for light plant near circus tent in good condition.

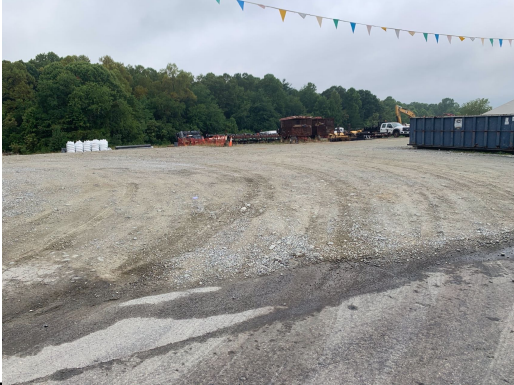
Insert image here			
<b>GPS Location</b> 000000000000		<b>GPS Location</b>			
<b>Field Station#</b> 0000+00		<b>Field Station#</b>			
<b>Pic 5 Desc.</b> RCE at gravel yard in good condition.		<b>Pic 6 Desc.</b>

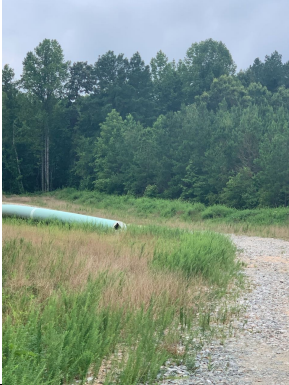
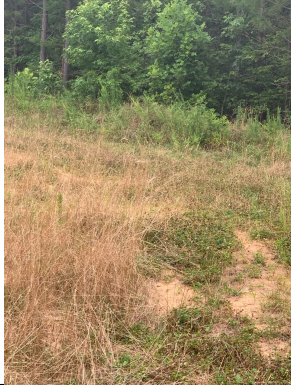
<b>GPS Location</b>	O	<b>GPS Location</b>	O		
<b>Field Station#</b>	7+00	<b>Field Station#</b>	11+00		
<b>Pic 1 Desc.</b>	Observing temporary vegetation.	<b>Pic 2 Desc.</b>	Observing temporary vegetation.

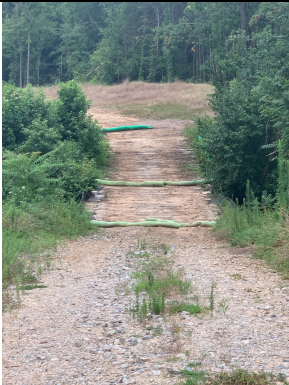
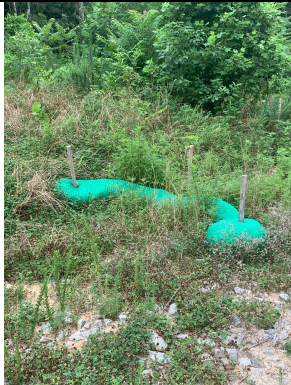
<b>GPS Location</b>	O	<b>GPS Location</b>	O		
<b>Field Station#</b>	12+65	<b>Field Station#</b>	12+00		
<b>Pic 3 Desc.</b>	Observing equipment crossing and ECD's performing as it should.	<b>Pic 4 Desc.</b>	Observing ECD performing as it should.		
Insert image here			Insert image here		
<b>GPS Location</b>		<b>GPS Location</b>			
<b>Field Station#</b>		<b>Field Station#</b>			
<b>Pic 5 Desc.</b>		<b>Pic 6 Desc.</b>

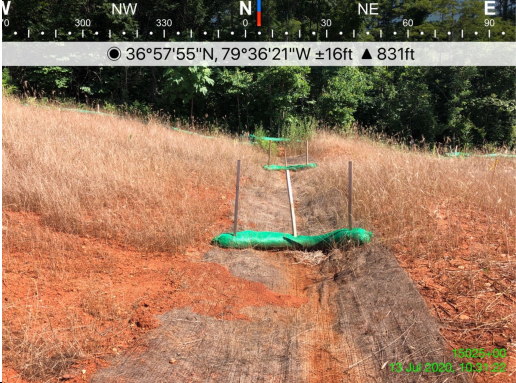
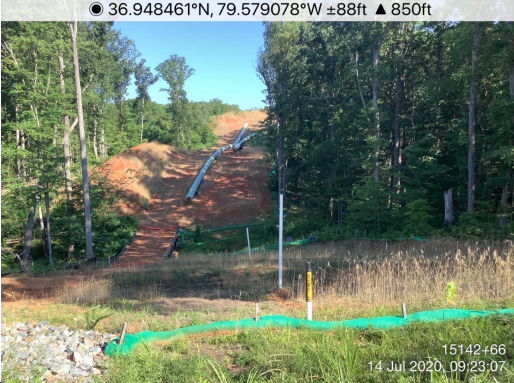
<b>GPS Location</b>	0	<b>GPS Location</b>	0		
<b>Field Station#</b>	15025+00	<b>Field Station#</b>	15142+00		
<b>Pic 1 Desc.</b>	Waterbar in acceptable condition		<b>Pic 2 Desc.</b>	CFS in acceptable condition

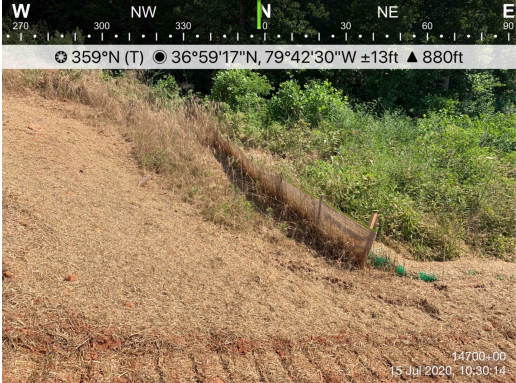
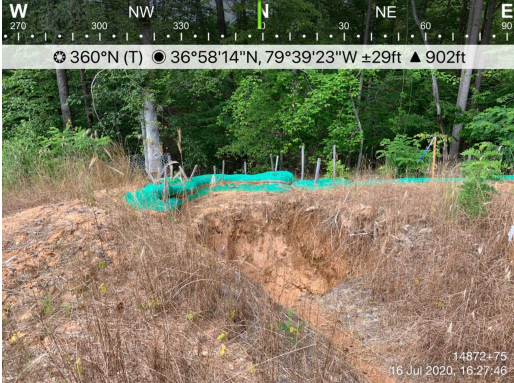
<b>GPS Location</b>	0	<b>GPS Location</b>	0		
<b>Field Station#</b>	14700+00	<b>Field Station#</b>	14872+75		
<b>Pic 3 Desc.</b>	P1 silt fence in acceptable condition		<b>Pic 4 Desc.</b>	Waterbar end treatment in acceptable condition	
Insert image here			Insert image here		
<b>GPS Location</b>		<b>GPS Location</b>			
<b>Field Station#</b>		<b>Field Station#</b>			
<b>Pic 5 Desc.</b>			<b>Pic 6 Desc.</b>

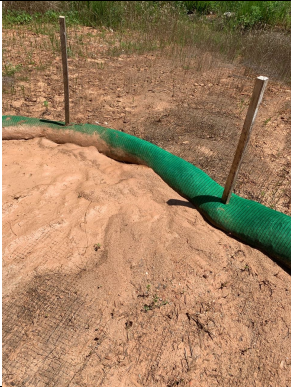
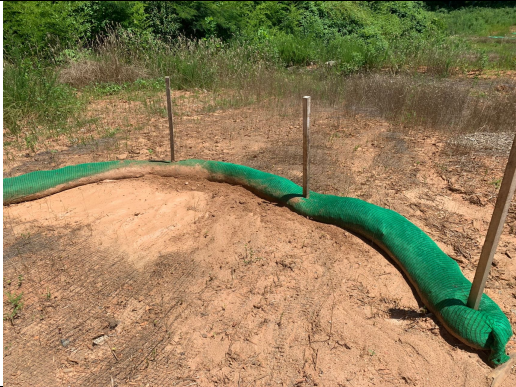
<b>GPS Location</b>	O	<b>GPS Location</b>	O		
<b>Field Station#</b>	15942+00	<b>Field Station#</b>	15942+00		
<b>Pic 1 Desc.</b>	Observing CFS that requires maintenance.	<b>Pic 2 Desc.</b>	Observing CFS that was cleaned out.

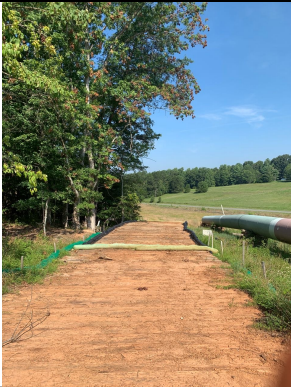
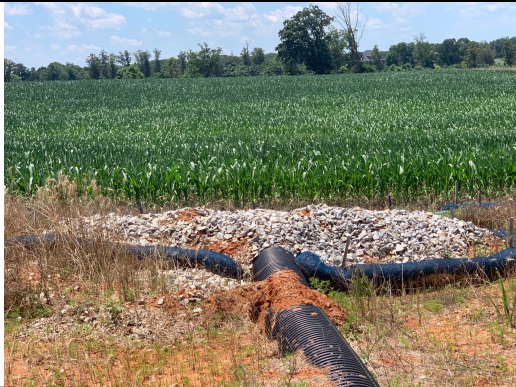
<b>GPS Location</b>	O	<b>GPS Location</b>	O		
<b>Field Station#</b>	15614+94	<b>Field Station#</b>	15735+00		
<b>Pic 3 Desc.</b>	Observing equipment crossing and ECD's performing as they should.	<b>Pic 4 Desc.</b>	Observing CWD outlet performing as it should.		
Insert image here			Insert image here		
<b>GPS Location</b>		<b>GPS Location</b>			
<b>Field Station#</b>		<b>Field Station#</b>			
<b>Pic 5 Desc.</b>		<b>Pic 6 Desc.</b>

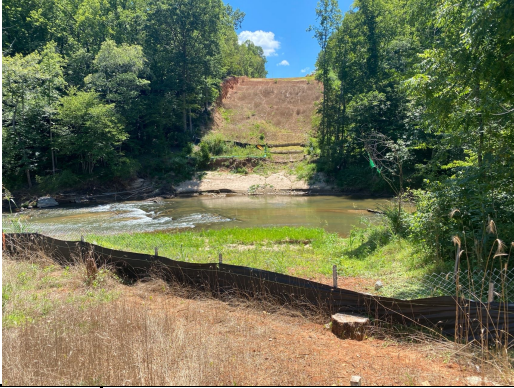
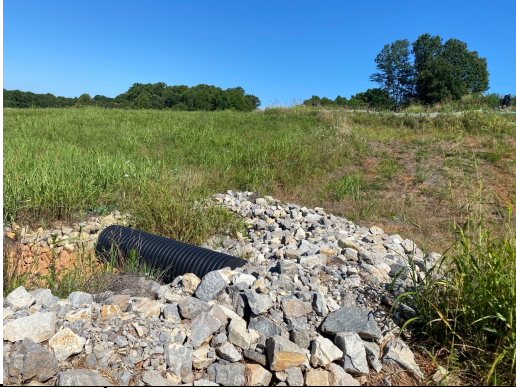
<b>GPS Location</b>	0	<b>GPS Location</b>	0		
<b>Field Station#</b>	14249+65	<b>Field Station#</b>	14132+10		
<b>Pic 1 Desc.</b>	Approximately 14249+65. Overview of stream crossing and ECDs at stream S-F11.		<b>Pic 2 Desc.</b>	Approximately 14132+10. CWD piping and plunge pool installed and appears to be functioning correctly at time of inspection.

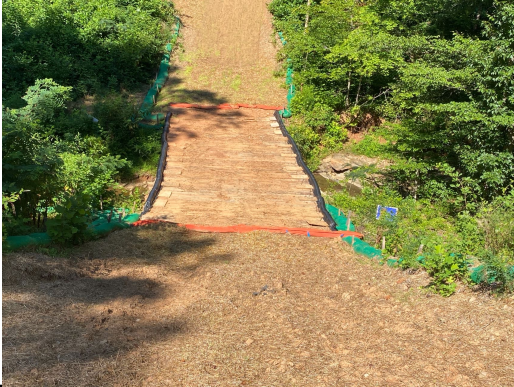
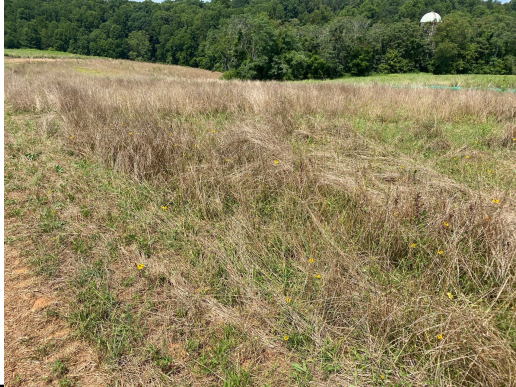
<b>GPS Location</b>	0	<b>GPS Location</b>	0		
<b>Field Station#</b>	14105+26	<b>Field Station#</b>	14161+00		
<b>Pic 3 Desc.</b>	Approximately 14105+26. Overview of stream crossing, equipment bridge and ECDs at stream S-KL41.		<b>Pic 4 Desc.</b>	Approximately 14161+00. Overview of ROW. ROW temporarily stabilized and has temporary vegetation growing.

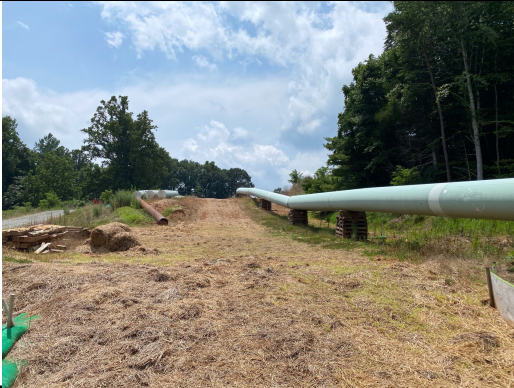
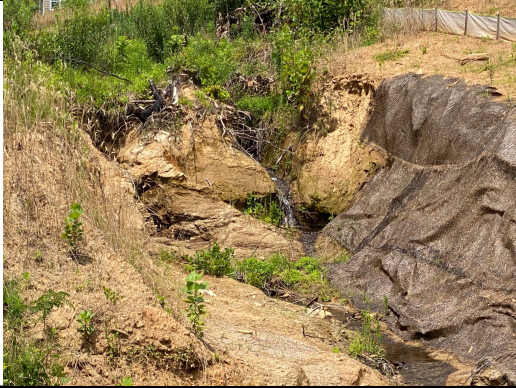
<b>GPS Location</b>	0	<b>GPS Location</b>	0		
<b>Field Station#</b>	13996+50	<b>Field Station#</b>	14000+00

<b>Pic 5 Desc.</b>	Approximately 13996+50. Overview of ROW. ROW temporarily stabilized and has temporary vegetation growing.		<b>Pic 6 Desc.</b>	Approximately 14000+00. Overview of flow path of adjacent pond overflow.

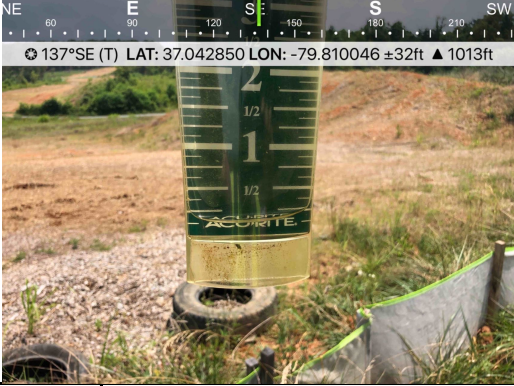
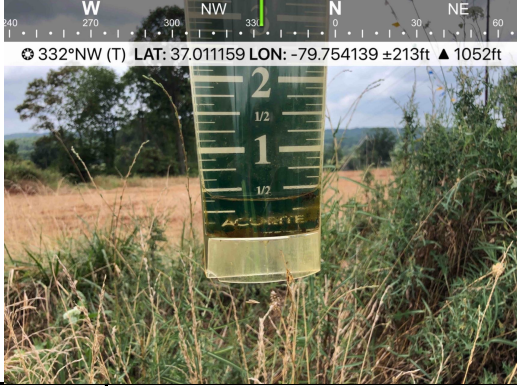
<b>GPS Location</b>	0	<b>GPS Location</b>	0		
<b>Field Station#</b>	14311+57	<b>Field Station#</b>	14524+76		
<b>Pic 1 Desc.</b>	Rain gauge at Farm View Road 0.25"	<b>Pic 2 Desc.</b>	Rain gauge at Timber Ridge Road 0.4"

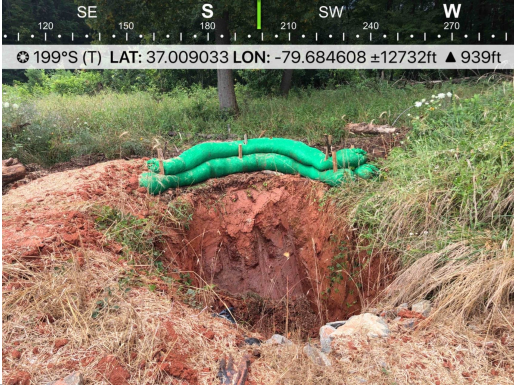
<b>GPS Location</b>	0	<b>GPS Location</b>	0		
<b>Field Station#</b>	14665+00	<b>Field Station#</b>	14672+50		
<b>Pic 3 Desc.</b>	Sump pit functioning as intended	<b>Pic 4 Desc.</b>	P1 silt fence torn and requires maintenance (this is an ongoing issue due to cattle)

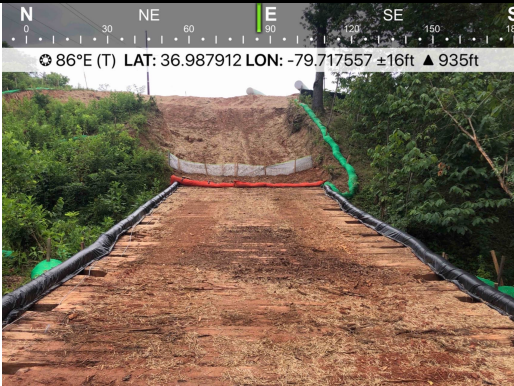
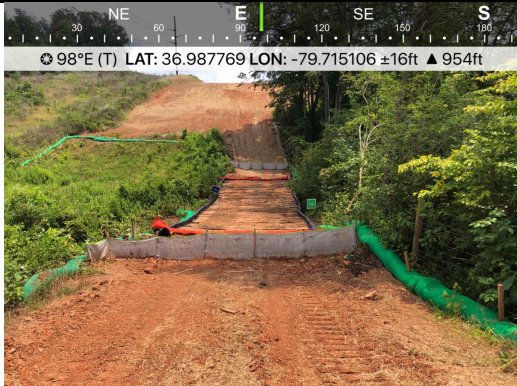
<b>GPS Location</b>	0	<b>GPS Location</b>	0		
<b>Field Station#</b>	14673+10	<b>Field Station#</b>	14680+37		
<b>Pic 5 Desc.</b>	Equipment bridge clean at stream S-H37	<b>Pic 6 Desc.</b>	Equipment bridge clean at stream S-H36

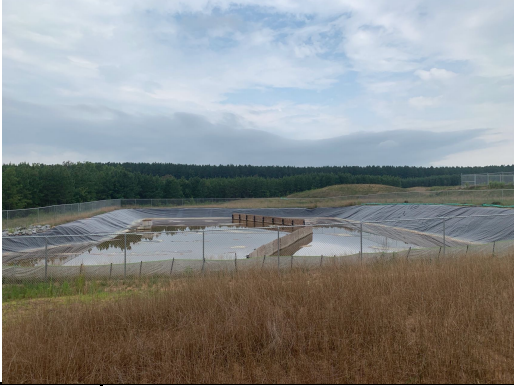
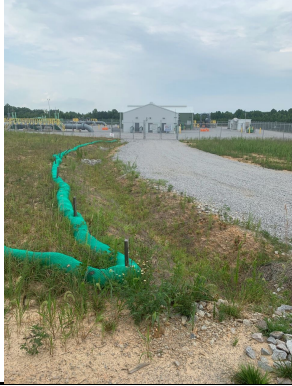
<b>GPS Location</b>	O	<b>GPS Location</b>	O		
<b>Field Station#</b>	00+00	<b>Field Station#</b>	00+00		
<b>Pic 1 Desc.</b>	Observing storm water pond and ECD's performing as they should.	<b>Pic 2 Desc.</b>	Observing rock check dams, road side ditch and CFS.

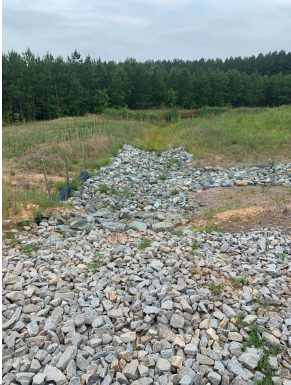
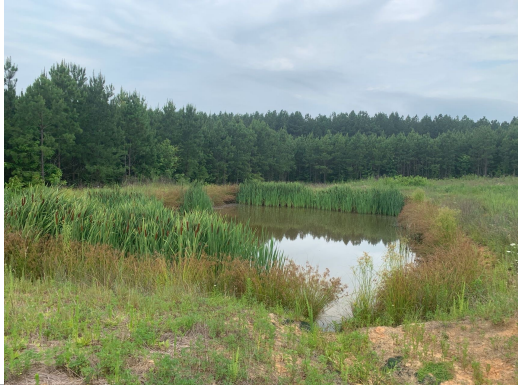
<b>GPS Location</b>	O	<b>GPS Location</b>	O		
<b>Field Station#</b>	00+00	<b>Field Station#</b>	00+00		
<b>Pic 3 Desc.</b>	Observing rock lined channel.	<b>Pic 4 Desc.</b>	Observing sediment basin.		
Insert image here			Insert image here		
<b>GPS Location</b>		<b>GPS Location</b>			
<b>Field Station#</b>		<b>Field Station#</b>			
<b>Pic 5 Desc.</b>		<b>Pic 6 Desc.</b>
