Visual Site Inspection Report

Project Name	H-600 Pipeline Spread I	AFE	124300139	Spread	H-600 Pipeline Spread I
Contractor	Precision			Report #	13034
Inspector	Glenn Mike Renfro			Date/Time	7/28/2020 9:43 AM
Permit #	TBD	Inspection Type	VA SWPP	Station Begin	0000+00
State	VA	Inspection Area	Full	Station End	0000+00
County	Franklin	Ground	Dry	Temperature (°F)	83.00
Municipality	N/A	Weather	Cloudy	Rain Gauge (in)	0.70
				Rain Accumulation Time (days)	6.00

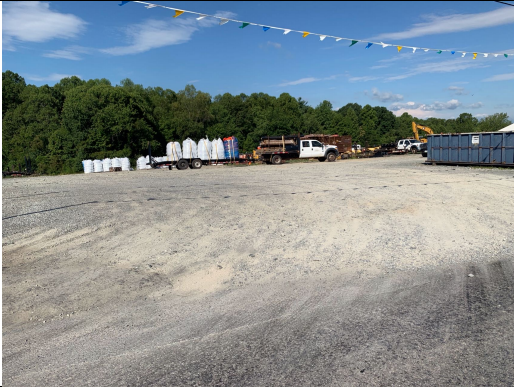
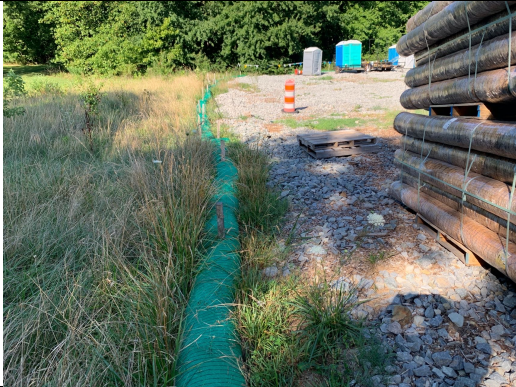
GPS Location	000000000000	GPS Location	000000000000		
Field Station#	0000+00	Field Station#	0000+00		
Pic 1 Desc.	The RCE at the gravel yard in good condition	Pic 2 Desc.	Perimeter ECD's on the south end of the gravel yard in good condition

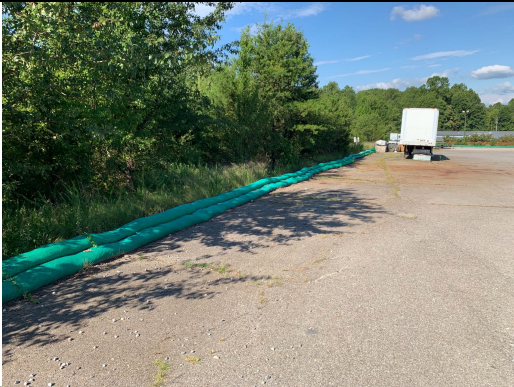
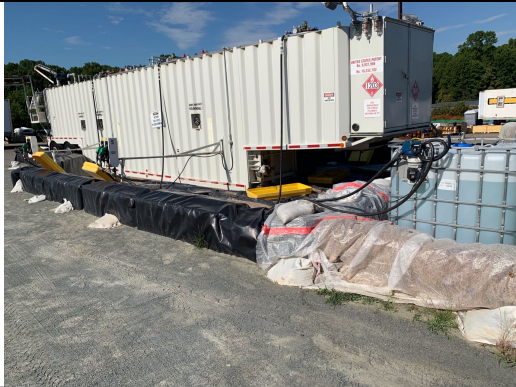
GPS Location	000000000000	GPS Location	000000000000		
Field Station#	0000+00	Field Station#	0000+00		
Pic 3 Desc.	Perimeter ECD's on the south end of paved yard in good condition	Pic 4 Desc.	Secondary containment structure for fuel cell in compliance.		
Insert image here			Insert image here		
GPS Location		GPS Location			
Field Station#		Field Station#			
Pic 5 Desc.		Pic 6 Desc.

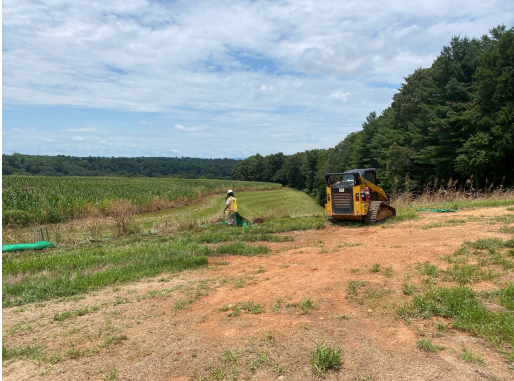
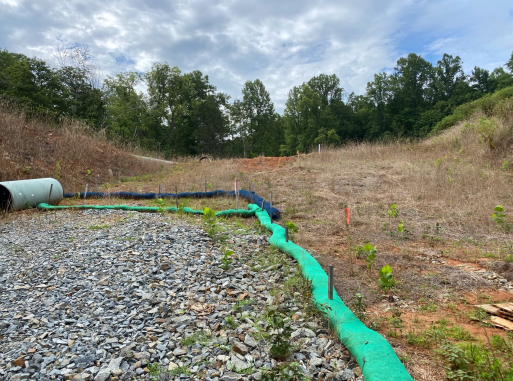
GPS Location	0	GPS Location	0		
Field Station#	13939+50	Field Station#	14210+50		
Pic 1 Desc.	Approximately 13939+50. Crews working at replacing ECDs that were damaged by a third party.		Pic 2 Desc.	Approximately 14210+50. RCE installed and appears to be functioning correctly at time of inspection. ROW temporarily stabilized and has temporary vegetation growing. ECDs

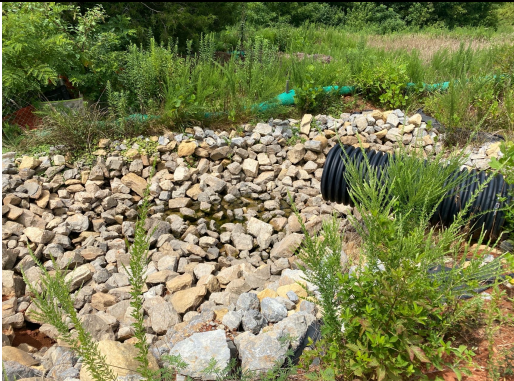
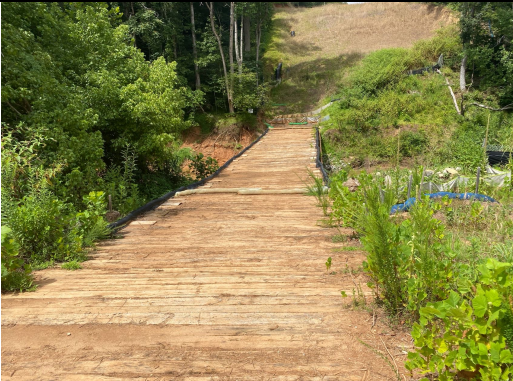
GPS Location	0	GPS Location	0		
Field Station#	14236+75	Field Station#	14233+34		
Pic 3 Desc.	Approximately 14236+75. CWD plunge pool and piping appears to be installed and functioning correctly at time of inspection.		Pic 4 Desc.	Approximately 14233+34. Overview of stream crossing, equipment bridge and ECDs at stream S-C19.

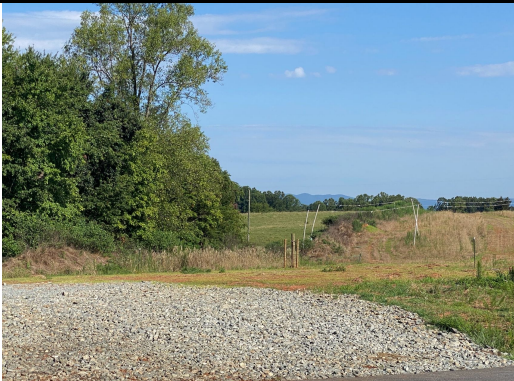
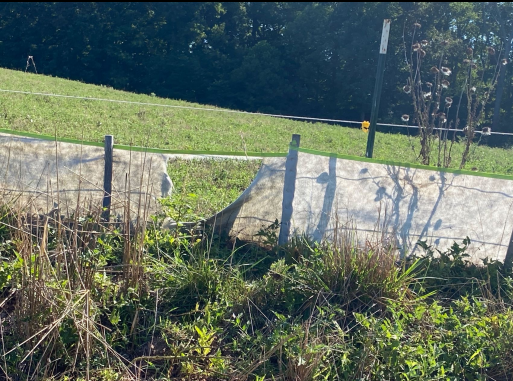
GPS Location	0	GPS Location	0		
Field Station#	14311+00	Field Station#	14202+00		
Pic 5 Desc.	Approximately 14311+00. Overview of ROW and RCE. RCE installed and appears to be functioning correctly at time of inspection. ROW temporarily stabilized and has temporary		Pic 6 Desc.	Approximately 14202+00. P-1 appears to have been damaged by livestock.

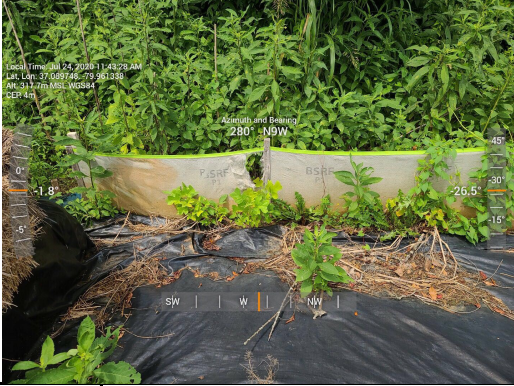
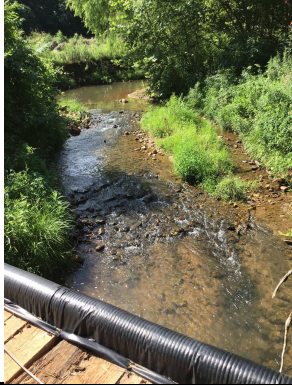
GPS Location	00000	GPS Location	00000		
Field Station#	13644+15	Field Station#	13755+49		
Pic 1 Desc.	P1 requires maintenance, added to the punch list		Pic 2 Desc.	Stream crossing photo facing upstream

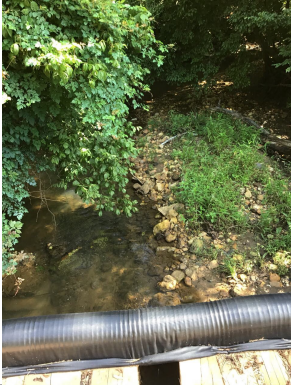
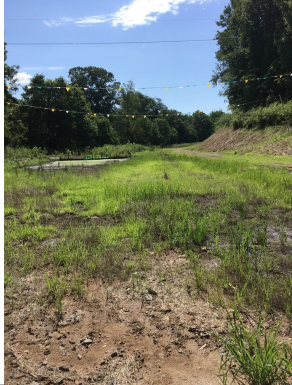
GPS Location	00000	GPS Location	00000		
Field Station#	13755+49	Field Station#	13757+00		
Pic 3 Desc.	Stream crossing photo facing downstream		Pic 4 Desc.	Row photo, showing stabilized top soil	
Insert image here			Insert image here		
GPS Location		GPS Location			
Field Station#		Field Station#			
Pic 5 Desc.			Pic 6 Desc.

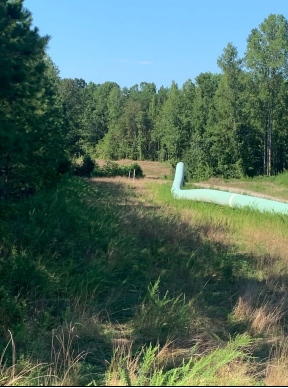
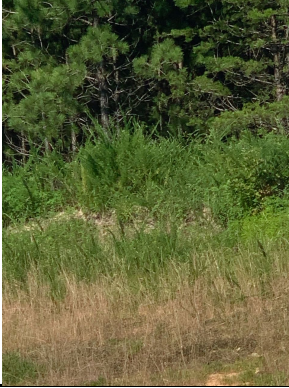
GPS Location	O	GPS Location	O		
Field Station#	7+00	Field Station#	6+00		
Pic 1 Desc.	Observing temporary vegetation.	Pic 2 Desc.	Observing stabilized top soil pile.

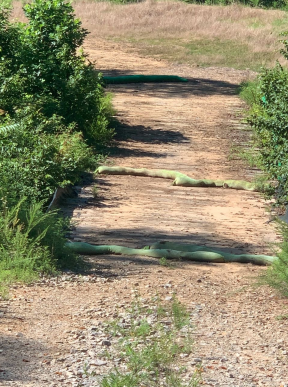
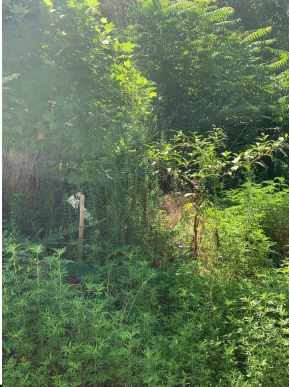
GPS Location	O	GPS Location	O		
Field Station#	12+65	Field Station#	12+30		
Pic 3 Desc.	Observing equipment crossing and ECD's performing as they should.	Pic 4 Desc.	Observing sensitive resource buffer.		
Insert image here			Insert image here		
GPS Location		GPS Location			
Field Station#		Field Station#			
Pic 5 Desc.		Pic 6 Desc.

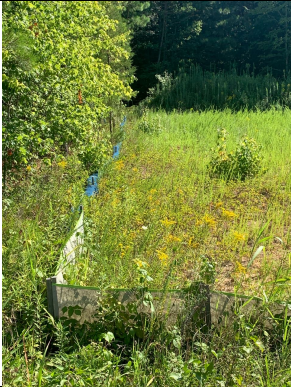
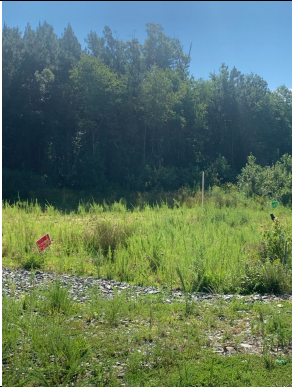
GPS Location	O	GPS Location	O.		
Field Station#	14+50	Field Station#	15+20		
Pic 1 Desc.	Observing Temporary vegetation and ECD's performing as they should.	Pic 2 Desc.	Observing RCE, signage and temporary vegetation.

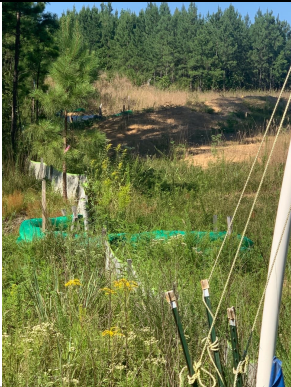
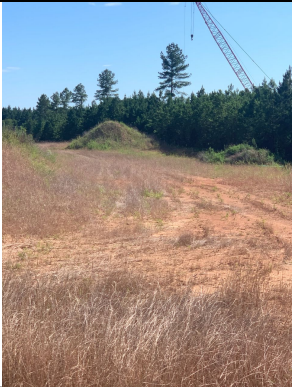
GPS Location	O	GPS Location	O		
Field Station#	13+00	Field Station#	5+00		
Pic 3 Desc.	Observing ECD's performing as they should.	Pic 4 Desc.	Observing temporary vegetation.		
Insert image here			Insert image here		
GPS Location		GPS Location			
Field Station#		Field Station#			
Pic 5 Desc.		Pic 6 Desc.

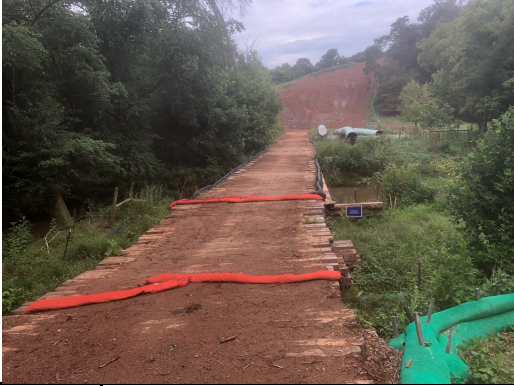
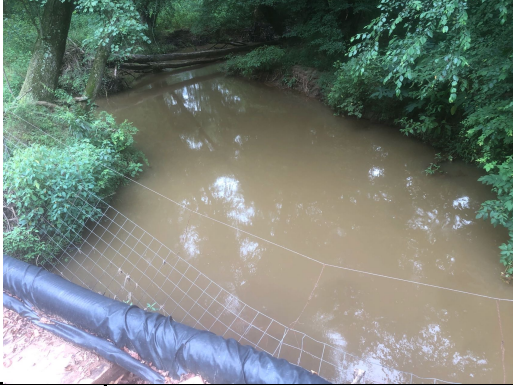
GPS Location	1	GPS Location	2		
Field Station#	15314+38	Field Station#	15314+38		
Pic 1 Desc.	Equipment bridge and surrounding ECD's in place and functional at S-C3.		Pic 2 Desc.	Upstream view of S-C3 at ROW crossing.

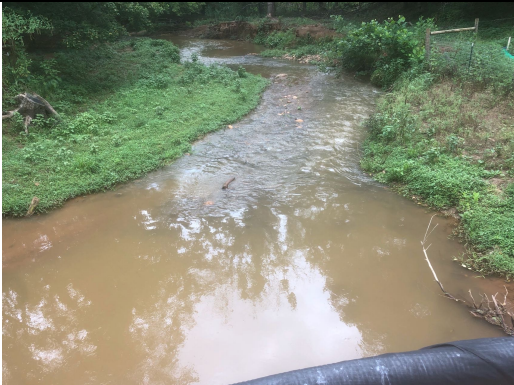
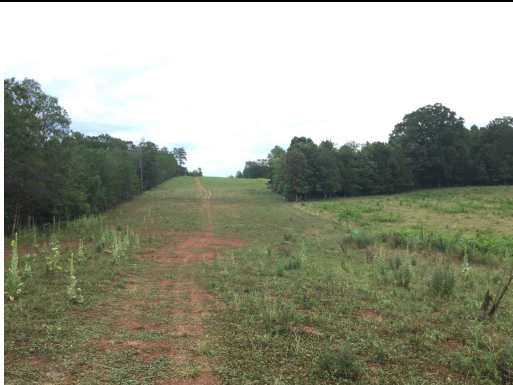
GPS Location	3	GPS Location	4		
Field Station#	15314+38	Field Station#	15174+00		
Pic 3 Desc.	Downstream view of S-C3 at ROW crossing.		Pic 4 Desc.	Final cleanup area between Rock Creek Rd and Star Land Dr. Permanent vegetation growing along ROW. Noticeable travel lane use by landowner. No issues observed.

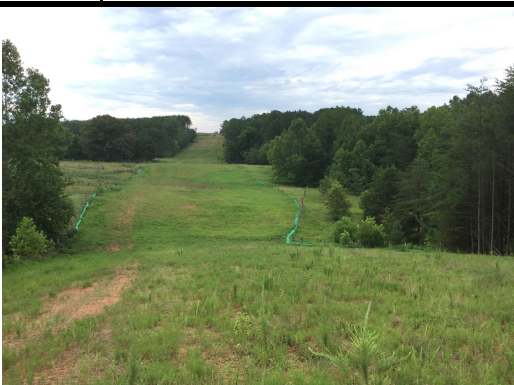
GPS Location	5	GPS Location	6		
Field Station#	15192+00	Field Station#	15485+00		
Pic 5 Desc.	Final cleanup area CIS Star Land Dr. Permanent vegetation growing along ROW. Noticeable travel lane use by landowner. No issues observed.		Pic 6 Desc.	Final cleanup area between a Toshes Rd and Climax Rd. Permanent vegetation growing along ROW. No issues observed.

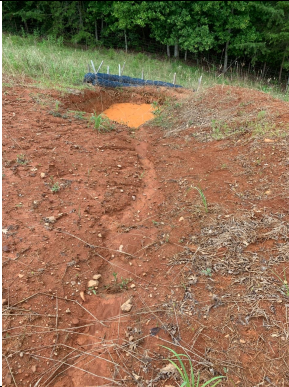
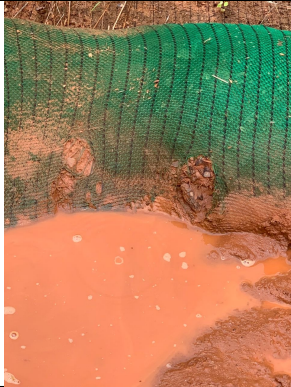
GPS Location	O	GPS Location	O		
Field Station#	15639+30	Field Station#	15632+50		
Pic 1 Desc.	Observing erosion in water bar.	Pic 2 Desc.	Observing CFS that required maintenance.

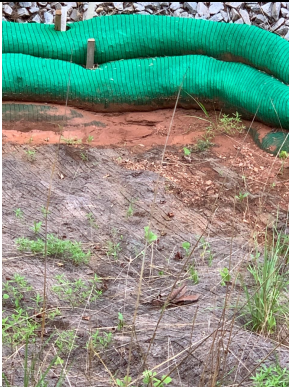
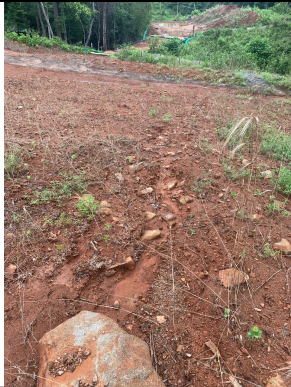
GPS Location	O	GPS Location	O		
Field Station#	15632+00	Field Station#	15601+25		
Pic 3 Desc.	Observing CFS that required maintenance.	Pic 4 Desc.	Observing erosion.		
Insert image here			Insert image here		
GPS Location		GPS Location			
Field Station#		Field Station#			
Pic 5 Desc.		Pic 6 Desc.

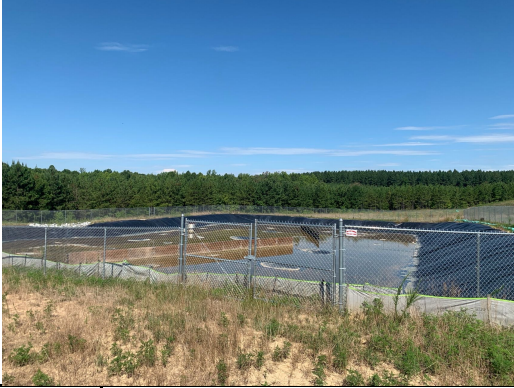
GPS Location	O	GPS Location	O		
Field Station#	00+00	Field Station#	00+00		
Pic 1 Desc.	Observing storm water pond.	Pic 2 Desc.	Observing ECD's performing as they should.

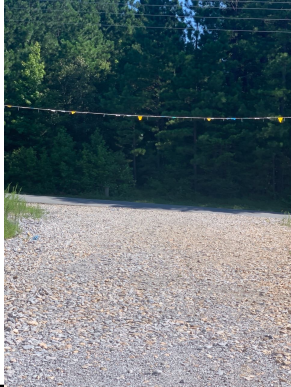
GPS Location	O	GPS Location	O		
Field Station#	00+00	Field Station#	00+00		
Pic 3 Desc.	Observing ECD's performing as they should.	Pic 4 Desc.	Observing RCE.		
Insert image here			Insert image here		
GPS Location		GPS Location			
Field Station#		Field Station#			
Pic 5 Desc.		Pic 6 Desc.
