# Visual Site Inspection Report

<b>Project Name</b>	H-603 Pipeline Spread I	<b>AFE</b>	124300139	<b>Spread</b>	H-603 Pipeline Spread I	
<b>Contractor</b>	Precision			<b>Report #</b>	13552	
<b>Inspector</b>	John White			<b>Date/Time</b>	8/13/2020 7:46 AM	
<b>Permit #</b>	TBD	<b>Inspection Type</b>	VA SWPP	<b>Station Begin</b>	00+00	
<b>State</b>	VA	<b>Inspection Area</b>	Full	<b>Station End</b>	24+53	
<b>County</b>	Pittsylvania	<b>Ground</b>	Dry	<b>Temperature (°F)</b>	85.00	
<b>Municipality</b>	Chatham	<b>Weather</b>	Cloudy	<b>Rain Gauge (in)</b>	0.00	
				<b>Rain Accumulation Time (days)</b>	4.00

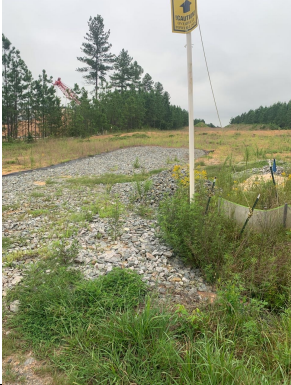
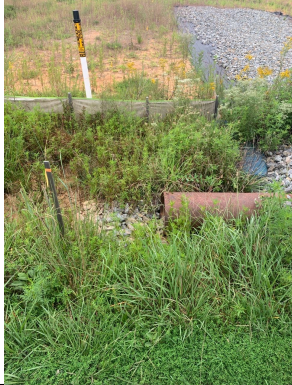
<b>GPS Location</b>	O	<b>GPS Location</b>	O		
<b>Field Station#</b>	13+75	<b>Field Station#</b>	13+77		
<b>Pic 1 Desc.</b>	Observing RCE.	<b>Pic 2 Desc.</b>	Observing outlet and outlet protection.

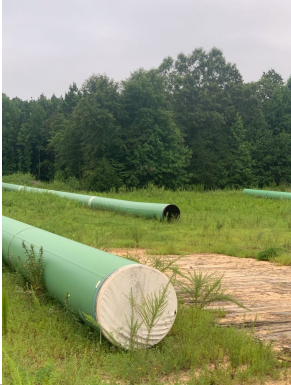
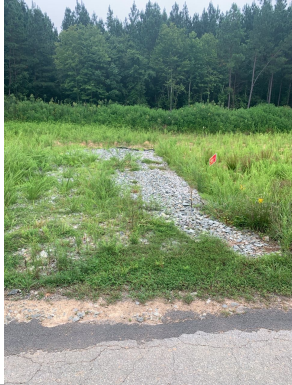
<b>GPS Location</b>	O	<b>GPS Location</b>	O		
<b>Field Station#</b>	21+00	<b>Field Station#</b>	13+95		
<b>Pic 3 Desc.</b>	Observing temporary vegetation.	<b>Pic 4 Desc.</b>	Observing RCE.		
Insert image here			Insert image here		
<b>GPS Location</b>		<b>GPS Location</b>			
<b>Field Station#</b>		<b>Field Station#</b>			
<b>Pic 5 Desc.</b>		<b>Pic 6 Desc.</b>

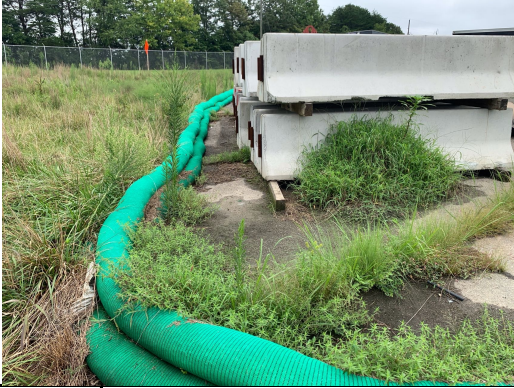
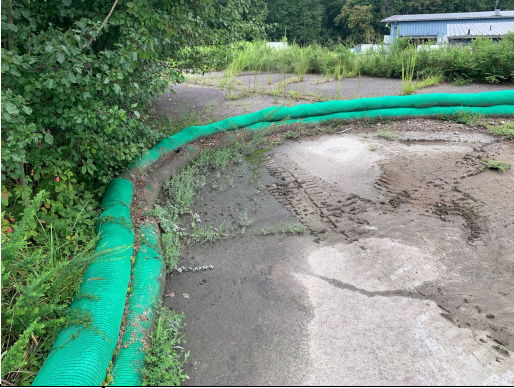
<b>GPS Location</b>	000000000000	<b>GPS Location</b>	000000000000		
<b>Field Station#</b>	0000+00	<b>Field Station#</b>	0000+00		
<b>Pic 1 Desc.</b>	Perimeter ECD's on north end of paved yard in good condition	<b>Pic 2 Desc.</b>	ECD's on southwest corner of paved yard in good condition.

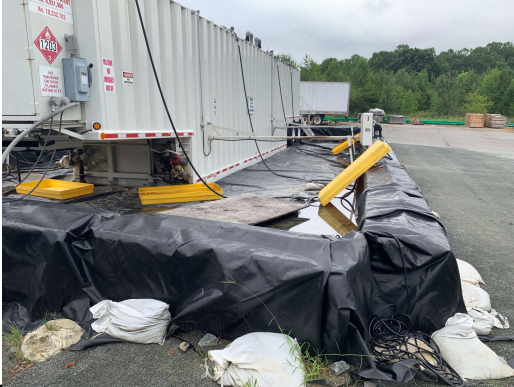
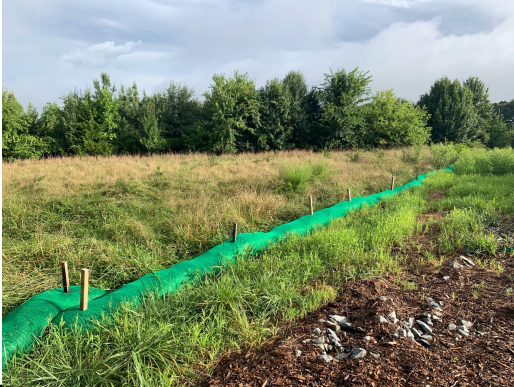
<b>GPS Location</b>	000000000000	<b>GPS Location</b>	000000000000		
<b>Field Station#</b>	0000+00	<b>Field Station#</b>	0000+00		
<b>Pic 3 Desc.</b>	Secondary containment structure for fuel cell in compliance.	<b>Pic 4 Desc.</b>	Perimeter ECD's on north end of gravel yard in good condition.		
Insert image here			Insert image here		
<b>GPS Location</b>		<b>GPS Location</b>			
<b>Field Station#</b>		<b>Field Station#</b>			
<b>Pic 5 Desc.</b>		<b>Pic 6 Desc.</b>

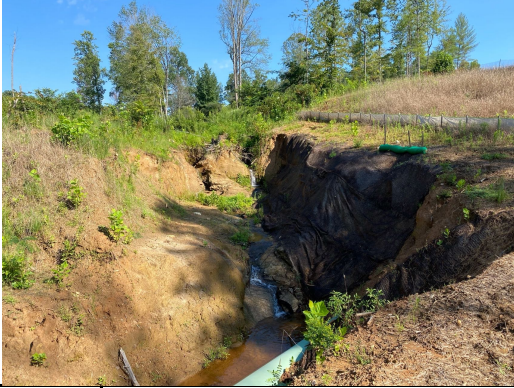
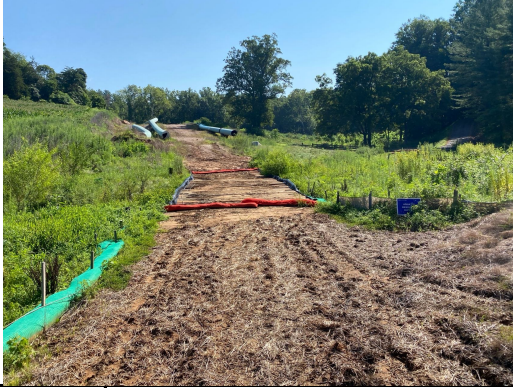
<b>GPS Location</b>	0	<b>GPS Location</b>	0		
<b>Field Station#</b>	14000+00	<b>Field Station#</b>	13991+69		
<b>Pic 1 Desc.</b>	Approximately 14000+00. Overview of adjacent pond overflow. Moderate flow at time of inspection.		<b>Pic 2 Desc.</b>	Approximately 13991+69. Overview of stream crossing, equipment bridge, and ECDs at stream S-KL35.

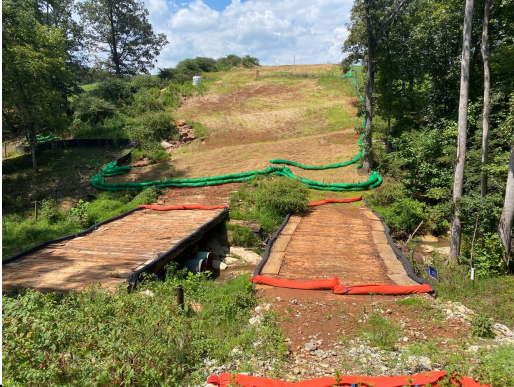
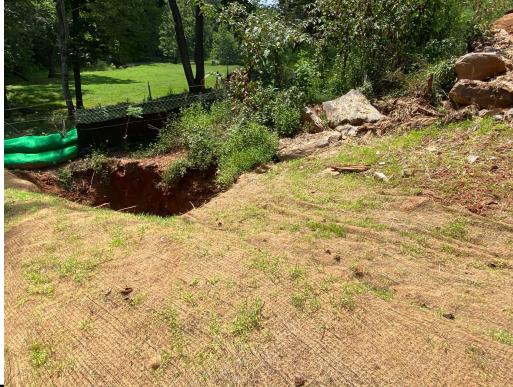
<b>GPS Location</b>	0	<b>GPS Location</b>	0		
<b>Field Station#</b>	14208+85	<b>Field Station#</b>	14208+00		
<b>Pic 3 Desc.</b>	Approximately 14208+85. Overview of stream crossing, equipment bridge and ECDs at stream S-F8.		<b>Pic 4 Desc.</b>	Approximately 14208+00. Overview of water bar and sump. Both appear to be installed and functioning correctly at time of inspection.

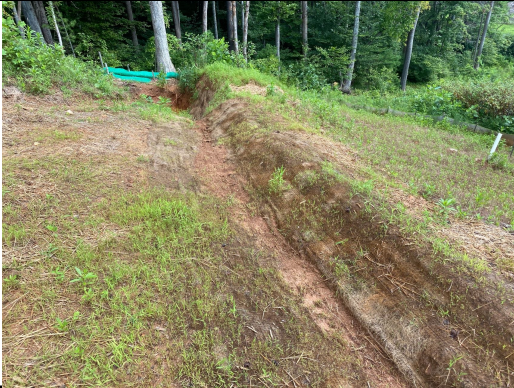
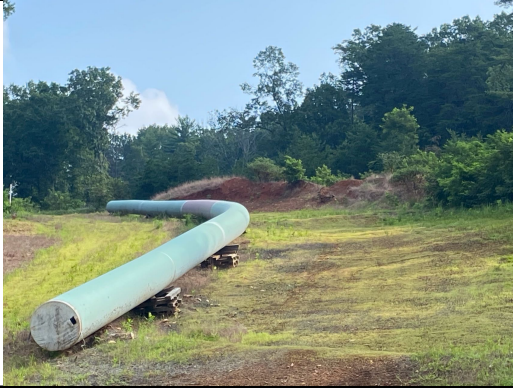
<b>Pic 5 Desc.</b>	Approximately 14033+50. Overview of ROW, sump and water bar. ROW temporarily stabilized and has temporary vegetation growing. Water bar and sump appear to be		<b>Pic 6 Desc.</b>	Approximately 14038+50. Overview of ROW. ROW temporarily stabilized and has temporary vegetation growing.

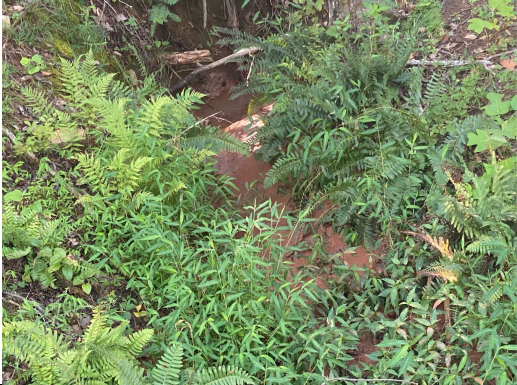
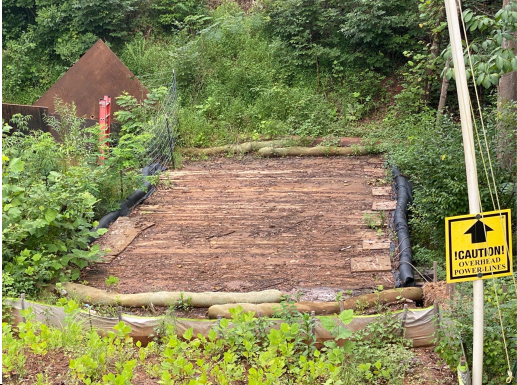
<b>GPS Location</b>	0	<b>GPS Location</b>	0		
<b>Field Station#</b>	14050+28	<b>Field Station#</b>	14009+20		
<b>Pic 7 Desc.</b>	Approximately 14050+28. View facing East beyond the LOD at S-YZ4 stream bed. Observed a significant amount of sediment		<b>Pic 8 Desc.</b>	Approximately 14009+20. Overview of stream crossing, equipment bridge and ECDs at stream S-KL38.

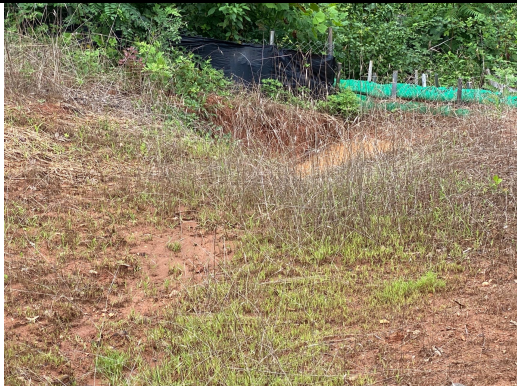
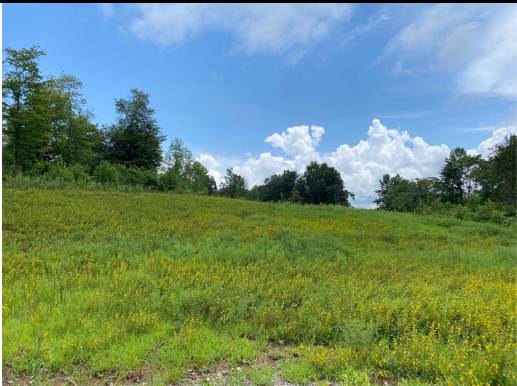
<b>GPS Location</b>	0	<b>GPS Location</b>	0		
<b>Field Station#</b>	14008+00	<b>Field Station#</b>	14012+50		
<b>Pic 9 Desc.</b>	Approximately 14008+00. Overview of ROW, water bar and sump. ROW temporarily stabilized and has temporary vegetation growing.		<b>Pic 10 Desc.</b>	Approximately 14012+50. Overview of ROW. ROW temporarily stabilized and has temporary vegetation growing.	
Insert image here			Insert image here		
<b>GPS Location</b>		<b>GPS Location</b>

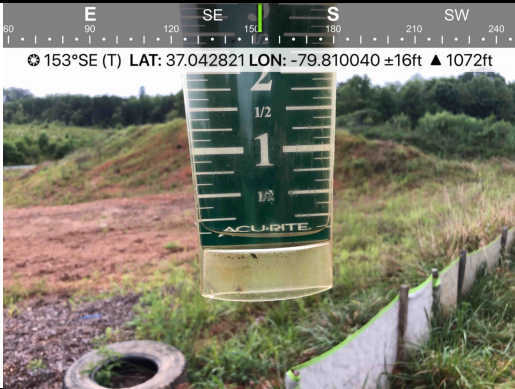
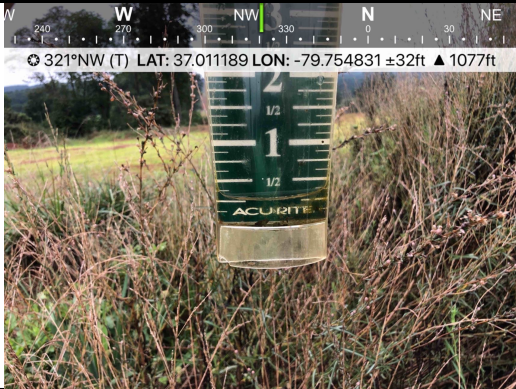
GPS Location		0		GPS Location	
Field Station#		14311+57		O	
Pic 1 Desc.		Rain gauge at Farm View Road 0.1"		Field Station#	
				14524+76	
Pic 2 Desc.		Rain gauge at Timber Ridge Road 0.25"

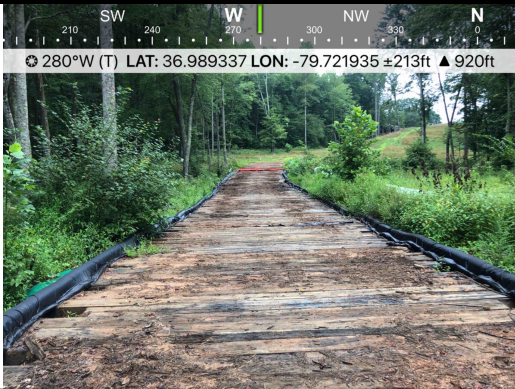
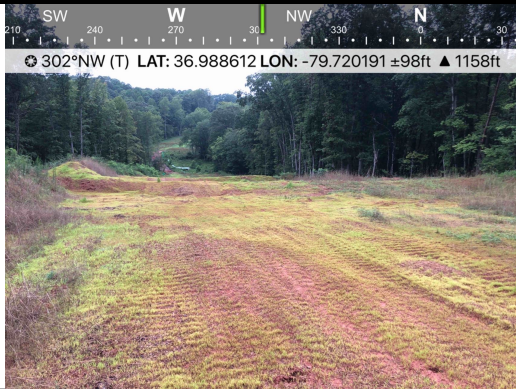
GPS Location		0		GPS Location	
Field Station#		14656+87		0	
Pic 3 Desc.		Equipment bridge clean at stream S-H38		Field Station#	
				14665+00	
Pic 4 Desc.		Temporary stabilization on the GAS of Hwy 40

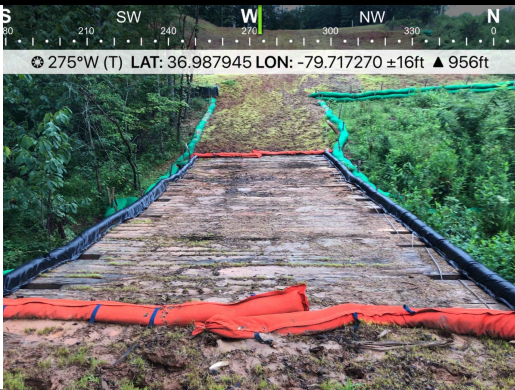
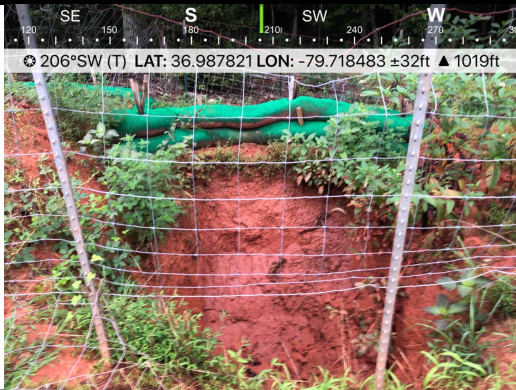
GPS Location		0		GPS Location	
Field Station#		14673+10		0	
Pic 5 Desc.		Equipment bridge clean at stream S-H37		Field Station#	
				14684+00	
Pic 6 Desc.		Sump pit functioning as intended

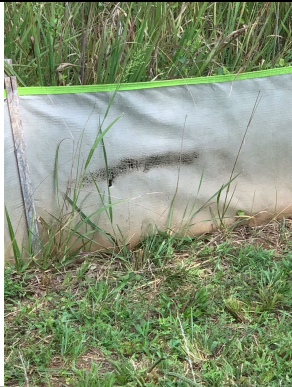
<b>GPS Location</b>	O		<b>GPS Location</b>	O	
<b>Field Station#</b>	15678+57		<b>Field Station#</b>	15678+57	
<b>Pic 1 Desc.</b>	Observing p1 that required maintenance .		<b>Pic 2 Desc.</b>	Observing p1 that required maintenance.

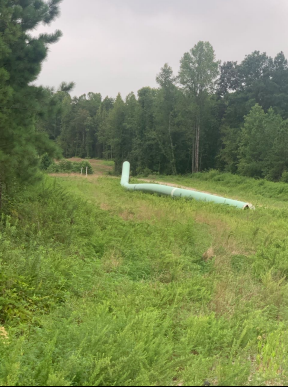
<b>GPS Location</b>	O		<b>GPS Location</b>	O	
<b>Field Station#</b>	8+00		<b>Field Station#</b>	11+50	
<b>Pic 1 Desc.</b>	Observing temporary vegetation.		<b>Pic 2 Desc.</b>	Observing temporary vegetation and signage.

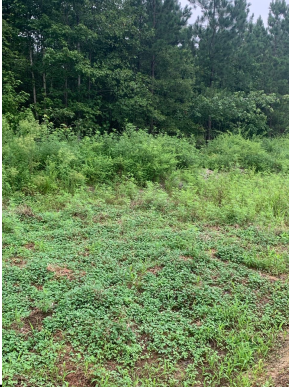
<b>GPS Location</b>	O		<b>GPS Location</b>	O	
<b>Field Station#</b>	12+65		<b>Field Station#</b>	11+00	
<b>Pic 3 Desc.</b>	Observing equipment crossing and ECD's performing as they should.		<b>Pic 4 Desc.</b>	Observing temporary vegetation.	
Insert image here			Insert image here		
<b>GPS Location</b>			<b>GPS Location</b>		
<b>Field Station#</b>			<b>Field Station#</b>		
<b>Pic 5 Desc.</b>			<b>Pic 6 Desc.</b>

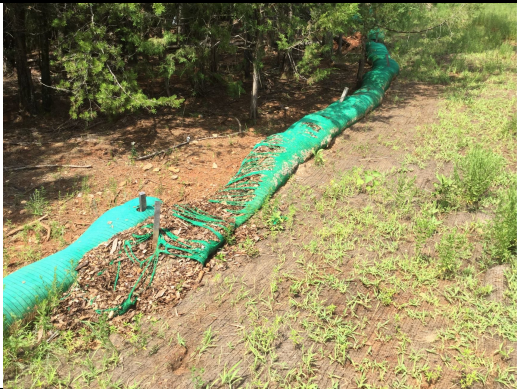
GPS Location	1	GPS Location	2		
Field Station#	15193+00	Field Station#	15193+00		
Pic 1 Desc.	Ineffective ESC measure. Perimeter CFS damaged and needs replaced.	Pic 2 Desc.	Contractor replaced with moveable wattle for landowner to have access across ROW.

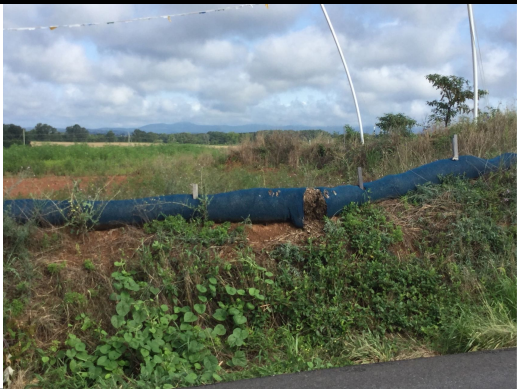
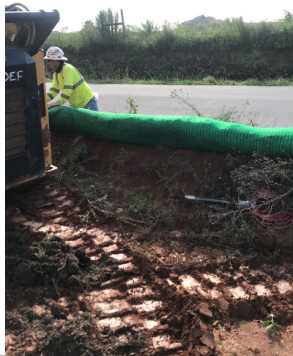
GPS Location	3	GPS Location	4		
Field Station#	15496+60	Field Station#	15496+60		
Pic 3 Desc.	Routine maintenance. Busted perimeter CFS needs replaced.	Pic 4 Desc.	Contractor replacing damaged perimeter CFS per punch list item.

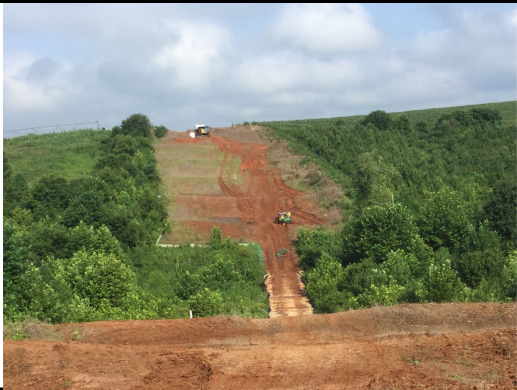
GPS Location	5	GPS Location	6		
Field Station#	14344+00	Field Station#	15355+00		
Pic 5 Desc.	Contractor going along ROW replacing end treatments and repairing equipment bridge crossings or any other ECD's as needed.	Pic 6 Desc.	Contractor going along ROW replacing end treatments and repairing equipment bridge crossings or and other ECD's as needed.

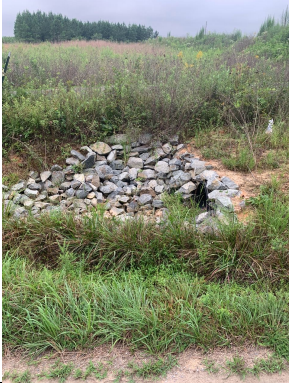
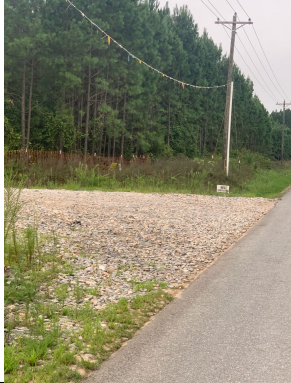
<b>GPS Location</b>	O	<b>GPS Location</b>	O		
<b>Field Station#</b>	00+00	<b>Field Station#</b>	00+00		
<b>Pic 1 Desc.</b>	Observing outlet and outlet protection.		<b>Pic 2 Desc.</b>	Observing RCE.

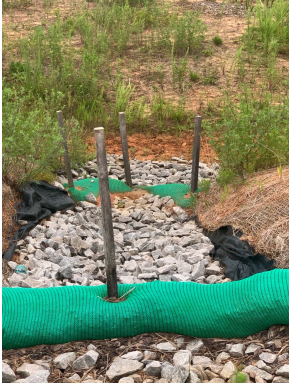
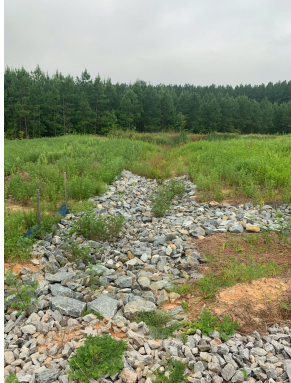
<b>GPS Location</b>	O	<b>GPS Location</b>	O		
<b>Field Station#</b>	00+00	<b>Field Station#</b>	00+00		
<b>Pic 3 Desc.</b>	Observing ECD's performing as they should.		<b>Pic 4 Desc.</b>	Observing rock lined channel.	
Insert image here			Insert image here		
<b>GPS Location</b>		<b>GPS Location</b>			
<b>Field Station#</b>		<b>Field Station#</b>			
<b>Pic 5 Desc.</b>		<b>Pic 6 Desc.</b>
