Visual Site Inspection Report

Project Name	H-600 Pipeline Spread I	AFE	124300139	Spread	H-600 Pipeline Spread I
Contractor	Precision			Report #	13213
Inspector	Glenn Mike Renfro			Date/Time	8/3/2020 9:24 AM
Permit #	TBD	Inspection Type	VA SWPP	Station Begin	0000+00
State	VA	Inspection Area	Full	Station End	0000+00
County	Franklin	Ground	Wet	Temperature (°F)	73.00
Municipality	N/A	Weather	Light Rain	Rain Gauge (in)	0.80
				Rain Accumulation Time (days)	0.80

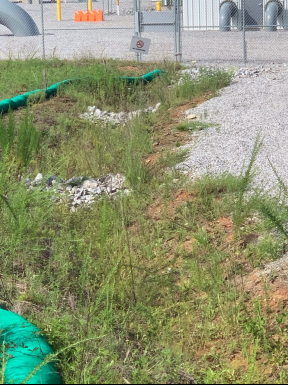
GPS Location	O	GPS Location	O		
Field Station#	00+00	Field Station#	15661+00		
Pic 1 Desc.	Observing ECD's performing as they should.	Pic 2 Desc.	Observing erosion.

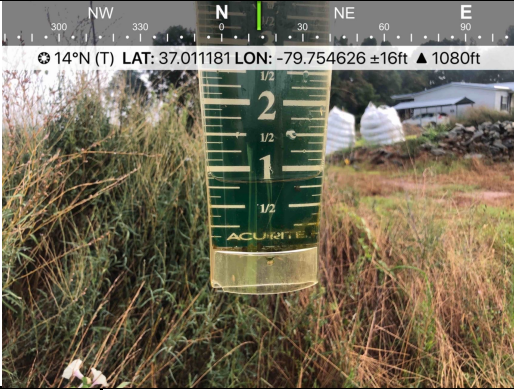
GPS Location	0	GPS Location	0		
Field Station#	14524+76	Field Station#	14311+57		
Pic 1 Desc.	Rain gauge at Timber Ridge Road 0.9"	Pic 2 Desc.	Rain gauge at Farm View Road 0.5"

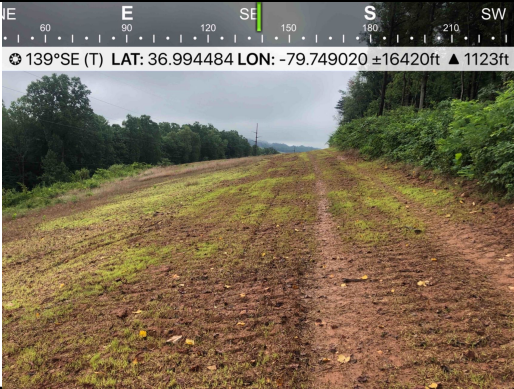
GPS Location	0	GPS Location	0		
Field Station#	14463+00	Field Station#	14475+00		
Pic 3 Desc.	Temporary stabilization on the GAS of Webster Road	Pic 4 Desc.	Sump pit and water bar end treatment functioning as intended

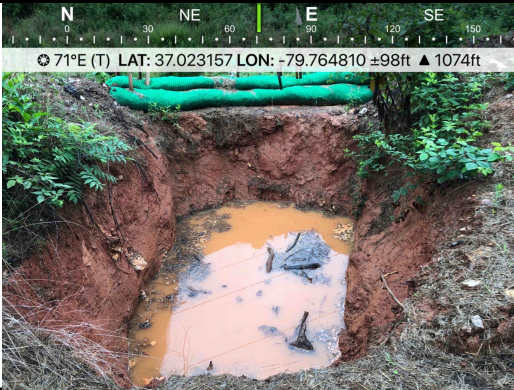
GPS Location	0	GPS Location	0		
Field Station#	14485+00	Field Station#	14520+00		
Pic 5 Desc.	Sump pit and water bar end treatment functioning as intended	Pic 6 Desc.	Temporary stabilization on the CIS of Timber Ridge Road

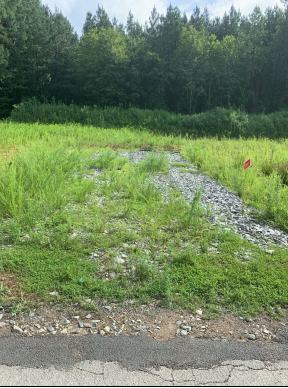
GPS Location	O	GPS Location	O		
Field Station#	14+00	Field Station#	18+83		
Pic 1 Desc.	Observing RCE and signage.	Pic 2 Desc.	Observing signage and ECD's performing as they should.

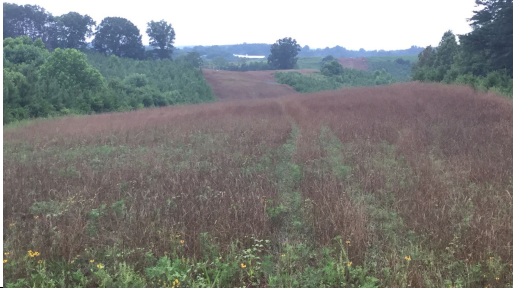
GPS Location	1		GPS Location	2	
Field Station#	15367+00		Field Station#	15378+00	
Pic 1 Desc.	Final cleanup area CIS Snowberry Rd. Good vegetative growth and no erosion issues observed.		Pic 2 Desc.	Routine maintenance. Tree knocked down by storm fell onto ROW and damaged perimeter P1 silt fence in vegetated area.

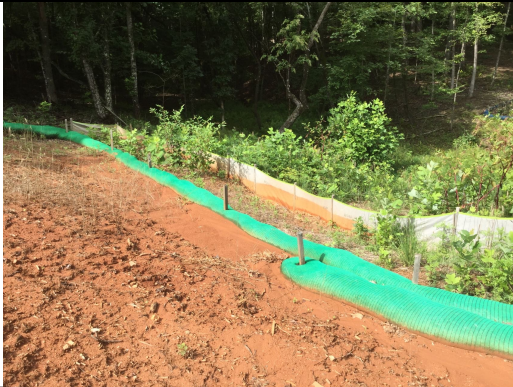
GPS Location	3		GPS Location	4	
Field Station#	15414+50		Field Station#	15483+00	
Pic 3 Desc.	Routine maintenance. CFS on GAS S-G5 more than half full with sediment. Secondary containment behind CFS.		Pic 4 Desc.	Final cleanup area GAS Toshes Rd. Good vegetative growth and no erosion issues observed.

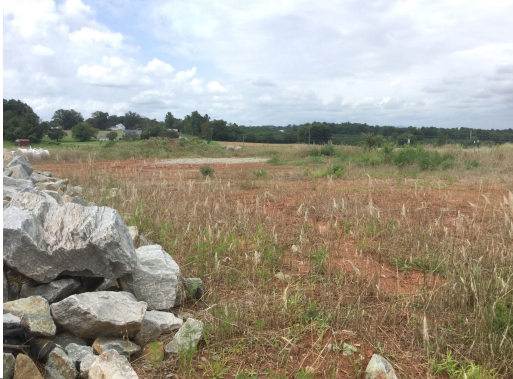
GPS Location	5		GPS Location	6	
Field Station#	15497+00		Field Station#	15510+00	
Pic 5 Desc.	Extra work space GAS Climax Rd. Pile of riprap in space and temporary vegetation stabilizing area. No issues observed.		Pic 6 Desc.	View of stabilized travel lane GAS S-CC14. No issues observed.

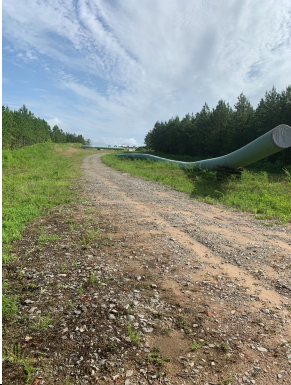
GPS Location	O	GPS Location	O		
Field Station#	11+00	Field Station#	12+65		
Pic 1 Desc.	Observing access road and temporary vegetation.	Pic 2 Desc.	Observing equipment crossing and ECD's performing as they should.

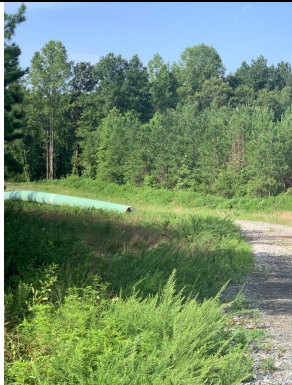
GPS Location	O	GPS Location	O		
Field Station#	10+00	Field Station#	7+00		
Pic 3 Desc.	Observing temporary vegetation.	Pic 4 Desc.	Observing temporary vegetation.		
Insert image here			Insert image here		
GPS Location		GPS Location			
Field Station#		Field Station#			
Pic 5 Desc.		Pic 6 Desc.

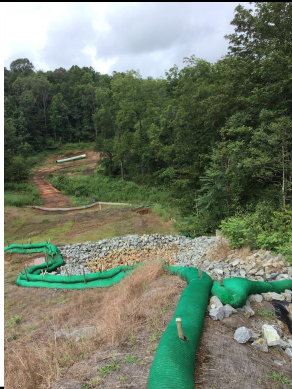
GPS Location	00000	GPS Location	00000		
Field Station#	13784+20	Field Station#	13784+24		
Pic 3 Desc.	ECDs monitored after rain events throughout		Pic 4 Desc.	Monitored sump pit and rock lined channel after rain events	
Insert image here			Insert image here		
GPS Location		GPS Location			
Field Station#		Field Station#			
Pic 5 Desc.			Pic 6 Desc.

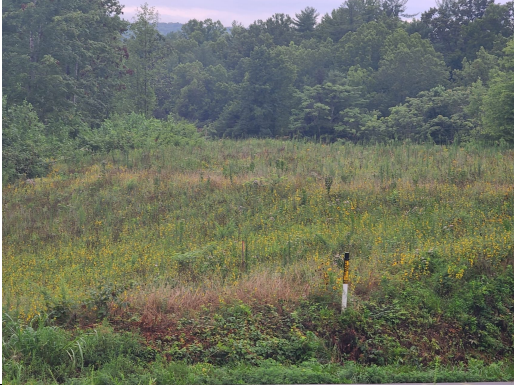
GPS Location	0	GPS Location	0		
Field Station#	14016+00	Field Station#	14236+75		
Pic 1 Desc.	Approximately 14016+00. Overview of ROW. ROW temporarily stabilized and has temporary vegetation growing.		Pic 2 Desc.	Approximately 14236+75. CWD piping and level spreader installed and appears to be functioning correctly at time of inspection.

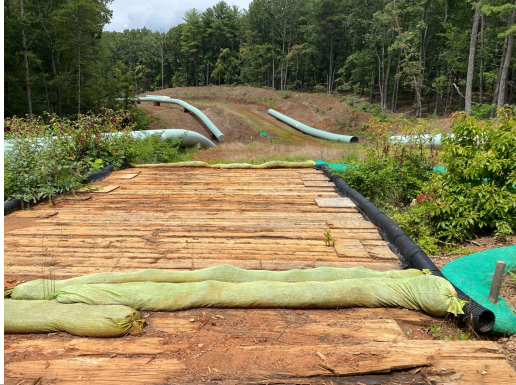
GPS Location	0	GPS Location	0		
Field Station#	14000+00	Field Station#	14072+75		
Pic 3 Desc.	Approximately 14000+00. Overview of adjacent pond overflow entering the ROW.		Pic 4 Desc.	Approximately 14072+75. Overview of stream crossing, equipment bridge and ECDs at stream S-KL61.

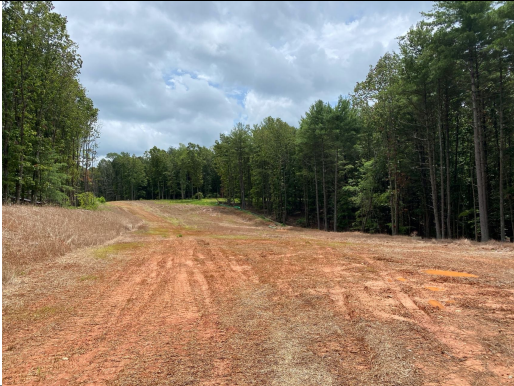
GPS Location	0	GPS Location	0		
Field Station#	14075+00	Field Station#	14172+00		
Pic 5 Desc.	Approximately 14075+00. Overview of ROW. ROW temporarily stabilized and has temporary vegetation growing.		Pic 6 Desc.	Approximately 14172+00. Overview of RCE. RCE appears to be installed and functioning correctly at time of inspection.

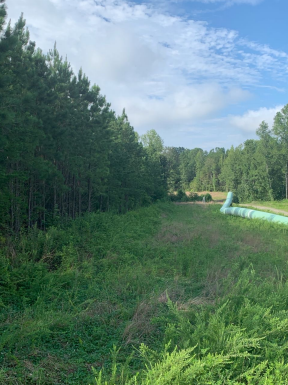
GPS Location	O		GPS Location	O	
Field Station#	7+00		Field Station#	10+00	
Pic 1 Desc.	Observing temporary vegetation.		Pic 2 Desc.	Observing temporary vegetation

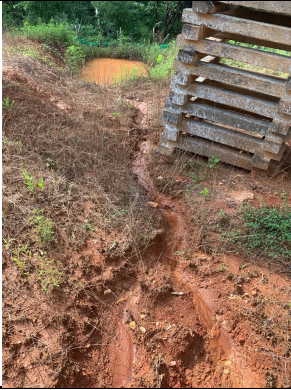
GPS Location	O		GPS Location	O	
Field Station#	16008+00		Field Station#	15837+00	
Pic 1 Desc.	Observing water bar that required maintenance.		Pic 2 Desc.	Observing CFS that required maintenance.

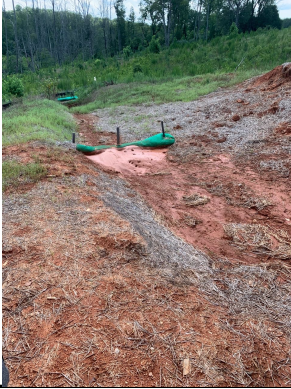
GPS Location	O		GPS Location	O	
Field Station#	15769+50		Field Station#	15630+00	
Pic 3 Desc.	Observing CFS that required maintenance.		Pic 4 Desc.	Observing the Contractor performing ECD maintenance.	
Insert image here			Insert image here		
GPS Location			GPS Location		
Field Station#			Field Station#		
Pic 5 Desc.			Pic 6 Desc.

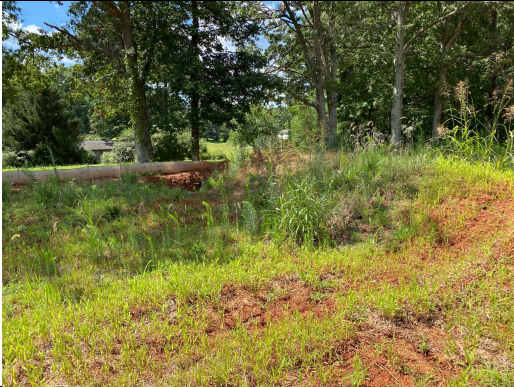
GPS Location	0	GPS Location	0		
Field Station#	13955+00	Field Station#	13947+00		
Pic 1 Desc.	Approximately 13955+00. Overview of ROW, water bar and sump. ROW temporarily stabilized and has temporary vegetation growing. Water bar and sump installed and		Pic 2 Desc.	Approximately 13947+00. Overview of ROW. ROW temporarily stabilized and has temporary vegetation growing.

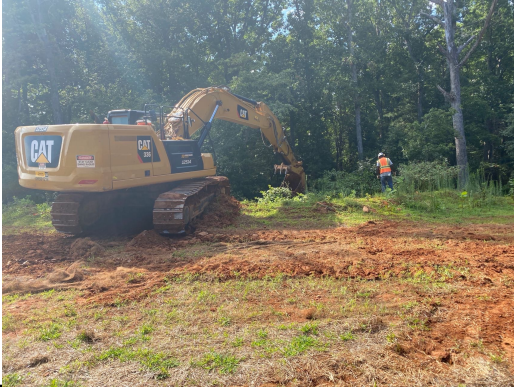
GPS Location	0	GPS Location	0		
Field Station#	14180+00	Field Station#	14186+00		
Pic 3 Desc.	Approximately 14180+00. Crews cleaning sumps and replacing ECDs.		Pic 4 Desc.	Approximately 14186+00. Crews replacing CFS end treatment at sump.

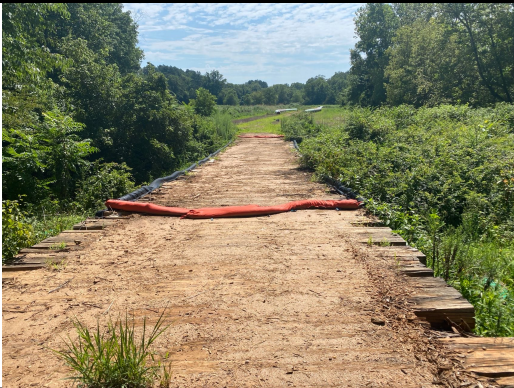
GPS Location	0	GPS Location	0		
Field Station#	13862+80	Field Station#	13958+31		
Pic 5 Desc.	Approximately 13862+80. Overview of stream crossing, equipment bridge and ECDs at stream S-C17.		Pic 6 Desc.	Approximately 13958+31. Third party has tracked mud onto Foggy Ridge Road.

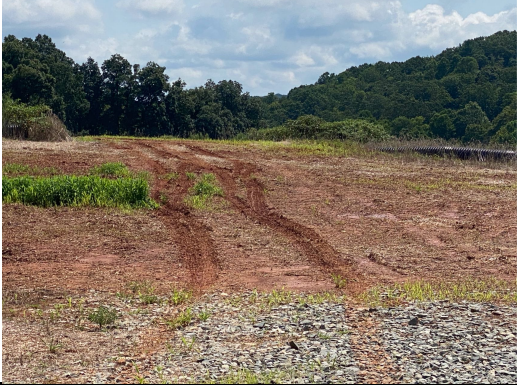
GPS Location	0	GPS Location	0		
Field Station#	13959+00	Field Station#	13960+50		
Pic 7 Desc.	Approximately 13959+00. Third party has driven approximately 300 feet down the ROW at the GAS of Foggy Ridge Road causing ruts.		Pic 8 Desc.	Approximately 13960+50. Overview of CWD piping and level spreader. CWD appears to be installed and functioning correctly at time of

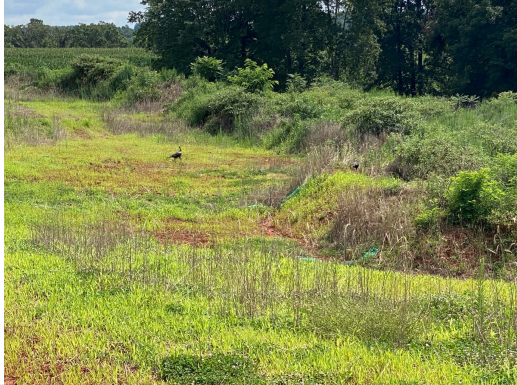
GPS Location	0	GPS Location	0		
Field Station#	13970+00	Field Station#	13998+15		
Pic 9 Desc.	Approximately 13970+00. Overview of ROW. ROW temporarily stabilized and has temporary vegetation growing.		Pic 10 Desc.	Approximately 13998+15. Overview of stream crossing, equipment bridge and ECDs at stream S-KL36.

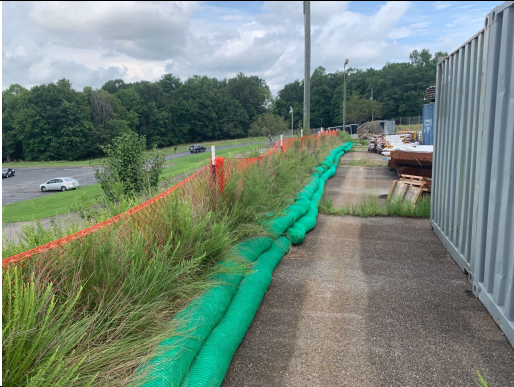
GPS Location 00000000000		GPS Location 00000000000			
Field Station# 0000+00		Field Station# 0000+00			
Pic 1 Desc. Perimeter ECD's on west side of paved yard in good condition.		Pic 2 Desc. Inlet protection for parking lot drain near storage building in good condition.

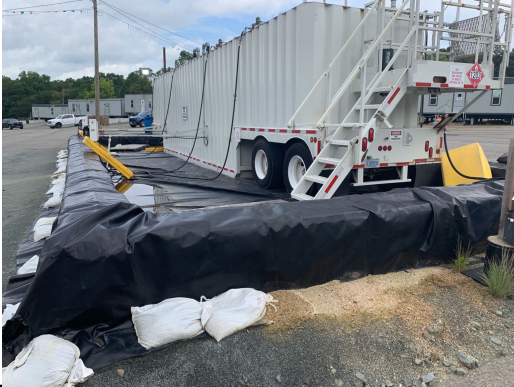
GPS Location 00000000000		GPS Location 00000000000			
Field Station# 0000+00		Field Station# 0000+00			
Pic 3 Desc. Secondary containment structure for fuel cell in compliance		Pic 4 Desc. RCE at gravel yard in acceptable condition.

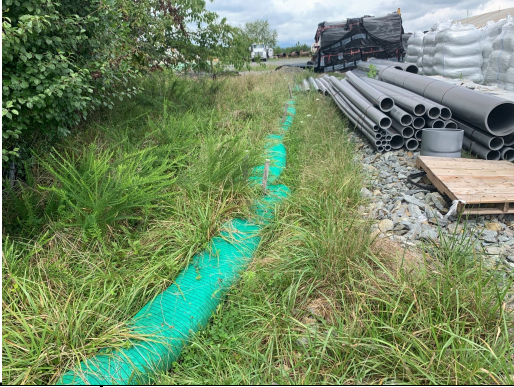
Insert image here			
GPS Location 00000000000		GPS Location			
Field Station# 0000+00		Field Station#			
Pic 5 Desc. Perimeter ECD's on west side of gravel yard in good condition.		Pic 6 Desc.

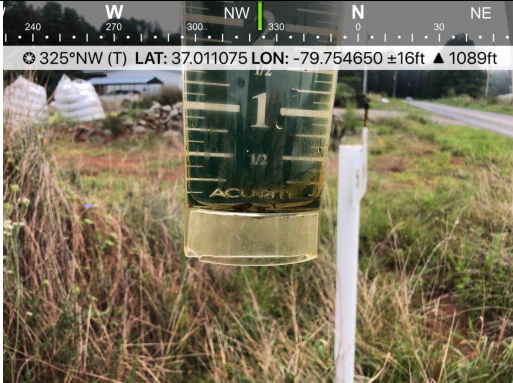
<p>169°S (T) LAT: 37.042842 LON: -79.810033 ±16ft ▲ 1079ft</p>			
GPS Location	0	GPS Location	0		
Field Station#	14524+76	Field Station#	14311+57		
Pic 1 Desc.	Rain gauge at Timber Ridge Road just a trace		Pic 2 Desc.	Rain gauge at Farm View Road 0.2"

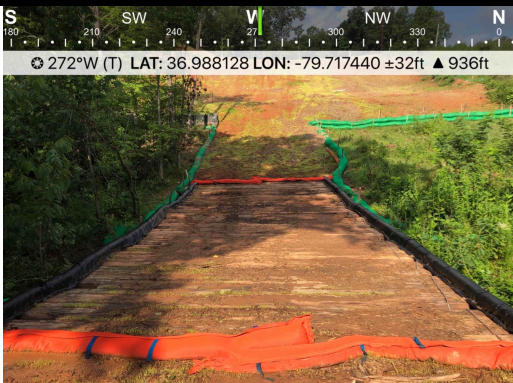
<p>181°S (T) LAT: 36.987821 LON: -79.717036 ±98ft ▲ 970ft</p>			
GPS Location	0	GPS Location	0		
Field Station#	14673+10	Field Station#	14675+00		
Pic 3 Desc.	Equipment bridge clean at stream S-H37		Pic 4 Desc.	Sump pit functioning as intended after rain events

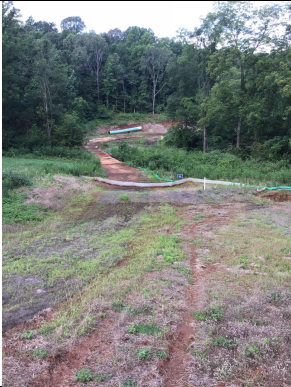
GPS Location	0000	GPS Location	0000		
Field Station#	13783+90	Field Station#	13784+00		
Pic 1 Desc.	Observed ECDs after recent rain showers	Pic 2 Desc.	Row photo showing ECDs in place and functioning

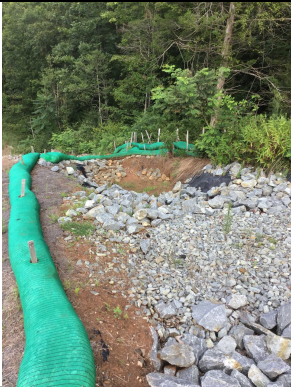
GPS Location	0000	GPS Location	0000		
Field Station#	13784+35	Field Station#	13784+40		
Pic 3 Desc.	Inspected sump and rock lined channel after recent rain showers	Pic 4 Desc.	Monitored sump pits after recent rain showers		
Insert image here			Insert image here		
GPS Location		GPS Location			
Field Station#		Field Station#			
Pic 5 Desc.		Pic 6 Desc.

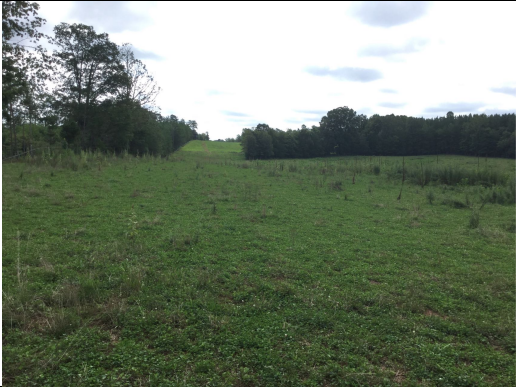
GPS Location	1		GPS Location	2	
Field Station#	15175+00		Field Station#	15196+00	
Pic 1 Desc.	Final cleanup area has uniform vegetative growth and no erosion issues observed.		Pic 2 Desc.	Final cleanup area has uniform vegetative growth and no erosion issues observed.

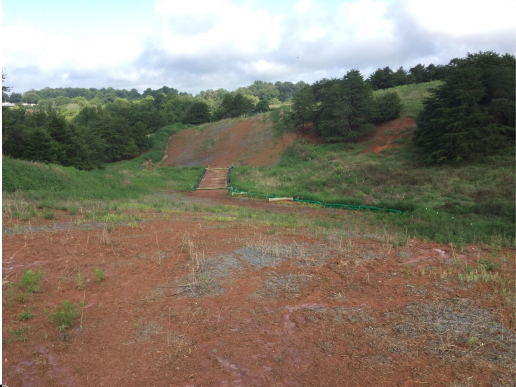
GPS Location	3		GPS Location	4	
Field Station#	15333+00		Field Station#	15361+00	
Pic 3 Desc.	Temporary stabilized area has all ECD's in place and functional with no issues observed.		Pic 4 Desc.	Final cleanup area has uniform vegetative growth and no erosion issues observed.

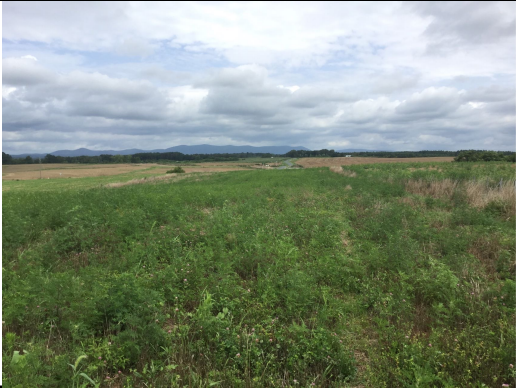
GPS Location	5		GPS Location	6	
Field Station#	15492+00		Field Station#	15226+00	
Pic 5 Desc.	Final cleanup area has uniform vegetative growth and no erosion issues observed.		Pic 6 Desc.	Temporary stabilized area has all ECD's in place and functional with no issues observed.

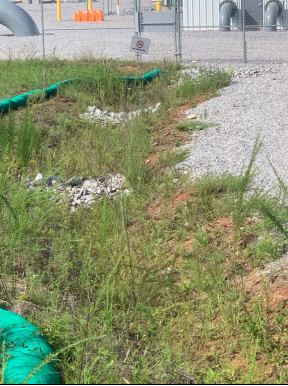
GPS Location	O	GPS Location	O		
Field Station#	00+00	Field Station#	00+00		
Pic 1 Desc.	Observing ECD's performing as they should	Pic 2 Desc.	Observing ECD's performing as they should

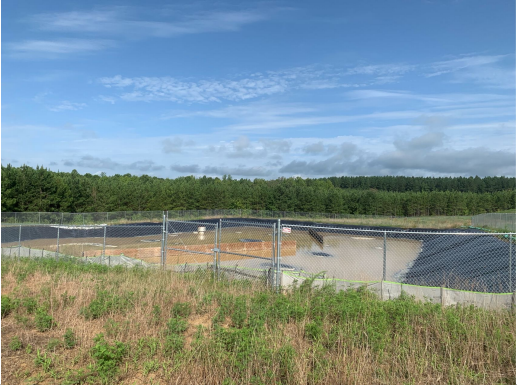
GPS Location	O	GPS Location	O		
Field Station#	00+00	Field Station#	00+00		
Pic 3 Desc.	Observing ECD's performing as they should.	Pic 4 Desc.	Observing storm water pond.		
Insert image here			Insert image here		
GPS Location		GPS Location			
Field Station#		Field Station#			
Pic 5 Desc.		Pic 6 Desc.

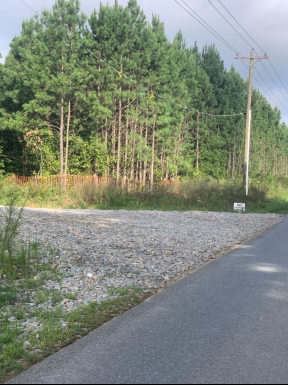
GPS Location	O		GPS Location	O	
Field Station#	00+00		Field Station#	00+00	
Pic 1 Desc.	Observing RCE.		Pic 2 Desc.	Observing outlet and outlet protection.

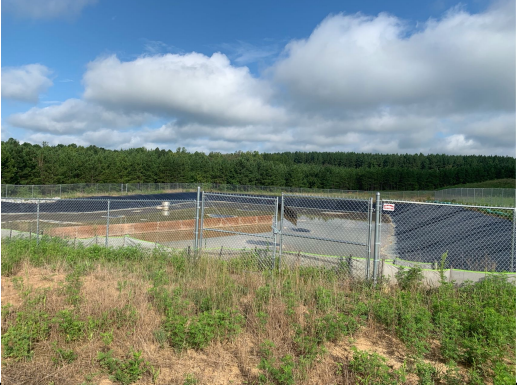
GPS Location	O		GPS Location	O	
Field Station#	00+00		Field Station#	00+00	
Pic 3 Desc.	Observing rock check dams.		Pic 4 Desc.	Observing storm water pond and ECD's performing as they should.	
Insert image here			Insert image here		
GPS Location			GPS Location		
Field Station#			Field Station#		
Pic 5 Desc.			Pic 6 Desc.
