# Visual Site Inspection Report

<b>Project Name</b>	H-600 Pipeline Spread I	<b>AFE</b>	124300139	<b>Spread</b>	H-600 Pipeline Spread I
<b>Contractor</b>	Precision			<b>Report #</b>	14132
<b>Inspector</b>	Justin Burch			<b>Date/Time</b>	8/31/2020 9:45 AM
<b>Permit #</b>	TBD	<b>Inspection Type</b>	VA SWPP	<b>Station Begin</b>	14694+77
<b>State</b>	VA	<b>Inspection Area</b>	Full	<b>Station End</b>	15142+66
<b>County</b>	Franklin/Pittsylvania	<b>Ground</b>	Wet	<b>Temperature (°F)</b>	74.00
<b>Municipality</b>	Chatham	<b>Weather</b>	Cloudy	<b>Rain Gauge (in)</b>	0.40
				<b>Rain Accumulation Time (days)</b>	6.00

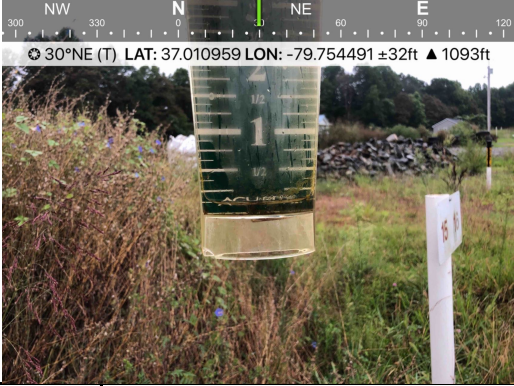
<p>30°NE (T) LAT: 37.010959 LON: -79.754491 ±32ft ▲ 1093ft</p>		  <p>113°E (T) LAT: 37.042926 LON: -79.809996 ±16ft ▲ 1065ft</p>			
<b>GPS Location</b>	0	<b>GPS Location</b>	0		
<b>Field Station#</b>	14524+76	<b>Field Station#</b>	14311+57		
<b>Pic 1 Desc.</b>	Rain gauges at Timber Ridge Road 0.1"		<b>Pic 2 Desc.</b>	Rain gauge at Farm View Road 0.2"

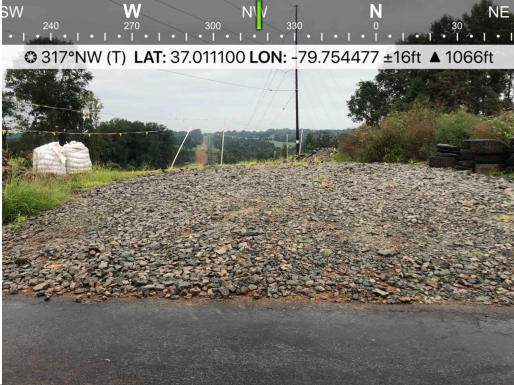
<p>317°NW (T) LAT: 37.011100 LON: -79.754477 ±16ft ▲ 1066ft</p>		  <p>109°E (T) LAT: 37.042909 LON: -79.809800 ±16ft ▲ 1057ft</p>			
<b>GPS Location</b>	0	<b>GPS Location</b>	0		
<b>Field Station#</b>	14524+76	<b>Field Station#</b>	14312+00		
<b>Pic 3 Desc.</b>	RCE at Timber Ridge Road functioning as intended		<b>Pic 4 Desc.</b>	Temporary stabilization holding up on the GAS of Farm View Road

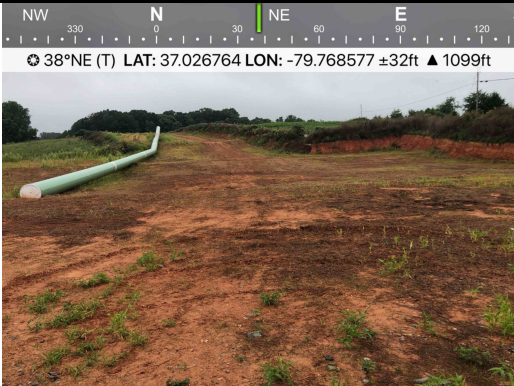
<b>GPS Location</b>	0	<b>GPS Location</b>	0		
<b>Field Station#</b>	14450+00	<b>Field Station#</b>	14600+00		
<b>Pic 5 Desc.</b>	Temporary stabilization holding up on the CIS of Webster Road		<b>Pic 6 Desc.</b>	Temporary stabilization holding up on the GAS of Simmons Creek Road

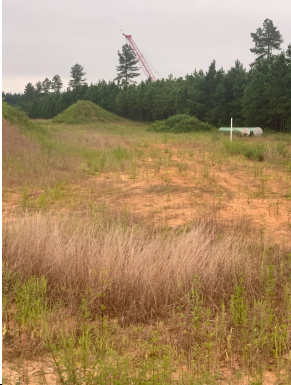
<b>GPS Location</b>	O	<b>GPS Location</b>	O		
<b>Field Station#</b>	4+00	<b>Field Station#</b>	13+77		
<b>Pic 1 Desc.</b>	Observing temporary vegetation.	<b>Pic 2 Desc.</b>	Observing RCE.

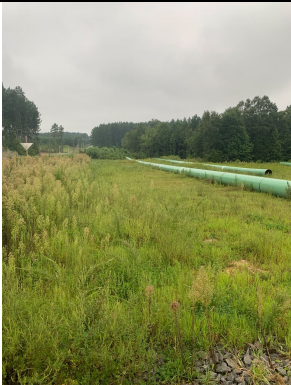
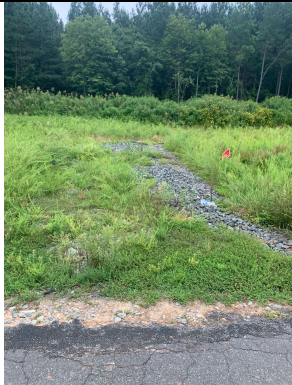
<b>GPS Location</b>	O	<b>GPS Location</b>	O		
<b>Field Station#</b>	21+00	<b>Field Station#</b>	13+95		
<b>Pic 3 Desc.</b>	Observing temporary vegetation.	<b>Pic 4 Desc.</b>	Observing RCE.		
Insert image here			Insert image here		
<b>GPS Location</b>		<b>GPS Location</b>			
<b>Field Station#</b>		<b>Field Station#</b>			
<b>Pic 5 Desc.</b>		<b>Pic 6 Desc.</b>

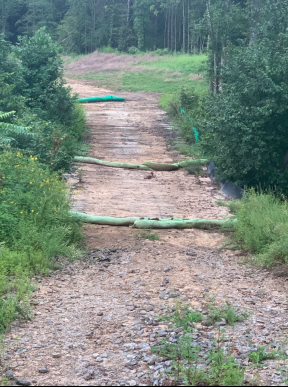
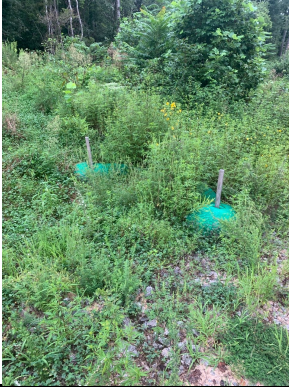
<b>GPS Location</b>	O	<b>GPS Location</b>	O		
<b>Field Station#</b>	12+65	<b>Field Station#</b>	12+00		
<b>Pic 1 Desc.</b>	Observing equipment crossing and ECD's performing as they should.	<b>Pic 2 Desc.</b>	Observing ECD's performing as they should.

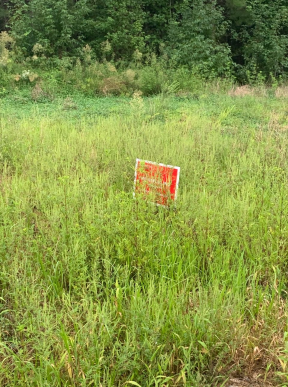
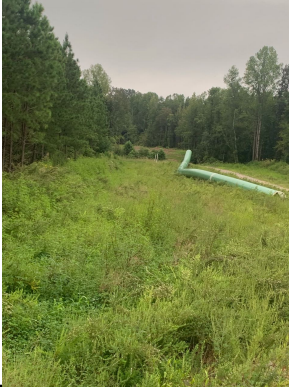
<b>GPS Location</b>	O	<b>GPS Location</b>	O		
<b>Field Station#</b>	11+00	<b>Field Station#</b>	6+00		
<b>Pic 3 Desc.</b>	Observing temporary vegetation and signage.	<b>Pic 4 Desc.</b>	Observing temporary vegetation.		
Insert image here			Insert image here		
<b>GPS Location</b>		<b>GPS Location</b>			
<b>Field Station#</b>		<b>Field Station#</b>			
<b>Pic 5 Desc.</b>		<b>Pic 6 Desc.</b>

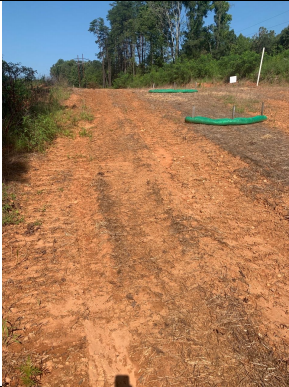
<b>GPS Location</b>	O		<b>GPS Location</b>	O	
<b>Field Station#</b>	15851+00		<b>Field Station#</b>	15851+00	
<b>Pic 1 Desc.</b>	Observing area that needs to be repaired and stabilized.		<b>Pic 2 Desc.</b>	Observing sediment in water bar that needs to be repaired and stabilized.

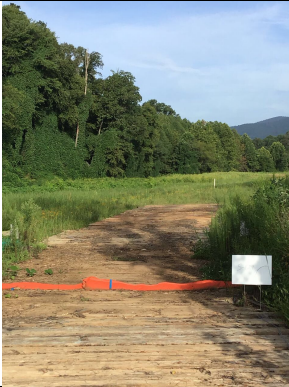
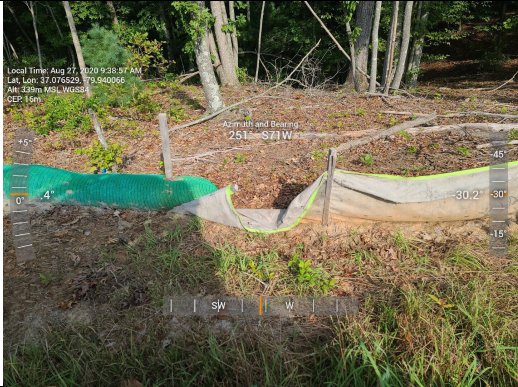
<b>GPS Location</b>	000000	<b>GPS Location</b>	000000		
<b>Field Station#</b>	13678+71	<b>Field Station#</b>	13741+40		
<b>Pic 1 Desc.</b>	Photo showing vegetation and ECDs in place at stream crossing	<b>Pic 2 Desc.</b>	P1 requires maintenance, added to the punch list

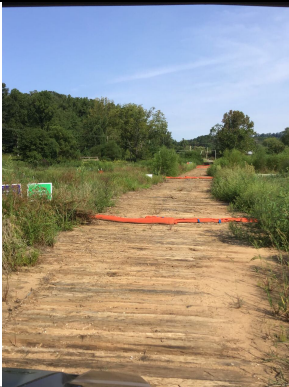
<b>GPS Location</b>	000000	<b>GPS Location</b>	000000		
<b>Field Station#</b>	13696+03	<b>Field Station#</b>	13704+33		
<b>Pic 3 Desc.</b>	Installed new signage at stream and wetland crossings	<b>Pic 4 Desc.</b>	Photo showing stabilized hill side with ECDs in place and functioning		
Insert image here		Insert image here			
<b>GPS Location</b>		<b>GPS Location</b>			
<b>Field Station#</b>		<b>Field Station#</b>			
<b>Pic 5 Desc.</b>		<b>Pic 6 Desc.</b>

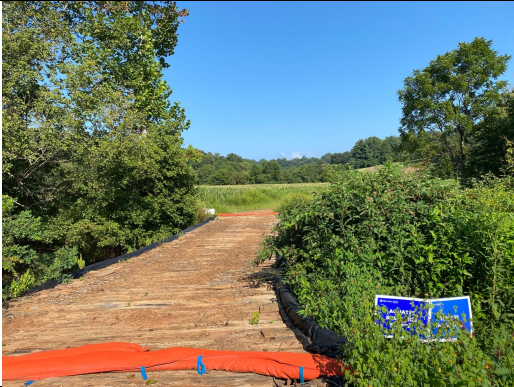
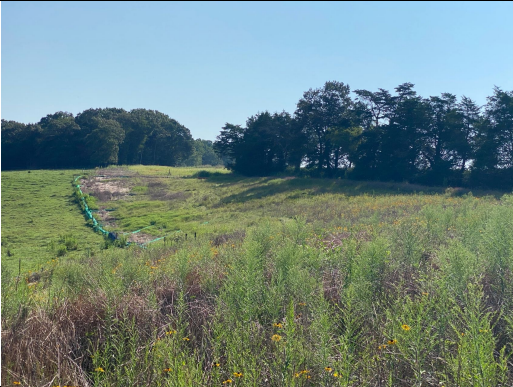
<b>GPS Location</b>	0	<b>GPS Location</b>	0		
<b>Field Station#</b>	13915+82	<b>Field Station#</b>	13922+00		
<b>Pic 1 Desc.</b>	Approximately 13915+82. Overview of stream crossing, equipment bridge and ECDs at stream S-II2.		<b>Pic 2 Desc.</b>	Approximately 13922+00. Overview of ROW and ECDs. ROW temporarily stabilized and has temporary vegetation growing. ECDs appear to be installed and functioning correctly.

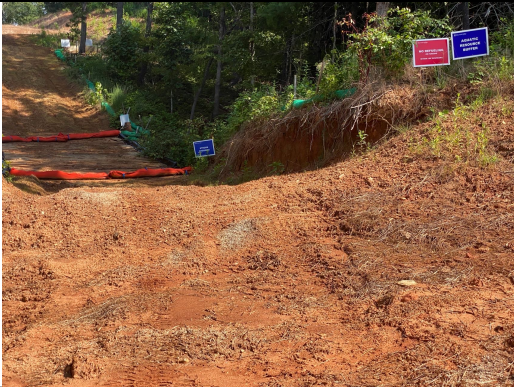
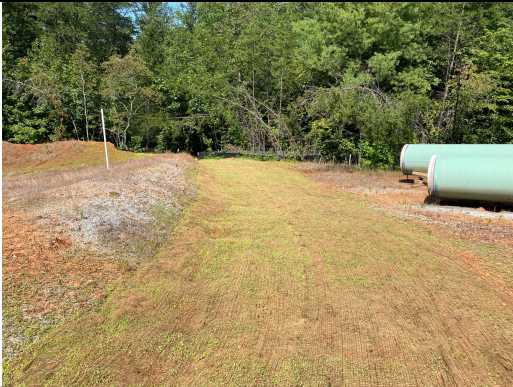
<b>GPS Location</b>	0	<b>GPS Location</b>	0		
<b>Field Station#</b>	14045+71	<b>Field Station#</b>	14052+50		
<b>Pic 3 Desc.</b>	Approximately 14045+71. Overview of stream crossing, equipment bridge and ECDs at stream S-YZ5.		<b>Pic 4 Desc.</b>	Approximately 14052+50. Overview of ROW and water bar. ROW temporarily stabilized and has temporary vegetation growing. Water appears to be installed and functioning correctly.

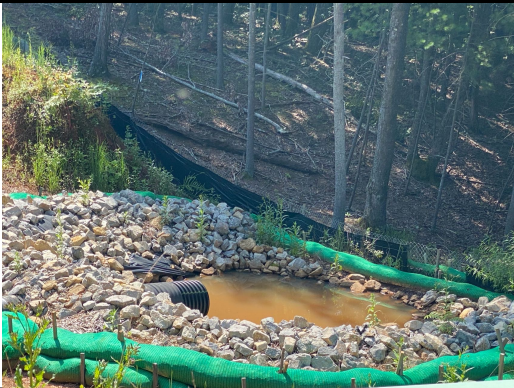
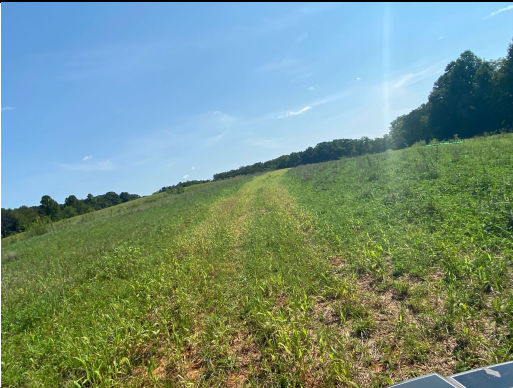
<b>GPS Location</b>	0	<b>GPS Location</b>	0		
<b>Field Station#</b>	14071+75	<b>Field Station#</b>	14113+50		
<b>Pic 5 Desc.</b>	Approximately 14071+75. Overview of CWD piping and plunge pool. CWD appears to be installed and functioning correctly at time of inspection.		<b>Pic 6 Desc.</b>	Approximately 14113+50. Overview of ROW. ROW temporarily stabilized and has temporary vegetation growing.

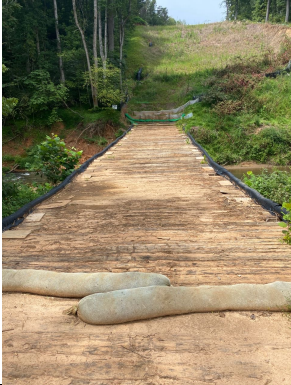
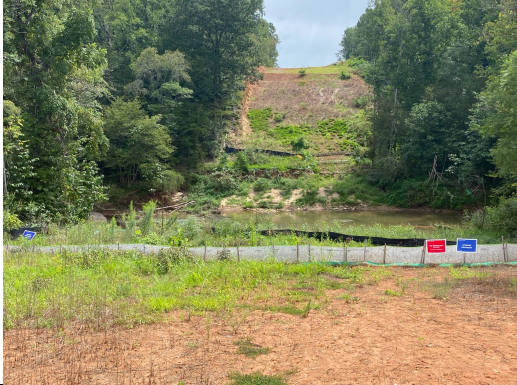
<b>GPS Location</b>	0	<b>GPS Location</b>	0		
<b>Field Station#</b>	14233+35	<b>Field Station#</b>	14249+65		
<b>Pic 7 Desc.</b>	Approximately 14233+35. Overview of stream crossing, equipment bridge and ECDs at stream S-C19.		<b>Pic 8 Desc.</b>	Approximately 14249+65. Overview of stream crossing and ECDs at stream S-C11.

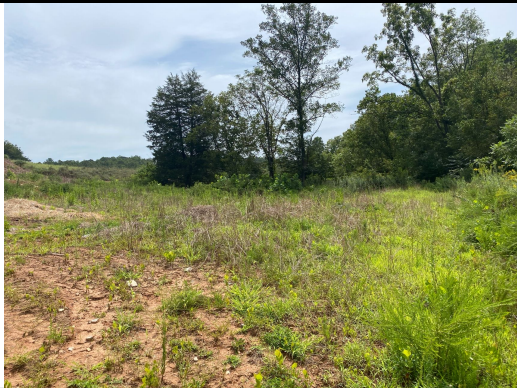
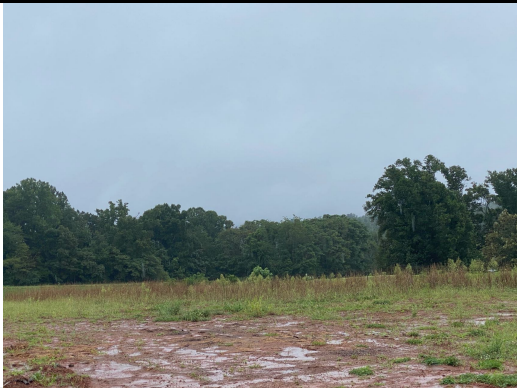
<b>GPS Location</b>	0	<b>GPS Location</b>	0		
<b>Field Station#</b>	14234+50	<b>Field Station#</b>	13896+00		
<b>Pic 9 Desc.</b>	Approximately 14234+50. Overview of ROW. ROW temporarily stabilized and has temporary vegetation growing.		<b>Pic 10 Desc.</b>	Approximately 13896+00. Overview of ROW. ROW temporarily stabilized and has temporary vegetation growing.

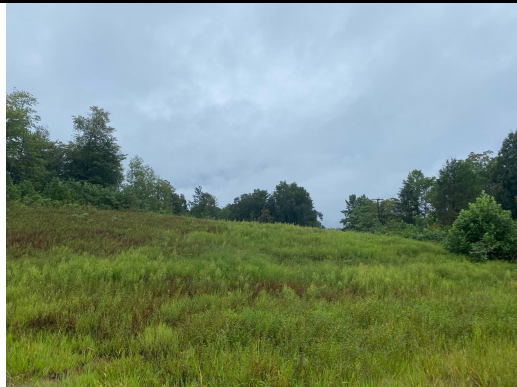
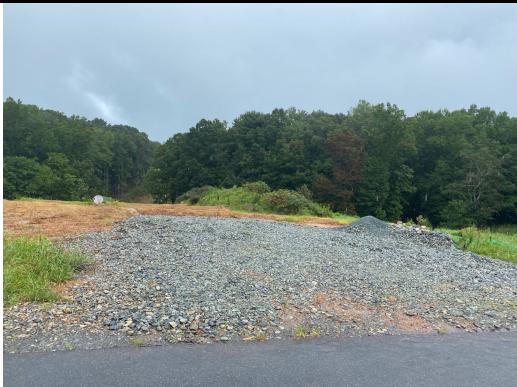
<b>GPS Location</b>	0	<b>GPS Location</b>	0		
<b>Field Station#</b>	14012+50	<b>Field Station#</b>	14172+00

<b>Pic 11 Desc.</b>	Approximately 14012+50. Overview of ROW. ROW temporarily stabilized and has temporary vegetation growing.		<b>Pic 12 Desc.</b>	Approximately 14172+00. Overview of RCE. RCE appears to be installed and functioning correctly at time of inspection.

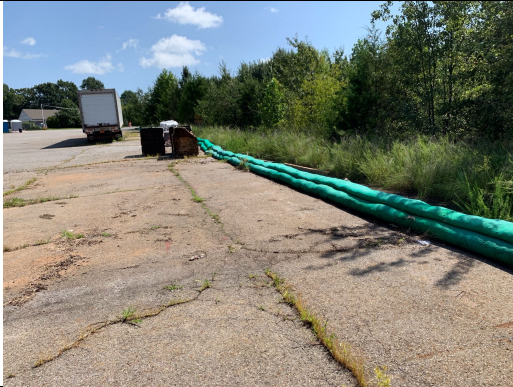
<b>GPS Location</b>	000000000000	<b>GPS Location</b>	000000000000		
<b>Field Station#</b>	0000+00	<b>Field Station#</b>	0000+00		
<b>Pic 1 Desc.</b>	Inlet protection for parking lot drains in the paved yard in acceptable condition.	<b>Pic 2 Desc.</b>	Perimeter ECD's on south end of paved yard in good condition.

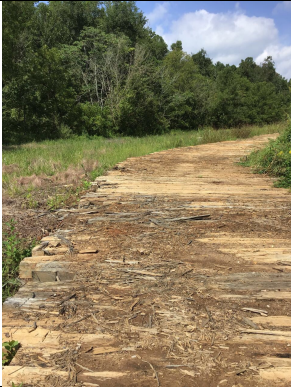
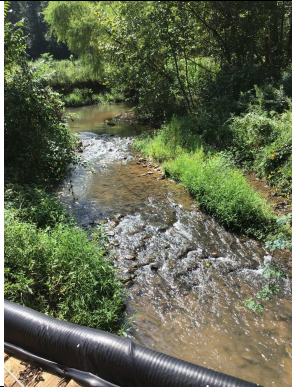
<b>GPS Location</b>	000000	<b>GPS Location</b>	000		
<b>Field Station#</b>	13755+40	<b>Field Station#</b>	13755+49		
<b>Pic 1 Desc.</b>	Vegetation photo down row from stream crossing	<b>Pic 2 Desc.</b>	Stream observation photo facing upstream

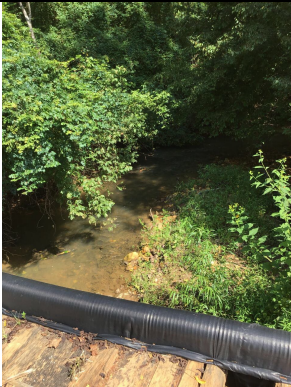
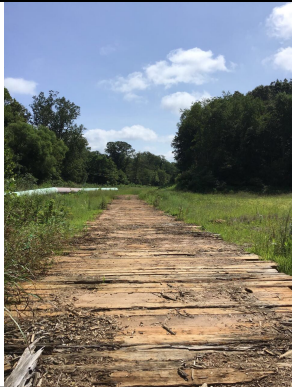
<b>GPS Location</b>	00000	<b>GPS Location</b>	00000		
<b>Field Station#</b>	13755+49	<b>Field Station#</b>	13756+00		
<b>Pic 3 Desc.</b>	Stream observation photo facing downstream	<b>Pic 4 Desc.</b>	Vegetation photo up row from stream crossing S-EF12		
Insert image here			Insert image here		
<b>GPS Location</b>		<b>GPS Location</b>			
<b>Field Station#</b>		<b>Field Station#</b>			
<b>Pic 5 Desc.</b>		<b>Pic 6 Desc.</b>

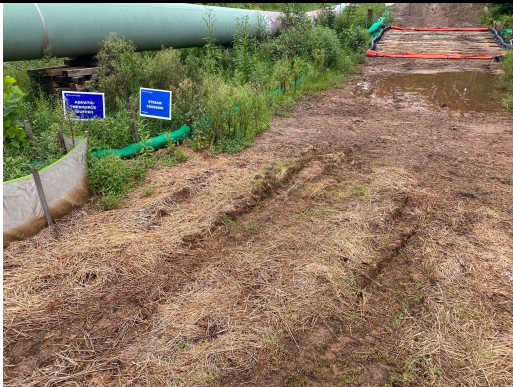
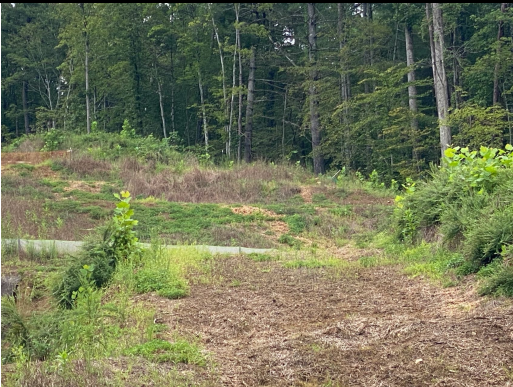
GPS Location	0	GPS Location	0		
Field Station#	13998+15	Field Station#	14000+00		
Pic 1 Desc.	Approximately 13998+15. Overview of stream crossing, equipment bridge and ECDs at stream S-KL36.		Pic 2 Desc.	Approximately 14000+00. Overview of ROW. ROW temporarily stabilized and has temporary vegetation growing.

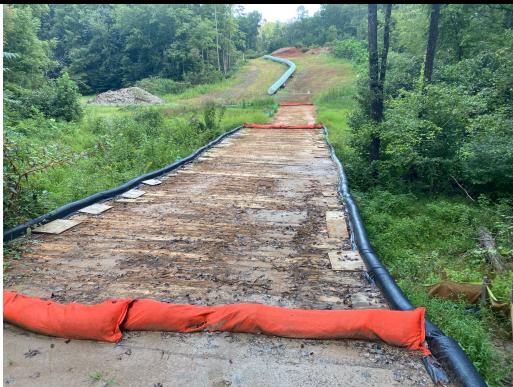
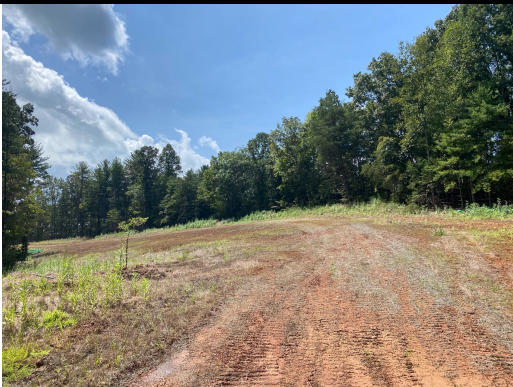
GPS Location	0	GPS Location	0		
Field Station#	14035+28	Field Station#	14030+75		
Pic 3 Desc.	Approximately 14035+28. Overview of stream crossing, equipment bridge and ECDs at stream S-KL39.		Pic 4 Desc.	Approximately 14030+75. Overview of ROW. ROW temporarily stabilized and has temporary vegetation growing.

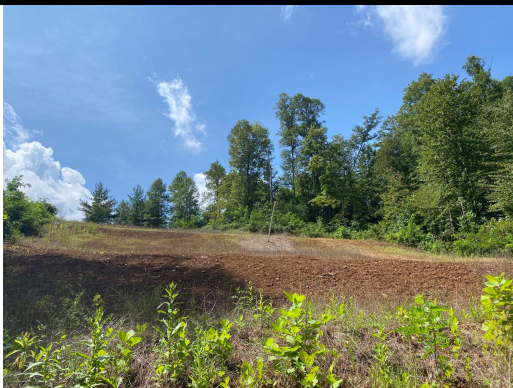
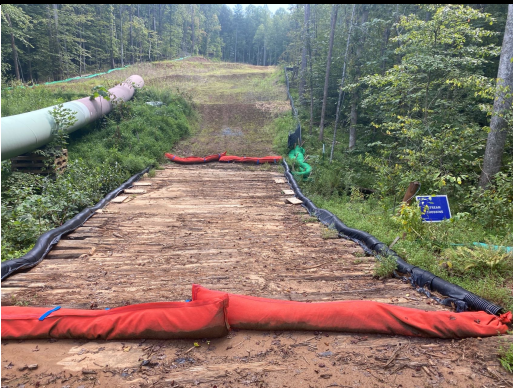
GPS Location	0	GPS Location	0		
Field Station#	14007+50	Field Station#	14213+75		
Pic 5 Desc.	Approximately 14007+50. Overview of ROW. ROW temporarily stabilized and has temporary vegetation growing.		Pic 6 Desc.	Approximately 14213+75. Overview of stream crossing, equipment bridge and ECDs at stream S-HH4.

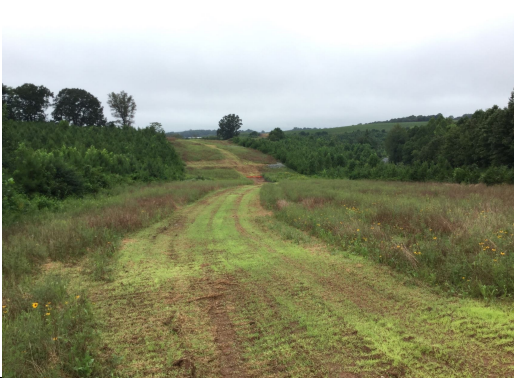
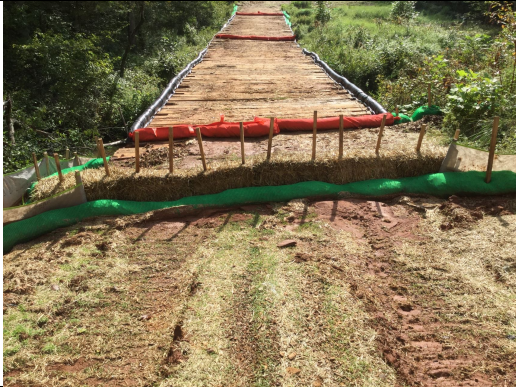
<b>GPS Location</b>	1	<b>GPS Location</b>	2		
<b>Field Station#</b>	15366+00	<b>Field Station#</b>	15426+00		
<b>Pic 1 Desc.</b>	New vegetation growing in travel lane of final cleanup area after contractor moved equipment.		<b>Pic 2 Desc.</b>	Contractor installed multiple levels of ECD's at streams between Snowberry Rd-Toshes Rd. No issues observed.

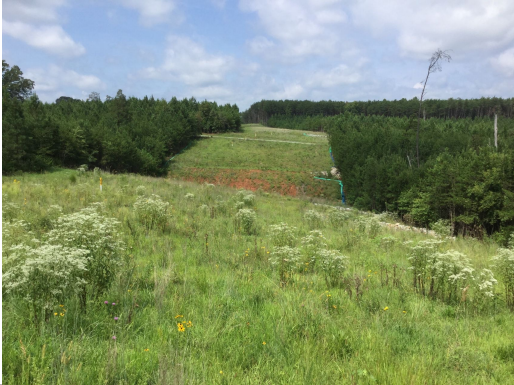
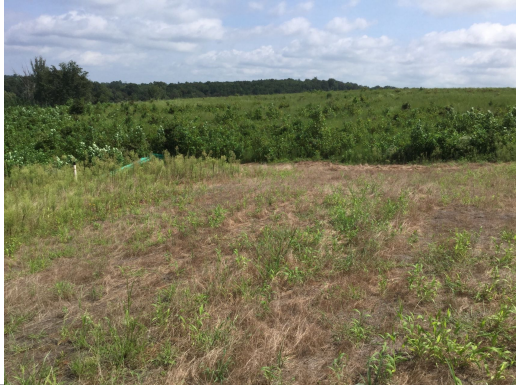
<b>GPS Location</b>	3	<b>GPS Location</b>	4		
<b>Field Station#</b>	15226+00	<b>Field Station#</b>	15258+00		
<b>Pic 3 Desc.</b>	Permanent section of ROW. Uniform vegetative growth and all ECD's in place and functional.		<b>Pic 4 Desc.</b>	Permanent section of ROW near HDD exit site. No issues observed.

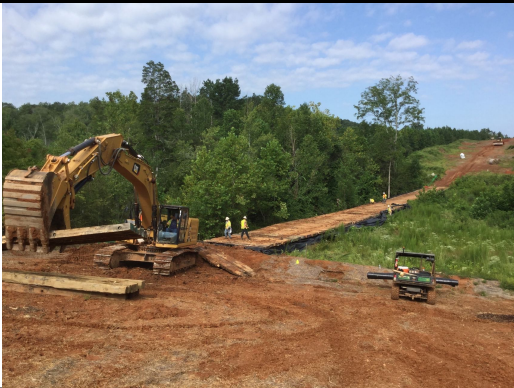
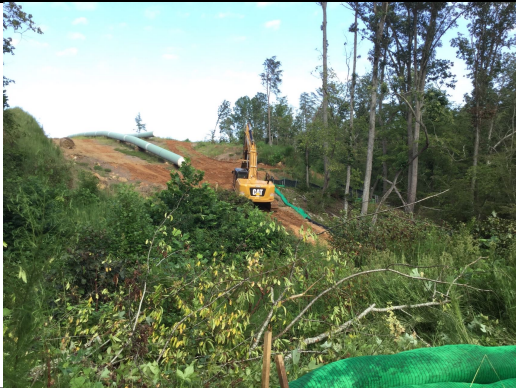
<b>GPS Location</b>	5	<b>GPS Location</b>	6		
<b>Field Station#</b>	15543+00	<b>Field Station#</b>	15573+00		
<b>Pic 5 Desc.</b>	Contractor repairing equipment bridges between Climax Rd-Anderson Mill RC1		<b>Pic 6 Desc.</b>	Contractor replacing ECD's along ROW between Climax Rd-Anderson Mill RC1.

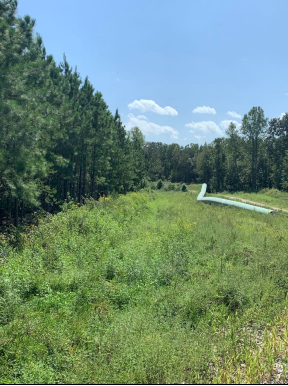
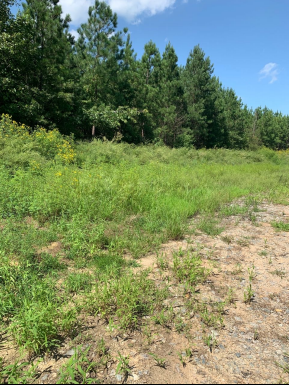
<b>GPS Location</b>	O	<b>GPS Location</b>	O		
<b>Field Station#</b>	8+00	<b>Field Station#</b>	11+00		
<b>Pic 1 Desc.</b>	Observing temporary vegetation.	<b>Pic 2 Desc.</b>	Observing temporary vegetation.

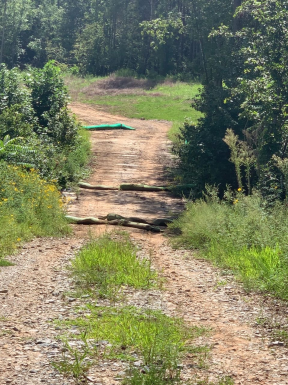
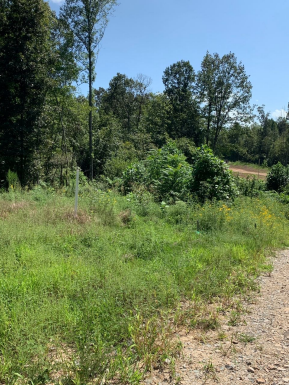
<b>GPS Location</b>	O	<b>GPS Location</b>	O		
<b>Field Station#</b>	12+65	<b>Field Station#</b>	12+00		
<b>Pic 3 Desc.</b>	Observing equipment crossing and ECD's performing as they should.	<b>Pic 4 Desc.</b>	Observing stream buffer.		
Insert image here			Insert image here		
<b>GPS Location</b>		<b>GPS Location</b>			
<b>Field Station#</b>		<b>Field Station#</b>			
<b>Pic 5 Desc.</b>		<b>Pic 6 Desc.</b>

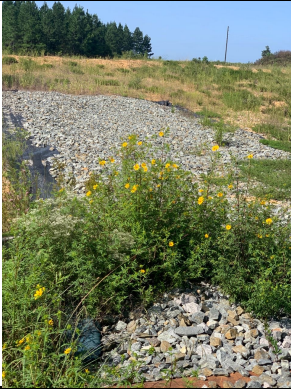
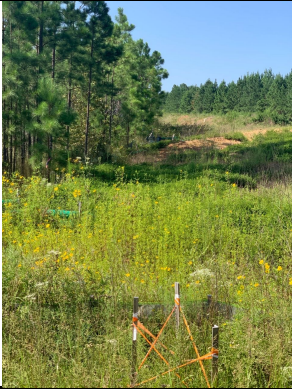
<b>GPS Location</b>	O		<b>GPS Location</b>	O	
<b>Field Station#</b>	13+77		<b>Field Station#</b>	13+00	
<b>Pic 1 Desc.</b>	Observing RCE.		<b>Pic 2 Desc.</b>	Observing temporary vegetation and ECD's performing as they should.

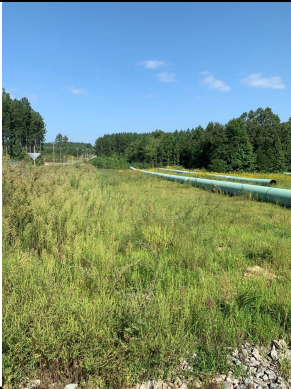
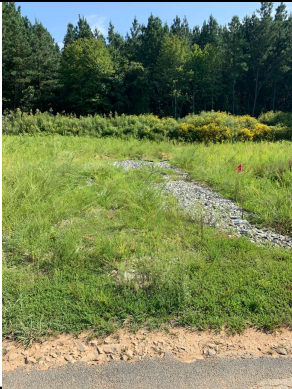
<b>GPS Location</b>	O		<b>GPS Location</b>	O	
<b>Field Station#</b>	21+00		<b>Field Station#</b>	13+95	
<b>Pic 3 Desc.</b>	Observing temporary vegetation.		<b>Pic 4 Desc.</b>	Observing RCE.	
Insert image here			Insert image here		
<b>GPS Location</b>			<b>GPS Location</b>		
<b>Field Station#</b>			<b>Field Station#</b>		
<b>Pic 5 Desc.</b>			<b>Pic 6 Desc.</b>

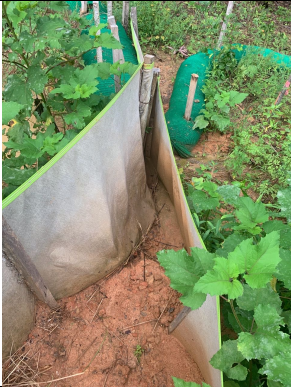
<b>GPS Location</b>	O	<b>GPS Location</b>	O		
<b>Field Station#</b>	15795+00	<b>Field Station#</b>	15630+00		
<b>Pic 1 Desc.</b>	Observing p1 that requires maintenance.	<b>Pic 2 Desc.</b>	Observing the Contractor performing ECD maintenance after the rain event.

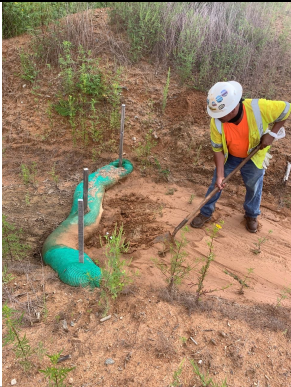
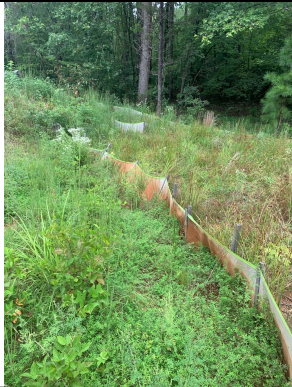
<b>GPS Location</b>	O	<b>GPS Location</b>	O		
<b>Field Station#</b>	15632+00	<b>Field Station#</b>	15750+00		
<b>Pic 3 Desc.</b>	Observing the Contractor performing ECD maintenance after the rain event.	<b>Pic 4 Desc.</b>	Observing p1 that requires maintenance.		
Insert image here			Insert image here		
<b>GPS Location</b>		<b>GPS Location</b>			
<b>Field Station#</b>		<b>Field Station#</b>			
<b>Pic 5 Desc.</b>		<b>Pic 6 Desc.</b>

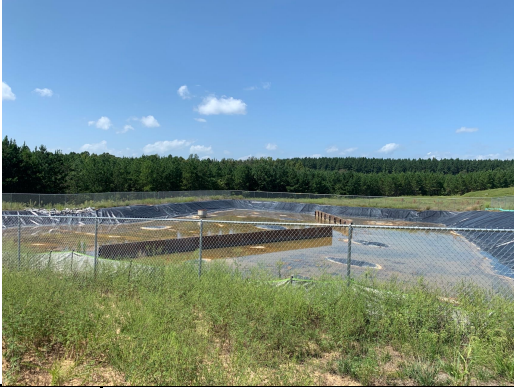
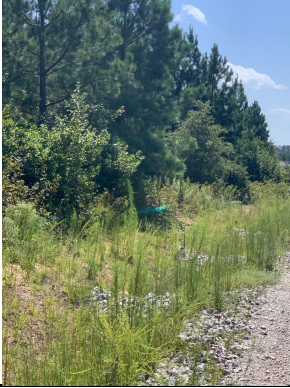
<b>GPS Location</b>	O	<b>GPS Location</b>	O		
<b>Field Station#</b>	00+00	<b>Field Station#</b>	00+00		
<b>Pic 1 Desc.</b>	Observing storm water pond and ECD's performing as they should.	<b>Pic 2 Desc.</b>	Observing ECD's performing as they should.

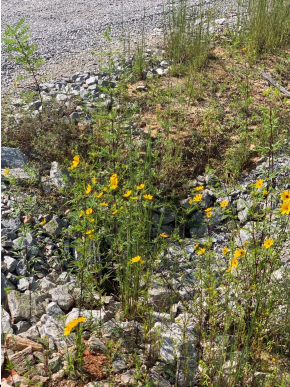
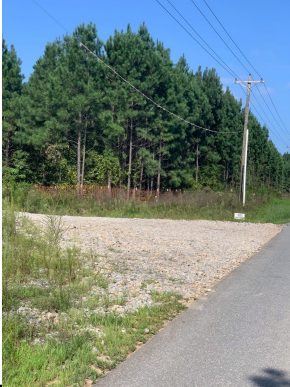
<b>GPS Location</b>	O	<b>GPS Location</b>	O		
<b>Field Station#</b>	00+00	<b>Field Station#</b>	00+00		
<b>Pic 3 Desc.</b>	Observing outlet and outlet protection.	<b>Pic 4 Desc.</b>	Observing RCE.		
Insert image here			Insert image here		
<b>GPS Location</b>		<b>GPS Location</b>			
<b>Field Station#</b>		<b>Field Station#</b>			
<b>Pic 5 Desc.</b>		<b>Pic 6 Desc.</b>
