# Visual Site Inspection Report

<b>Project Name</b>	H-600 Pipeline Spread G	<b>AFE</b>	124300137	<b>Spread</b>	H-600 Pipeline Spread G
<b>Contractor</b>	Precision			<b>Report #</b>	15492
<b>Inspector</b>	Len Kruizenga			<b>Date/Time</b>	10/12/2020 1:20 PM
<b>Permit #</b>	TBD	<b>Inspection Type</b>	VA SWPP	<b>Station Begin</b>	12005+00
<b>State</b>	VA	<b>Inspection Area</b>	Full	<b>Station End</b>	12005+00
<b>County</b>	Giles	<b>Ground</b>	Wet	<b>Temperature (°F)</b>	60.00
<b>Municipality</b>	N/A	<b>Weather</b>	Cloudy	<b>Rain Gauge (in)</b>	1.40
				<b>Rain Accumulation Time (days)</b>	2.00

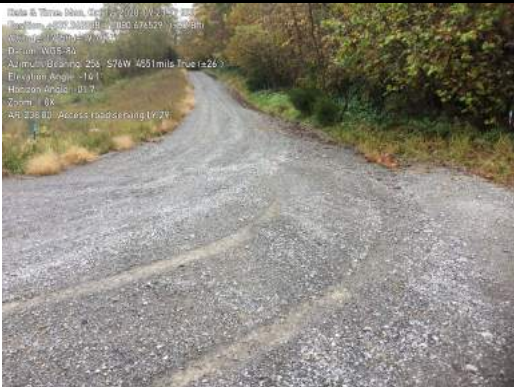
<b>GPS Location</b>	See photo GPS	<b>GPS Location</b>	See photo GPS		
<b>Field Station#</b>	12005+00	<b>Field Station#</b>	12005+00		
<b>Pic 1 Desc.</b>	AR-238.00- Access road serving LY- 29	<b>Pic 2 Desc.</b>	LY-29- Culvert and drainage feature.

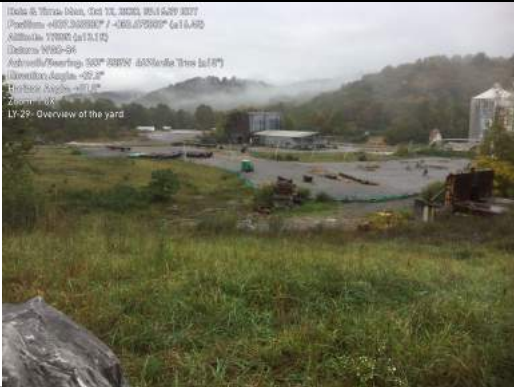
<b>GPS Location</b>	See photo GPS	<b>GPS Location</b>	See photo GPS		
<b>Field Station#</b>	12005+00	<b>Field Station#</b>	12005+00		
<b>Pic 3 Desc.</b>	LY-29- Over view of the yard.	<b>Pic 4 Desc.</b>	LY-29- CFS triple stack perimeter controls.

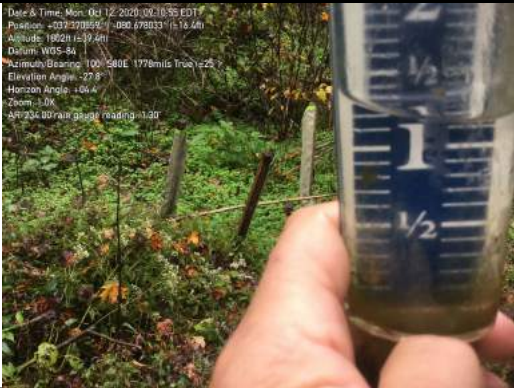
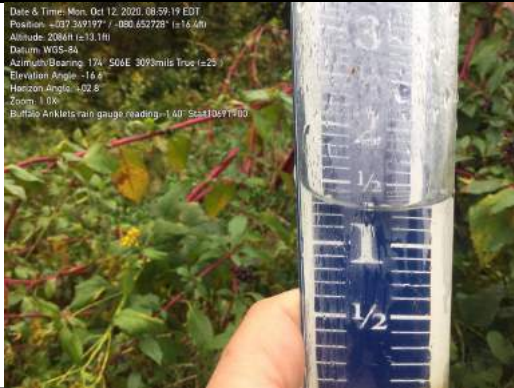
<b>GPS Location</b>	See photo GPS	<b>GPS Location</b>	See photo GPS		
<b>Field Station#</b>	11571+00	<b>Field Station#</b>	11671+00		
<b>Pic 5 Desc.</b>	AR-234.00 rain gauge reading- 1.30"	<b>Pic 6 Desc.</b>	Buffalo Anklets rain gauge reading- 1.40"

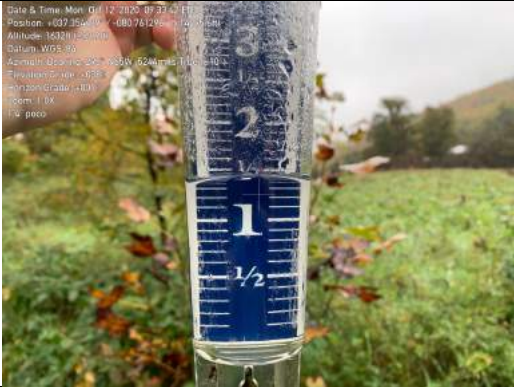
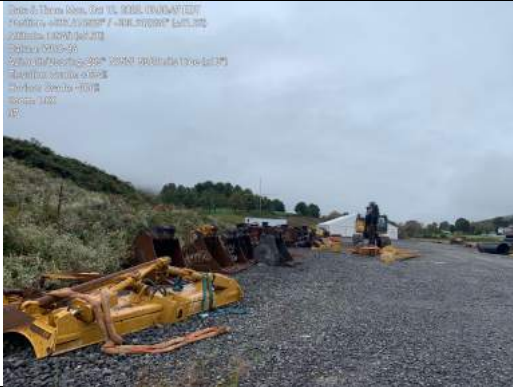
<b>GPS Location</b>	See picture above for GPS coordinates		<b>GPS Location</b>	See picture above for GPS coordinates	
<b>Field Station#</b>	+1		<b>Field Station#</b>	12005+00	
<b>Pic 1 Desc.</b>	1.4" of rain recorded		<b>Pic 2 Desc.</b>	ECD's and row conditions

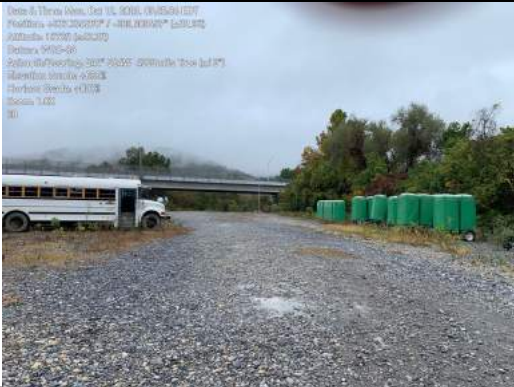
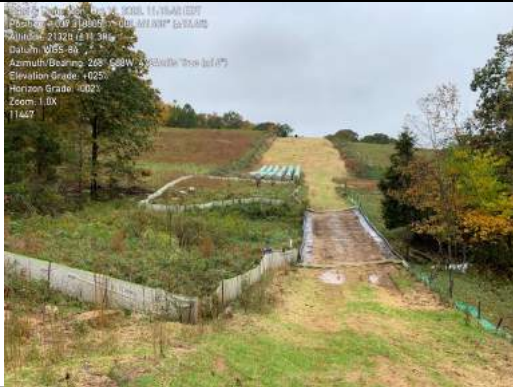
<b>GPS Location</b>	See picture above for GPS coordinates		<b>GPS Location</b>	See picture above for GPS coordinates	
<b>Field Station#</b>	12005+00		<b>Field Station#</b>	11447+00	
<b>Pic 3 Desc.</b>	ECD's and row conditions		<b>Pic 4 Desc.</b>	ECD's and row conditions

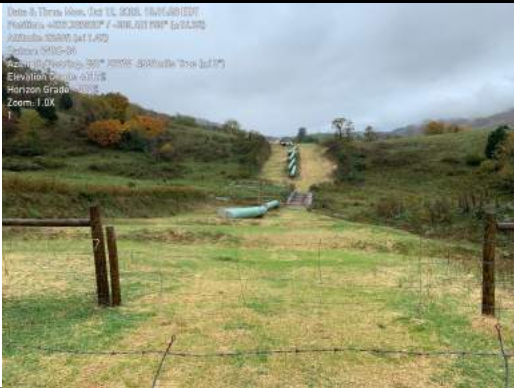
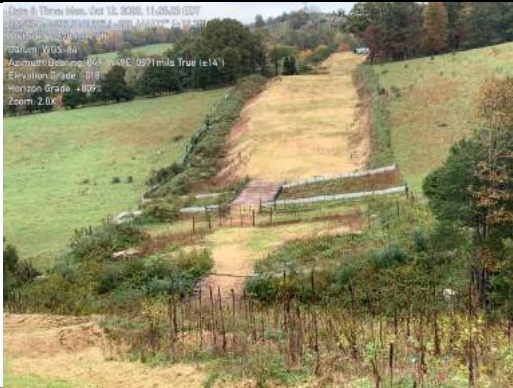
<b>GPS Location</b>	See picture above for GPS coordinates		<b>GPS Location</b>	See picture above for GPS coordinates	
<b>Field Station#</b>	11440+00		<b>Field Station#</b>	11460+00	
<b>Pic 5 Desc.</b>	ECD's and row conditions		<b>Pic 6 Desc.</b>	ECD's and row conditions

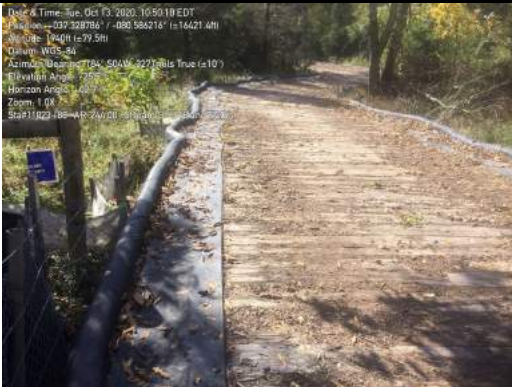
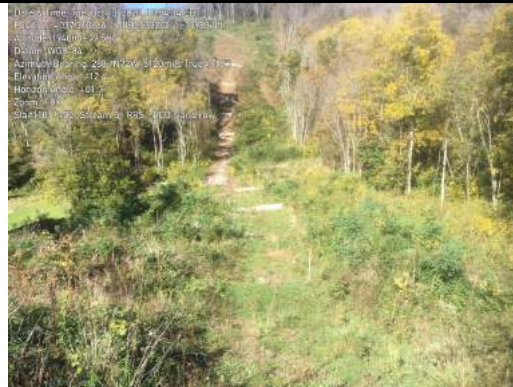
GPS Location		See photo GPS				GPS Location		See photo GPS			
Field Station#		11023+88				Field Station#		11019+00			
Pic 1 Desc.		Stream S- IJ18 ECD's				Pic 2 Desc.		Stream S- RR5 and row.

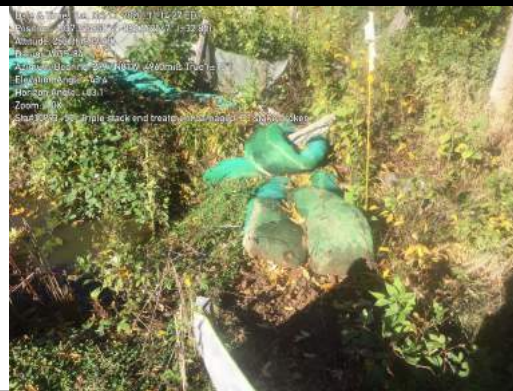
GPS Location		See photo GPS				GPS Location		See photo GPS			
Field Station#		10999+00				Field Station#		10993+50			
Pic 3 Desc.		Black snake on row.				Pic 4 Desc.		Bear damaged CFS end treatment, contractor notified and item punch listed.

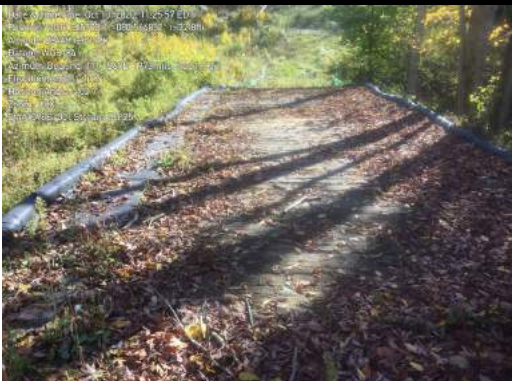
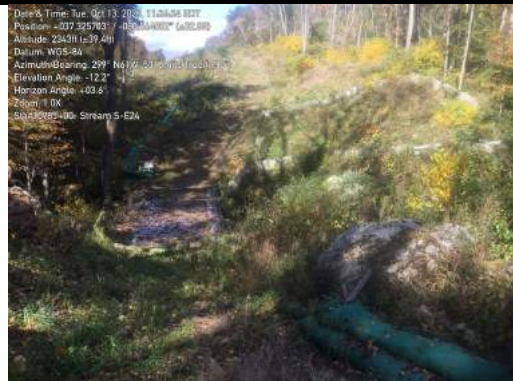
GPS Location		See photo GPS				GPS Location		See photo GPS			
Field Station#		10986+00				Field Station#		10985+00			
Pic 5 Desc.		Stream S- E25				Pic 6 Desc.		Stream S- E24

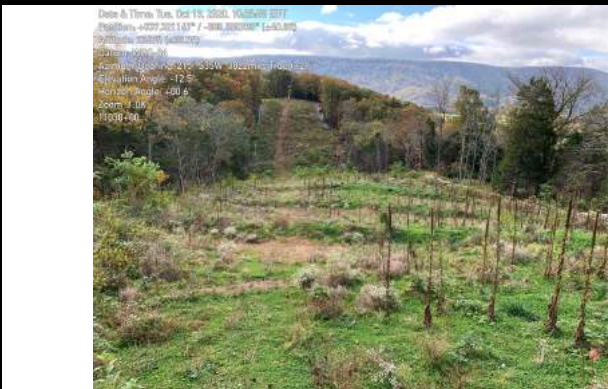
<p>Date &amp; Time: Tue, Oct 13, 2020 11:36:59 EDT Position: +027.3511437 / -089.4528907 (+15.7m) Altitude: 2070ft (+9.7m) Datum: WGS-84 Azimuth/Bearing: 125.348E 26.5mils True (+10.1) Elevation Angle: -12.5 Horizon Angle: -80.6 Zoom: 1.0X 11030+00</p>		
<b>GPS Location</b>	See photo for GPS location.		<b>GPS Location</b>	See photo for GPS location.	
<b>Field Station#</b>	10696+00		<b>Field Station#</b>	11030+00	
<b>Pic 1 Desc.</b>	RCE in place at Buffalo Anklets Road.		<b>Pic 2 Desc.</b>	ROW stabilized with natural vegetation. Waterbar in place.

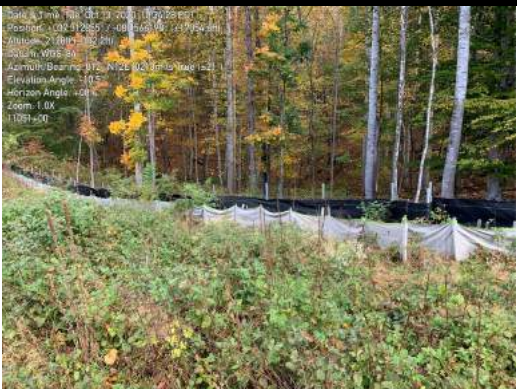
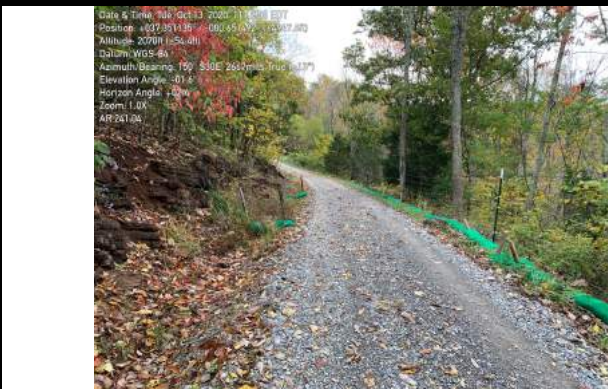
<b>GPS Location</b>	See photo for GPS location.		<b>GPS Location</b>	See photo for GPS location.	
<b>Field Station#</b>	11051+00		<b>Field Station#</b>	10711+00	
<b>Pic 3 Desc.</b>	Triple barrier ECDs in place at off ROW Karst feature.		<b>Pic 4 Desc.</b>	Compost filter sock in place along access road 241.04.

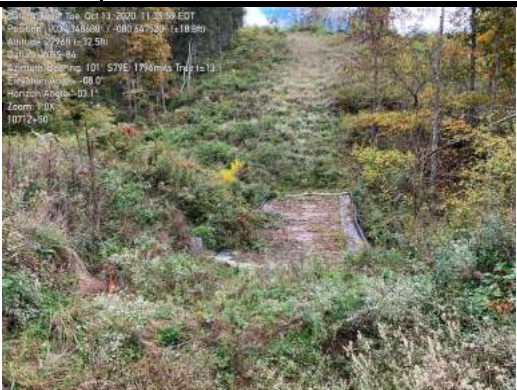
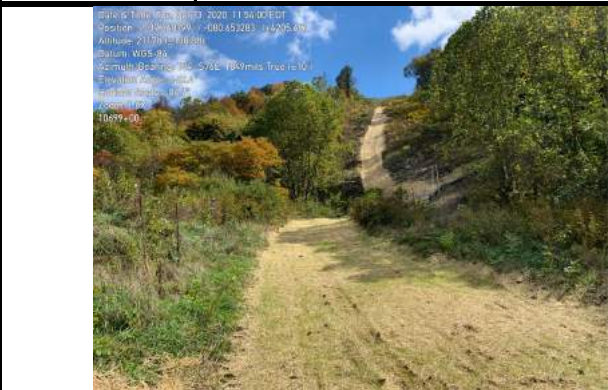
<b>Field Station#</b>	10712+50		<b>Field Station#</b>	10699+00	
<b>Pic 5 Desc.</b>	Sensitive resource buffer in place at stream S-G33.		<b>Pic 6 Desc.</b>	ROW stabilized with seed and mulch. ECB in place over step slope.

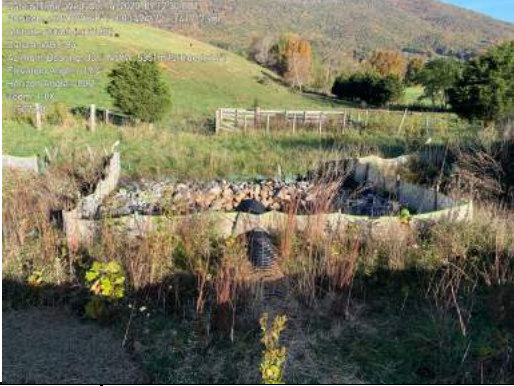
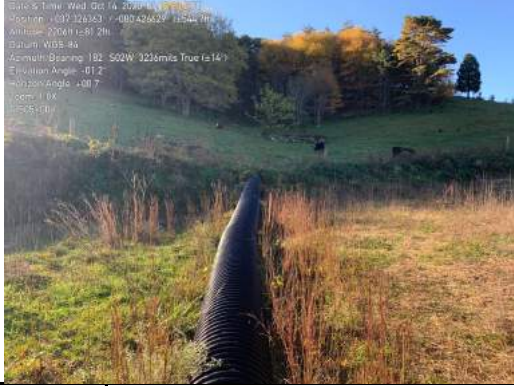
<b>GPS Location</b>	See photo for GPS location.		<b>GPS Location</b>	See photo for GPS location.	
<b>Field Station#</b>	11507+00		<b>Field Station#</b>	11505+00	
<b>Pic 1 Desc.</b>	Clean water diversion pipe and plunge pool in place.		<b>Pic 2 Desc.</b>	Clean water diversion pipe and clean water diversion berm in place.

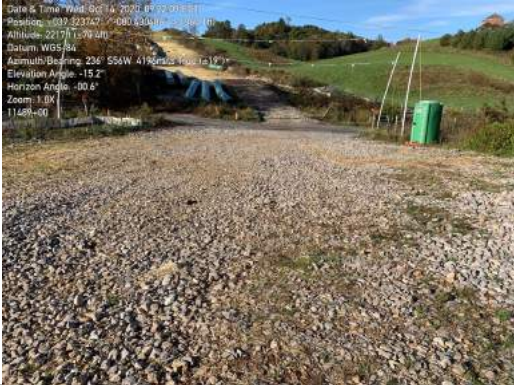
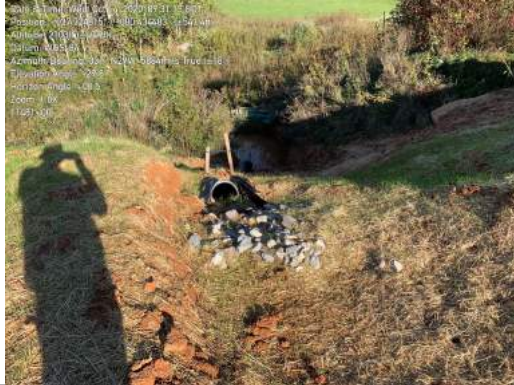
<b>GPS Location</b>	See photo for GPS location.		<b>GPS Location</b>	See photo for GPS location.	
<b>Field Station#</b>	11489+00		<b>Field Station#</b>	11481+00	
<b>Pic 3 Desc.</b>	RCE in place at Stevers Gap Road.		<b>Pic 4 Desc.</b>	Slope drain in place over fill slope.

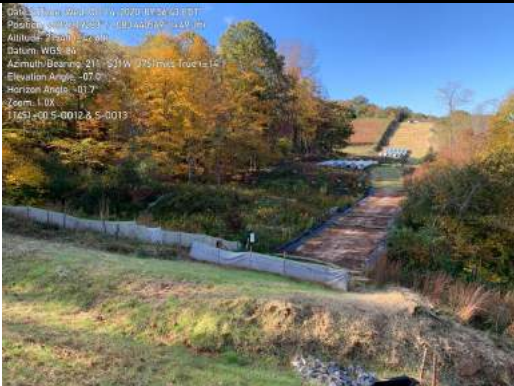
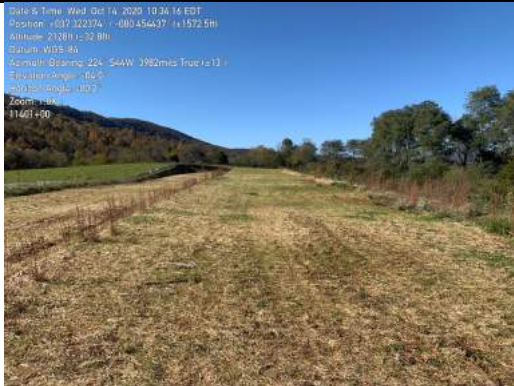
<b>GPS Location</b>	See photo for GPS location.		<b>GPS Location</b>	See photo for GPS location.	
<b>Field Station#</b>	11451+00		<b>Field Station#</b>	11401+00	
<b>Pic 5 Desc.</b>	Sensitive resource buffer in place at streams S-0012 and S-0013.		<b>Pic 6 Desc.</b>	ROW stabilized with seed and mulch. Minor vegetation growth present.

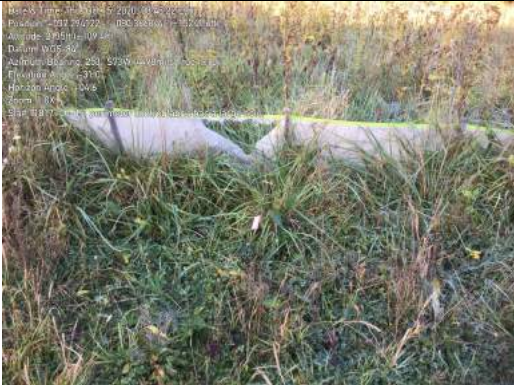
<b>GPS Location</b>	See photo GPS	<b>GPS Location</b>	See photo GPS		
<b>Field Station#</b>	11817+00	<b>Field Station#</b>	11835+00		
<b>Pic 1 Desc.</b>	P1 silt fence damaged, contractor notified, item added to the punch list.	<b>Pic 2 Desc.</b>	Level spreaders on slope.

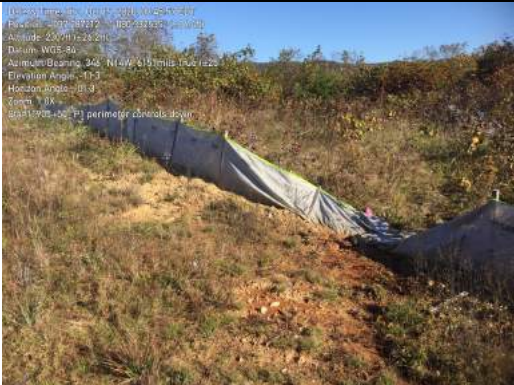
<b>GPS Location</b>	See photo GPS	<b>GPS Location</b>	See photo GPS		
<b>Field Station#</b>	11905+50	<b>Field Station#</b>	11947+00		
<b>Pic 3 Desc.</b>	P1 silt fence damaged by bear. Contractor notified and item added to the punch list.	<b>Pic 4 Desc.</b>	Row vegetation & perimeter controls.

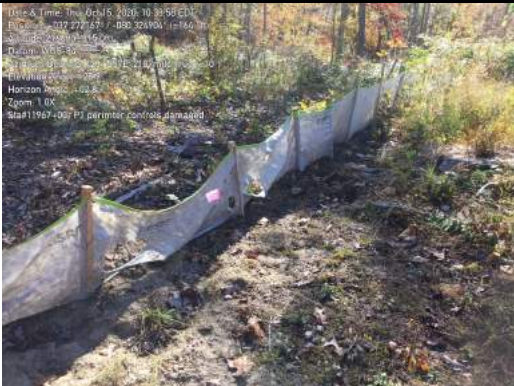
<b>GPS Location</b>	See photo GPS	<b>GPS Location</b>	See photo GPS		
<b>Field Station#</b>	11967+00	<b>Field Station#</b>	11979+00		
<b>Pic 5 Desc.</b>	P1 perimeter controls damaged by bear. Contractor notified and item added to the punch list.	<b>Pic 6 Desc.</b>	Karst ECD's.

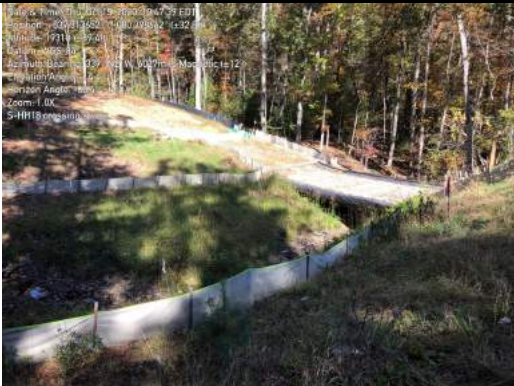
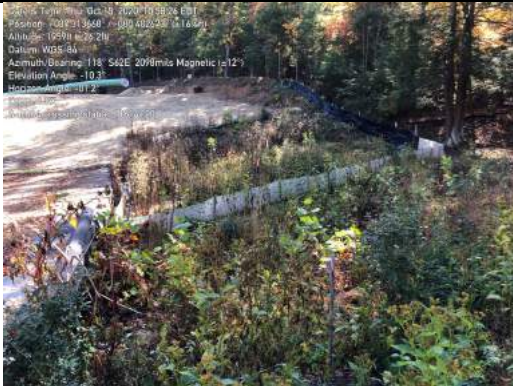
<b>GPS Location</b>		On photo		<b>GPS Location</b>	
<b>Field Station#</b>		11626+04		<b>Field Station#</b>	
<b>Pic 5 Desc.</b>		The S-HH18 crossing is stable with ECDs in place		<b>Pic 6 Desc.</b>	
				The S-RR14 crossing is stable with ECDs in place

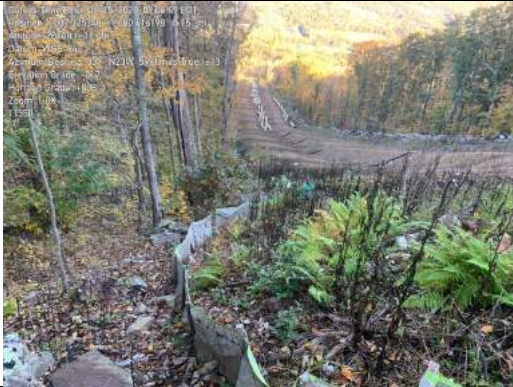
<b>GPS Location</b>	See picture above for GPS coordinates		<b>GPS Location</b>	See picture above for GPS coordinates	
<b>Field Station#</b>	11530+00		<b>Field Station#</b>	11550+00	
<b>Pic 1 Desc.</b>	ECD's and row conditions		<b>Pic 2 Desc.</b>	Damaged P1

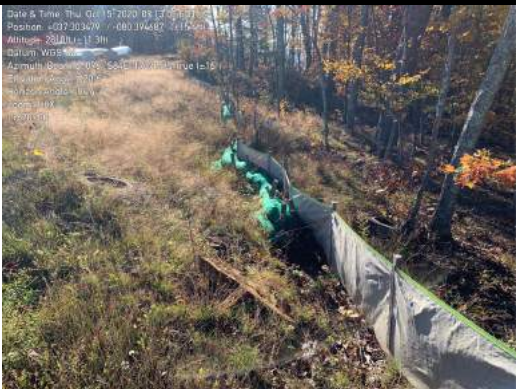
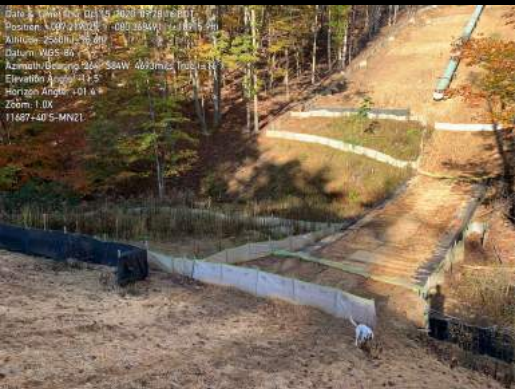
<b>GPS Location</b>	See photo for GPS location.		<b>GPS Location</b>	See photo for GPS location.	
<b>Field Station#</b>	11670+00		<b>Field Station#</b>	11687+40	
<b>Pic 1 Desc.</b>	Triple stack cfs and priority one silt fence in place along LOD.		<b>Pic 2 Desc.</b>	Sensitive resource buffer in place at stream S-MN21.

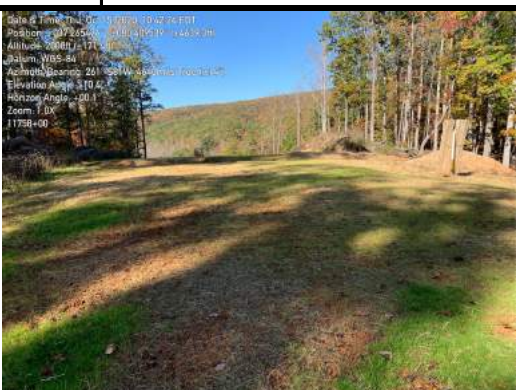
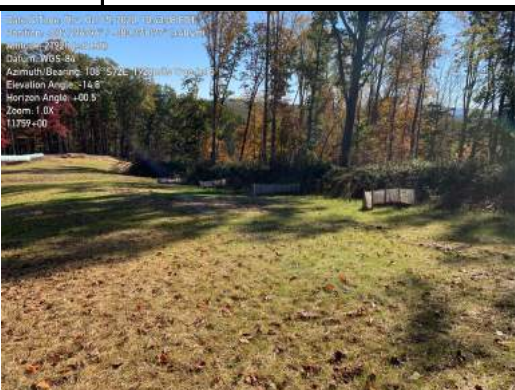
<b>GPS Location</b>	See photo for GPS location.		<b>GPS Location</b>	See photo for GPS location.	
<b>Field Station#</b>	11758+00		<b>Field Station#</b>	11759+00	
<b>Pic 3 Desc.</b>	ROW stabilized with seed and mulch. Minor vegetation growth present.		<b>Pic 4 Desc.</b>	Priority one silt fence checks in place.

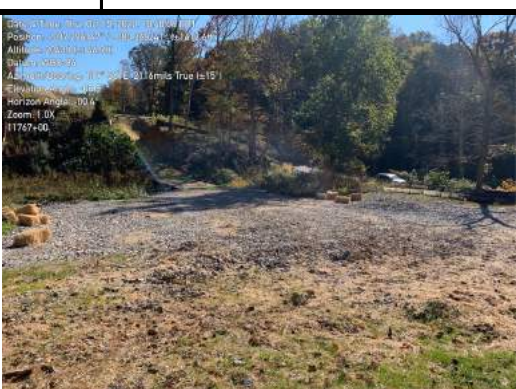
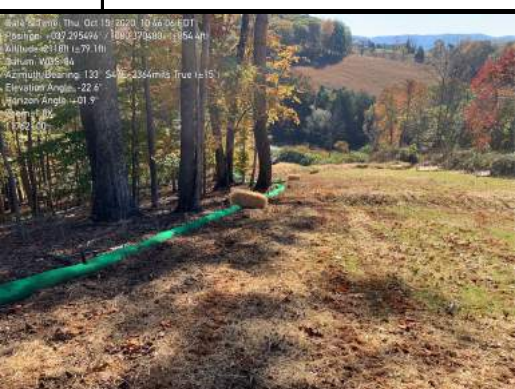
<b>GPS Location</b>	See photo for GPS location.		<b>GPS Location</b>	See photo for GPS location.	
<b>Field Station#</b>	11767+00		<b>Field Station#</b>	11762+00	
<b>Pic 5 Desc.</b>	RCE in place at MLV 26.		<b>Pic 6 Desc.</b>	Environmental crew replacing compost filter sock along LOD.
