# Visual Site Inspection Report

<b>Project Name</b>	H-600 Pipeline Spread G	<b>AFE</b>	124300137	<b>Spread</b>	H-600 Pipeline Spread G
<b>Contractor</b>	Precision			<b>Report #</b>	16918
<b>Inspector</b>	Len Kruizenga			<b>Date/Time</b>	11/16/2020 8:29 AM
<b>Permit #</b>	TBD	<b>Inspection Type</b>	VA SWPP	<b>Station Begin</b>	10930+00
<b>State</b>	VA	<b>Inspection Area</b>	Full	<b>Station End</b>	11064+53
<b>County</b>	Giles	<b>Ground</b>	Damp	<b>Temperature (°F)</b>	39.00
<b>Municipality</b>	N/A	<b>Weather</b>	Sunny	<b>Rain Gauge (in)</b>	0.00
				<b>Rain Accumulation Time (days)</b>	1.00

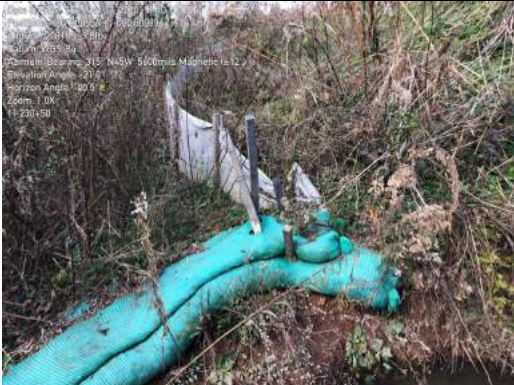
<b>GPS Location</b>	On photo	<b>GPS Location</b>	On photo		
<b>Field Station#</b>	11230+50	<b>Field Station#</b>	11231+70		
<b>Pic 1 Desc.</b>	P1 silt fence stake repair need identified. Contractor notified via punch list.	<b>Pic 2 Desc.</b>	P1 silt fence maintenance need identified. Contractor notified via punch list.

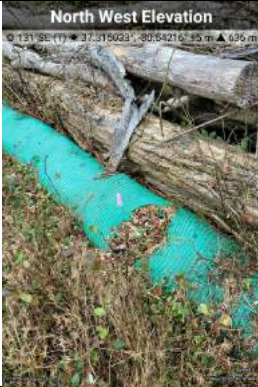
<b>GPS Location</b>	See photo		<b>GPS Location</b>	See Photo	
<b>Field Station#</b>	11070+50		<b>Field Station#</b>	11110+00	
<b>Pic 1 Desc.</b>	Compost Filter sock in need of repair		<b>Pic 2 Desc.</b>	stabilized ROW conditions

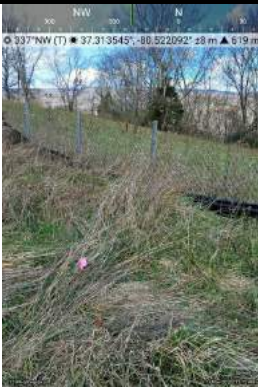
<b>GPS Location</b>	See Photo		<b>GPS Location</b>	See photo	
<b>Field Station#</b>	11128+00		<b>Field Station#</b>	11149+50	
<b>Pic 3 Desc.</b>	Installed Perimeter controls		<b>Pic 4 Desc.</b>	ssf in need of repair

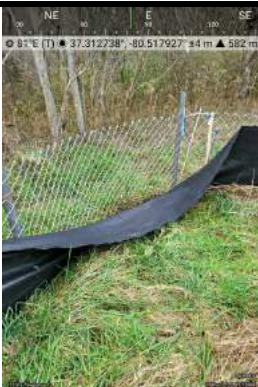
<b>GPS Location</b>	See Photo		<b>GPS Location</b>	See Photo	
<b>Field Station#</b>	11151+75		<b>Field Station#</b>	11182+30	
<b>Pic 5 Desc.</b>	ssf in need of repair		<b>Pic 6 Desc.</b>	silt fence in need of repair.

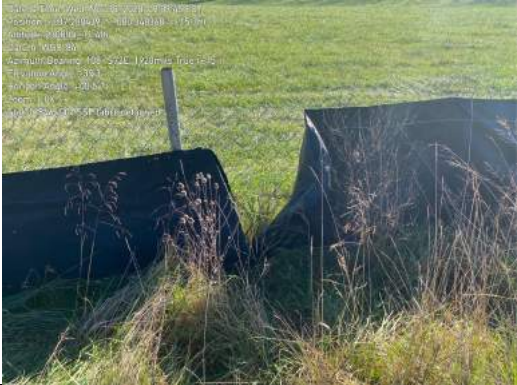
<b>GPS Location</b>	See photo GPS	<b>GPS Location</b>	See photo GPS		
<b>Field Station#</b>	11846+50	<b>Field Station#</b>	11846+50		
<b>Pic 7 Desc.</b>	Torn SSF fabric	<b>Pic 8 Desc.</b>	Repaired SSF fabric

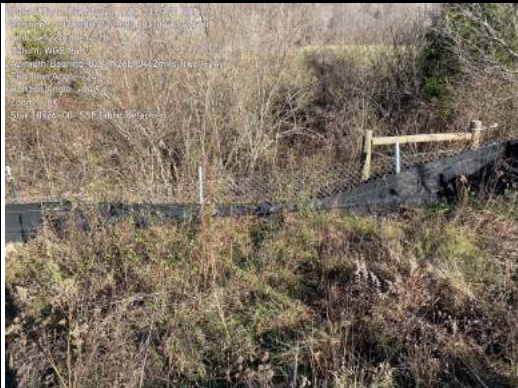
<b>GPS Location</b>	See photo GPS	<b>GPS Location</b>	See photo GPS		
<b>Field Station#</b>	10934+00	<b>Field Station#</b>	10934+00		
<b>Pic 9 Desc.</b>	SSF fabric detached from chain link	<b>Pic 10 Desc.</b>	Contractor has reattached fabric

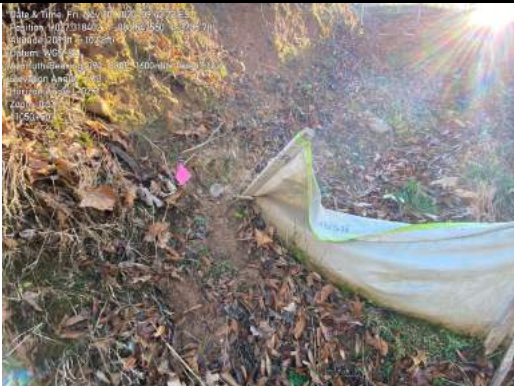
<b>GPS Location</b>	5	<b>GPS Location</b>	6		
<b>Field Station#</b>	11050+50	<b>Field Station#</b>	11055+00		
<b>Pic 5 Desc.</b>	Downed P-1. Item punch listed.	<b>Pic 6 Desc.</b>	Section of RoW showing conditions and controls.
