Visual Site Inspection Report

| Project Name | H-600 Pipeline Spread G | AFE | 124300137 | Spread | H-600 Pipeline Spread G |

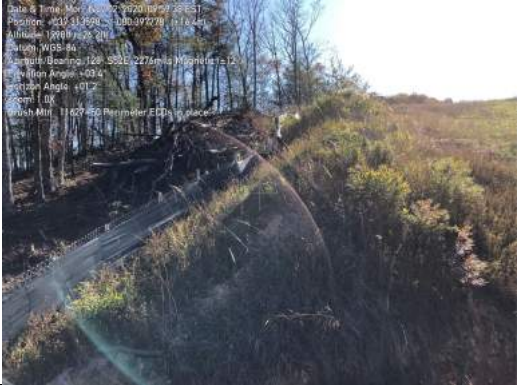
| Field Station# | 11627+50 | Field Station# | 11626+04 | | |

| Pic 7 Desc. | Perimeter controls are in place. | Pic 8 Desc. | The S-HH18 crossing is currently stable. No impact has occurred to the resource. | | |

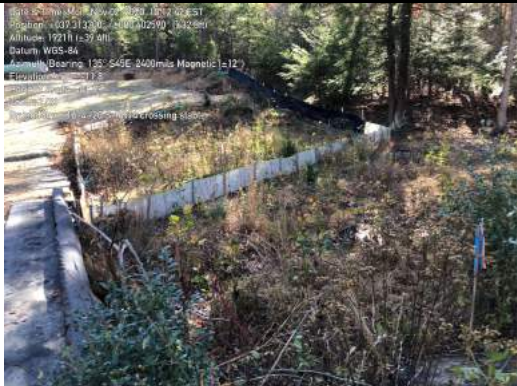
| Field Station# | 11614+20 | Field Station# | 11613+69 | | |

| Pic 9 Desc. | The S-RR14 crossing is stable with ECDs in place. | Pic 10 Desc. | The S-RR13 crossing at MN-258.04 is stable with ECDs in place. | | |

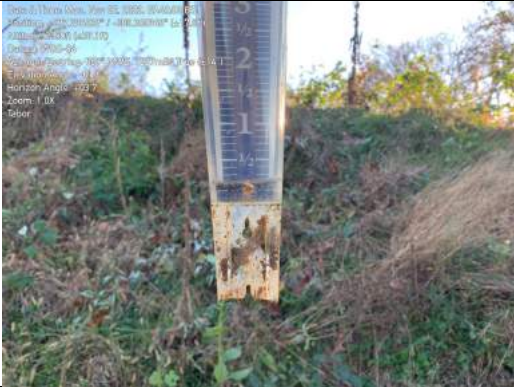
| Pic 1 Desc. | Checked rain gauge at Mount Tabor Road. Gauge reads 0.2 inches. | | Pic 2 Desc. | CFS and priority one silt fence in place along LOD. | |

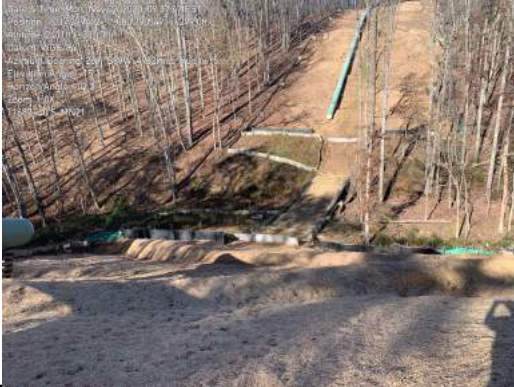
| Pic 3 Desc. | Sensitive resource buffer in place at stream S-MN21. | | Pic 4 Desc. | RCE in place at Main Line Valve 26 entrance. | |

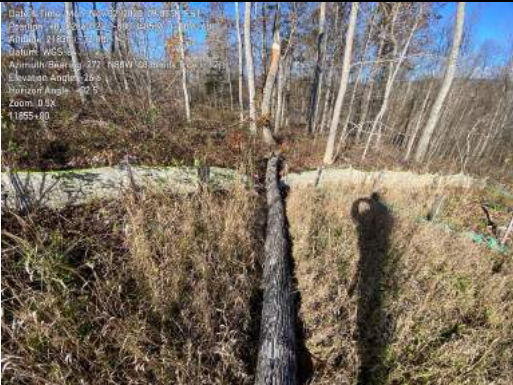
| Pic 3 Desc. | Section of restored RoW showing conditions and controls. | | Pic 4 Desc. | Tree fell in from off RoW onto the RoW damaging P-1 silt fence perimeter control. | |

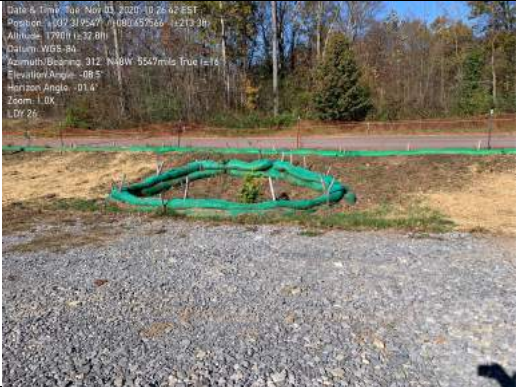
| Pic 1 Desc. | Triple stack cfs in place around drainage. | | Pic 2 Desc. | RCE in place at MLV 26 entrance. | |

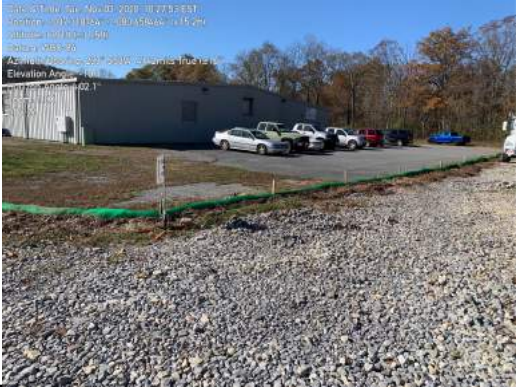
| Pic 3 Desc. | 18 inch compost filter sock in place along LOD. | | Pic 4 Desc. | Dumpsters being utilized for trash management | |

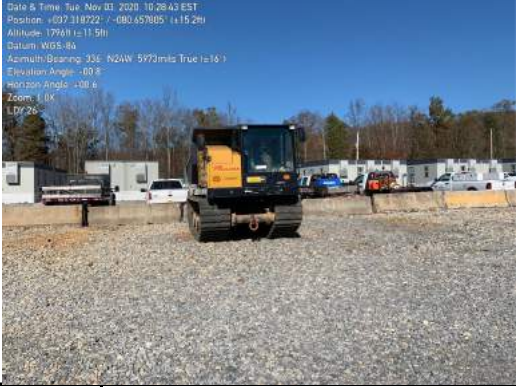
| Pic 5 Desc. | Checked staged equipment for leaks. | | Pic 6 Desc. | Secondary containment in place under fuel. | |

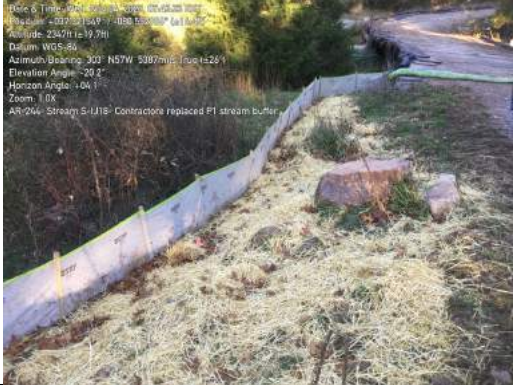
| Pic 1 Desc. | Contractor has replaced P1 buffer at stream. | Pic 2 Desc. | Row, water bars, stream S-RR5 | | |

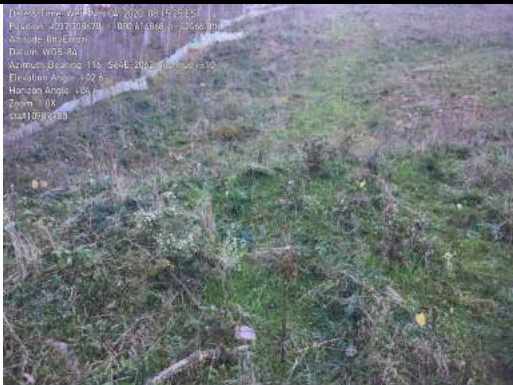
| Pic 3 Desc. | Steep slope perimeter controls. | Pic 4 Desc. | Stream S- E25 | | |

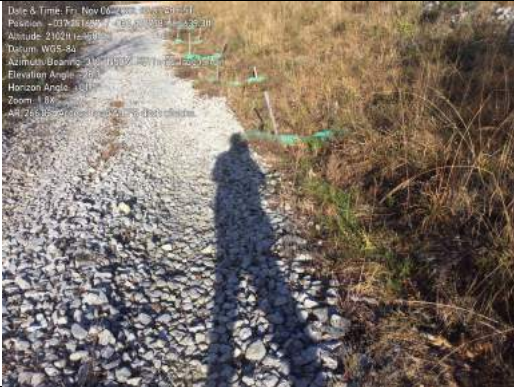
| Pic 1 Desc. | AR-266.03- Access road and CFS ditch check dams. | Pic 2 Desc. | Row vegetation, level spreaders, water bars, & ECD's. | | |

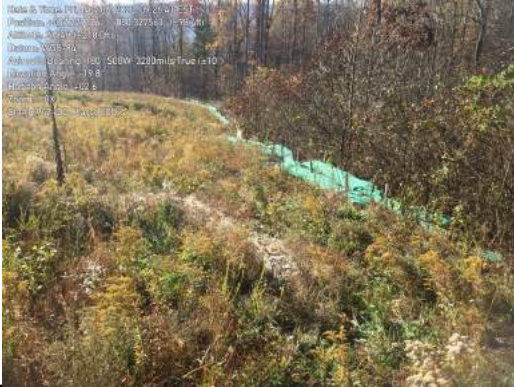
| Pic 3 Desc. | Karst ECD's | Pic 4 Desc. | Row condition & ECD's | | |

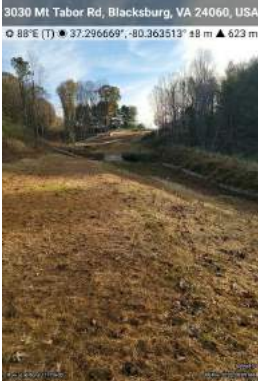
| Pic 1 Desc. | ROW stabilized with seed and mulch. Minor vegetation growth present. | | Pic 2 Desc. | CFS needs repaired. Item added to punchlist. | |

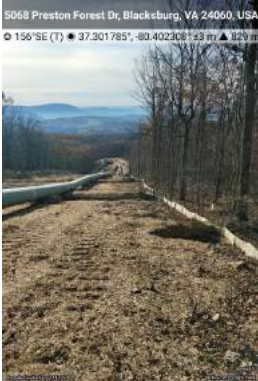
| Pic 3 Desc. | ROW stabilized with seed and mulch. ECDs in place. | | Pic 4 Desc. | ROW stabilized with seed and mulch. | |
