Visual Site Inspection Report

Project Name	H-600 Pipeline Spread G	AFE	124300137	Spread	H-600 Pipeline Spread G
Contractor	Precision			Report #	17199
Inspector	Chris Burns			Date/Time	11/23/2020 7:58 AM
Permit #	TBD	Inspection Type	VA SWPP	Station Begin	11254+99
State	VA	Inspection Area	Partial	Station End	11353+67
County	Giles	Ground	Damp	Temperature (°F)	45.00
Municipality	N/A	Weather	Sunny	Rain Gauge (in)	0.00
				Rain Accumulation Time (days)	1.00

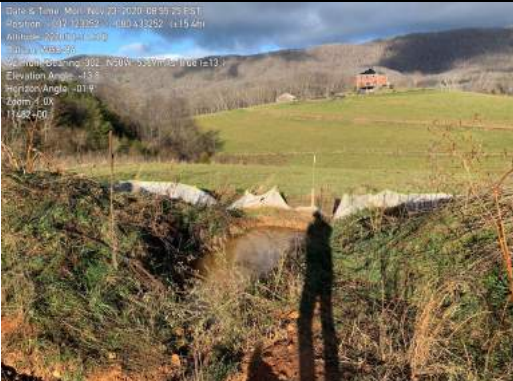
GPS Location	See photo for GPS location.		GPS Location	See photo for GPS location.	
Field Station#	11489+00		Field Station#	11482+00	
Pic 3 Desc.	RCE in place at Stevers Gap Road.		Pic 4 Desc.	Priority one silt fence damaged by animals.

E&S BMPs	Compliance Level	Corrective Action	Corrective Time Frame	Date Repaired
Cleanwater Diversion Berm	Acceptable			
Broad-Based Dip	Acceptable			
Cleanwater Diversion Pipe	Acceptable			
Compost Filter Sock	Acceptable			
Equipment Bridge	Acceptable			
Sensitive Resource Buffer	Acceptable			
Silt Fence (Filter Fabric Fence)	Communication	Repair damaged silt fence.	24 Hours	
Housekeeping	Acceptable			
Waterbar	Acceptable

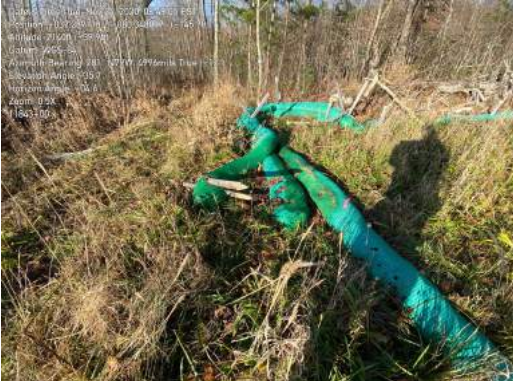
GPS Location	3	GPS Location	4		
Field Station#	11841+00	Field Station#	11843+00		
Pic 3 Desc.	Section of restored RoW showing conditions and controls.		Pic 4 Desc.	Wildlife damage to CFS.

E&S BMPs	Compliance Level	Corrective Action	Corrective Time Frame	Date Repaired
Compost Filter Sock	Communication	Repair damaged CFS	24 Hours	
Housekeeping	Acceptable			
Rock Construction Entrance	Acceptable			
Silt Fence (Filter Fabric Fence)	Communication	Repair damaged or downed P-1	24 Hours	
Silt Fence (Reinforce Filter Fence)	Acceptable			
Vegetative Stabilization (Temporary)	Acceptable			
Waterbar	Acceptable			
Waterbar End Treatment	Acceptable			
Waterbar Outlet Protection	Acceptable

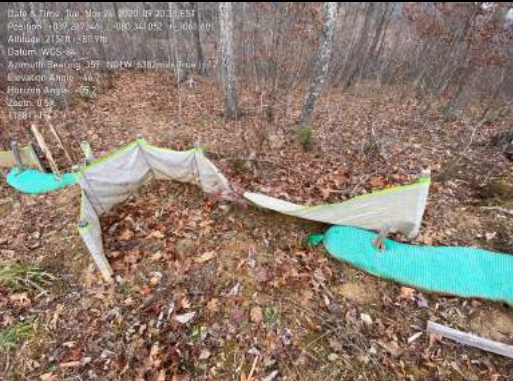
GPS Location	5	GPS Location	6		
Field Station#	11863+65	Field Station#	11881+15		
Pic 5 Desc.	P-KL2 and controls.		Pic 6 Desc.	Wildlife damage to P-1 silt fence.

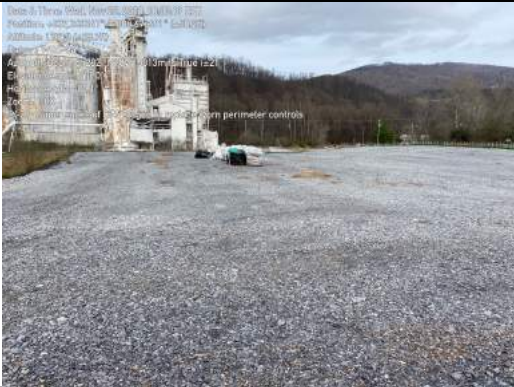
GPS Location	See photo GPS		GPS Location	See photo GPS	
Field Station#	12005+00		Field Station#	12005+00	
Pic 3 Desc.	Super sacks of CFS staged to replace worn perimeter controls.		Pic 4 Desc.	CFS triple stack perimeter controls.

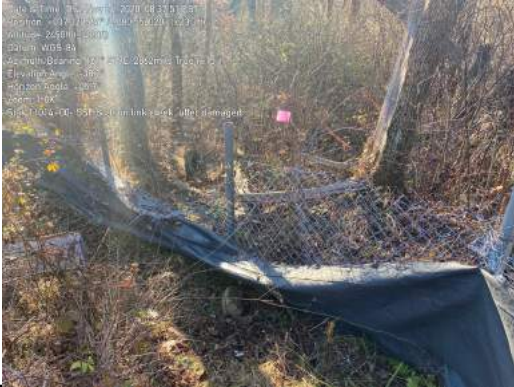
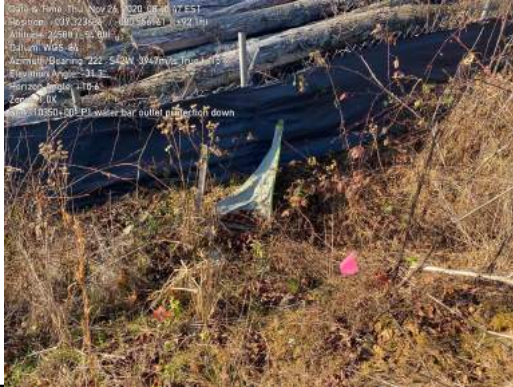
GPS Location	See photo GPS		GPS Location	See photo GPS	
Field Station#	11014+00		Field Station#	11013+50	
Pic 3 Desc.	SSF fabric detached from chain link and chain link damaged above stream S-RR5. Item punch listed		Pic 4 Desc.	P1 water bar outlet protection is down. Item punch listed.

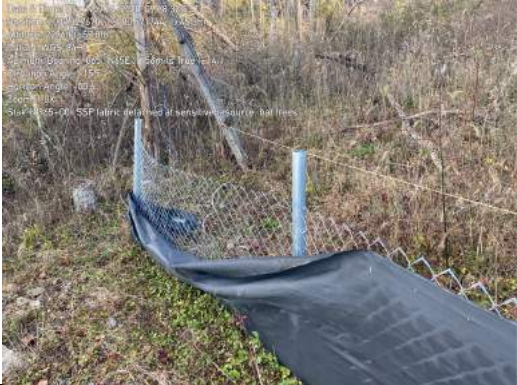
GPS Location	See photo GPS	GPS Location	See photo GPS		
Field Station#	10965+00	Field Station#	10963+65		
Pic 7 Desc.	SSF fabric detached from chain link at sensitive resource area. (Bat habitat).	Pic 8 Desc.	P1 stake broken off and holes in fabric at drainage feature.		
Insert image here		Insert image here			
GPS Location		GPS Location			
Field Station#		Field Station#			
Pic 9 Desc.		Pic 10 Desc.			
Insert image here		Insert image here			
GPS Location		GPS Location			
Field Station#		Field Station#			
Pic 11 Desc.		Pic 12 Desc.

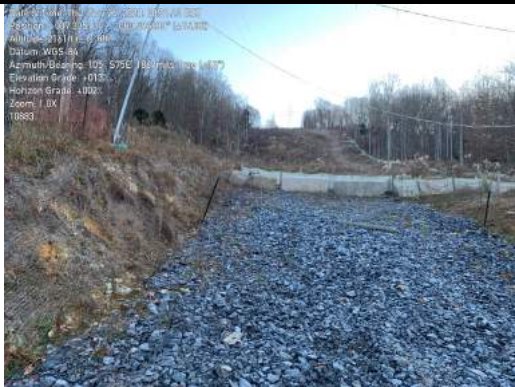
GPS Location	See picture above for GPS coordinates		GPS Location	See picture above for GPS coordinates	
Field Station#	10881+00		Field Station#	10883+00	
Pic 3 Desc.	ECD's and row conditions		Pic 4 Desc.	Damaged curlex and cowboy gap

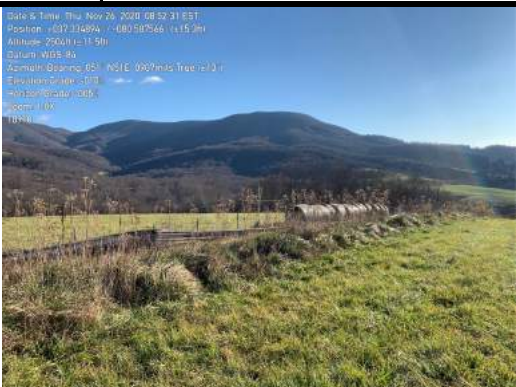
GPS Location	See picture above for GPS coordinates		GPS Location	See picture above for GPS coordinates	
Field Station#	10910+00		Field Station#	+1	
Pic 5 Desc.	Damaged SSF		Pic 6 Desc.	.3" of rain recorded

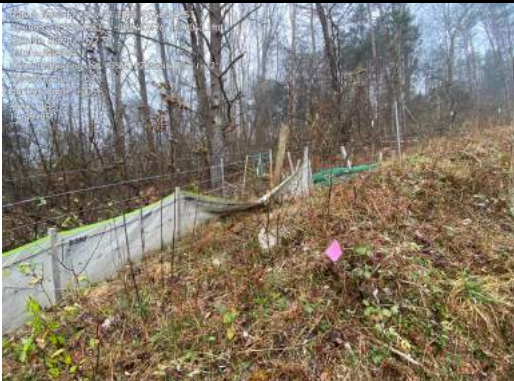
GPS Location	5	GPS Location	6		
Field Station#	11345+85	Field Station#	11352+97		
Pic 5 Desc.	Damaged P-1 perimeter controls.	Pic 6 Desc.	S-NN11 and controls.
