# Visual Site Inspection Report

<b>Project Name</b>	H-600 Pipeline Spread G	<b>AFE</b>	124300137	<b>Spread</b>	H-600 Pipeline Spread G
<b>Contractor</b>	Precision			<b>Report #</b>	17455
<b>Inspector</b>	Chris Burns			<b>Date/Time</b>	11/30/2020 8:01 AM
<b>Permit #</b>	TBD	<b>Inspection Type</b>	VA SWPP	<b>Station Begin</b>	11788+52
<b>State</b>	VA	<b>Inspection Area</b>	Partial	<b>Station End</b>	11899+99
<b>County</b>	Montgomery	<b>Ground</b>	Wet	<b>Temperature (°F)</b>	46.00
<b>Municipality</b>	N/A	<b>Weather</b>	Light Rain	<b>Rain Gauge (in)</b>	1.00
				<b>Rain Accumulation Time (days)</b>	0.00

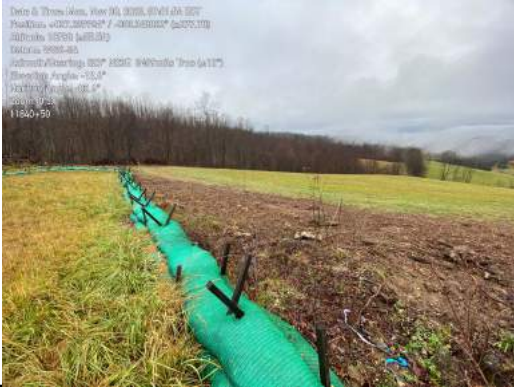
<b>GPS Location</b>	3	<b>GPS Location</b>	4		
<b>Field Station#</b>	11840+50	<b>Field Station#</b>	11844+00		
<b>Pic 3 Desc.</b>	Landowner disturbance tract VA-MO-5528.	<b>Pic 4 Desc.</b>	Minor damage to P-1.

E&S BMPs	Compliance Level	Corrective Action	Corrective Time Frame	Date Repaired
Compost Filter Sock	Communication	Repair holes (3 day)		
Housekeeping	Acceptable			
Rock Construction Entrance	Acceptable			
Silt Fence (Filter Fabric Fence)	Acceptable			
Silt Fence (Reinforce Filter Fence)	Communication	Repair damaged P-1	24 Hours	
Vegetative Stabilization (Temporary)	Acceptable			
Waterbar	Acceptable			
Waterbar End Treatment	Acceptable			
Waterbar Outlet Protection	Acceptable

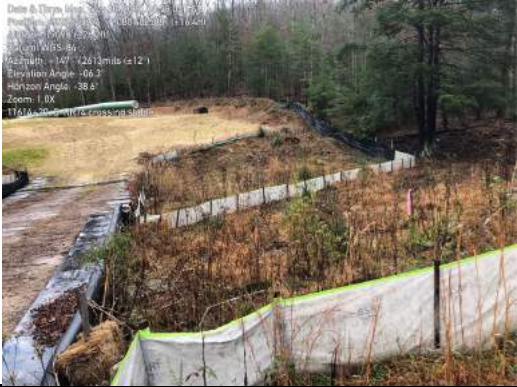
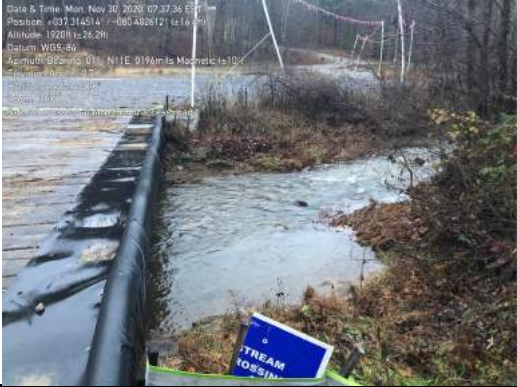
<b>GPS Location</b>	On photo	<b>GPS Location</b>	On photo		
<b>Field Station#</b>	11614+20	<b>Field Station#</b>	11613+69		
<b>Pic 7 Desc.</b>	The S-RR14 crossing is stable with ECDs in place.	<b>Pic 8 Desc.</b>	The S-RR13 crossing is currently stable at the MN-258.04 access road.

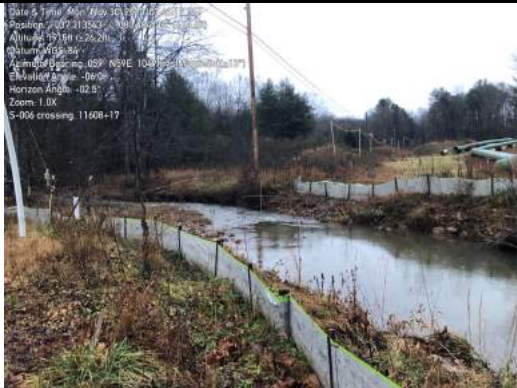
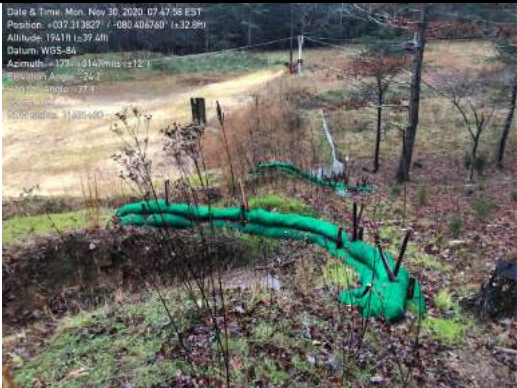
<b>GPS Location</b>	On photo	<b>GPS Location</b>	On photo		
<b>Field Station#</b>	11608+17	<b>Field Station#</b>	11601+00		
<b>Pic 9 Desc.</b>	The S-006 crossing is currently stable with ECDs in place.	<b>Pic 10 Desc.</b>	Perimeter controls are in place.		
Insert image here		Insert image here			
<b>GPS Location</b>		<b>GPS Location</b>			
<b>Field Station#</b>		<b>Field Station#</b>			
<b>Pic 11 Desc.</b>		<b>Pic 12 Desc.</b>

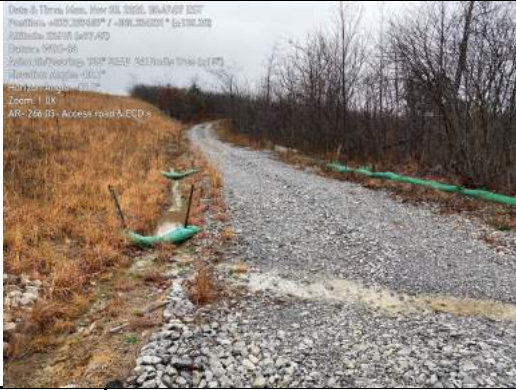
<b>GPS Location</b>	See photo GPS	<b>GPS Location</b>	See photo GPS		
<b>Field Station#</b>	11989+00	<b>Field Station#</b>	11900+00		
<b>Pic 1 Desc.</b>	Catawba rain gauge reading- 1.00"	<b>Pic 2 Desc.</b>	AR-266.03- Access road and ECD's.

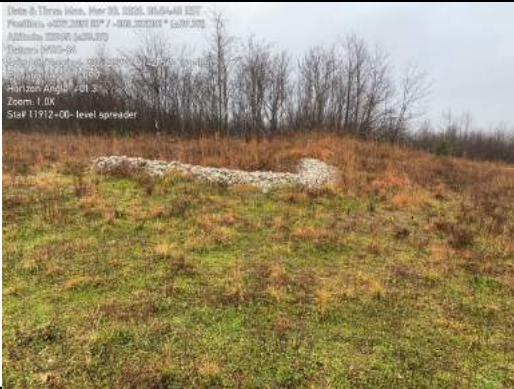
<b>GPS Location</b>	See photo GPS	<b>GPS Location</b>	See photo GPS		
<b>Field Station#</b>	11912+00	<b>Field Station#</b>	11921+00		
<b>Pic 3 Desc.</b>	Level spreader	<b>Pic 4 Desc.</b>	Water bar outlet protection and perimeter controls.

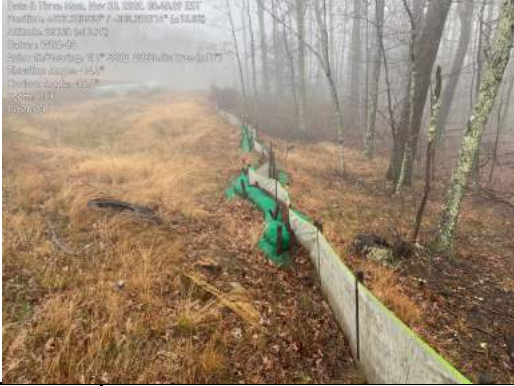
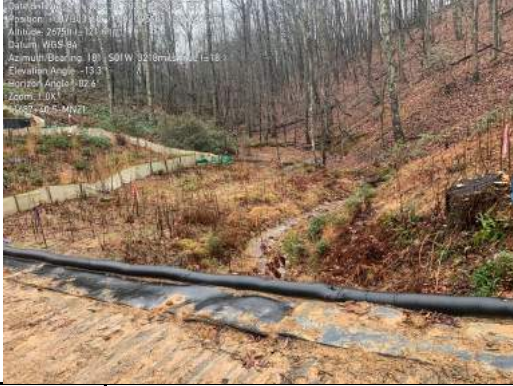
<b>GPS Location</b>	See photo for GPS location.		<b>GPS Location</b>	See photo for GPS location.	
<b>Field Station#</b>	11670+00		<b>Field Station#</b>	11687+00	
<b>Pic 1 Desc.</b>	Triple stack compost filter sock and priority one silt fence in place along LOD.		<b>Pic 2 Desc.</b>	Sensitive resource buffer in place at stream S-MN21.

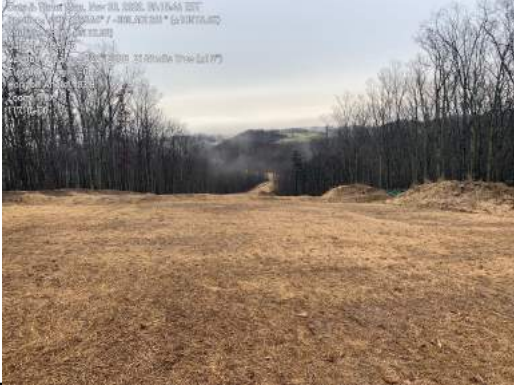
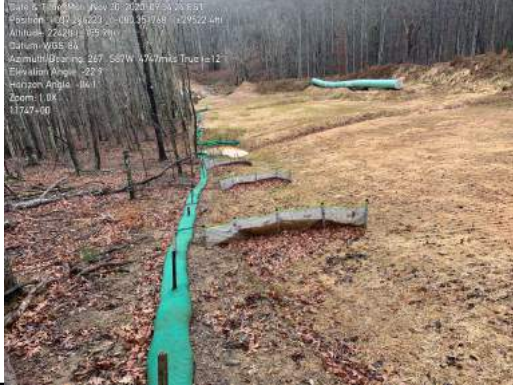
<b>GPS Location</b>	See photo for GPS location.		<b>GPS Location</b>	See photo for GPS location.	
<b>Field Station#</b>	11710+00		<b>Field Station#</b>	11747+00	
<b>Pic 3 Desc.</b>	ROW stabilized with seed and mulch.		<b>Pic 4 Desc.</b>	Priority one silt fence checks in place.

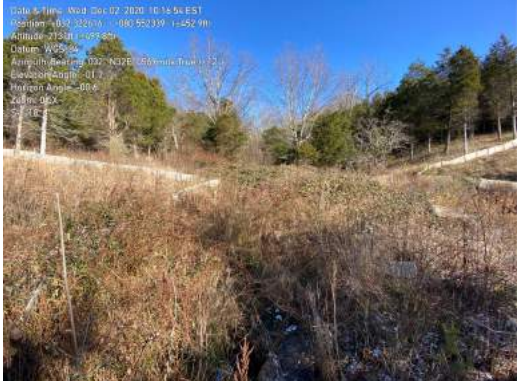
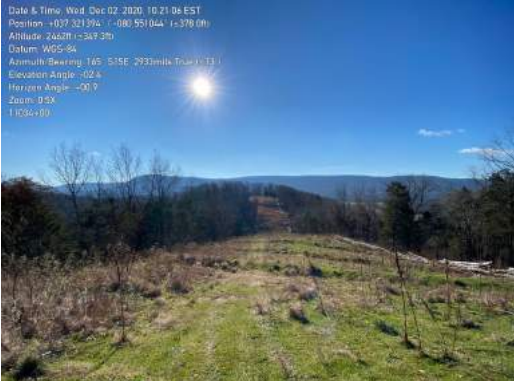
GPS Location	1	GPS Location	2		
Field Station#	11025+50	Field Station#	11034+00		
Pic 1 Desc.	S-IJ18 and controls.	Pic 2 Desc.	Section of RoW showing conditions and controls.

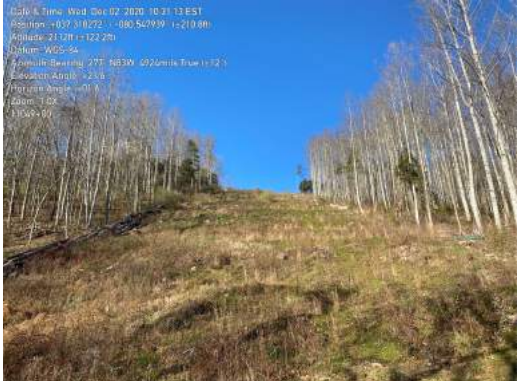
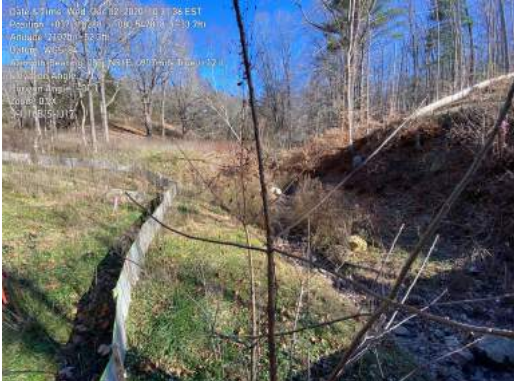
GPS Location	3	GPS Location	4		
Field Station#	11049+00	Field Station#	11050+10		
Pic 3 Desc.	Section of RoW showing conditions and controls.	Pic 4 Desc.	S-IJ16B/S-IJ17 and controls.

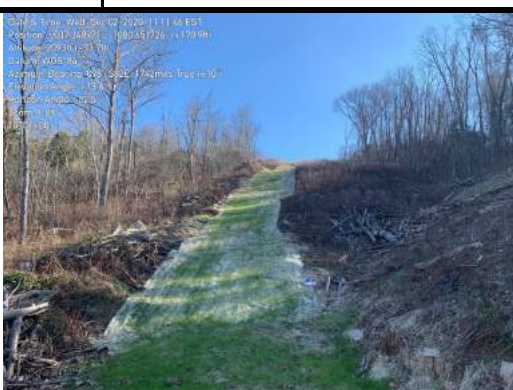
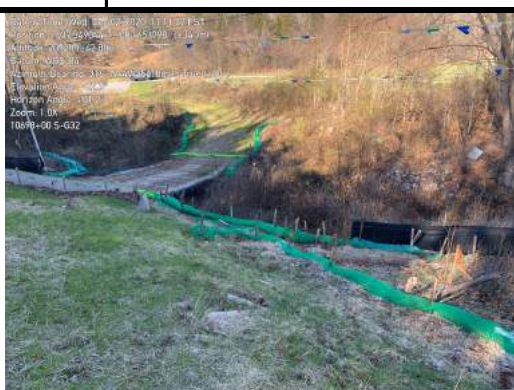
GPS Location	See photo for GPS location.		GPS Location	See photo for GPS location.	
Field Station#	10701+00		Field Station#	10698+00	
Pic 3 Desc.	Steep slope stabilized with ECB.		Pic 4 Desc.	Sensitive resource buffer in place at stream S-G32.

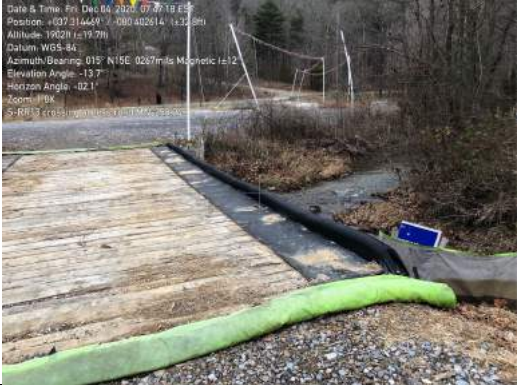
<p> <small> Date &amp; Time: Fri, Dec 04, 2020, 07:45:18 EST  Position: +037.314449° / -550.482614° (+12.8m)  Altitude: 1902ft (+19.7m)  Datum: WGS-84  Azimuth/Bearing: 015° N/SE 0267mils Magnetic (+12°)  Elevation Angle: -13.7°  Horizon Angle: -02.1°  Zoom: 1.0X  S-RR13 crossing 11613+69 </small> </p>			
<b>GPS Location</b>	On photo	<b>GPS Location</b>	On photo		
<b>Field Station#</b>	11614+20	<b>Field Station#</b>	11613+69		
<b>Pic 7 Desc.</b>	The S-RR14 crossing is stable with ECDs in place.	<b>Pic 8 Desc.</b>	The S-RR13 crossing on access road MN-258.04 is in compliance.

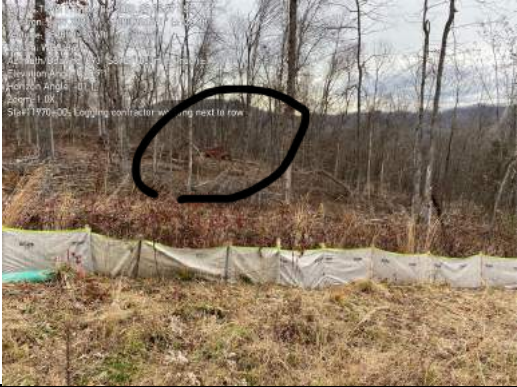
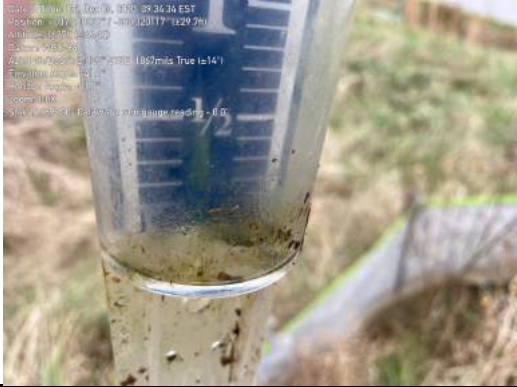
<b>GPS Location</b>	See photo GPS	<b>GPS Location</b>	See photo GPS		
<b>Field Station#</b>	11970+00	<b>Field Station#</b>	11989+00		
<b>Pic 7 Desc.</b>	Logging contractor working adjacent to row	<b>Pic 8 Desc.</b>	Catawba rain gauge reading- 0.00"

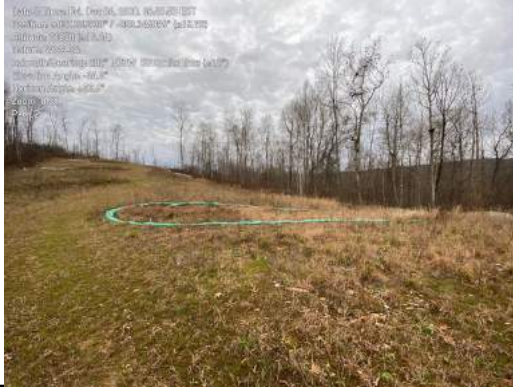
<b>GPS Location</b>	3	<b>GPS Location</b>	4		
<b>Field Station#</b>	11840+82	<b>Field Station#</b>	11863+65		
<b>Pic 3 Desc.</b>	Area to be seeded and stabilized due to landowner disturbance on tract VA-MO-5528.	<b>Pic 4 Desc.</b>	P-KL2 and controls.

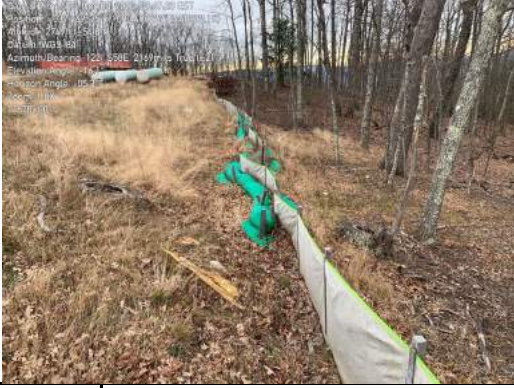
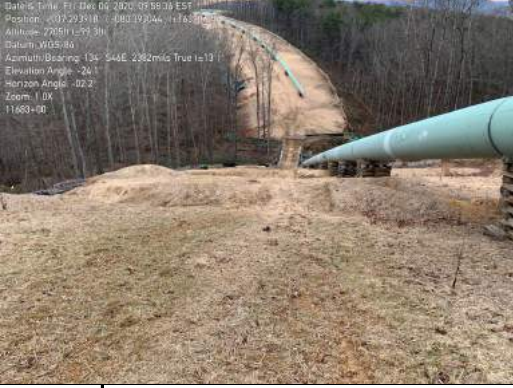
<b>GPS Location</b>	See photo for GPS location.		<b>GPS Location</b>	See photo for GPS location.	
<b>Field Station#</b>	11670+00		<b>Field Station#</b>	11683+00	
<b>Pic 1 Desc.</b>	Triple stack compost filter sock and priority one silt in place along LOD.		<b>Pic 2 Desc.</b>	ROW stabilized with seed and mulch.

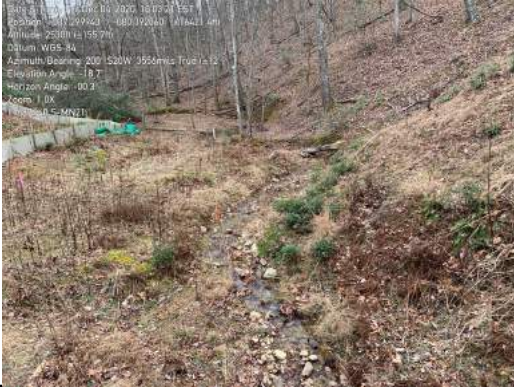
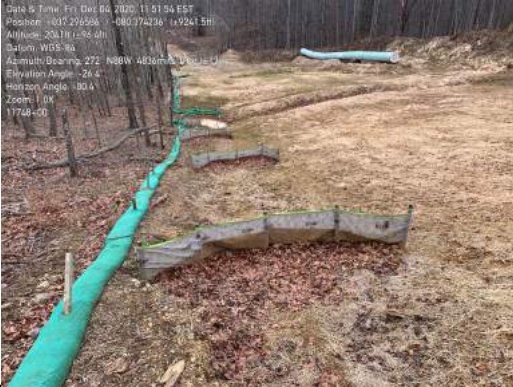
<b>GPS Location</b>	See photo for GPS location.		<b>GPS Location</b>	See photo for GPS location.	
<b>Field Station#</b>	11687+40		<b>Field Station#</b>	11748+00	
<b>Pic 3 Desc.</b>	Stream bed conditions at stream S-MN21.		<b>Pic 4 Desc.</b>	Priority one silt fence checks in place.

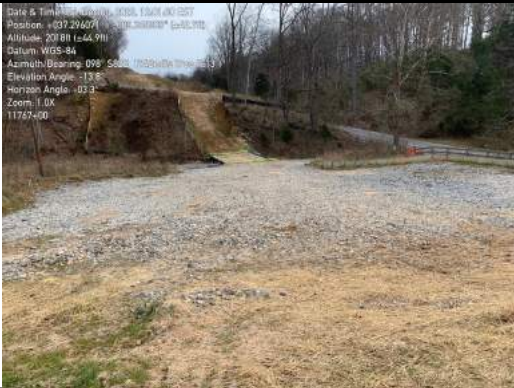
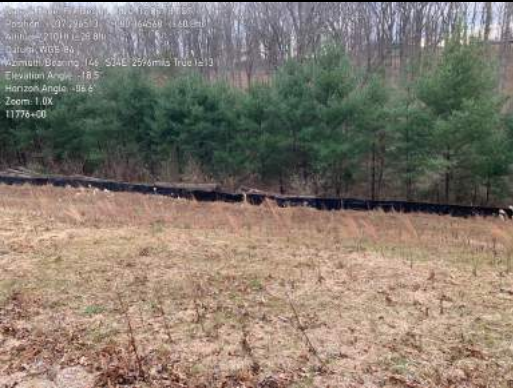
<b>GPS Location</b>	See photo for GPS location.		<b>GPS Location</b>	See photo for GPS location.	
<b>Field Station#</b>	11767+00		<b>Field Station#</b>	11776+00	
<b>Pic 5 Desc.</b>	RCE in place at Main Line Valve 26.		<b>Pic 6 Desc.</b>	Reinforced super silt fence fence in place along LOD.
