Visual Site Inspection Report

Project Name	H-600 Pipeline Spread G	AFE	124300137	Spread	H-600 Pipeline Spread G
Contractor	Precision			Report #	16591
Inspector	Len Kruizenga			Date/Time	11/9/2020 9:01 AM
Permit #	TBD	Inspection Type	VA SWPP	Station Begin	12005+00
State	VA	Inspection Area	Full	Station End	12005+00
County	Giles	Ground	Dry	Temperature (°F)	67.00
Municipality	N/A	Weather	Sunny	Rain Gauge (in)	0.00
				Rain Accumulation Time (days)	1.00

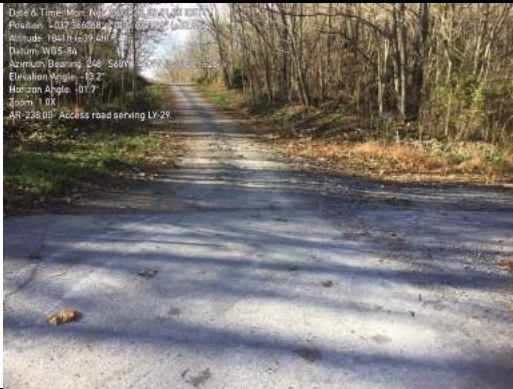
<p>Date & Time: Mon, Nov 9, 2020, 09:01:00 AM Position: 4227.345404°N 77°40'00.0000°W Elevation: 1041 ft (317.27 m) Datum: WGS-84 Azimuth Bearing: 242° 54'00" (428.0000° True) Elevation Angle: -13.2° Horizon Angle: -01.7° Zoom: 1.0x LY-29: Access road serving LY-29.</p>

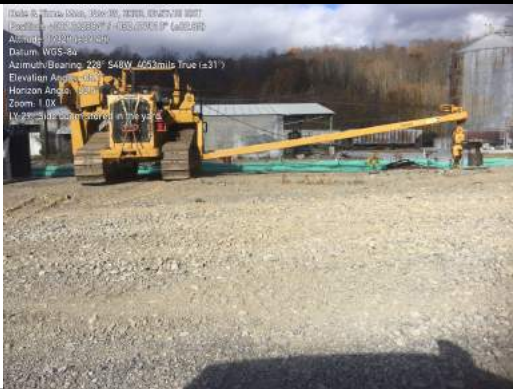
<p>Date & Time: Mon, Nov 9, 2020, 09:05:00 AM Position: 4227.345404°N 77°40'00.0000°W Elevation: 1041 ft (317.27 m) Datum: WGS-84 Azimuth Bearing: 228° 54'00" (453.0000° True) Elevation Angle: -16.0° Horizon Angle: -01.7° Zoom: 1.0x LY-29: Side boom stored in the yard.</p>

GPS Location	See photo GPS	GPS Location	See photo GPS		
Field Station#	12005+00	Field Station#	12005+00		
Pic 3 Desc.	LY-29- Side boom stored in the yard.	Pic 4 Desc.	The contractor is hauling out CFS that has been replaced by new controls.

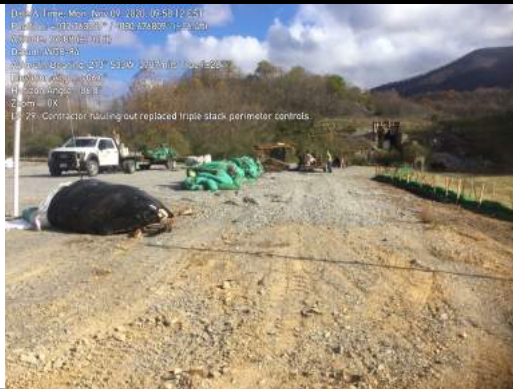
<p>Date & Time: Mon, Nov 9, 2020, 09:07:00 AM Position: 4227.345404°N 77°40'00.0000°W Elevation: 1041 ft (317.27 m) Datum: WGS-84 Azimuth Bearing: 270° 54'00" (450.0000° True) Elevation Angle: -16.0° Horizon Angle: -01.7° Zoom: 1.0x LY-29: Contractor hauling out replaced triple stack perimeter controls.</p>

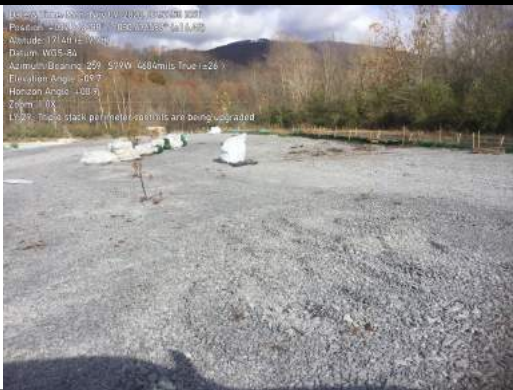
<p>Date & Time: Mon, Nov 9, 2020, 09:07:00 AM Position: 4227.345404°N 77°40'00.0000°W Elevation: 1041 ft (317.27 m) Datum: WGS-84 Azimuth Bearing: 229° 54'00" (450.0000° True) Elevation Angle: -16.0° Horizon Angle: -01.7° Zoom: 1.0x LY-29: These stack perimeter controls are being upgraded.</p>

Pic 5 Desc.	Contractor is replacing old CFS perimeter controls.	Pic 6 Desc.	Culvert and drainage feature.

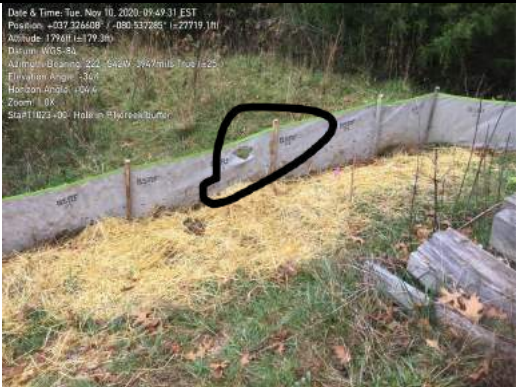
GPS Location	See photo GPS		GPS Location	See photo GPS	
Field Station#	11023+88		Field Station#	10986+00	
Pic 1 Desc.	P1 damaged, added to the punch list.		Pic 2 Desc.	Stream S- E25

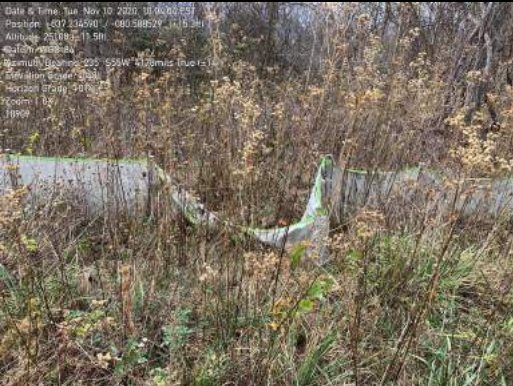
GPS Location	See picture above for GPS coordinates		GPS Location	See picture above for GPS coordinates	
Field Station#	10906+00		Field Station#	10909+00	
Pic 5 Desc.	ECD's and row conditions		Pic 6 Desc.	Damaged P1

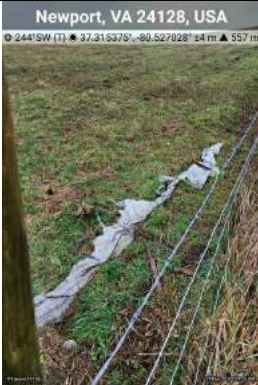
GPS Location	see photo		GPS Location	see photo	
Field Station#	11086+00		Field Station#	11136+00	
Pic 1 Desc.	stabilized row conditions		Pic 2 Desc.	downed p1, cause unknown

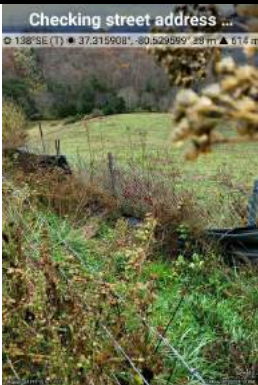
GPS Location	see photo		GPS Location	see photo	
Field Station#	11115+00		Field Station#	11105+00	
Pic 3 Desc.	ssf need repair.		Pic 4 Desc.	cfs needs repair

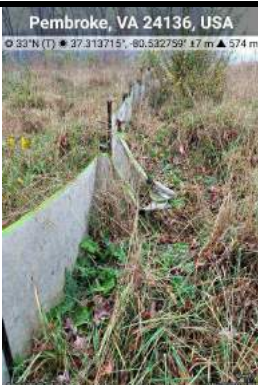
GPS Location	see photo		GPS Location	see photo	
Field Station#	11102+25		Field Station#	11100+70	
Pic 5 Desc.	sf needs repair		Pic 6 Desc.	cfs need repair.

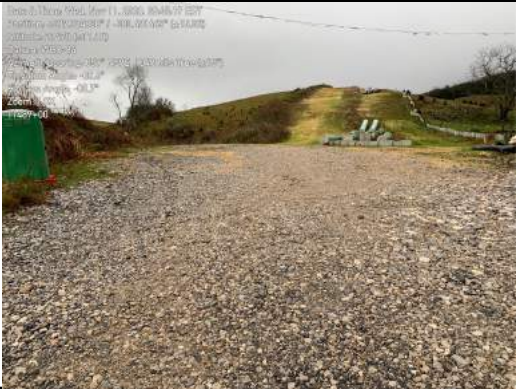
GPS Location	See photo for GPS location.		GPS Location	See photo for GPS location.	
Field Station#	11489+00		Field Station#	11507+05	
Pic 3 Desc.	RCE in place at Stevers Gap Road.		Pic 4 Desc.	Priority one silt fence has broken stakes and holes. Item added to punchlist.

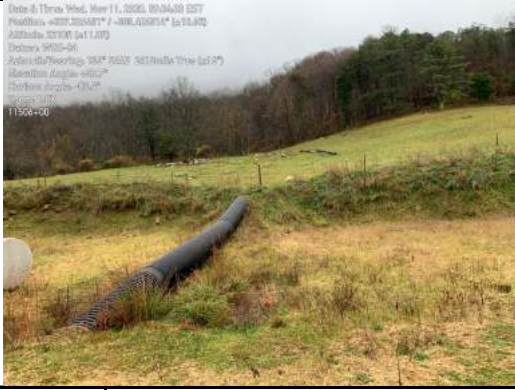
GPS Location	See photo for GPS location.		GPS Location	See photo for GPS location.	
Field Station#	11505+00		Field Station#	11506+00	
Pic 5 Desc.	Broken priority one silt fence stake. Item added to punchlist.		Pic 6 Desc.	Clean water diversion pipe and clean water diversion berm in place.

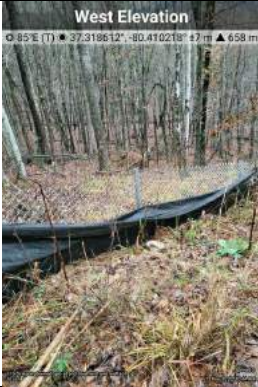
GPS Location	see photo		GPS Location	see photo	
Field Station#	11576+00		Field Station#	11588+00	
Pic 1 Desc.	ssf in need of repair		Pic 2 Desc.	s-pp20 crossing through the row

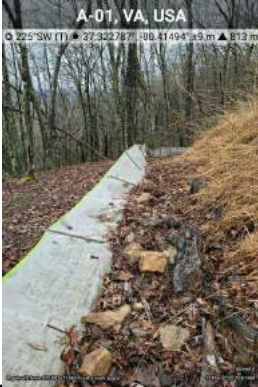
GPS Location	see photo		GPS Location	see photo	
Field Station#	11569+15		Field Station#	11558+00	
Pic 3 Desc.	clean water discharge off row		Pic 4 Desc.	silt fence down

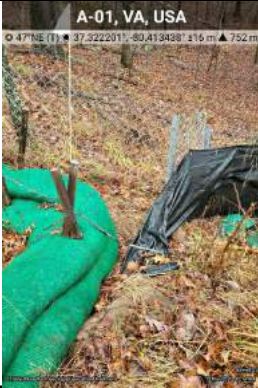
GPS Location	see photo		GPS Location	see photo	
Field Station#	11565+00		Field Station#	11552+00	
Pic 5 Desc.	ssf in need of repair		Pic 6 Desc.	cfs damaged
