Visual Site Inspection Report

Project Name	H-600 Pipeline Spread G	AFE	124300137	Spread	H-600 Pipeline Spread G
Contractor	Precision			Report #	14558
Inspector	Len Kruizenga			Date/Time	9/14/2020 12:54 PM
Permit #	TBD	Inspection Type	VA SWPP	Station Begin	12005+00
State	VA	Inspection Area	Full	Station End	12005+00
County	Giles	Ground	Dry	Temperature (°F)	70.00
Municipality	N/A	Weather	Cloudy	Rain Gauge (in)	0.00
				Rain Accumulation Time (days)	1.00

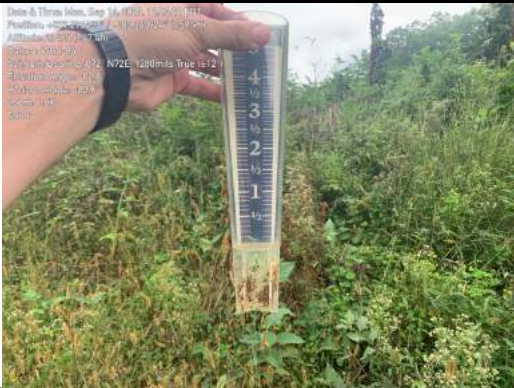
GPS Location	See photo for GPS location.		GPS Location	See photo for GPS location.	
Field Station#	11788+00		Field Station#	11990+00	
Pic 5 Desc.	Rain gauge at Mount Tabor reads 0.0 inches.		Pic 6 Desc.	Rain gauge at Catawba Road reads 0.05 inches.

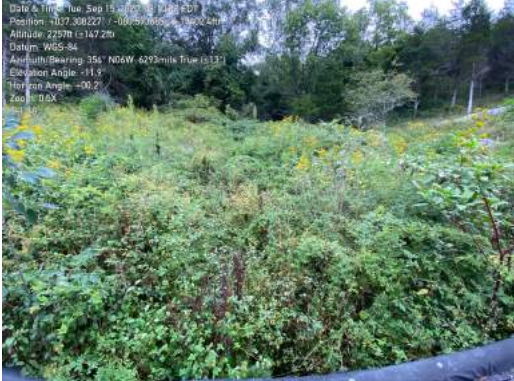
GPS Location	1	GPS Location	2		
Field Station#	11025+50	Field Station#	11034+00		
Pic 1 Desc.	S-IJ18 and controls.	Pic 2 Desc.	Section of RoW showing conditions and controls.

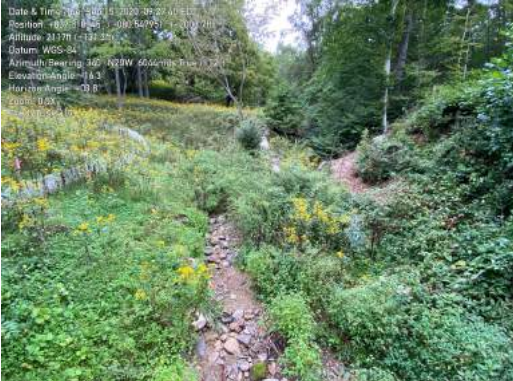
GPS Location	3	GPS Location	4		
Field Station#	11049+00	Field Station#	11050+10		
Pic 3 Desc.	Section of RoW showing conditions and controls.	Pic 4 Desc.	S-IJ16B/S-IJ17 and controls.

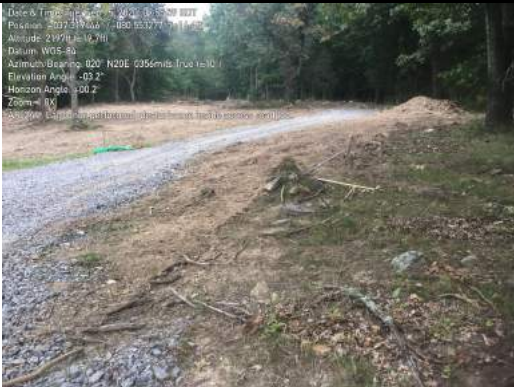
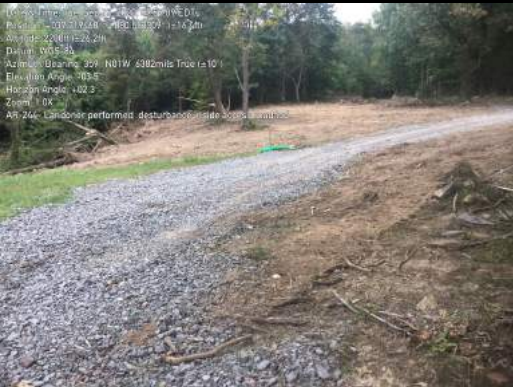
GPS Location	See photo GPS		GPS Location	See photo GPS	
Field Station#	11023+88		Field Station#	11023+88	
Pic 1 Desc.	AR-244- Landowner has performed soil disturbance inside access road Lod.		Pic 2 Desc.	AR-244- Landowner has performed soil disturbance inside access road Lod.

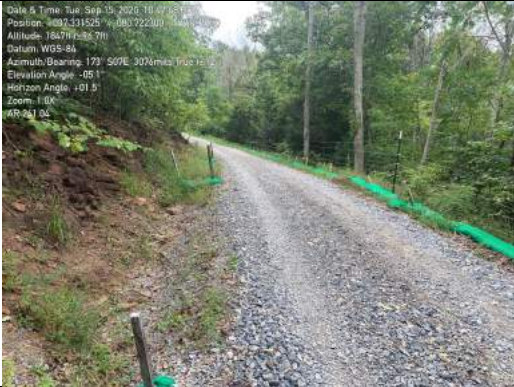
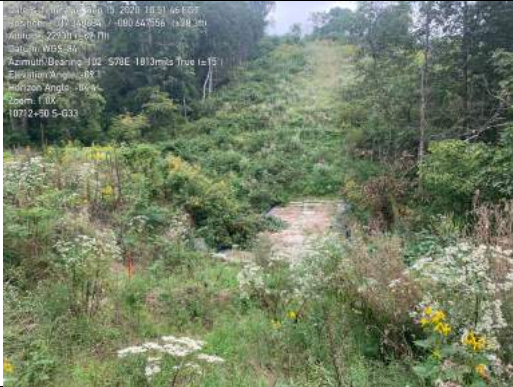
GPS Location	See photo for GPS location.		GPS Location	See photo for GPS location.	
Field Station#	10711+00		Field Station#	10712+50	
Pic 1 Desc.	CFS in place along access road 241.04.		Pic 2 Desc.	Sensitive resource buffer in place at stream S-G33.

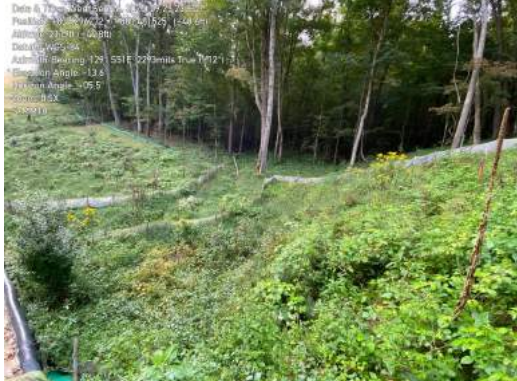
GPS Location	1	GPS Location	2		
Field Station#	11263+00	Field Station#	11292+80		
Pic 1 Desc.	Section of RoW showing conditions and controls.	Pic 2 Desc.	S-MM18 and controls.

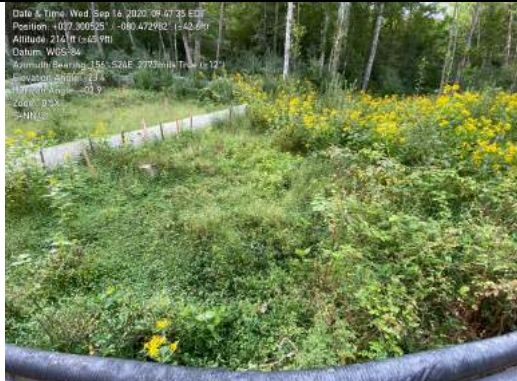
GPS Location	3	GPS Location	4		
Field Station#	11300+00	Field Station#	11327+85		
Pic 3 Desc.	Section of RoW showing conditions and controls.	Pic 4 Desc.	S-NN12 and controls.

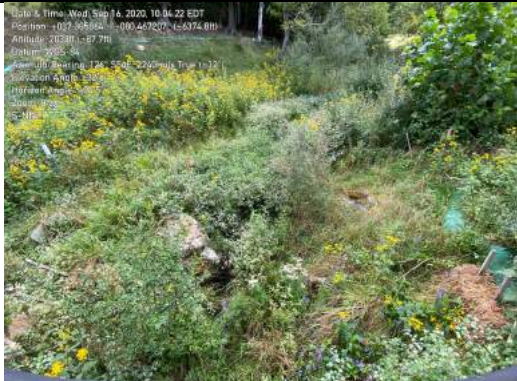
GPS Location	5	GPS Location	6		
Field Station#	11351+00	Field Station#	11352+97		
Pic 5 Desc.	Section of RoW showing conditions and controls.	Pic 6 Desc.	S-NN11 and controls.

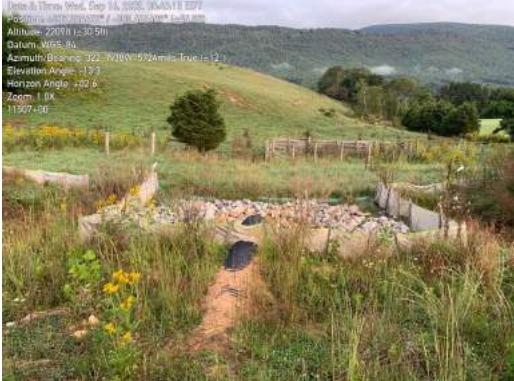
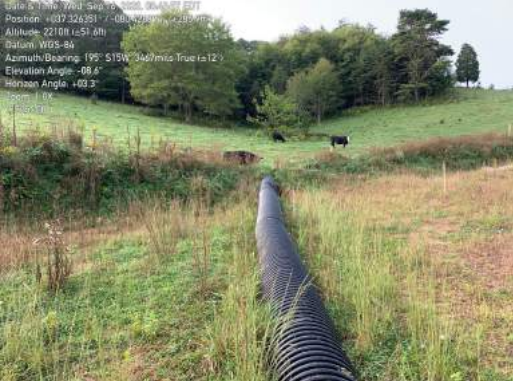
GPS Location	See photo for GPS location.		GPS Location	See photo for GPS location.	
Field Station#	11507+00		Field Station#	11505+00	
Pic 1 Desc.	Clean water diversion pipe and plunge pool in place.		Pic 2 Desc.	Clean water diversion berm and clean water diversion pipe inlet in place.

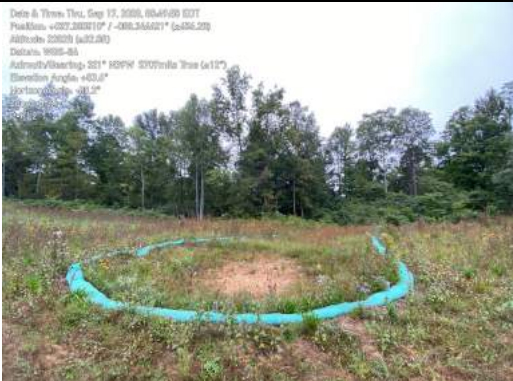
GPS Location	3	GPS Location	4		
Field Station#	11849+00	Field Station#	11863+65		
Pic 3 Desc.	Section of restored RoW showing conditions and controls.		Pic 4 Desc.	P-KL2 and controls.

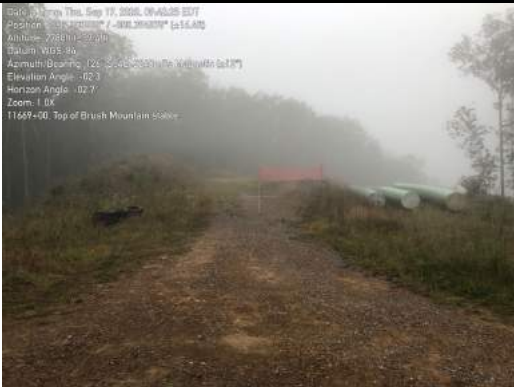
<p>Date & Time: Thu, Sep 17, 2020, 09:40:31 EDT Position: 43°31'38.99"N / -88°39'53.17"W (43.52747) Altitude: 25811 (ft/7866m) Datum: WGS 84 Azimuth/Heading: 124.5 (az/353.1) (m/az/353.1) Elevation Angle: -62.3 Horizon Angle: -62.7 Zoom: 1.0x 11669+00: Perimeter controls in place.</p>

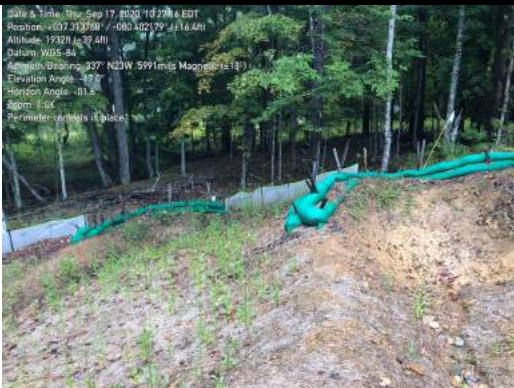
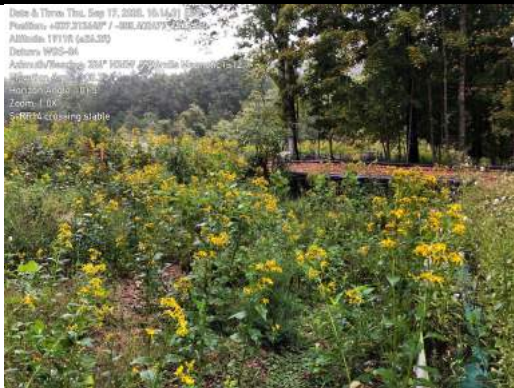
<p>Date & Time: Thu, Sep 17, 2020, 10:14:11 EDT Position: 43°31'38.99"N / -88°40'21.79"W (43.52747) Altitude: 19115 (ft/5826m) Datum: WGS 84 Azimuth/Heading: 337° N23W 5991m (m/az/353.1) Elevation Angle: -47.7 Horizon Angle: -48.1 Zoom: 1.0x S-RR14 crossing stable.</p>

GPS Location	On photo	GPS Location	On photo		
Field Station#	11614+75	Field Station#	11614+20		
Pic 5 Desc.	Perimeter controls in place and functional.	Pic 6 Desc.	S-RR14 crossing is stable with ECDs in place.

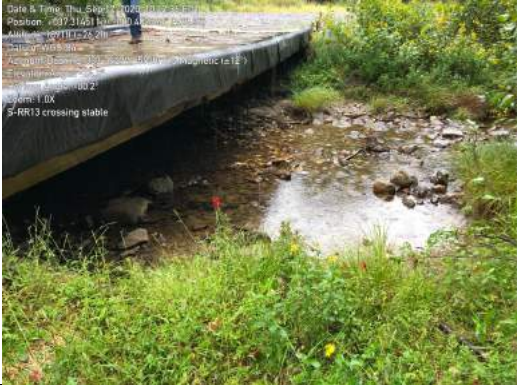
GPS Location	On photo	GPS Location	On photo		
Field Station#	11613+69	Field Station#	11608+17		
Pic 7 Desc.	S-RR13 crossing on access road MN-258.04 is stable.	Pic 8 Desc.	S-006 crossing is stable with ECDs in place.

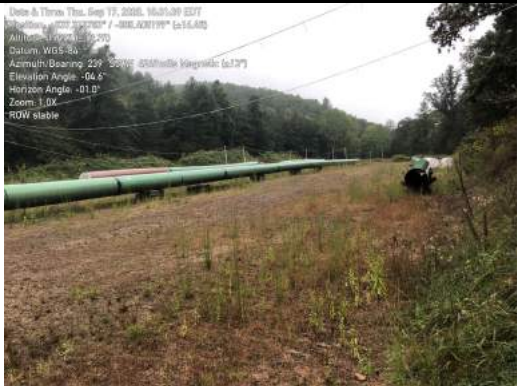
GPS Location	On photo	GPS Location			
Field Station#	11606+50	Field Station#			
Pic 9 Desc.	ROW surface stable. Perimeter controls in place.	Pic 10 Desc.

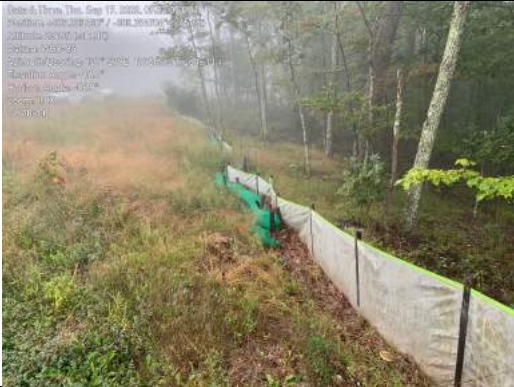
GPS Location	See photo for GPS location.		GPS Location	See photo for GPS location.	
Field Station#	11670+00		Field Station#	11683+00	
Pic 1 Desc.	Triple stack compost filter sock and priority one silt fence in place along LOD.		Pic 2 Desc.	Travel lane needs re-stabilized after rain washed area of straw.
