Visual Site Inspection Report

Project Name	H-600 Pipeline Spread G	AFE	124300137	Spread	H-600 Pipeline Spread G
Contractor	Precision			Report #	14769
Inspector	Len Kruizenga			Date/Time	9/21/2020 8:43 AM
Permit #	TBD	Inspection Type	VA SWPP	Station Begin	1102388+00
State	VA	Inspection Area	Full	Station End	10930+00
County	Giles	Ground	Dry	Temperature (°F)	64.00
Municipality	N/A	Weather	Sunny	Rain Gauge (in)	0.00
				Rain Accumulation Time (days)	1.00

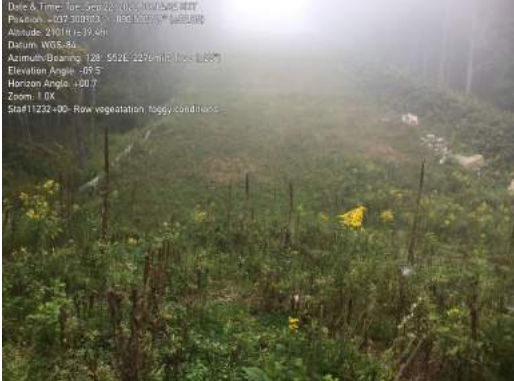
<p>Date & Time: Tue, Sep 22, 2020, 08:07 AM Position: 4232.202111, -71.053111, 19468.14 Altitude: 19468.14 Datum: WGS-84 Azimuth/Bearing: 128.542E, 327.0mils true (+10°) Elevation Angle: -09.5° Horizon Angle: +00.7° Zoom: 1.0x Stn#11232+00- Row vegetation, foggy conditions.</p>

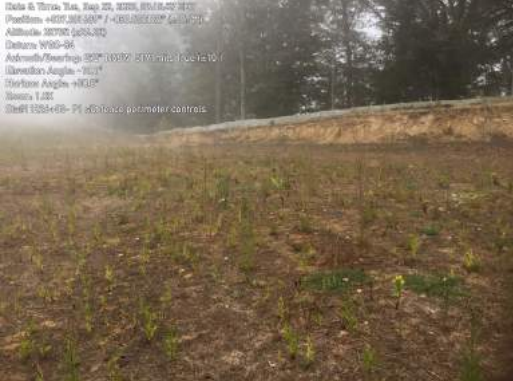
<p>Date & Time: Tue, Sep 22, 2020, 08:07 AM Position: 4232.202111, -71.053111, 19468.14 Altitude: 19468.14 Datum: WGS-84 Azimuth/Bearing: 128.542E, 327.0mils true (+10°) Elevation Angle: -09.5° Horizon Angle: +00.7° Zoom: 1.0x Stn#11232+00- P1 distance perimeter controls.</p>			
GPS Location	See photo GPS		GPS Location	See photo GPS	
Field Station#	11232+00		Field Station#	11224+00	
Pic 1 Desc.	Row vegetation, foggy conditions during inspection.		Pic 2 Desc.	P1 perimeter controls.	
  <p>Date & Time: Tue, Sep 22, 2020, 09:46:52 AM Position: 4232.202111, -71.053111, 19468.14 Altitude: 19468.14 Datum: WGS-84 Azimuth/Bearing: 128.542E, 327.0mils true (+10°) Elevation Angle: -09.5° Horizon Angle: +00.7° Zoom: 1.0x Stn#11225+00- P1 silt fence perimeter control stake stake.</p>

GPS Location	See photo GPS		GPS Location	See photo GPS	
Field Station#	11225+00		Field Station#	11191+00	
Pic 3 Desc.	P1 silt fence stake broken off, contractor has been notified, item added to the punch list.		Pic 4 Desc.	P1 silt fence stakes broken off, contractor has been notified and item added to the punch list.

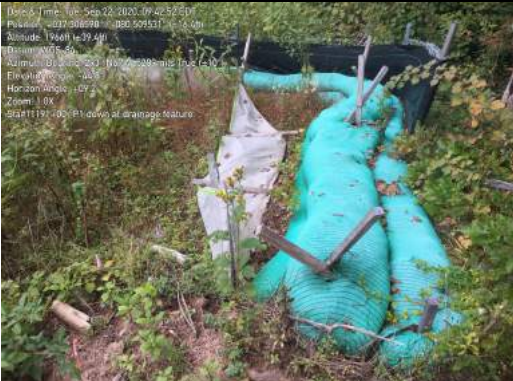
<p>Date & Time: Tue, Sep 22, 2020, 09:46:52 AM Position: 4232.202111, -71.053111, 19468.14 Altitude: 19468.14 Datum: WGS-84 Azimuth/Bearing: 128.542E, 327.0mils true (+10°) Elevation Angle: -09.5° Horizon Angle: +00.7° Zoom: 1.0x Stn#11191+00- P1 down at drainage feature.</p>

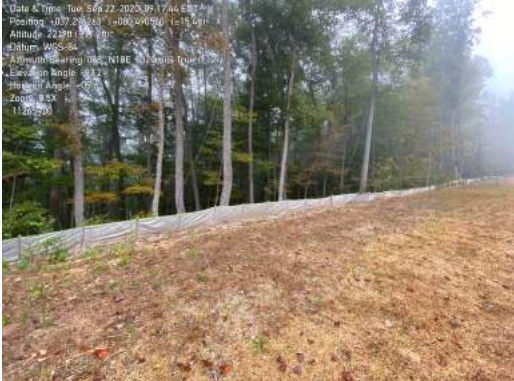
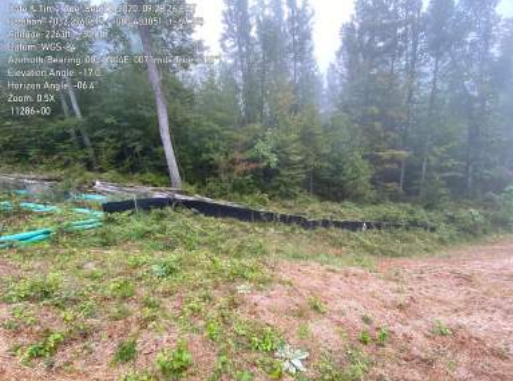
GPS Location	1	GPS Location	2		
Field Station#	11265+00	Field Station#	11286+00		
Pic 1 Desc.	Perimeter controls functional.	Pic 2 Desc.	Perimeter controls functional.

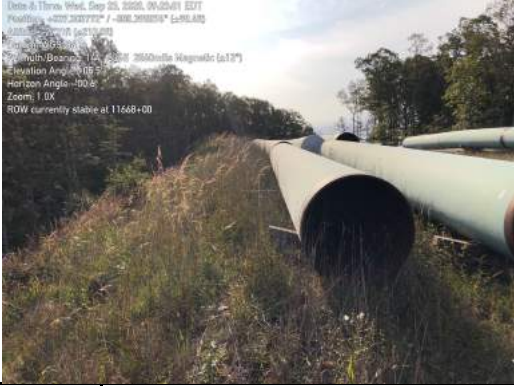
<p> Date & Time Wed, Sep 23, 2020, 09:25:41 EDT Position: +422.302772° / -808.391892° (+15.82) Altitude: 321.9 ft (+215.08) Azimuth/Heading: 147° 30206 361 Binsla Magnetar (+13°) Elevation Angle: +01.0° Horizontal Angle: +00.0° Zoom: 1.0x ROW currently stable at 11668+00 </p>

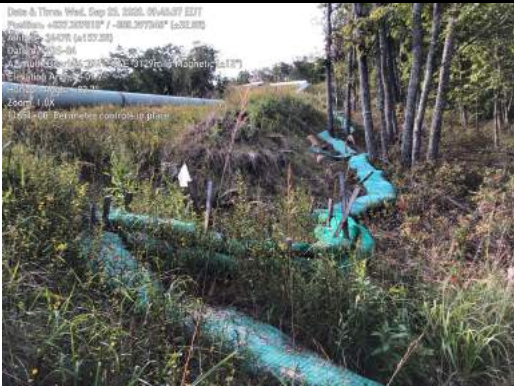
<p> Date & Time Wed, Sep 23, 2020, 09:26:58 EDT Position: +422.302772° / -808.391892° (+15.82) Altitude: 321.9 ft (+215.08) Azimuth/Heading: 147° 30206 361 Binsla Magnetar (+13°) Elevation Angle: +01.0° Horizontal Angle: +00.0° Zoom: 1.0x Perimeter controls in place. </p>

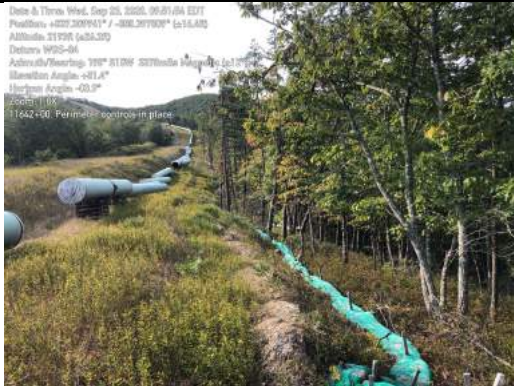
<p> Date & Time Wed, Sep 23, 2020, 09:26:58 EDT Position: +422.302772° / -808.391892° (+15.82) Altitude: 321.9 ft (+215.08) Azimuth/Heading: 147° 30206 361 Binsla Magnetar (+13°) Elevation Angle: +01.0° Horizontal Angle: +00.0° Zoom: 1.0x 11642+00: Perimeter controls in place. </p>

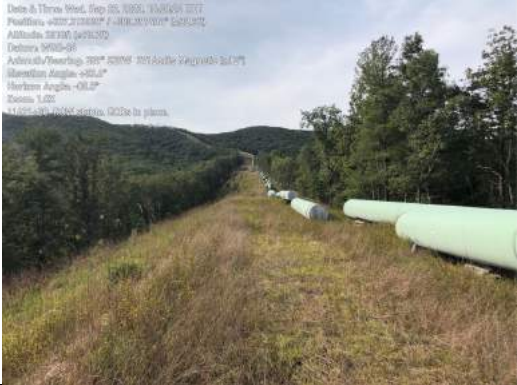
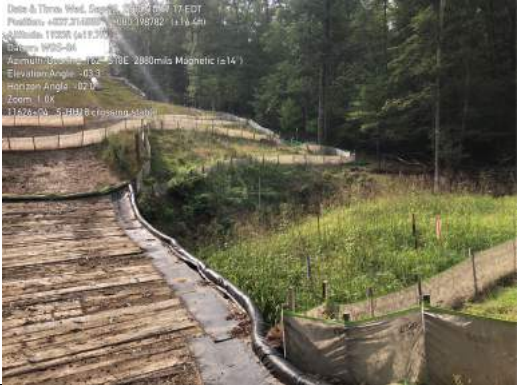
GPS Location	On photo	GPS Location	On photo		
Field Station#	11631+00	Field Station#	11626+04		
Pic 7 Desc.	ROW currently stable.	Pic 8 Desc.	S-HH18 crossing is stable with environmental controls in place.

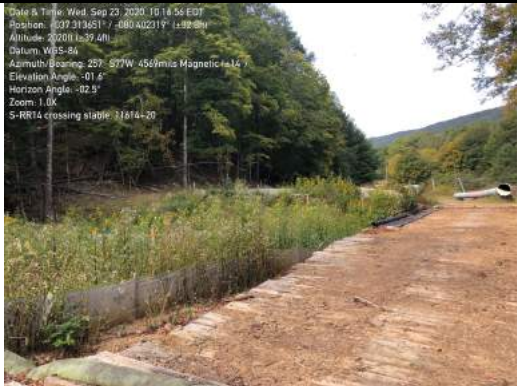
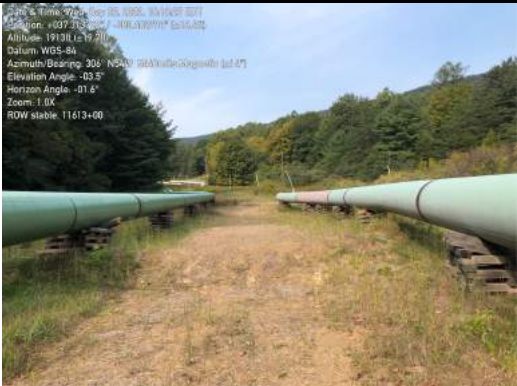
GPS Location	On photo	GPS Location	On photo		
Field Station#	11614+20	Field Station#	11613+00		
Pic 9 Desc.	S-RR14 crossing stable with environmental controls in place.	Pic 10 Desc.	ROW stable currently. Perimeter controls in place.

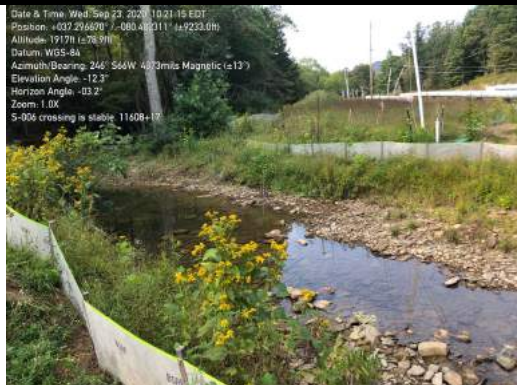
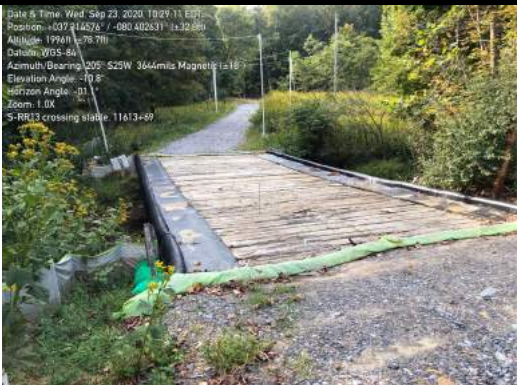
GPS Location	On photo	GPS Location	On photo		
Field Station#	11608+17	Field Station#	11613+69		
Pic 11 Desc.	S-006 crossing is currently stable with ECDs in place.	Pic 12 Desc.	S-RR13 crossing on access road MN-258.04 is stable with ECDs in place.
