# Visual Site Inspection Report

<b>Project Name</b>	H-600 Pipeline Spread G	<b>AFE</b>	124300137	<b>Spread</b>	H-600 Pipeline Spread G
<b>Contractor</b>	Precision			<b>Report #</b>	14982
<b>Inspector</b>	Chris Burns			<b>Date/Time</b>	9/28/2020 7:51 AM
<b>Permit #</b>	TBD	<b>Inspection Type</b>	VA SWPP	<b>Station Begin</b>	11254+99
<b>State</b>	VA	<b>Inspection Area</b>	Partial	<b>Station End</b>	11353+67
<b>County</b>	Giles	<b>Ground</b>	Wet	<b>Temperature (°F)</b>	72.00
<b>Municipality</b>	N/A	<b>Weather</b>	Cloudy	<b>Rain Gauge (in)</b>	0.00
				<b>Rain Accumulation Time (days)</b>	1.00

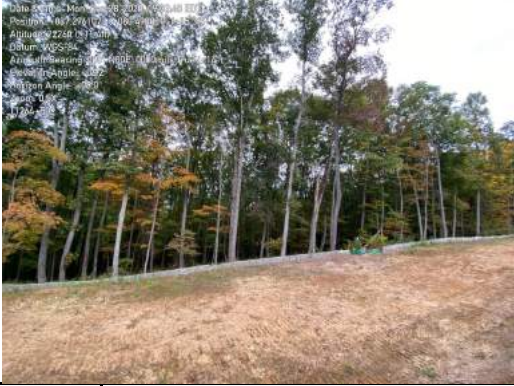
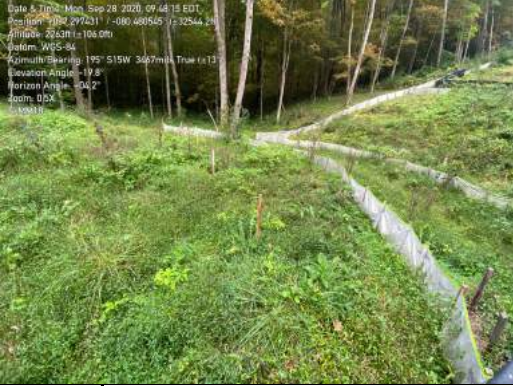
<b>GPS Location</b>	1	<b>GPS Location</b>	2		
<b>Field Station#</b>	11264+50	<b>Field Station#</b>	11292+80		
<b>Pic 1 Desc.</b>	Perimeter controls functional.	<b>Pic 2 Desc.</b>	S-MM18 and controls.

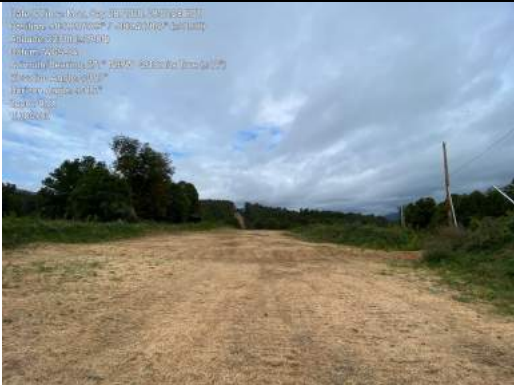
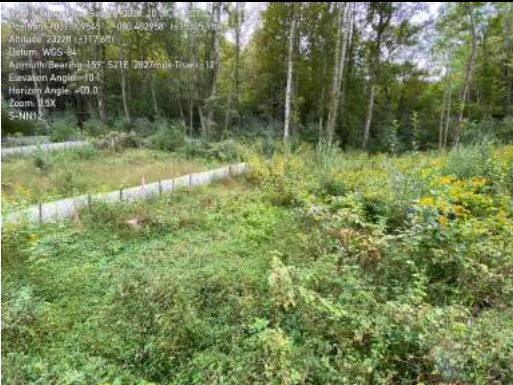
<b>GPS Location</b>	3	<b>GPS Location</b>	4		
<b>Field Station#</b>	11304+00	<b>Field Station#</b>	11327+85		
<b>Pic 3 Desc.</b>	Section of RoW showing conditions and controls.	<b>Pic 4 Desc.</b>	S-NN12 and controls.

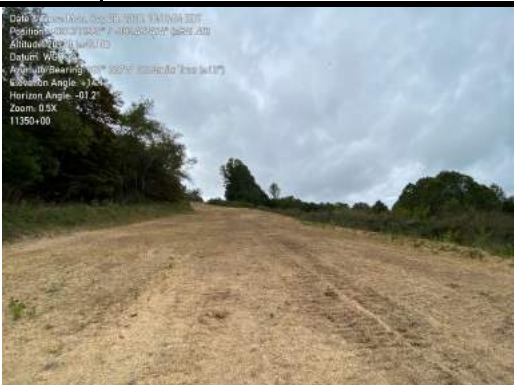
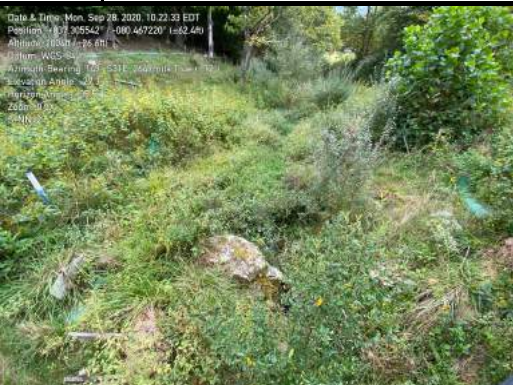
<b>GPS Location</b>	5	<b>GPS Location</b>	6		
<b>Field Station#</b>	11350+00	<b>Field Station#</b>	11352+97		
<b>Pic 5 Desc.</b>	Section of RoW showing conditions and controls.	<b>Pic 6 Desc.</b>	S-NN11 and controls.

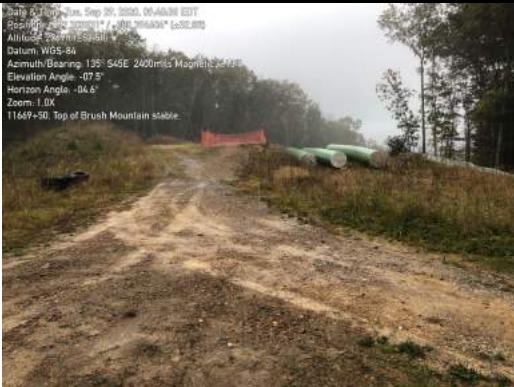
<b>A/E</b>	124300137	<b>Date/Time</b>	9/29/2020 11:46 AM	<b>Report #</b>	
<b>Pictures</b>					
<p>Date &amp; Time: Sun, Sep 27, 2020, 05:55:27 EDT  Position: +422.303842° / -886.395881° (s15.418)  Altitude: 323700 (s15.370)  Datum: WGS-84  Azimuth/Bearing: 135° S45E 2400mils Magnetic (s13°)  Elevation Angle: -07.5°  Horizon Angle: -04.6°  Zoom: 1.0X  11669+50, Top of Brush Mountain stable.</p>

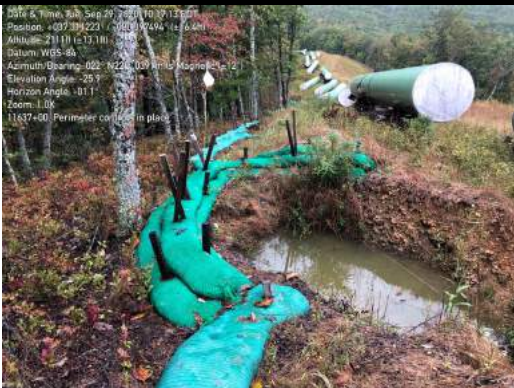
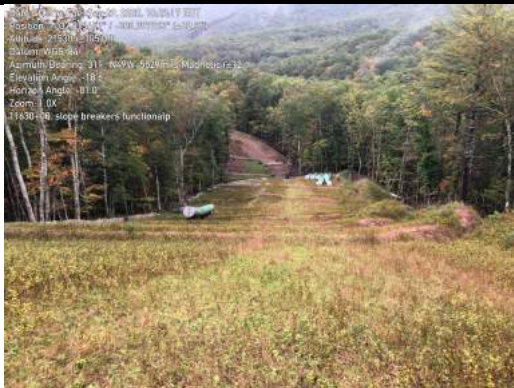
<p>Date &amp; Time: Sun, Sep 27, 2020, 10:17:13 EDT  Position: +422.311820° / -886.397920° (s15.418)  Altitude: 31300 (s15.370)  Datum: WGS-84  Azimuth/Bearing: 311° N69W 5000mils Magnetic (s12°)  Elevation Angle: -18.5°  Horizon Angle: -01.0°  Zoom: 1.0X  11630+00, Slope breakers functional.</p>

<b>GPS Location</b>	On photo	<b>GPS Location</b>	On photo		
<b>Field Station#</b>	11637+00	<b>Field Station#</b>	11630+00		
<b>Pic 5 Desc.</b>	End treatments are functioning as designed.	<b>Pic 6 Desc.</b>	Slope breakers are functional.

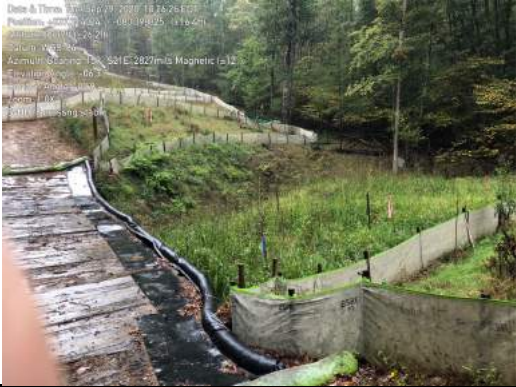
<p><small>Date &amp; Time: Sun, Sep 29, 2020 15:35:25 EDT Position: +031.174866 / -080.482997 (s14.04) Altitude: 198ft (s14.04) Datum: WGS-84 Azimuth/Bearing: 156° S24E 2773mils Magnetic (s12) Elevation Angle: -10.3° Horizon Angle: -01.9° Zoom: 1.0X S-HH18 crossing stable</small></p>

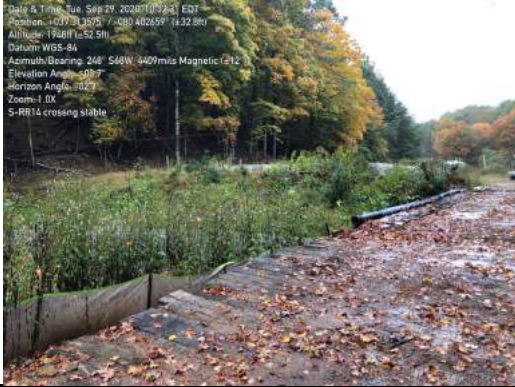
<p><small>Date &amp; Time: Sun, Sep 29, 2020 15:42:59 EDT Position: +031.17575 / -080.482659 (s14.04) Altitude: 196ft (s14.04) Datum: WGS-84 Azimuth/Bearing: 248° S48W 3409mils Magnetic (s12) Elevation Angle: -10.3° Horizon Angle: -01.9° Zoom: 1.0X S-RR14 crossing stable</small></p>			
<b>GPS Location</b>	On photo	<b>GPS Location</b>	On photo		
<b>Field Station#</b>	11626+04	<b>Field Station#</b>	11614+20		
<b>Pic 7 Desc.</b>	The S-HH18 crossing is stable.	<b>Pic 8 Desc.</b>	The S-RR14 crossing is stable.

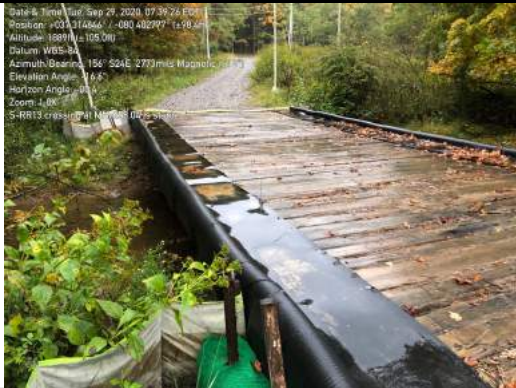
<p><small>Date &amp; Time: Sun, Sep 29, 2020 07:39:24 EDT Position: +031.174866 / -080.482997 (s14.04) Altitude: 198ft (s14.04) Datum: WGS-84 Azimuth/Bearing: 156° S24E 2773mils Magnetic (s12) Elevation Angle: -10.3° Horizon Angle: -01.9° Zoom: 1.0X S-RR13 crossing at MN-258.04 is stable</small></p>

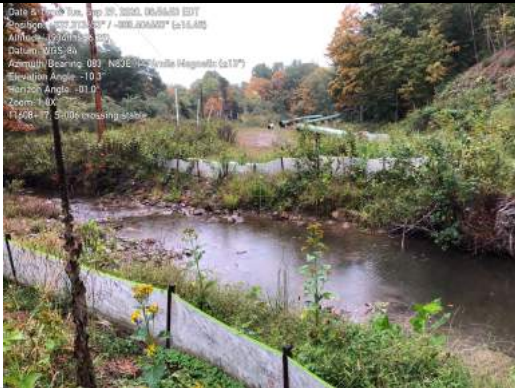
<p><small>Date &amp; Time: Sun, Sep 29, 2020 08:54:03 EDT Position: +031.17575 / -080.482659 (s14.04) Altitude: 196ft (s14.04) Datum: WGS-84 Azimuth/Bearing: 081° N53E 1000mils Magnetic (s13) Elevation Angle: -10.3° Horizon Angle: -01.9° Zoom: 1.0X S-006 crossing stable</small></p>

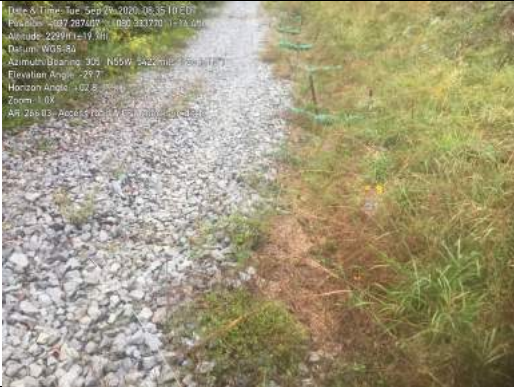
<p>Date &amp; Time: Tue, Sep 29, 2020, 06:35:10 EDT Position: +037.269744° / -080.333720° (+32.80) Altitude: 2299ft (+710) Datum: WGS 84 Azimuth Bearing: 304.5559, 342.2mils, 150.3171° Elevation Angle: -21.7° Horizon Angle: -102.8° Zoom: 1.0x AR-266.03- Access road and CFS checks in ditch.</p>

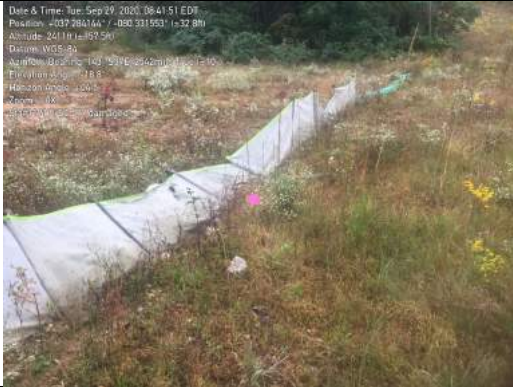
<p>Date &amp; Time: Tue, Sep 29, 2020, 06:41:51 EDT Position: +037.269744° / -080.331953° (+32.80) Altitude: 2411ft (+737.20) Datum: WGS 84 Azimuth Bearing: 149.5216, 236.2mils, 102.450° Elevation Angle: -18.3° Horizon Angle: -100.1° Zoom: 1.0x P1 damaged</p>			
<b>GPS Location</b>	See photo GPS	<b>GPS Location</b>	See photo GPS		
<b>Field Station#</b>	11900+00	<b>Field Station#</b>	11917+50		
<b>Pic 1 Desc.</b>	AR-266.03- Access road and CFS checks in ditch.	<b>Pic 2 Desc.</b>	P1 damaged

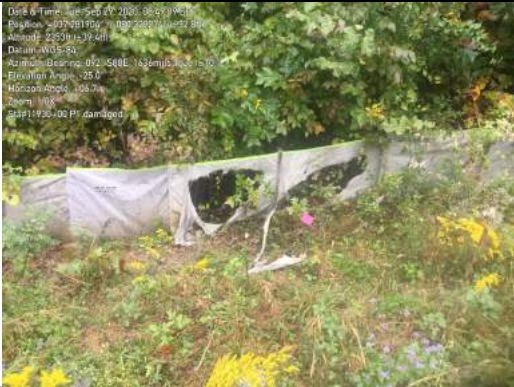
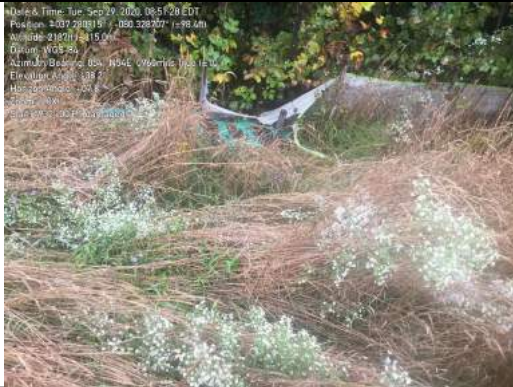
<p>Date &amp; Time: Tue, Sep 29, 2020, 06:51:09 EDT Position: +037.269719° / -080.328707° (+32.80) Altitude: 2353ft (+720) Datum: WGS 84 Azimuth Bearing: 87.5486, 132mils, 59.110° Elevation Angle: -25.0° Horizon Angle: -105.3° Zoom: 1.0x P1 damaged</p>

<p>Date &amp; Time: Tue, Sep 29, 2020, 06:51:29 EDT Position: +037.269719° / -080.328707° (+32.80) Altitude: 2187ft (+671.50) Datum: WGS 84 Azimuth Bearing: 88.1934, 134.0mils, 59.110° Elevation Angle: -38.2° Horizon Angle: -100.8° Zoom: 1.0x P1 damaged</p>

<b>GPS Location</b>	See photo GPS	<b>GPS Location</b>	See photo GPS		
<b>Field Station#</b>	11930+00	<b>Field Station#</b>	11932+00		
<b>Pic 3 Desc.</b>	P1 damaged	<b>Pic 4 Desc.</b>	P1 damaged

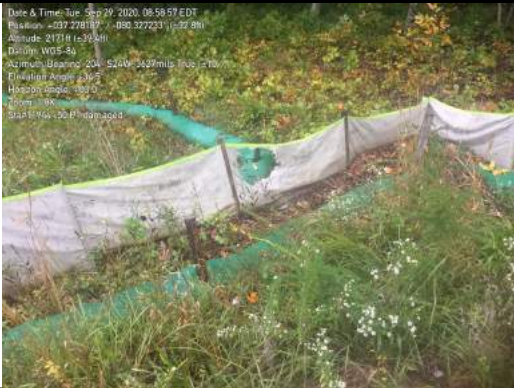
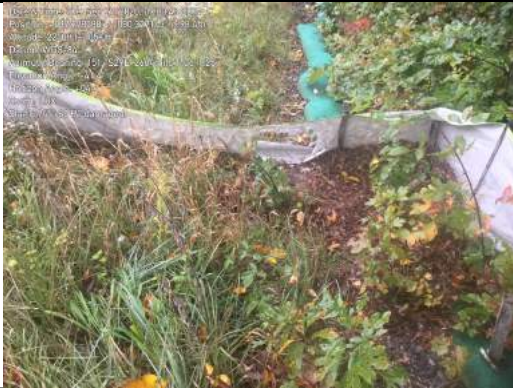
<p>Date &amp; Time: Tue, Sep 29, 2020, 06:58:57 EDT Position: +037.272811° / -080.327223° (+32.80) Altitude: 2171ft (+664) Datum: WGS 84 Azimuth Bearing: 204.5240, 343mils, 170.170° Elevation Angle: -30.5° Horizon Angle: -104.0° Zoom: 1.0x P1 damaged</p>

<p>Date &amp; Time: Tue, Sep 29, 2020, 06:59:12 EDT Position: +037.272811° / -080.327223° (+32.80) Altitude: 2171ft (+664) Datum: WGS 84 Azimuth Bearing: 151.5217, 241.0mils, 102.450° Elevation Angle: -31.0° Horizon Angle: -103.9° Zoom: 1.0x P1 damaged</p>			
<b>GPS Location</b>	See photo GPS	<b>GPS Location</b>	See photo GPS		
<b>Field Station#</b>	11944+50	<b>Field Station#</b>	11945+50		
<b>Pic 5 Desc.</b>	P1 damaged	<b>Pic 6 Desc.</b>	P1 damaged

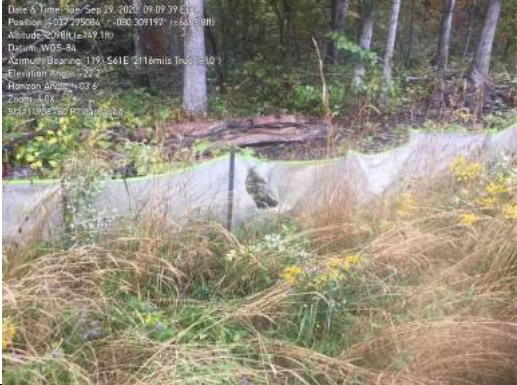
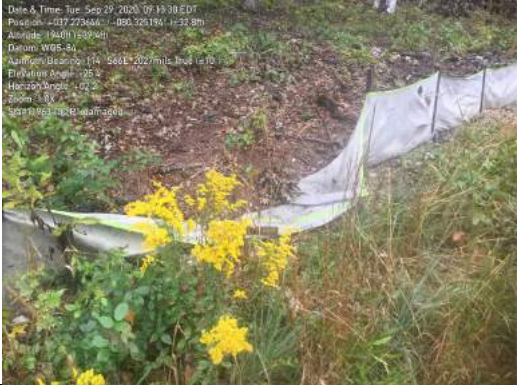
<p><small>Date &amp; Time: Tue, Sep 29, 2020 09:19:30 EDT Position: +037 273444, -080 326190, 1152+00 Altitude: 1940ft (591m) Datum: WGS-84 Azimuth/Bearing: 114.544E, 302mils True (10.1) Elevation Angle: +35.2 Horizon Angle: +10.2 Zoom: 1.0X Catawba Field Station# 11963</small></p>			
<b>GPS Location</b>	See photo GPS	<b>GPS Location</b>	See photo GPS		
<b>Field Station#</b>	11958+60	<b>Field Station#</b>	11963+00		
<b>Pic 7 Desc.</b>	P1 damaged	<b>Pic 8 Desc.</b>	P1 damaged

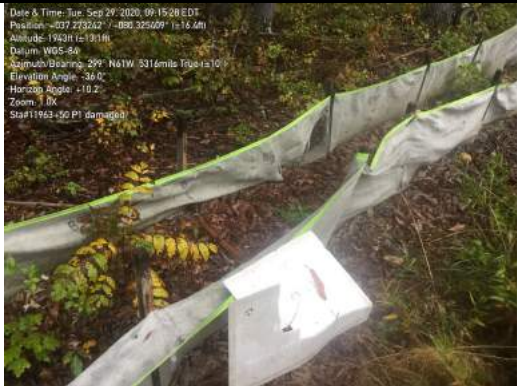
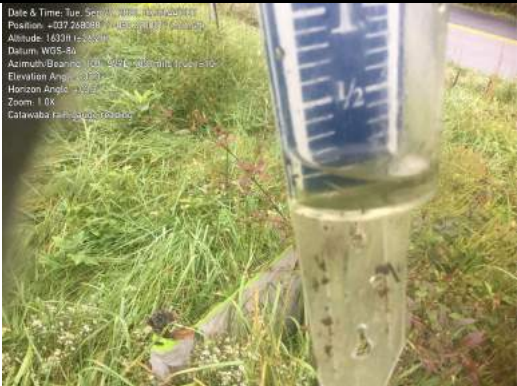
<b>GPS Location</b>	See photo GPS	<b>GPS Location</b>	See photo GPS		
<b>Field Station#</b>	11963+50	<b>Field Station#</b>	11989+00		
<b>Pic 9 Desc.</b>	P1 damaged	<b>Pic 10 Desc.</b>	Catawba rain gauge reading- 0.20"		
Insert image here		Insert image here			
<b>GPS Location</b>		<b>GPS Location</b>			
<b>Field Station#</b>		<b>Field Station#</b>			
<b>Pic 11 Desc.</b>		<b>Pic 12 Desc.</b>

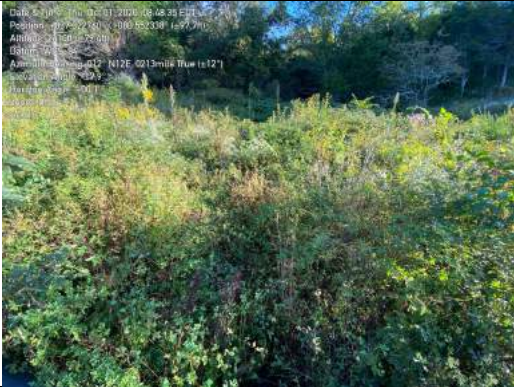
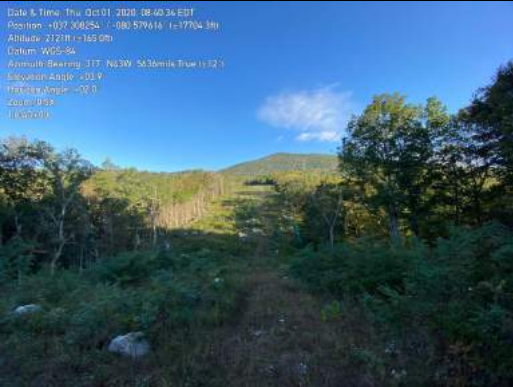
<b>GPS Location</b>	1	<b>GPS Location</b>	2		
<b>Field Station#</b>	11025+50	<b>Field Station#</b>	11040+00		
<b>Pic 1 Desc.</b>	S-IJ18 and controls.	<b>Pic 2 Desc.</b>	Section of RoW showing conditions and controls.

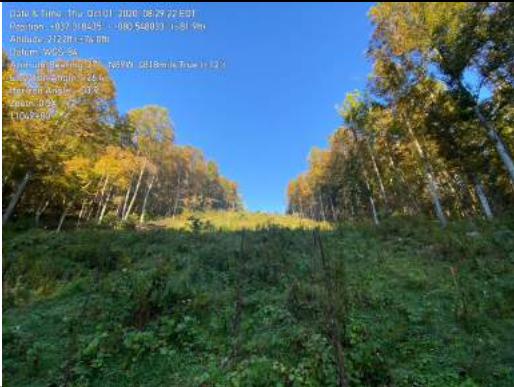
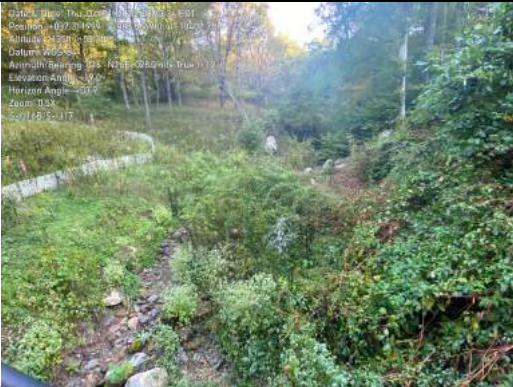
<b>GPS Location</b>	3	<b>GPS Location</b>	4		
<b>Field Station#</b>	11049+00	<b>Field Station#</b>	11050+10		
<b>Pic 3 Desc.</b>	Section of RoW showing conditions and controls.	<b>Pic 4 Desc.</b>	S-IJ16B/S-IJ17 and controls.

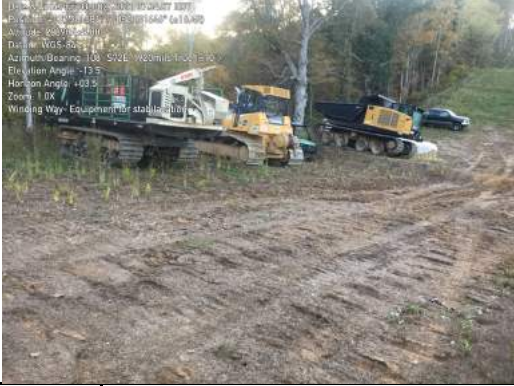
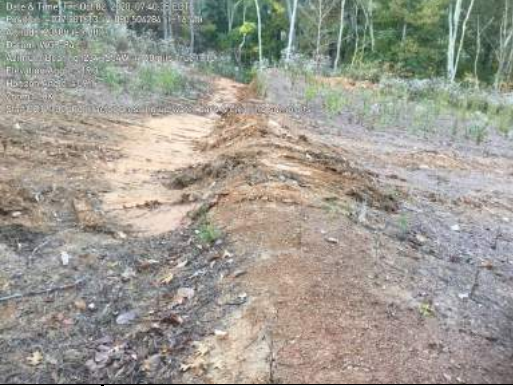
<b>GPS Location</b>	See photo GPS	<b>GPS Location</b>	See photo GPS		
<b>Field Station#</b>	11227+00	<b>Field Station#</b>	11217+00		
<b>Pic 1 Desc.</b>	Equipment being used to re - stabilize row	<b>Pic 2 Desc.</b>	Water bar flow line dressed up

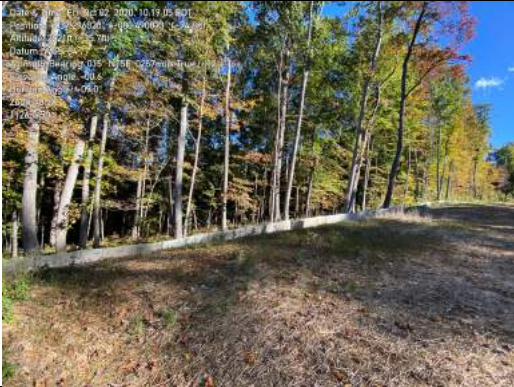
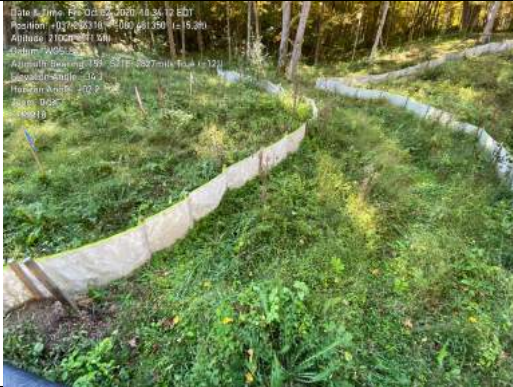
<b>GPS Location</b>	1	<b>GPS Location</b>	2		
<b>Field Station#</b>	11263+50	<b>Field Station#</b>	11292+80		
<b>Pic 1 Desc.</b>	Perimeter controls functional.		<b>Pic 2 Desc.</b>	S-MM18 and controls.

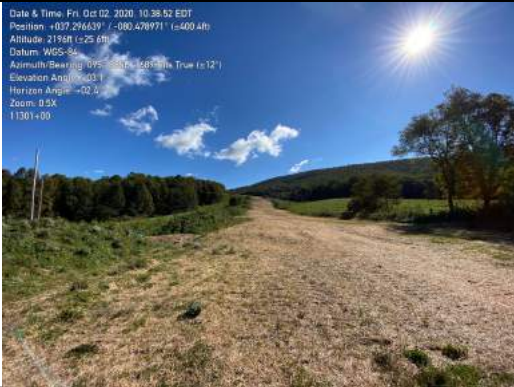
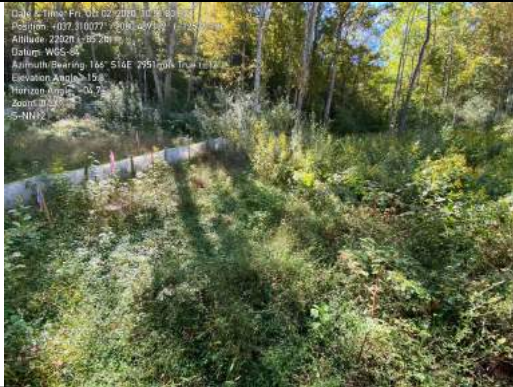
<b>GPS Location</b>	3	<b>GPS Location</b>	4		
<b>Field Station#</b>	11301+00	<b>Field Station#</b>	11327+85		
<b>Pic 3 Desc.</b>	Section of RoW showing conditions and controls.		<b>Pic 4 Desc.</b>	S-NN12 and controls.

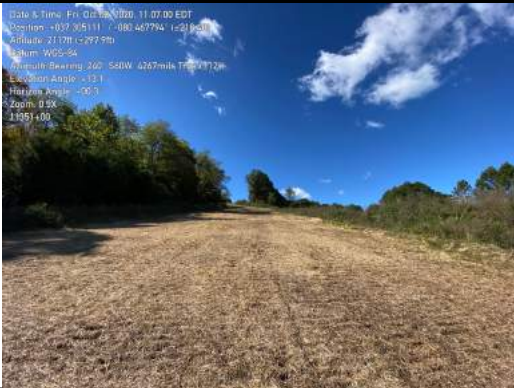
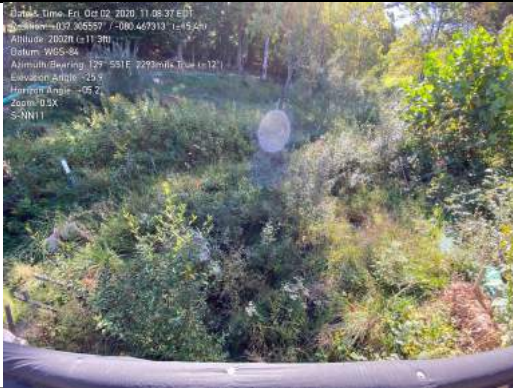
<b>GPS Location</b>	5	<b>GPS Location</b>	6		
<b>Field Station#</b>	11351+00	<b>Field Station#</b>	11352+97		
<b>Pic 5 Desc.</b>	Section of RoW showing conditions and controls.		<b>Pic 6 Desc.</b>	S-NN11 and controls.
