Visual Site Inspection Report

Project Name	H-600 Pipeline Spread G	AFE	124300137	Spread	H-600 Pipeline Spread G
Contractor	Precision			Report #	14394
Inspector	Len Kruizenga			Date/Time	9/8/2020 8:28 AM
Permit #	TBD	Inspection Type	VA SWPP	Station Begin	12005+00
State	VA	Inspection Area	Full	Station End	12005+00
County	Giles	Ground	Dry	Temperature (°F)	76.00
Municipality	N/A	Weather	Cloudy	Rain Gauge (in)	0.00
				Rain Accumulation Time (days)	1.00

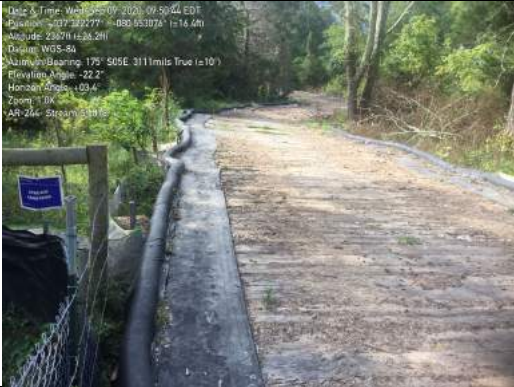
GPS Location	See photo GPS	GPS Location	See photo GPS		
Field Station#	11023+88	Field Station#	11017+00		
Pic 1 Desc.	AR-244- stream S-IJ18	Pic 2 Desc.	Stream S- RR5

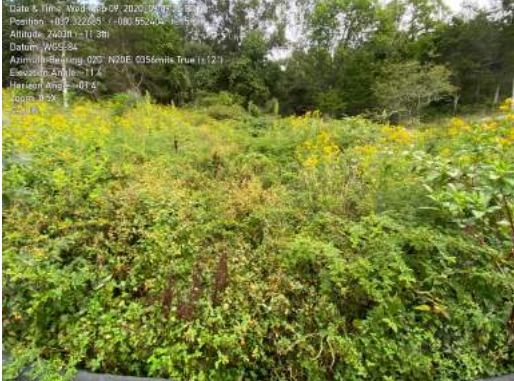
GPS Location	1	GPS Location	2		
Field Station#	11025+50	Field Station#	11034+00		
Pic 1 Desc.	S-IJ18.	Pic 2 Desc.	Section of RoW showing conditions and controls.

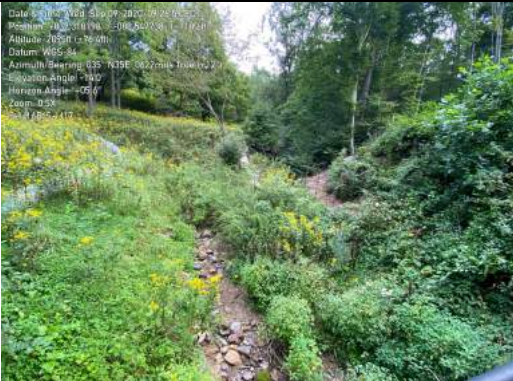
GPS Location	3	GPS Location	4		
Field Station#	11049+00	Field Station#	11050+10		
Pic 3 Desc.	Section of RoW showing conditions and controls.	Pic 4 Desc.	S-IJ16B/S-IJ17 and controls.

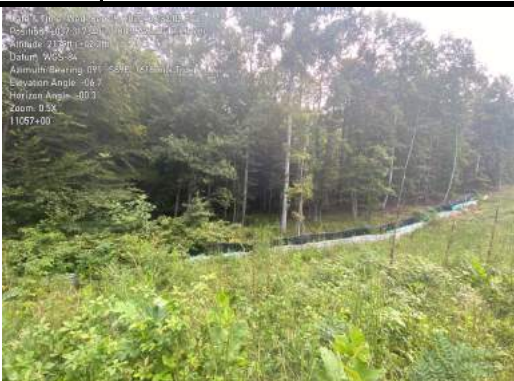
GPS Location	5	GPS Location	6		
Field Station#	11057+00	Field Station#	11064+50		
Pic 5 Desc.	Karst protection controls.	Pic 6 Desc.	Section of RoW showing conditions and controls.

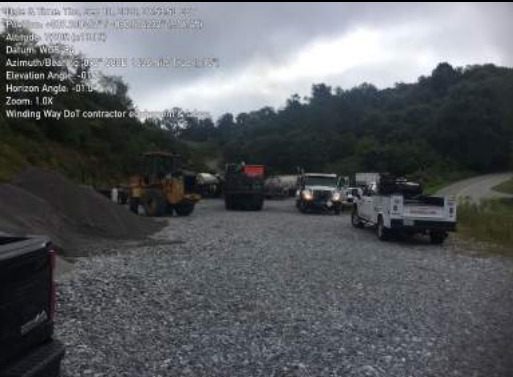
Pic 5 Desc.	CWD pipe and plunge pool.		Pic 6 Desc.	Winding Way- DOT Contractor equipment

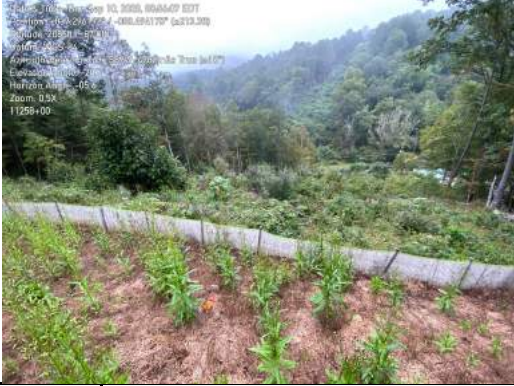
GPS Location	1	GPS Location	2		
Field Station#	11258+00	Field Station#	11265+00		
Pic 1 Desc.	Clearing/grading stopping point.		Pic 2 Desc.	Perimeter controls functional.

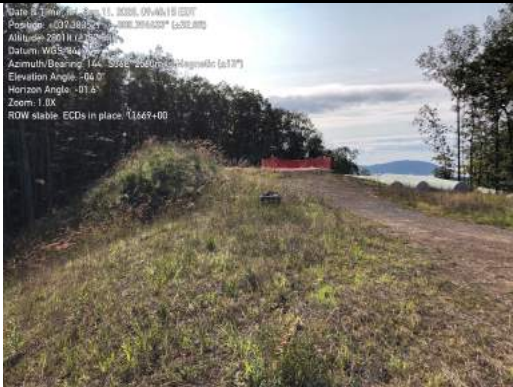
GPS Location	On photo	GPS Location	On photo		
Field Station#	11669+00	Field Station#	11657+00		
Pic 1 Desc.	ROW stable at top of Brush Mountain	Pic 2 Desc.	Perimeter controls in place and functioning

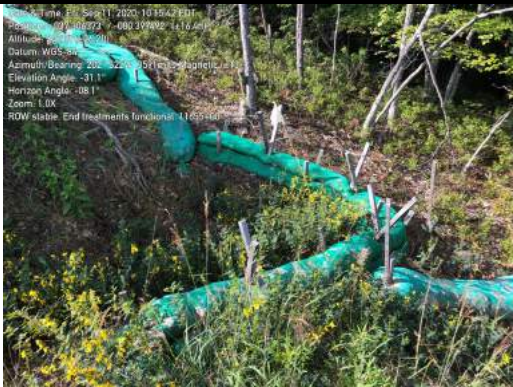
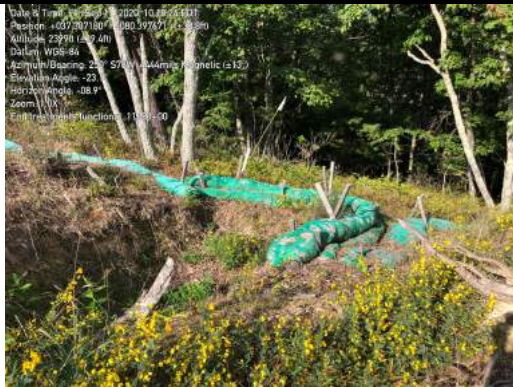
GPS Location	On photo	GPS Location	On photo		
Field Station#	11655+00	Field Station#	11653+00		
Pic 3 Desc.	Perimeter controls in place and functioning	Pic 4 Desc.	Perimeter controls in place and functioning

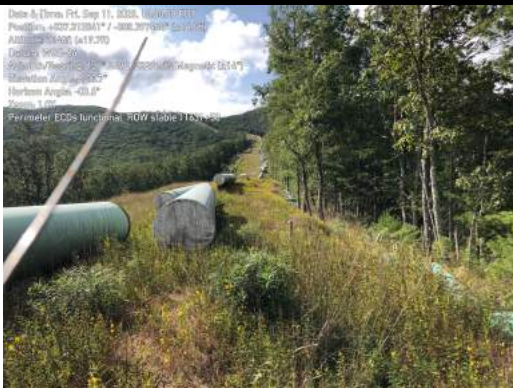
GPS Location	On photo	GPS Location	On photo		
Field Station#	11631+50	Field Station#	11626+04		
Pic 5 Desc.	Slope breakers effective. ECDs functional	Pic 6 Desc.	S-HH18 crossing stable. ECDs in place.

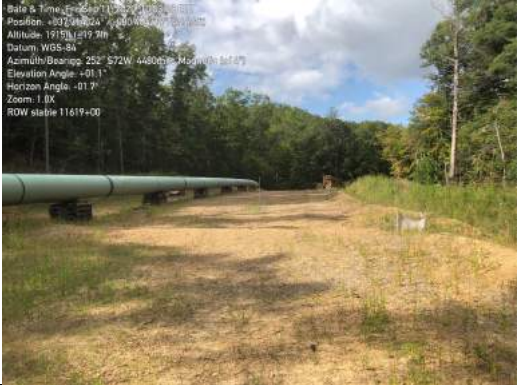
GPS Location	On photo	GPS Location	On photo		
Field Station#	11619+00	Field Station#	11614+20		
Pic 7 Desc.	ROW stable. ECDs in place.	Pic 8 Desc.	S-RR14 crossing stable.

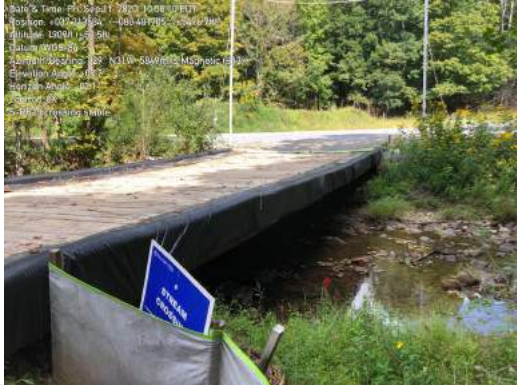
GPS Location	On photo	GPS Location	On photo		
Field Station#	11613+69	Field Station#	11608+17		
Pic 9 Desc.	S-RR13 crossing on access road MN-258.04 is stable.	Pic 10 Desc.	S006 crossing stable with ECDs in place.

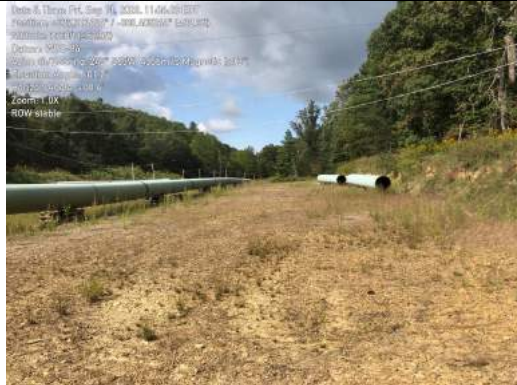
<p>Insert image here</p>			
GPS Location	On photo	GPS Location			
Field Station#	11606+50	Field Station#			
Pic 11 Desc.	ROW stable. ECDs in place.	Pic 12 Desc.

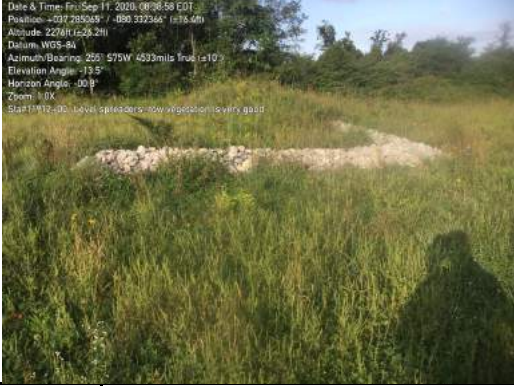
<p>Date & Time Fri, Sep 11, 2020, 09:38:58 EDT Position: +027.235847° / -080.332244° (a15.6N) Altitude: 2220ft (a25.2N) Datum: WGS-84 Azimuth/Bearing: 255° 57'5W 453mils True (a10°) Elevation Angle: -13.5° Horizon Angle: -00.8° Zoom: 1.0X Sta#11912+00- Level spreaders row vegetation is very good.</p>

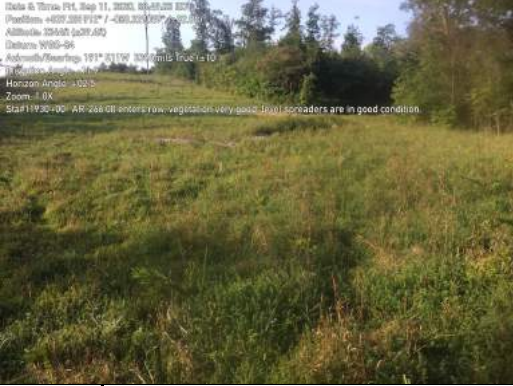
<p>Date & Time Fri, Sep 11, 2020, 09:40:00 EDT Position: +027.235847° / -080.332244° (a15.6N) Altitude: 2240ft (a25.2N) Datum: WGS-84 Azimuth/Bearing: 191° 51'1W 305mils True (a10°) Elevation Angle: -13.5° Horizon Angle: -00.8° Zoom: 1.0X Sta#11930+00- AR-266 enters row vegetation very good, level spreaders are in good condition.</p>			
GPS Location	See photo GPS		GPS Location	See photo GPS	
Field Station#	11912+00		Field Station#	11930+00	
Pic 1 Desc.	Level spreader and row vegetation		Pic 2 Desc.	AR-266 enters row, vegetation very good, level spreaders are in good condition.

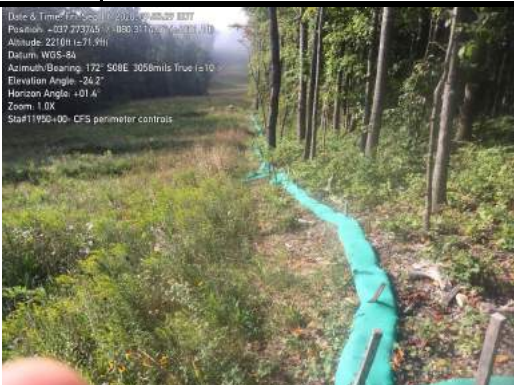
<p>Date & Time Fri, Sep 11, 2020, 10:00:00 EDT Position: +027.235847° / -080.332244° (a15.6N) Altitude: 2210ft (a25.2N) Datum: WGS-84 Azimuth/Bearing: 172° 50'E 305mils True (a10°) Elevation Angle: -24.2° Horizon Angle: +01.4° Zoom: 1.0X Sta#11950+00- CFS perimeter controls.</p>

GPS Location	See photo GPS		GPS Location	See photo GPS	
Field Station#	11950+00		Field Station#	11953+00	
Pic 5 Desc.	CFS perimeter controls		Pic 6 Desc.	Row heavily vegetated, no sediment movement observed in inspection area.

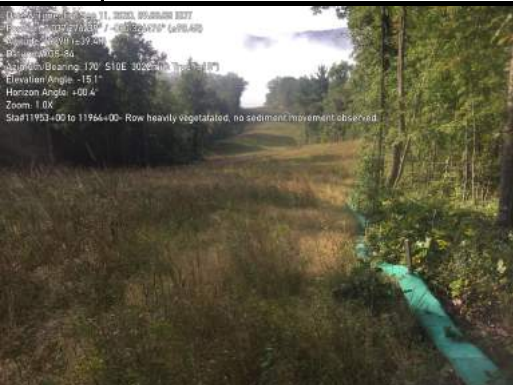
<p>Date & Time Fri, Sep 11, 2020, 10:00:00 EDT Position: +027.235847° / -080.332244° (a15.6N) Altitude: 2210ft (a25.2N) Datum: WGS-84 Azimuth/Bearing: 170° 51'E 302mils True (a10°) Elevation Angle: -15.1° Horizon Angle: +00.4° Zoom: 1.0X Sta#11953+00 to 11964+00- Row heavily vegetated, no sediment movement observed.</p>

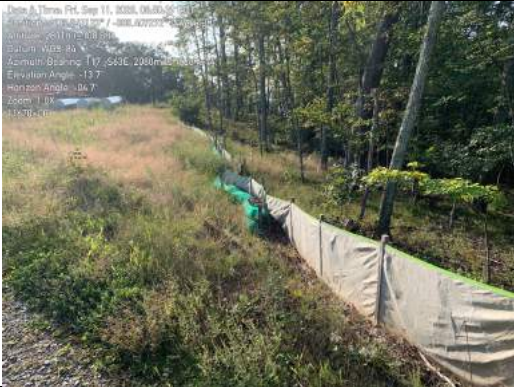
GPS Location	See photo for GPS location.		GPS Location	See photo for GPS location.	
Field Station#	11670+00		Field Station#	11675+00	
Pic 1 Desc.	Triple stack compost filter sock and priority one silt fence in place along LOD.		Pic 2 Desc.	Waterbar, sump pit and waterbar end treatment in place.

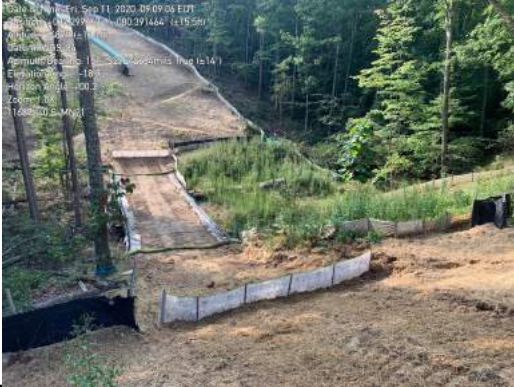
GPS Location	See photo for GPS location.		GPS Location	See photo for GPS location.	
Field Station#	11687+40		Field Station#	11767+00	
Pic 3 Desc.	Sensitive resource buffer in place at stream S-MN21.		Pic 4 Desc.	RCE in place at Main Line Valve 26.

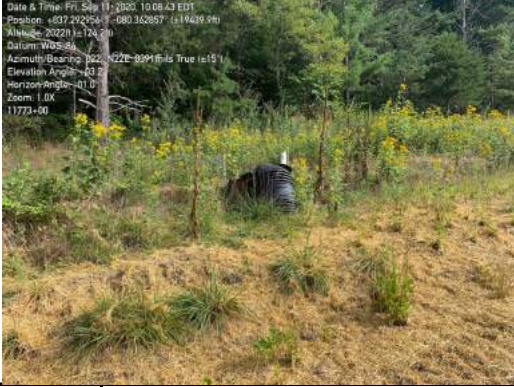
GPS Location	See photo for GPS location.		GPS Location	See photo for GPS location.	
Field Station#	11773+00		Field Station#	11775+00	
Pic 5 Desc.	Clean water diversion pipe inlet and clean water diversion berm in place.		Pic 6 Desc.	Clean water diversion pipe and plunge pool in place.
