Visual Site Inspection Report

Project Name	H-600 Pipeline Spread G	AFE	124300137	Spread	H-600 Pipeline Spread G
Contractor	Precision			Report #	15212
Inspector	Rob Robertson			Date/Time	10/5/2020 11:29 AM
Permit #	TBD	Inspection Type	VA SWPP	Station Begin	11600+01
State	VA	Inspection Area	Full	Station End	11670+00
County	Montgomery	Ground	Damp	Temperature (°F)	50.00
Municipality	N/A	Weather	Sunny	Rain Gauge (in)	0.00
				Rain Accumulation Time (days)	1.00

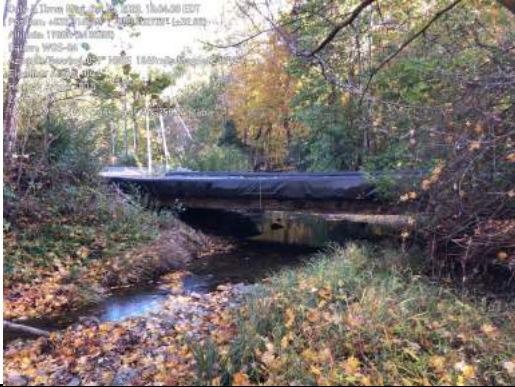
<p> Date & Time: Mon, Oct 5, 2020, 10:10:38 EDT Position: 43°07'31.9670"N 116°02'28.011"W (44°) Altitude: 928ft (±19.5ft) Datum: WGS-84 Azimuth/Heading: 250° 57'W 144mils Magnetic (±14°) Deviation Angle: 10°W Horizon Angle: 70°W Zoom: 1.0X 11614+20, S-RR14 crossing stable </p>			
GPS Location	On photo	GPS Location	On photo		
Field Station#	11614+20	Field Station#	11613+69		
Pic 7 Desc.	The S-RR14 crossing is stable with ECDs in place.	Pic 8 Desc.	The S-RR13 crossing at MN-258.04 is stable.

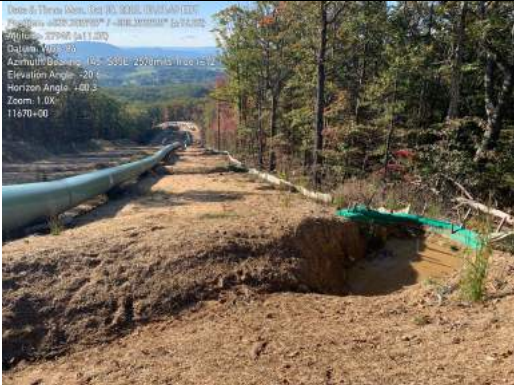
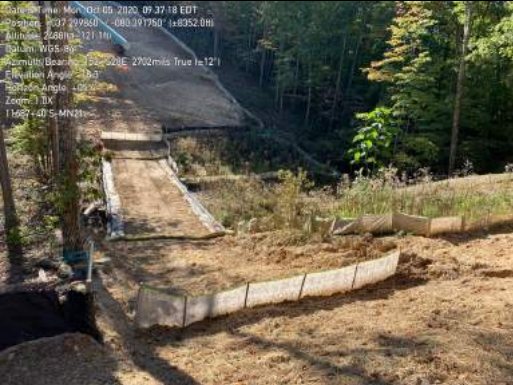
GPS Location	See photo for GPS location.		GPS Location	See photo for GPS location.	
Field Station#	11670+00		Field Station#	11687+40	
Pic 1 Desc.	Waterbar sump pit and waterbar end treatment in place.		Pic 2 Desc.	Sensitive resource buffer in place at stream S-MN21.

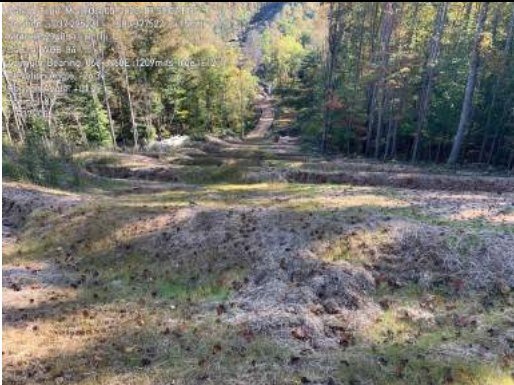
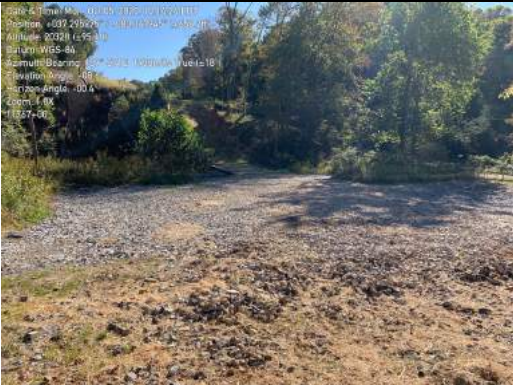
GPS Location	See photo for GPS location.		GPS Location	See photo for GPS location.	
Field Station#	11737+00		Field Station#	11767+00	
Pic 3 Desc.	ROW stabilized with seed and mulch. Minor vegetation growth.		Pic 4 Desc.	RCE in place at Main Line Valve in place.

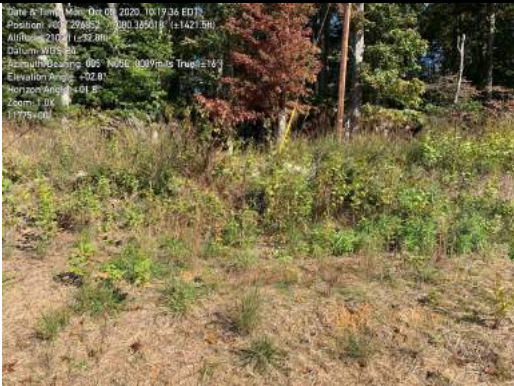
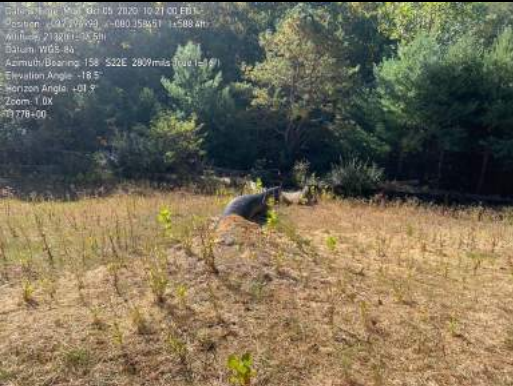
GPS Location	See photo for GPS location.		GPS Location	See photo for GPS location.	
Field Station#	11775+00		Field Station#	11778+00	
Pic 5 Desc.	Clean water diversion pipe and clean water diversion berm in place.		Pic 6 Desc.	Clean water diversion pipe and plunge pool in place.

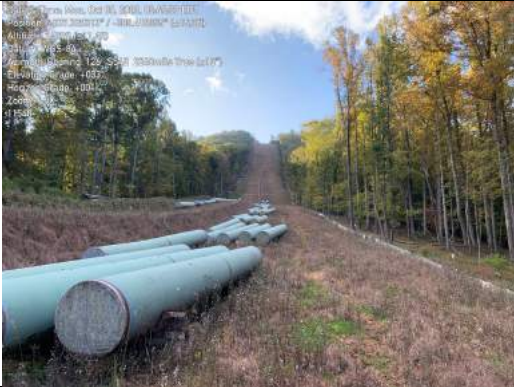
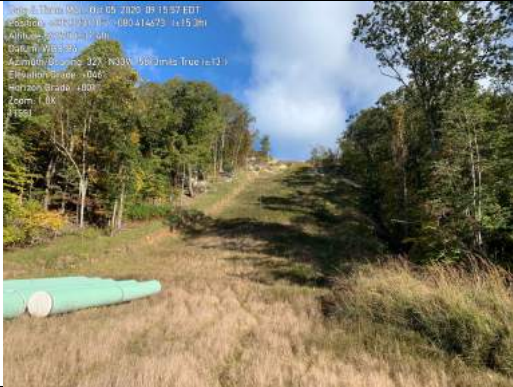
GPS Location	See picture above for GPS coordinates		GPS Location	See picture above for GPS coordinates	
Field Station#	11540+00		Field Station#	11551+00	
Pic 1 Desc.	ECD's and row conditions		Pic 2 Desc.	ECD's and row conditions

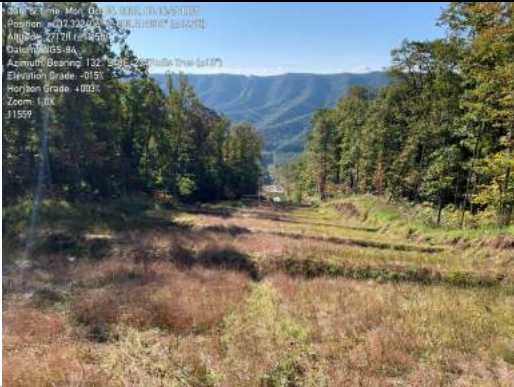
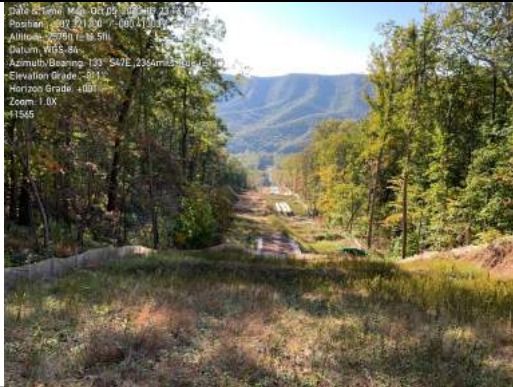
GPS Location	See picture above for GPS coordinates		GPS Location	See picture above for GPS coordinates	
Field Station#	11559+00		Field Station#	11565+00	
Pic 3 Desc.	ECD's and row conditions		Pic 4 Desc.	ECD's and row conditions

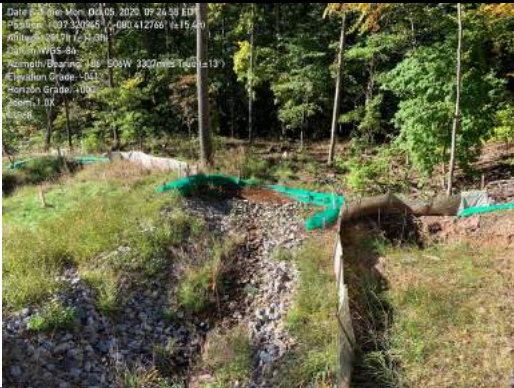
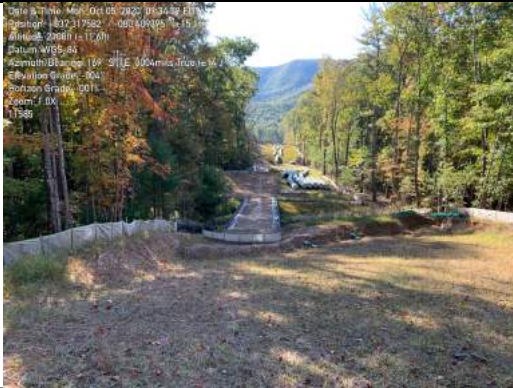
GPS Location	See picture above for GPS coordinates		GPS Location	See picture above for GPS coordinates	
Field Station#	11568+00		Field Station#	11585+00	
Pic 5 Desc.	ECD's and row conditions		Pic 6 Desc.	ECD's and row conditions

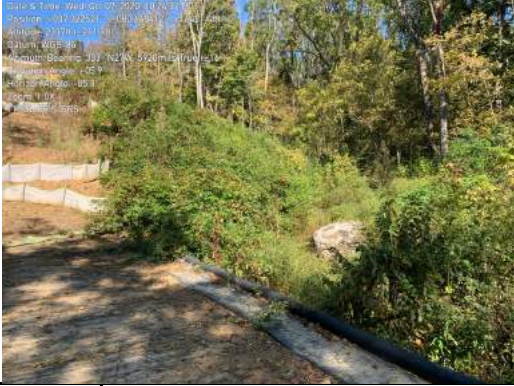
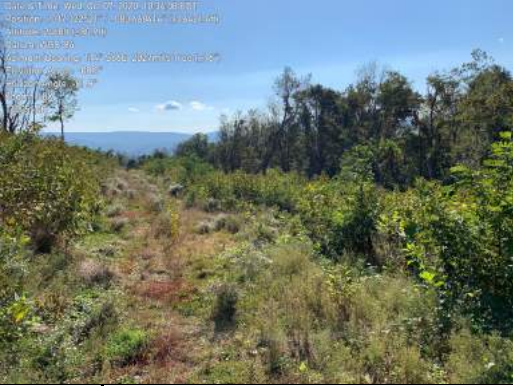
GPS Location	See photo for GPS location.		GPS Location	See photo for GPS location.	
Field Station#	11015+75		Field Station#	11005+00	
Pic 1 Desc.	Sensitive resource buffer in place at stream S-RR5.		Pic 2 Desc.	ROW stabilized with natural vegetation.

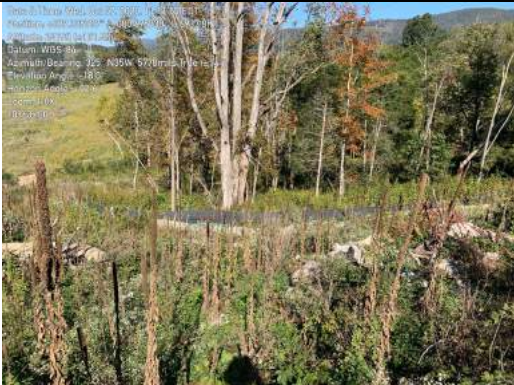
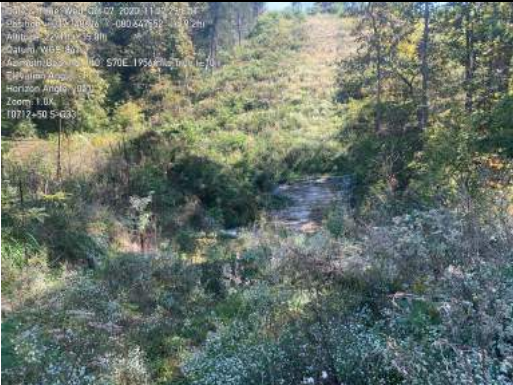
GPS Location	See photo for GPS location.		GPS Location	See photo for GPS location.	
Field Station#	10963+00		Field Station#	10712+50	
Pic 3 Desc.	Triple barrier ECDs in place at Karst feature.		Pic 4 Desc.	Sensitive resource buffer in place at stream S-G33.

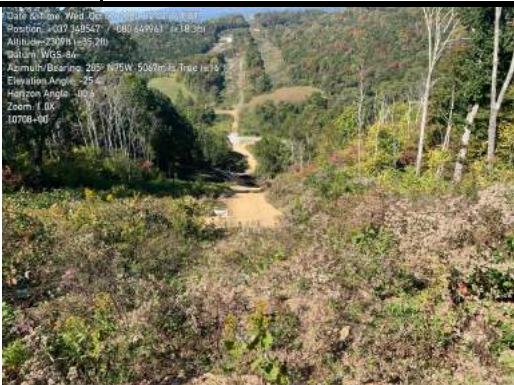
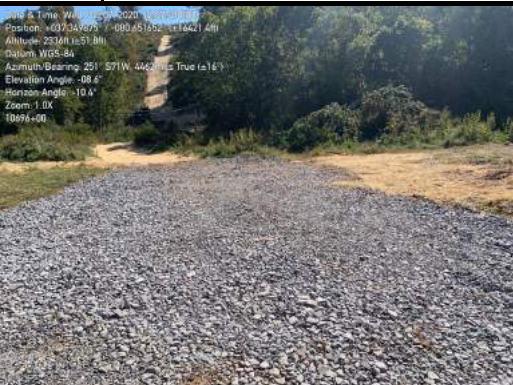
GPS Location	See photo for GPS location.		GPS Location	See photo for GPS location.	
Field Station#	10708+00		Field Station#	10696+00	
Pic 5 Desc.	Travel lane stabilized with ECB.		Pic 6 Desc.	RCE in place at Buffalo Anklets Road.

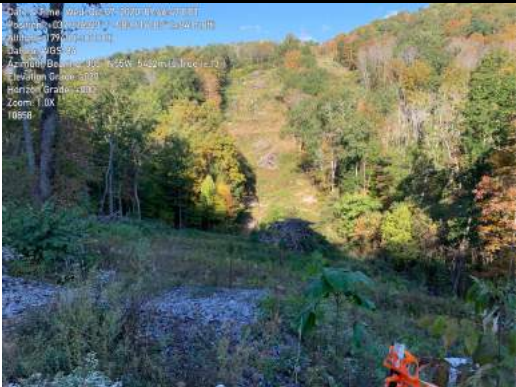
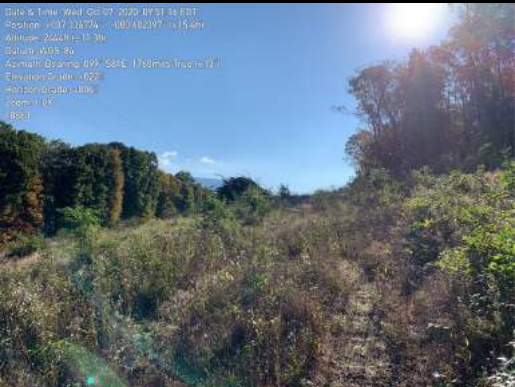
GPS Location	See picture above for GPS coordinates		GPS Location	See picture above for GPS coordinates	
Field Station#	10858+00		Field Station#	10863+00	
Pic 1 Desc.	ECD's and row conditions		Pic 2 Desc.	ECD's and row conditions

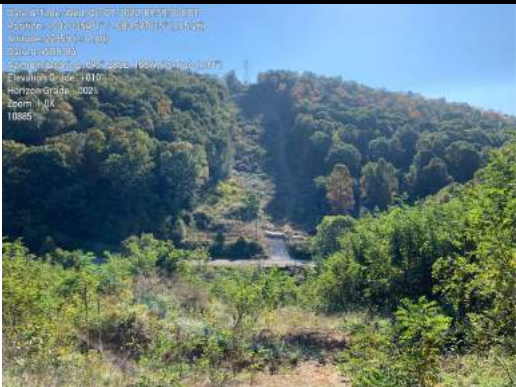
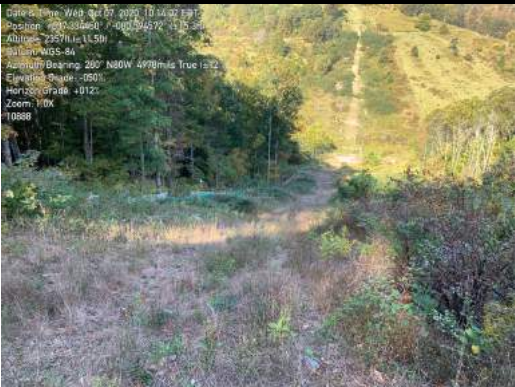
GPS Location	See picture above for GPS coordinates		GPS Location	See picture above for GPS coordinates	
Field Station#	10885+00		Field Station#	10888+00	
Pic 3 Desc.	ECD's and row conditions		Pic 4 Desc.	ECD's and row conditions

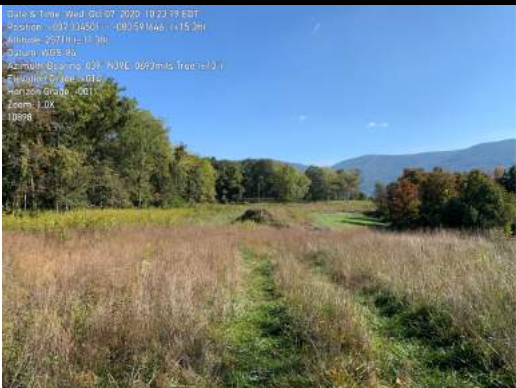
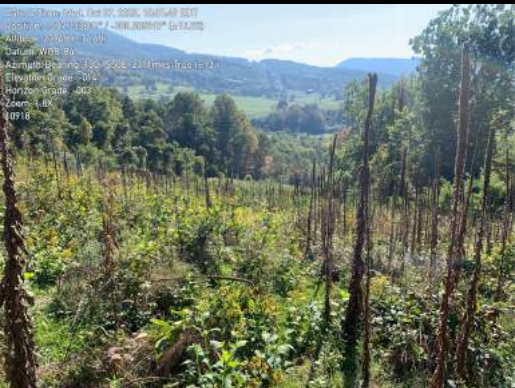
GPS Location	See picture above for GPS coordinates		GPS Location	See picture above for GPS coordinates	
Field Station#	10898+00		Field Station#	10918+00	
Pic 5 Desc.	ECD's and row conditions		Pic 6 Desc.	ECD's and row conditions

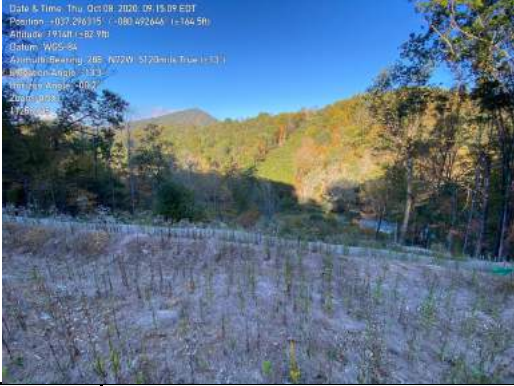
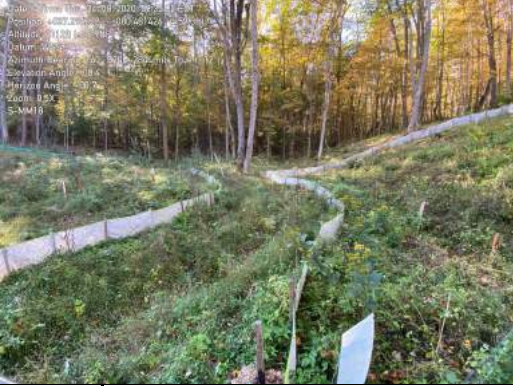
GPS Location	1	GPS Location	2		
Field Station#	11238+35	Field Station#	11292+80		
Pic 1 Desc.	Section of RoW showing conditions and controls.	Pic 2 Desc.	S-MM18 and controls.

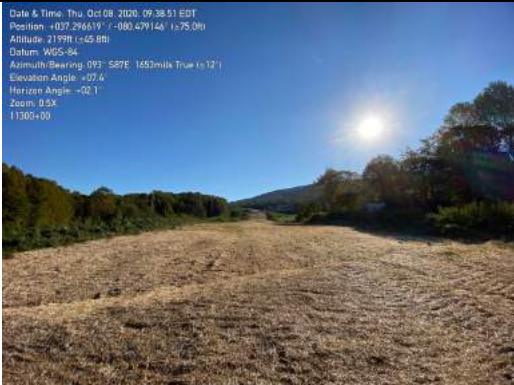
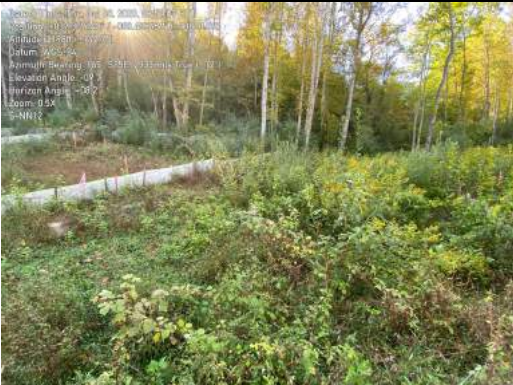
GPS Location	3	GPS Location	4		
Field Station#	11300+00	Field Station#	11327+85		
Pic 3 Desc.	Section of RoW showing conditions and controls.	Pic 4 Desc.	S-NN12 and controls.

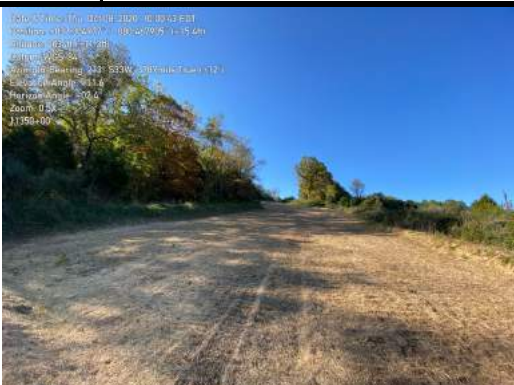
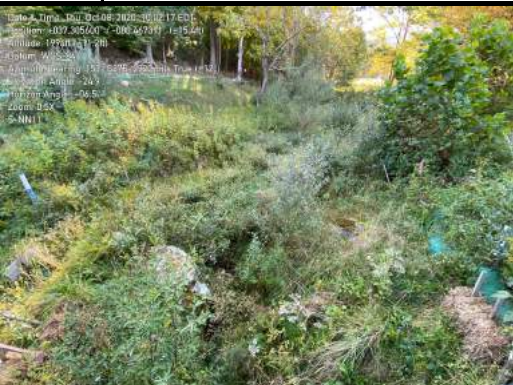
GPS Location	5	GPS Location	6		
Field Station#	11350+00	Field Station#	11352+97		
Pic 5 Desc.	Section of RoW showing conditions and controls.	Pic 6 Desc.	S-NN11 and controls.

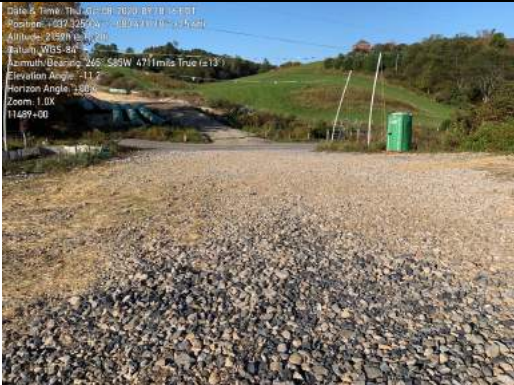
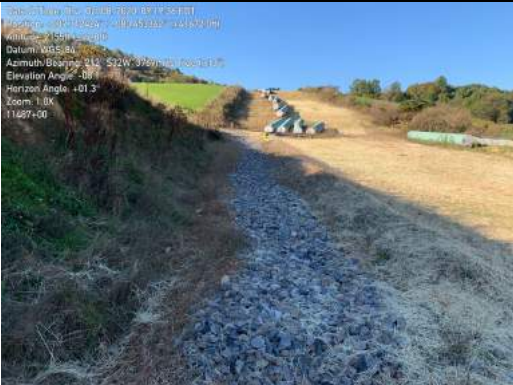
GPS Location		See photo for GPS location.		GPS Location	
Field Station#		11489+00		Field Station#	
Pic 3 Desc.		RCE in place at Stevers Gap Road.		Pic 4 Desc.

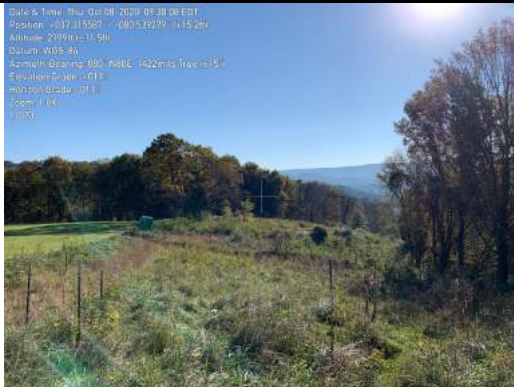
GPS Location	See picture above for GPS coordinates		GPS Location	See picture above for GPS coordinates	
Field Station#	11068+00		Field Station#	11073+00	
Pic 1 Desc.	ECD's and row conditions		Pic 2 Desc.	ECD's and row conditions

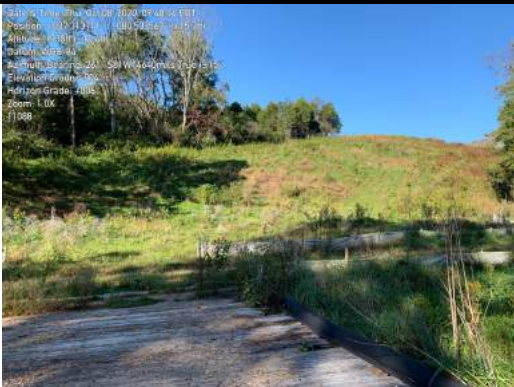
GPS Location	See picture above for GPS coordinates		GPS Location	See picture above for GPS coordinates	
Field Station#	11088+00		Field Station#	11111+00	
Pic 3 Desc.	ECD's and row conditions		Pic 4 Desc.	ECD's and row conditions

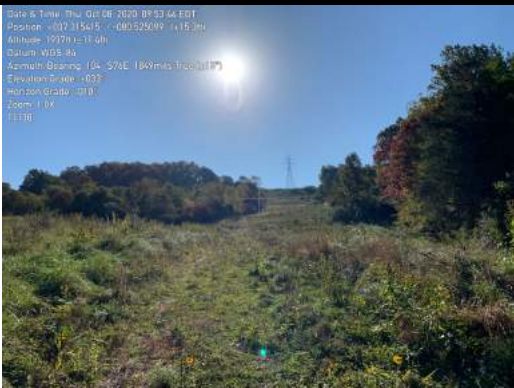
GPS Location	See picture above for GPS coordinates		GPS Location	See picture above for GPS coordinates	
Field Station#	11130+00		Field Station#	11140+00	
Pic 5 Desc.	ECD's and row conditions		Pic 6 Desc.	ECD's and row conditions

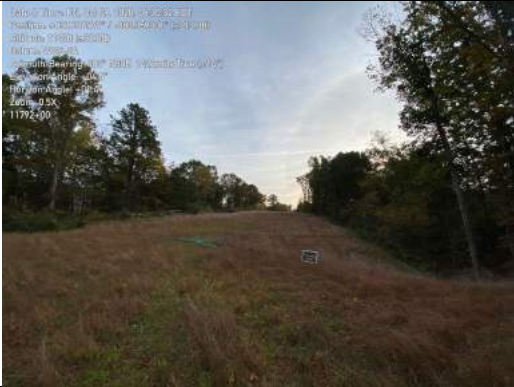
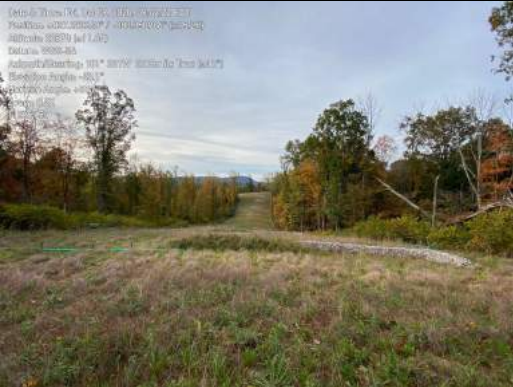
GPS Location	1	GPS Location	2		
Field Station#	11792+00	Field Station#	11825+50		
Pic 1 Desc.	Section of restored RoW showing conditions and controls.	Pic 2 Desc.	Section of restored RoW showing conditions and controls.

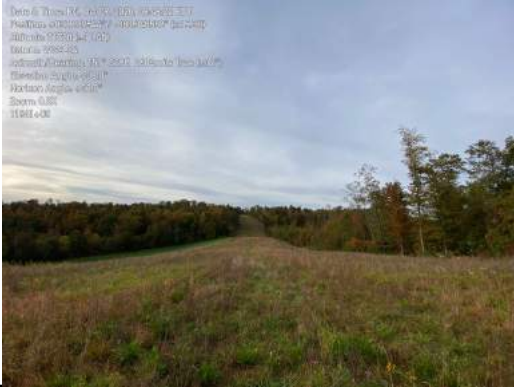
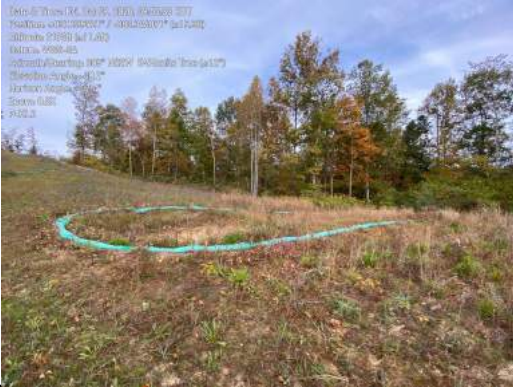
GPS Location	3	GPS Location	4		
Field Station#	11841+00	Field Station#	11863+65		
Pic 3 Desc.	Section of restored RoW showing conditions and controls.	Pic 4 Desc.	P-KL2 and controls.

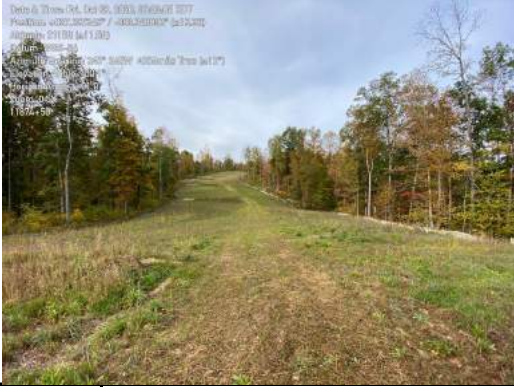
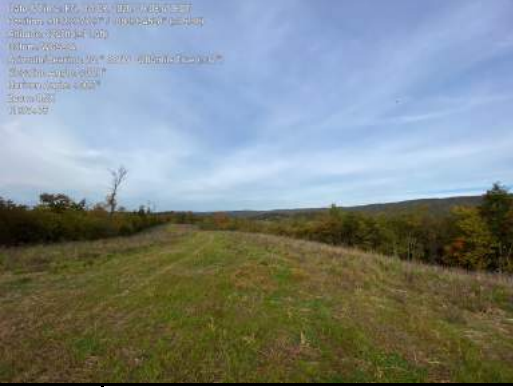
GPS Location	5	GPS Location	6		
Field Station#	11874+50	Field Station#	11899+75		
Pic 5 Desc.	Section of restored RoW showing conditions and controls.	Pic 6 Desc.	Section of restored RoW showing conditions and controls.

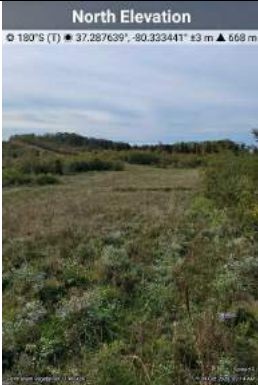
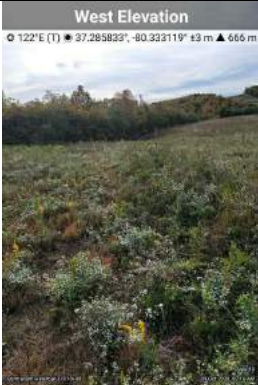
GPS Location	see photo		GPS Location	see photo	
Field Station#	11606+00		Field Station#	11910+00	
Pic 1 Desc.	permanent vegetation growth		Pic 2 Desc.	installed permanent waterbar	
	West Elevation

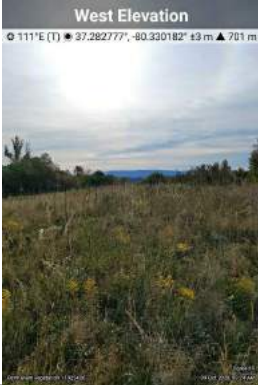
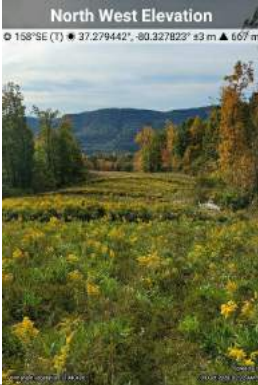
GPS Location	see photo		GPS Location	see photo	
Field Station#	11925+00		Field Station#	11940+00	
Pic 3 Desc.	permanent vegetation growth		Pic 4 Desc.	permanent vegetation growth	
	North Elevation

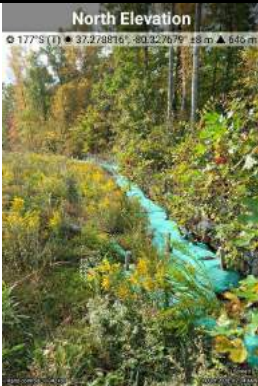
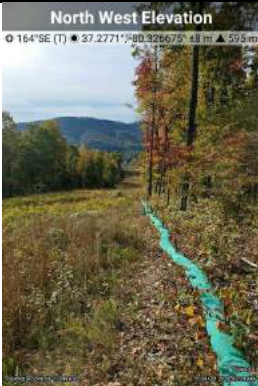
GPS Location	see photo		GPS Location	see photo	
Field Station#	11942+00		Field Station#	11949+00	
Pic 5 Desc.	installed controls in sensitive resource area		Pic 6 Desc.	installed perimeter controls

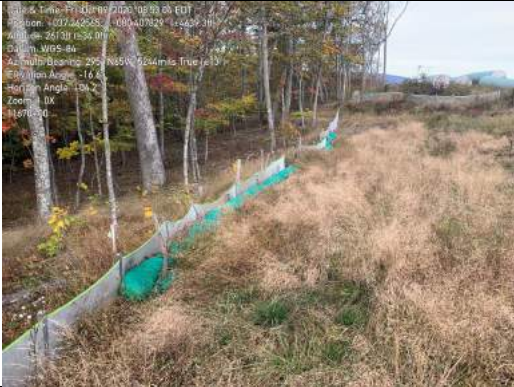
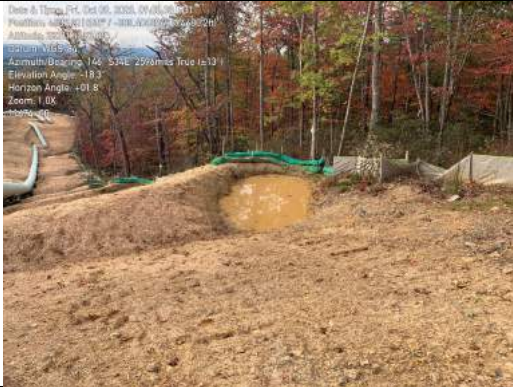
GPS Location	See photo for GPS location.		GPS Location	See photo for GPS location.	
Field Station#	11670+00		Field Station#	11674+00	
Pic 1 Desc.	Triple stack CFS and priority one silt fence in place along LOD.		Pic 2 Desc.	Waterbar sump pit and waterbar end treatment in place.

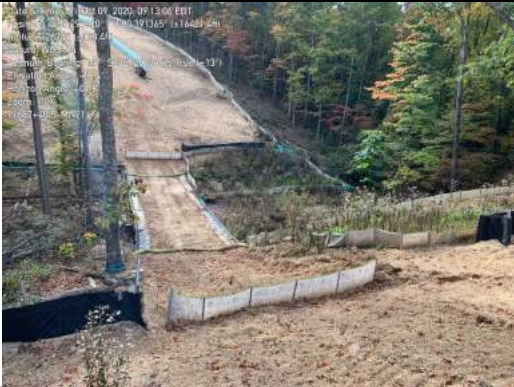
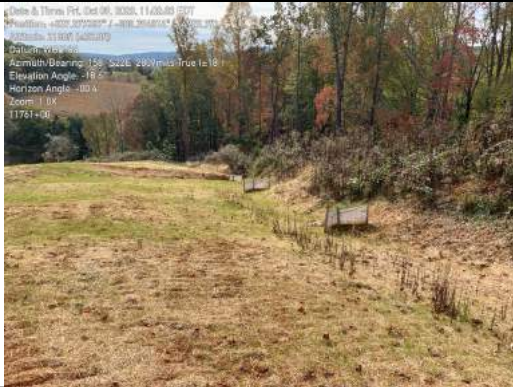
GPS Location	See photo for GPS location.		GPS Location	See photo for GPS location.	
Field Station#	11687+40		Field Station#	11761+00	
Pic 3 Desc.	Sensitive resource buffer in place at stream S-MN21.		Pic 4 Desc.	ROW stabilized with seed and mulch. Priority one silt fence checks in place.

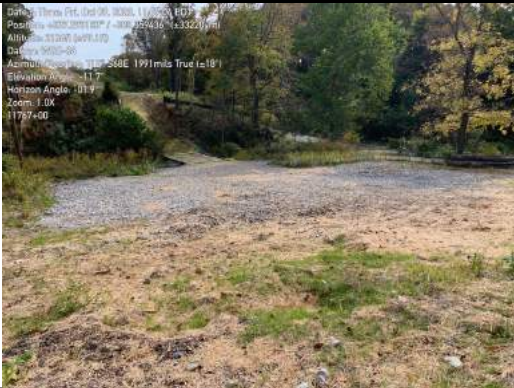
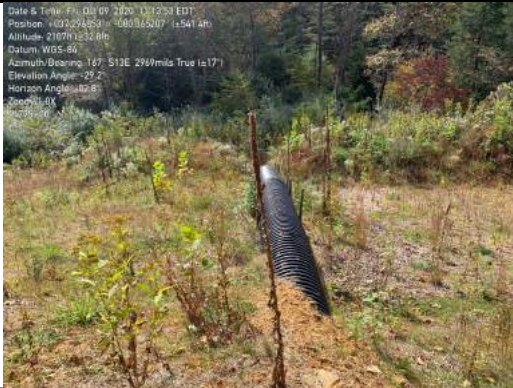
GPS Location	See photo for GPS location.		GPS Location	See photo for GPS location.	
Field Station#	11767+00		Field Station#	11775+00	
Pic 5 Desc.	RCE in place at MLV 26.		Pic 6 Desc.	Clean water diversion pipe and plunge pool in place.

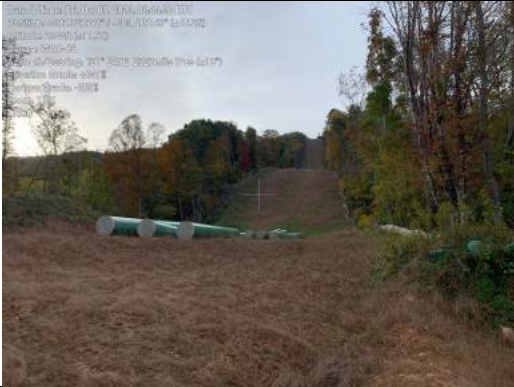
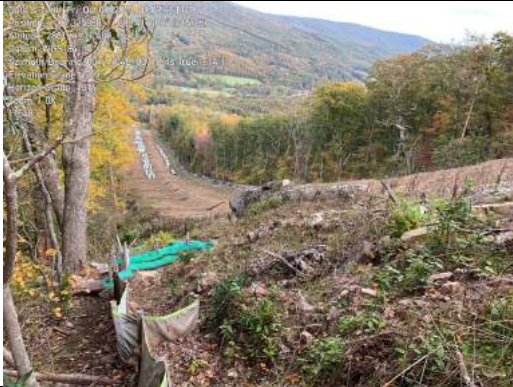
GPS Location	See picture above for GPS coordinates		GPS Location	See picture above for GPS coordinates	
Field Station#	11530+00		Field Station#	11548+00	
Pic 1 Desc.	ECD's and row conditions		Pic 2 Desc.	ECD's and row conditions

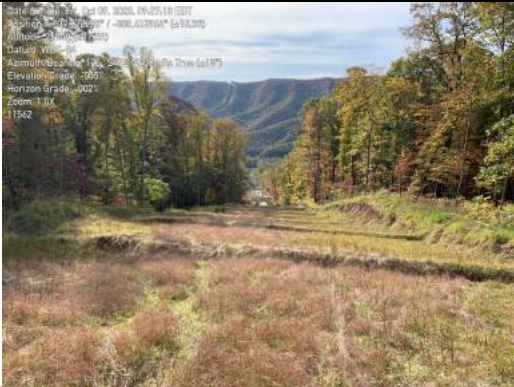
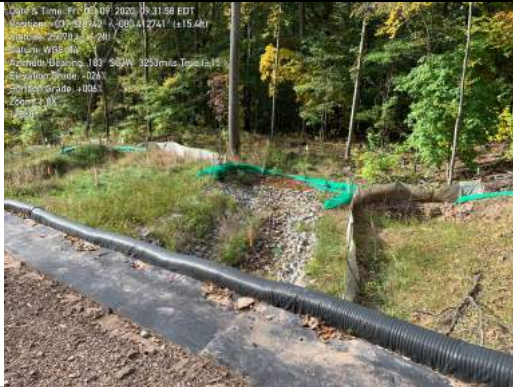
GPS Location	See picture above for GPS coordinates		GPS Location	See picture above for GPS coordinates	
Field Station#	11562+00		Field Station#	11568+00	
Pic 3 Desc.	ECD's and row conditions		Pic 4 Desc.	ECD's and row conditions

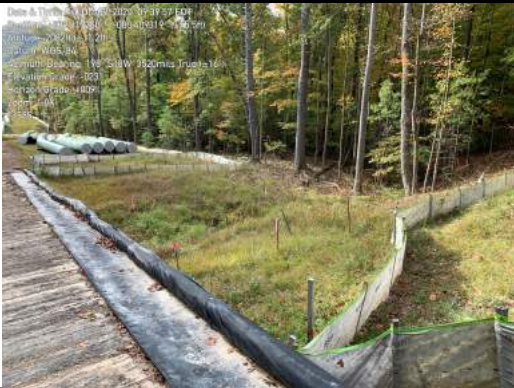
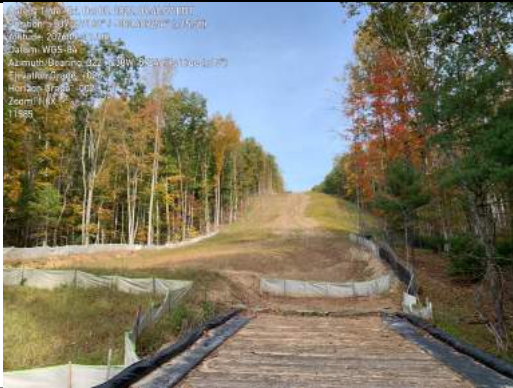
GPS Location	See picture above for GPS coordinates		GPS Location	See picture above for GPS coordinates	
Field Station#	11585+00		Field Station#	11585+00	
Pic 5 Desc.	ECD's and row conditions		Pic 6 Desc.	ECD's and row conditions
