Visual Site Inspection Report

Project Name	H-600 Pipeline Spread H	AFE	124300138	Spread	H-600 Pipeline Spread H
Contractor	Precision			Report #	17755
Inspector	John Brcic			Date/Time	12/7/2020 10:10 AM
Permit #	TBD	Inspection Type	VA SWPP	Station Begin	13262+50
State	VA	Inspection Area	Partial	Station End	13315+70
County	Franklin	Ground	Damp	Temperature (°F)	31.00
Municipality	N/A	Weather	Snow/Sleet	Rain Gauge (in)	0.10
				Rain Accumulation Time (days)	2.00

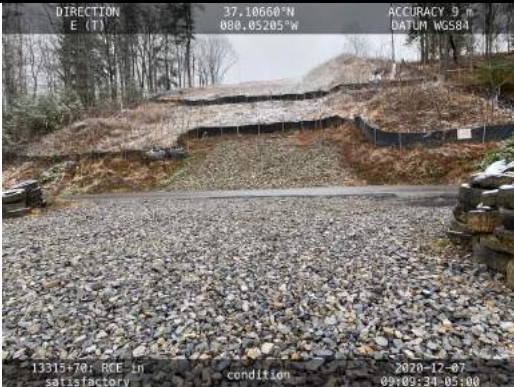
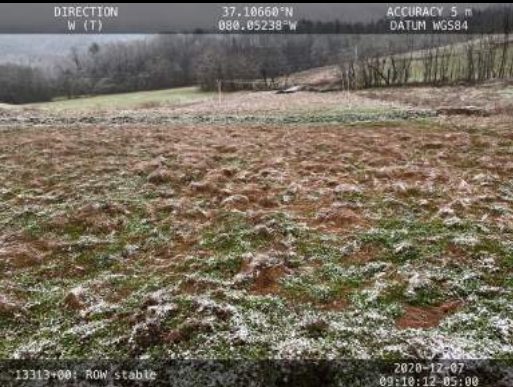
GPS Location	See photo		GPS Location	See photo	
Field Station#	13315+70		Field Station#	13313+00	
Pic 1 Desc.	The RCE at Wades Gap Road is in satisfactory condition.		Pic 2 Desc.	Temporary stabilization between stream S-GH7 and Wades Gap Road remains stable.

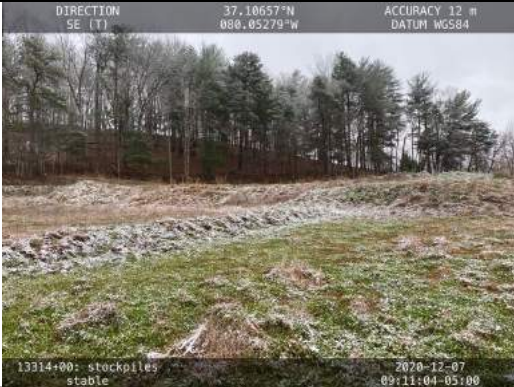
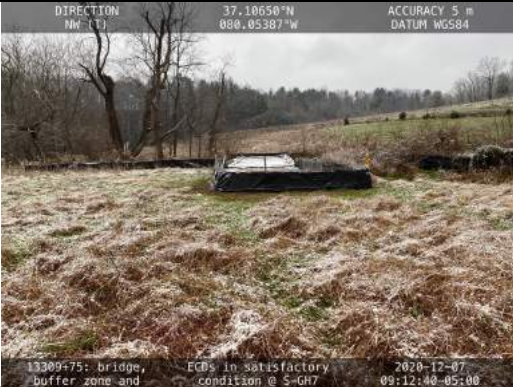
GPS Location	See photo		GPS Location	See photo	
Field Station#	13314+00		Field Station#	13309+75	
Pic 3 Desc.	Stockpiles on the coming in side of Wades Gap Road are well vegetated and stable.		Pic 4 Desc.	The bridge, buffer zone and ECDs at stream S-GH7 are in satisfactory condition.

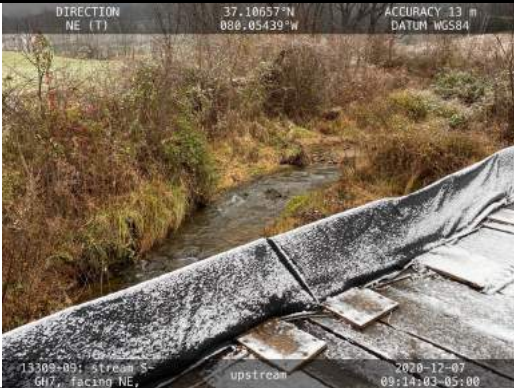
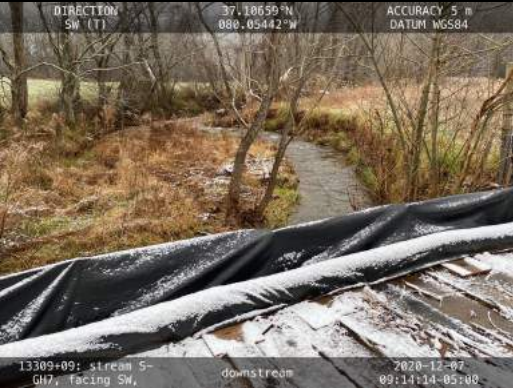
GPS Location	See photo		GPS Location	See photo	
Field Station#	13309+09		Field Station#	13309+09	
Pic 5 Desc.	Stream S-GH7, facing northeast, upstream		Pic 6 Desc.	Stream S-GH7, facing southwest, downstream

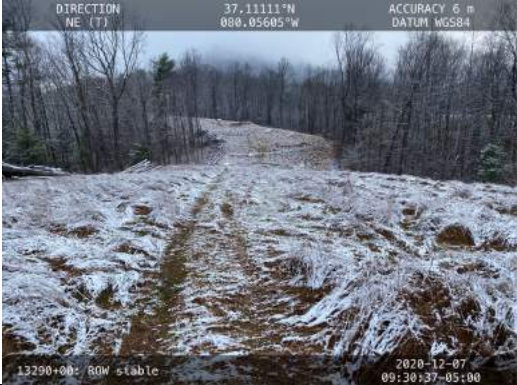
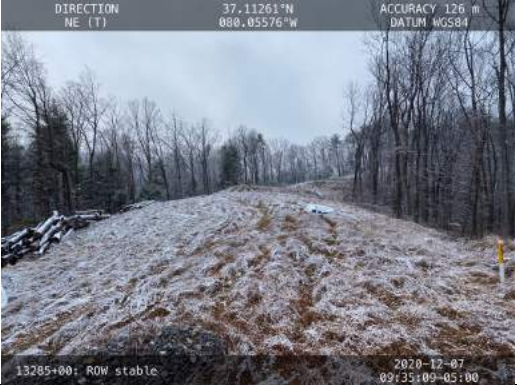
GPS Location	See photo		GPS Location	See photo	
Field Station#	13290+00		Field Station#	13285+00	
Pic 13 Desc.	ROW stable		Pic 14 Desc.	ROW stable

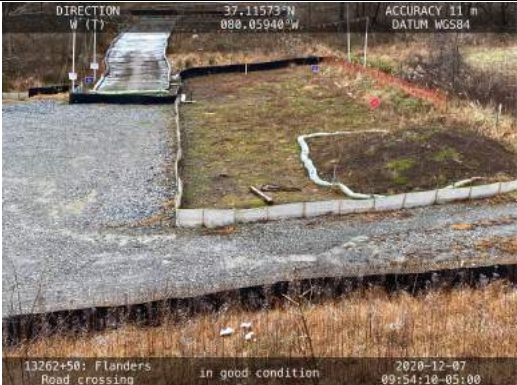
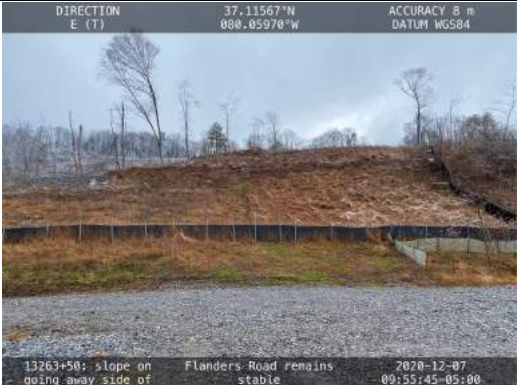
GPS Location	See photo		GPS Location	See photo	
Field Station#	13262+50		Field Station#	13263+50	
Pic 17 Desc.	The Flanders Road crossing is in good condition.		Pic 18 Desc.	The slope on the going away side of Flanders Road remains stable.

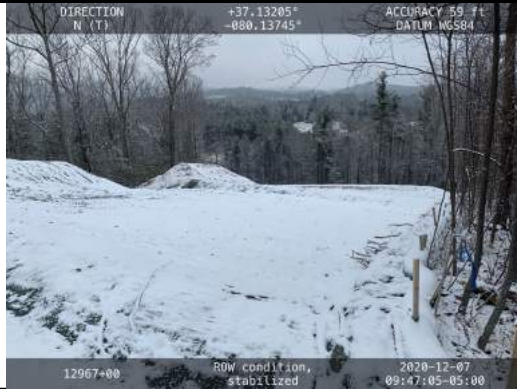
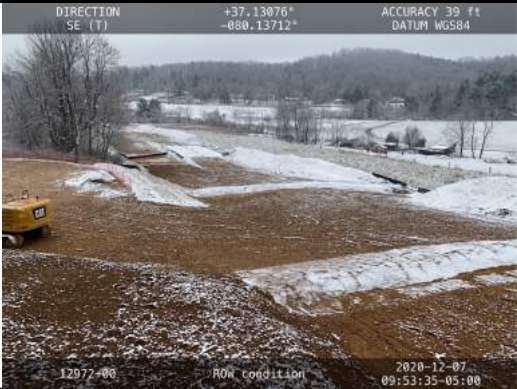
GPS Location	See photo for gps location data.		GPS Location	See photo for gps location data.	
Field Station#	12967+00		Field Station#	12972+00	
Pic 11 Desc.	Photo shows the ROW condition from about 12964+00 to 12967+00. Area is stabilized with hydro-mulch.		Pic 12 Desc.	Photo shows the ROW condition from about 12972+00 to about 12975+00.

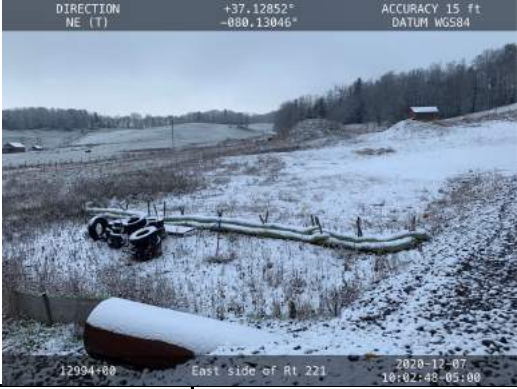
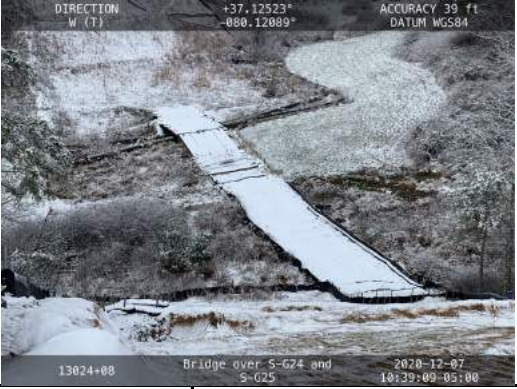
GPS Location	See photo for gps location data.		GPS Location	See photo for gps location data.	
Field Station#	12994+00		Field Station#	1302+08	
Pic 13 Desc.	Photo shows the ROW on the east side of Rt 221.		Pic 14 Desc.	Photo shows the bridge over streams S-G24 and S-G25.

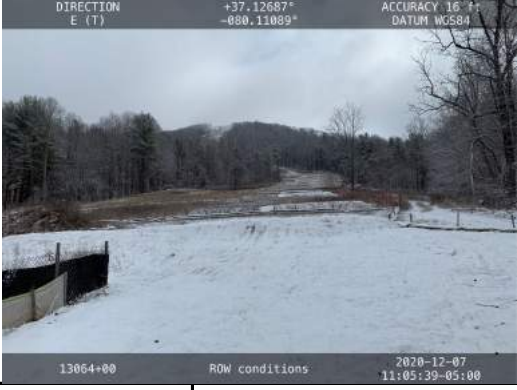
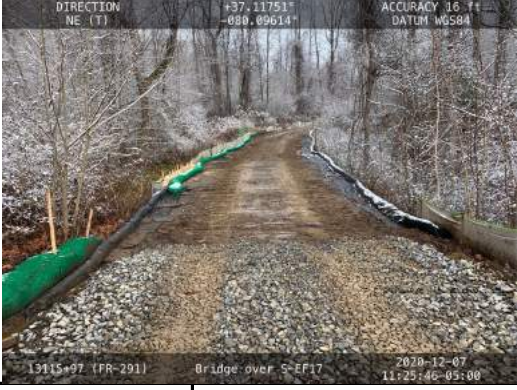
GPS Location	See photo for gps location data.		GPS Location	See photo for gps location data.	
Field Station#	13064+00		Field Station#	13115+97	
Pic 17 Desc.	Photo shows the ROW condition from about 13064+00 to about 13069+00.		Pic 18 Desc.	Photo shows the bridge over stream S-EF17.

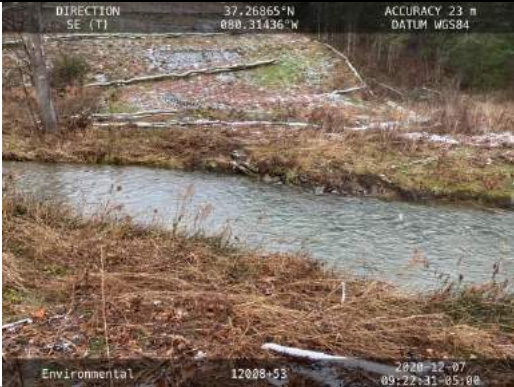
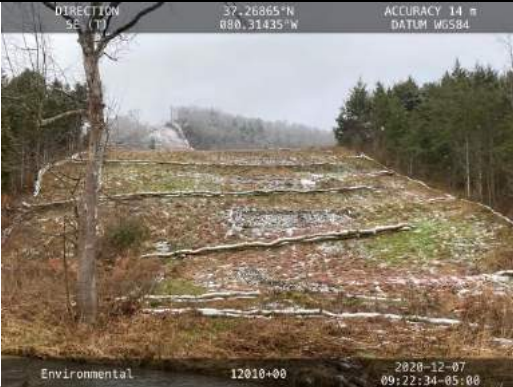
GPS Location	See photo for GPS coordinates		GPS Location	See photo for GPS coordinates	
Field Station#	12008+53		Field Station#	12010+00	
Pic 3 Desc.	S-G36 stream crossing in acceptable condition		Pic 4 Desc.	Well vegetated and stabilized coverage across LOD on the GAS of S-G36

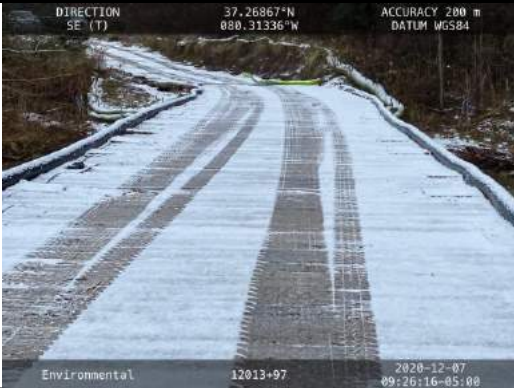
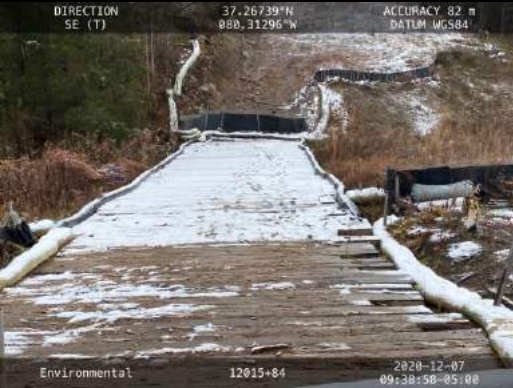
GPS Location	See photo for GPS coordinates		GPS Location	See photo for GPS coordinates	
Field Station#	12013+97		Field Station#	12015+84	
Pic 5 Desc.	Bridge crossing S-G36 along access road MVP-MN-268.01		Pic 6 Desc.	Bridge and ECDs crossing S-G38 in acceptable condition.

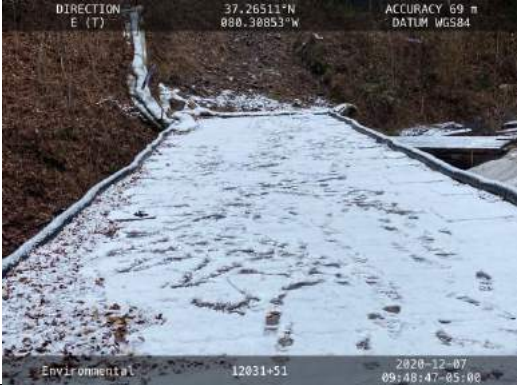
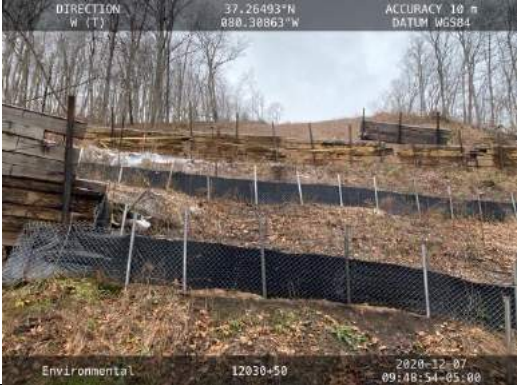
GPS Location	See photo for GPS		GPS Location	See photo for GPS coordinates	
Field Station#	12031+51		Field Station#	12030+50	
Pic 7 Desc.	Bridge and ECDs at S-G39 in acceptable condition.		Pic 8 Desc.	Well stabilized ROW with a mat wall for extra protection above the stream.

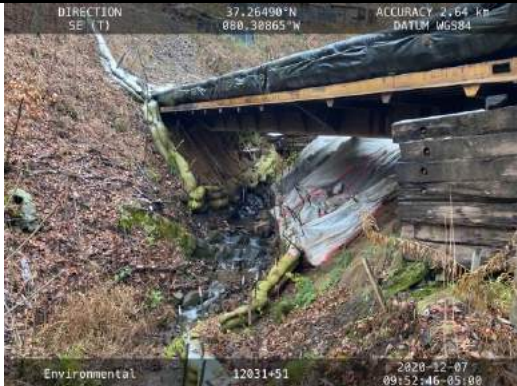
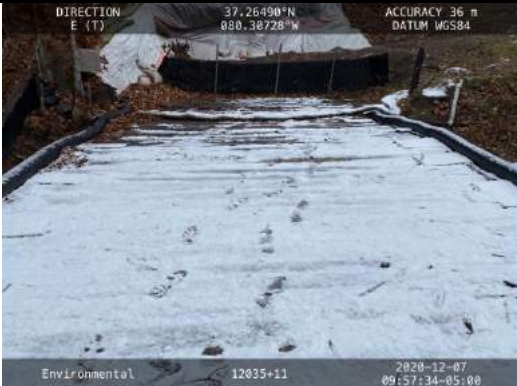
GPS Location	See photo for GPS coordinates		GPS Location	See photo for GPS coordinates	
Field Station#	12031+51		Field Station#	12035+11	
Pic 9 Desc.	ECDs underneath the bridge in acceptable and no impacts recorded.		Pic 10 Desc.	Bridge and ECDs at S-G40 in acceptable condition.

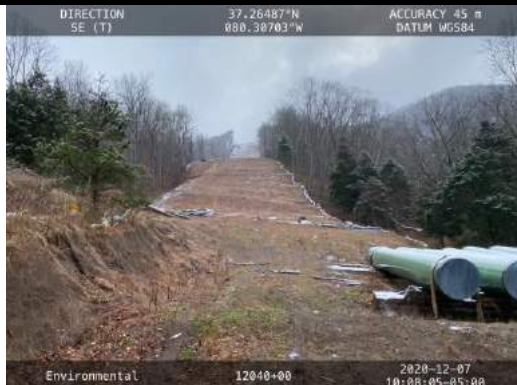
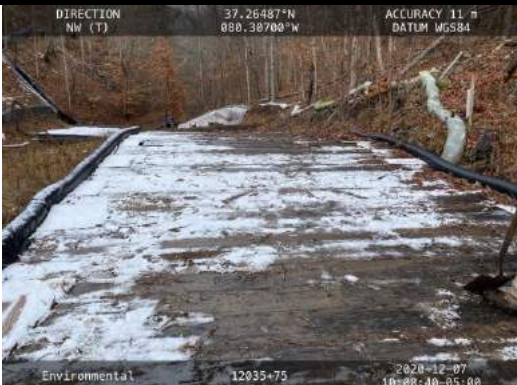
GPS Location	See photo for GPS coordinates		GPS Location	See photo for GPS coordinates	
Field Station#	12040+00		Field Station#	12035+75	
Pic 11 Desc.	Well vegetated coverage across the LOD.		Pic 12 Desc.	Bridge and ECDs at S-PP23 are in acceptable condition.

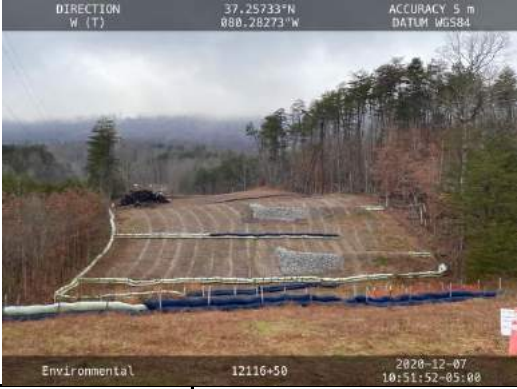
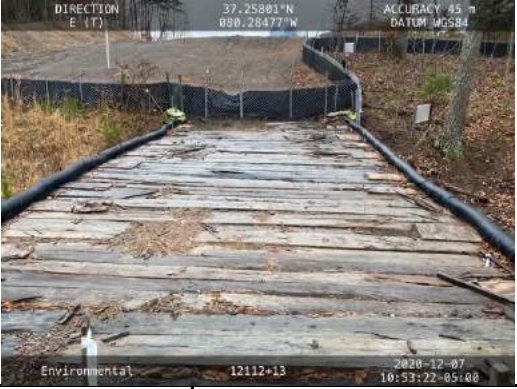
GPS Location	See photo for GPS coordinates		GPS Location	See photo for GPS coordinates	
Field Station#	12116+50		Field Station#	12112+13	
Pic 13 Desc.	Final restoration with well vegetated coverage across LOD.		Pic 14 Desc.	Bridge and ECDs at S-F16A/B are in acceptable condition

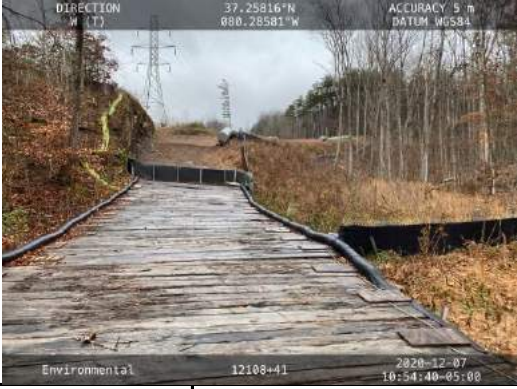
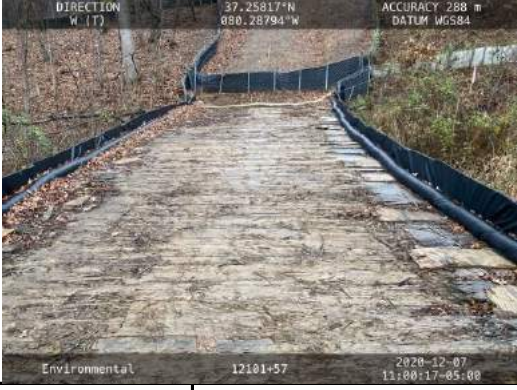
GPS Location	See photo for GPS coordinates		GPS Location	See photo for GPS coordinates	
Field Station#	12108+41		Field Station#	12102+75	
Pic 15 Desc.	Bridge and ECDs in working conditions and well vegetated buffer zone.		Pic 16 Desc.	Rain gauge totals following the snow from the previous night melting. (0.1"). Half Acre of Rock Rd

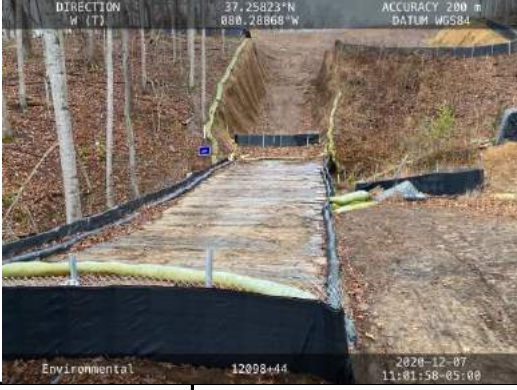
GPS Location	See photo for GPS coordinates		GPS Location	See photo for GPS coordinates	
Field Station#	12101+57		Field Station#	12098+44	
Pic 17 Desc.	Bridge and ECDs at S-MM11 are in acceptable condition.		Pic 18 Desc.	S-MM13 bridge and ECDs in acceptable condition.

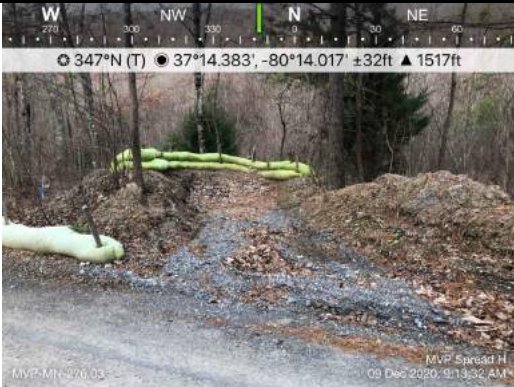
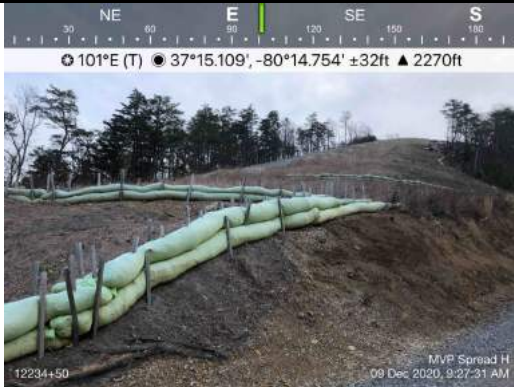
GPS Location	See Picture Watermark		GPS Location	See Picture Watermark	
Field Station#	12234+50		Field Station#	12234+50	
Pic 1 Desc.	Sump and end treatment along MVP-MN-76.03 remains in good condition.		Pic 2 Desc.	Start of inspection area. No maintenance needed.

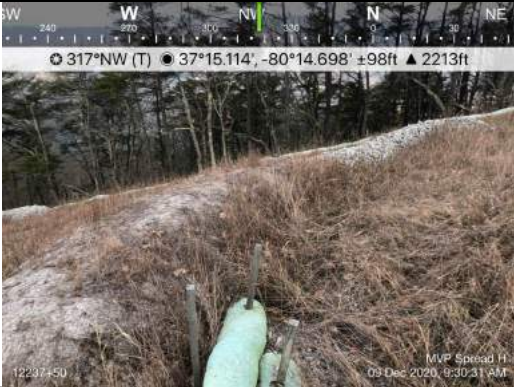
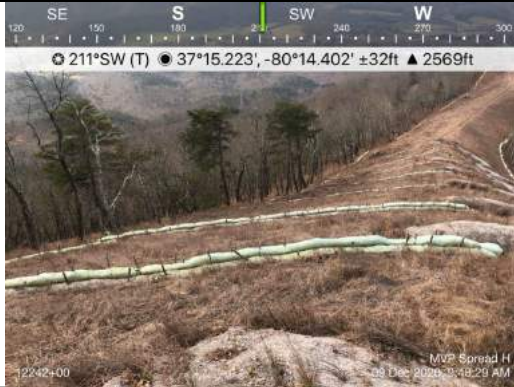
GPS Location	See Picture Watermark		GPS Location	See Picture Watermark	
Field Station#	12237+50		Field Station#	12242+00	
Pic 3 Desc.	Perm. waterbar and end treatment in good condition.		Pic 4 Desc.	CFS and perm. waterbars in good condition. No maintenance needed.

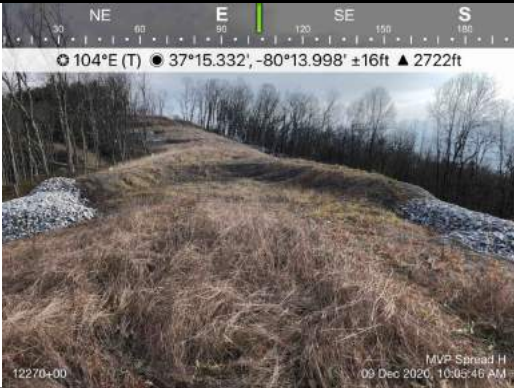
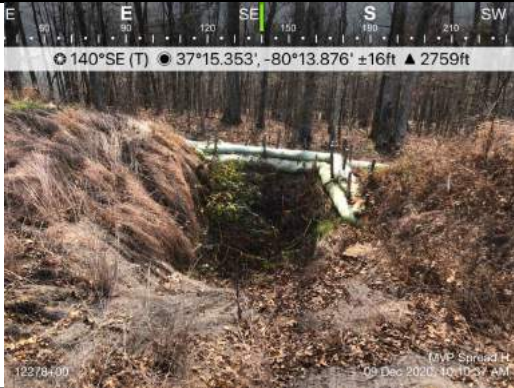
GPS Location	See Picture Watermark		GPS Location	See Picture Watermark	
Field Station#	12270+00		Field Station#	12278+00	
Pic 5 Desc.	ROW and controls are in good condition, and no signs of accelerated erosion were found.		Pic 6 Desc.	Sump pit is in good condition with no signs of sediment accumulation.

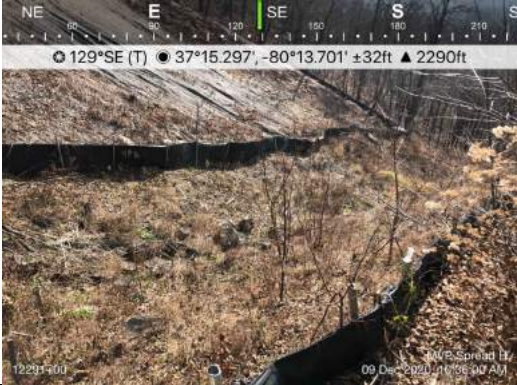
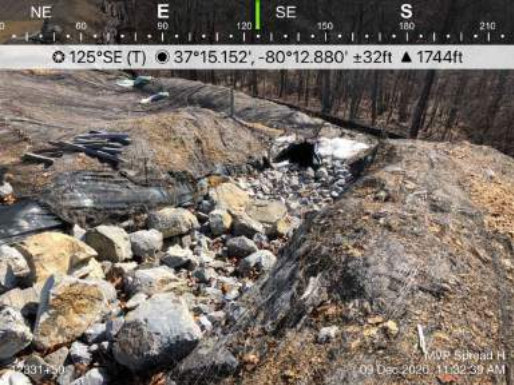
GPS Location	See Picture Watermark		GPS Location	See Picture Watermark	
Field Station#	12291+00		Field Station#	12331+50	
Pic 7 Desc.	Controls at bottom of Reese "V" are in good condition, and no maintenance is needed.		Pic 8 Desc.	Slope conveyance channel found to be in good condition and no maintenance is needed.

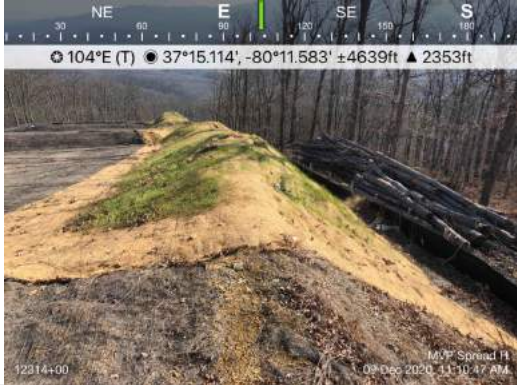
GPS Location	See Picture Watermark		GPS Location	See Picture Watermark	
Field Station#	12314+00		Field Station#	12333+00	
Pic 9 Desc.	Recently restabilized area continues to germinate and prevent accelerated erosion.		Pic 10 Desc.	Slope drains remain installed, functional, and no maintenance is needed.

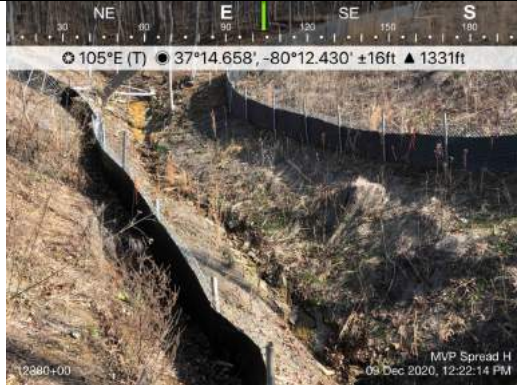
GPS Location	See Picture Watermark		GPS Location	See Picture Watermark	
Field Station#	12380+00		Field Station#	12380+00	
Pic 11 Desc.	S-NN19 is in good condition, and no maintenance is needed in the area.		Pic 12 Desc.	Equipment bridge at S-NN19 is in good condition.

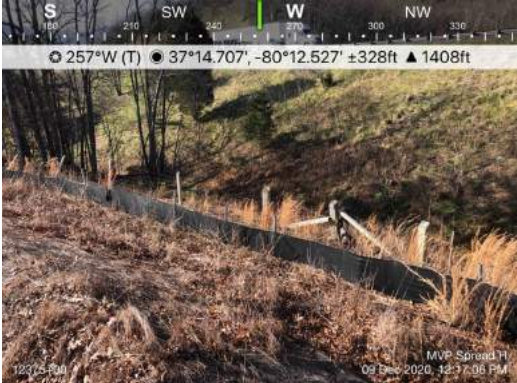
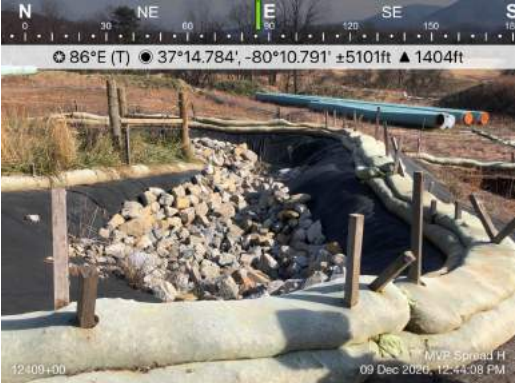
GPS Location	See Picture Watermark		GPS Location	See Picture Watermark	
Field Station#	12375+00		Field Station#	12409+00	
Pic 13 Desc.	SSF and ROW vegetation remains in good condition.		Pic 14 Desc.	Clean water diversion inlet is in good condition, and no accumulated sediment was observed.

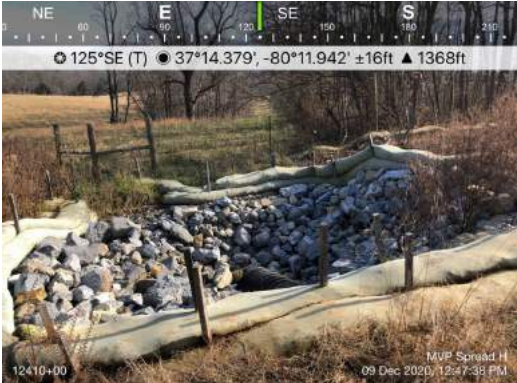
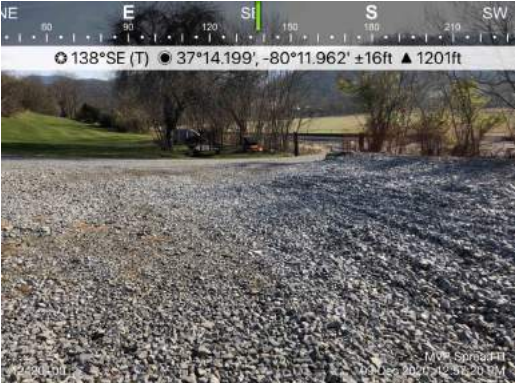
GPS Location	See Picture Watermark		GPS Location	See Picture Watermark	
Field Station#	12410+00		Field Station#	12420+00	
Pic 15 Desc.	Clean water diversion outlet is in good condition with no accumulated sediment observed.		Pic 16 Desc.	RCE is in good condition, and no tracked sediment was observed.

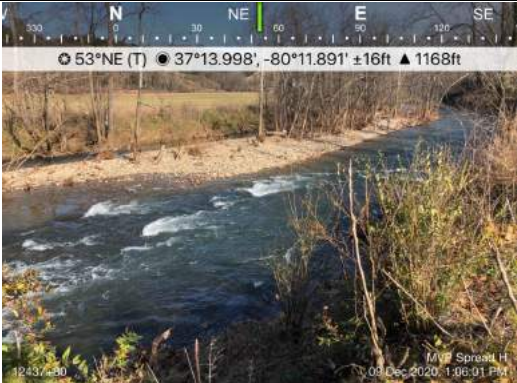
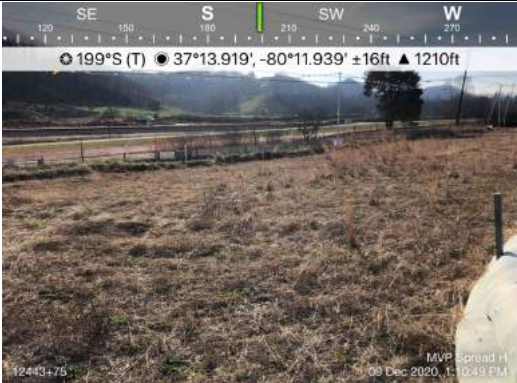
GPS Location	See Picture Watermark		GPS Location	See Picture Watermark	
Field Station#	12437+00		Field Station#	12443+75	
Pic 17 Desc.	S-NN11 (Roanoke River) is in good condition and the buffer zone remains unimpacted by construction.		Pic 18 Desc.	End of inspection area. ROW remains well vegetated and no maintenance is needed in the area.

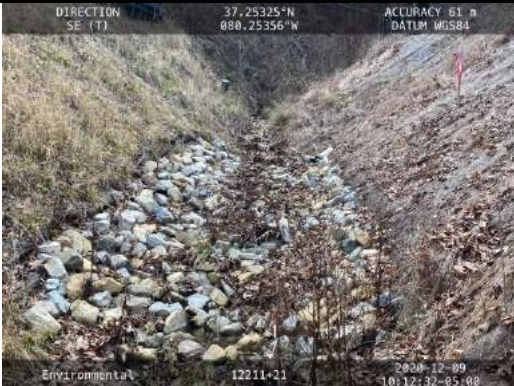
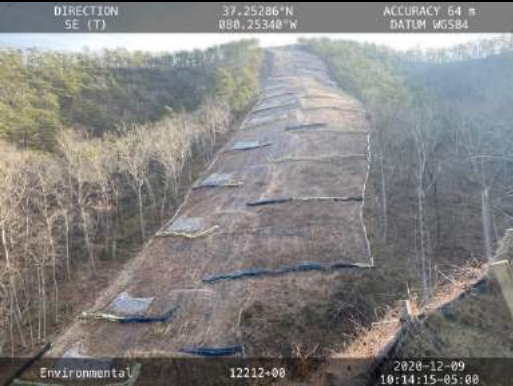
GPS Location	See photo for GPS coordinates		GPS Location	See photo for GPS coordinates	
Field Station#	12211+21		Field Station#	12212+00	
Pic 5 Desc.	Rip Rap lined drainage in acceptable condition		Pic 6 Desc.	Final stabilization in acceptable condition with vegetive coverage across LOD.

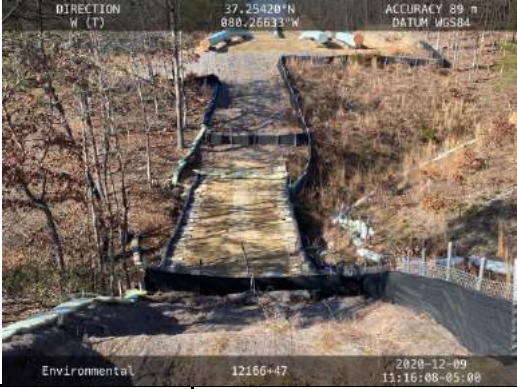
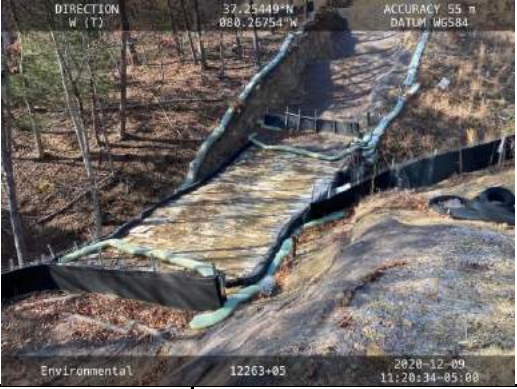
GPS Location	See photo for GPS coordinates		GPS Location	See photo for GPS coordinates	
Field Station#	12166+47		Field Station#	12263+05	
Pic 13 Desc.	Bridge and ECDs at S-C24 are in acceptable condition.		Pic 14 Desc.	Bridge and ECDs at S-C25 are in acceptable condition.

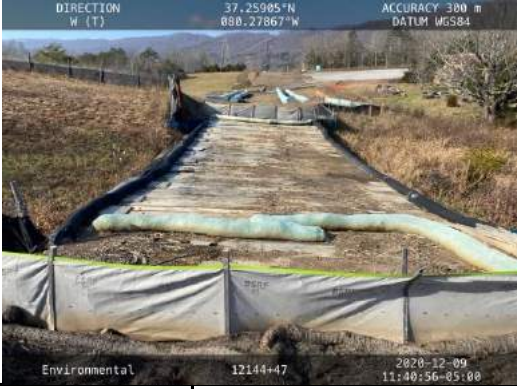
GPS Location	See photo for GPS coordinates		GPS Location	See photo for GPS coordinates	
Field Station#	12144+77		Field Station#	12135+00	
Pic 15 Desc.	W-C5 mats and ECDs are in acceptable condition.		Pic 16 Desc.	Stabilized ROW in acceptable condition with vegetive coverage across LOD

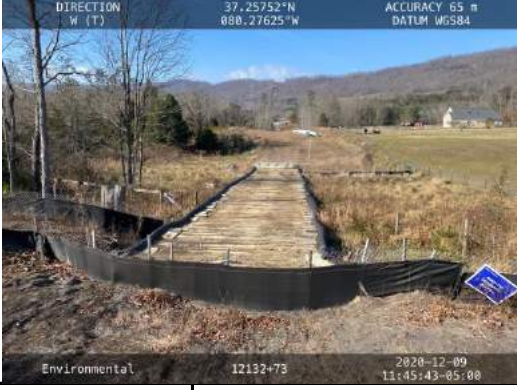
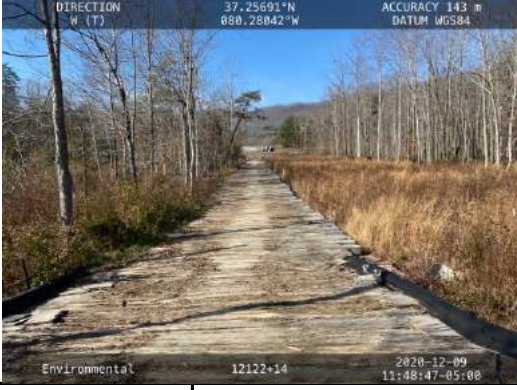
GPS Location	See photo for GPS coordinates		GPS Location	See photo for GPS coordinates	
Field Station#	12132+74		Field Station#	12122+14	
Pic 17 Desc.	Bridge and ECDs at stream crossing S-C29 in acceptable condition		Pic 18 Desc.	Bridge crossing multiple streams and wetlands is in acceptable condition.

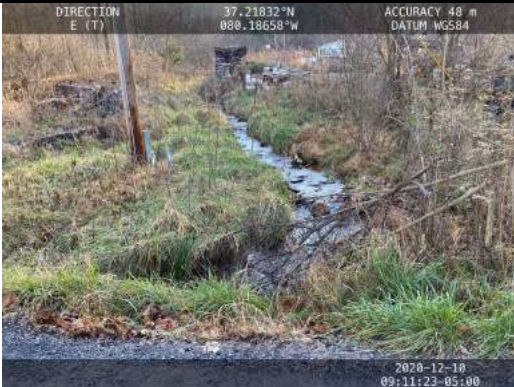
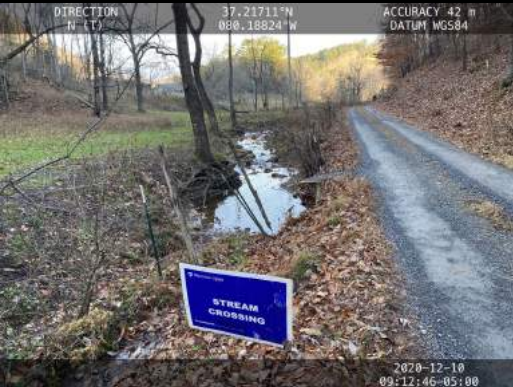
GPS Location	See photo		GPS Location	See photo	
Field Station#	12544+06		Field Station#	12544+06	
Pic 1 Desc.	Stream S-KL32, facing east, upstream from Yellow Finch Road		Pic 2 Desc.	Stream S-EF20b, facing north, downstream from Yellow Finch Road

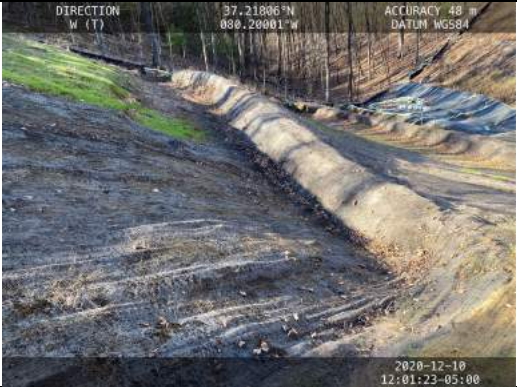
GPS Location	See photo		GPS Location	See photo	
Field Station#	12508+00		Field Station#	12505+00	
Pic 13 Desc.	Fill slope drain in satisfactory condition.		Pic 14 Desc.	Waterbars in satisfactory condition and functioning properly.

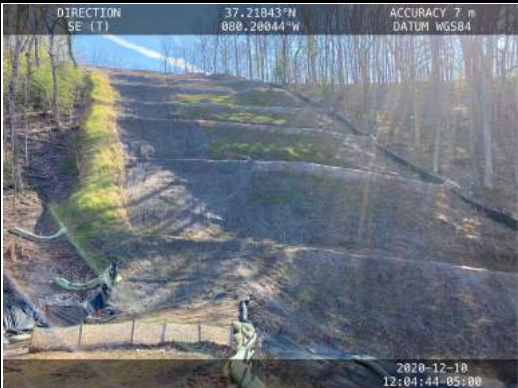
GPS Location	See photo		GPS Location	See photo	
Field Station#	12506+00		Field Station#	12464+25	
Pic 15 Desc.	Slope on going away side of clean water diversion pipe remains stable.		Pic 16 Desc.	ROW stable

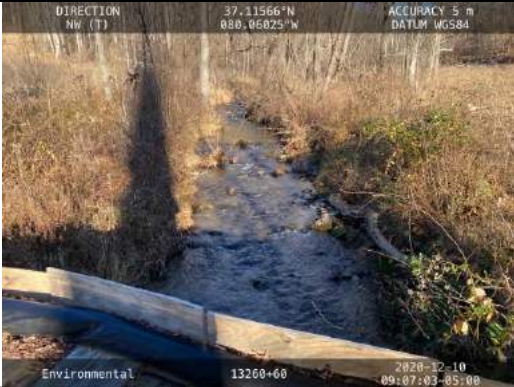
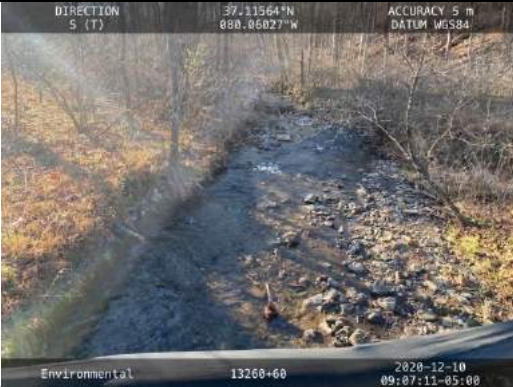
GPS Location	See photo for GPS coordinates		GPS Location	See photo for GPS coordinates	
Field Station#	13260+60		Field Station#	13260+60	
Pic 3 Desc.	S-II4, upstream, no changes noted, no environmental concerns.		Pic 4 Desc.	S-II4, downstream, stream bed and banks stable, no ROW impacts observed.

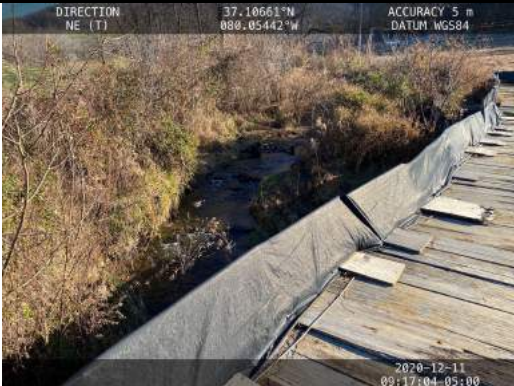
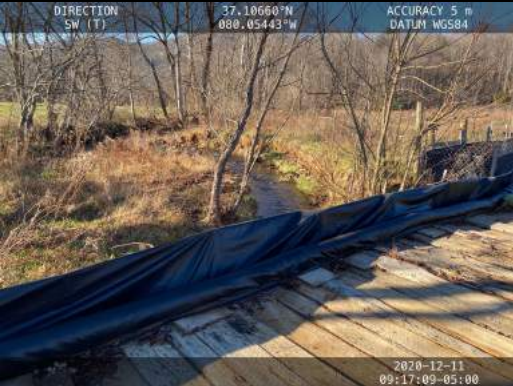
GPS Location	See photo		GPS Location	See photo	
Field Station#	13309+09		Field Station#	13309+09	
Pic 5 Desc.	Stream S-GH, facing northeast, upstream		Pic 6 Desc.	Stream S-GH7, facing southwest, downstream

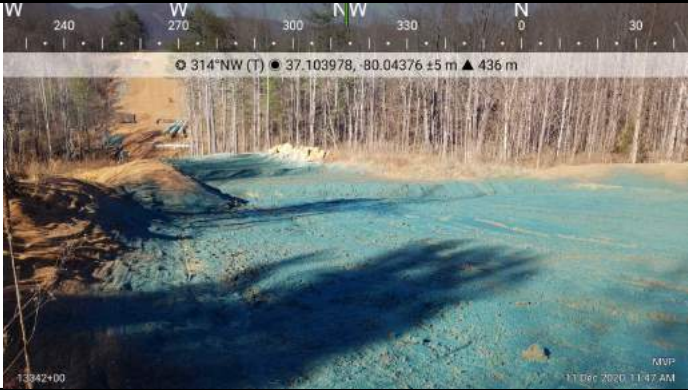
GPS Location	See Above		GPS Location	See Above	
Field Station#	13339+00		Field Station#	13342+00	
Pic 9 Desc.	Waterbody S-GH9. ECDs are functional. Crew is installing erosion control blanket on top of completed hydromulching in his area.		Pic 10 Desc.	ROW Overview. ECDs are functional. Hydromulching was completed today in this area.

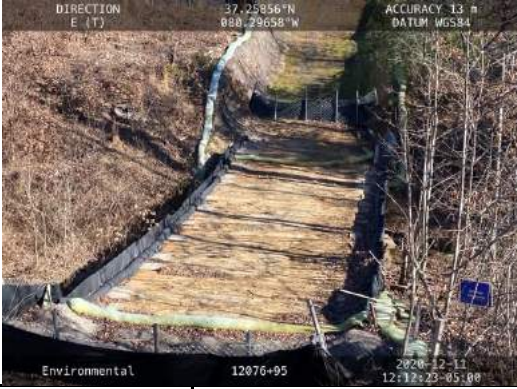
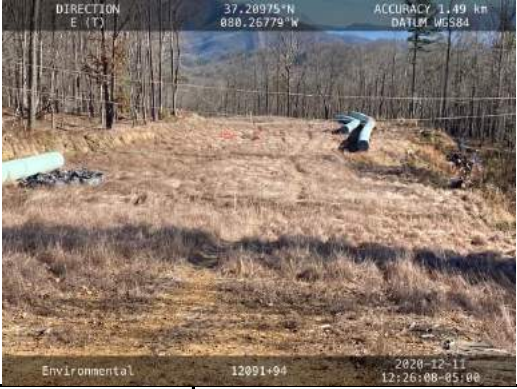
GPS Location	See photo for GPS coordinates		GPS Location	See photo for GPS coordinates	
Field Station#	12076+95		Field Station#	12091+94	
Pic 13 Desc.	Equipment bridge crossing S-MM15 in acceptable condition.		Pic 14 Desc.	Stabilized ROW with acceptable vegetative coverage across LOD

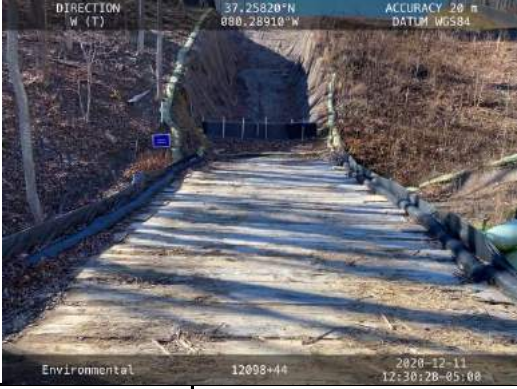
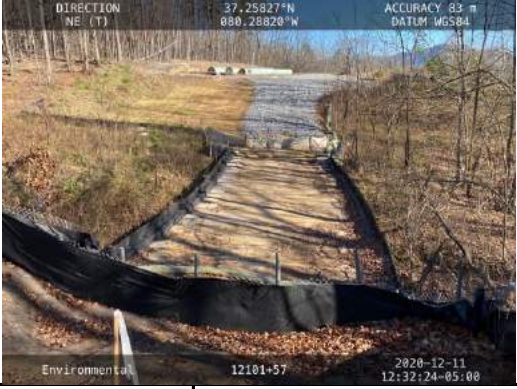
GPS Location	See photo for GPS		GPS Location	See photo for GPS coordinates	
Field Station#	12098+44		Field Station#	12101+57	
Pic 15 Desc.	Equipment bridge crossing S-MM13 in acceptable condition.		Pic 16 Desc.	Equipment bridge crossing S-MM11 is in acceptable condition

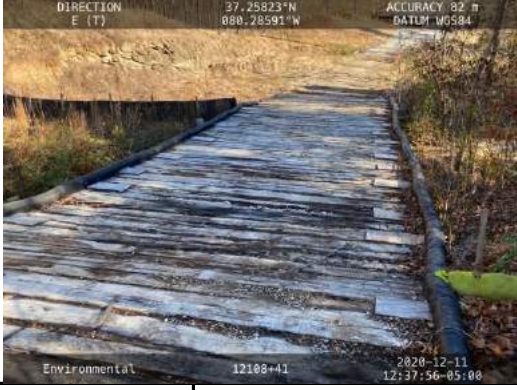
GPS Location	See photo for GPS coordinates		GPS Location	See photo for GPS coordinates	
Field Station#	12102+75		Field Station#	12108+41	
Pic 17 Desc.	RCE on the GAS of Half Acre of Rock Rd in acceptable condition		Pic 18 Desc.	Equipment bridge crossing S-F15 in acceptable condition
