Visual Site Inspection Report

Project Name	H-600 Pipeline Spread H	AFE	124300138	Spread	H-600 Pipeline Spread H
Contractor	Precision			Report #	14139
Inspector	Kaitlyn Ball			Date/Time	8/31/2020 1:08 PM
Permit #	TBD	Inspection Type	VA SWPP	Station Begin	12233+50
State	VA	Inspection Area	Partial	Station End	12443+75
County	Montgomery	Ground	Damp	Temperature (°F)	67.00
Municipality	N/A	Weather	Light Rain	Rain Gauge (in)	0.20
				Rain Accumulation Time (days)	1.00

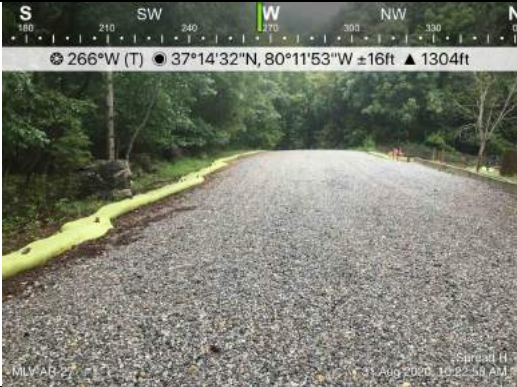
<p>GPS photo showing MLV-AR-27 road. Coordinates: 266°W (T) 37°14'32"N, 80°11'53"W ±16ft ▲ 1304ft. Date/Time: 31 Aug 2020, 10:27:49 AM.</p>

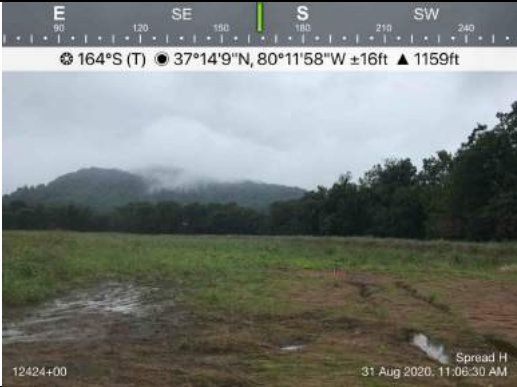
<p>GPS photo showing area near the Roanoke River bore crossing. Coordinates: 164°S (T) 37°14'9"N, 80°11'58"W ±16ft ▲ 1159ft. Date/Time: 31 Aug 2020, 11:06:30 AM.</p>			
GPS Location	See photo		GPS Location	See photo	
Field Station#	+27		Field Station#	12424+00	
Pic 7 Desc.	MLV-AR-27 in good condition.		Pic 8 Desc.	Area near the Roanoke River bore crossing in acceptable condition.

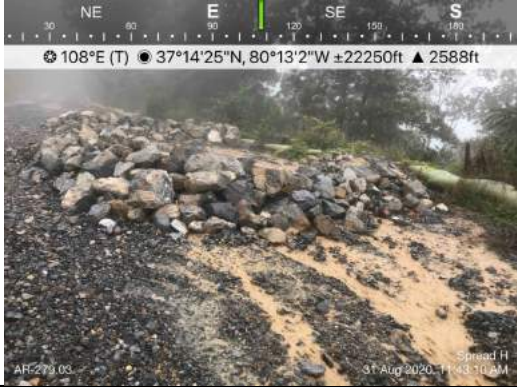
<p>GPS photo showing rock check dam near the Reese Mtn Switchback. Coordinates: 108°E (T) 37°14'25"N, 80°13'2"W ±22250ft ▲ 2588ft. Date/Time: 31 Aug 2020, 11:43:10 AM.</p>

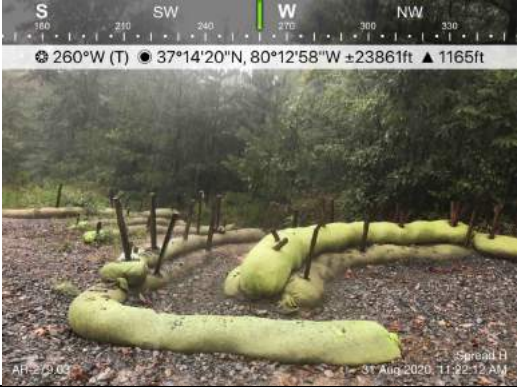
<p>GPS photo showing CFS controls. Coordinates: 260°W (T) 37°14'20"N, 80°12'58"W ±23861ft ▲ 1165ft. Date/Time: 31 Aug 2020, 11:22:12 AM.</p>

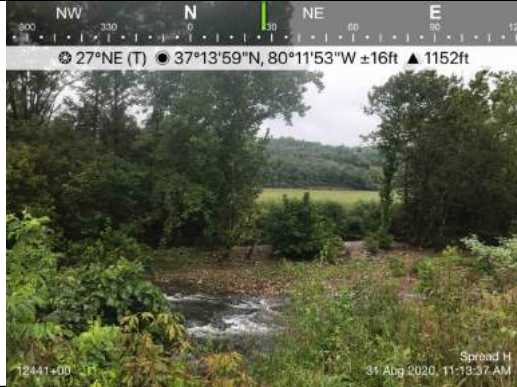
<p>GPS photo showing Roanoke River crossing area. Coordinates: 27°NE (T) 37°13'59"N, 80°11'53"W ±16ft ▲ 1152ft. Date/Time: 31 Aug 2020, 11:19:37 AM.</p>

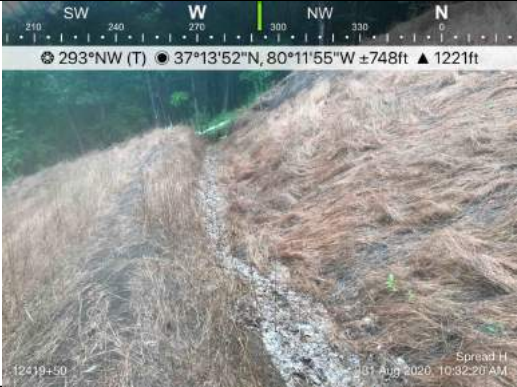
<p>GPS photo showing stabilized waterbar. Coordinates: 293°NW (T) 37°13'52"N, 80°11'55"W ±748ft ▲ 1221ft. Date/Time: 31 Aug 2020, 10:32:20 AM.</p>			
GPS Location	See photo		GPS Location	See photo	
Field Station#	12441+00		Field Station#	12419+50	
Pic 11 Desc.	Roanoke River crossing area in good condition.		Pic 12 Desc.	Waterbar is stabilized and in good condition.

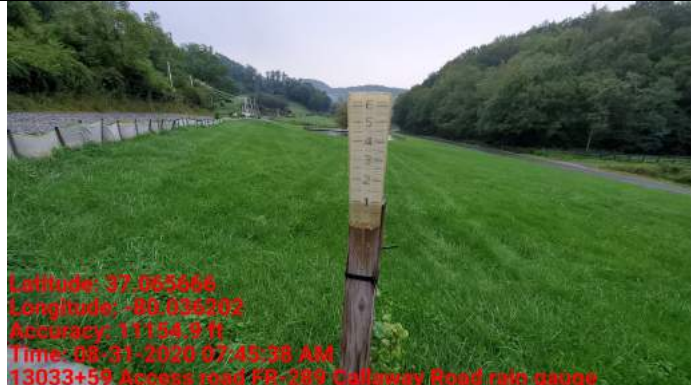
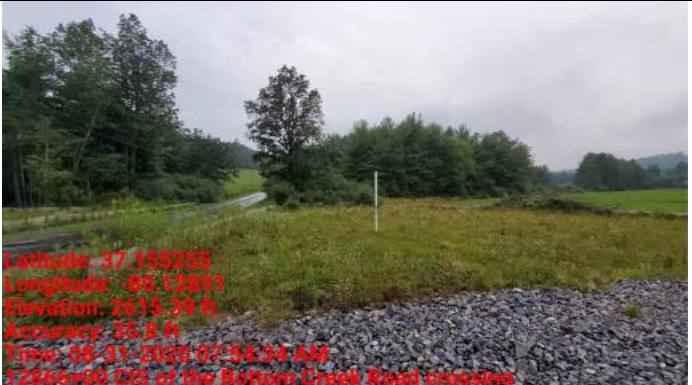
GPS Location	See pic for GPS location	GPS Location	See pic for GPS location		
Field Station#	13033+59	Field Station#	12866+00		
Pic 1 Desc.	Callaway Road rain gauge 0.1" total precipitation.	Pic 2 Desc.	CIS of the Bottom Creek Road crossing.

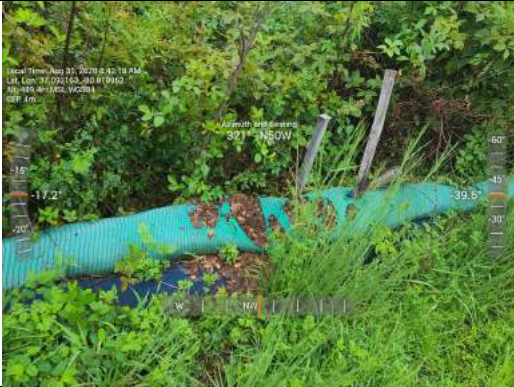
GPS Location	00000	GPS Location	00000		
Field Station#	13437+75	Field Station#	13541+53		
Pic 1 Desc.	CFS damaged and needs repaired , added to the punch list	Pic 2 Desc.	Row photo showing vegetation while checking row conditions during rain events

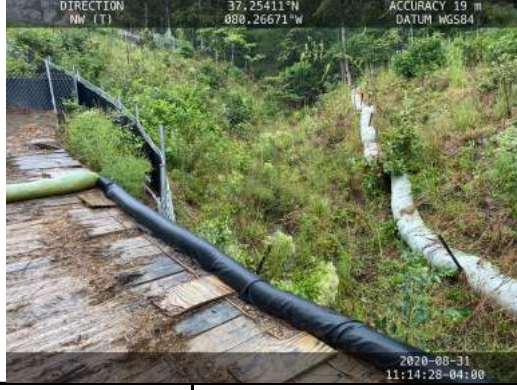
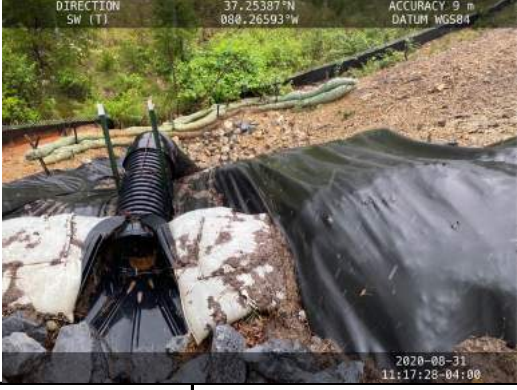
GPS Location	See photo	GPS Location	See photo		
Field Station#	12166+47	Field Station#	12169+00		
Pic 11 Desc.	Stream S-C24, facing northwest, upstream	Pic 12 Desc.	This slope drain remains in good repair and functions as needed.

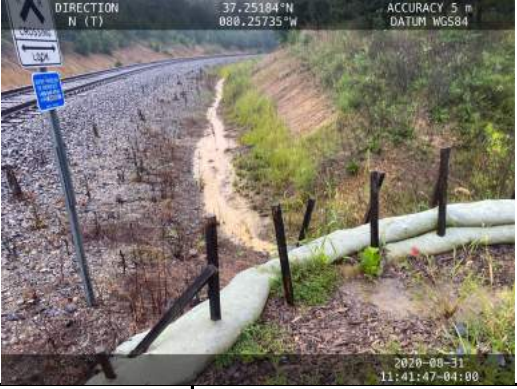
GPS Location	See photo		GPS Location	See photo	
Field Station#	12197+37		Field Station#	12197+55	
Pic 15 Desc.	Stream S-OO11, facing west, downstream		Pic 16 Desc.	Very turbid water was observed flowing from ditch next to railroad tracks, under AR 275, and into stream S-OO11.

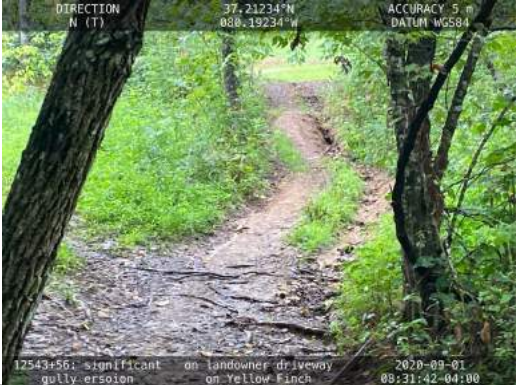
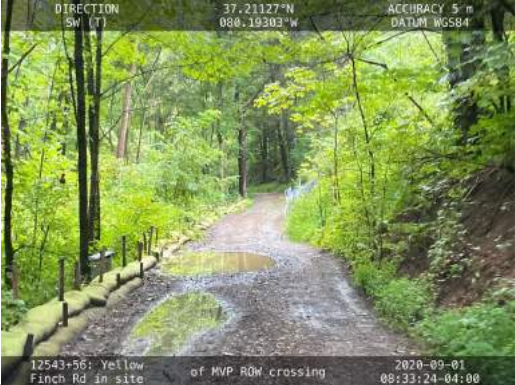
GPS Location	See photo		GPS Location	See photo	
Field Station#	12543+56		Field Station#	12543+56	
Pic 3 Desc.	Gully erosion was observed on the landowner driveway from which sediment is washing into Yellow Finch Road.		Pic 4 Desc.	Yellow Finch Road, MVP-MN-278.01, facing the MVP ROW crossing.

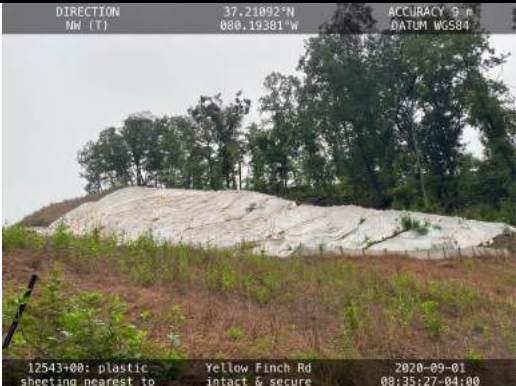
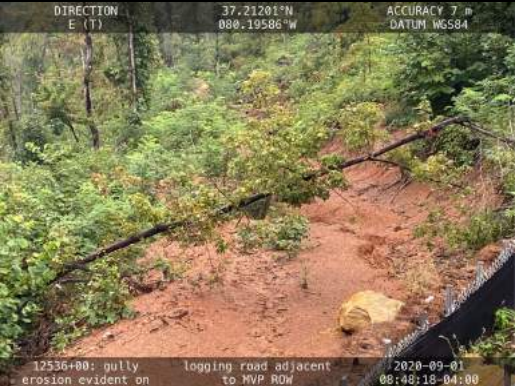
GPS Location	See photo		GPS Location	See photo	
Field Station#	12543+00		Field Station#	12536+00	
Pic 5 Desc.	Plastic sheeting on the stockpile nearest to Yellow Finch Road remains intact and secure.		Pic 6 Desc.	Gully erosion observed on the logging road adjacent to MVP ROW.
