Visual Site Inspection Report

| Project Name | H-600 Pipeline Spread H | AFE | 124300138 | Spread | H-600 Pipeline Spread H |
| Inspector | John Brcic | | | Date/Time | 11/3/2020 1:28 PM |

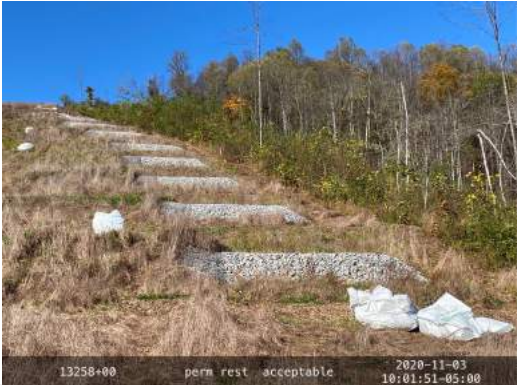
| Pic 13 Desc. | Permanent restoration is in acceptable condition. | | Pic 14 Desc. | Perimeter controls are acceptable. | |

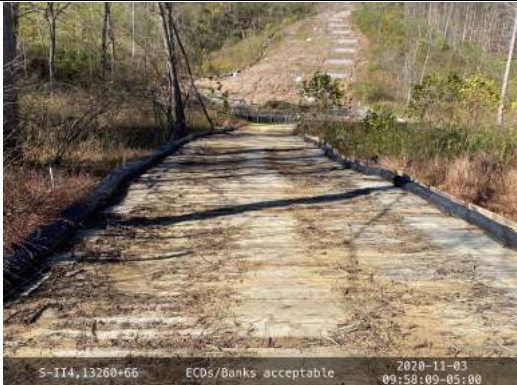
| Pic 17 Desc. | Downstream | | Pic 18 Desc. | Bridge and all surrounding stream and buffer ECDs in acceptable condition. | |

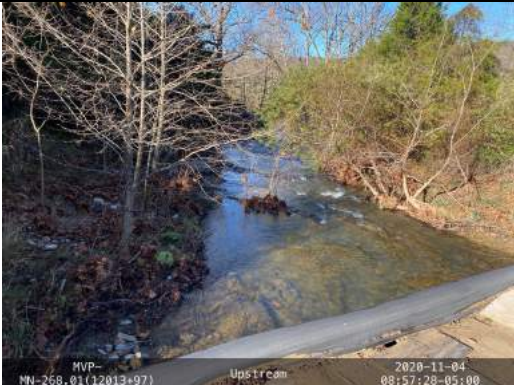
| Pic 1 Desc. | Surrounding ECDs at bridge crossing of S-G36 are in acceptable condition. | | Pic 2 Desc. | Surrounding ECDs at bridge crossing of S-G36 are in acceptable condition. | |

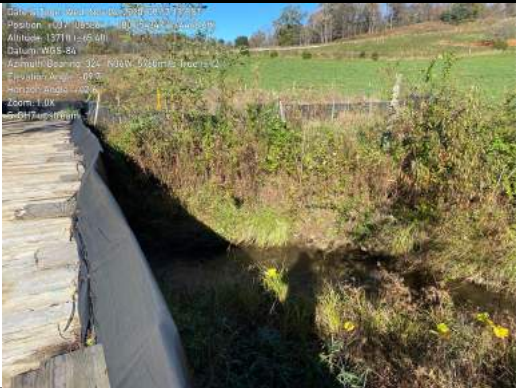
| Pic 3 Desc. | ROW stable with acceptable vegetative cover across LOD, bridge in acceptable condition at S-GH7. | | Pic 4 Desc. | S-GH7, upstream, no ROW impacts or changes noted at stream crossing. | |

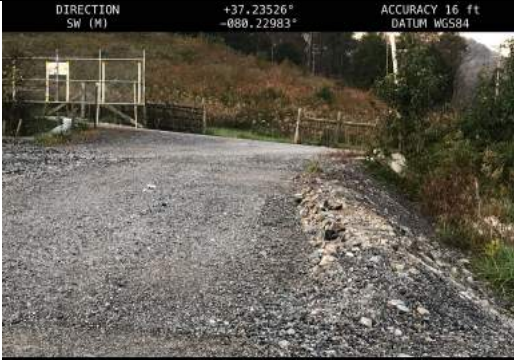
| Pic 1 Desc. | Condition of west Rock Entrance. No sediment on the stone surface and no erosion. Looking W. | | Pic 2 Desc. | Condition of containment under light plant. Free of stormwater. Looking NE. | |

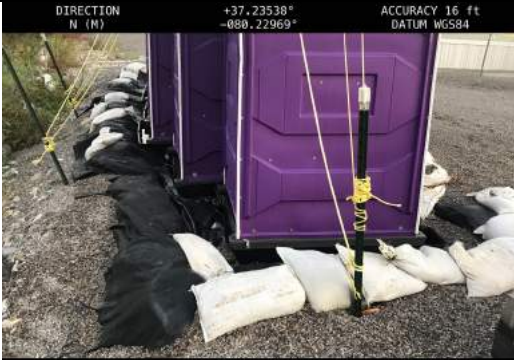
| Pic 3 Desc. | Condition of trays and containment under toilets. Looking N. | | Pic 4 Desc. | Condition of signage, compost filter sock and buffer. Compost filter sock is over grown with vegetation. Looking E. | |

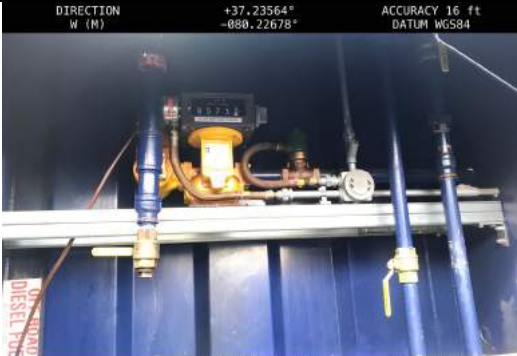
| Pic 7 Desc. | Blue Bulk Fuel tanks no leaky internal fittings. Looking W. | | Pic 8 Desc. | Condition of containment under DEF tank. Looking S. | |

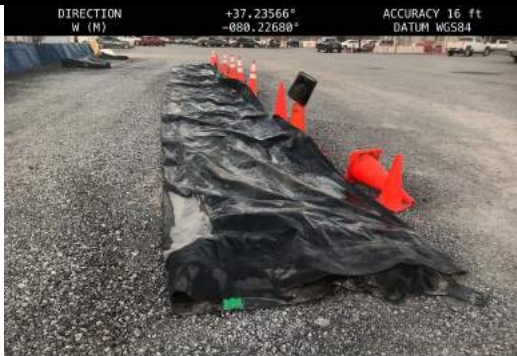
| Pic 9 Desc. | Secondary containment on site for tankers offloading fuel into the Blue Bulk fuel tanks. Looking W. | | Pic 10 Desc. | Blue Bulk Fuel tanks no fuel spills on the north side of the tanks. Looking SW. | |

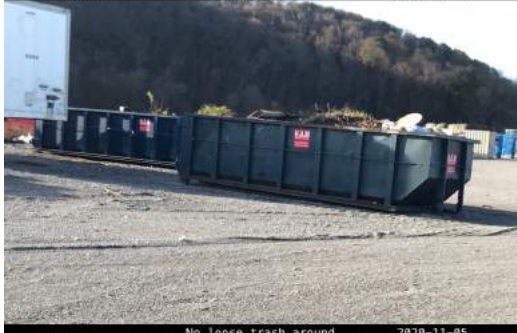
| Pic 9 Desc. | | No loose trash around south dumpsters. Looking SW. | | Pic 10 Desc. | |

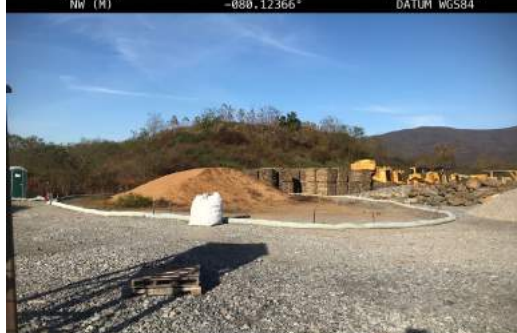
| Pic 11 Desc. | | Condition of compost filter sock around sand pile. Looking NW. | | Pic 12 Desc. | |

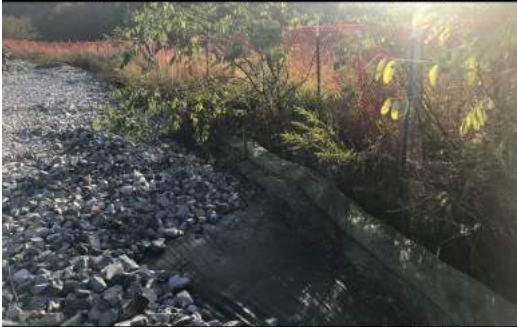
| Pic 13 Desc. | Condition of compost filter sock and safety fence along south LOD. Looking E. | | Pic 14 Desc. | Condition of containment under stored vehicle. Looking S. | |

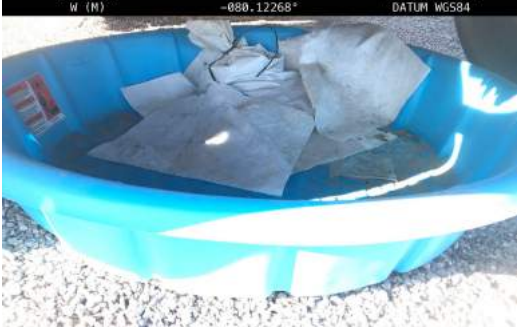
| Pic 15 Desc. | Condition of containment under stored vehicle. Looking W. | | Pic 16 Desc. | Condition of containment under stored vehicle. Looking W. | |

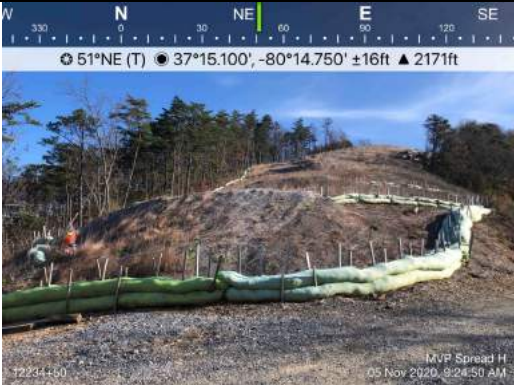
| Pic 1 Desc. | Sump end treatment along MVP-MN-276.03. No maintenance necessary. | | Pic 2 Desc. | CFS treatment train along MVP-MN-276.01 in good condition and no maintenance necessary. | |

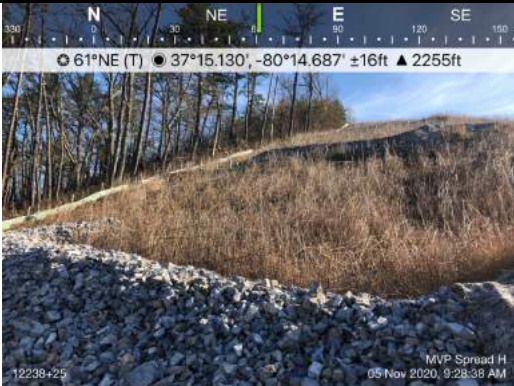
| Pic 3 Desc. | Start of inspection area. ROW is well vegetated and no accelerated erosion was observed. | | Pic 4 Desc. | CFS along ROW in good condition. No maintenance necessary. | |

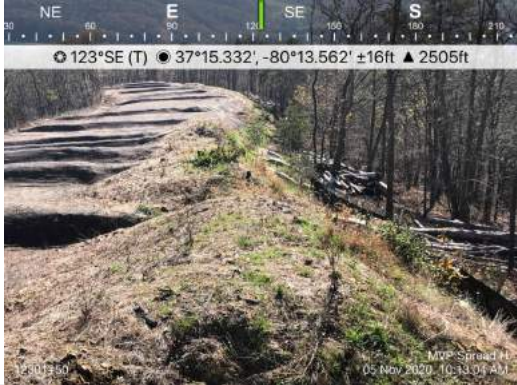
| Pic 7 Desc. | MVP-MN-276.03 crossing controls are installed and no maintenance is necessary. | | Pic 8 Desc. | GAS Reese "V" diversion berm is in good condition. | |

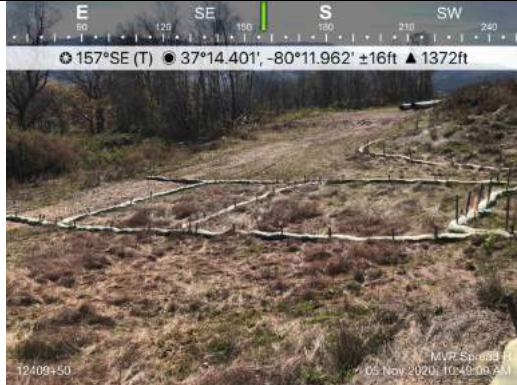
| Pic 9 Desc. | Berms remain vegetated and waterbars covered in erosion matting. No maintenance necessary. | | Pic 10 Desc. | CWD inlet structure in good condition and no accumulated sediment observed. No maintenance necessary. | |
