## Visual Site Inspection Report

<b>Project Name</b>	H-600 Pipeline Spread H	<b>AFE</b>	124300138	<b>Spread</b>	H-600 Pipeline Spread H
<b>Contractor</b>	Precision			<b>Report #</b>	14570
<b>Inspector</b>	John Brcic			<b>Date/Time</b>	9/14/2020 11:57 AM
<b>Permit #</b>	TBD	<b>Inspection Type</b>	VA SWPP	<b>Station Begin</b>	12443+75
<b>State</b>	VA	<b>Inspection Area</b>	Partial	<b>Station End</b>	12544+06
<b>County</b>	Montgomery	<b>Ground</b>	Damp	<b>Temperature (°F)</b>	78.00
<b>Municipality</b>	N/A	<b>Weather</b>	Sunny	<b>Rain Gauge (in)</b>	0.00
				<b>Rain Accumulation Time (days)</b>	3.00

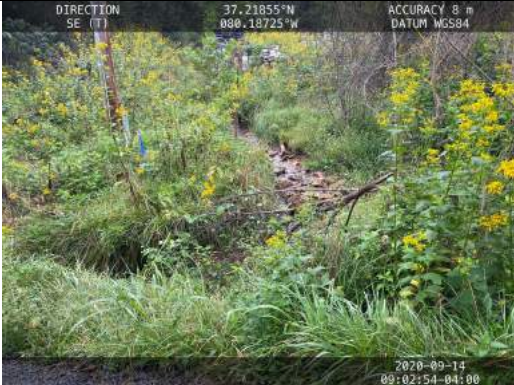
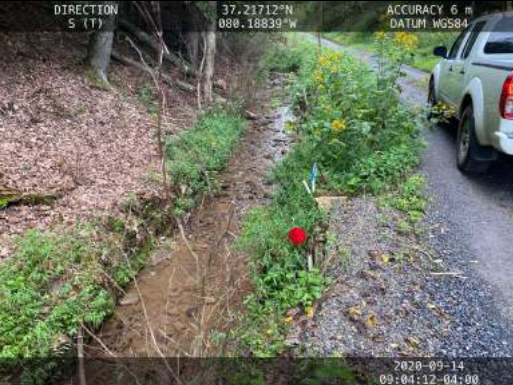
<b>GPS Location</b>	See photo		<b>GPS Location</b>	See photo	
<b>Field Station#</b>	12543+56		<b>Field Station#</b>	12543+56	
<b>Pic 1 Desc.</b>	Stream S-KL32, facing southeast from Yellow Finch Road, upstream		<b>Pic 2 Desc.</b>	Stream S-EF20b, facing south, upstream

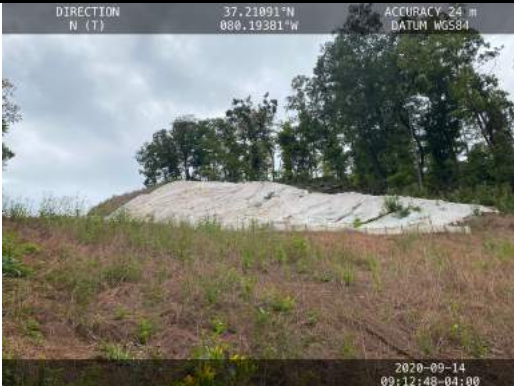
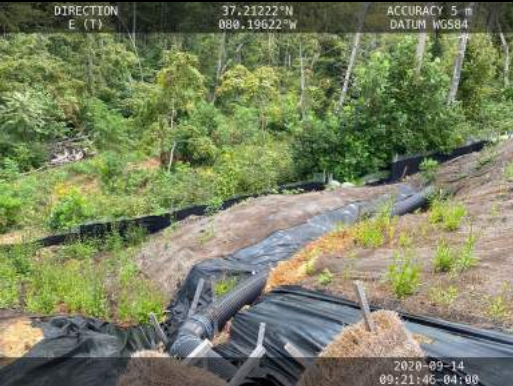
<b>GPS Location</b>	See photo		<b>GPS Location</b>	See photo	
<b>Field Station#</b>	12543+00		<b>Field Station#</b>	12535+00	
<b>Pic 5 Desc.</b>	Plastic sheeting intact and secure on stockpiles nearest to Yellow Finch Road.		<b>Pic 6 Desc.</b>	Fill slope drain in satisfactory condition and functioning properly.

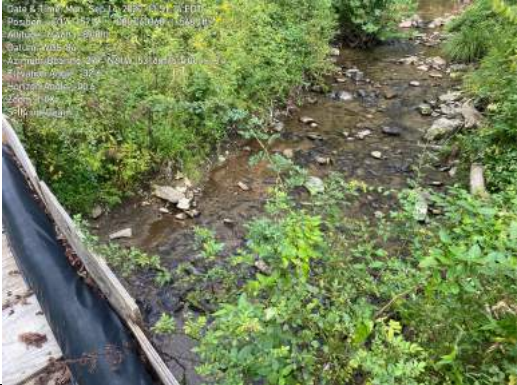
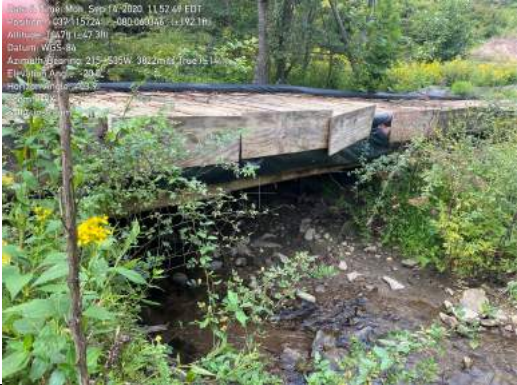
<b>GPS Location</b>	See photo for coordinates.		<b>GPS Location</b>	See photo for coordinates.	
<b>Field Station#</b>	13260+60		<b>Field Station#</b>	13260+60	
<b>Pic 7 Desc.</b>	S-II4, upstream, no changes noted to stream bed or banks.		<b>Pic 8 Desc.</b>	S-II4, upstream of bridge, bridge in acceptable condition.

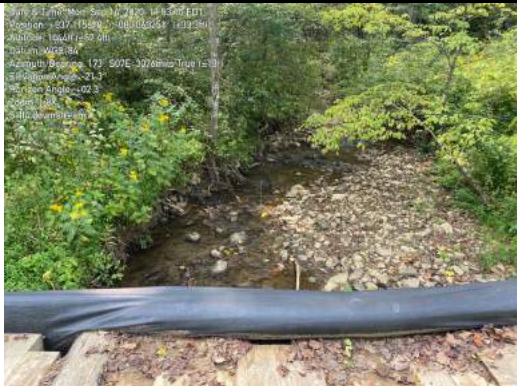
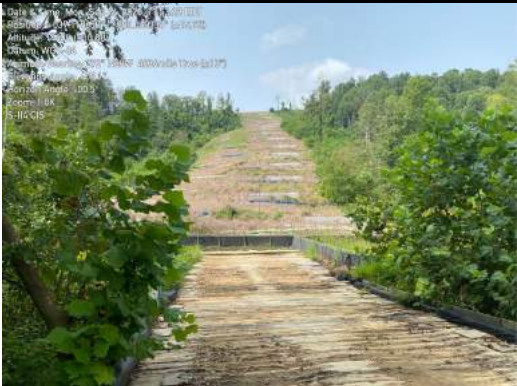
<b>GPS Location</b>	See photo for coordinates.		<b>GPS Location</b>	See photo for coordinates.	
<b>Field Station#</b>	13260+60		<b>Field Station#</b>	13260+60	
<b>Pic 9 Desc.</b>	S-II4, downstream. No changes noted to stream bed or banks.		<b>Pic 10 Desc.</b>	ROW stable, with vegetative cover across LOD.

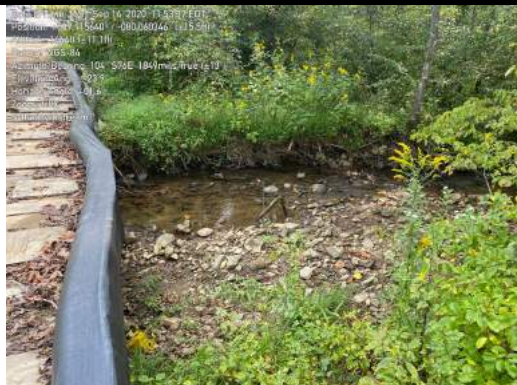
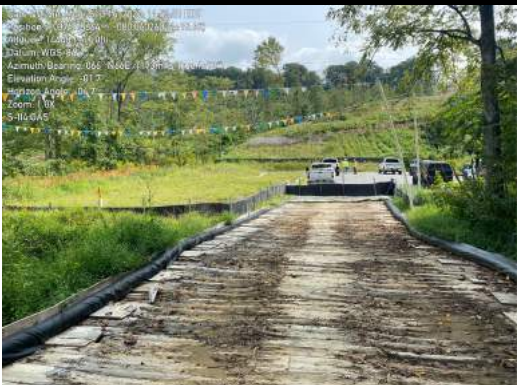
<b>Pic 11 Desc.</b>	S-II4, downstream, no change noted, water flowing clear.		<b>Pic 12 Desc.</b>	GAS of S-II4, perimeter controls in acceptable condition.

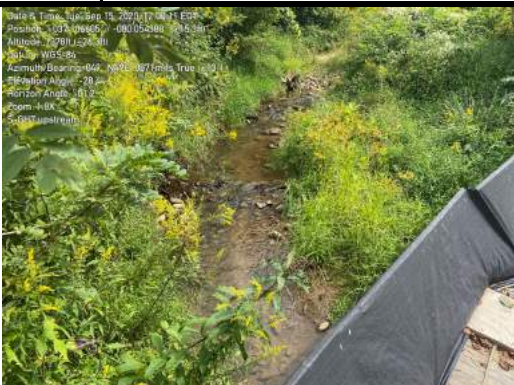
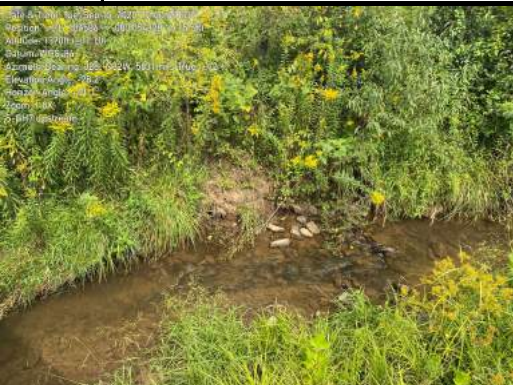
<b>GPS Location</b>	See photo for coordinates.		<b>GPS Location</b>	See photo for coordinates.	
<b>Field Station#</b>	13309+09		<b>Field Station#</b>	13309+09	
<b>Pic 5 Desc.</b>	S-GH7, upstream, water clear.		<b>Pic 6 Desc.</b>	S-GH7, upstream, minor bank collapse noted on right descending bank, undercutting noted.

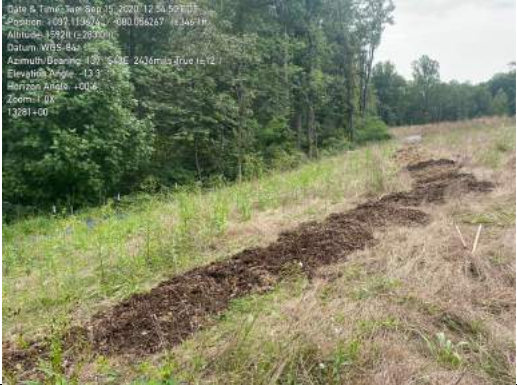
<b>GPS Location</b>	See photo for coordinates.		<b>GPS Location</b>	See photo for coordinates.	
<b>Field Station#</b>	13294+00		<b>Field Station#</b>	13281+00	
<b>Pic 13 Desc.</b>	Vegetative coverage noted across LOD with sparse coverage permanent species noted.		<b>Pic 14 Desc.</b>	Removal of damaged and deteriorating CFS.

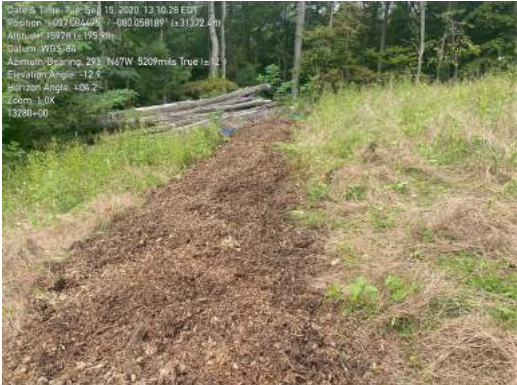
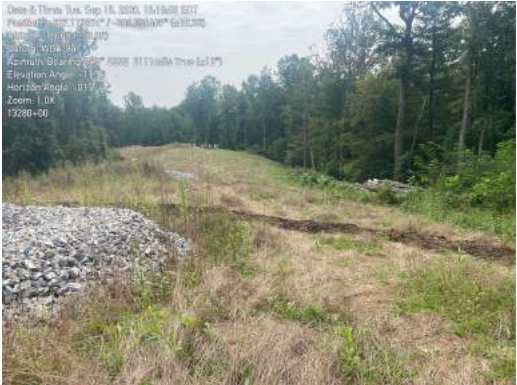
<b>GPS Location</b>	See photo for coordinates.		<b>GPS Location</b>	See photo for coordinates.	
<b>Field Station#</b>	13280+00		<b>Field Station#</b>	13280+00	
<b>Pic 15 Desc.</b>	Mulch berm from removal of damaged and deteriorating CFS.		<b>Pic 16 Desc.</b>	ROW stable.

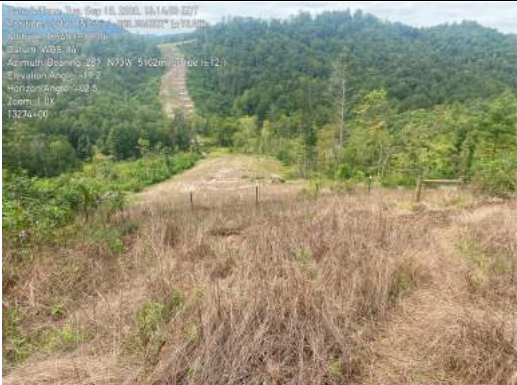
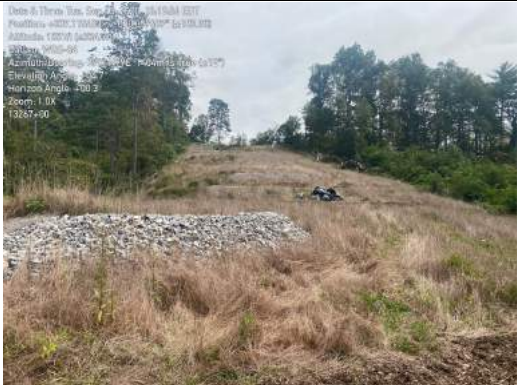
<b>GPS Location</b>	See photo for coordinates.		<b>GPS Location</b>	See photo for coordinates.	
<b>Field Station#</b>	13274+00		<b>Field Station#</b>	13267+00	
<b>Pic 17 Desc.</b>	Vegetative cover noted across LOD, ROW stable.		<b>Pic 18 Desc.</b>	Vegetative cover noted across LOD, ROW stable, temporary debris pile from CFS removal.

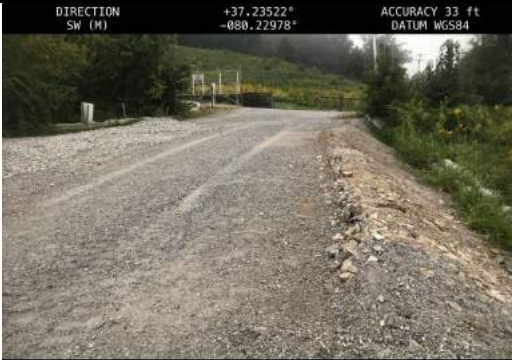
<p>DIRECTION SW (M) +37.23522° -080.22978° ACCURACY 33 ft DATUM WGS84</p> <p>MVP-PY-006_091620 Condition of west rock entrance 2020-09-16 07:44:13-04:00</p>

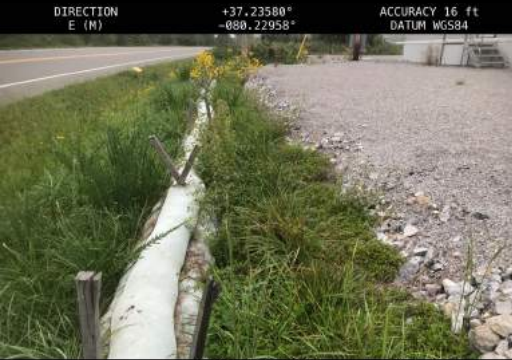
<p>DIRECTION E (M) +37.23580° -080.22958° ACCURACY 16 ft DATUM WGS84</p> <p>MVP-PY-006_091620 Condition of CFS along LOD 2020-09-16 07:52:09-04:00</p>			
<b>GPS Location</b>	MVP-PY-006 See photo for gps data	<b>GPS Location</b>	MVP-PY-006 See photo for gps data		
<b>Field Station#</b>	+0	<b>Field Station#</b>	+0		
<b>Pic 1 Desc.</b>	Condition of west rock entrance. No sediment on stone surface. Looking W.	<b>Pic 2 Desc.</b>	Condition of compost filter sock along North LOD. Looking E.

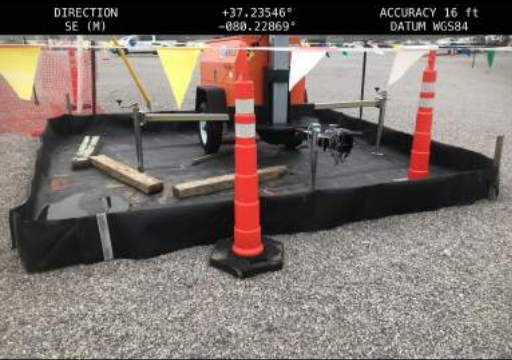
<p>DIRECTION SE (M) +37.23546° -080.22869° ACCURACY 16 ft DATUM WGS84</p> <p>MVP-PY-006_091620 Condition of containment 2020-09-16 07:54:06-04:00</p>			
<b>GPS Location</b>	MVP-PY-006 See photo for gps data	<b>GPS Location</b>	MVP-PY-006 See photo for gps data		
<b>Field Station#</b>	+0	<b>Field Station#</b>	+0		
<b>Pic 5 Desc.</b>	Condition of signage and buffer flagging for feature W-008. Looking N.	<b>Pic 6 Desc.</b>	Condition of containment under light plant. Looking SE.

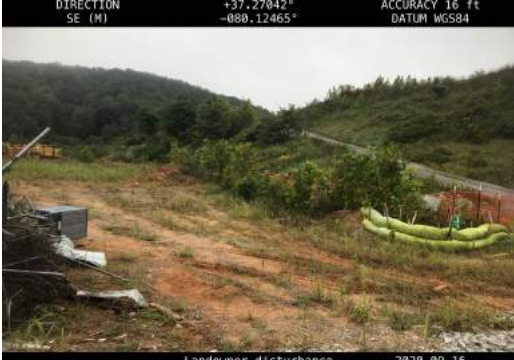
<p>DIRECTION SE (N) +37.27042° -080.12465° ACCURACY 16 ft DATUM WGS84</p> <p>MVP-LY-049_091620 Landowner disturbance along CFS &amp; safety ... 2020-09-16 08:22:20-04:00</p>

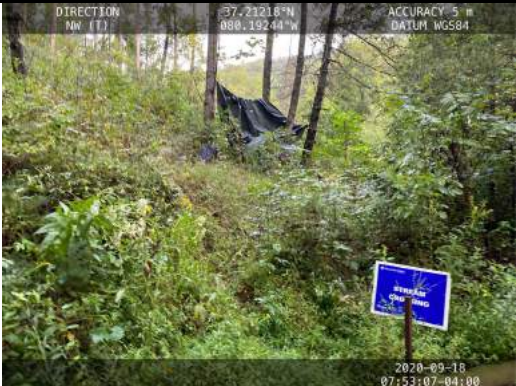
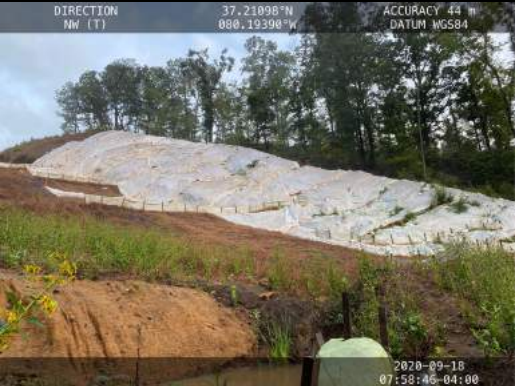
<b>GPS Location</b>	See photo		<b>GPS Location</b>	See photo	
<b>Field Station#</b>	12543+56		<b>Field Station#</b>	12543+00	
<b>Pic 5 Desc.</b>	A new shelter was observed close to stream S-EF54, approximately 50 feet west from Yellow Finch Road.		<b>Pic 6 Desc.</b>	Plastic sheeting used for stabilizing stockpiles nearest to Yellow Finch Road is intact and secure.
