## Visual Site Inspection Report

<b>Project Name</b>	H-600 Pipeline Spread H	<b>AFE</b>	124300138	<b>Spread</b>	H-600 Pipeline Spread H
<b>Contractor</b>	Precision			<b>Report #</b>	14983
<b>Inspector</b>	Pat Davis			<b>Date/Time</b>	9/28/2020 4:00 PM
<b>Permit #</b>	TBD	<b>Inspection Type</b>	VA SWPP	<b>Station Begin</b>	+0
<b>State</b>	VA	<b>Inspection Area</b>	Partial	<b>Station End</b>	+0
<b>County</b>	Montgomery	<b>Ground</b>	Damp	<b>Temperature (°F)</b>	78.00
<b>Municipality</b>	N/A	<b>Weather</b>	Cloudy	<b>Rain Gauge (in)</b>	0.00
				<b>Rain Accumulation Time (days)</b>	0.00

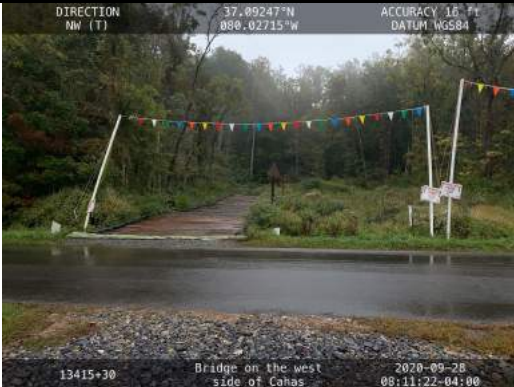
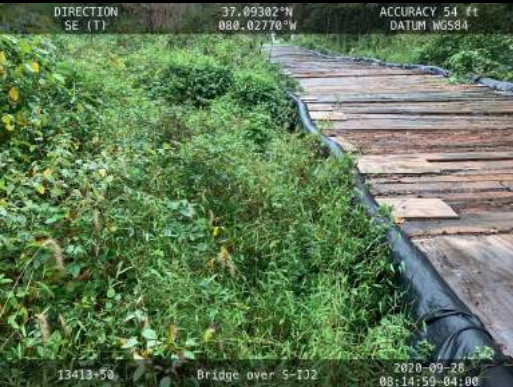
<b>GPS Location</b>	See photo for gps location data.		<b>GPS Location</b>	See photo for gps location data.	
<b>Field Station#</b>	13415+30		<b>Field Station#</b>	13413+50	
<b>Pic 1 Desc.</b>	Photo shows the bridge on the west side of Cahas.		<b>Pic 2 Desc.</b>	Photo shows the bridge over stream S-IJ2.

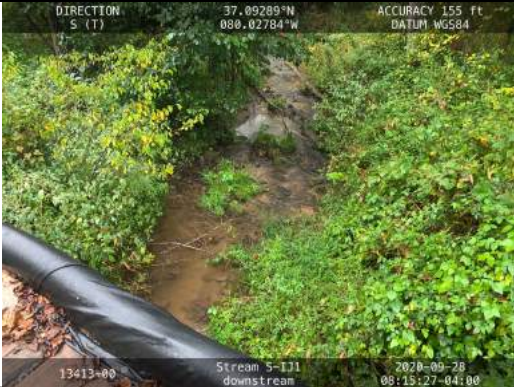
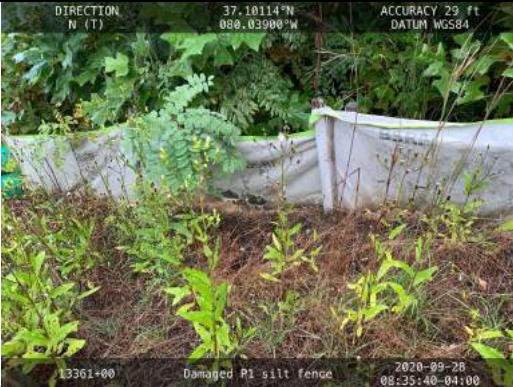
<b>GPS Location</b>	See photo for gps location data.		<b>GPS Location</b>	See photo for gps location data.	
<b>Field Station#</b>	13413+00		<b>Field Station#</b>	13361+00	
<b>Pic 3 Desc.</b>	Photo shows stream S-IJ1 downstream from the bridge.		<b>Pic 4 Desc.</b>	Photo shows the damaged P1 silt fence at 13361+00.

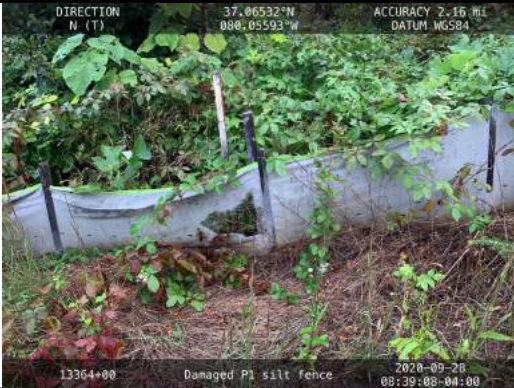
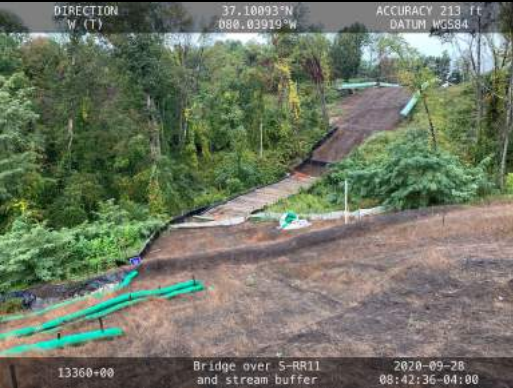
<b>Pic 5 Desc.</b>	Photo shows the damaged P1 silt fence at about 13364+00.		<b>Pic 6 Desc.</b>	Photo shows the bridge over stream S-RR11 and adjacent stream buffer.

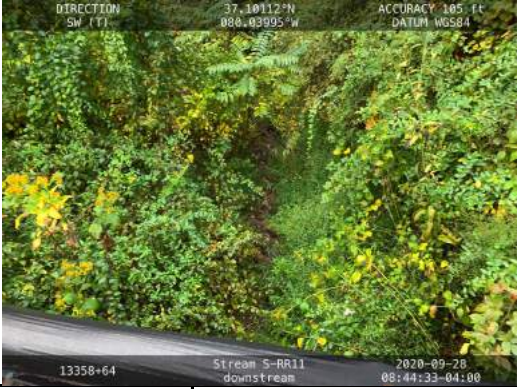
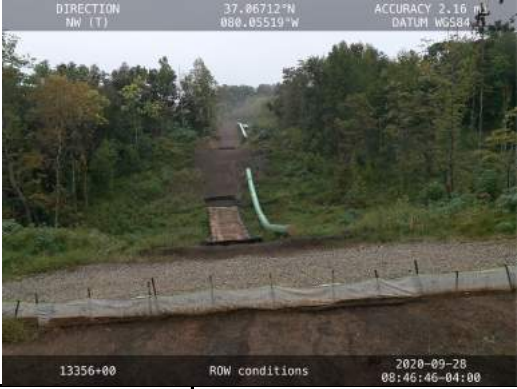
<b>GPS Location</b>	See photo for gps location data.		<b>GPS Location</b>	See photo for gps location data.	
<b>Field Station#</b>	13358+64		<b>Field Station#</b>	13356+00	
<b>Pic 7 Desc.</b>	Photo shows stream S-RR11 downstream from the bridge.		<b>Pic 8 Desc.</b>	Photo shows the ROW condition from about 13353+00 to 13356+00.

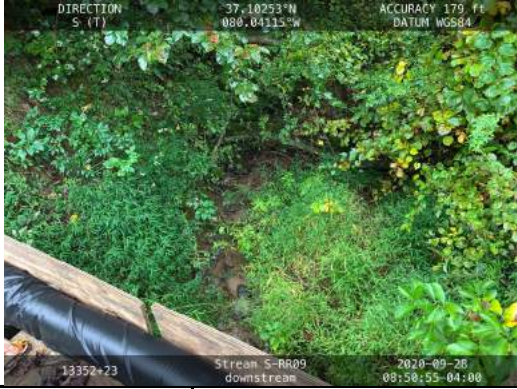
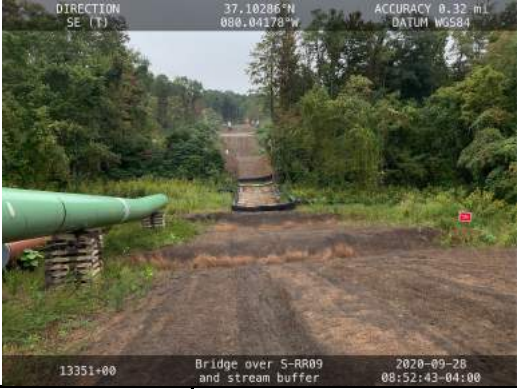
<b>GPS Location</b>	See photo for gps location data.		<b>GPS Location</b>	See photo for gps location data.	
<b>Field Station#</b>	13352+23		<b>Field Station#</b>	13351+00	
<b>Pic 9 Desc.</b>	Photo shows stream S-RR09 downstream from the bridge.		<b>Pic 10 Desc.</b>	Photo shows the bridge over stream S-RR09 and adjacent stream buffer.

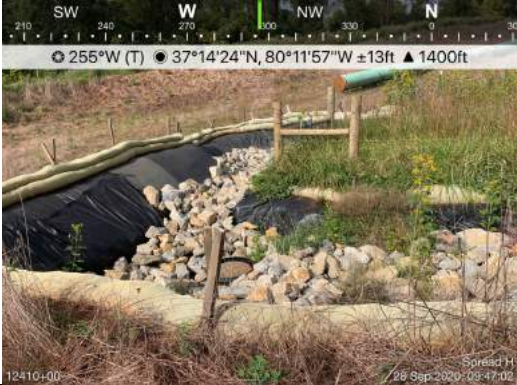
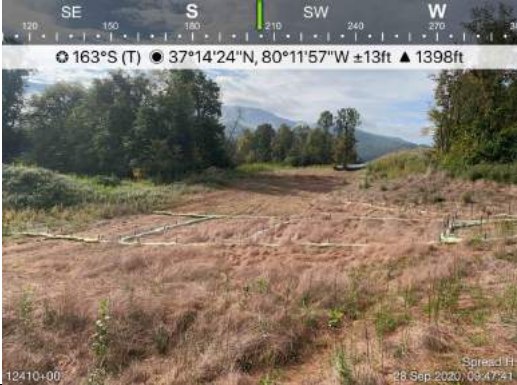
<b>GPS Location</b>	See photo		<b>GPS Location</b>	See photo	
<b>Field Station#</b>	12410+00		<b>Field Station#</b>	12410+00	
<b>Pic 7 Desc.</b>	CWD inlet in good condition.		<b>Pic 8 Desc.</b>	CFS controls are keyed in and in good condition. Vegetative stabilization is mature and uniform.

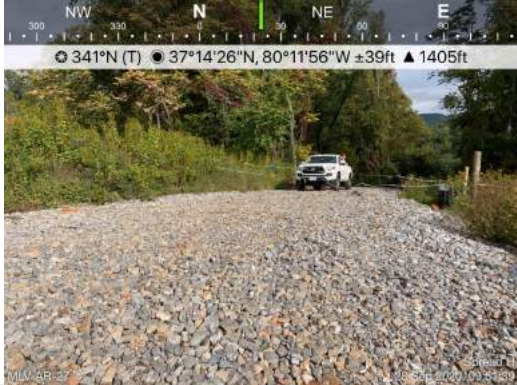
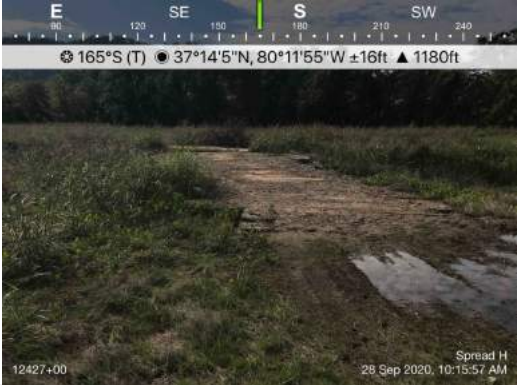
<b>GPS Location</b>	See photo		<b>GPS Location</b>	See photo	
<b>Field Station#</b>	+27		<b>Field Station#</b>	12427+00	
<b>Pic 9 Desc.</b>	Rock CE is in good condition on MLV-AR-27		<b>Pic 10 Desc.</b>	Equipment bridge and CWD pipe is in good condition near the future bore crossing of the Roanoke River.

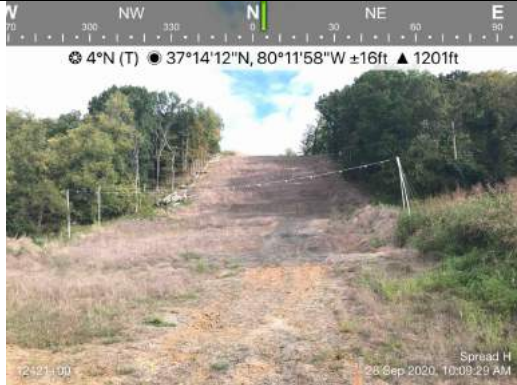
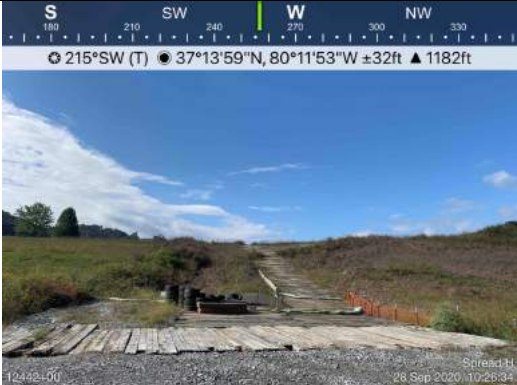
<b>GPS Location</b>	See photo		<b>GPS Location</b>	See photo	
<b>Field Station#</b>	12421+00		<b>Field Station#</b>	12442+00	
<b>Pic 11 Desc.</b>	Waterbars and end treatments are in good condition on this slope.		<b>Pic 12 Desc.</b>	Timbermatting, CFS, and SF controls are in good condition on this slope.

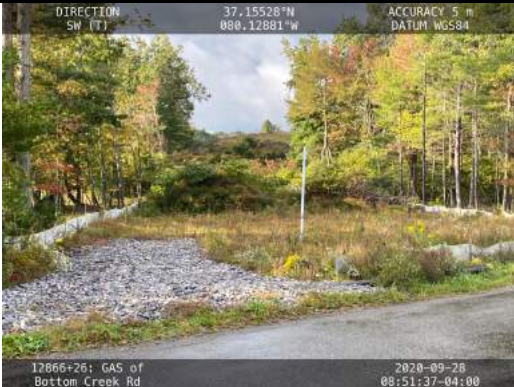
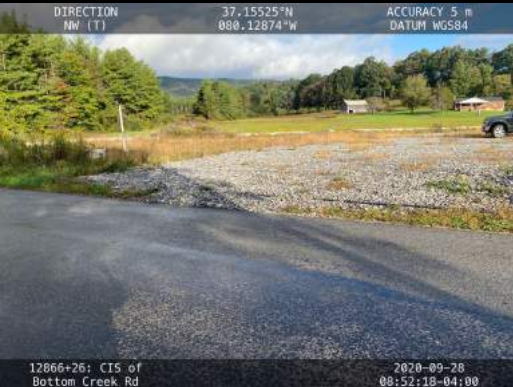
<b>GPS Location</b>	See photo		<b>GPS Location</b>	See photo	
<b>Field Station#</b>	12866+26		<b>Field Station#</b>	12866+26	
<b>Pic 1 Desc.</b>	Going away side of Bottom Creek Road crossing.		<b>Pic 2 Desc.</b>	Coming in side of Bottom Creek Road crossing.

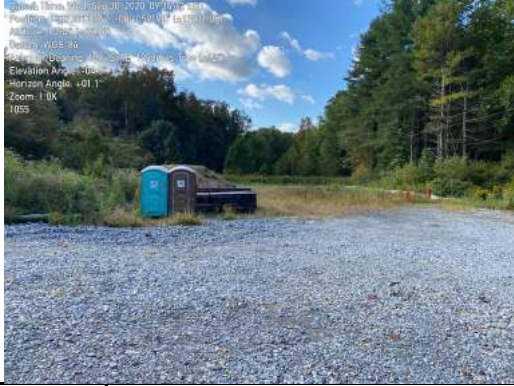
<p> <small> Date &amp; Time: Wed Sep 30, 2020 09:34:18 EDT  Position: 40.1715710, -80.0596780 (152.2m)  Altitude: 1452m (125.3m)  Datum: WGS 84  Azimuth Bearing: 201.7020N 570mils True (12)  Elevation Angle: +01.5  Horizon Angle: 100  Zoom: 1.0x  Pic: 02 </small> </p>			
<b>GPS Location</b>	See photo for coordinates.		<b>GPS Location</b>	See photo for coordinates.	
<b>Field Station#</b>	13262+00		<b>Field Station#</b>	13262+00	
<b>Pic 1 Desc.</b>	MVP-FR-293.01, road crossing in acceptable condition.		<b>Pic 2 Desc.</b>	ATWS-1055, partially restored with acceptable vegetative cover.

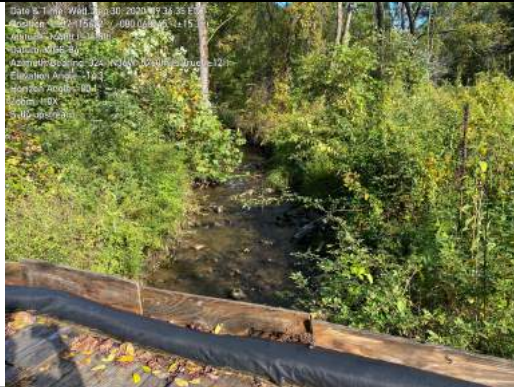
<p> <small> Date &amp; Time: Wed Sep 30, 2020 09:35:15 EDT  Position: 40.1715710, -80.0596780 (152.2m)  Altitude: 1452m (125.3m)  Datum: WGS 84  Azimuth Bearing: 201.7020N 570mils True (12)  Elevation Angle: +01.5  Horizon Angle: 100  Zoom: 1.0x  Pic: 04 </small> </p>			
<b>GPS Location</b>	See photo for coordinates.		<b>GPS Location</b>	See photo for coordinates.	
<b>Field Station#</b>	13262+00		<b>Field Station#</b>	13260+60	
<b>Pic 3 Desc.</b>	ROW temporarily stabilized.		<b>Pic 4 Desc.</b>	S-II4, upstream, no changes noted to stream bed or banks.

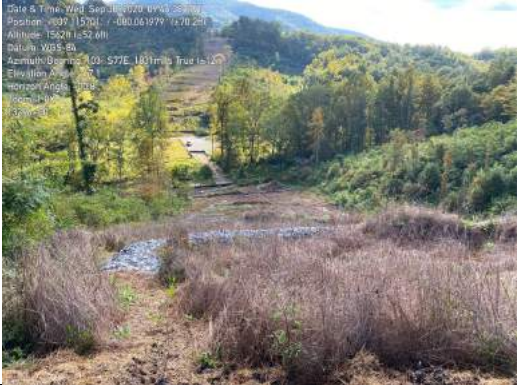
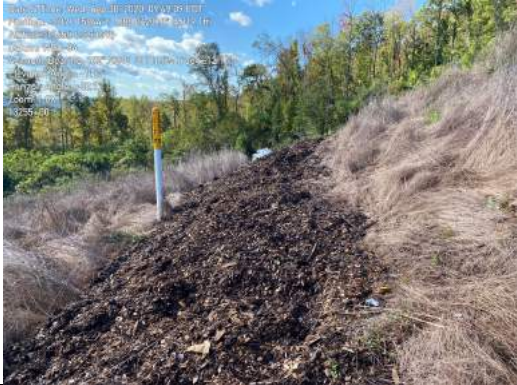
<b>GPS Location</b>	See photo for coordinates.		<b>GPS Location</b>	See photo for coordinates.	
<b>Field Station#</b>	13256+00		<b>Field Station#</b>	12255+00	
<b>Pic 7 Desc.</b>	ROW stable with vegetative cover across LOD.		<b>Pic 8 Desc.</b>	Mulch berm left from CFS removal.

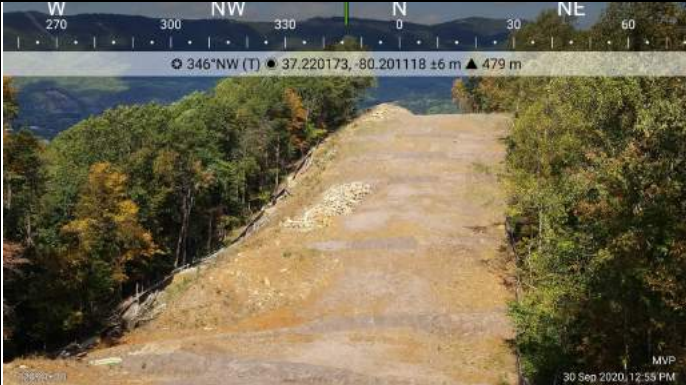
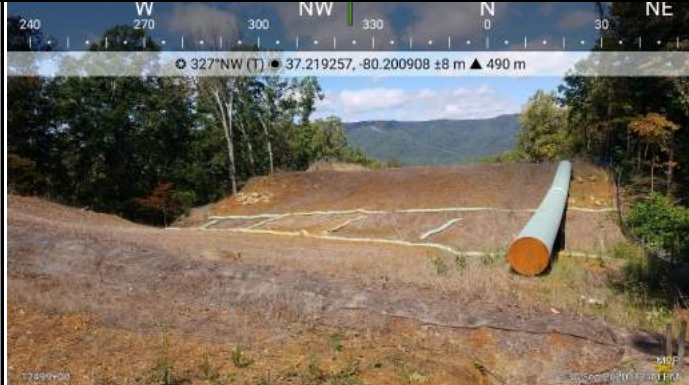
GPS Location	See Above		GPS Location	See Above	
Field Station#	12494+00		Field Station#	12499+00	
Pic 7 Desc.	ROW Overview. Temporary Restoration. ECDs functional and in good condition.		Pic 8 Desc.	ROW Overview. Temporary Restoration. ECDs functional and in good condition.

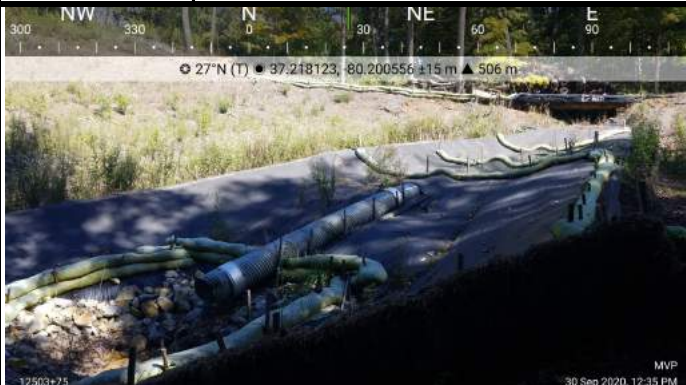
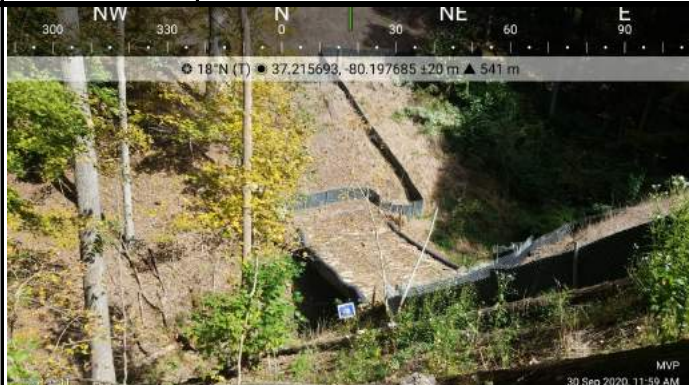
GPS Location	See Above		GPS Location	See Above	
Field Station#	12503+75		Field Station#	12519+41	
Pic 9 Desc.	ROW Overview. Temporary Restoration. ECDs functional and in good condition.		Pic 10 Desc.	Overview of Waterbody S-EF19. ECDs functional and in good condition.

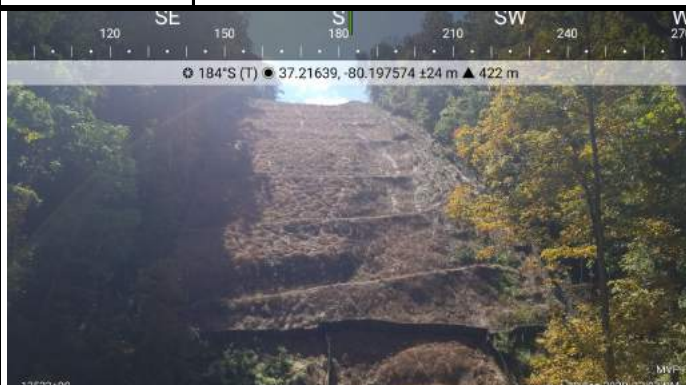
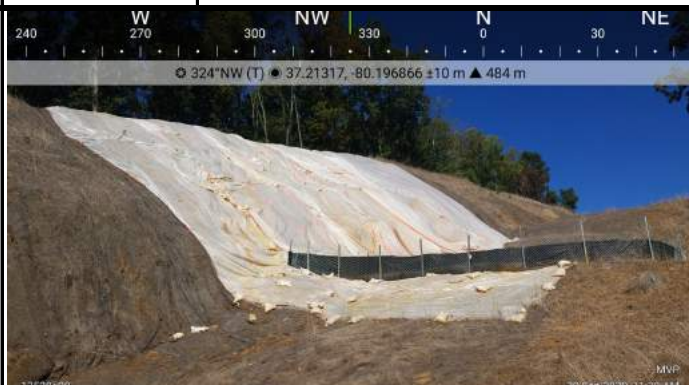
GPS Location	See Above		GPS Location	See Above	
Field Station#	12522+00		Field Station#	12528+00	
Pic 11 Desc.	ROW Overview. Temporary Restoration. ECDs functional and in good condition.		Pic 12 Desc.	Plastic sheeting is intact and secure in the areas where it was used to stabilize stockpile.

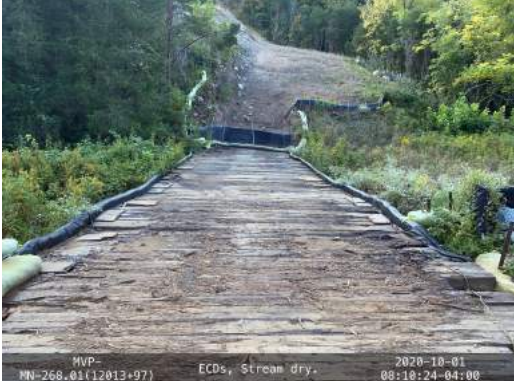
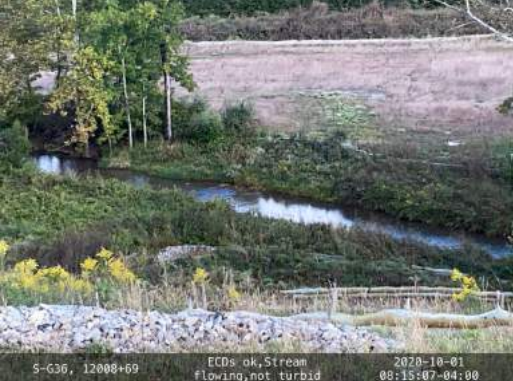
<b>GPS Location</b>	See photo GPS for location		<b>GPS Location</b>	See photo GPS for location	
<b>Field Station#</b>	12013+97		<b>Field Station#</b>	12008+69	
<b>Pic 1 Desc.</b>	All surrounding ECDs are in acceptable condition.		<b>Pic 2 Desc.</b>	All ECDs are in acceptable condition. Level spreaders are in tact. Stream banks are stable.

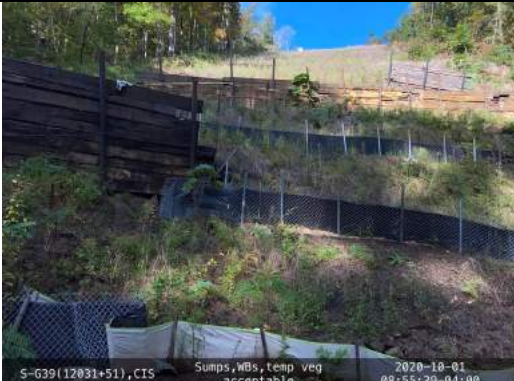
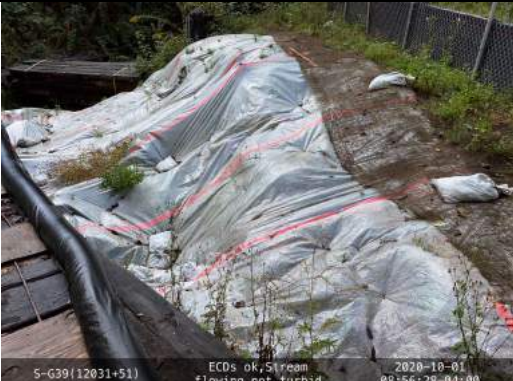
<b>GPS Location</b>	See photo GPS for location		<b>GPS Location</b>	See photo GPS for location	
<b>Field Station#</b>	12031+51		<b>Field Station#</b>	12031+51	
<b>Pic 3 Desc.</b>	All ECDs are in acceptable condition. Sumps and vegetation is in acceptable condition.		<b>Pic 4 Desc.</b>	All surrounding ECDs are in acceptable condition.

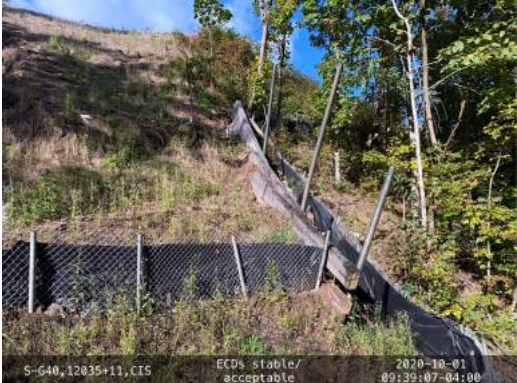
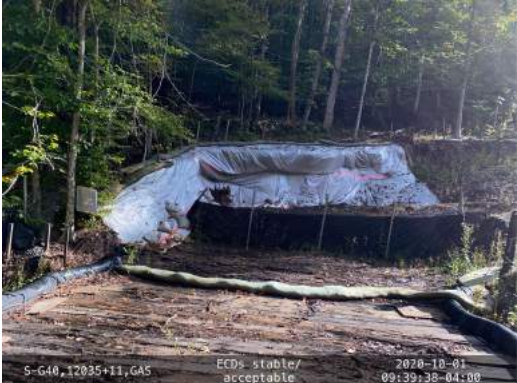
<b>GPS Location</b>	See photo GPS for location		<b>GPS Location</b>	See photo GPS for location	
<b>Field Station#</b>	12035+11		<b>Field Station#</b>	12035+11	
<b>Pic 7 Desc.</b>	All ECDs are in acceptable condition. Sumps and vegetation is in acceptable condition.		<b>Pic 8 Desc.</b>	All ECDs are in acceptable condition and stable.

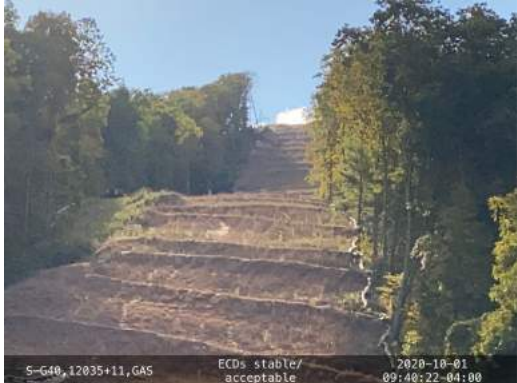
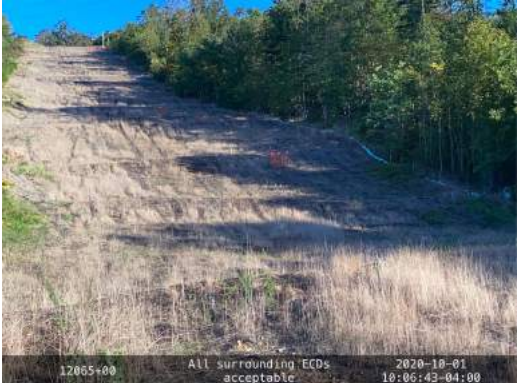
<b>GPS Location</b>	See photo GPS for location		<b>GPS Location</b>	See photo GPS for location	
<b>Field Station#</b>	12035+11		<b>Field Station#</b>	12065+00	
<b>Pic 9 Desc.</b>	All ECDs are in acceptable condition. Sumps and vegetation is in acceptable condition.		<b>Pic 10 Desc.</b>	All ECDs are in acceptable condition. Sumps and vegetation is in acceptable condition.

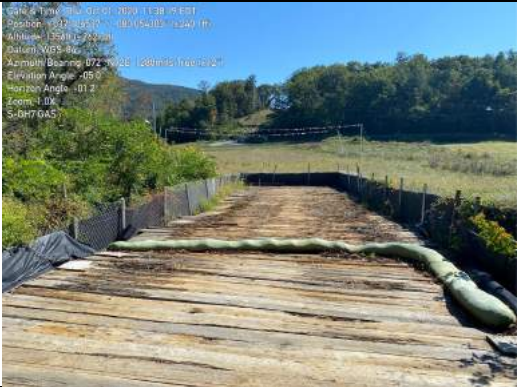
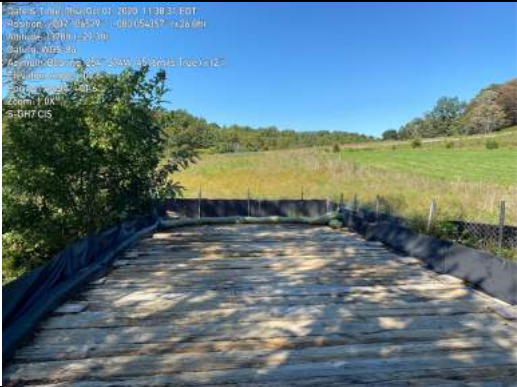
<b>GPS Location</b>	See phot for coordinates.		<b>GPS Location</b>	See phot for coordinates.	
<b>Field Station#</b>	13309+09		<b>Field Station#</b>	13409+09	
<b>Pic 7 Desc.</b>	GAS S-GH7, ECDs along stream crossing in acceptable condition.		<b>Pic 8 Desc.</b>	CIS S-GH7, ECDs along stream crossing in acceptable condition.

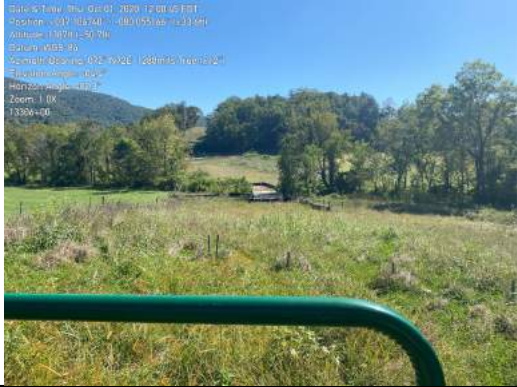
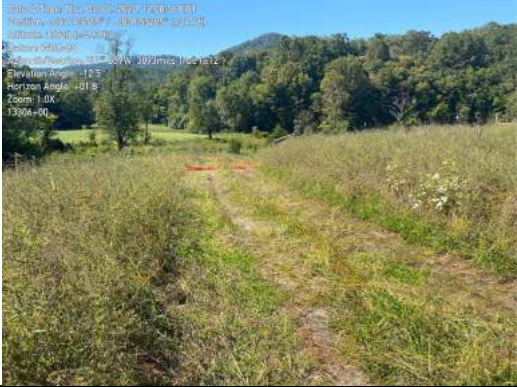
<b>GPS Location</b>	See phot for coordinates.		<b>GPS Location</b>	See phot for coordinates.	
<b>Field Station#</b>	13406+00		<b>Field Station#</b>	13306+00	
<b>Pic 9 Desc.</b>	ROW stable with acceptable vegetative cover across LOD.		<b>Pic 10 Desc.</b>	ROW stable with acceptable vegetative cover across LOD.

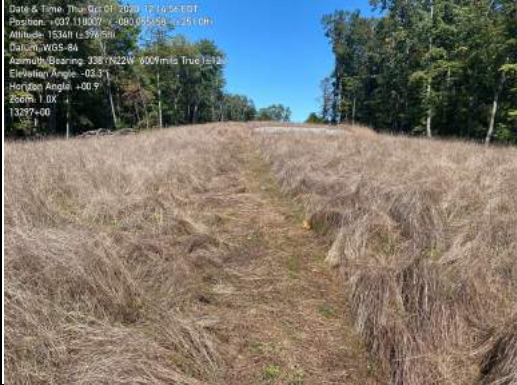
<b>GPS Location</b>	See phot for coordinates.		<b>GPS Location</b>	See phot for coordinates.	
<b>Field Station#</b>	13300+00		<b>Field Station#</b>	13297+00	
<b>Pic 13 Desc.</b>	ROW stable with acceptable vegetative cover across LOD, ATV tracks noted.		<b>Pic 14 Desc.</b>	ROW stable with acceptable vegetative cover across LOD.

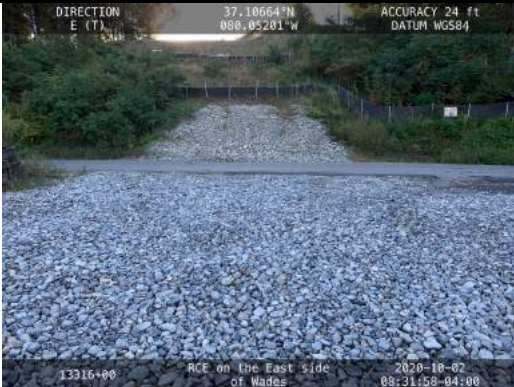
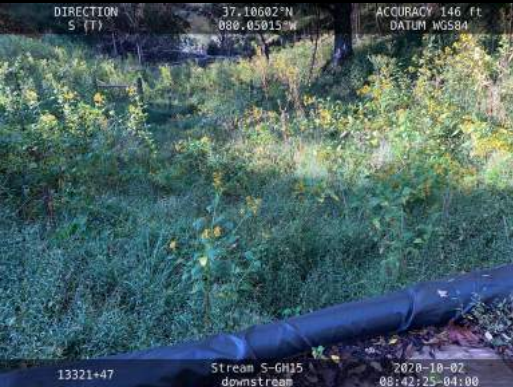
<b>GPS Location</b>	See photo for gps location data.		<b>GPS Location</b>	See photo for gps location data.	
<b>Field Station#</b>	13316+00		<b>Field Station#</b>	13321+47	
<b>Pic 1 Desc.</b>	Photo shows the RCE on the east side of Wades Gap Road.		<b>Pic 2 Desc.</b>	Photo shows stream S-GH15 downstream from the bridge.

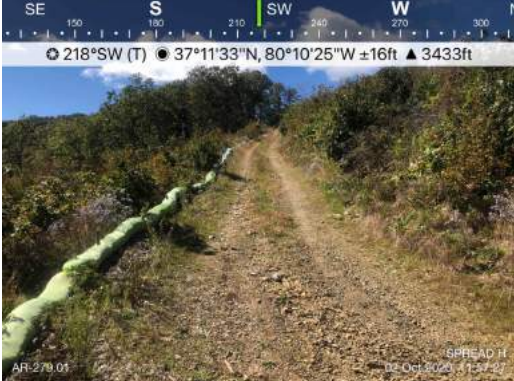
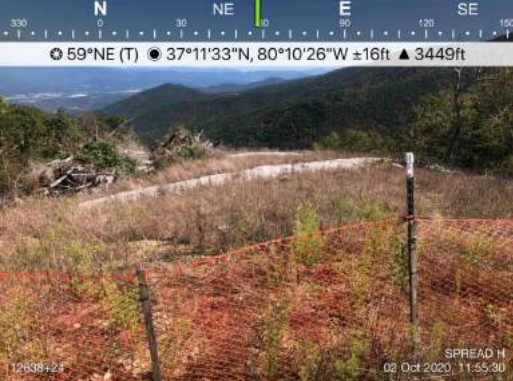
<b>GPS Location</b>	see photo		<b>GPS Location</b>	see photo	
<b>Field Station#</b>	279+01		<b>Field Station#</b>	12638+24	
<b>Pic 1 Desc.</b>	AR-279.01 in good condition with controls in place.		<b>Pic 2 Desc.</b>	GAS of AR-279.01 remains stable with controls in place.

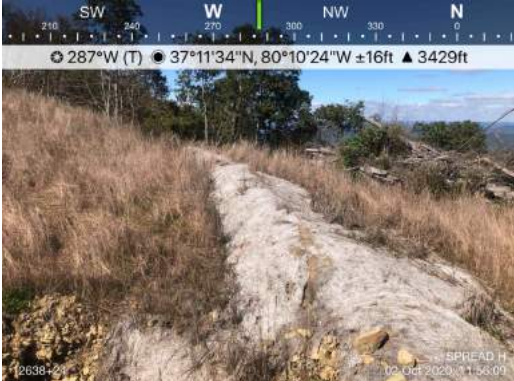
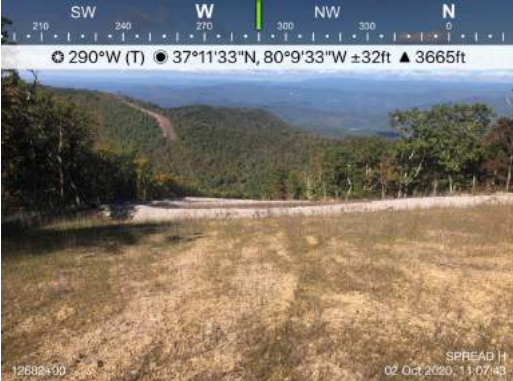
<b>GPS Location</b>	see photo		<b>GPS Location</b>	see photo	
<b>Field Station#</b>	12638+24		<b>Field Station#</b>	12682+00	
<b>Pic 3 Desc.</b>	Waterbars on this slope in good condition.		<b>Pic 4 Desc.</b>	CIS slope of Honeysuckle Rd. remains stable with controls in place.

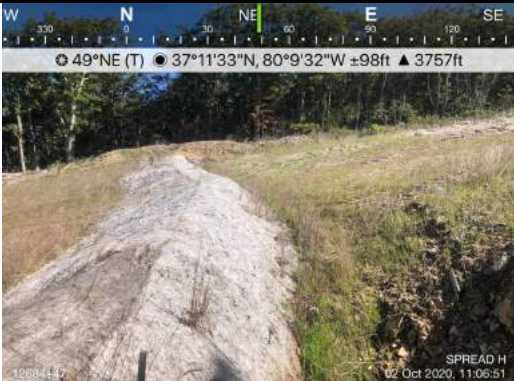
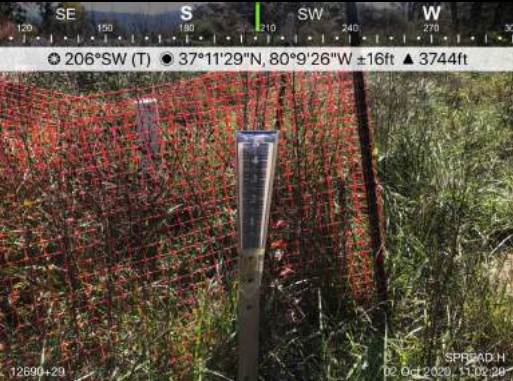
<b>GPS Location</b>	see photo		<b>GPS Location</b>	see photo	
<b>Field Station#</b>	12684+47		<b>Field Station#</b>	12690+29	
<b>Pic 5 Desc.</b>	Waterbars in good condition on the CIS slope of Honeysuckle Rd.		<b>Pic 6 Desc.</b>	Rain gauge showing 0" at Honeysuckle Rd.

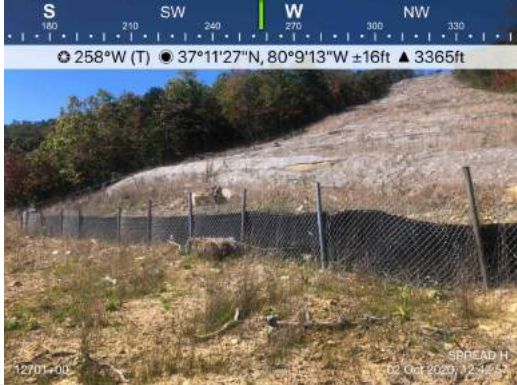
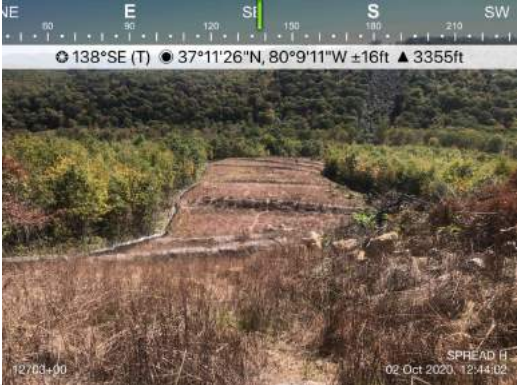
<b>GPS Location</b>	see photo		<b>GPS Location</b>	see photo	
<b>Field Station#</b>	12701+00		<b>Field Station#</b>	12703+00	
<b>Pic 9 Desc.</b>	Additional controls at this location in good condition and functioning.		<b>Pic 10 Desc.</b>	GAS of AR-280 remains stabilized with controls in place.

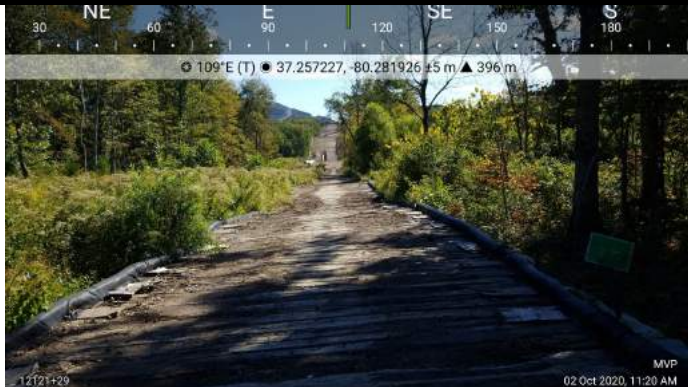
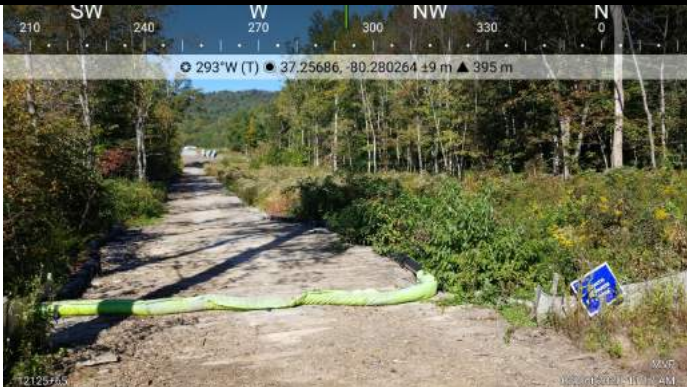
GPS Location	See Above		GPS Location	See Above	
Field Station#	12121+29		Field Station#	12125+65	
Pic 1 Desc.	Overview of Wetland W-C12. ECDs functional and in good condition.		Pic 2 Desc.	Overview of Waterbody S-MM31. ECDs functional and in good condition.

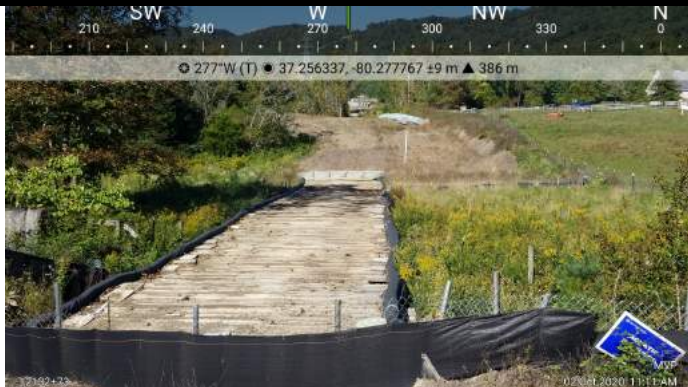
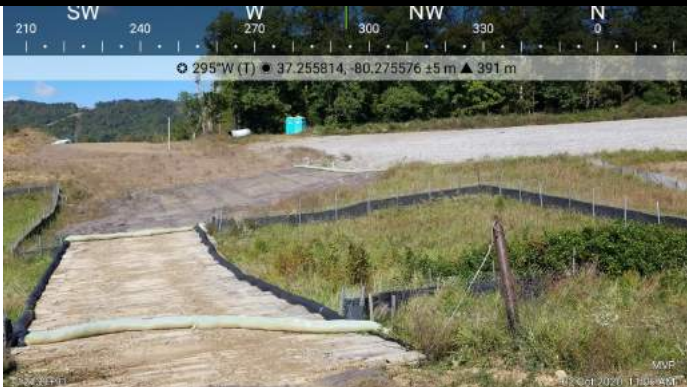
GPS Location	See Above		GPS Location	See Above	
Field Station#	12132+73		Field Station#	12139+91	
Pic 3 Desc.	Overview of Waterbody S-C29. ECDs functional and in good condition.		Pic 4 Desc.	Overview of Wetland W-C6. ECDs functional and in good condition.

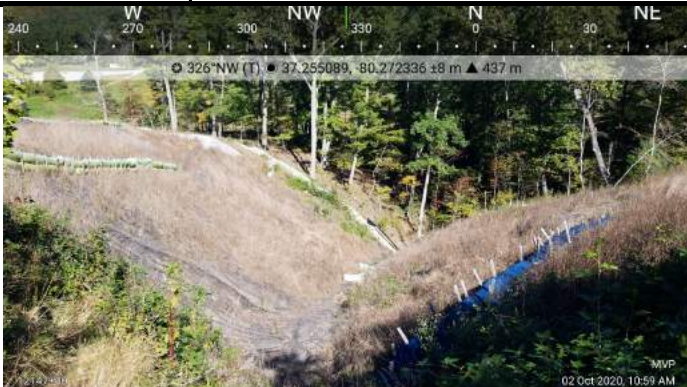
GPS Location	See Above		GPS Location	See Above	
Field Station#	12144+47		Field Station#	12147+00	
Pic 5 Desc.	Overview of Wetland W-C5. ECDs functional and in good condition.		Pic 6 Desc.	ROW Overview. Temporary and Permanent Restoration. ECDs functional and in good condition.

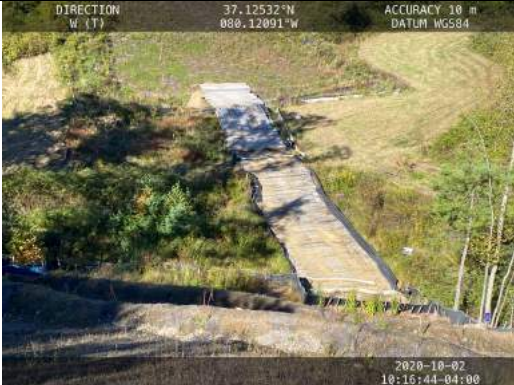
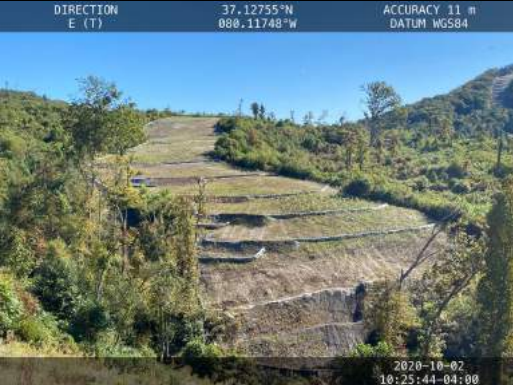
<b>GPS Location</b>	See photo		<b>GPS Location</b>	See photo	
<b>Field Station#</b>	13024+07		<b>Field Station#</b>	13045+00	
<b>Pic 1 Desc.</b>	Streams S-G24 and S-G25, facing west		<b>Pic 2 Desc.</b>	Permanent restoration on the going away side of stream S-H1 remains stable, moderate vegetative cover.
