Visual Site Inspection Report

Project Name	H-600 Pipeline Spread H	AFE	124300138	Spread	H-600 Pipeline Spread H
Contractor	Precision			Report #	15207
Inspector	Logan Box			Date/Time	10/5/2020 10:02 AM
Permit #	TBD	Inspection Type	VA SWPP	Station Begin	13415+51
State	VA	Inspection Area	Partial	Station End	13670+00
County	Franklin	Ground	Dry	Temperature (°F)	81.00
Municipality	N/A	Weather	Sunny	Rain Gauge (in)	1.25
				Rain Accumulation Time (days)	6.00

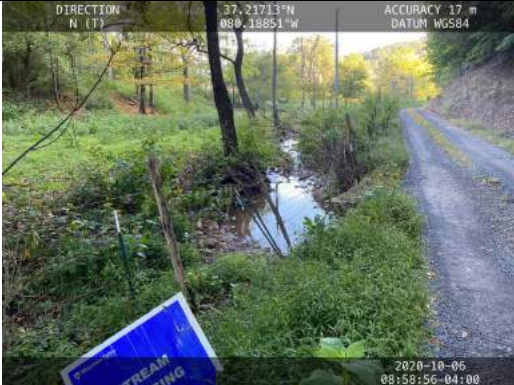
GPS Location	See photo		GPS Location	See photo	
Field Station#	12543+56		Field Station#	12543+56	
Pic 1 Desc.	Stream S-EF20b on Yellow Finch Road, facing north, downstream		Pic 2 Desc.	Stream S-KL32 on Yellow Finch Road, facing southeast, upstream

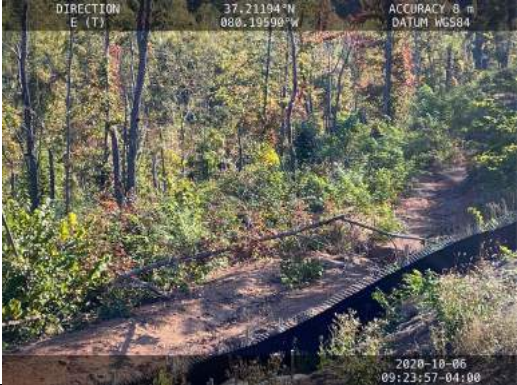
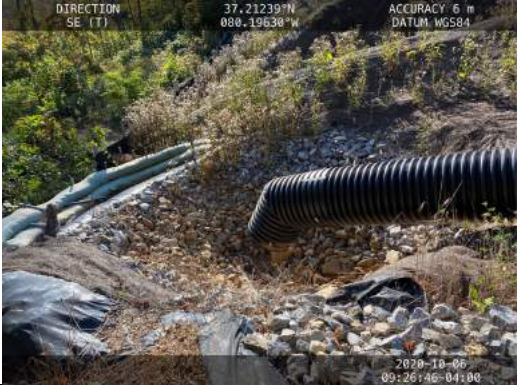
GPS Location	See photo		GPS Location	See photo	
Field Station#	12536+00		Field Station#	12534+00	
Pic 7 Desc.	This denuded logging road adjacent to MVP ROW remains unstabilized.		Pic 8 Desc.	This clean water diversion pipe outlet plunge pool is in satisfactory condition.

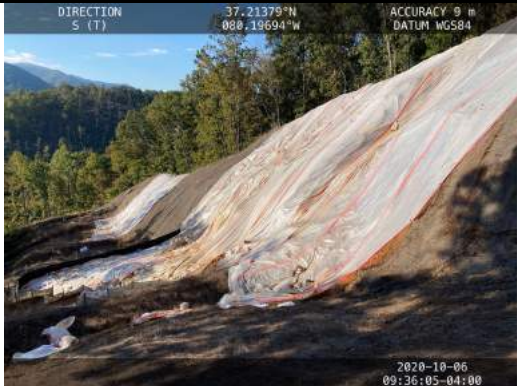
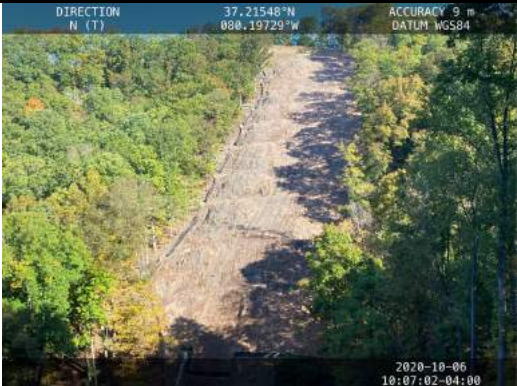
GPS Location	See photo		GPS Location	See photo	
Field Station#	12529+00		Field Station#	12517+00	
Pic 9 Desc.	Plastic sheeting approximately 1500 feet from Yellow Finch Road remains intact and secure.		Pic 10 Desc.	The slope on the coming in side of stream S-EF19 remains stable.

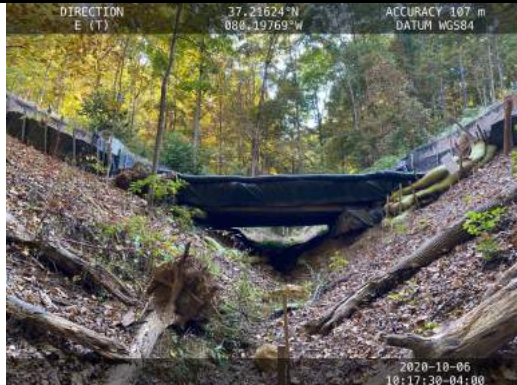
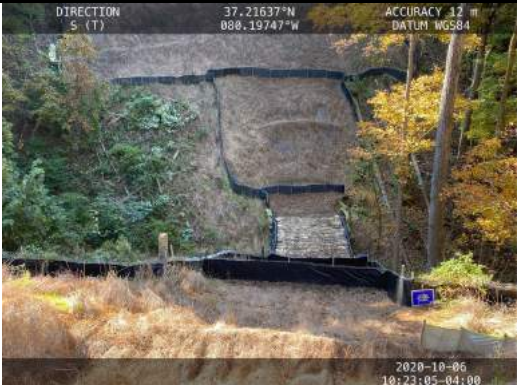
GPS Location	See photo		GPS Location	See photo	
Field Station#	12519+41		Field Station#	12519+41	
Pic 11 Desc.	Stream S-EF19, facing east, upstream		Pic 12 Desc.	Buffer zone of stream S-EF19 remains stable and ECDs are in satisfactory condition.

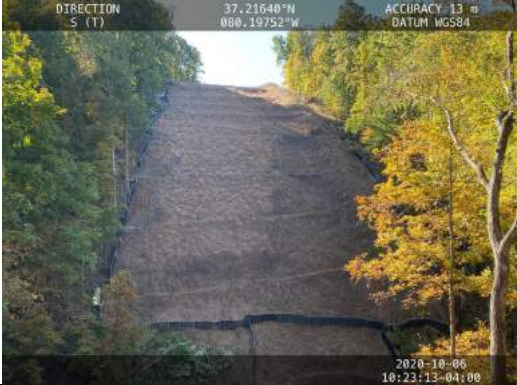
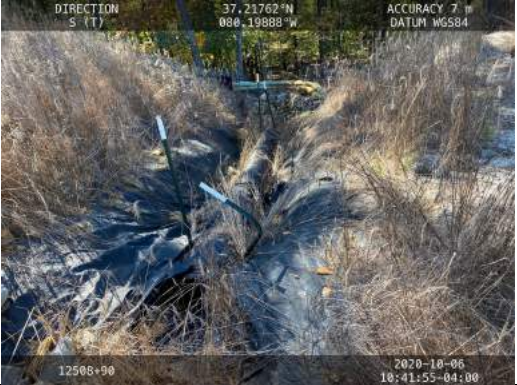
GPS Location	See photo		GPS Location	See photo	
Field Station#	12522+00		Field Station#	12508+90	
Pic 13 Desc.	The slope on the going away side of stream S-EF19 remains stable.		Pic 14 Desc.	This fill slope drain remains in good repair and functioning properly.

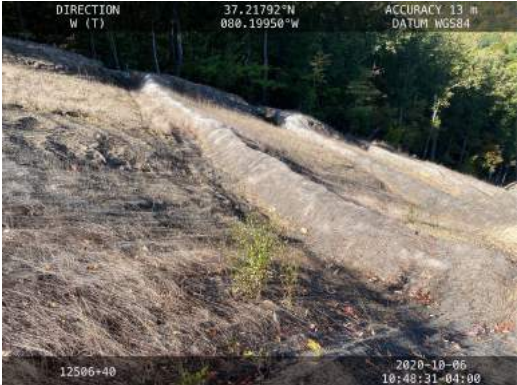
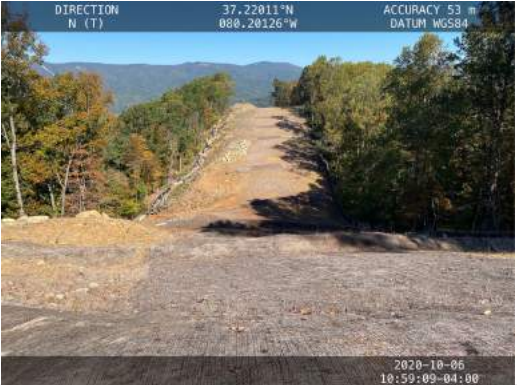
GPS Location	See photo		GPS Location	See photo	
Field Station#	12506+00		Field Station#	12496+00	
Pic 15 Desc.	Waterbars are in good condition and functioning well.		Pic 16 Desc.	ROW stable

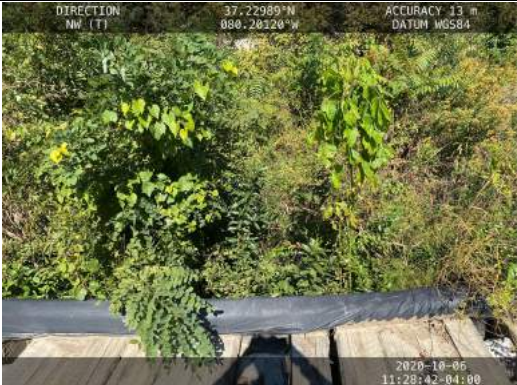
GPS Location	See photo		GPS Location	See photo	
Field Station#	12455+21		Field Station#	12444+94	
Pic 17 Desc.	Stream S-CD12, facing northwest, downstream		Pic 18 Desc.	Stream S-I1, facing southwest, upstream

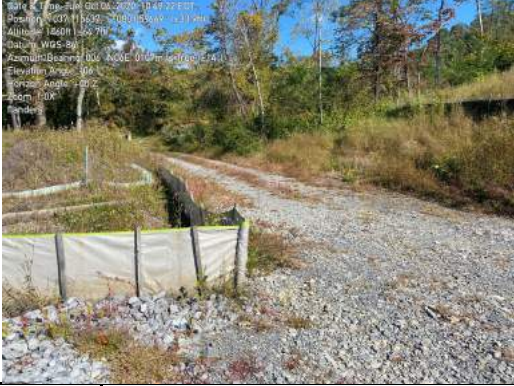
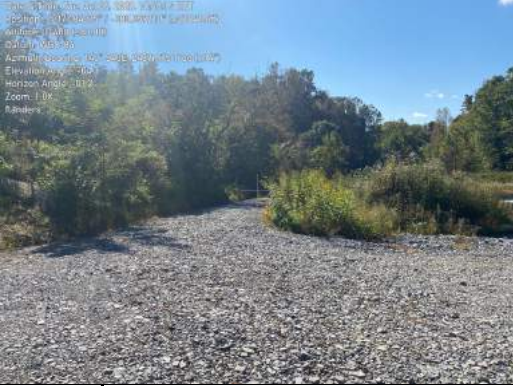
GPS Location	See photo for coordinates.		GPS Location	See photo for coordinates.	
Field Station#	13262+50		Field Station#	13262+50	
Pic 1 Desc.	MVP-FR-293.01, Flanders Road, access road and crossing in acceptable condition.		Pic 2 Desc.	MVP-FR-293.01, Flanders Road, access road and crossing in acceptable condition.

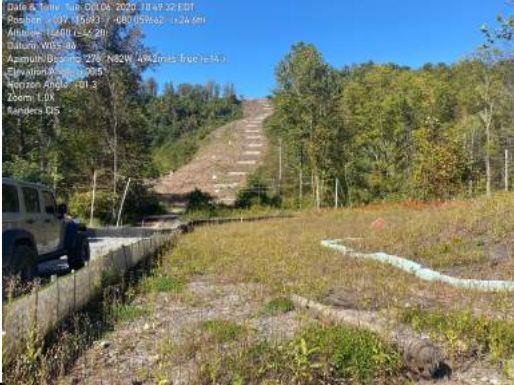
GPS Location	See photo for coordinates.		GPS Location	See photo for coordinates.	
Field Station#	13262+50		Field Station#	13260+60	
Pic 3 Desc.	ROW temporarily stabilized, perimeter ECDs in acceptable condition.		Pic 4 Desc.	S-II4, upstream, no changes noted to stream bed or banks.

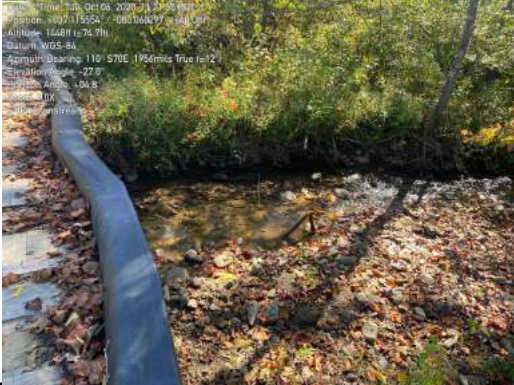
GPS Location	See photo for coordinates.		GPS Location	See photo for coordinates.	
Field Station#	13260+60		Field Station#	13256+00	
Pic 5 Desc.	S-II4, downstream, no changes noted to stream bed or banks.		Pic 6 Desc.	ROW stable with acceptable vegetative cover.

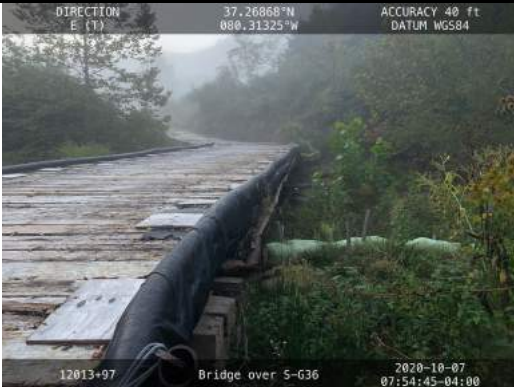
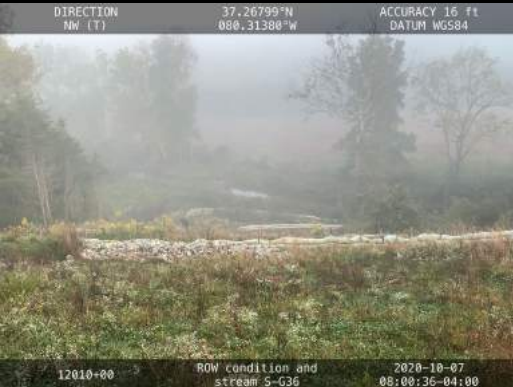
GPS Location	See photo for gps location data.		GPS Location	See photo for gps location data.	
Field Station#	12013+97		Field Station#	12010+00	
Pic 1 Desc.	Photo shows the bridge over stream S-G36 on access road MN-268.01.		Pic 2 Desc.	Photo shows the ROW condition from about 12008+00 to 12010+00 and stream S-G36.

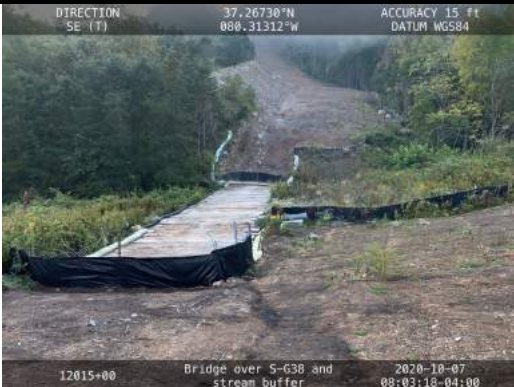
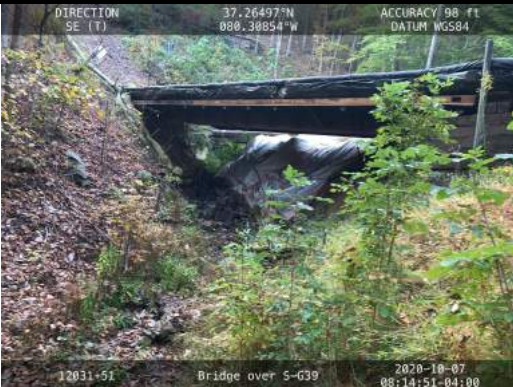
GPS Location	See photo for gps location data.		GPS Location	See photo for gps location data.	
Field Station#	12015+00		Field Station#	13031+51	
Pic 3 Desc.	Photo shows the bridge over stream S-G38 and adjacent stream buffer.		Pic 4 Desc.	Photo shows the bridge over stream S-G39.

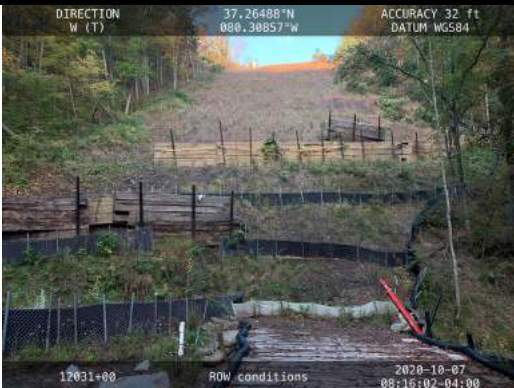
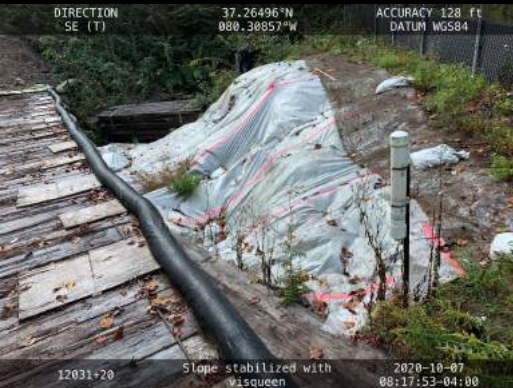
GPS Location	See photo for gps location data.		GPS Location	See photo for gps location data.	
Field Station#	13031+00		Field Station#	12031+20	
Pic 5 Desc.	Photo shows the ROW condition from about 13028+00 to 13031+00.		Pic 6 Desc.	Photo shows the visqueen stabilization adjacent to stream S-G39.

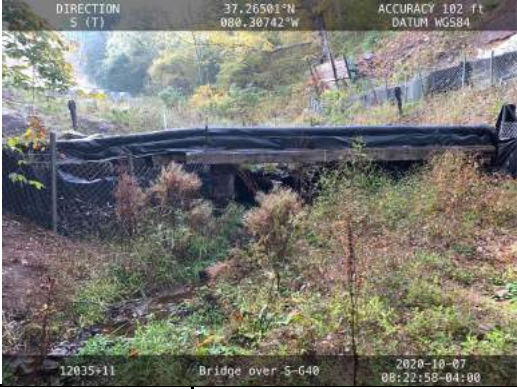
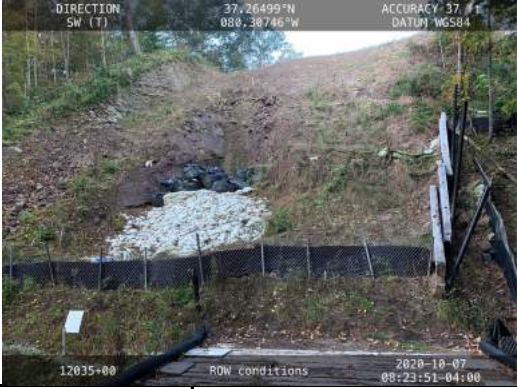
GPS Location	See photo for gps location data.		GPS Location	See photo for gps location data.	
Field Station#	12035+11		Field Station#	12035+00	
Pic 7 Desc.	Photo shows the bridge over stream S-G40.		Pic 8 Desc.	Photo shows the ROW condition from about 12033+00 to 12035+00.

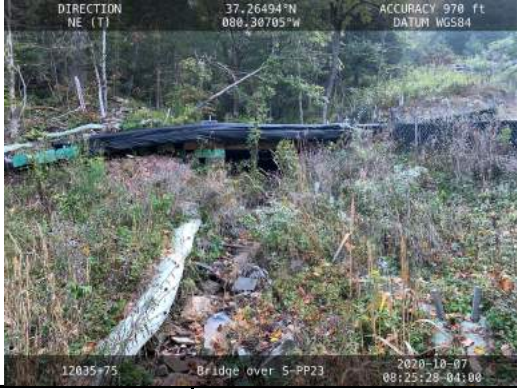
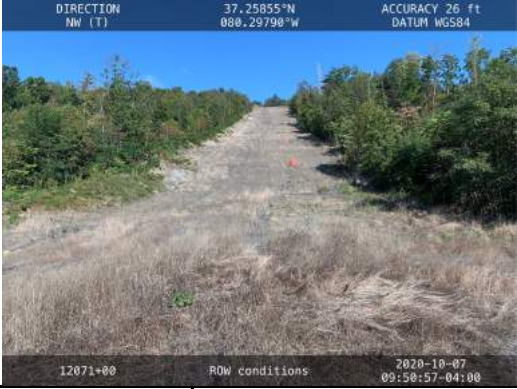
GPS Location	See photo for gps location data.		GPS Location	See photo for gps location data.	
Field Station#	12035+75		Field Station#	12071+00	
Pic 9 Desc.	Photo shows the bridge over stream S-PP23.		Pic 10 Desc.	Photo shows the ROW condition from about 12065+00 to 12071+00.

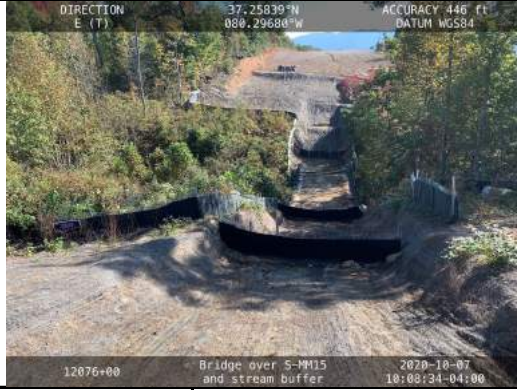
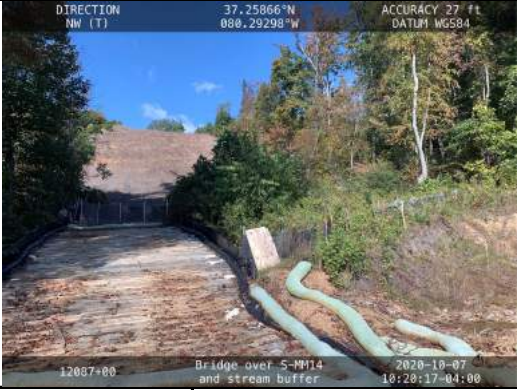
GPS Location	See photo for gps location data.		GPS Location	See photo for gps location data.	
Field Station#	12076+00		Field Station#	12087+00	
Pic 11 Desc.	Photo shows the bridge over stream S-MM15 and adjacent stream buffer.		Pic 12 Desc.	Photo shows the bridge over stream S-MM14 and adjacent stream buffer.

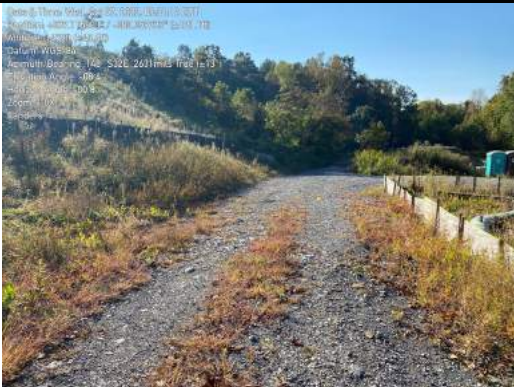
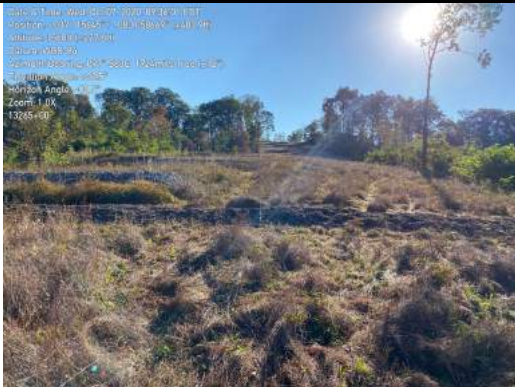
GPS Location	See photo for coordinates.		GPS Location	See photo for coordinates.	
Field Station#	13262+50		Field Station#	13265+00	
Pic 1 Desc.	MVP-FR-293.01, road crossing in acceptable condition.		Pic 2 Desc.	ROW stable with acceptable vegetative cover across LOD.

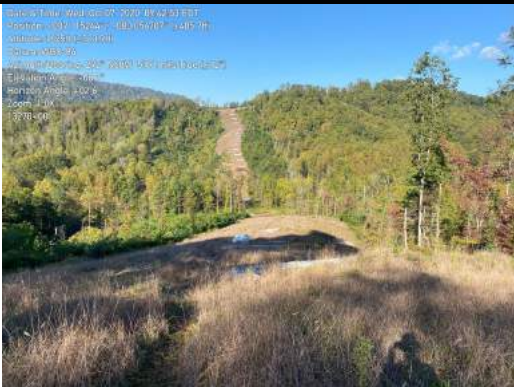
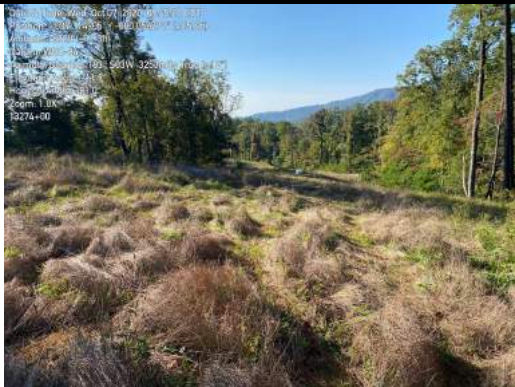
GPS Location	See photo for coordinates.		GPS Location	See photo for coordinates.	
Field Station#	13270+00		Field Station#	13274+00	
Pic 3 Desc.	ROW stable with acceptable vegetative cover across LOD.		Pic 4 Desc.	ROW stable with acceptable vegetative cover across LOD.

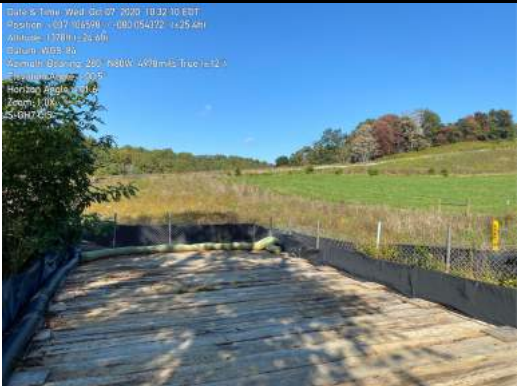
GPS Location	See photo for coordinates.		GPS Location	See photo for coordinates.	
Field Station#	13292+00		Field Station#	13309+09	
Pic 9 Desc.	ROW stable with acceptable vegetative cover across LOD.		Pic 10 Desc.	S-GH7, CIS, ROW stable and well vegetated.

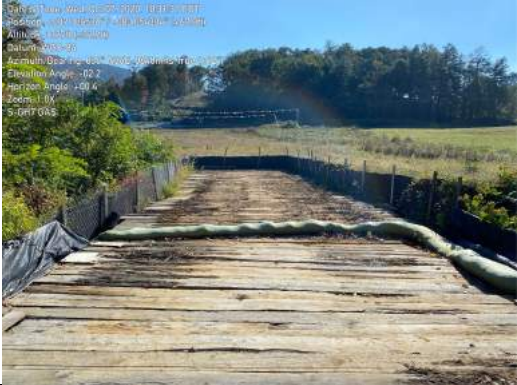
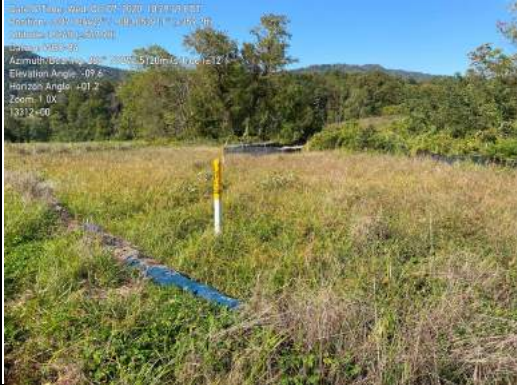
GPS Location	See photo for coordinates.	GPS Location	See photo for coordinates.		
Field Station#	13309+25	Field Station#	13312+00		
Pic 13 Desc.	S-GH7, GAS, ECDs in acceptable condition.	Pic 14 Desc.	ROW stable with acceptable vegetative cover across LOD.

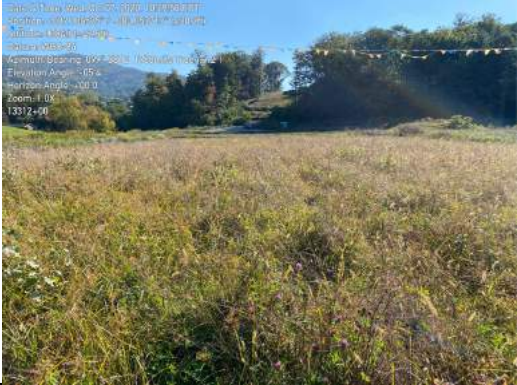
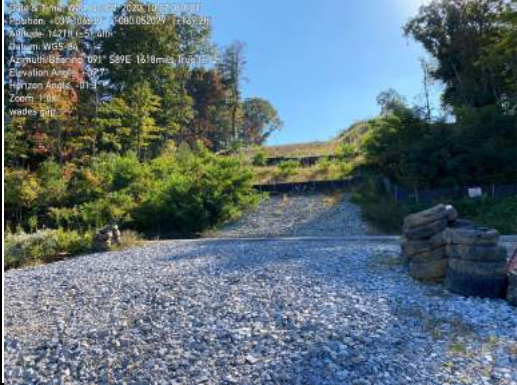
GPS Location	See photo for coordinates.	GPS Location	See photo for coordinates.		
Field Station#	13312+00	Field Station#	13314+00		
Pic 15 Desc.	ROW stable with acceptable vegetative cover in temporary and permanent areas.	Pic 16 Desc.	Wades Gap, RCE in acceptable condition.		
Insert image here		Insert image here			
GPS Location		GPS Location			
Field Station#		Field Station#			
Pic 17 Desc.		Pic 18 Desc.

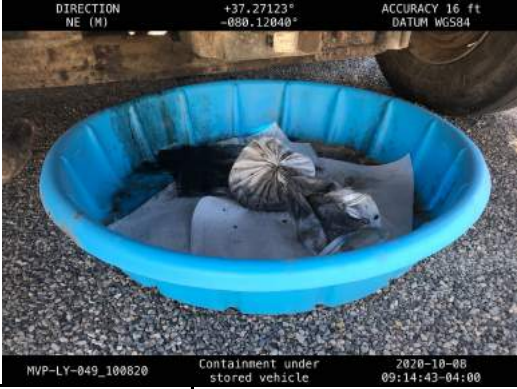
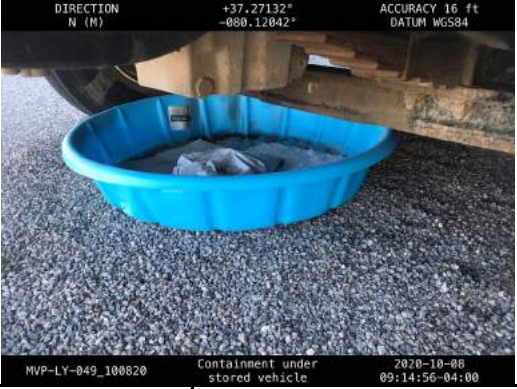
GPS Location	MVP-LY-049 See photo for gps data		GPS Location	MVP-LY-049 See photo for gps data	
Field Station#	+0		Field Station#	+0	
Pic 13 Desc.	Condition of containment under stored vehicle. Looking NE.		Pic 14 Desc.	Condition of containment under stored vehicle. Looking N.

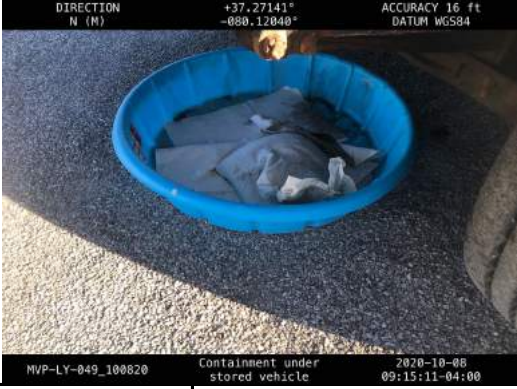
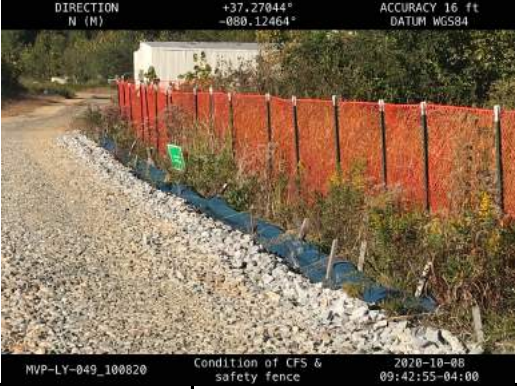
GPS Location	MVP-LY-049 See photo for gps data		GPS Location	MVP-LY-049 See photo for gps data	
Field Station#	+0		Field Station#	+0	
Pic 15 Desc.	Condition of containment under stored vehicle. Looking N.		Pic 16 Desc.	Condition of compost filter sock and safety fence along feature W-CV21A. Looking W.

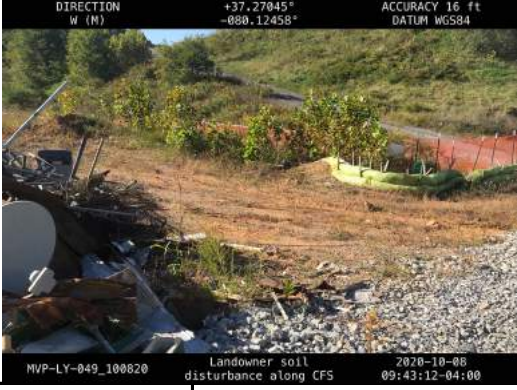
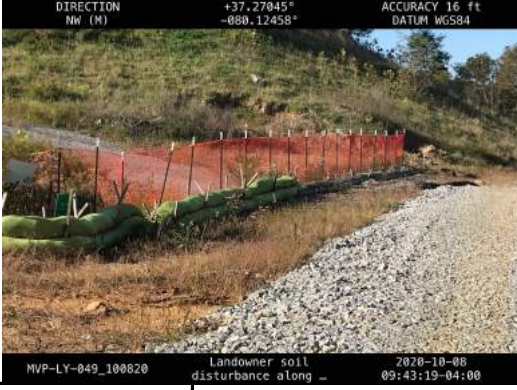
GPS Location	MVP-LY-049 See photo for gps data		GPS Location	MVP-LY-049 See photo for gps data	
Field Station#	+0		Field Station#	+0	
Pic 17 Desc.	Landowner soil disturbance along compost filter sock and feature W-CV21B. No impacts. Looking S.		Pic 18 Desc.	Landowner soil disturbance within 66' of feature W-CV21B. No impacts. Looking NW.

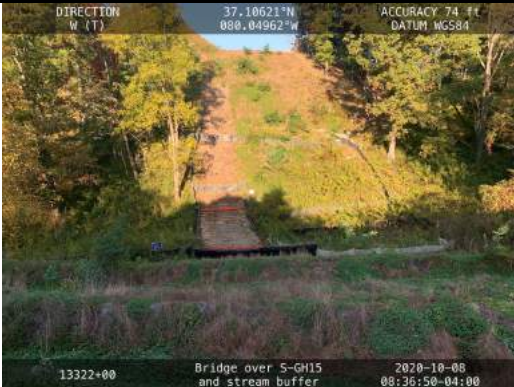
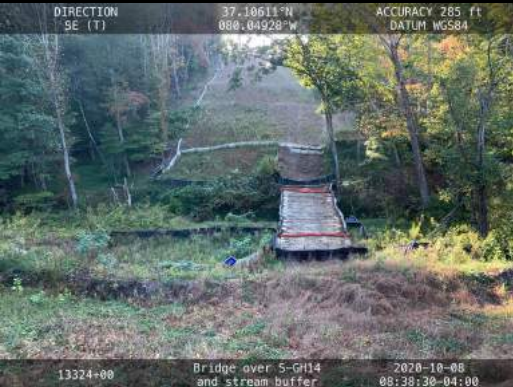
GPS Location	See photo for gps location data.		GPS Location	See photo for gps location data.	
Field Station#	13322+00		Field Station#	13324+00	
Pic 1 Desc.	Photo shows the bridge over stream S-GH15 and adjacent stream buffer.		Pic 2 Desc.	Photo shows the bridge over stream S-GH14 and adjacent stream buffer.

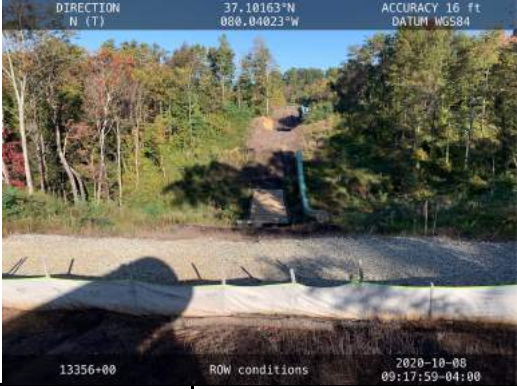
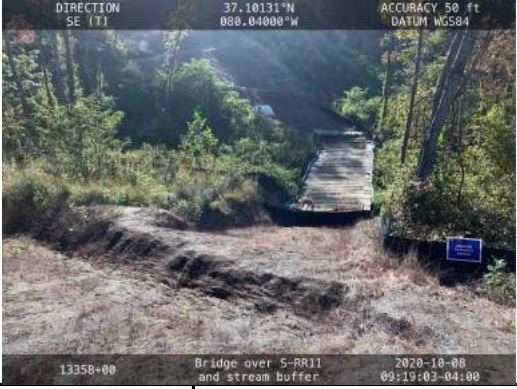
GPS Location	See photo for gps location data.		GPS Location	See photo for gps location data.	
Field Station#	13356+00		Field Station#	13358+00	
Pic 15 Desc.	Photo shows the ROW condition from about 13353+00 to 13356+00.		Pic 16 Desc.	Photo shows the bridge over stream S-RR11 and adjacent stream buffer.

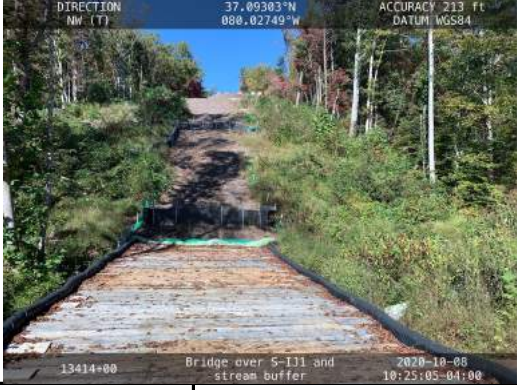
GPS Location	See photo for gps location data.		GPS Location	See photo for gps location data.	
Field Station#	13413+00		Field Station#	13414+00	
Pic 17 Desc.	Photo shows stream S-IJ1 downstream from the bridge.		Pic 18 Desc.	Photo shows the bridge over stream S-IJ1 and adjacent stream buffer.

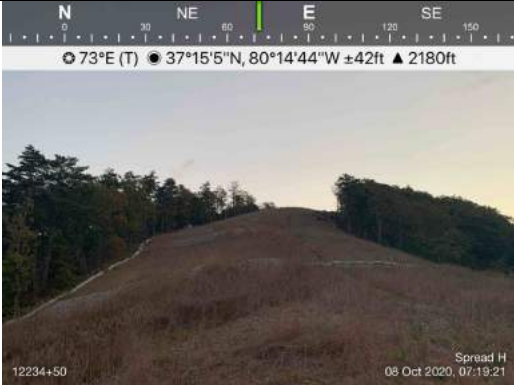
GPS Location	See Photograph.		GPS Location	See Photograph.	
Field Station#	12234+50		Field Station#	12234+50	
Pic 1 Desc.	ROW is in acceptable condition.		Pic 2 Desc.	Rock Check dams are in acceptable condition.

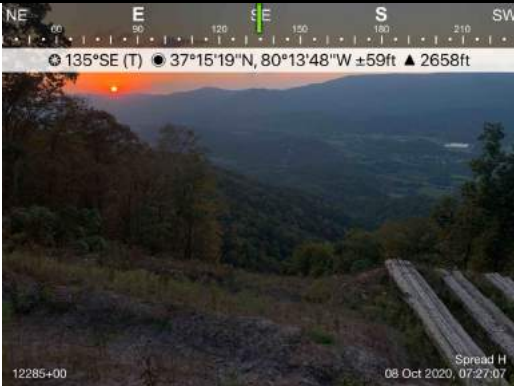
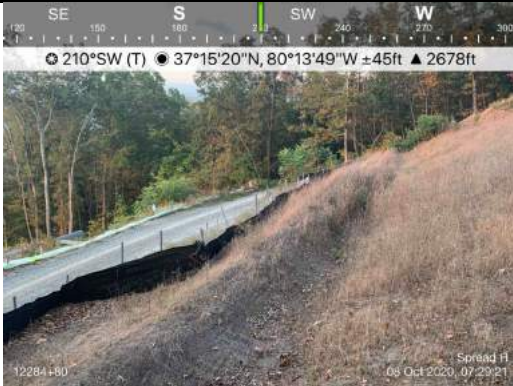
GPS Location	See Photograph.		GPS Location	See Photograph.	
Field Station#	12286+00		Field Station#	12284+80	
Pic 5 Desc.	Waterbars and vegetation within section known as the "V" are in acceptable condition,		Pic 6 Desc.	Reinforced silt fence is in acceptable condition.

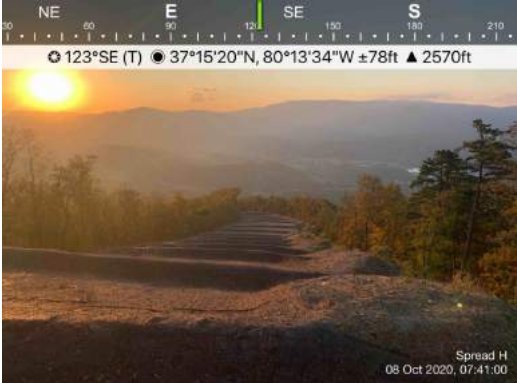
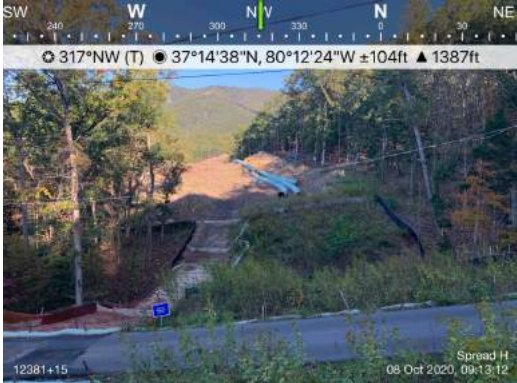
GPS Location	See Photograph.		GPS Location	See Photograph.	
Field Station#	12301+00		Field Station#	12381+15	
Pic 7 Desc.	ROW is in acceptable condition.		Pic 8 Desc.	Bridge crossing in acceptable condition with controls in place.

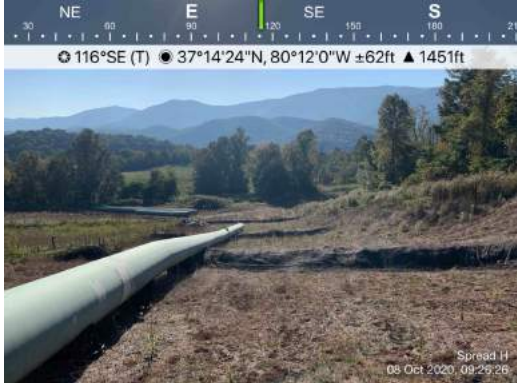
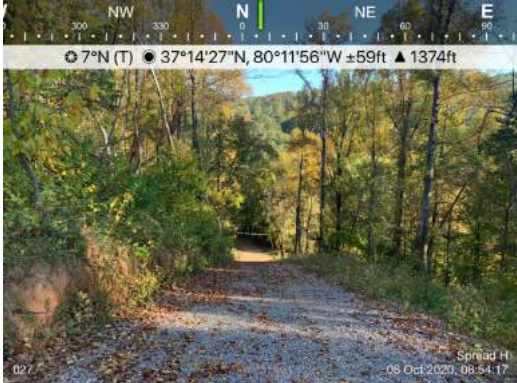
GPS Location	See Photograph.		GPS Location	See Photograph.	
Field Station#	12393+00		Field Station#	0+27	
Pic 9 Desc.	ROW is in acceptable condition.		Pic 10 Desc.	AR-27 is in acceptable condition with gates in good condition and security measures in place.

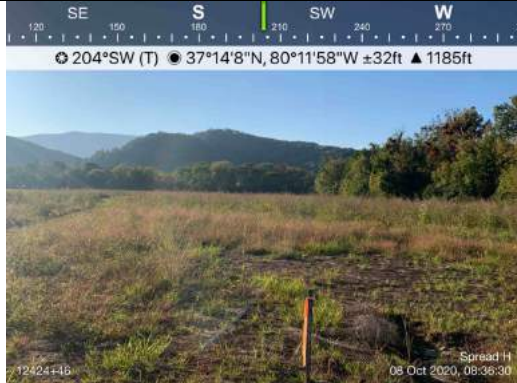
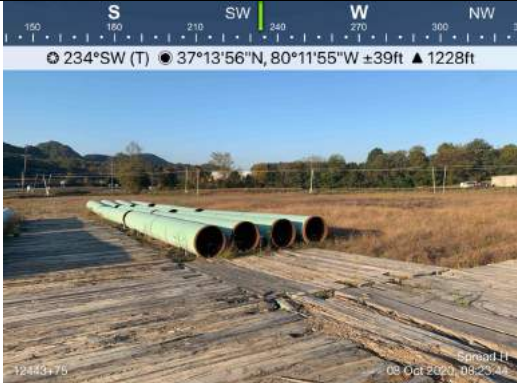
GPS Location	See Photograph.		GPS Location	See Photograph.	
Field Station#	12424+46		Field Station#	12443+75	
Pic 11 Desc.	ROW is in acceptable condition.		Pic 12 Desc.	Timber matting and stockpiles are in acceptable condition.

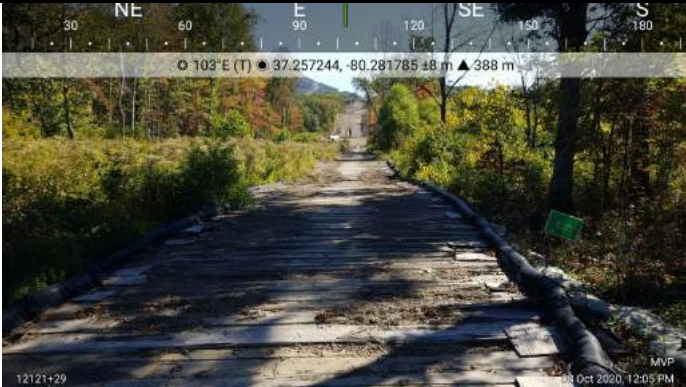
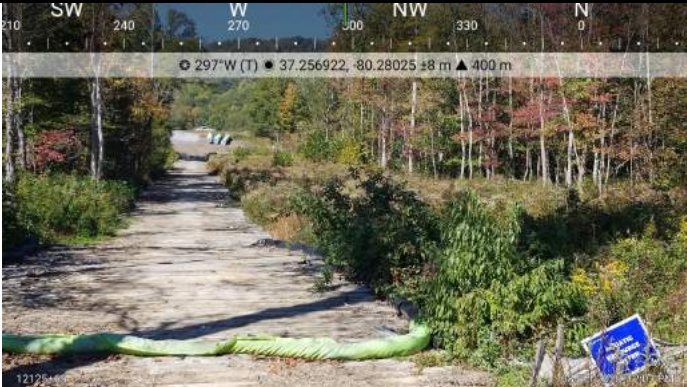
GPS Location	See Above	GPS Location	See Above		
Field Station#	12121+29	Field Station#	12125+65		
Pic 1 Desc.	Overview of Wetland W-C12. ECDs functional and in good condition.	Pic 2 Desc.	Overview of Waterbody S-MM31. ECDs functional and in good condition.

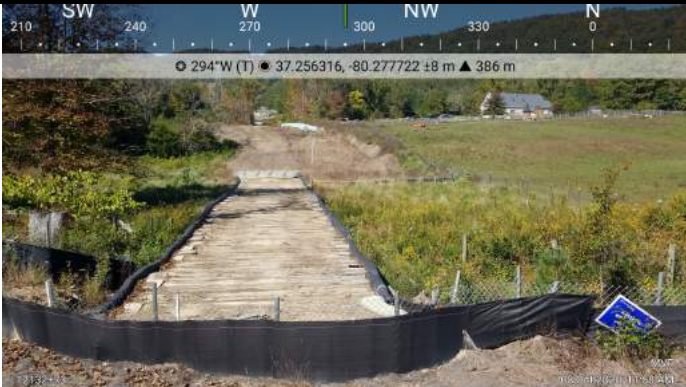
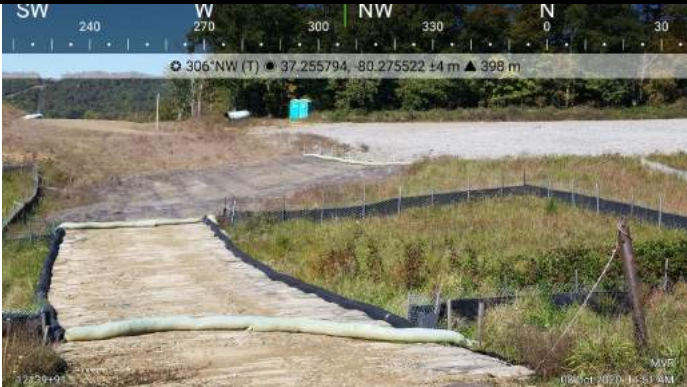
GPS Location	See Above	GPS Location	See Above		
Field Station#	12132+73	Field Station#	12139+91		
Pic 3 Desc.	Overview of Waterbody S-C29. ECDs functional and in good condition.	Pic 4 Desc.	Overview of Wetland W-C6. ECDs functional and in good condition.

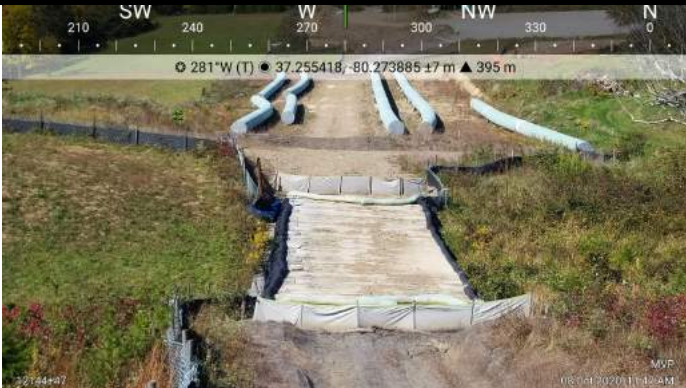
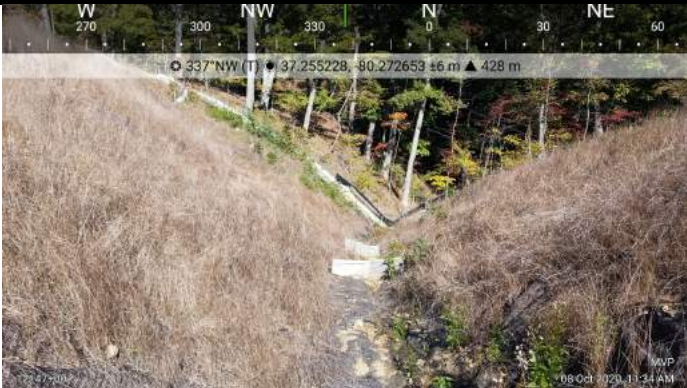
GPS Location	See Above	GPS Location	See Above		
Field Station#	12144+47	Field Station#	12147+00		
Pic 5 Desc.	Overview of Wetland W-C5. ECDs functional and in good condition.	Pic 6 Desc.	ROW Overview. Temporary and Permanent Restoration. ECDs functional and in good condition.

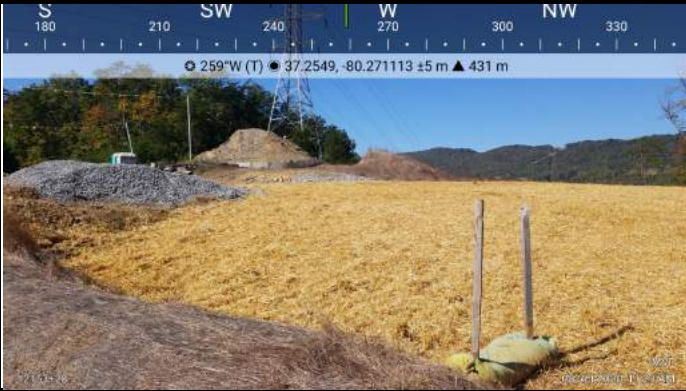
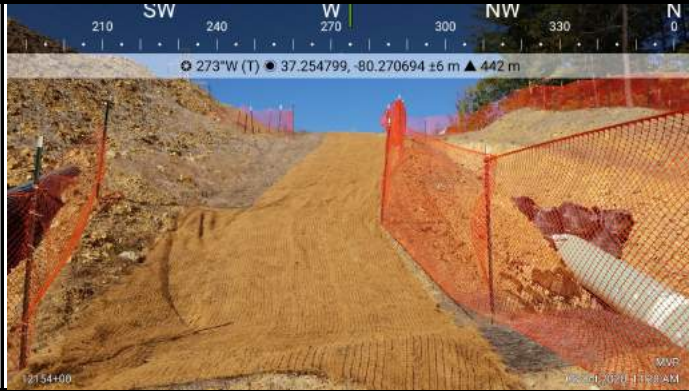
GPS Location	See Above		GPS Location	See Above	
Field Station#	12153+28		Field Station#	12154+00	
Pic 7 Desc.	ROW Overview. Temporary Restoration. ECDs functional and in good condition.		Pic 8 Desc.	ROW Overview. Temporary Restoration. ECDs functional and in good condition.

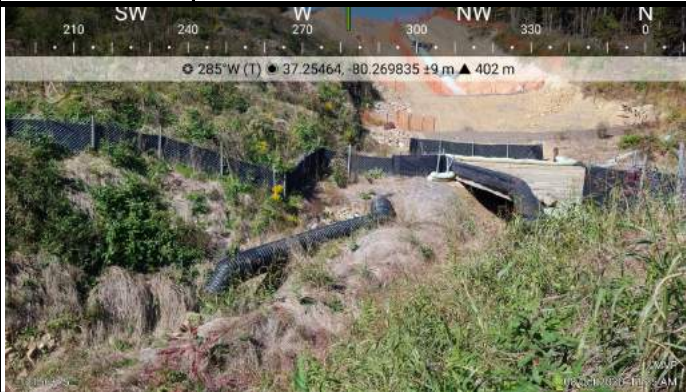
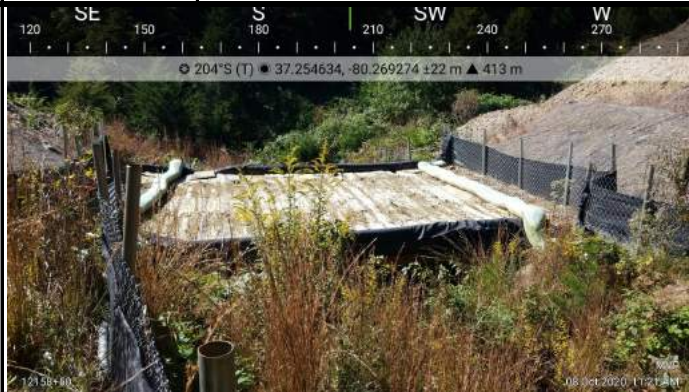
GPS Location	See Above		GPS Location	See Above	
Field Station#	12156+75		Field Station#	12158+50	
Pic 9 Desc.	Overview of Head Water Area of Waterbody S-C23. ECDs functional and in good condition.		Pic 10 Desc.	Overview of Head Water Area of Waterbody S-C23. ECDs functional and in good condition.

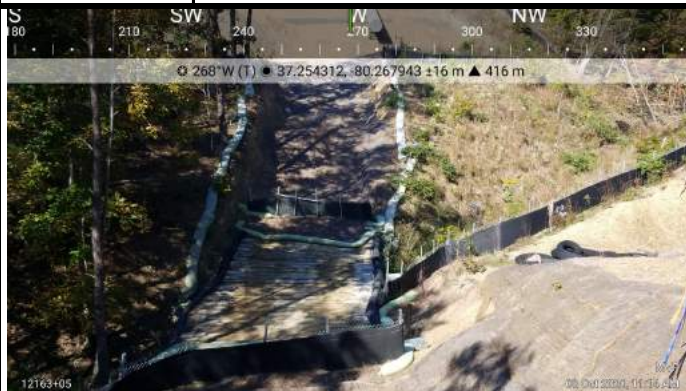
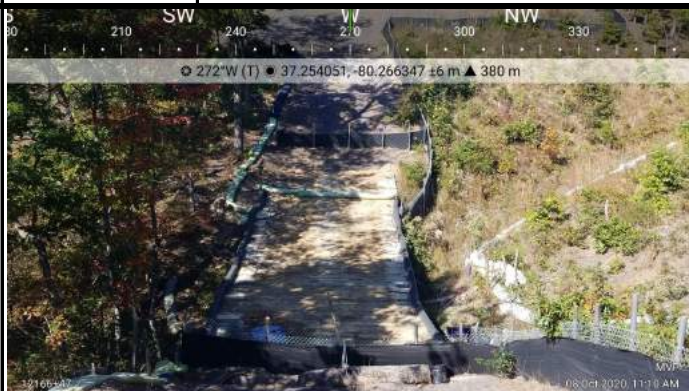
GPS Location	See Above		GPS Location	See Above	
Field Station#	12163+05		Field Station#	12166+47	
Pic 11 Desc.	Overview of Waterbody S-C25. ECDs functional and in good condition.		Pic 12 Desc.	Overview of Waterbody S-C24. ECDs functional and in good condition.

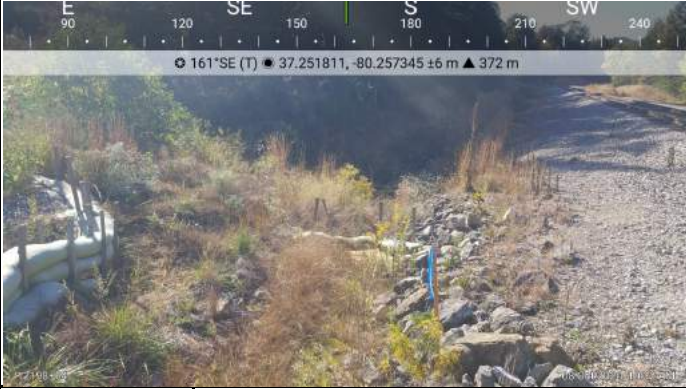
GPS Location	See Above		GPS Location	See Above	
Field Station#	12198+64		Field Station#	12212+00	
Pic 15 Desc.	ECDs near stream S-0011 are functional and in good condition. CFS is trapping sediment from off ROW before it enters creek.		Pic 16 Desc.	ROW Overview. Temporary and Permanent Restoration. ECDs functional and in good condition.
