# Visual Site Inspection Report

<b>Project Name</b>	H-600 Pipeline Spread I	<b>AFE</b>	124300139	<b>Spread</b>	H-600 Pipeline Spread I
<b>Contractor</b>	Precision			<b>Report #</b>	15747
<b>Inspector</b>	Justin Burch			<b>Date/Time</b>	10/19/2020 12:48 PM
<b>Permit #</b>	TBD	<b>Inspection Type</b>	VA SWPP	<b>Station Begin</b>	14802+19
<b>State</b>	VA	<b>Inspection Area</b>	Full	<b>Station End</b>	14928+52
<b>County</b>	Franklin	<b>Ground</b>	Damp	<b>Temperature (°F)</b>	70.00
<b>Municipality</b>	N/A	<b>Weather</b>	Sunny	<b>Rain Gauge (in)</b>	0.00
				<b>Rain Accumulation Time (days)</b>	6.00

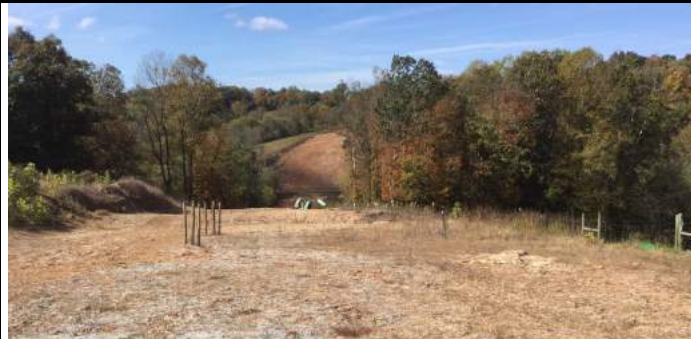
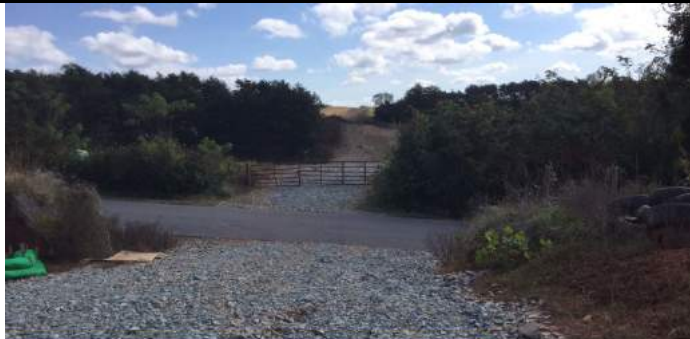
36°55'46" N 79°31'28" W 245°SW COURSE -1° GPS 1624 Lark Dr, Chatham, VA 24531, United States 10.19.2020 12:51:24 Accur +/-16.4 Ft ALT 719 Ft			36°55'46" N 79°31'24" W 195°S COURSE 206° GPS 1624 Lark Dr, Chatham, VA 24531, United States 10.19.2020 12:53:04 Accur +/-16.4 Ft ALT 736 Ft		
GPS Location	1	GPS Location	2		
Field Station#	15318+00	Field Station#	15323+24		
Pic 1 Desc.	ROW stabilized in temporary section CIS Lark Dr but limited vegetative growth observed.		Pic 2 Desc.	RCE at Lark Dr in good condition at the time of inspection.

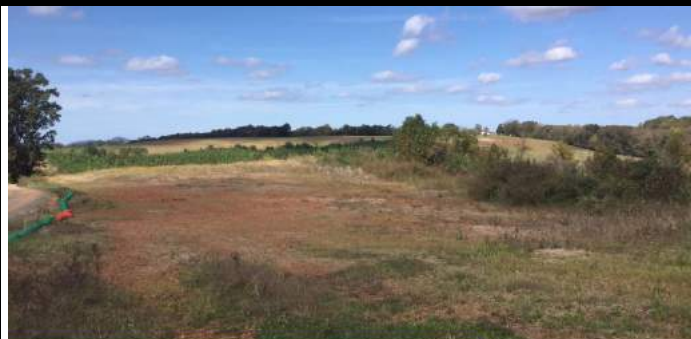
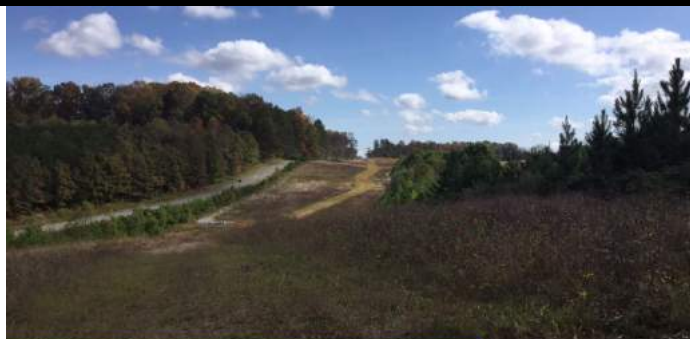
GPS Location	3	GPS Location	4		
Field Station#	15354+00	Field Station#	15358+00		
Pic 3 Desc.	Permanent section of ROW stabilized. Perimeter CFS in place and functional.		Pic 4 Desc.	Permanent section of ROW stabilized. Perimeter CFS and end treatments in place and functional.

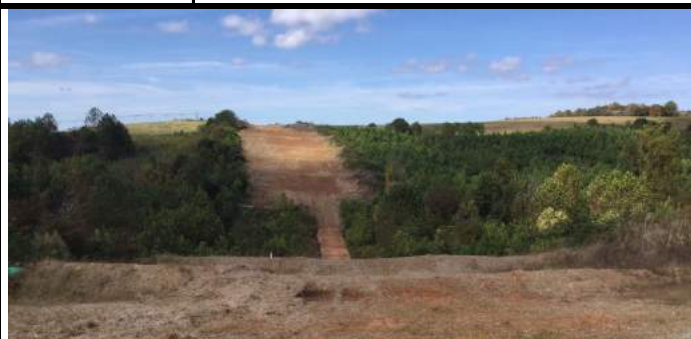
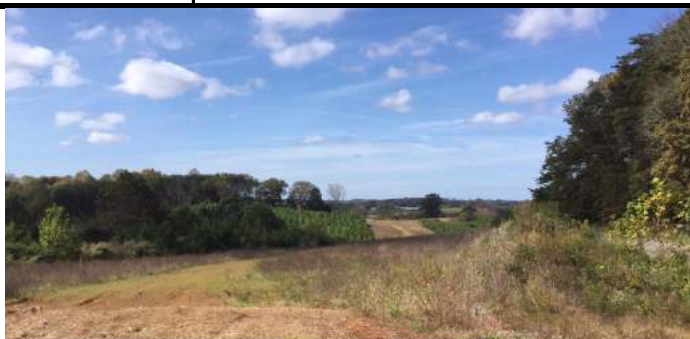
36°55'28" N 79°30'58" W 359°N COURSE 8° GPS Chatham, VA 24531, United States 10.19.2020 12:58:29 Accur +/-16.4 Ft ALT 741 Ft			36°55'20" N 79°30'39" W 297°NW COURSE 354° GPS Chatham, VA 24531, United States 10.19.2020 12:59:58 Accur +/-16.4 Ft ALT 736 Ft		
GPS Location	5	GPS Location	6		
Field Station#	15349+00	Field Station#	15368+00		
Pic 5 Desc.	ROW stabilized in temporary section CIS Lark Dr but limited vegetative growth observed.		Pic 6 Desc.	Permanent section of ROW stabilized. Water bars performing intended function.

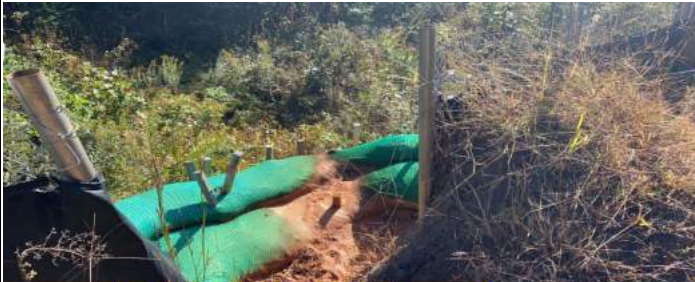
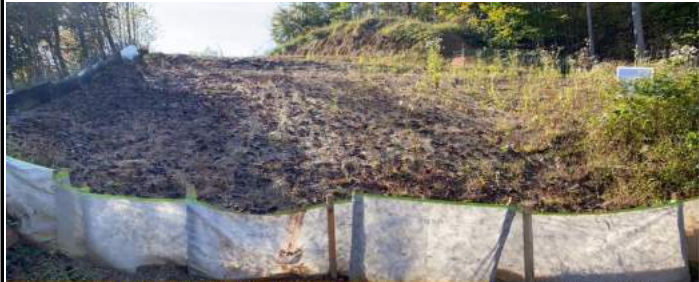
37°12'8" N 79°45'56" W 152°SE COURSE -1° GPS Glade Hill, VA 24092, United States 10.19.2020 10:02:40 Accur +/-15.3 Ft ALT 1036 Ft			37°11'10" N 79°45'42" W 178°S COURSE 216° GPS Glade Hill, VA 24092, United States 10.19.2020 10:31:01 Accur +/-39.6 Ft ALT 905 Ft		
<b>GPS Location</b>	1		<b>GPS Location</b>	2	
<b>Field Station#</b>	14459+00		<b>Field Station#</b>	14486+75	
<b>Pic 1 Desc.</b>	Routine maintenance. CFS triple stack not filtering and overtopping with sediment. Needs repaired.		<b>Pic 2 Desc.</b>	Ineffective ESC measure. Base of P1 silt fence GAS S-G22 travel lane has holes in fabric. Fence needs replaced.

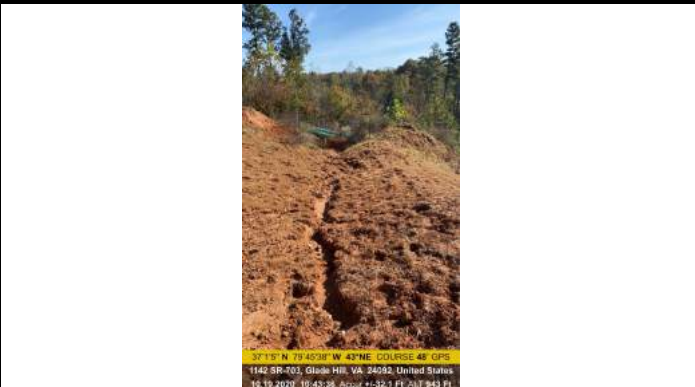
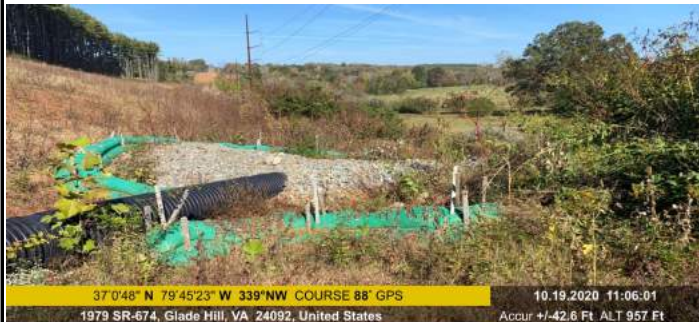
<b>GPS Location</b>	3		<b>GPS Location</b>	4	
<b>Field Station#</b>	14493+00		<b>Field Station#</b>	14514+00	
<b>Pic 3 Desc.</b>	Routine maintenance. Erosion channel forming in throat of water bar. Repair and stabilize.		<b>Pic 4 Desc.</b>	Routine maintenance. CFS triple stack fabric is torn/disintegrating around drain tile outlet. Triple stack will need replaced.

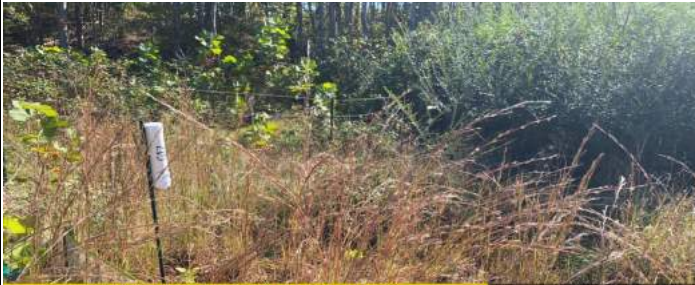
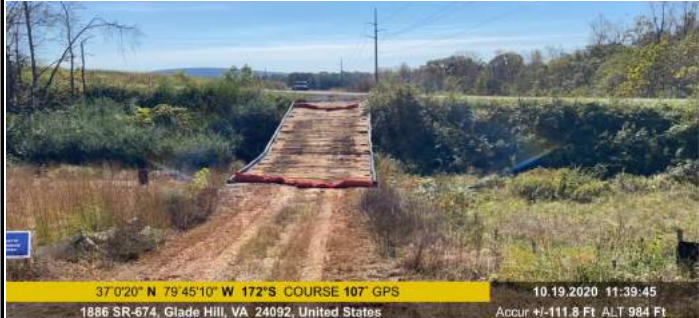
37°0'20" N 79°45'9" W 185°S COURSE 316° GPS Sorry no results found 10.19.2020 11:41:21 Accur +/-191.6 Ft ALT 944 Ft			37°0'20" N 79°45'10" W 172°S COURSE 107° GPS 1886 SR-674, Glade Hill, VA 24092, United States 10.19.2020 11:39:45 Accur +/-111.8 Ft ALT 984 Ft		
<b>GPS Location</b>	5		<b>GPS Location</b>	6	
<b>Field Station#</b>	14546+33		<b>Field Station#</b>	14546+33	
<b>Pic 5 Desc.</b>	Mailboxes installed at stream locations where unable to locate.		<b>Pic 6 Desc.</b>	Bridge crossing and surrounding ECD's in place and functional at the time of inspection.

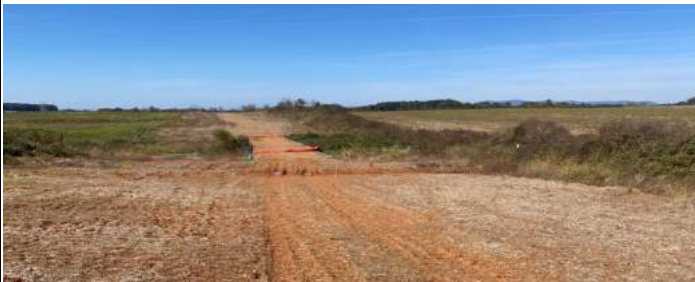
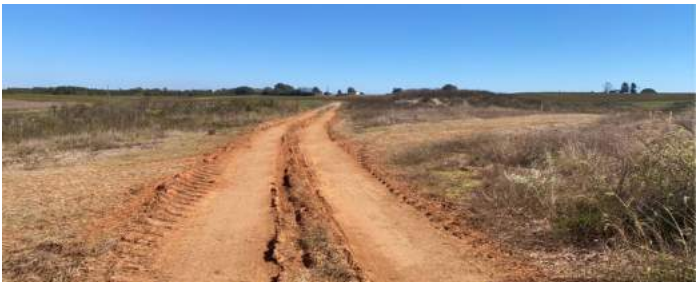
36°54'38" N 79°28'41" W 314°NW COURSE 293' GPS 1535-2357 Tashes Rd, Chatham, VA 24531, United States 10.20.2020 12:56:52 Accur +/-34.1 Ft ALT 901 Ft			36°54'41" N 79°28'51" W 87°E COURSE 307' GPS 1535-2357 Tashes Rd, Chatham, VA 24531, United States 10.20.2020 13:00:12 Accur +/-124.4 Ft ALT 898 Ft		
GPS Location	1		GPS Location	2	
Field Station#	15476+00		Field Station#	15469+74	
Pic 1 Desc.	Equipment bridge and surrounding ECD's in place and functional over natural drainage area.		Pic 2 Desc.	Landowner has been using private access road to cross ROW. Area is well worn and no vegetation growing. No issues identified.

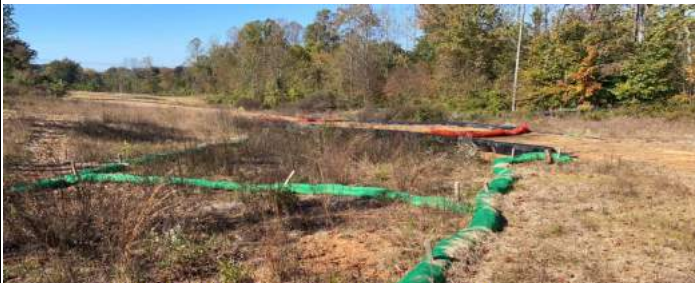
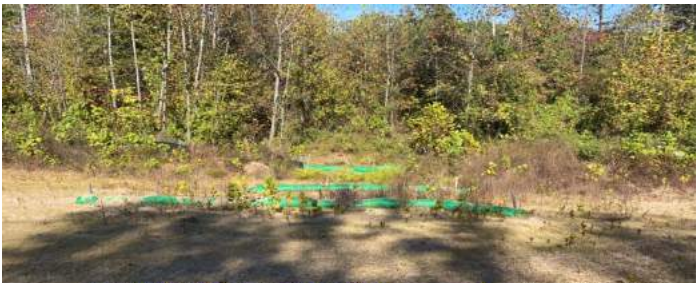
GPS Location	3		GPS Location	4	
Field Station#	15457+00		Field Station#	15452+00	
Pic 3 Desc.	Perimeter CFS around natural drainage area in place and functional.		Pic 4 Desc.	CFS check dams performing intended function.

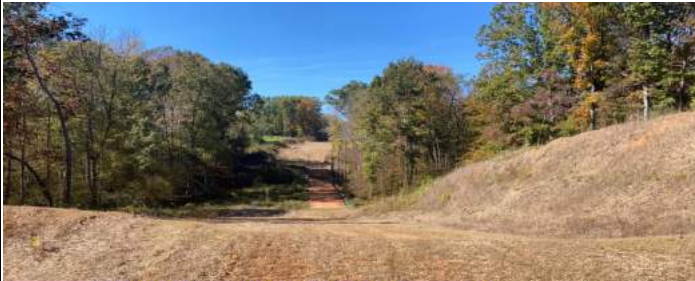
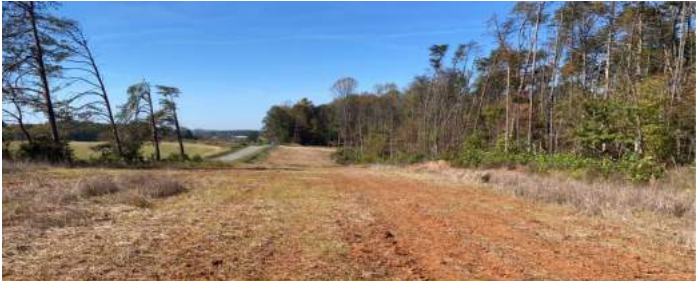
36°54'58" N 79°29'29" W 291°W COURSE 293' GPS Chatham, VA 24531, United States 10.20.2020 13:16:07 Accur +/-37.4 Ft ALT 802 Ft			36°55'17" N 79°30'30" W 300°NW COURSE 311' GPS 2736-2798 Snowberry Rd, Chatham, VA 24531, United States 10.20.2020 13:35:05 Accur +/-15.4 Ft ALT 804 Ft		
GPS Location	5		GPS Location	6	
Field Station#	15429+00		Field Station#	15376+00	
Pic 5 Desc.	ROW in stable condition upon inspection. ECD's in place and functional. No environmental issues observed.		Pic 6 Desc.	ROW in stable condition upon inspection. ECD's in place and functional. No environmental issues observed.

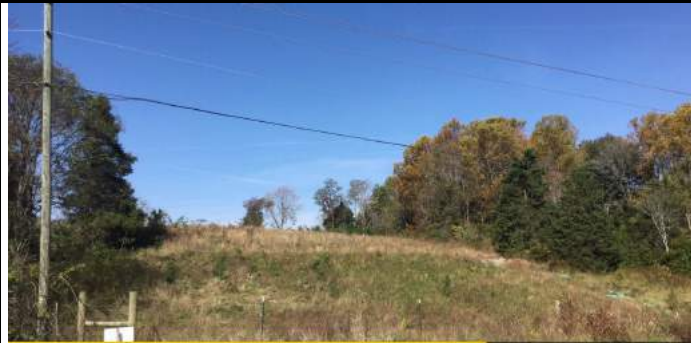
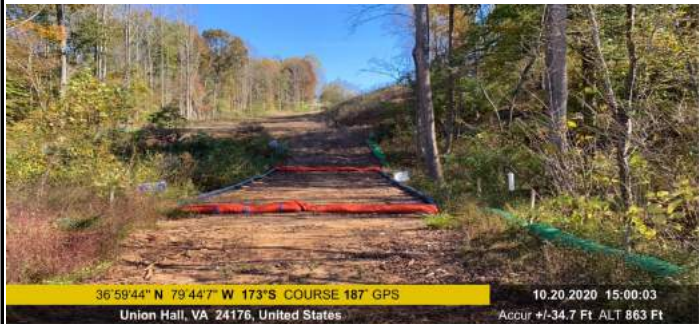
36°59'25" N 79°43'27" W 295°NW COURSE 326° GPS 10.20.2020 11:46:55 9400-9598 Old Franklin Tpke, Union Hall, VA 24176, United States Accur +/-16.4 Ft ALT 978 Ft			36°59'44" N 79°44'7" W 173°S COURSE 187° GPS 10.20.2020 15:00:03 Union Hall, VA 24176, United States Accur +/-34.7 Ft ALT 863 Ft		
GPS Location	1		GPS Location	2	
Field Station#	14649+00		Field Station#	14641+17	
Pic 1 Desc.	Final cleanup area CIS Hwy 40 stable with uniform vegetative growth observed.		Pic 2 Desc.	Equipment bridge and surrounding ECD's in place and functional at S-E14

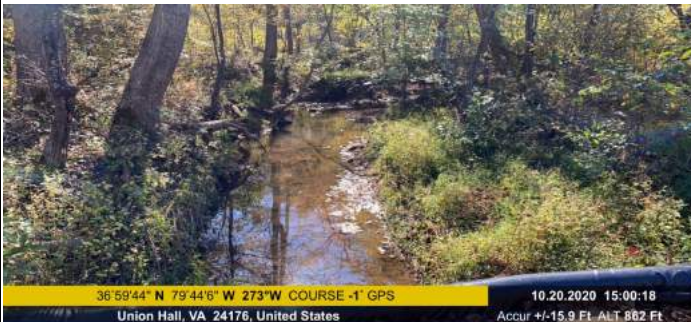
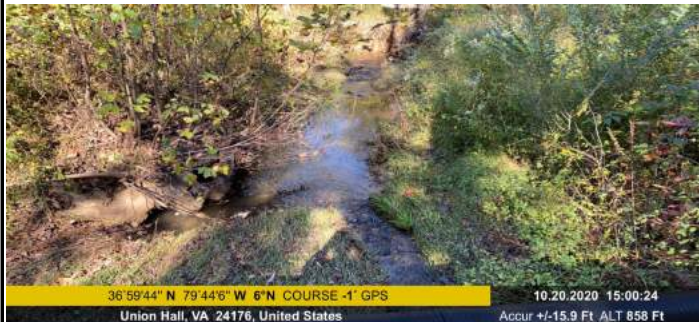
Field Station#	14641+17		Field Station#	14641+17	
Pic 3 Desc.	Upstream view of S-E14		Pic 4 Desc.	Downstream view of S-E14

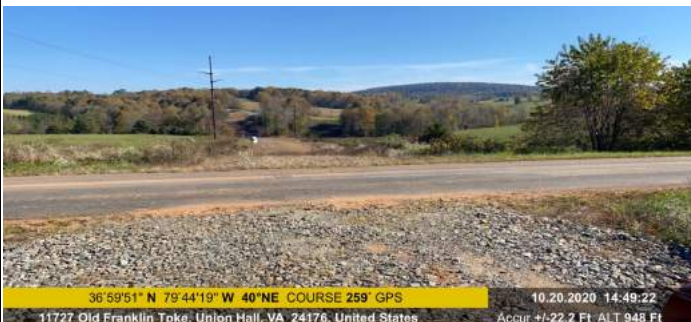
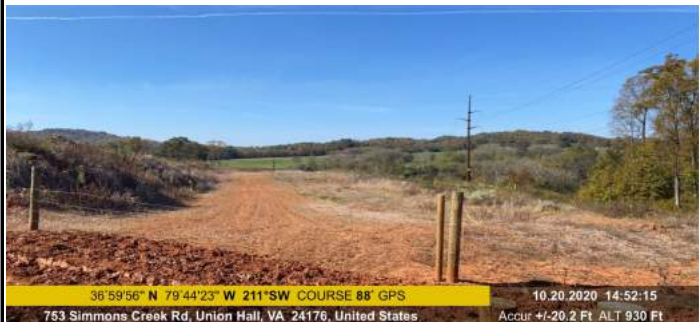
36°59'51" N 79°44'19" W 40°NE COURSE 259° GPS 10.20.2020 14:49:22 11727 Old Franklin Tpke, Union Hall, VA 24176, United States Accur +/-22.2 Ft ALT 948 Ft			36°59'56" N 79°44'23" W 211°SW COURSE 88° GPS 10.20.2020 14:52:15 753 Simmons Creek Rd, Union Hall, VA 24176, United States Accur +/-20.2 Ft ALT 930 Ft		
GPS Location	5		GPS Location	6	
Field Station#	14599+24		Field Station#	14594+00	
Pic 5 Desc.	RCE at Simmons Creek Rd in good condition at the time of inspection.		Pic 6 Desc.	ROW stable upon inspection. Noticeable cattle lane across ROW through fence gaps but no issues observed.

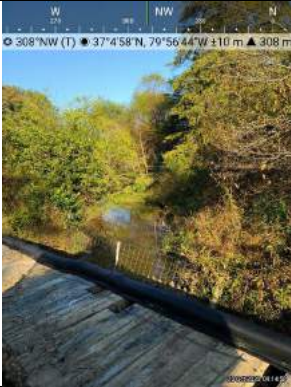
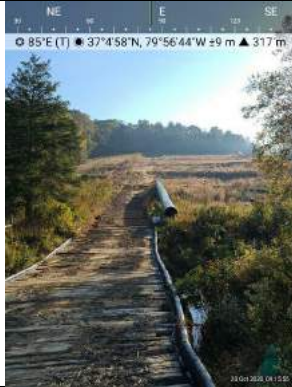
<b>GPS Location</b>	00000	<b>GPS Location</b>	00000		
<b>Field Station#</b>	13704+90	<b>Field Station#</b>	13704+90		
<b>Pic 1 Desc.</b>	Stream observation photo facing upstream, no environmental issue observed at the time of inspection		<b>Pic 2 Desc.</b>	Equipment bridge inspected and all ECDs functioning, photo shows CFS opened at the time of inspection as travel was being done at the time

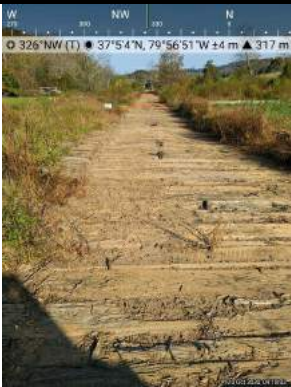
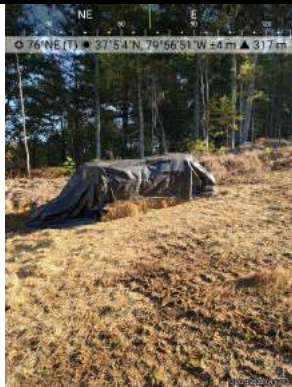
<b>GPS Location</b>	00000	<b>GPS Location</b>	00000		
<b>Field Station#</b>	13696+03	<b>Field Station#</b>	13707+58		
<b>Pic 3 Desc.</b>	The EI observed equipment mats across a wetland and all ECDs where in place and functioning. No environmental issues were observed at the time of inspection		<b>Pic 4 Desc.</b>	EI observed de-water structure built by the the contractor the structure was covered until needed to be used

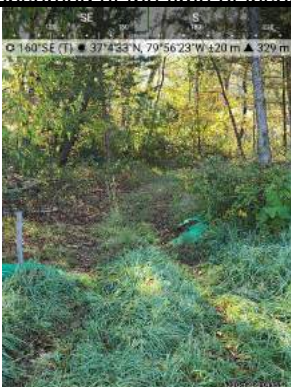
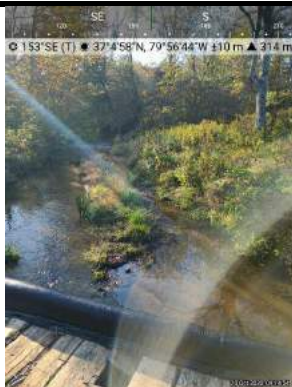
<b>GPS Location</b>	00000	<b>GPS Location</b>	00000		
<b>Field Station#</b>	13746+56	<b>Field Station#</b>	13704+90		
<b>Pic 5 Desc.</b>	EI observed area where a land owner continues to drive over CFS to access the row, recommended to installed orange CFS to allow access and not damage the creek. Will		<b>Pic 6 Desc.</b>	Stream observation photo facing downstream, no environmental issues observed at the time of inspection.

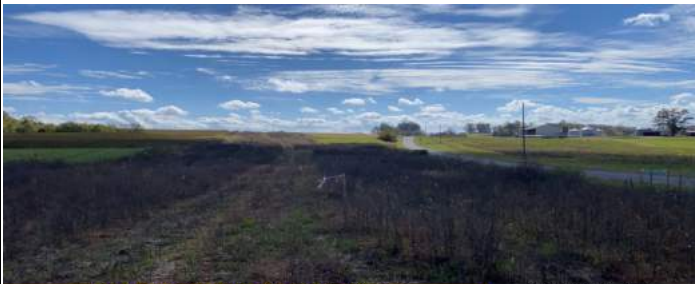
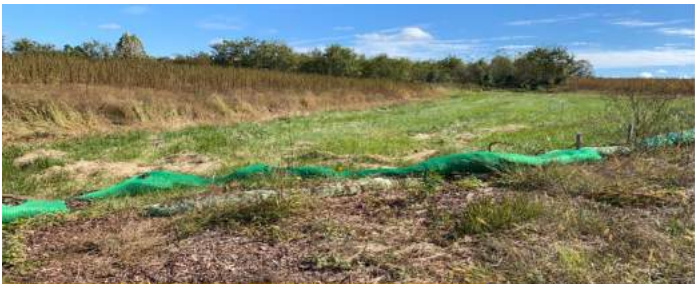
<small>36°54'37" N 79°26'37" W 193°S COURSE 263° GPS 1534-2356 Toshes Rd, Chatham, VA 24531, United States 10.21.2020 12:43:59 Accur +/-19.4 Ft ALT 904 Ft</small>			<small>36°54'31" N 79°28'33" W 96°E COURSE 16° GPS 5301-5699 Climax Rd, Chatham, VA 24531, United States 10.21.2020 12:40:42 Accur +/-71.0 Ft ALT 935 Ft</small>		
<b>GPS Location</b>	1	<b>GPS Location</b>	2		
<b>Field Station#</b>	15482+00	<b>Field Station#</b>	15490+00		
<b>Pic 1 Desc.</b>	Final cleanup area between Toshes-Climax Rd. Travel lane has been utilized.		<b>Pic 2 Desc.</b>	Perimeter CFS has been run over by farm equipment from landowner use. No environmental issues identified.

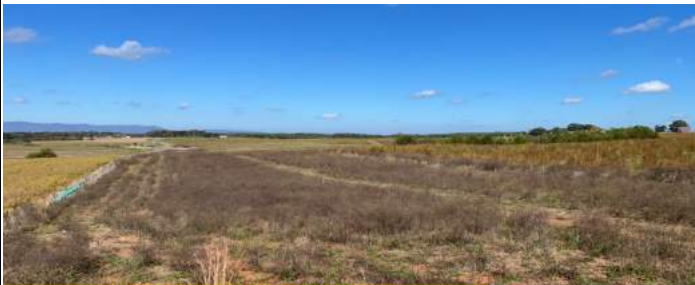
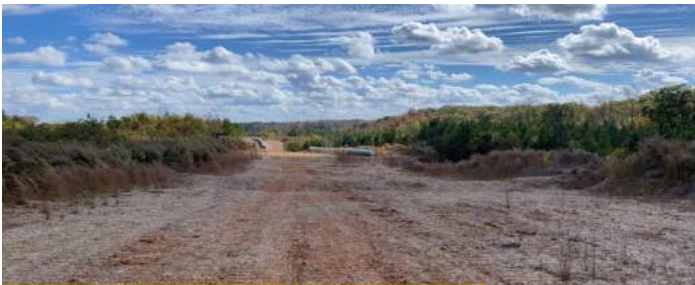
<b>GPS Location</b>	3	<b>GPS Location</b>	4		
<b>Field Station#</b>	15493+00	<b>Field Station#</b>	15517+00		
<b>Pic 3 Desc.</b>	Final cleanup area between Toshes-Climax Rd. Travel lane has been utilized.		<b>Pic 4 Desc.</b>	ROW stabilized and no erosion issues observed. Limited vegetative growth spotted during inspection.

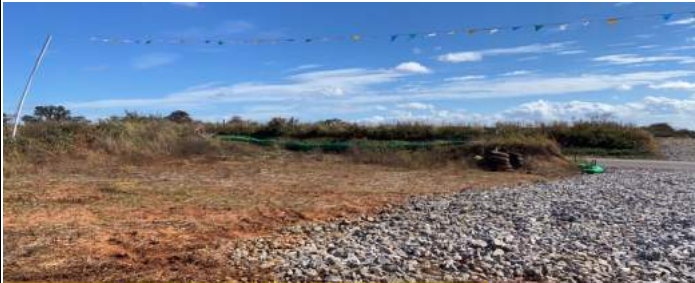
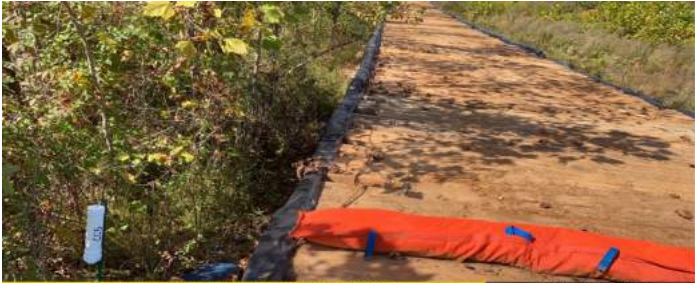
<small>36°54'24" N 79°28'30" W 90°E COURSE 309° GPS 5301-5699 Climax Rd, Chatham, VA 24531, United States 10.21.2020 12:36:28 Accur +/-53.6 Ft ALT 910 Ft</small>			<small>36°53'57" N 79°27'43" W 1°N COURSE 188° GPS 5300-5698 Climax Rd, Chatham, VA 24531, United States 10.21.2020 13:16:16 Accur +/-33.6 Ft ALT 786 Ft</small>		
<b>GPS Location</b>	5	<b>GPS Location</b>	6		
<b>Field Station#</b>	15496+50	<b>Field Station#</b>	15542+32		
<b>Pic 5 Desc.</b>	RCE at Climax Rd in good condition. Extra workspace is stabilized with no issues observed at the time of inspection.		<b>Pic 6 Desc.</b>	Missing mailbox installed at S-CC5

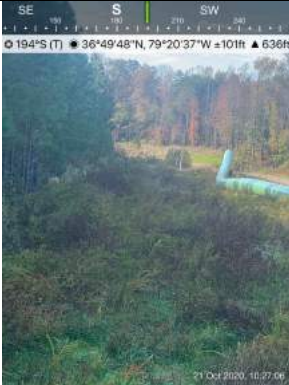
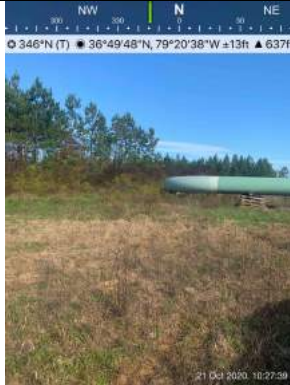
<b>GPS Location</b>	O	<b>GPS Location</b>	O		
<b>Field Station#</b>	10+00	<b>Field Station#</b>	7+00		
<b>Pic 1 Desc.</b>	Observing temporary vegetation.	<b>Pic 2 Desc.</b>	Observing temporary vegetation.

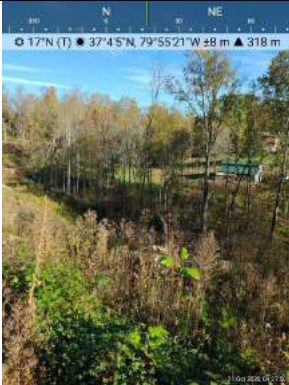
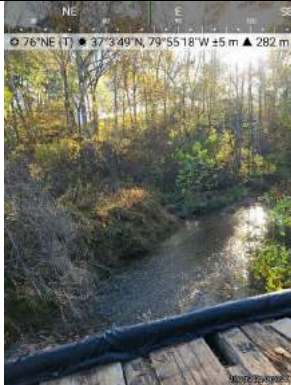
<b>GPS Location</b>	00000	<b>GPS Location</b>	00000		
<b>Field Station#</b>	13822+00	<b>Field Station#</b>	13834+04		
<b>Pic 1 Desc.</b>	Vegetation photo showing good coverage with ECDs in place and functioning on hill side		<b>Pic 2 Desc.</b>	Stream observation photo facing upstream during routine row inspection. No environmental issues were observed at the time of inspection

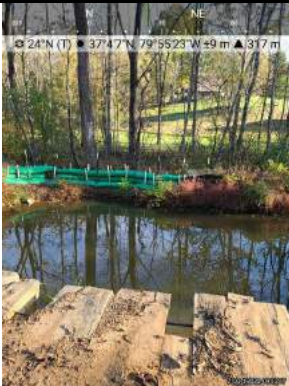
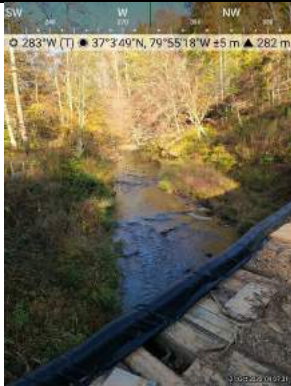
<b>GPS Location</b>	00000	<b>GPS Location</b>	00000		
<b>Field Station#</b>	13813+07	<b>Field Station#</b>	13834+04		
<b>Pic 5 Desc.</b>	Ecds in place at plunge pool location , no environmental issues were observed at the time of inspection.		<b>Pic 6 Desc.</b>	Stream observation photo facing downstream during routine inspection, no environmental issues were observed at the time inspection.

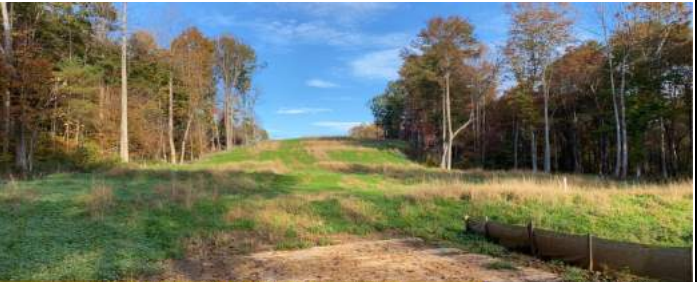
36°59'24" N 79°43'24" W 160°S COURSE 179° GPS 9400-9598 Old Franklin Tpke, Union Hall, VA 24176, United States 10.21.2020 09:02:09 Accur +/-47.7 Ft ALT 977 Ft			36°59'21" N 79°43'21" W 352°N COURSE 222° GPS 9400-9598 Old Franklin Tpke, Union Hall, VA 24176, United States 10.21.2020 09:08:01 Accur +/-192.8 Ft ALT 942 Ft		
GPS Location	1		GPS Location	2	
Field Station#	14651+00		Field Station#	14655+00	
Pic 1 Desc.	Final cleanup area GAS Hwy 40. Good vegetative growth observed. No issues identified at the time of inspection.		Pic 2 Desc.	Final cleanup area GAS Hwy 40. Good vegetative growth observed. No issues identified at the time of inspection.

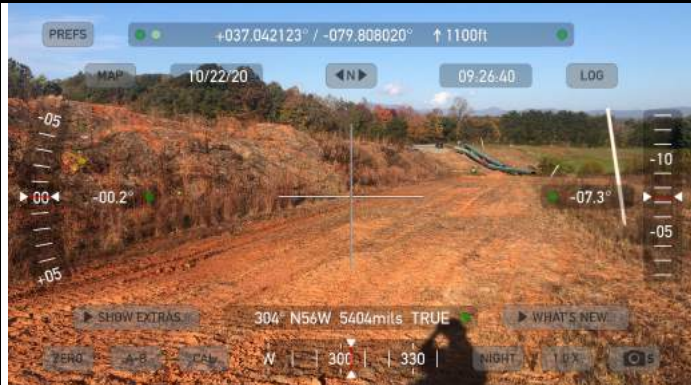
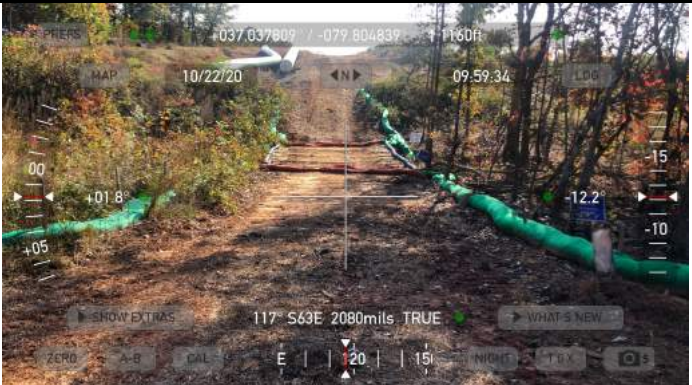
GPS Location	0	GPS Location	0		
Field Station#	14325+50	Field Station#	14338+56		
Pic 1 Desc.	GAS Farm View Rd ROW temporary stabilization very limited vegetative growth observed during this inspection		Pic 2 Desc.	GAS Golden View Rd stream crossing A-36 all EDC's are functioning properly at the time of inspection

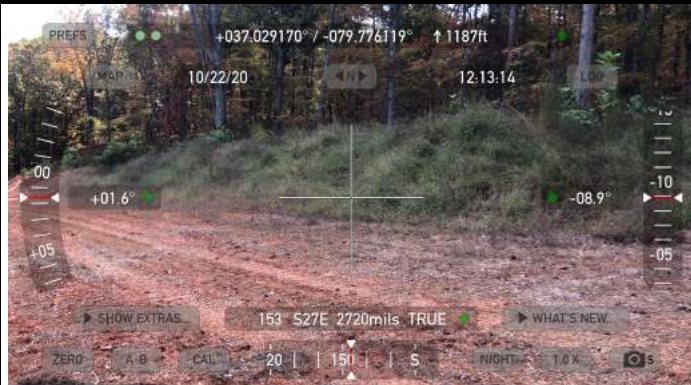
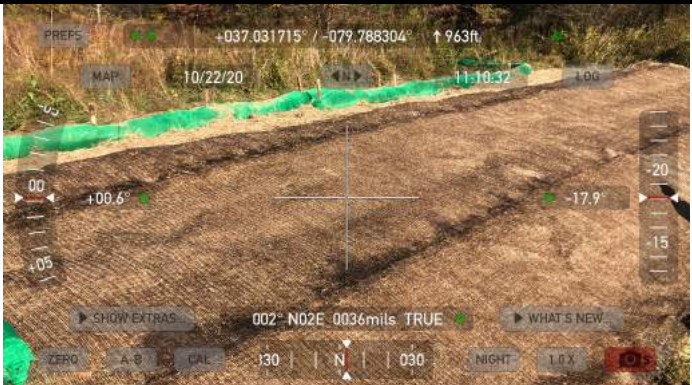
GPS Location	0	GPS Location	0		
Field Station#	14395+75	Field Station#	14391+59		
Pic 3 Desc.	Spoil pile stabilized with no issues observed during inspection		Pic 4 Desc.	Erosion Control Blanket installed on bank of stream A-41 to Prevent bank from sloughing off

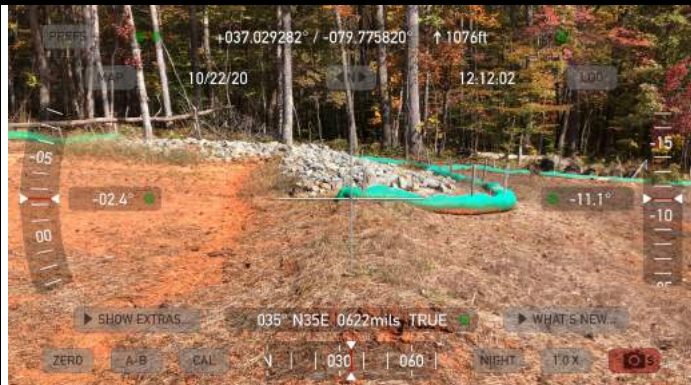
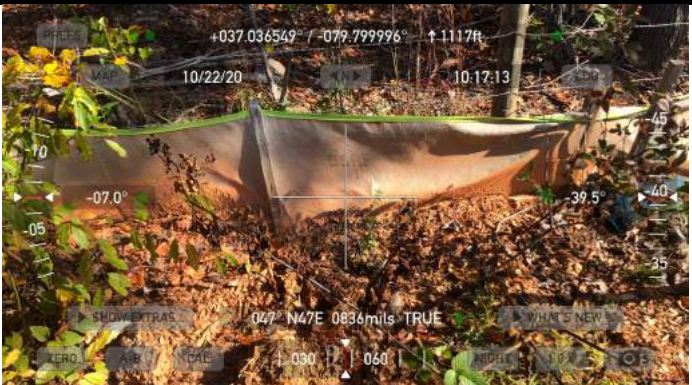
GPS Location	0	GPS Location	0		
Field Station#	14430+00	Field Station#	14345+50		
Pic 5 Desc.	Permanent water bar has a RipRap outlet installed functioning properly		Pic 6 Desc.	P1 silt fence is at least at 50% full also findings of rips & deterioration during this inspection

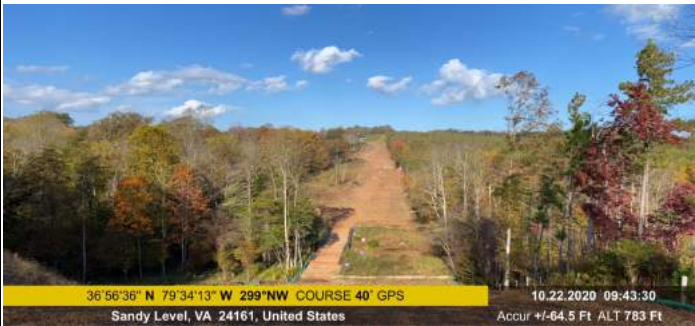
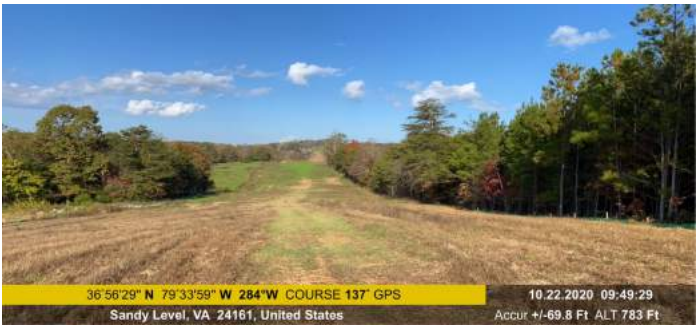
GPS Location	1	GPS Location	2		
Field Station#	15173+00	Field Station#	15185+00		
Pic 1 Desc.	Temporary vegetation growing in places along ROW. ROW stable. No issues observed.		Pic 2 Desc.	Final cleanup area. Use of travel lane observed. Vegetation growing evenly along ROW. No issues observed.

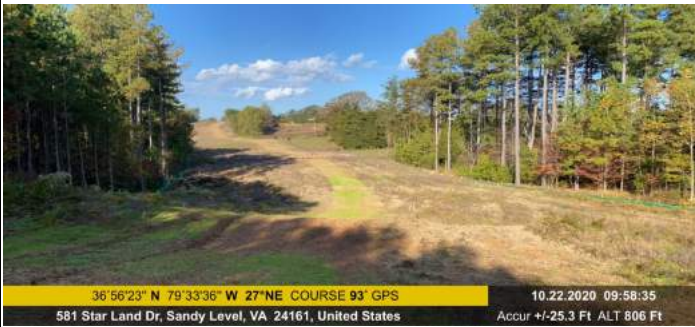
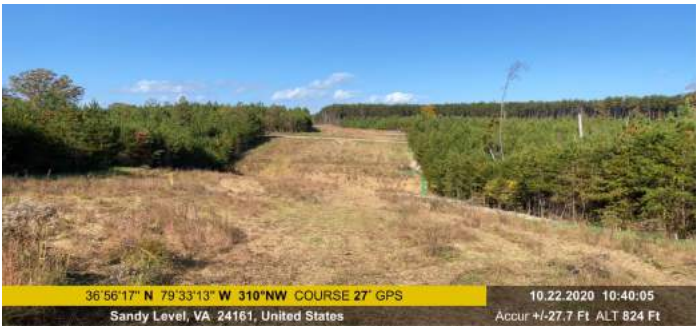
GPS Location	3	GPS Location	4		
Field Station#	15202+00	Field Station#	15226+00		
Pic 3 Desc.	Final cleanup area. Use of travel lane observed. Vegetation growing evenly along ROW. No issues observed.		Pic 4 Desc.	Final cleanup area. Use of travel lane observed. Vegetation growing evenly along ROW. No issues observed.

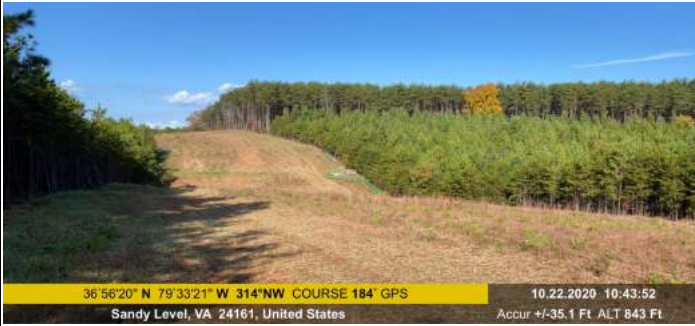
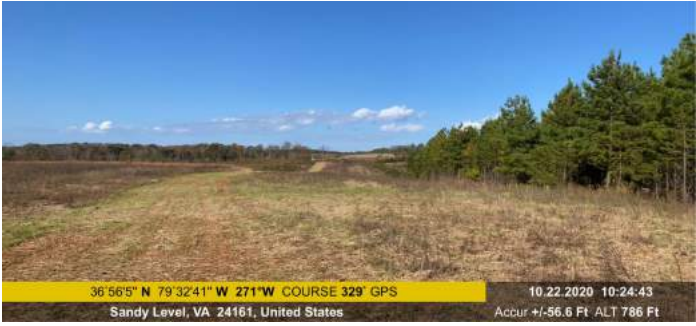
GPS Location	5	GPS Location	6		
Field Station#	15214+00	Field Station#	15254+00		
Pic 5 Desc.	Final cleanup area. Use of travel lane observed. Vegetation growing evenly along ROW. No issues observed.		Pic 6 Desc.	Final cleanup area. Use of travel lane observed. Vegetation growing evenly along ROW. No issues observed.

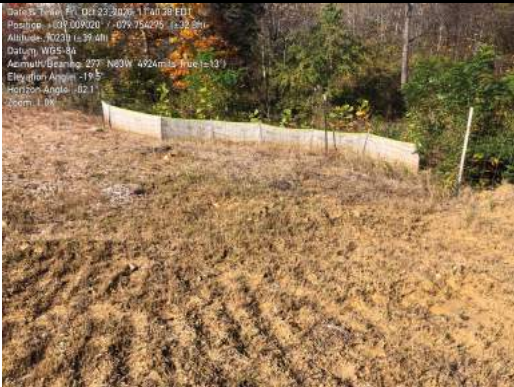
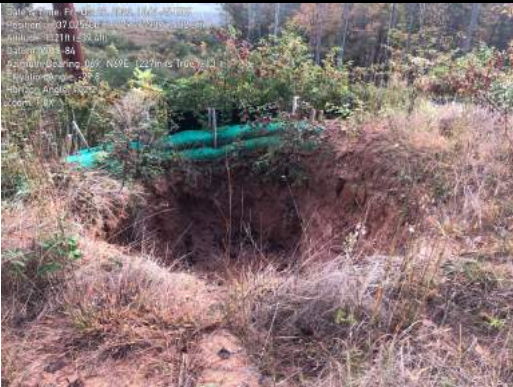
<b>GPS Location</b>	0	<b>GPS Location</b>	0		
<b>Field Station#</b>	14480+50	<b>Field Station#</b>	14464+21		
<b>Pic 1 Desc.</b>	P1 silt fence in acceptable condition	<b>Pic 2 Desc.</b>	Sump functioning properly

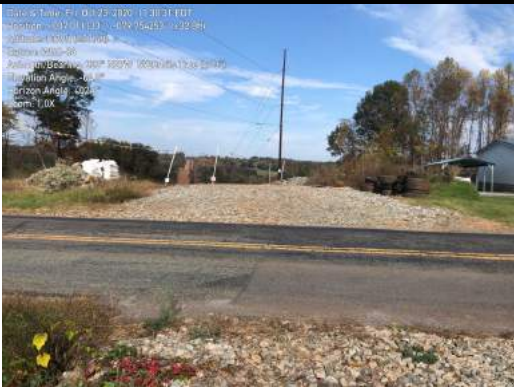
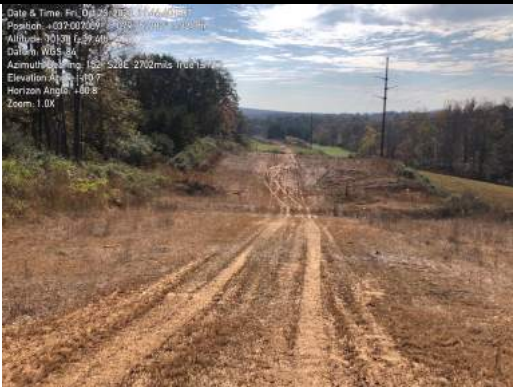
<b>GPS Location</b>	0	<b>GPS Location</b>	0		
<b>Field Station#</b>	14524+75	<b>Field Station#</b>	14540+50		
<b>Pic 3 Desc.</b>	RCE in acceptable condition GAS Timber Ridge Rd	<b>Pic 4 Desc.</b>	ROW has been temporarily stabilized

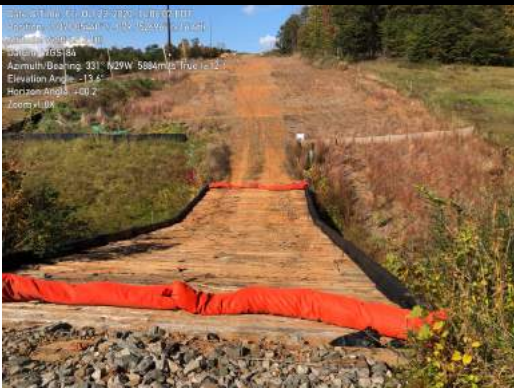
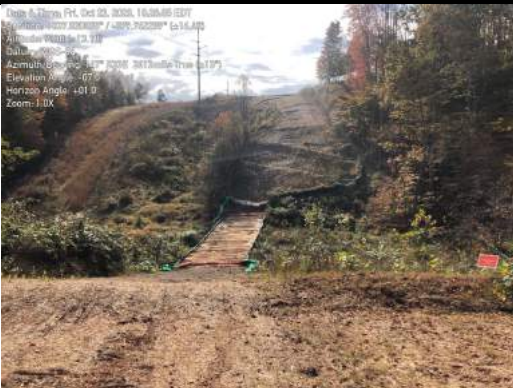
<b>GPS Location</b>	0	<b>GPS Location</b>	0		
<b>Field Station#</b>	14546+75	<b>Field Station#</b>	14475+00		
<b>Pic 5 Desc.</b>	CIS Tobacco Rd mat bridge in acceptable condition EDC's functioning properly	<b>Pic 6 Desc.</b>	Stream G22 temporary stabilization very little vegetative growth in this area

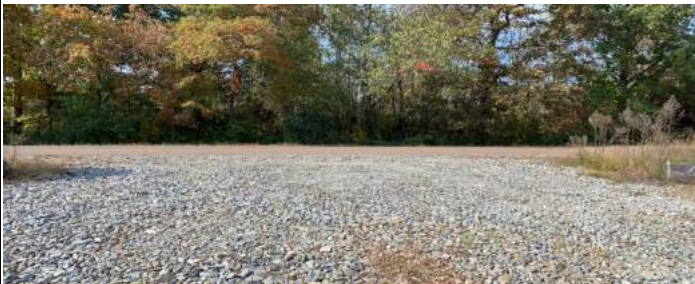
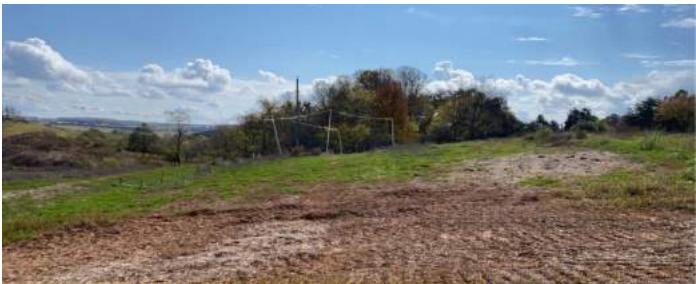
36°55'56" N 79°31'52" W 239°SW COURSE 40° GPS 2737-2799 Snowberry Rd, Chatham, VA 24531, United States 10.23.2020 12:38:10 Accur +/-65.0 Ft ALT 738 Ft			36°55'56" N 79°31'51" W 138°SE COURSE 30° GPS 2737-2799 Snowberry Rd, Chatham, VA 24531, United States 10.23.2020 12:38:27 Accur +/-18.3 Ft ALT 771 Ft		
GPS Location	1	GPS Location	2		
Field Station#	15296+00	Field Station#	15298+00		
Pic 1 Desc.	RCE at Oxford Rd in good condition		Pic 2 Desc.	Extra workspace at HDD entry site stabilized. CFS check dams in throats of water bars performing intended functions.

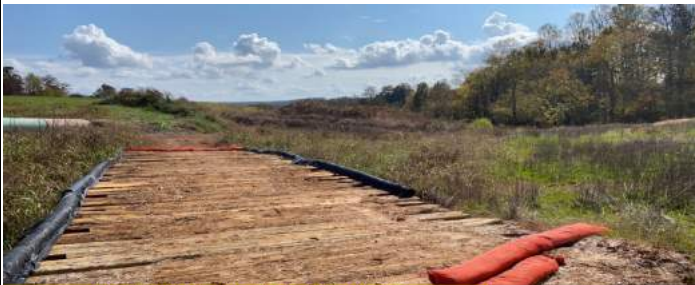
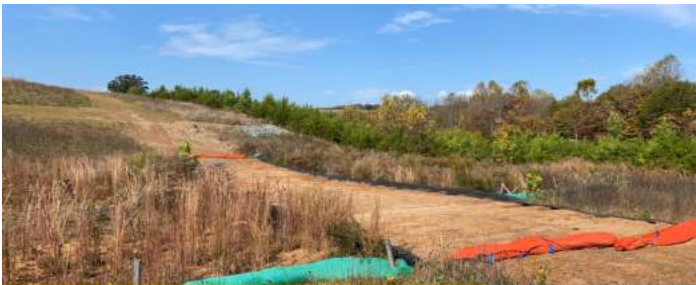
GPS Location	3	GPS Location	4		
Field Station#	15300+00	Field Station#	15360+00		
Pic 3 Desc.	Equipment bridge and surrounding ECD's at CWD in place and functional. No issues observed at the time of inspection.		Pic 4 Desc.	Equipment bridge and surrounding ECD's at CWD in place and functional. No issues observed at the time of inspection.

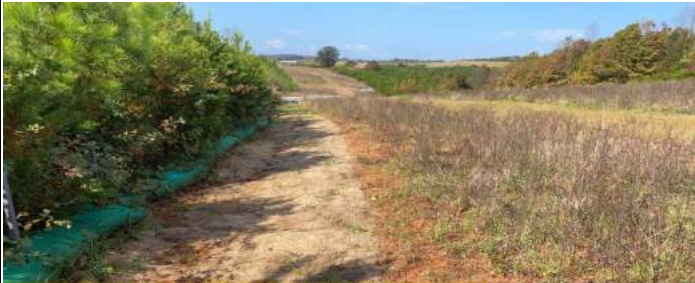
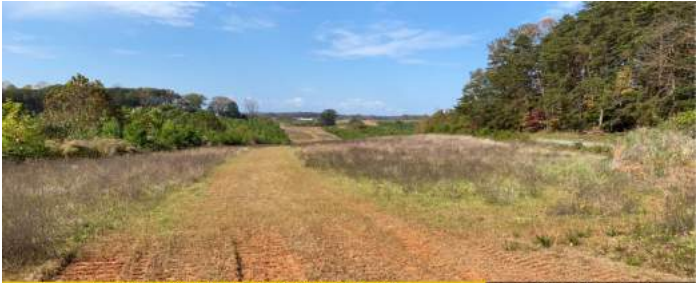
36°55'20" N 79°30'43" W 332°NW COURSE 359° GPS 2737-2799 Snowberry Rd, Chatham, VA 24531, United States 10.23.2020 12:27:54 Accur +/-29.0 Ft ALT 770 Ft			36°55'20" N 79°30'39" W 313°NW COURSE 0° GPS 2737-2799 Snowberry Rd, Chatham, VA 24531, United States 10.23.2020 12:26:29 Accur +/-97.4 Ft ALT 0 Ft		
GPS Location	5	GPS Location	6		
Field Station#	15366+00	Field Station#	15368+50		
Pic 5 Desc.	Erosion control blanket running down perimeter of ROW inside perimeter CFS. Erosion channel still visible but not causing issues down ROW. Will continue to monitor		Pic 6 Desc.	View of temporary stabilization going into permanent vegetation area CIS Snowberry Rd. ROW is stabilized and no issues identified.

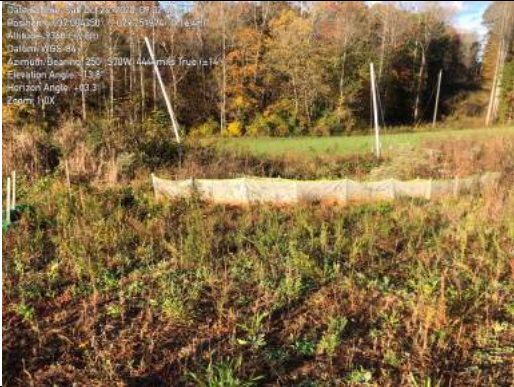
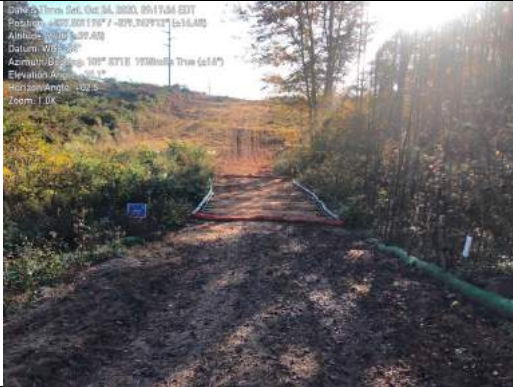
<b>GPS Location</b>	0	<b>GPS Location</b>	0		
<b>Field Station#</b>	14550+50	<b>Field Station#</b>	14610+17		
<b>Pic 1 Desc.</b>	P1 silt fence is acceptable	<b>Pic 2 Desc.</b>	S-E14 ECD's that are around stream crossing are acceptable and functioning properly
