# Visual Site Inspection Report

| <b>Project Name</b> | H-600 Pipeline Spread I | <b>AFE</b> | 124300139 | <b>Spread</b> | H-600 Pipeline Spread I |
| <b>Inspector</b> | John White | | | <b>Date/Time</b> | 10/26/2020 10:40 AM |

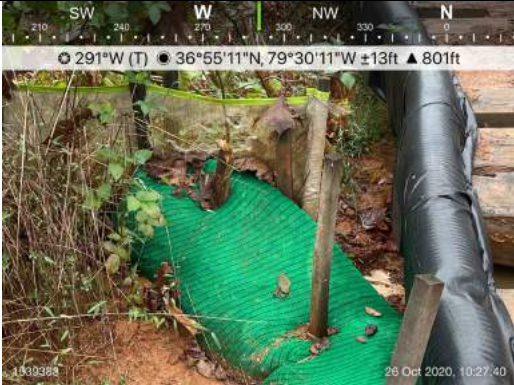
| <b>Pic 1 Desc.</b> | Hole in P1 next to equipment bridge. Panel of P1 needs to be replaced. | <b>Pic 2 Desc.</b> | Undermined CFS around water bar end treatment. | | |

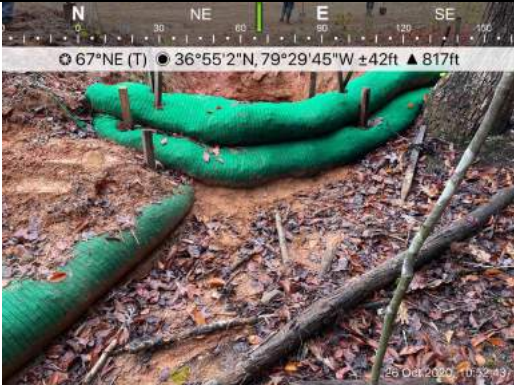
| <b>Pic 3 Desc.</b> | Undermined CFS immediately repaired by environmental crew upon discovery. | <b>Pic 4 Desc.</b> | Equipment bridges and controls at all stream crossings throughout this section are in good condition. | | |

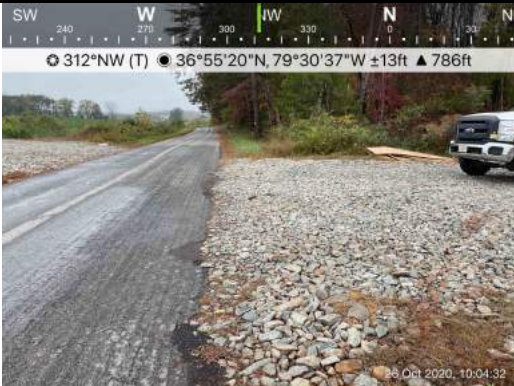
| <b>Pic 5 Desc.</b> | CE at Snowberry Road crossing in good condition. No tracking present. | <b>Pic 6 Desc.</b> | CWDs throughout this area are in good condition and functioning as intended. | | |

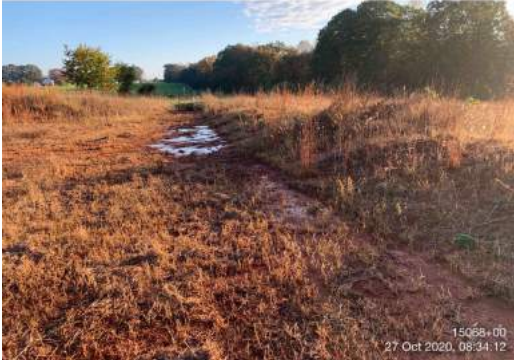
| <b>Pic 1 Desc.</b> | Temporary vegetative stabilization in acceptable condition | <b>Pic 2 Desc.</b> | Permanent vegetative stabilization in acceptable condition | | |

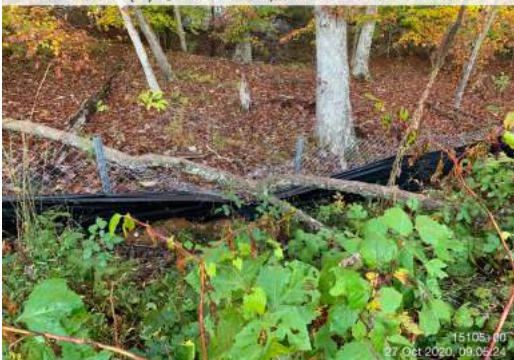
| <b>Pic 3 Desc.</b> | Super silt fence was damaged by a fallen tree | <b>Pic 4 Desc.</b> | Super silt fence in acceptable condition with tree removed and SSF repaired | | |

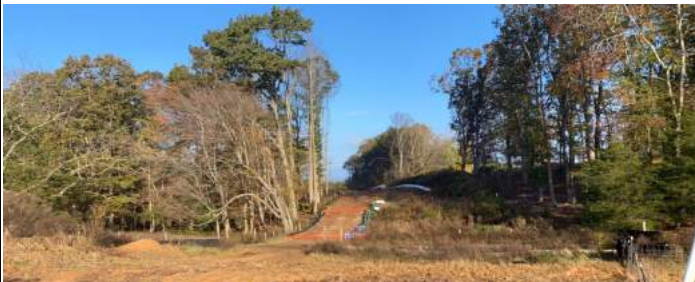
| Pic 1 Desc. | ROW stabilized in temporary area. Equipment bridge and surrounding ECD's in place and functional at stream crossing. | | Pic 2 Desc. | ROW stabilized in temporary area. Equipment bridge and surrounding ECD's in place and functional at stream crossing. | |

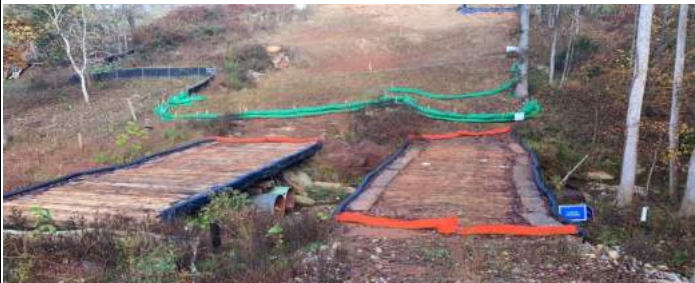
| Pic 3 Desc. | ROW stabilized in temporary area. Equipment bridge and surrounding ECD's in place and functional at stream crossing. | | Pic 4 Desc. | ROW stabilized in temporary area. Equipment bridge and surrounding ECD's in place and functional at stream crossing. | |

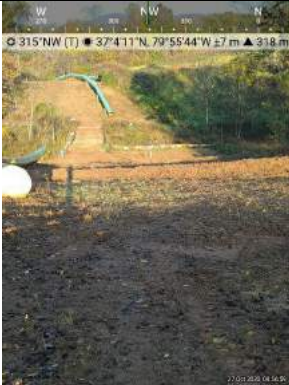
| <b>Pic 1 Desc.</b> | Row photo showing vegetation, ECDs in place at stream crossing , no environmental issue were observed by the EI. | | <b>Pic 2 Desc.</b> | Photo showing ECDs opened up on travel lane during work activities conducted by the contractor today. | |

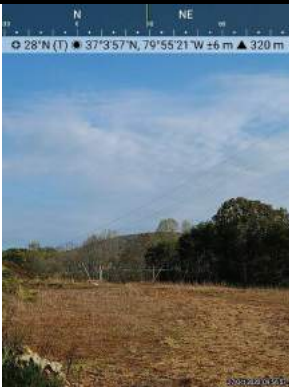
| <b>Pic 3 Desc.</b> | Row photo taken during routine inspection throughout | | <b>Pic 4 Desc.</b> | Stream observation photo facing downstream, no environmental issues observed at the time of inspection. | |

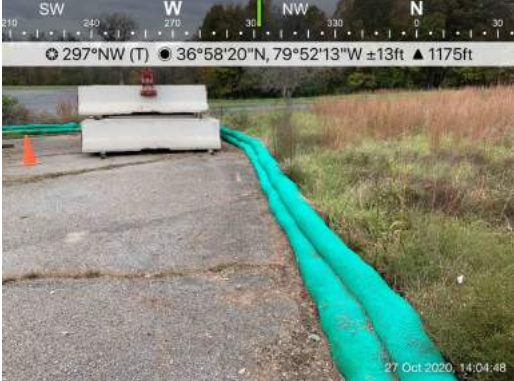
| <b>Pic 1 Desc.</b> | Perimeter ECD's on north end of paved yard in good condition | | <b>Pic 2 Desc.</b> | Inlet protection for parking lot drain on south end of paved yard needs maintenance. | |

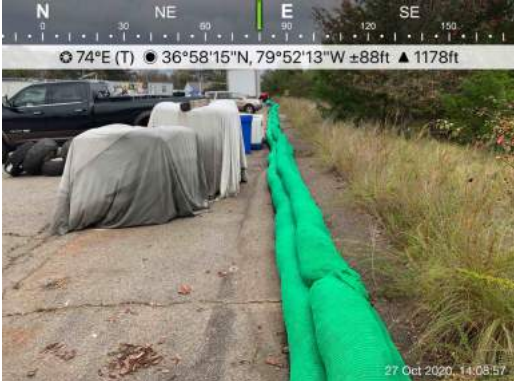
| <b>Pic 3 Desc.</b> | Perimeter ECD's on south end of paved yard in good condition | | <b>Pic 4 Desc.</b> | Secondary containment structure for fuel cell in compliance. | |

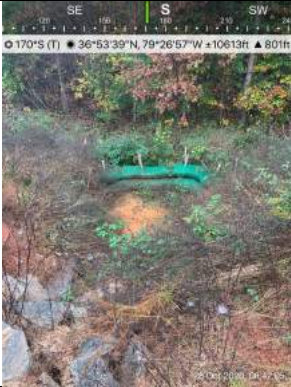
| <b>Pic 1 Desc.</b> | Observing sump and end treatment. | <b>Pic 2 Desc.</b> | Observing CWD outlet and ECD's performing as they should. | | |

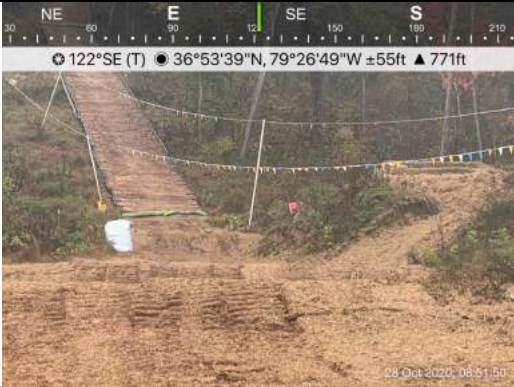
| <b>Pic 3 Desc.</b> | Observing equipment crossing, temporary stabilization and signage. | <b>Pic 4 Desc.</b> | Observing temporary stabilization and signage. | | |

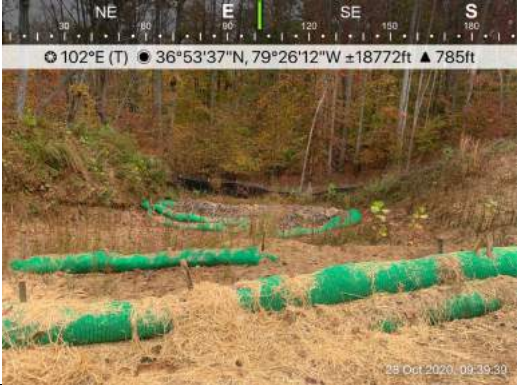
| <b>Pic 7 Desc.</b> | Observing CWD outlet and ECD's performing as they should. | <b>Pic 8 Desc.</b> | Observing equipment crossing,buffer, signage and ECD's performing as they should. | | |

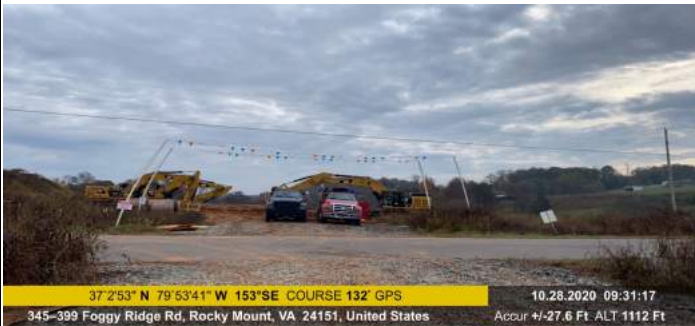
| Pic 1 Desc. | Equipment being staged at Foggy Ridge Rd. | | Pic 2 Desc. | Permanent vegetation growing along ROW. Area is stable with no issues observed. | |

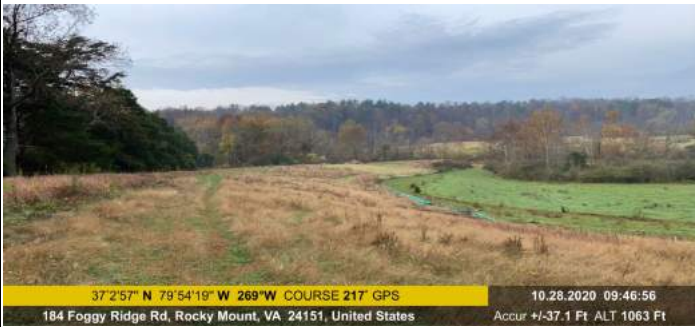
| Pic 3 Desc. | Temporary vegetation growing along ROW. Area is stable with no issues observed. | | Pic 4 Desc. | Equipment bridge and surrounding ECD's in place and functional at stream crossing. | |

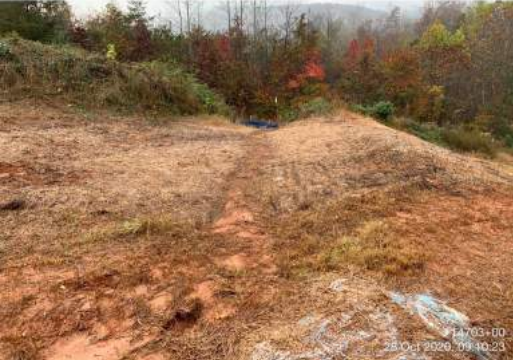
| <b>Pic 1 Desc.</b> | Erosion control blanket in acceptable condition | <b>Pic 2 Desc.</b> | Waterbar in acceptable condition | | |

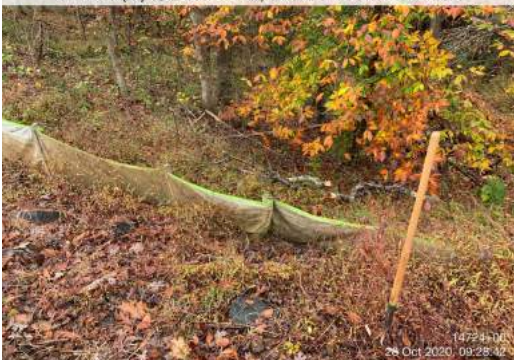
| <b>Pic 3 Desc.</b> | P1 silt fence has a broken stake | <b>Pic 4 Desc.</b> | P1 silt fence in acceptable condition; P1 silt fence was repaired with new stake installed | | |

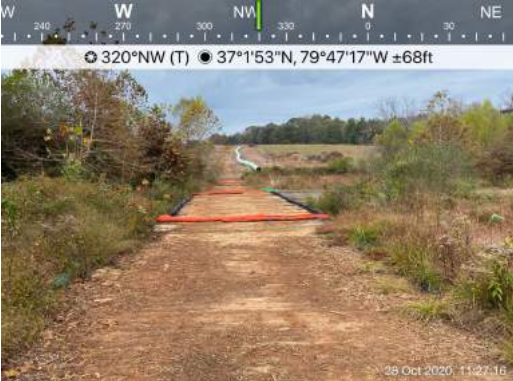
| <b>Pic 3 Desc.</b> | Approximately 14330+00. Overview of ROW and ECDs. ROW temporarily stabilized and has temporary vegetation growing. | | <b>Pic 4 Desc.</b> | Approximately 14391+53. Overview of stream crossing, equipment bridge and ECDs at stream S-A41. | |

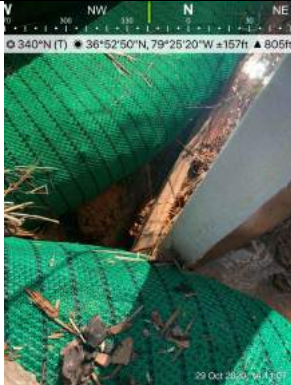
| <b>Pic 1 Desc.</b> | Observing water flowing into sump after the rain event. | <b>Pic 2 Desc.</b> | Observing undermined end treatment that requires maintenance. | | |

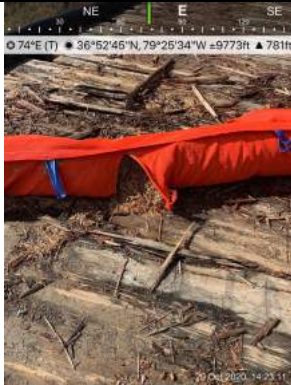
| <b>Pic 3 Desc.</b> | Observing water bar that is dNot discharging water off row. | <b>Pic 4 Desc.</b> | Observing wattle that requires maintenance. | | |

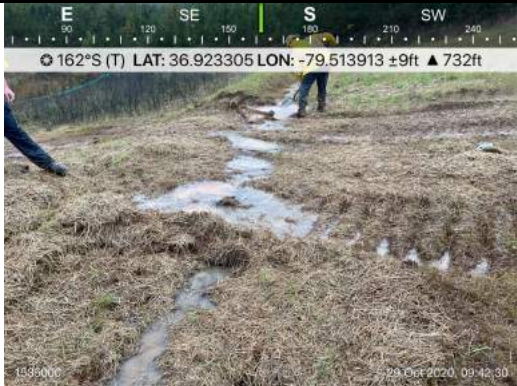
| <b>Pic 9 Desc.</b> | Waterbar flow path is obstructed. | | <b>Pic 10 Desc.</b> | Sediment and straw have been removed from flow path. | |

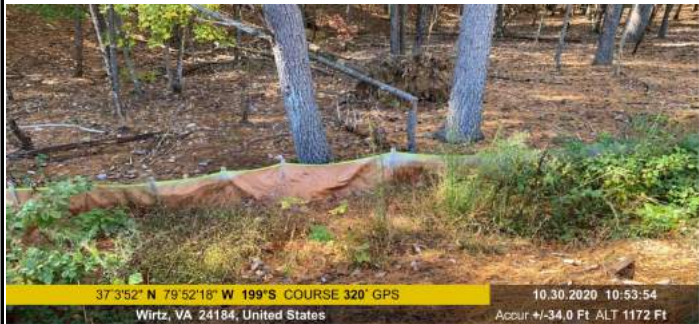
| Pic 1 Desc. | Ineffective ESC measure. Replace CFS triple stack. Clogged and not filtering. Was damaged by piece of equipment which ran into it. | Pic 2 Desc. | Routine maintenance. Replace damaged panels of P1 silt fence. Stakes were snapped from heavy water flow. | | |

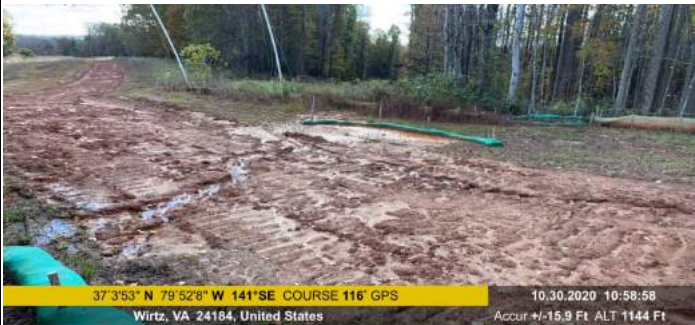
| Pic 3 Desc. | Routine maintenance. Rill erosion across ROW needs repaired and stabilized. | Pic 4 Desc. | Routine maintenance. Throat of water bar eroding away from heavy water flow. Repair and stabilize area. | | |

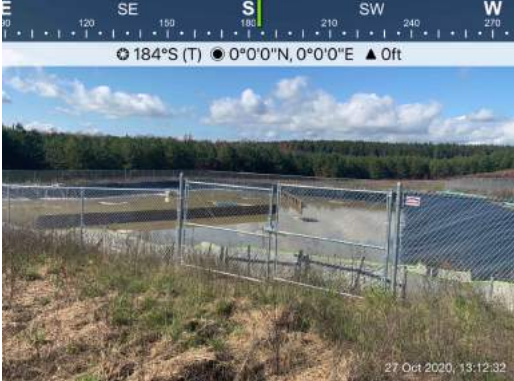
| <b>Pic 1 Desc.</b> | Observing storm water pond and ECD's performing as they should. | | <b>Pic 2 Desc.</b> | Observing temporary vegetation, rock check dam and ECD's performing as they should. | |
