# Visual Site Inspection Report

<b>Project Name</b>	H-603 Pipeline Spread I	<b>AFE</b>	124300139	<b>Spread</b>	H-603 Pipeline Spread I	
<b>Contractor</b>	Precision			<b>Report #</b>	16311	
<b>Inspector</b>	John White			<b>Date/Time</b>	11/2/2020 10:31 AM	
<b>Permit #</b>	TBD	<b>Inspection Type</b>	VA SWPP	<b>Station Begin</b>	00+00	
<b>State</b>	VA	<b>Inspection Area</b>	Full	<b>Station End</b>	24+53	
<b>County</b>	Pittsylvania	<b>Ground</b>	Wet	<b>Temperature (°F)</b>	47.00	
<b>Municipality</b>	Chatham	<b>Weather</b>	Sunny	<b>Rain Gauge (in)</b>	2.60	
				<b>Rain Accumulation Time (days)</b>	6.00

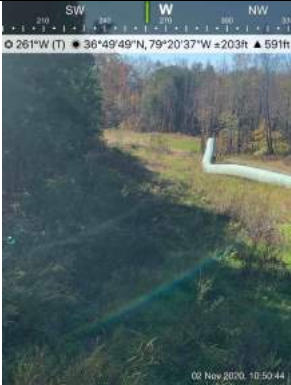
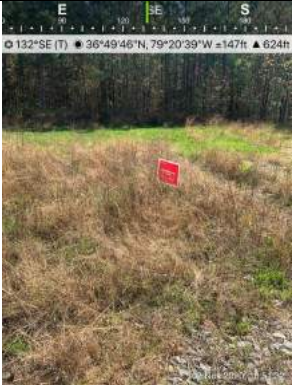
<b>GPS Location</b>	O	<b>GPS Location</b>	O		
<b>Field Station#</b>	7+00	<b>Field Station#</b>	11+00		
<b>Pic 1 Desc.</b>	Observing temporary vegetation.		<b>Pic 2 Desc.</b>	Observing temporary vegetation and signage.

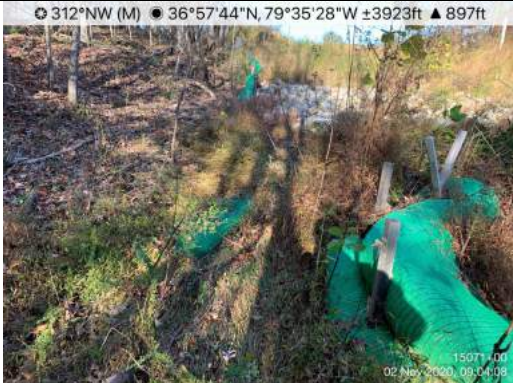
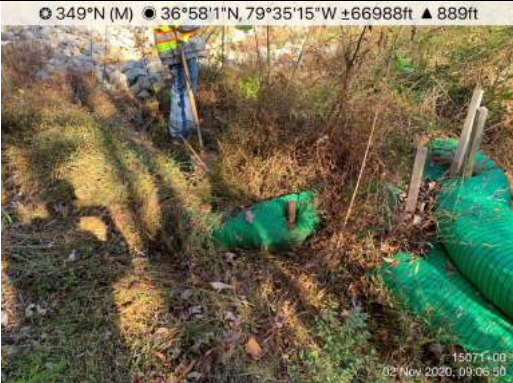
<p>349°N (M) 36°58'11"N, 79°35'15"W ±66988ft ▲889ft 15071+00 02 Nov 2020, 09:06:50</p>		
GPS Location	0		GPS Location	0	
Field Station#	15071+00		Field Station#	15071+00	
Pic 1 Desc.	Perimeter CFS was dislocated		Pic 2 Desc.	Perimeter CFS was staked back into place by contractor

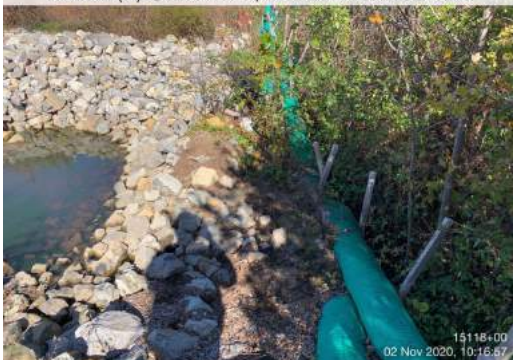
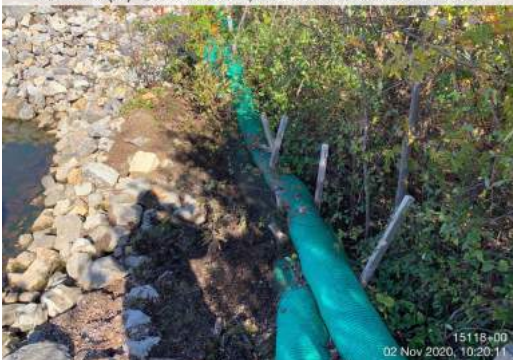
<p>355°N (M) 36°57'39"N, 79°35'3"W ±66988ft ▲903ft 15118+00 02 Nov 2020, 10:20:11</p>		
GPS Location	0		GPS Location	0	
Field Station#	15118+00		Field Station#	15118+00	
Pic 3 Desc.	Triple stack CFS over half full of sediment		Pic 4 Desc.	Sediment was removed from triple stack CFS by the contractor

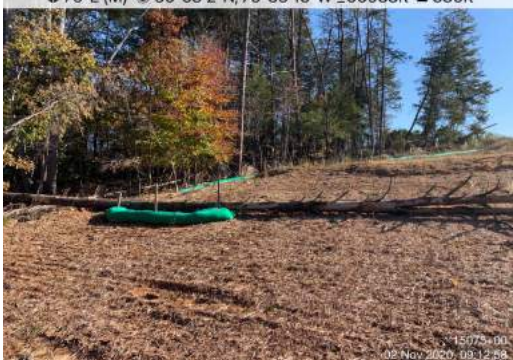
GPS Location	0		GPS Location	0	
Field Station#	15075+00		Field Station#	15091+00	
Pic 5 Desc.	A fallen tree on ROW. No ECDs were affected.		Pic 6 Desc.	Erosion over 6" deep

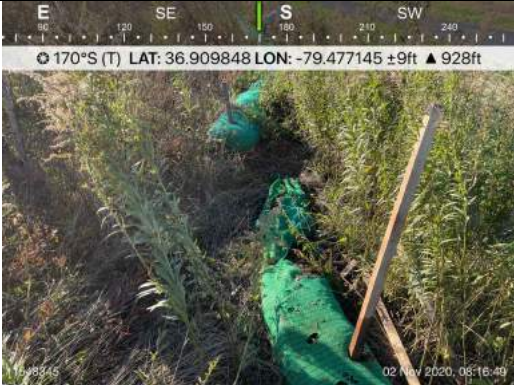
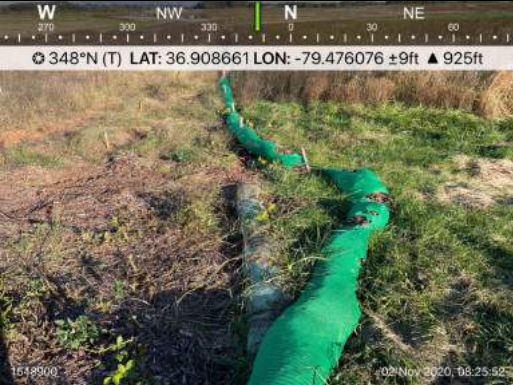
<b>GPS Location</b>	1	<b>GPS Location</b>	2		
<b>Field Station#</b>	15483+45	<b>Field Station#</b>	15489+00		
<b>Pic 1 Desc.</b>	Damaged CFS needs to be replaced.		<b>Pic 2 Desc.</b>	Damaged CFS needs to be replaced.

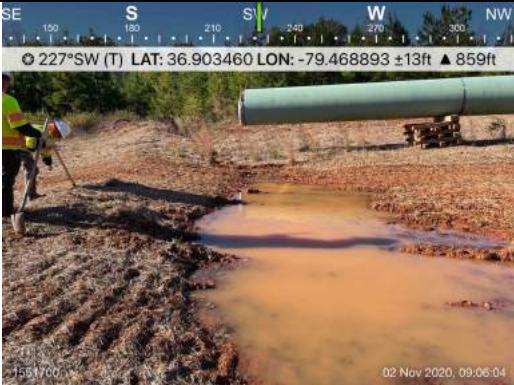
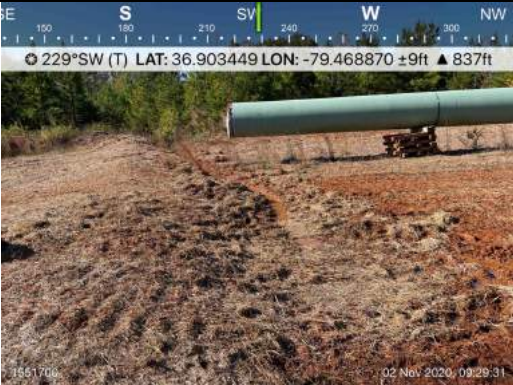
<b>GPS Location</b>	3	<b>GPS Location</b>	4		
<b>Field Station#</b>	15517+00	<b>Field Station#</b>	15517+00		
<b>Pic 3 Desc.</b>	Multiple waterbars in this area are holding water.		<b>Pic 4 Desc.</b>	Environmental crew on site has regraded and stabilized these waterbar channels.

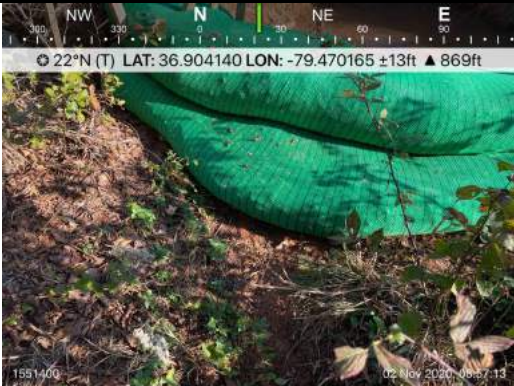
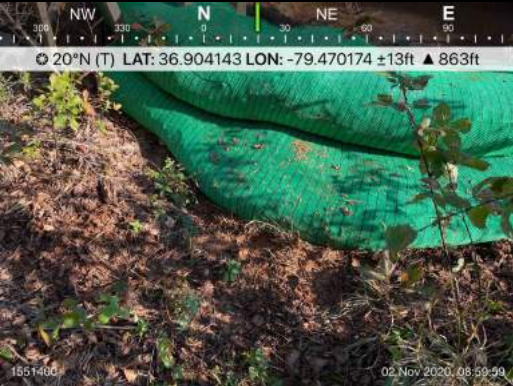
<b>GPS Location</b>	5	<b>GPS Location</b>	6		
<b>Field Station#</b>	15514+00	<b>Field Station#</b>	15514+00		
<b>Pic 5 Desc.</b>	Multiple sumps in this area have been undermined.		<b>Pic 6 Desc.</b>	Environmental crew on site has corrected this issue.

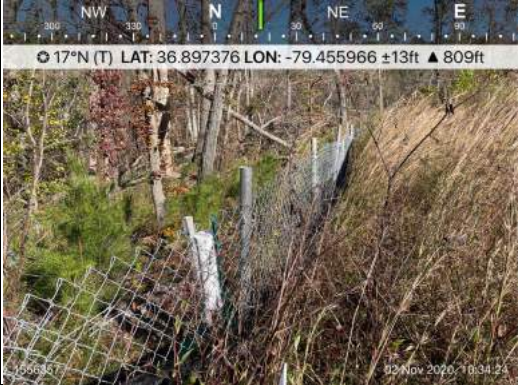
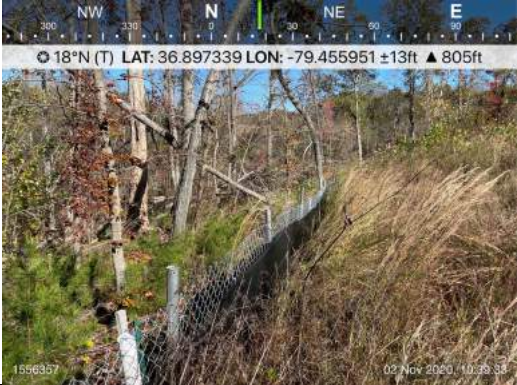
<b>GPS Location</b>	7	<b>GPS Location</b>	8		
<b>Field Station#</b>	15563+57	<b>Field Station#</b>	15563+57		
<b>Pic 7 Desc.</b>	SSF fabric down at this location.		<b>Pic 8 Desc.</b>	Environmental crew on site has reattached SSF fabric.	
Insert image here		Insert image here			
<b>GPS Location</b>		<b>GPS Location</b>			
<b>Field Station#</b>		<b>Field Station#</b>			
<b>Pic 9 Desc.</b>			<b>Pic 10 Desc.</b>		
Insert image here		Insert image here			
<b>GPS Location</b>		<b>GPS Location</b>			
<b>Field Station#</b>		<b>Field Station#</b>			
<b>Pic 11 Desc.</b>			<b>Pic 12 Desc.</b>

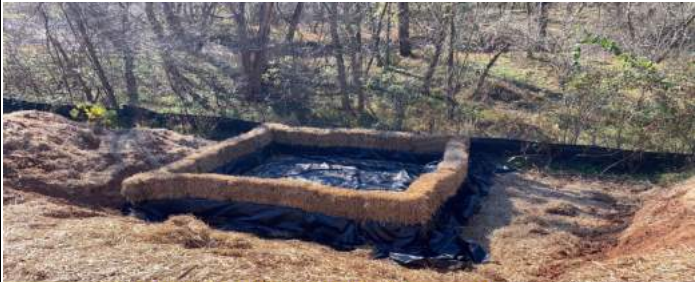
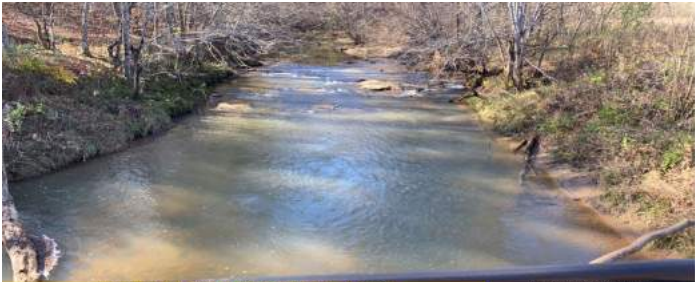
<div>37°3'30" N 79°55'6" W 164°S COURSE 212' GPS11.03.2020 09:48:49Rocky Mount, VA 24151, United StatesAccur +/-41.2 Ft ALT 1041 Ft</div>			<div>37°3'27" N 79°54'50" W 166°S COURSE 83' GPS11.03.2020 09:55:32Rocky Mount, VA 24151, United StatesAccur +/-191.0 Ft ALT 1033 Ft</div>		
<b>GPS Location</b>	1	<b>GPS Location</b>	2		
<b>Field Station#</b>	13861+00	<b>Field Station#</b>	13875+16		
<b>Pic 1 Desc.</b>	Dewatering structure installed and functional.		<b>Pic 2 Desc.</b>	Upstream view of S-CD6

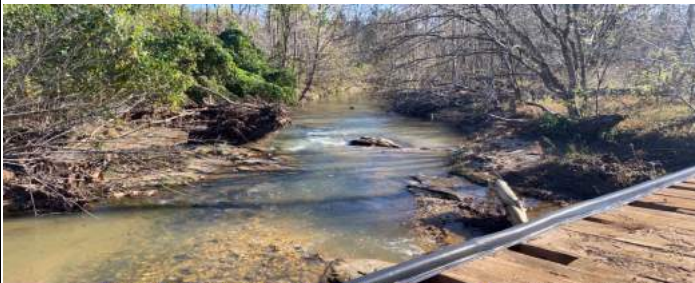
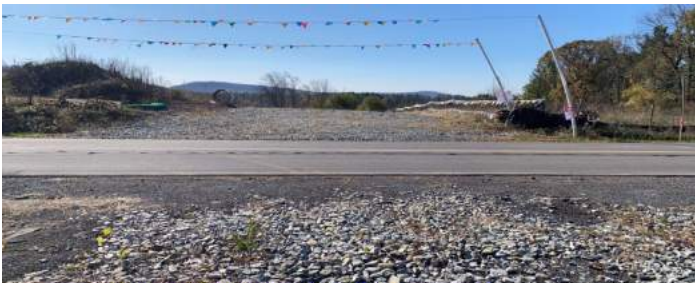
<b>Field Station#</b>	13875+16	<b>Field Station#</b>	13892+45		
<b>Pic 3 Desc.</b>	Downstream view of S-CD6		<b>Pic 4 Desc.</b>	RCE at Iron Ridge Rd in good condition at time of inspection.

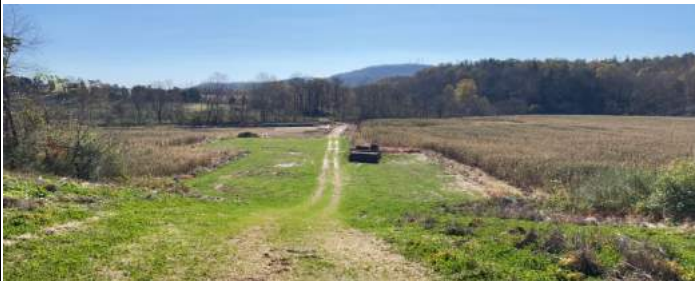
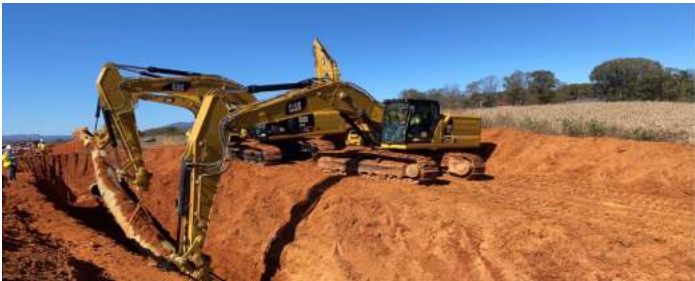
<div>37°3'16" N 79°54'36" W 173°S COURSE 166' GPS11.03.2020 10:10:251071-1315 Iron Ridge Rd, Rocky Mount, VA 24151, United StatesAccur +/-293.2 Ft ALT 1135 Ft</div>			<div>37°2'51" N 79°53'54" W 343°N COURSE -1' GPS11.03.2020 11:42:35184 Foggy Ridge Rd, Rocky Mount, VA 24151, United StatesAccur +/-50.9 Ft ALT 1100 Ft</div>		
<b>GPS Location</b>	5	<b>GPS Location</b>	6		
<b>Field Station#</b>	13908+00	<b>Field Station#</b>	13946+00		
<b>Pic 5 Desc.</b>	View of ROW in final cleanup area and transition to temporary toward stream crossing. No issues identified.		<b>Pic 6 Desc.</b>	Contractor excavating ditch and lifting pipe section during construction activities.

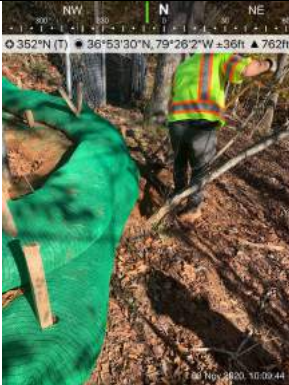
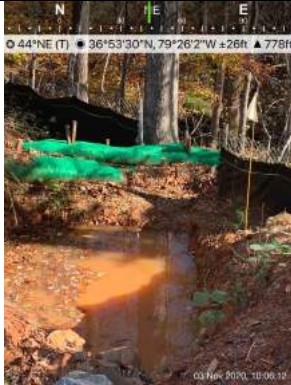
<b>GPS Location</b>	O	<b>GPS Location</b>	O		
<b>Field Station#</b>	15635+50	<b>Field Station#</b>	15635+50		
<b>Pic 1 Desc.</b>	Observing the Contractor performing ECD maintenance.	<b>Pic 2 Desc.</b>	Observing end treatment that required maintenance.

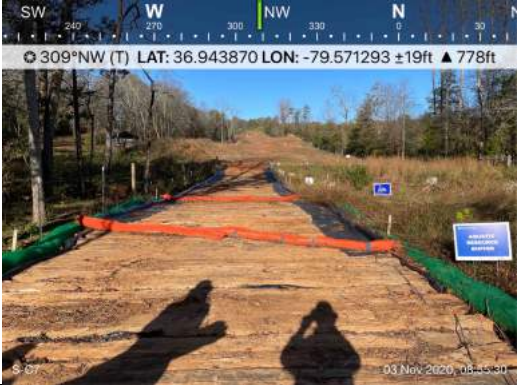
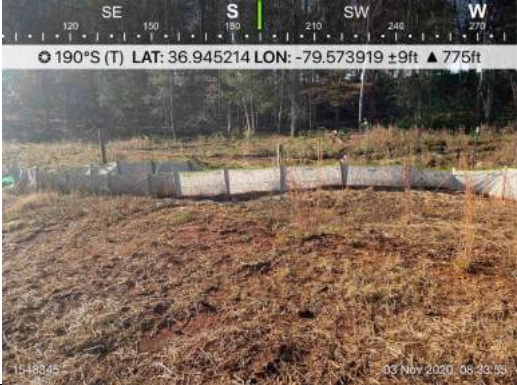
<b>GPS Location</b>	7	<b>GPS Location</b>	8		
<b>Field Station#</b>	15168+49	<b>Field Station#</b>	15483+45		
<b>Pic 7 Desc.</b>	Equipment bridges in this section are in good condition with controls in place.	<b>Pic 8 Desc.</b>	P1 in this section is in good condition and functioning.		
Insert image here		Insert image here			
<b>GPS Location</b>		<b>GPS Location</b>			
<b>Field Station#</b>		<b>Field Station#</b>			
<b>Pic 9 Desc.</b>		<b>Pic 10 Desc.</b>			
Insert image here		Insert image here			
<b>GPS Location</b>		<b>GPS Location</b>			
<b>Field Station#</b>		<b>Field Station#</b>			
<b>Pic 11 Desc.</b>		<b>Pic 12 Desc.</b>

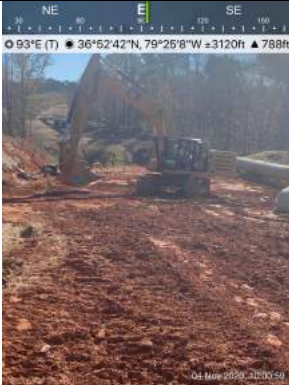
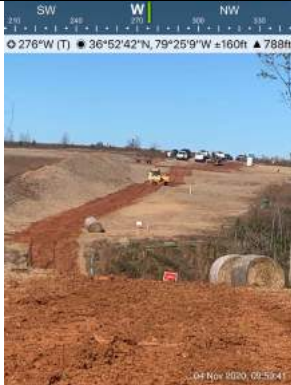
<b>GPS Location</b>	O		<b>GPS Location</b>	O	
<b>Field Station#</b>	15705+00		<b>Field Station#</b>	15699+00	
<b>Pic 1 Desc.</b>	Observing the Contractor cleaning up the row.		<b>Pic 2 Desc.</b>	Observing the Contractor repairing the travel lane.

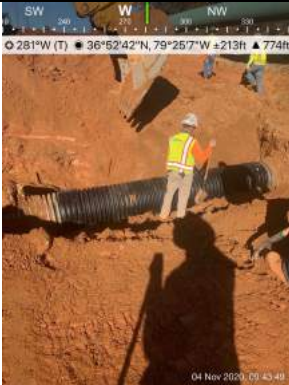
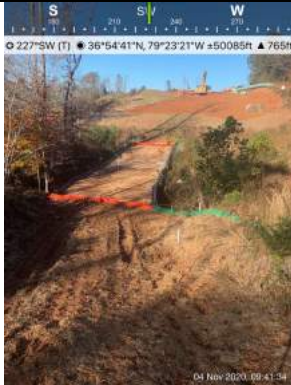
<b>GPS Location</b>	O		<b>GPS Location</b>	O	
<b>Field Station#</b>	15704+00		<b>Field Station#</b>	15708+02	
<b>Pic 3 Desc.</b>	Observing the Contractor repairing the CWD pipe that was dug up yesterday.		<b>Pic 4 Desc.</b>	Observing equipment crossing and ECD's performing as they should.

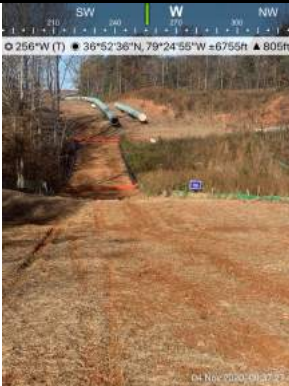
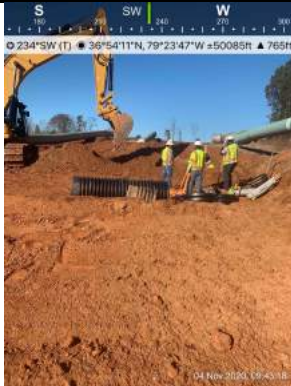
<b>GPS Location</b>	O		<b>GPS Location</b>	O	
<b>Field Station#</b>	15713+52		<b>Field Station#</b>	15704+00	
<b>Pic 5 Desc.</b>	Observing equipment crossing, signage,buffer and ECD's performing as they should.		<b>Pic 6 Desc.</b>	Observing the Contractor repairing CWD pipe that was dug up yesterday.

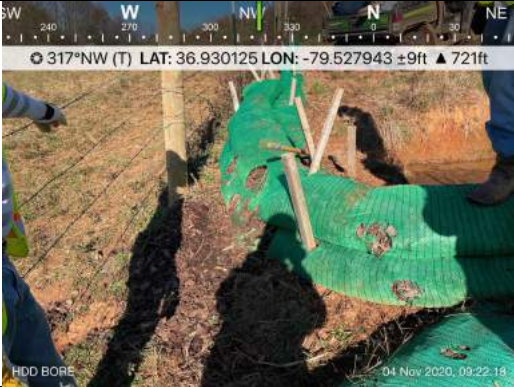
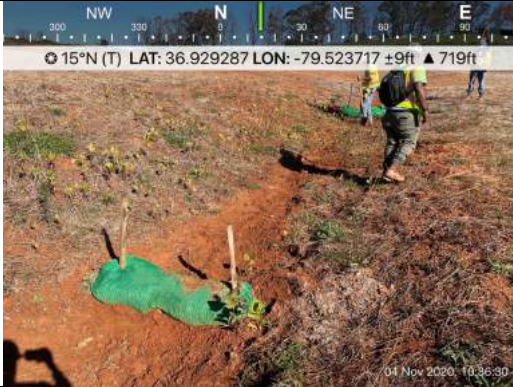
<b>GPS Location</b>	1	<b>GPS Location</b>	2		
<b>Field Station#</b>	15310+00	<b>Field Station#</b>	15322+00		
<b>Pic 1 Desc.</b>	Damaged CFS end treatment needs to be replaced.	<b>Pic 2 Desc.</b>	Drainage channel needs to be regraded and stabilized to prevent erosion.

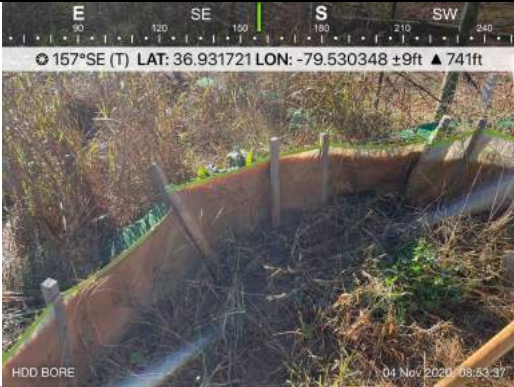
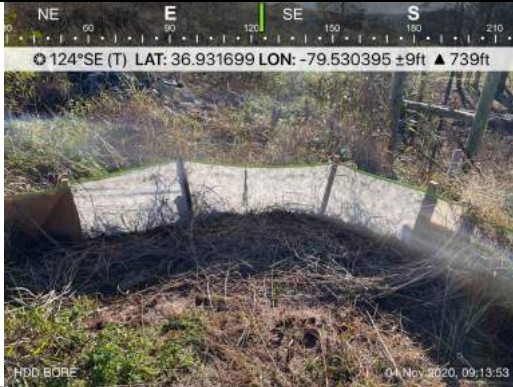
<b>GPS Location</b>	3	<b>GPS Location</b>	4		
<b>Field Station#</b>	15300+00	<b>Field Station#</b>	15300+00		
<b>Pic 3 Desc.</b>	Damaged P1 needs to be replaced.	<b>Pic 4 Desc.</b>	Environmental crew on site has corrected this issue.

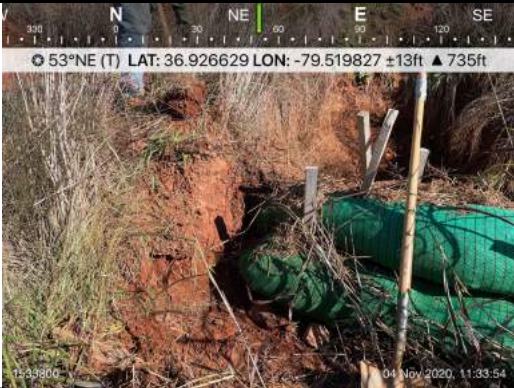
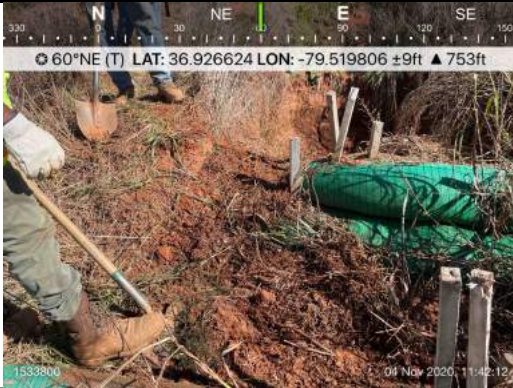
<b>GPS Location</b>	5	<b>GPS Location</b>	6		
<b>Field Station#</b>	15338+00	<b>Field Station#</b>	15338+00		
<b>Pic 5 Desc.</b>	Erosion occurring around CFS end treatment.	<b>Pic 6 Desc.</b>	Environmental crew on site has corrected this issue.

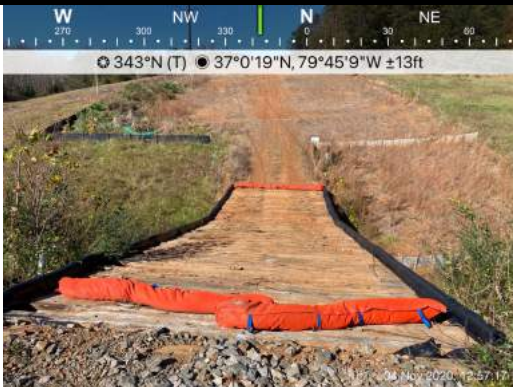
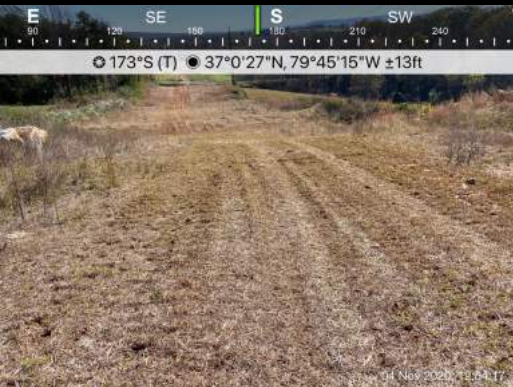
<p>GPS photo showing a road with temporary vegetation. The photo includes a compass overlay with coordinates: 173°S (T) 37°0'27"N, 79°45'15"W ±13ft.</p>	
GPS Location	0		GPS Location	0	
Field Station#	14546+33		Field Station#	14539+00	
Pic 1 Desc.	Approximately 14546+33. Overview of stream crossing, equipment bridge and ECDs at stream S-G17.		Pic 2 Desc.	Overview of ROW. ROW temporarily stabilized and has temporary vegetation growing.

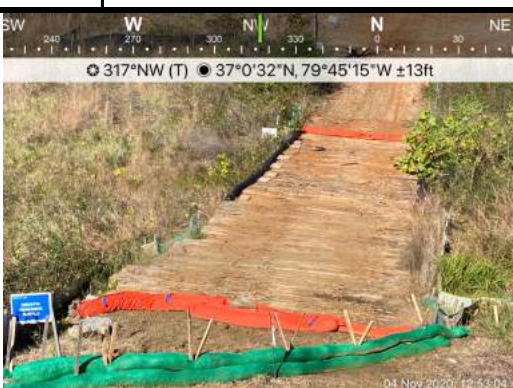
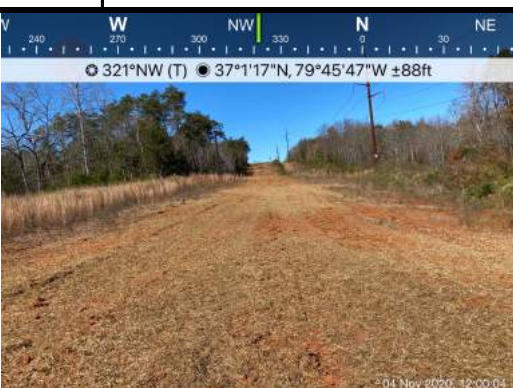
GPS Location	0		GPS Location	0	
Field Station#	14531+58		Field Station#	14471+00	
Pic 3 Desc.	Approximately 14531+58. Overview of stream crossing, equipment bridge and ECDs at stream S-G18.		Pic 4 Desc.	Approximately 14471+00. Overview of ROW. ROW temporarily stabilized and has temporary vegetation growing. Travel lane has been temporarily stabilized and seeded.

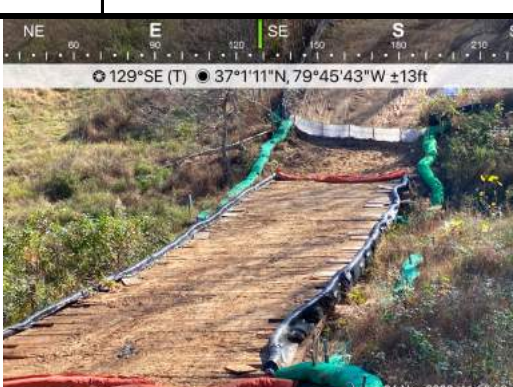
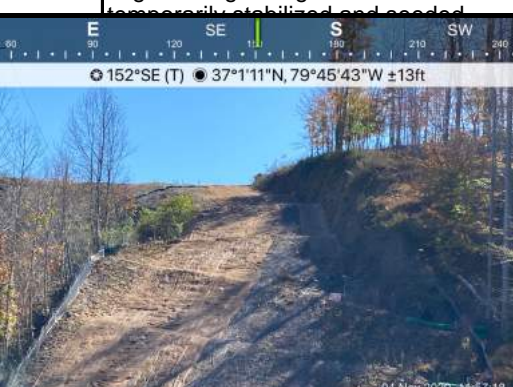
<p>GPS photo showing a road with temporary vegetation. The photo includes a compass overlay with coordinates: 152°SE (T) 37°1'11"N, 79°45'43"W ±13ft.</p>	
GPS Location	0		GPS Location	0	
Field Station#	14486+64		Field Station#	14500+00	
Pic 5 Desc.	Approximately 14486+64. Overview of stream crossing, equipment bridge and ECDs at stream S-G22.		Pic 6 Desc.	Approximately 14500+00. Overview of ROW. ROW temporarily stabilized and has temporary vegetation growing. Travel lane has been temporarily stabilized with erosion control.

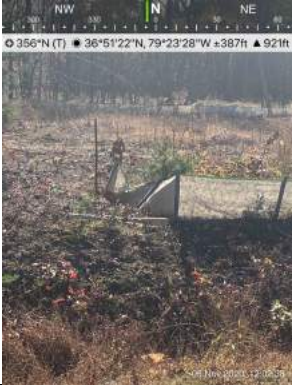
<b>GPS Location</b>	O	<b>GPS Location</b>	O		
<b>Field Station#</b>	15827+00	<b>Field Station#</b>	15827+00		
<b>Pic 7 Desc.</b>	Observing p1 that requires maintenance.	<b>Pic 8 Desc.</b>	Observing p1 that requires maintenance.		
Insert image here		Insert image here			
<b>GPS Location</b>		<b>GPS Location</b>			
<b>Field Station#</b>		<b>Field Station#</b>			
<b>Pic 9 Desc.</b>		<b>Pic 10 Desc.</b>			
Insert image here		Insert image here			
<b>GPS Location</b>		<b>GPS Location</b>			
<b>Field Station#</b>		<b>Field Station#</b>			
<b>Pic 11 Desc.</b>		<b>Pic 12 Desc.</b>

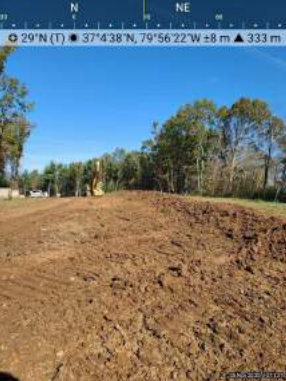
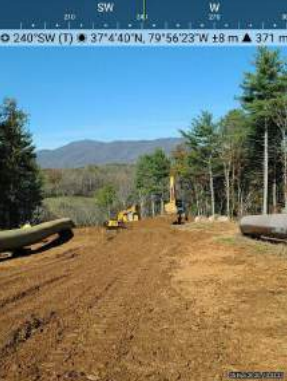
<b>GPS Location</b>	000000	<b>GPS Location</b>	000000		
<b>Field Station#</b>	13739+00	<b>Field Station#</b>	13731+30		
<b>Pic 1 Desc.</b>	Photo taken by the EI showing top soil segregation on a travel lane where work activities are taking place. No environmental issues observed at the time of inspection.		<b>Pic 2 Desc.</b>	Additional photo taken by the EI showing contractor work activities.

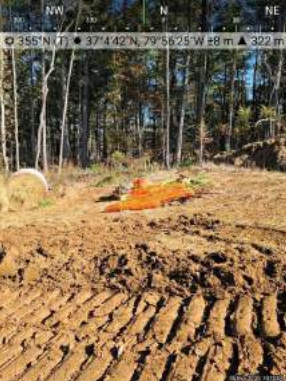
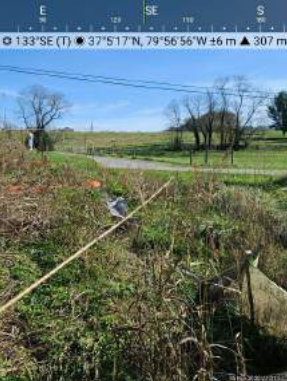
<b>GPS Location</b>	0000	<b>GPS Location</b>	0000		
<b>Field Station#</b>	13730+99	<b>Field Station#</b>	13681+20		
<b>Pic 3 Desc.</b>	Photo taken by the EI showing gas cans and water pumps in containment.		<b>Pic 4 Desc.</b>	P1 around ATWS-614 damaged from land owner activities, P1 needs replaced, documented and sent in to be added to the punch list.

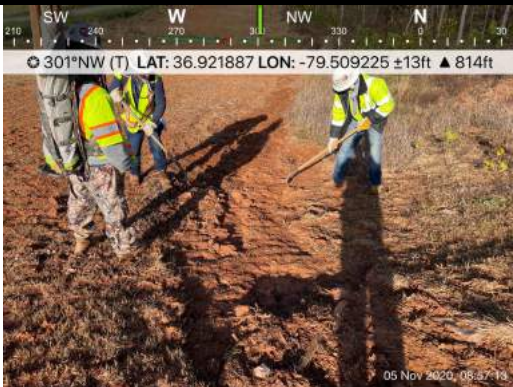
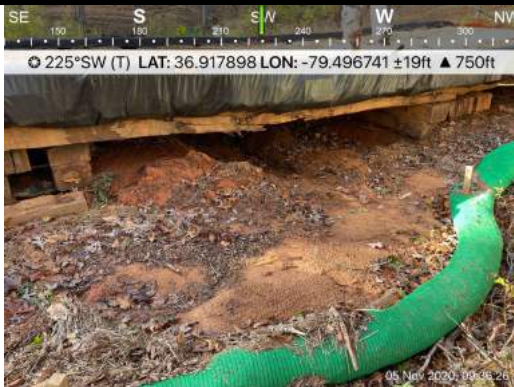
GPS Location	1	GPS Location	2		
Field Station#	15377+00	Field Station#	15413+72		
Pic 1 Desc.	Rill erosion at this location needs to be regraded and stabilized.		Pic 2 Desc.	Drainage channel causing erosion under equipment bridge. Sediment needs to be removed and channel stabilized.

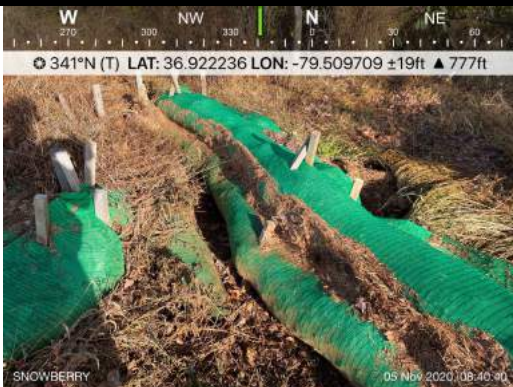
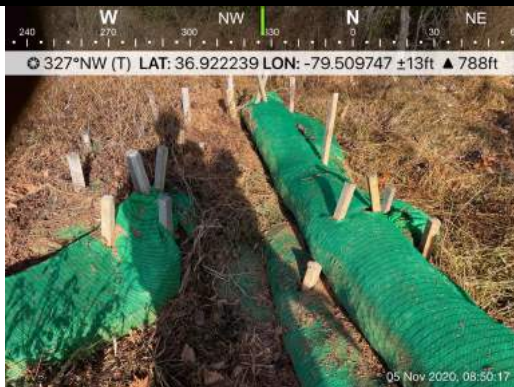
GPS Location	3	GPS Location	4		
Field Station#	15373+00	Field Station#	15373+00		
Pic 3 Desc.	CFS needs to be restaked.		Pic 4 Desc.	Environmental crew on site has corrected this issue.

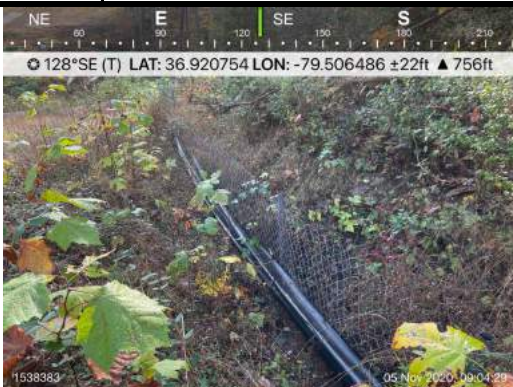
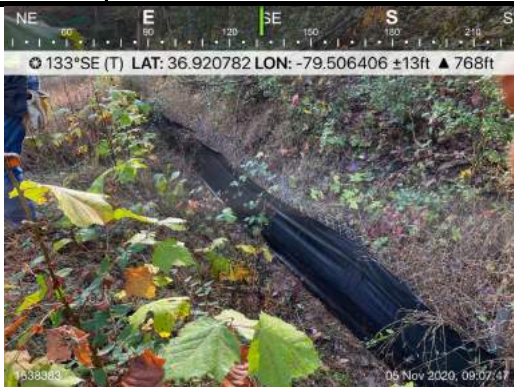
GPS Location	5	GPS Location	6		
Field Station#	15383+83	Field Station#	15383+83		
Pic 5 Desc.	SSF fabric needs to be reattached.		Pic 6 Desc.	Environmental crew on site has reattached SSF fabric.

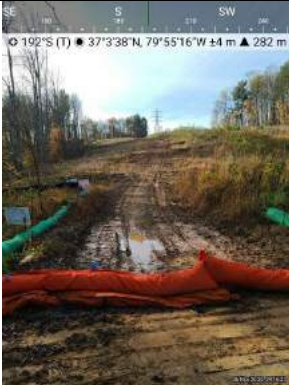
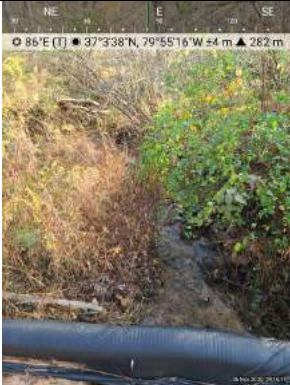
<b>GPS Location</b>	000000	<b>GPS Location</b>	000000		
<b>Field Station#</b>	13846+93	<b>Field Station#</b>	13846+93		
<b>Pic 1 Desc.</b>	ECDS in place and fun ting up row from stream crossing, no environmental issues observed at the time of inspection.		<b>Pic 2 Desc.</b>	Stream observation photo facing downstream, no environmental issues observed at time of inspection

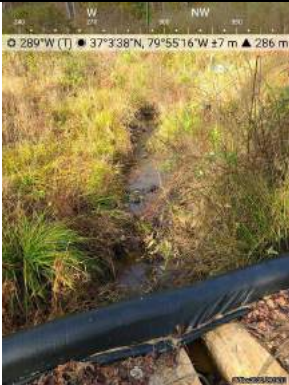
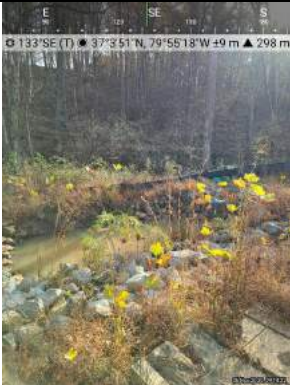
<b>GPS Location</b>	0000	<b>GPS Location</b>	0000		
<b>Field Station#</b>	13846+93	<b>Field Station#</b>	13844+34		
<b>Pic 3 Desc.</b>	Stream observation photo facing upstream, no environmental issues observed at time of inspection		<b>Pic 4 Desc.</b>	Clean water diversion observed and no environmental issue noticed at the time of inspection

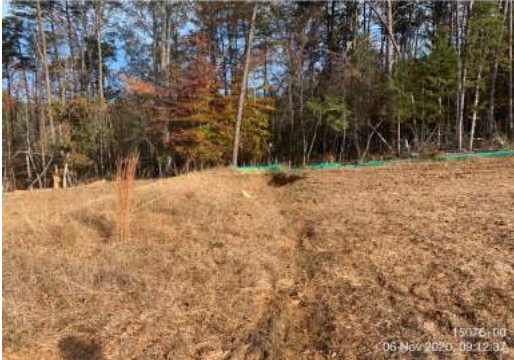
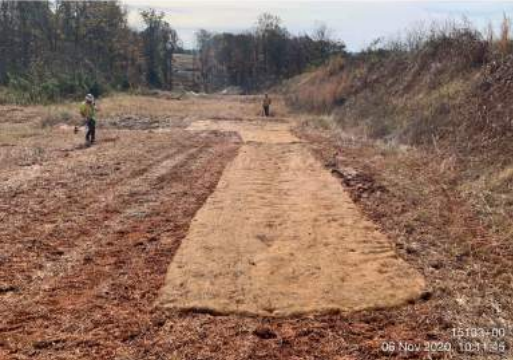
<b>GPS Location</b>	0	<b>GPS Location</b>	0		
<b>Field Station#</b>	15076+00	<b>Field Station#</b>	15132+00		
<b>Pic 1 Desc.</b>	Waterbar in acceptable condition	<b>Pic 2 Desc.</b>	Erosion control blanket in acceptable condition: DEQ punch list item addressed

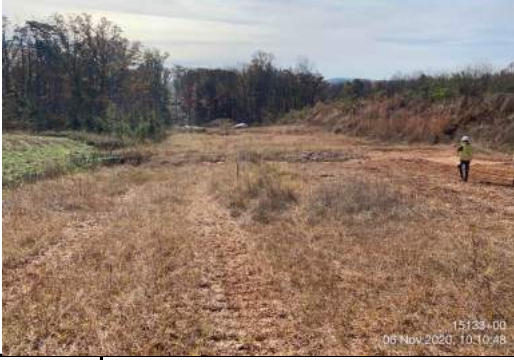
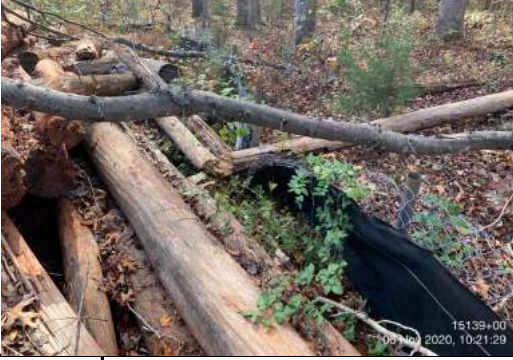
<b>GPS Location</b>	0	<b>GPS Location</b>	0		
<b>Field Station#</b>	15133+00	<b>Field Station#</b>	15139+00		
<b>Pic 3 Desc.</b>	Temporary vegetative stabilization in acceptable condition	<b>Pic 4 Desc.</b>	Super silt fence damaged by a fallen tree

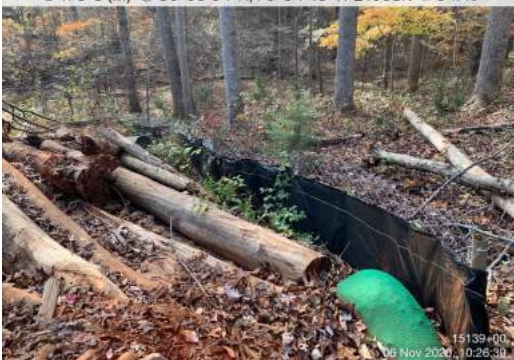
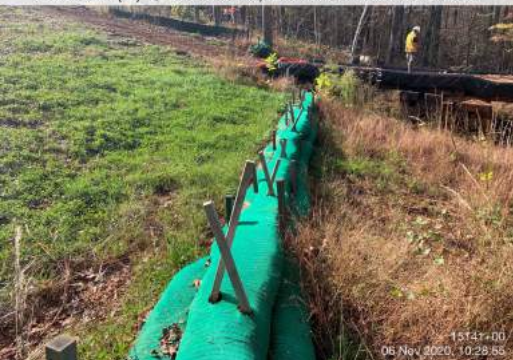
<b>GPS Location</b>	0	<b>GPS Location</b>	0		
<b>Field Station#</b>	15139+00	<b>Field Station#</b>	15141+00		
<b>Pic 5 Desc.</b>	Super silt fence with fallen tree removed and fence repaired	<b>Pic 6 Desc.</b>	CFS in acceptable condition

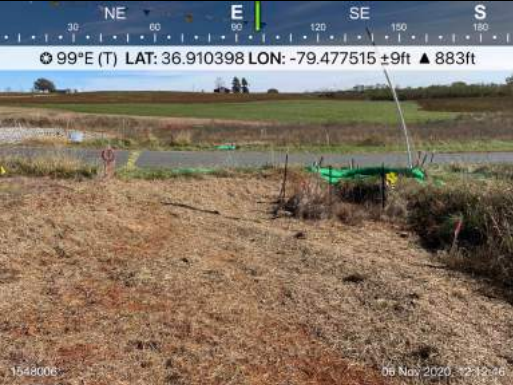
<b>GPS Location</b>	1	<b>GPS Location</b>	2		
<b>Field Station#</b>	15480+06	<b>Field Station#</b>	15480+06		
<b>Pic 1 Desc.</b>	Disturbance from ground wire install needs to be stabilized.	<b>Pic 2 Desc.</b>	Environmental crew on site has stabilized this area.
