Visual Site Inspection Report

Project Name	H-600 Pipeline Spread I	AFE	124300139	Spread	H-600 Pipeline Spread I
Contractor	Precision			Report #	16592
Inspector	Ben Davenport			Date/Time	11/9/2020 9:09 AM
Permit #	TBD	Inspection Type	VA SWPP	Station Begin	13853+45
State	VA	Inspection Area	Partial	Station End	13958+31
County	Franklin	Ground	Dry	Temperature (°F)	74.00
Municipality	N/A	Weather	Sunny	Rain Gauge (in)	0.00
				Rain Accumulation Time (days)	0.00

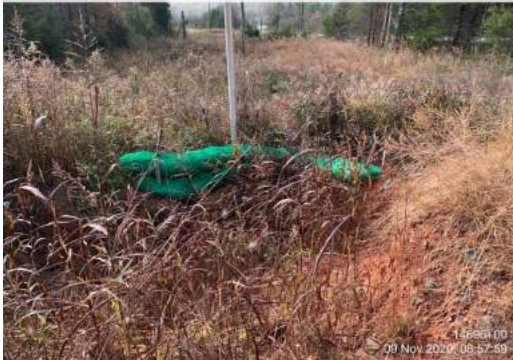
GPS Location	0		GPS Location	0	
Field Station#	14696+00		Field Station#	14729+00	
Pic 1 Desc.	Sump pit in acceptable condition		Pic 2 Desc.	P1 silt fence in acceptable condition

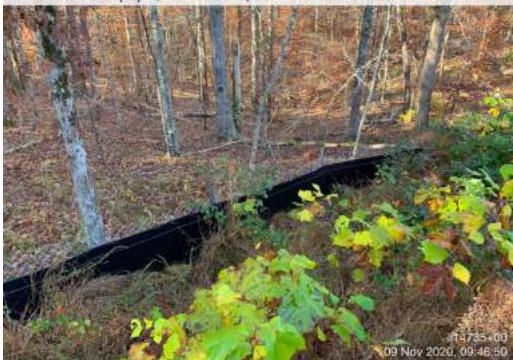
GPS Location	0		GPS Location	0	
Field Station#	14735+00		Field Station#	14750+00	
Pic 3 Desc.	Super silt fence in acceptable condition		Pic 4 Desc.	Waterbar end treatment in acceptable condition

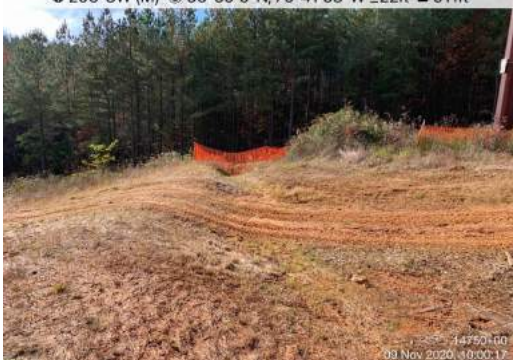
GPS Location	0		GPS Location	0	
Field Station#	14750+00		Field Station#	14780+00	
Pic 5 Desc.	Waterbar in acceptable condition		Pic 6 Desc.	Perimeter CFS in acceptable condition

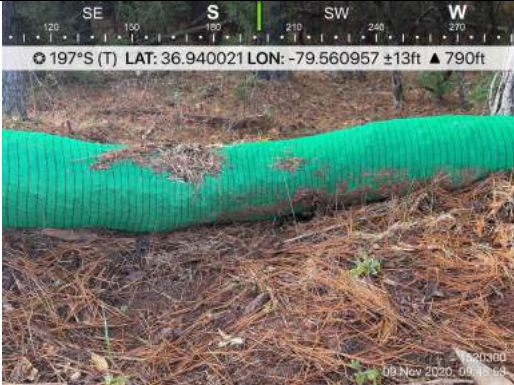
GPS Location	1	GPS Location	2		
Field Station#	15203+00	Field Station#	15203+00		
Pic 1 Desc.	Undermined CFS needs to be addressed.		Pic 2 Desc.	Environmental crew on site has corrected this issue.

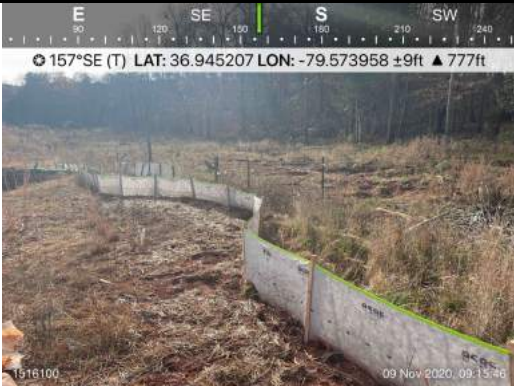
GPS Location	5	GPS Location	6		
Field Station#	15161+00	Field Station#	15167+95		
Pic 5 Desc.	P1 in good condition throughout this section of ROW.		Pic 6 Desc.	Equipment bridges in good condition with controls in place.

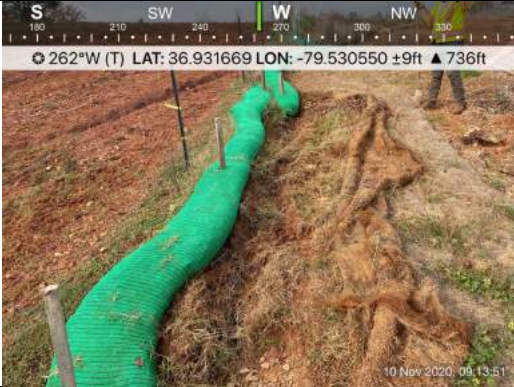
GPS Location	1	GPS Location	2		
Field Station#	15298+34	Field Station#	15298+34		
Pic 1 Desc.	Rill erosion along this CFS needs to be regraded and stabilized.		Pic 2 Desc.	Environmental crew on site has corrected this issue.

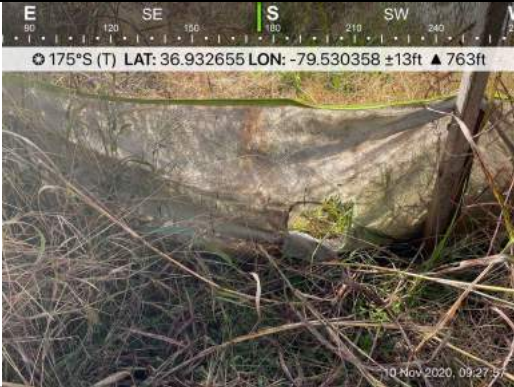
GPS Location	3	GPS Location	4		
Field Station#	15299+00	Field Station#	15299+00		
Pic 3 Desc.	Damaged P1 needs to be replaced.		Pic 4 Desc.	Environmental crew on site has corrected this issue.

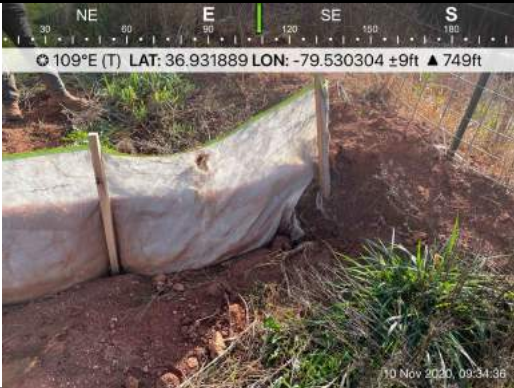
GPS Location	5	GPS Location	6		
Field Station#	15300+00	Field Station#	15300+00		
Pic 5 Desc.	Damaged P1 needs to be replaced.		Pic 6 Desc.	Environmental crew on site has corrected this issue.

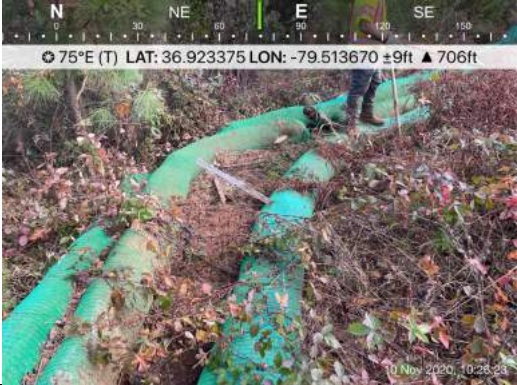
GPS Location	7	GPS Location	8		
Field Station#	15360+00	Field Station#	15360+00		
Pic 7 Desc.	CFS in this drainage has been damaged/displaced.	Pic 8 Desc.	Environmental crew on site has corrected this issue.		
Insert image here		Insert image here			
GPS Location		GPS Location			
Field Station#		Field Station#			
Pic 9 Desc.		Pic 10 Desc.			
Insert image here		Insert image here			
GPS Location		GPS Location			
Field Station#		Field Station#			
Pic 11 Desc.		Pic 12 Desc.

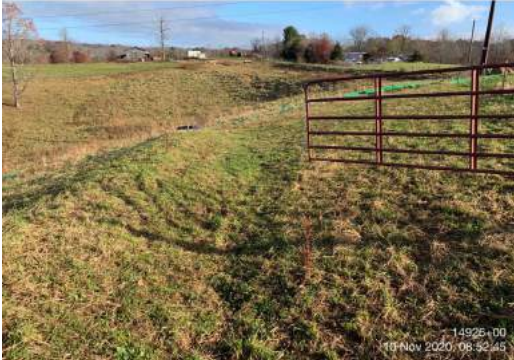
GPS Location	0	GPS Location	0		
Field Station#	14926+00	Field Station#	14923+35		
Pic 1 Desc.	Waterbar in acceptable condition	Pic 2 Desc.	P1 silt fence damaged by livestock

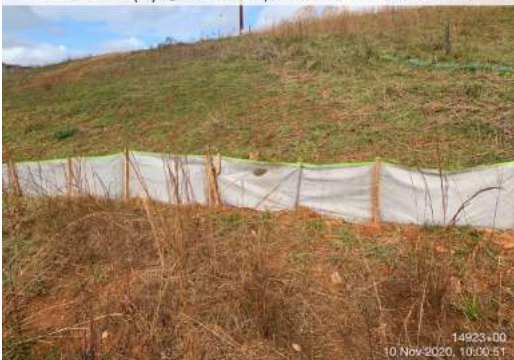
GPS Location	0	GPS Location	0		
Field Station#	14923+00	Field Station#	14904+00		
Pic 3 Desc.	P1 silt fence damaged by livestock	Pic 4 Desc.	Waterbar height is compromised by sediment in its flow line and erosion over 6" deep on the downhill slope

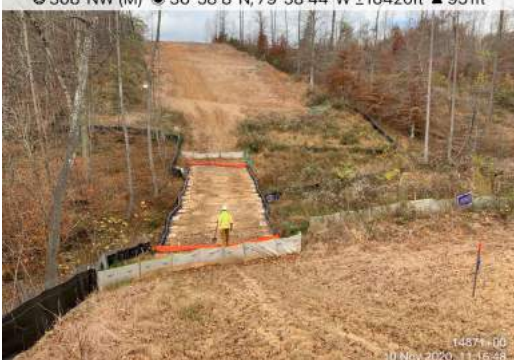
GPS Location	0	GPS Location	0		
Field Station#	14871+00	Field Station#	14813+00		
Pic 5 Desc.	Equipment bridge in acceptable condition	Pic 6 Desc.	Permanent vegetative stabilization in acceptable condition

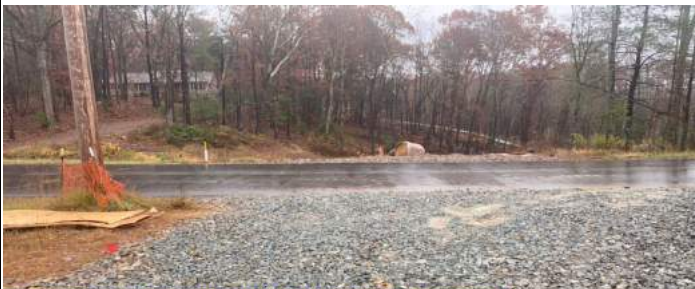
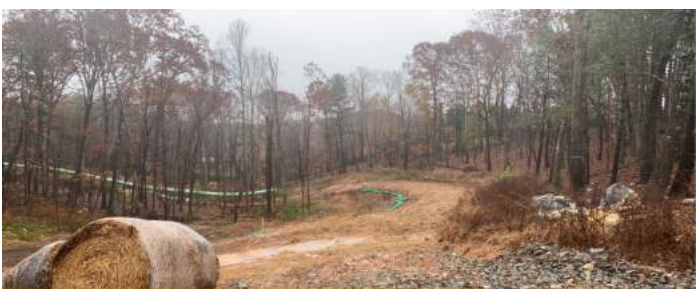
37°3'55" N 79°52'31" W 132°SE COURSE 350' GPS 1315 Bonbrook Mill Rd, Rocky Mount, VA 24151, United States 11.11.2020 11:21:55 Accur +/-48.6 Ft ALT 1211 Ft			37°3'55" N 79°52'30" W 229°SW COURSE -1' GPS 1315 Bonbrook Mill Rd, Rocky Mount, VA 24151, United States 11.11.2020 11:22:16 Accur +/-29.3 Ft ALT 1207 Ft		
GPS Location	1	GPS Location	2		
Field Station#	14062+17	Field Station#	14065+00		
Pic 1 Desc.	RCE at Bonbrook Mill RC2 in good condition.	Pic 2 Desc.	Travel lane stabilized and CFS down slope in place and functional.

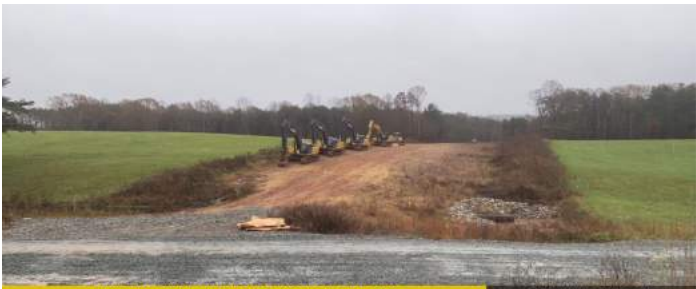
GPS Location	3	GPS Location	4		
Field Station#	14128+00	Field Station#	14131+28		
Pic 3 Desc.	Temporary stabilization CIS Jones Mill Rd. No vegetation observed growing/no erosion issues observed.	Pic 4 Desc.	RCE at Jones Mill Rd in good condition. Equipment staged GAS road crossing and not moved during rain event.

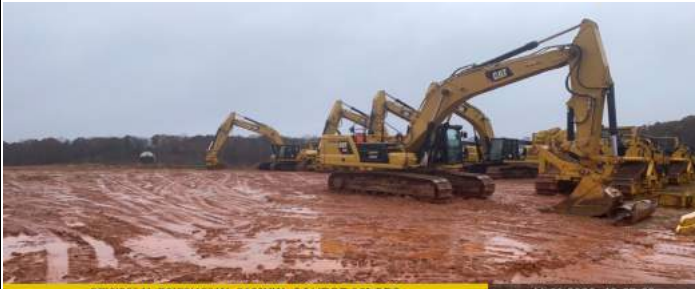
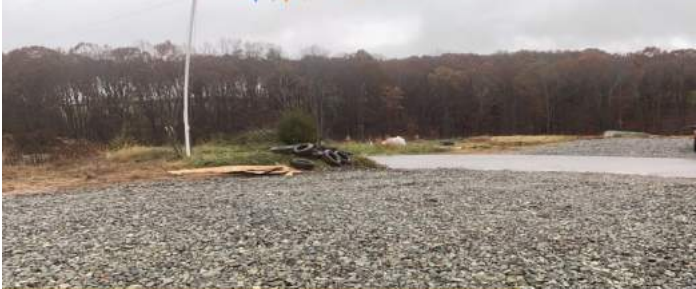
37°3'25" N 79°50'46" W 310°NW COURSE 99' GPS 131-429 Angle Plantation Rd, Rocky Mount, VA 24151, United States 11.11.2020 10:57:03 Accur +/-27.3 Ft ALT 1046 Ft			37°3'25" N 79°50'45" W 43°NE COURSE 181' GPS 131-429 Angle Plantation Rd, Rocky Mount, VA 24151, United States 11.11.2020 11:01:16 Accur +/-26.1 Ft ALT 1038 Ft		
GPS Location	5	GPS Location	6		
Field Station#	14169+00	Field Station#	14171+36		
Pic 5 Desc.	Equipment staged CIS Angle Plantation. No equipment moved during rain event.	Pic 6 Desc.	RCE at Angle Plantation Rd in good condition. All materials to move equipment across road properly staged.

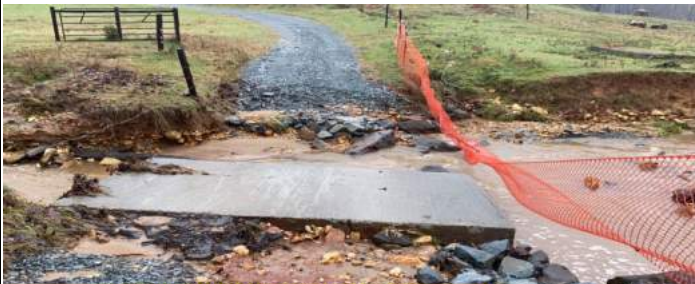
37°3'28" N 79°50'19" W 85°E COURSE 251° GPS 3175 Booker T Washington Hwy, Rocky Mount, VA 24151, United States Accur +/-88.4 Ft ALT 859 Ft			37°3'16" N 79°49'50" W 140°SE COURSE 88° GPS Rocky Mount, VA 24151, United States Accur +/-71.7 Ft ALT 983 Ft		
GPS Location	1	GPS Location	2		
Field Station#	14196+90	Field Station#	14233+57		
Pic 1 Desc.	Bridge out on access road MVP-FR-310.	Pic 2 Desc.	Remove sediment from bridge at S-C19 and reset bridge wattles. Repair damming at bridge.

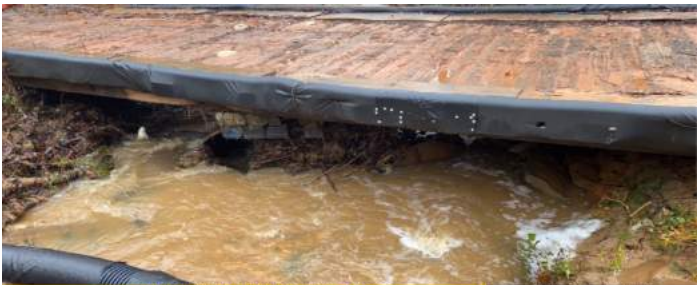
37°2'38" N 79°48'38" W 89°E COURSE 121° GPS 955 Greenway Rd, Glade Hill, VA 24092, United States Accur +/-381.5 Ft ALT 961 Ft			37°3'27" N 79°50'10" W 27°NE COURSE 65° GPS Rocky Mount, VA 24151, United States Accur +/-366.3 Ft ALT 895 Ft		
GPS Location	3	GPS Location	4		
Field Station#	14308+00	Field Station#	14028+69		
Pic 3 Desc.	Subsidence observed in ditch line. Area needs repaired.	Pic 4 Desc.	Flume pipe beginning to dam at S-F8. Remove debris from entryways.

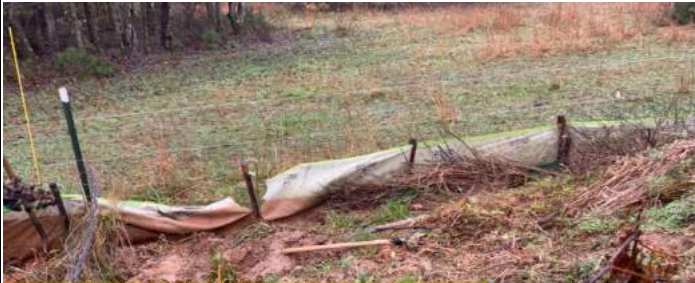
37°3'27" N 79°50'19" W 333°NW COURSE 256° GPS 3175 Booker T Washington Hwy, Rocky Mount, VA 24151, United States Accur +/-224.8 Ft ALT 893 Ft			37°2'47" N 79°48'45" W 310°NW COURSE 121° GPS Glade Hill, VA 24092, United States Accur +/-280.5 Ft ALT 961 Ft		
GPS Location	5	GPS Location	6		
Field Station#	14306+00	Field Station#	14296+00		
Pic 5 Desc.	Routine maintenance. Damage to P1 silt fence. Replace damaged panels.	Pic 6 Desc.	Slip of fill slope onto portion of travel lane. Area needs repaired and stabilized.

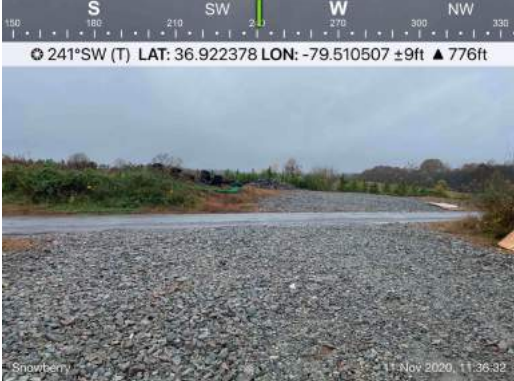
GPS Location	1	GPS Location	2		
Field Station#	15370+50	Field Station#	15384+24		
Pic 1 Desc.	CE at Snowberry Rd is in good condition.	Pic 2 Desc.	Equipment bridges in this section are in good condition with additional controls in place.

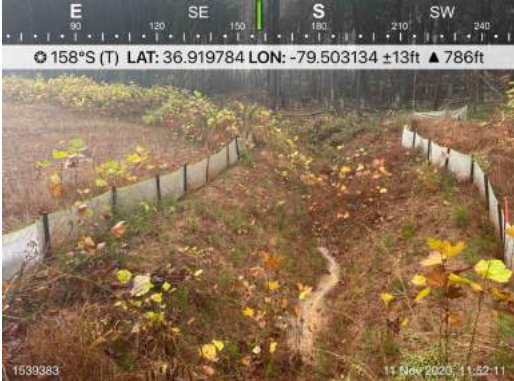
GPS Location	3	GPS Location	4		
Field Station#	15393+83	Field Station#	15396+00		
Pic 3 Desc.	P1 in good condition throughout this area.	Pic 4 Desc.	Temporary vegetation is inhibiting erosion.

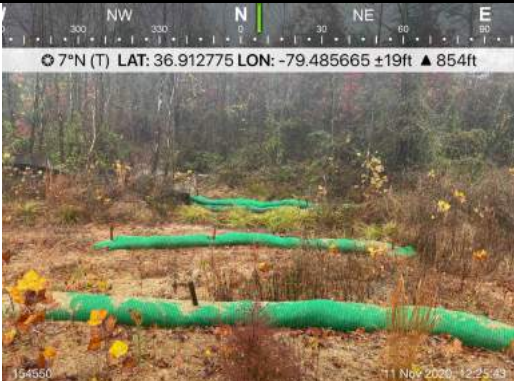
GPS Location	5	GPS Location	6		
Field Station#	15455+00	Field Station#	15460+00		
Pic 5 Desc.	CFS in good condition throughout this section.	Pic 6 Desc.	CWDs in good condition and functioning.

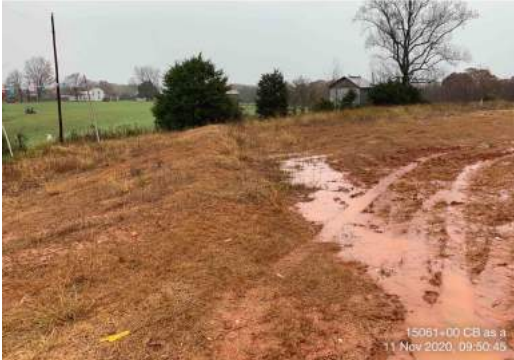
GPS Location	0	GPS Location	0		
Field Station#	15061+00	Field Station#	15061+00		
Pic 1 Desc.	Waterbar in acceptable condition	Pic 2 Desc.	Waterbar end treatment in acceptable condition

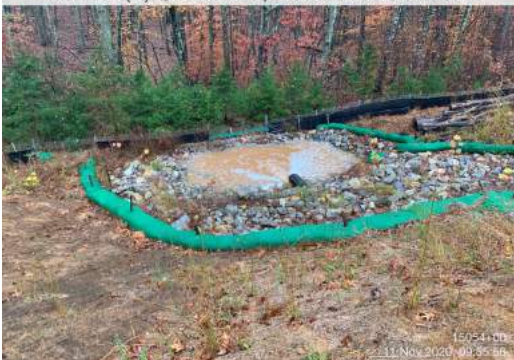
GPS Location	0	GPS Location	0		
Field Station#	15054+00	Field Station#	14992+00		
Pic 3 Desc.	Clean water diversion plunge pool in acceptable condition	Pic 4 Desc.	Equipment bridge in acceptable condition

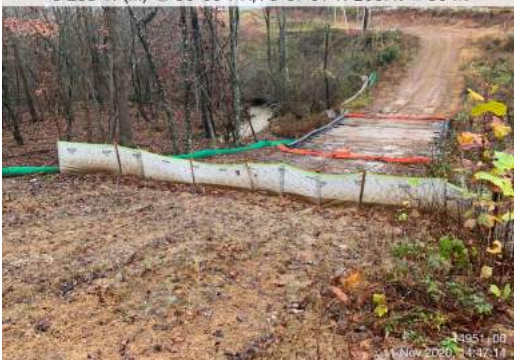
GPS Location	0	GPS Location	0		
Field Station#	14951+00	Field Station#	14932+00		
Pic 5 Desc.	P1 silt fence in acceptable condition	Pic 6 Desc.	Temporary vegetative stabilization in acceptable condition

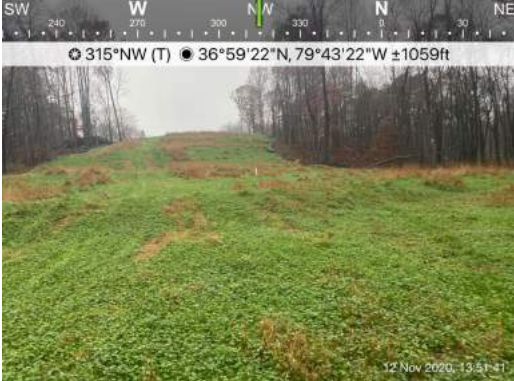
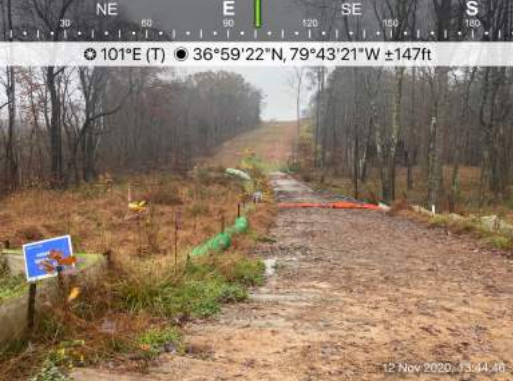
GPS Location	0	GPS Location	0		
Field Station#	14654+00	Field Station#	14656+94		
Pic 1 Desc.	Approximately 14654+00. Overview of ROW. ROW temporarily temporarily stabilized and has temporary vegetation growing.		Pic 2 Desc.	Approximately 14656+94. Overview of stream crossing, equipment bridge and ECDs at stream S-H38.

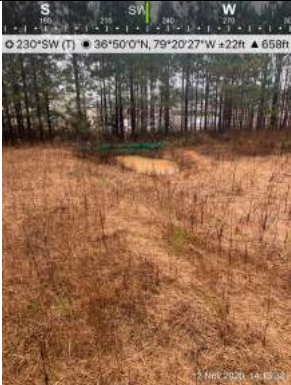
GPS Location	O	GPS Location	O		
Field Station#	8+00	Field Station#	6+00		
Pic 1 Desc.	Observing water bar, sump and end treatment.	Pic 2 Desc.	Observing temporary vegetation.

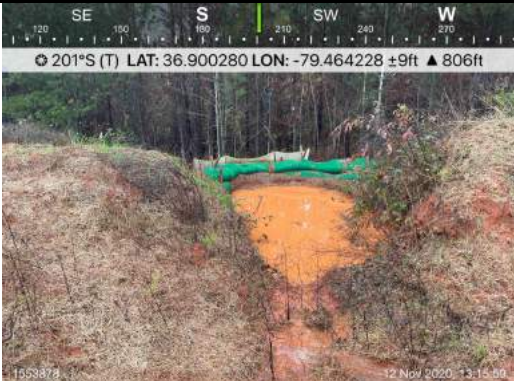
GPS Location	5	GPS Location	6		
Field Station#	15538+78	Field Station#	15527+00		
Pic 5 Desc.	Sumps are functioning in this section.	Pic 6 Desc.	CWD's in good condition and functioning.

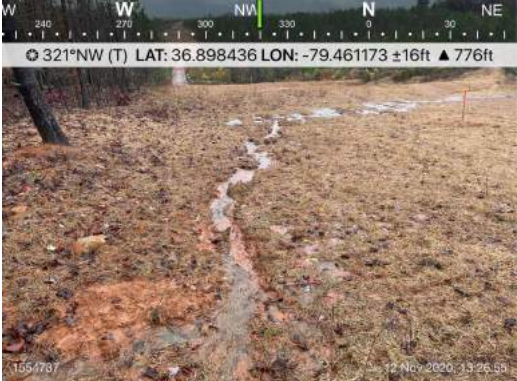
GPS Location	7	GPS Location			
Field Station#	15547+37	Field Station#			
Pic 7 Desc.	Minor rill on this slope will be monitored and repaired when site conditions allow.	Pic 8 Desc.			
Insert image here		Insert image here			
GPS Location		GPS Location			
Field Station#		Field Station#			
Pic 9 Desc.		Pic 10 Desc.			
Insert image here		Insert image here			
GPS Location		GPS Location			
Field Station#		Field Station#			
Pic 11 Desc.		Pic 12 Desc.

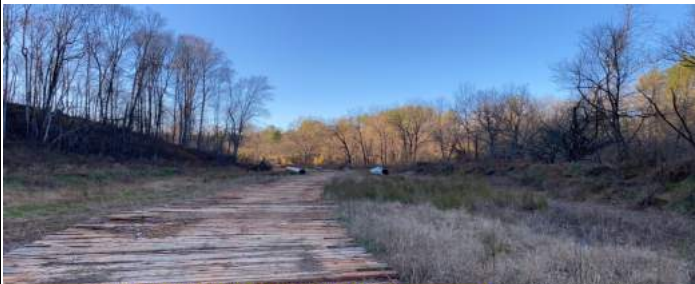
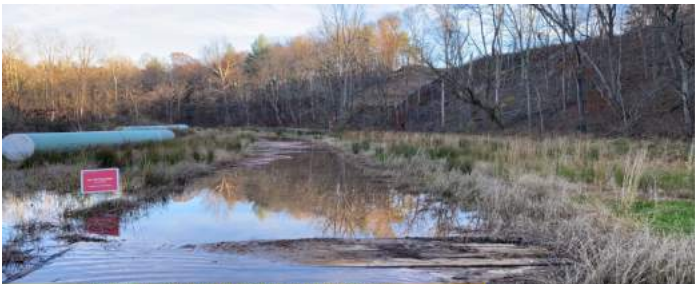
37°32'1" N 79°54'43" W 15°N COURSE 149° GPS 404 Old Mill Creek Ln, Rocky Mount, VA 24151, United States Accur +/-31.2 Ft ALT 1029 Ft			37°32'7" N 79°54'50" W 116°SE COURSE 82° GPS 404 Old Mill Creek Ln, Rocky Mount, VA 24151, United States Accur +/-15698.8 Ft ALT 1031 Ft		
GPS Location	1		GPS Location	2	
Field Station#	13877+00		Field Station#	13886+00	
Pic 1 Desc.	Portions of ROW underwater due to high water levels. Bridge mats in this location were not impacted.		Pic 2 Desc.	Portions of ROW underwater due to high water levels. Bridge mats in this location were not impacted.

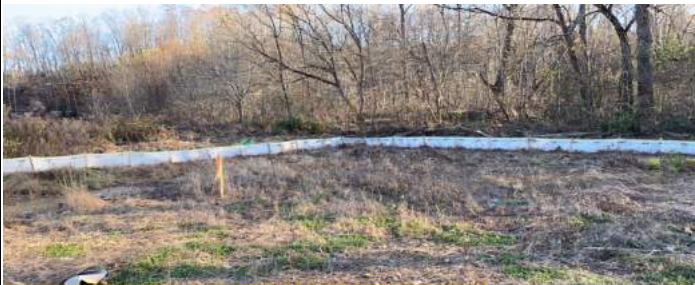
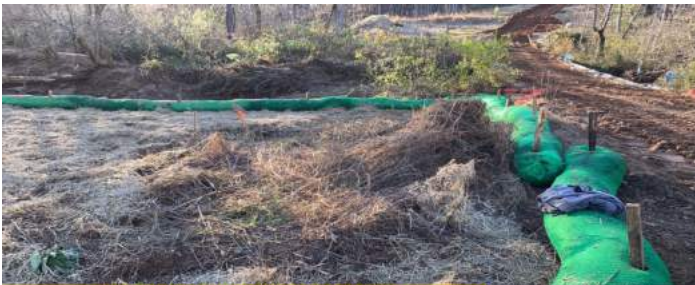
GPS Location	3		GPS Location	4	
Field Station#	13873+00		Field Station#	13863+25	
Pic 3 Desc.	Contractor replaced P1 silt fence along perimeter of ROW.		Pic 4 Desc.	Contractor replaced CFS throughout impacted area.

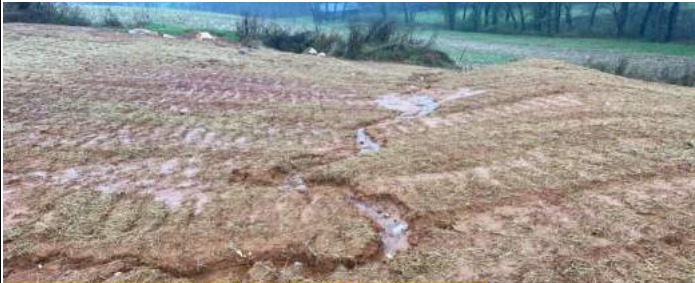
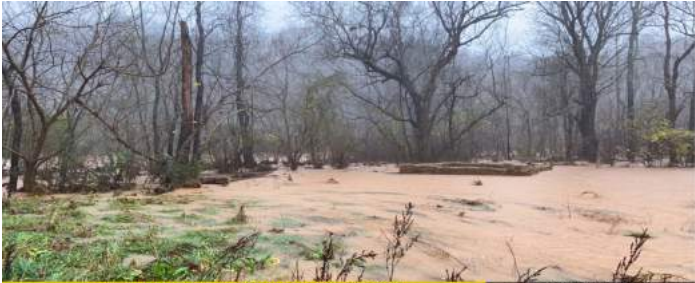
37°2'52" N 79°53'54" W 35°NE COURSE 296° GPS 332 Foggy Ridge Rd, Rocky Mount, VA 24151, United States Accur +/-125.6 Ft ALT 1084 Ft			37°2'56" N 79°54'29" W 238°SW COURSE 313° GPS 1770 Iron Ridge Rd, Rocky Mount, VA 24151, United States Accur +/-656.2 Ft ALT 996 Ft		
GPS Location	5		GPS Location	6	
Field Station#	13974+00		Field Station#	13916+75	
Pic 5 Desc.	Erosion channel forming in throat of water bar. Repair and stabilize.		Pic 6 Desc.	High water levels had knocked bridge mats out of place and to the edge of tree line.

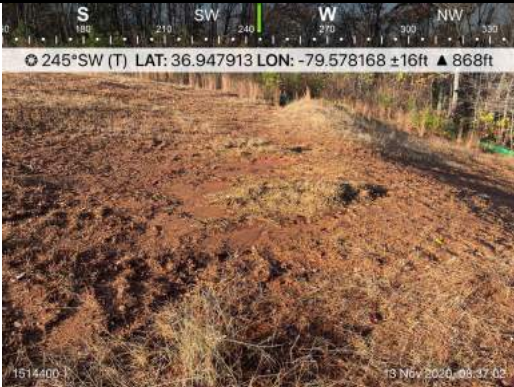
GPS Location	1	GPS Location	2		
Field Station#	15144+00	Field Station#	15144+00		
Pic 1 Desc.	Sediment and straw obstructing waterbar channel.	Pic 2 Desc.	Environmental crew on site has corrected this issue.

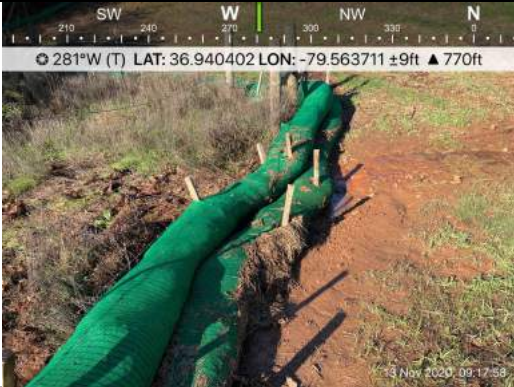
GPS Location	3	GPS Location	4		
Field Station#	15195+00	Field Station#	15195+00		
Pic 3 Desc.	CFS has been displaced and needs restaking.	Pic 4 Desc.	Environmental crew on site has corrected this issue.

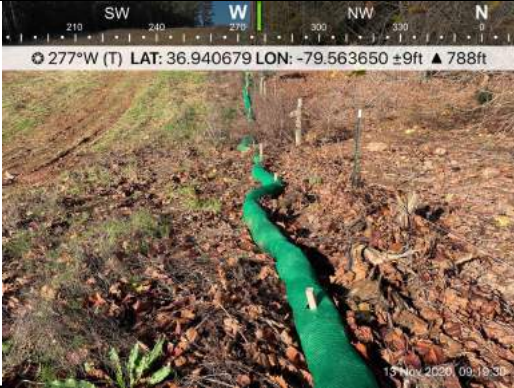
GPS Location	5	GPS Location	6		
Field Station#	15195+00	Field Station#	15195+00		
Pic 5 Desc.	CFS has been displaced and needs to be restaked.	Pic 6 Desc.	Environmental crew on site has corrected this issue.

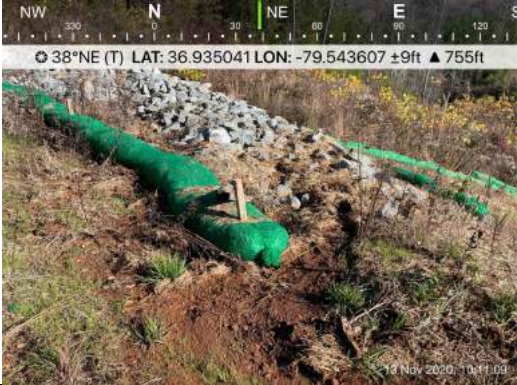
GPS Location	7	GPS Location	8		
Field Station#	15256+00	Field Station#	15256+00		
Pic 7 Desc.	Waterbar channel is obstructed by CFS.		Pic 8 Desc.	Environmental crew on site has stabilized has corrected this issue.

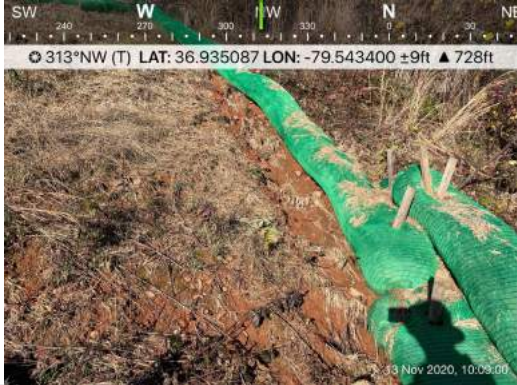
GPS Location	9	GPS Location	10		
Field Station#	15256+00	Field Station#	15256+00		
Pic 9 Desc.	Rill erosion along this CFS needs to be regraded.		Pic 10 Desc.	Environmental crew on site has corrected this issue.

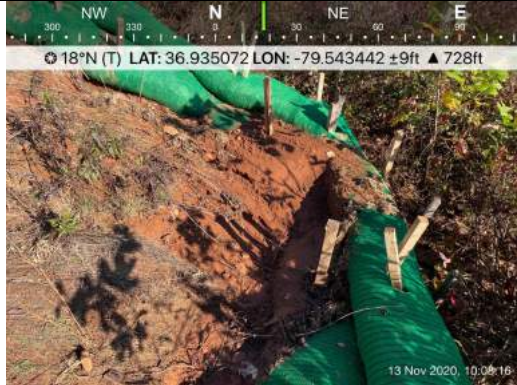
GPS Location	11	GPS Location	12		
Field Station#	15256+00	Field Station#	15256+00		
Pic 11 Desc.	Sediment obstructing CFS needs to be removed.		Pic 12 Desc.	Environmental crew on site has corrected this issue.

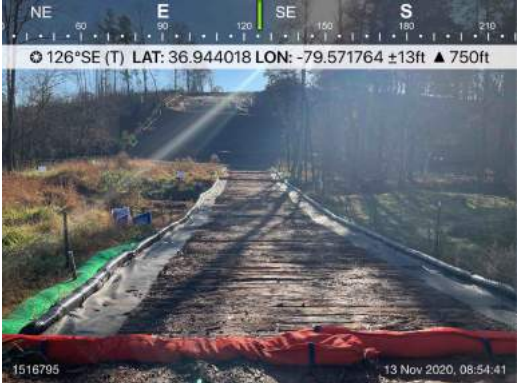
GPS Location	13	GPS Location			
Field Station#	15167+95	Field Station#			
Pic 13 Desc.	Equipment bridges throughout this section are in good condition with controls in place.	Pic 14 Desc.			
Insert image here		Insert image here			
GPS Location		GPS Location			
Field Station#		Field Station#			
Pic 15 Desc.		Pic 16 Desc.			
Insert image here		Insert image here			
GPS Location		GPS Location			
Field Station#		Field Station#			
Pic 17 Desc.		Pic 18 Desc.

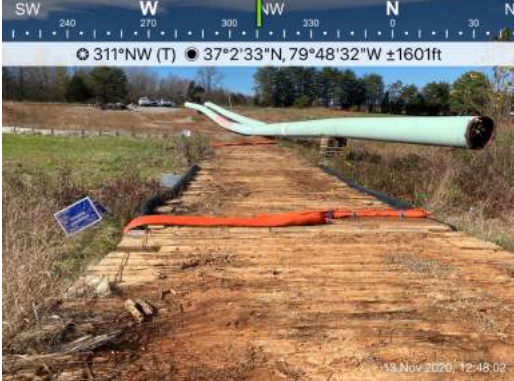
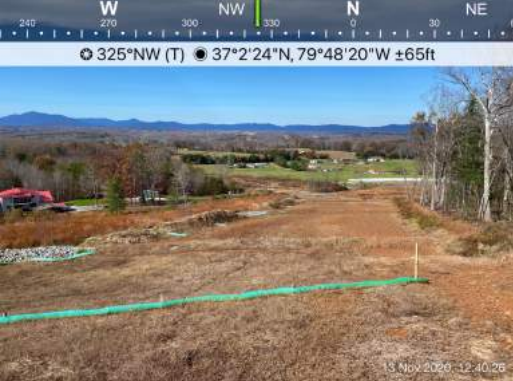
GPS Location	0	GPS Location	0		
Field Station#	14314+79	Field Station#	14330+00		
Pic 1 Desc.	Approximately 14314+79. Overview of stream, equipment bridge and ECDs at stream S-GG4.		Pic 2 Desc.	Approximately 14330+00. Overview of ROW. ROW temporarily stabilized and has temporary vegetation growing.
