# Visual Site Inspection Report

<b>Project Name</b>	H-600 Pipeline Spread I	<b>AFE</b>	124300139	<b>Spread</b>	H-600 Pipeline Spread I
<b>Contractor</b>	Precision			<b>Report #</b>	14635
<b>Inspector</b>	Logan Box			<b>Date/Time</b>	9/17/2020 5:19 PM
<b>Permit #</b>	TBD	<b>Inspection Type</b>	VA SWPP	<b>Station Begin</b>	13670+00
<b>State</b>	VA	<b>Inspection Area</b>	Full	<b>Station End</b>	13853+45
<b>County</b>	Franklin	<b>Ground</b>	Wet	<b>Temperature (°F)</b>	73.00
<b>Municipality</b>	N/A	<b>Weather</b>	Light Rain	<b>Rain Gauge (in)</b>	0.10
				<b>Rain Accumulation Time (days)</b>	6.00

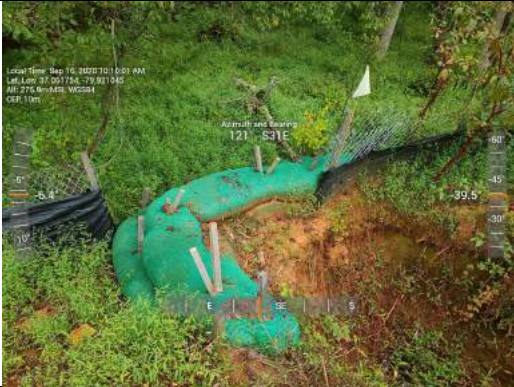
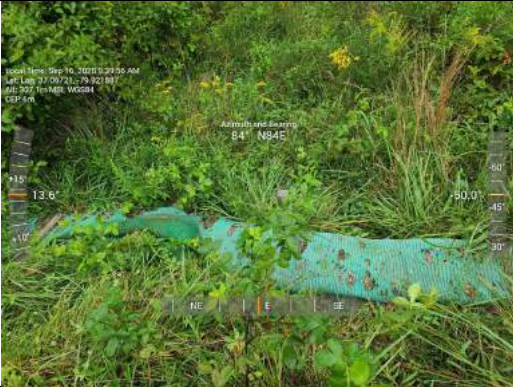
<b>GPS Location</b>	00000	<b>GPS Location</b>	00000		
<b>Field Station#</b>	13842+50	<b>Field Station#</b>	13822+00		
<b>Pic 1 Desc.</b>	CFS end treatment needs replaced	<b>Pic 2 Desc.</b>	CFS needs replaced

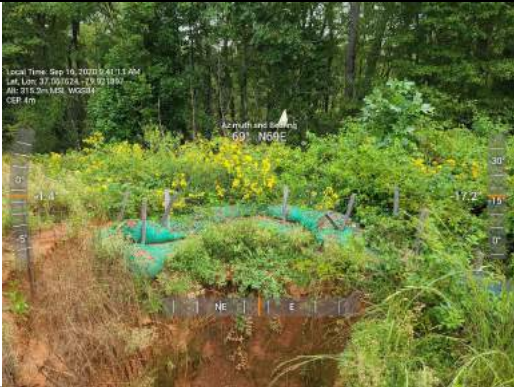
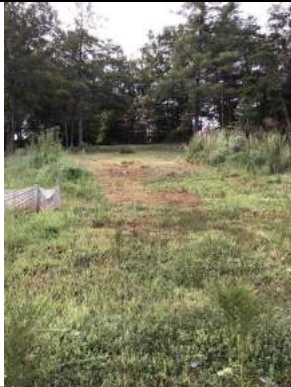
<b>GPS Location</b>	000000	<b>GPS Location</b>	0000		
<b>Field Station#</b>	13820+30	<b>Field Station#</b>	13812+00		
<b>Pic 3 Desc.</b>	CFS end treatment needs replaced	<b>Pic 4 Desc.</b>	Land owner mowed inside the work space at Brick Church rd crossing. Not project related		
Insert image here		Insert image here			
<b>GPS Location</b>		<b>GPS Location</b>			
<b>Field Station#</b>		<b>Field Station#</b>			
<b>Pic 5 Desc.</b>		<b>Pic 6 Desc.</b>

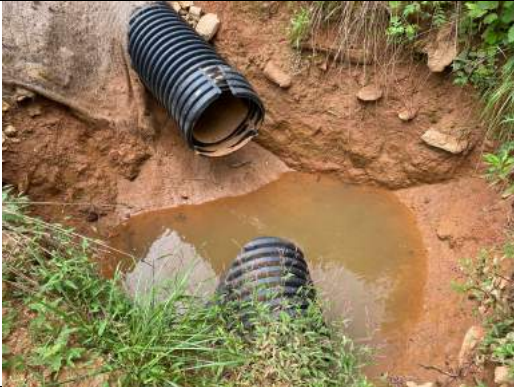
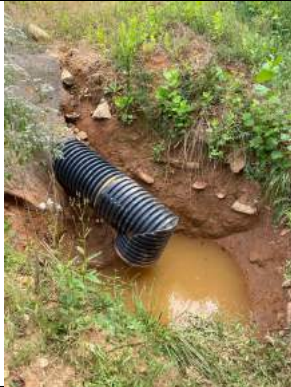
<b>GPS Location</b>	1	<b>GPS Location</b>	2		
<b>Field Station#</b>	15169+00	<b>Field Station#</b>	15169+00		
<b>Pic 1 Desc.</b>	Elbow on slope drain tile has fallen off into sump and needs reattached.		<b>Pic 2 Desc.</b>	Contractor repaired slope drain tile per punch list item.

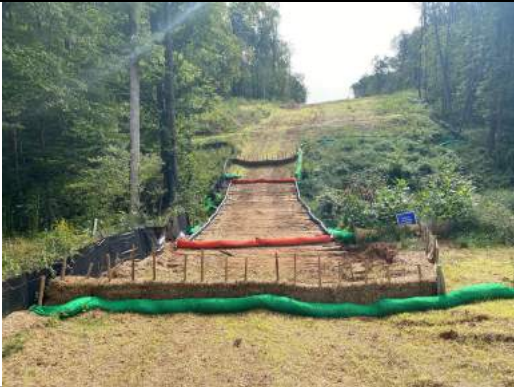
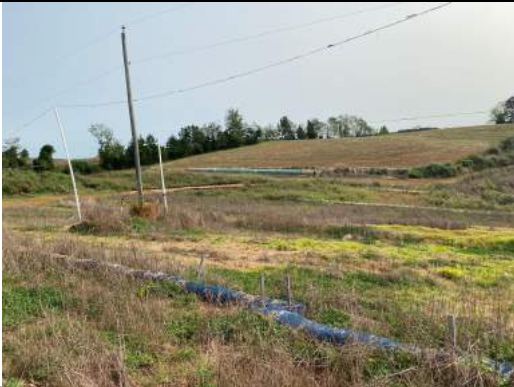
<b>GPS Location</b>	3	<b>GPS Location</b>	4		
<b>Field Station#</b>	15383+00	<b>Field Station#</b>	15298+00		
<b>Pic 3 Desc.</b>	Contractor installed multiple levels of ECD's leading into equipment bridge to prevent sediment from impacting stream.		<b>Pic 4 Desc.</b>	View of extra workspace near HDD Entry Site GAS Oxford Rd. No issues observed.

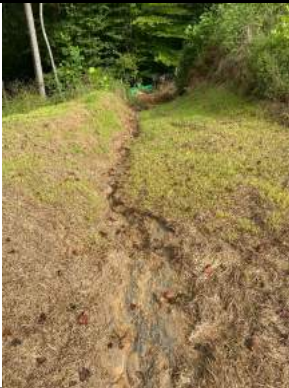
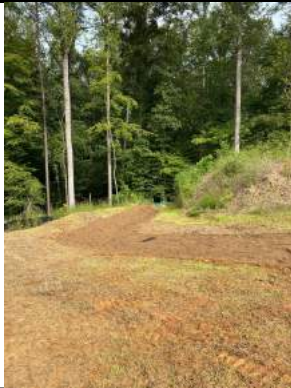
<b>GPS Location</b>	5	<b>GPS Location</b>	6		
<b>Field Station#</b>	15385+00	<b>Field Station#</b>	15385+00		
<b>Pic 5 Desc.</b>	Routine maintenance. Erosion channels forming down ROW. Area needs repaired and stabilized.		<b>Pic 6 Desc.</b>	Contractor installed erosion control blanket and seeded area per punch list item.

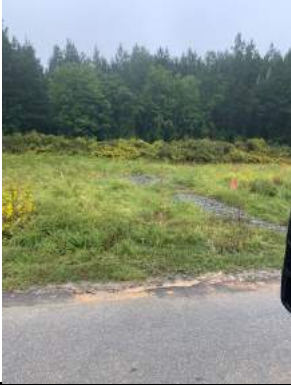
<b>GPS Location</b>	O		<b>GPS Location</b>	O	
<b>Field Station#</b>	14+00		<b>Field Station#</b>	22+00	
<b>Pic 1 Desc.</b>	Observing temporary vegetation and RCE.		<b>Pic 2 Desc.</b>	Observing temporary vegetation

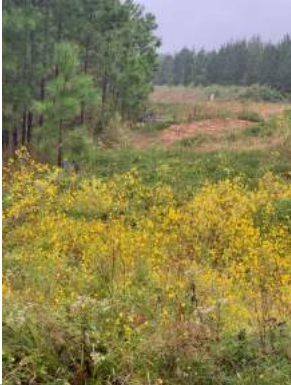
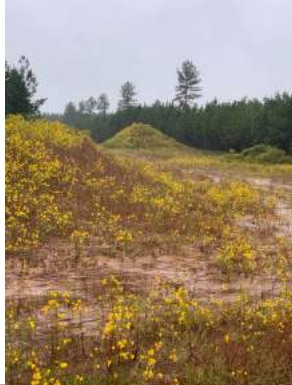
<b>GPS Location</b>	O		<b>GPS Location</b>	O	
<b>Field Station#</b>	13+50		<b>Field Station#</b>	4+00	
<b>Pic 3 Desc.</b>	Observing temporary vegetation.		<b>Pic 4 Desc.</b>	Observing temporary vegetation.	
Insert image here			Insert image here		
<b>GPS Location</b>			<b>GPS Location</b>		
<b>Field Station#</b>			<b>Field Station#</b>		
<b>Pic 5 Desc.</b>			<b>Pic 6 Desc.</b>

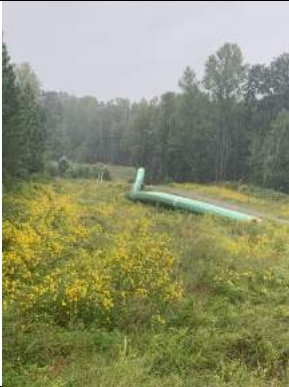
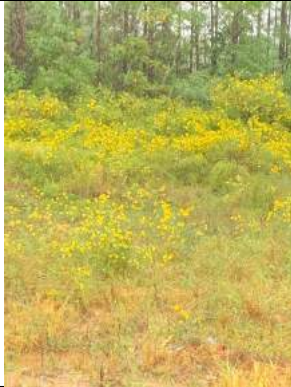
<b>GPS Location</b>	O	<b>GPS Location</b>	O		
<b>Field Station#</b>	9+00	<b>Field Station#</b>	6+00		
<b>Pic 1 Desc.</b>	Observing temporary vegetation.	<b>Pic 2 Desc.</b>	Observing temporary vegetation.

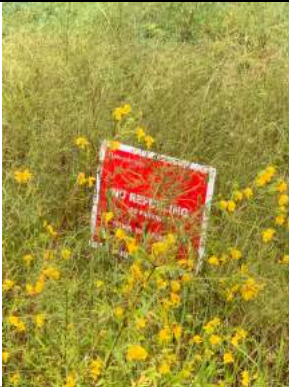
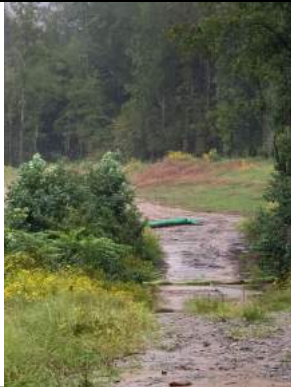
<b>GPS Location</b>	O	<b>GPS Location</b>	O		
<b>Field Station#</b>	11+00	<b>Field Station#</b>	12+45		
<b>Pic 3 Desc.</b>	Observing signage.	<b>Pic 4 Desc.</b>	Observing equipment crossing and ECD's performing as they should during the rain event.		
Insert image here			Insert image here		
<b>GPS Location</b>		<b>GPS Location</b>			
<b>Field Station#</b>		<b>Field Station#</b>			
<b>Pic 5 Desc.</b>		<b>Pic 6 Desc.</b>

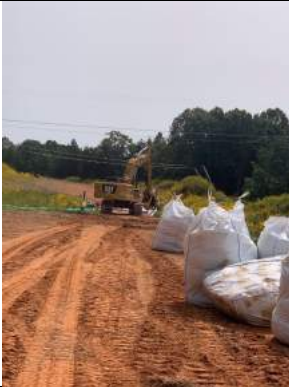
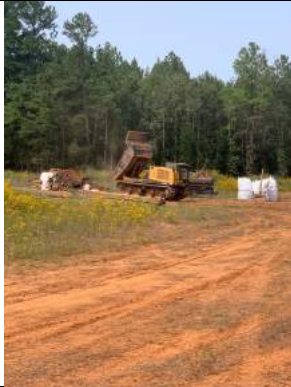
<b>GPS Location</b>	O		<b>GPS Location</b>	O	
<b>Field Station#</b>	15837+00		<b>Field Station#</b>	15855+00	
<b>Pic 1 Desc.</b>	Observing the Contractor performing ECD maintenance.		<b>Pic 2 Desc.</b>	Observing the Contractor stockpiling debris to be hauled off.

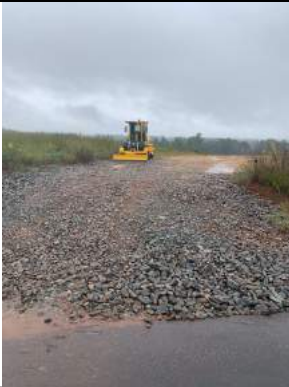
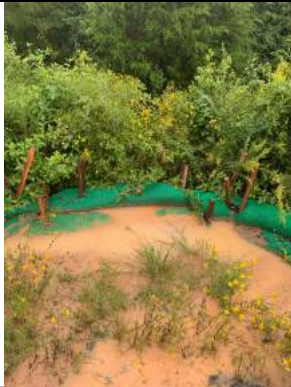
<b>GPS Location</b>	O		<b>GPS Location</b>	O	
<b>Field Station#</b>	15693+80		<b>Field Station#</b>	16026+00	
<b>Pic 3 Desc.</b>	Observing RCE performing as it should during the rain event.		<b>Pic 4 Desc.</b>	Observing CFS performing as it should during the rain event.	
Insert image here			Insert image here		
<b>GPS Location</b>			<b>GPS Location</b>		
<b>Field Station#</b>			<b>Field Station#</b>		
<b>Pic 5 Desc.</b>			<b>Pic 6 Desc.</b>

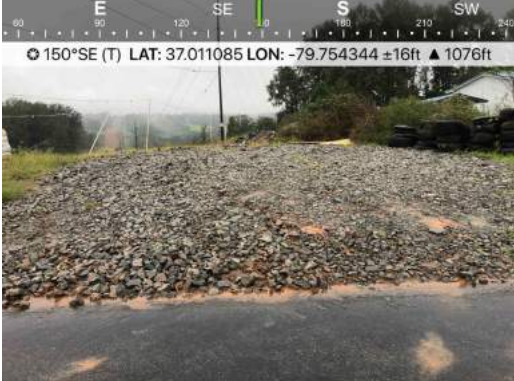
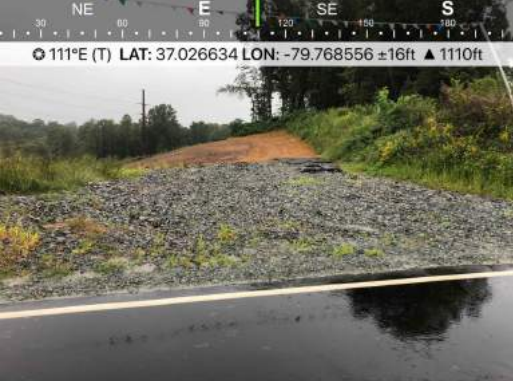
<b>GPS Location</b>	0	<b>GPS Location</b>	0		
<b>Field Station#</b>	14524+76	<b>Field Station#</b>	14454+22		
<b>Pic 1 Desc.</b>	RCE functioning as intended on the CIS of Timber Ridge Road	<b>Pic 2 Desc.</b>	RCE functioning as intended on the GAS of Webster Road

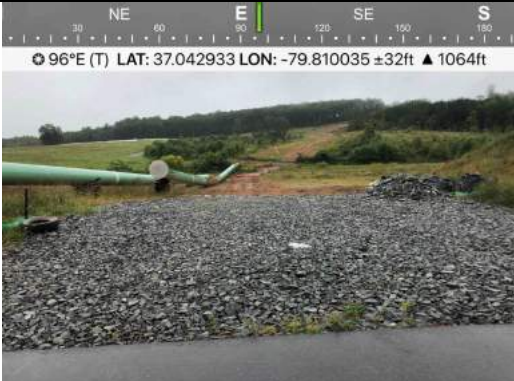
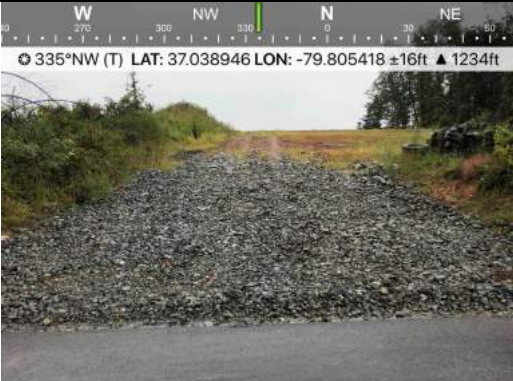
<b>GPS Location</b>	0	<b>GPS Location</b>	0		
<b>Field Station#</b>	14311+57	<b>Field Station#</b>	14333+27		
<b>Pic 3 Desc.</b>	RCE functioning as intended on the GAS of Farm View Road	<b>Pic 4 Desc.</b>	RCE functioning as intended on the CIS of Golden View Road

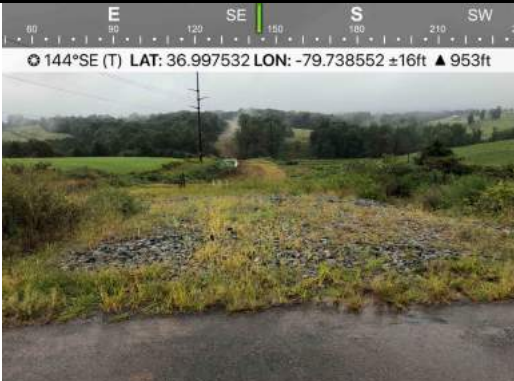
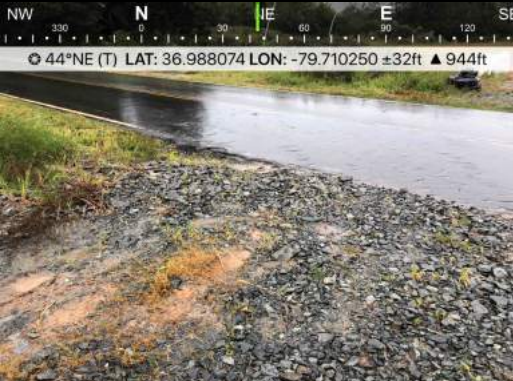
<b>GPS Location</b>	0	<b>GPS Location</b>	0		
<b>Field Station#</b>	14599+24	<b>Field Station#</b>	14694+77		
<b>Pic 5 Desc.</b>	RCE functioning as intended on the GAS of Simmons Creek Road	<b>Pic 6 Desc.</b>	RCE functioning as intended on the CIS of Jacks Creek Road

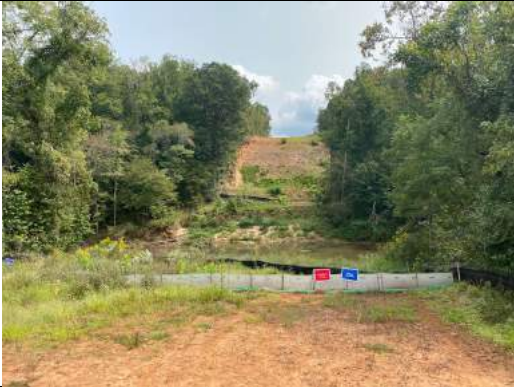
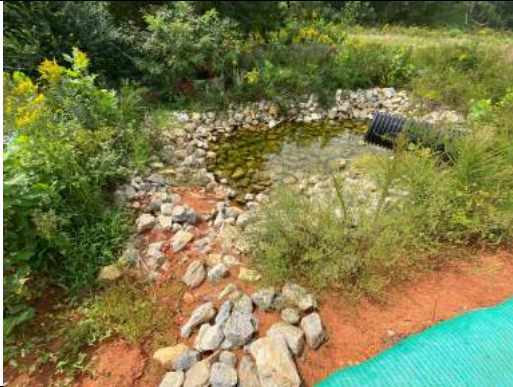
<b>GPS Location</b>	0	<b>GPS Location</b>	0		
<b>Field Station#</b>	14249+60	<b>Field Station#</b>	14236+50		
<b>Pic 1 Desc.</b>	Approximately 14249+60. Overview of stream and ECDs at stream S-F11.		<b>Pic 2 Desc.</b>	Approximately 14236+50. Overview of CWD piping and plunge pool. CWD piping and plunge pool appears to be installed and functioning correctly at time of inspection.

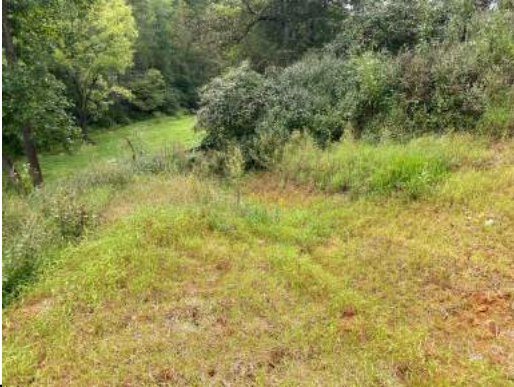
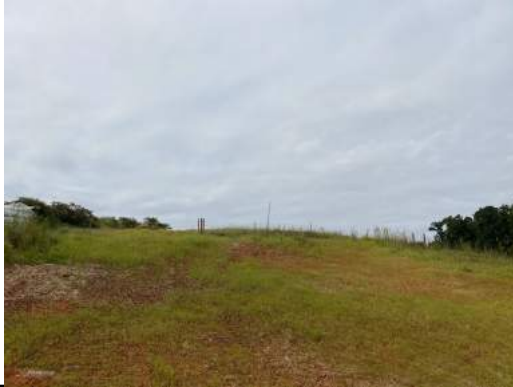
<b>GPS Location</b>	0	<b>GPS Location</b>	0		
<b>Field Station#</b>	14208+00	<b>Field Station#</b>	14205+25		
<b>Pic 3 Desc.</b>	Approximately 14208+00. Overview of ROW, water bar and sump. ROW temporarily stabilized and has temporary vegetation growing. Water bar and sump installed and		<b>Pic 4 Desc.</b>	Approximately 14205+25. Overview of ROW. ROW temporarily stabilized and has temporary vegetation growing.

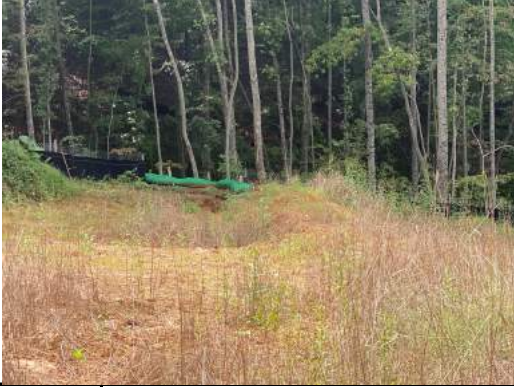
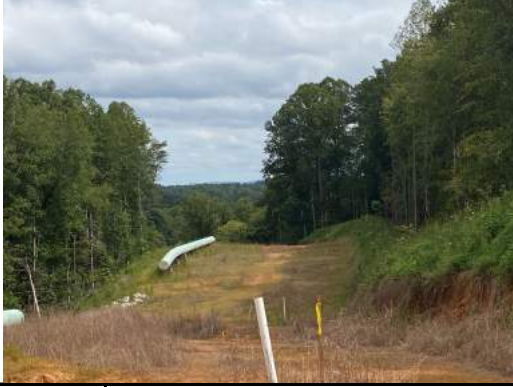
<b>GPS Location</b>	0	<b>GPS Location</b>	0		
<b>Field Station#</b>	14222+00	<b>Field Station#</b>	14227+00		
<b>Pic 5 Desc.</b>	Approximately 14220+00. Overview of ROW, water bar, sump and end treatment. ROW temporarily stabilized and has temporary vegetation growing. Water bar, sump and end		<b>Pic 6 Desc.</b>	Approximately 14227+00. Overview of ROW. ROW temporarily stabilized and has temporary vegetation growing.

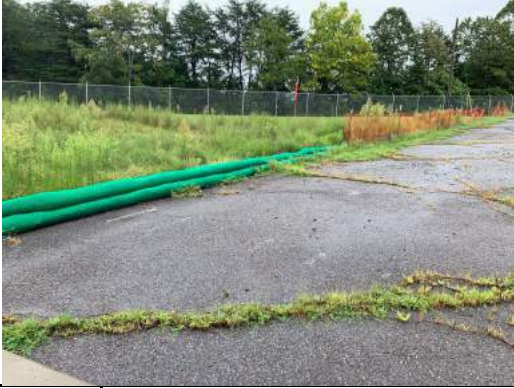
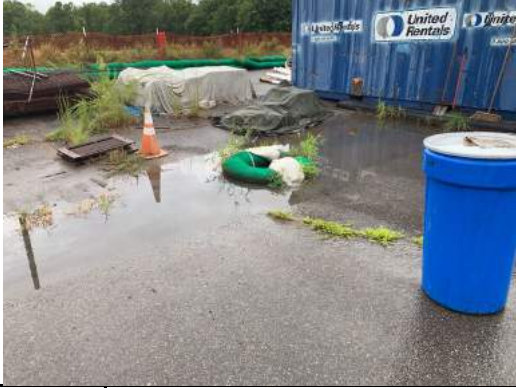
<b>GPS Location</b>	000000000000	<b>GPS Location</b>	000000000000		
<b>Field Station#</b>	0000+00	<b>Field Station#</b>	0000+00		
<b>Pic 1 Desc.</b>	Perimeter ECD's on north end of paved yard in good condition.	<b>Pic 2 Desc.</b>	Inlet protection for parking lot drain on north end of paved yard in good condition

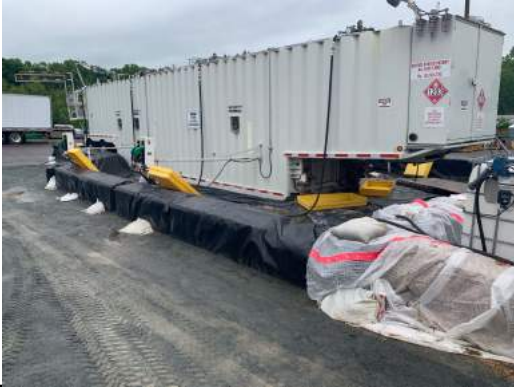
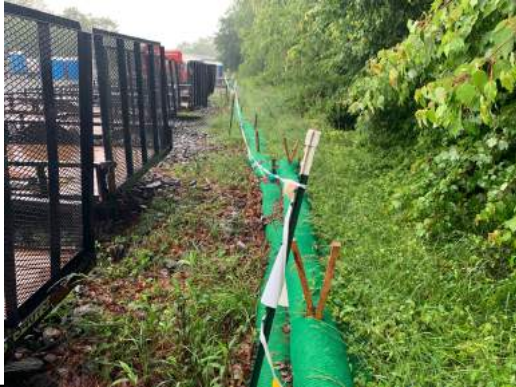
<b>GPS Location</b>	000000000000	<b>GPS Location</b>	000000000000		
<b>Field Station#</b>	0000+00	<b>Field Station#</b>	0000+00		
<b>Pic 3 Desc.</b>	Secondary containment structure for fuel cell in compliance.	<b>Pic 4 Desc.</b>	Perimeter ECD's on west side of gravel yard near employee parking area in good condition.		
Insert image here		Insert image here			
<b>GPS Location</b>		<b>GPS Location</b>			
<b>Field Station#</b>		<b>Field Station#</b>			
<b>Pic 5 Desc.</b>		<b>Pic 6 Desc.</b>

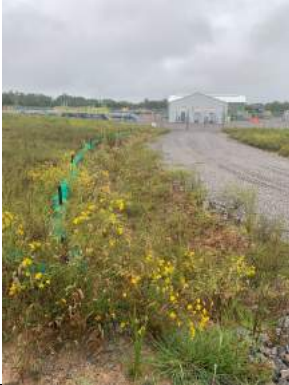
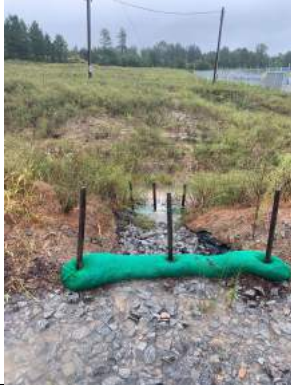
<b>GPS Location</b>	O	<b>GPS Location</b>	O		
<b>Field Station#</b>	00+00	<b>Field Station#</b>	00+00		
<b>Pic 1 Desc.</b>	Observing ECD's performing as they should during the rain event.	<b>Pic 2 Desc.</b>	Observing ECD's performing as they should during the rain event.

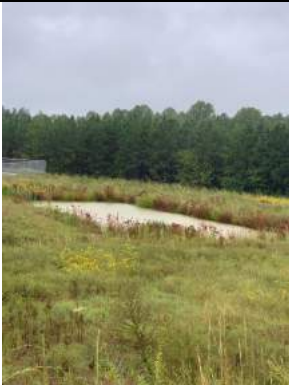
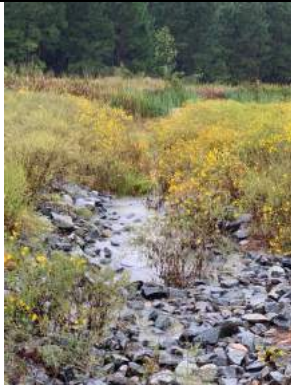
<b>GPS Location</b>	O	<b>GPS Location</b>	O		
<b>Field Station#</b>	00+00	<b>Field Station#</b>	00+00		
<b>Pic 3 Desc.</b>	Observing sediment basin performing as it should during the rain event.	<b>Pic 4 Desc.</b>	Observing ECD's performing as they should during the rain event.		
Insert image here			Insert image here		
<b>GPS Location</b>		<b>GPS Location</b>			
<b>Field Station#</b>		<b>Field Station#</b>			
<b>Pic 5 Desc.</b>		<b>Pic 6 Desc.</b>
