Visual Site Inspection Report

Project Name	H-600 Pipeline Spread I	AFE	124300139	Spread	H-600 Pipeline Spread I
Contractor	Precision			Report #	14997
Inspector	Ben Davenport			Date/Time	9/29/2020 9:11 AM
Permit #	TBD	Inspection Type	VA SWPP	Station Begin	15142+66
State	VA	Inspection Area	Partial	Station End	15584+23
County	Pittsylvania	Ground	Wet	Temperature (°F)	71.00
Municipality	Chatham	Weather	Cloudy	Rain Gauge (in)	1.60
				Rain Accumulation Time (days)	6.00

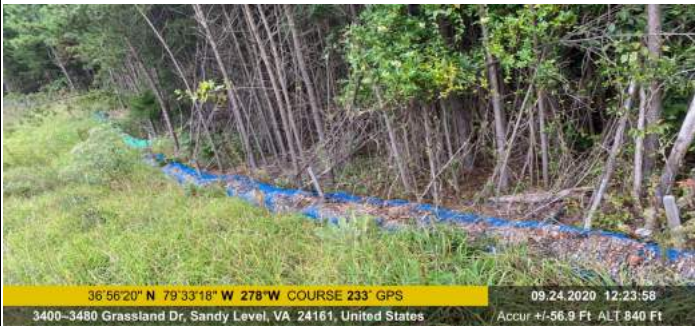
GPS Location	1	GPS Location	2		
Field Station#	15213+00	Field Station#	15250+00		
Pic 1 Desc.	Damaged/worn perimeter CFS needs replaced in final cleanup area		Pic 2 Desc.	Damaged/worn perimeter CFS needs replaced in final cleanup area

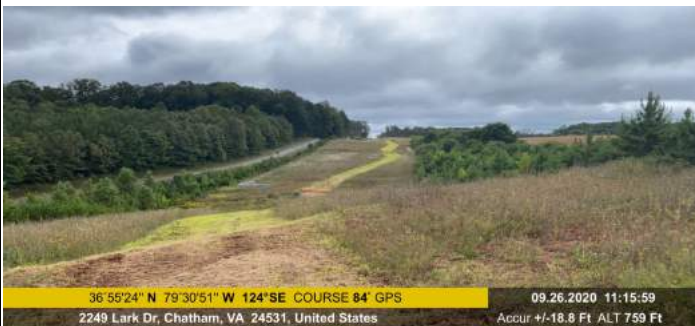
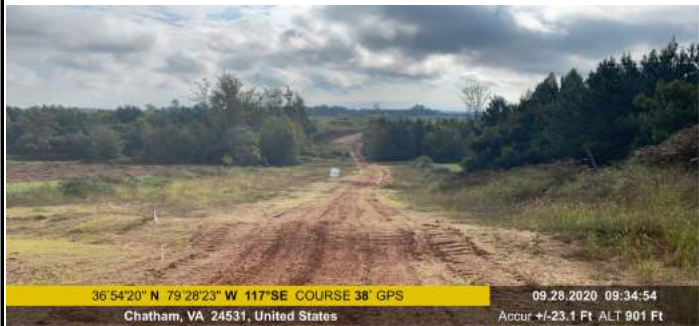
GPS Location	5	GPS Location	6		
Field Station#	15358+00	Field Station#	15501+00		
Pic 5 Desc.	Final cleanup area CIS Snowberry Rd. No issues observed at the time of inspection.		Pic 6 Desc.	Temporary stabilized area GAS Climax Rd. No issues observed at the time of inspection.

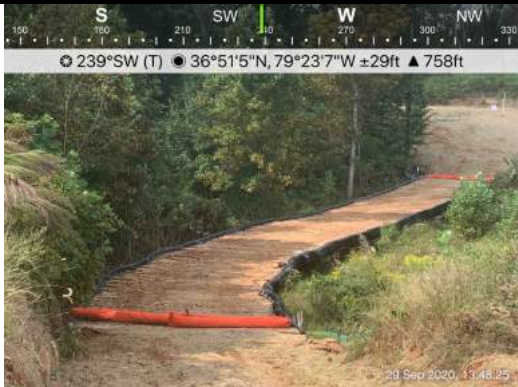
GPS Location	O	GPS Location	O		
Field Station#	15853+73	Field Station#	15852+88		
Pic 3 Desc.	Observing ECD's performing as they should.		Pic 4 Desc.	Observing equipment crossing, stabilized row and ECD's performing as they should.	
Insert image here			Insert image here		
GPS Location		GPS Location			
Field Station#		Field Station#			
Pic 5 Desc.			Pic 6 Desc.

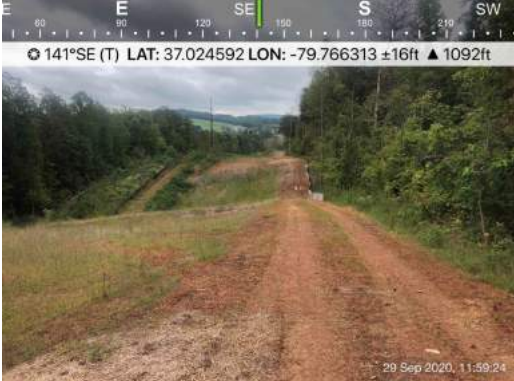
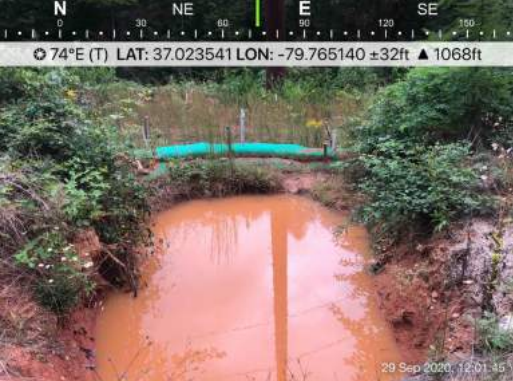
GPS Location	0	GPS Location	0		
Field Station#	14465+00	Field Station#	14475+00		
Pic 1 Desc.	Temporary stabilization on the GAS of Webster Road	Pic 2 Desc.	Sump pit functioning as intended on the GAS of Webster Road

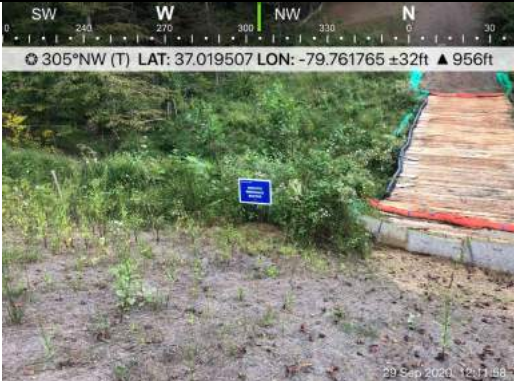
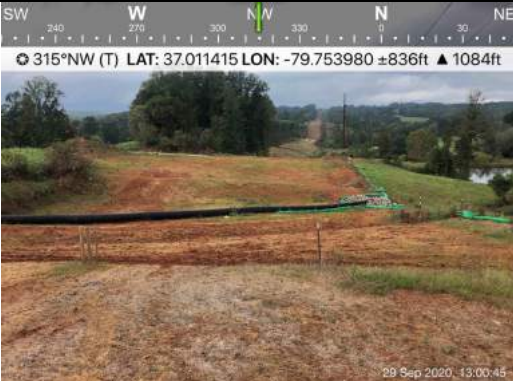
GPS Location	0	GPS Location	0		
Field Station#	14486+68	Field Station#	14520+00		
Pic 3 Desc.	Buffer zone signs were refreshed on the GAS of Webster Road	Pic 4 Desc.	Temporary stabilization functioning as intended on the CIS of Timber Ridge Road

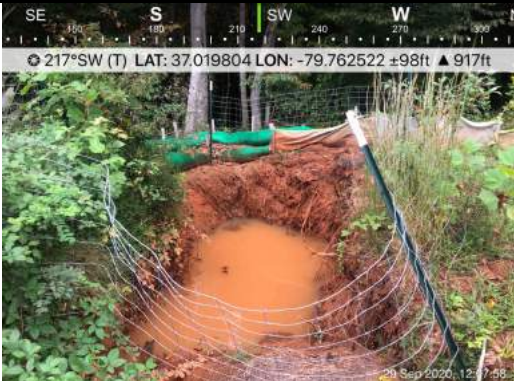
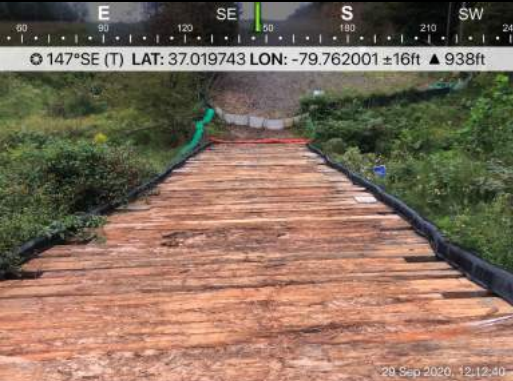
GPS Location	0	GPS Location	0		
Field Station#	14484+00	Field Station#	14486+56		
Pic 5 Desc.	Sump pit functioning as intended on the GAS of Webster Road	Pic 6 Desc.	Equipment bridge clean at stream S-G22

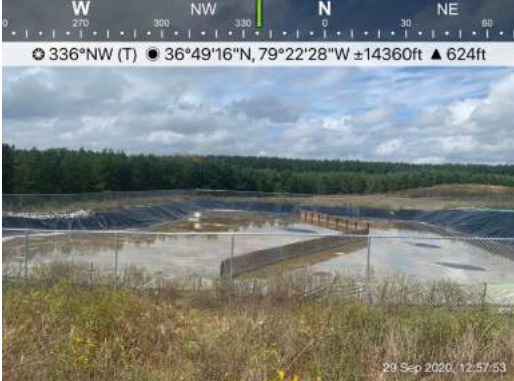
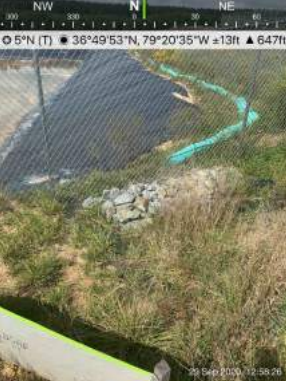
GPS Location	O	GPS Location	O		
Field Station#	00+00	Field Station#	00+00		
Pic 1 Desc.	Observing storm water pond and ECD's performing as they should.	Pic 2 Desc.	Observing ECD's performing as they should.

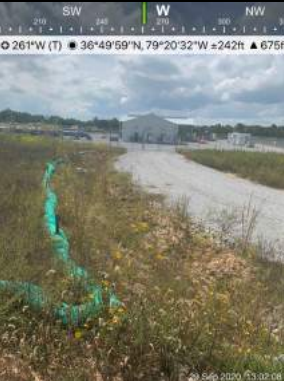
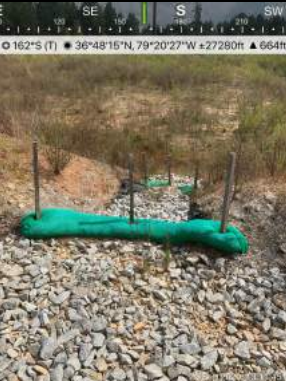
GPS Location	O	GPS Location	O		
Field Station#	00+00	Field Station#	00+00		
Pic 3 Desc.	Observing ECD's performing as they should.	Pic 4 Desc.	Observing ECD's performing as they should.		
Insert image here			Insert image here		
GPS Location		GPS Location			
Field Station#		Field Station#			
Pic 5 Desc.		Pic 6 Desc.
