Visual Site Inspection Report

Project Name	H-600 Pipeline Spread I	AFE	124300139	Spread	H-600 Pipeline Spread I
Contractor	Precision			Report #	14441
Inspector	Ben Davenport			Date/Time	9/11/2020 5:00 PM
Permit #	TBD	Inspection Type	VA SWPP	Station Begin	15142+66
State	VA	Inspection Area	Partial	Station End	15584+23
County	Pittsylvania	Ground	Wet	Temperature (°F)	82.00
Municipality	Chatham	Weather	Sunny	Rain Gauge (in)	0.10
				Rain Accumulation Time (days)	4.00

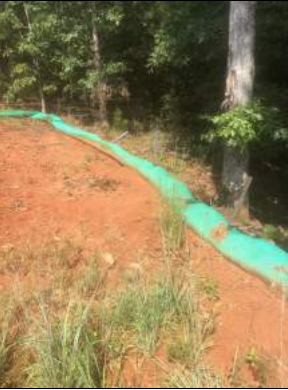
GPS Location	1	GPS Location	2		
Field Station#	15255+00	Field Station#	15255+00		
Pic 1 Desc.	Perimeter CFS undermining but sediment still within LOD staking. Sediment needed shoveled, CFS needed repaired, and area needed stabilized.		Pic 2 Desc.	Contractor performing environmental maintenance and completing punch list items as needed.

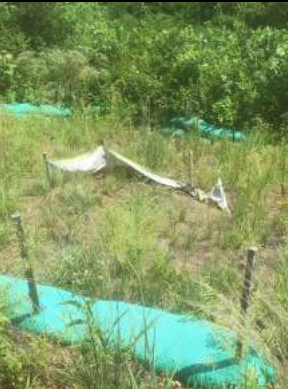
GPS Location	3	GPS Location	4		
Field Station#	15257+50	Field Station#	15257+50		
Pic 3 Desc.	Replace or repair damaged P1 silt fence.		Pic 4 Desc.	Contractor removed damaged P1 silt fence due to good vegetative growth in area with no signs of erosion occurring.

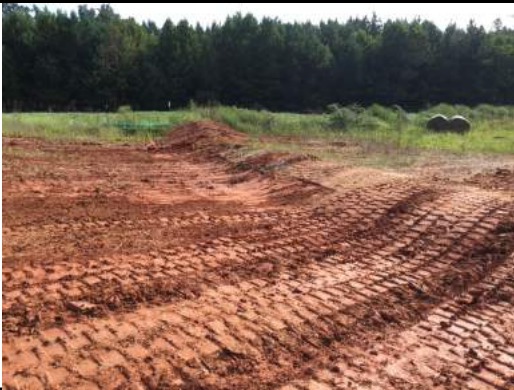
GPS Location	5	GPS Location	6		
Field Station#	15552+00	Field Station#	15318+00		
Pic 5 Desc.	Contractor rebuilt water bar to spec along ROW. Area was then seeded and stabilized.		Pic 6 Desc.	View of temporary vegetation growing once again CIS Lark Dr.

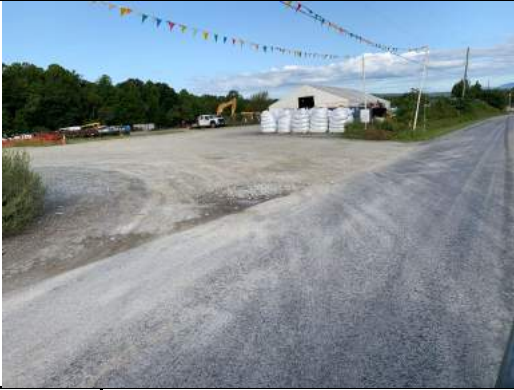
GPS Location	00000000000	GPS Location	00000000000		
Field Station#	0000+00	Field Station#	0000+00		
Pic 1 Desc.	RCE at gravel yard in acceptable condition.	Pic 2 Desc.	Perimeter ECD's on west side of gravel yard in good condition.

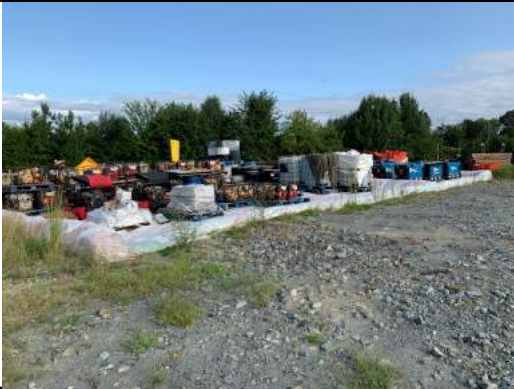
GPS Location	00000000000	GPS Location	00000000000		
Field Station#	0000+00	Field Station#	0000+00		
Pic 3 Desc.	Secondary containment structure on north end of gravel yard in good condition.	Pic 4 Desc.	Perimeter ECD's on west side of paved yard in acceptable condition

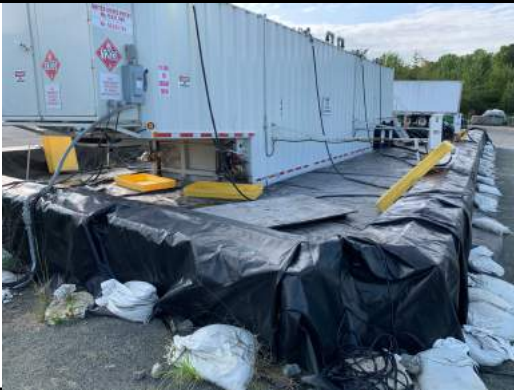
Insert image here			
GPS Location	00000000000	GPS Location			
Field Station#	0000+00	Field Station#			
Pic 5 Desc.	Secondary containment structure for fuel cell in compliance	Pic 6 Desc.

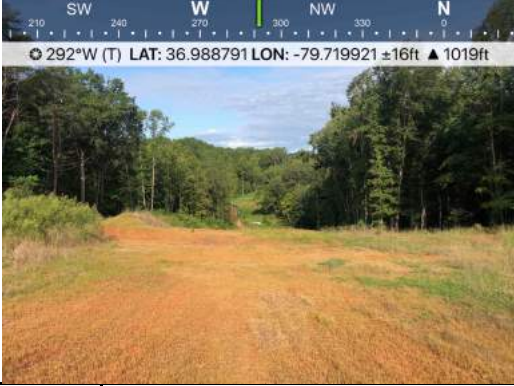
GPS Location	0	GPS Location	0		
Field Station#	14667+00	Field Station#	14665+00		
Pic 1 Desc.	Temporary stabilization on the GAS of Hwy 40		Pic 2 Desc.	Sump pit functioning as intended

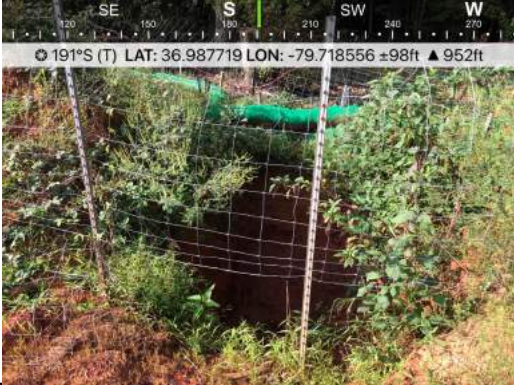
GPS Location	0	GPS Location	0		
Field Station#	14670+00	Field Station#	14673+10		
Pic 3 Desc.	Sump pit functioning as intended		Pic 4 Desc.	Equipment bridge clean at stream S-H37

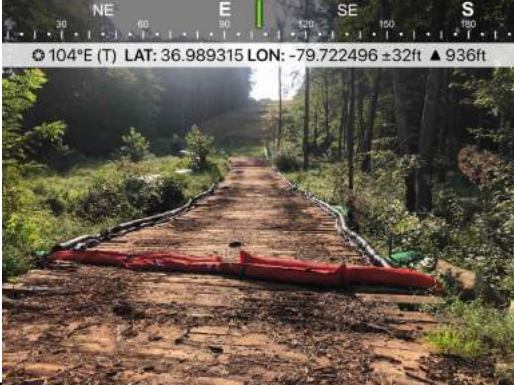
GPS Location	0	GPS Location	0		
Field Station#	14656+87	Field Station#	14655+00		
Pic 5 Desc.	Equipment bridge clean at stream S-H38		Pic 6 Desc.	Sump pit functioning as intended

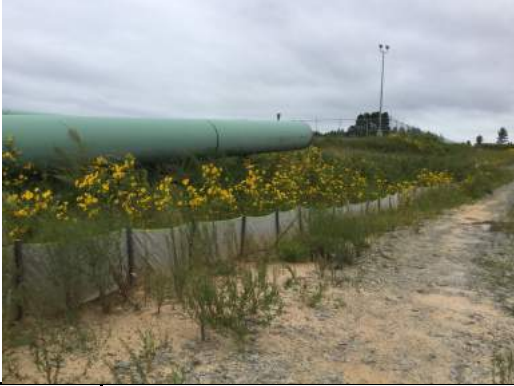
GPS Location	1	GPS Location	2		
Field Station#	17+50	Field Station#	12+65		
Pic 1 Desc.	P1 silt fence along access road in place and functional.	Pic 2 Desc.	Wattles across bridge have been run over but all ECD's in place and functional at S-H42

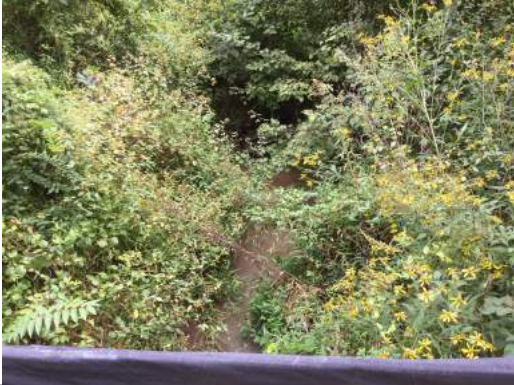
GPS Location	3	GPS Location	4		
Field Station#	12+65	Field Station#	12+65		
Pic 3 Desc.	Upstream view of S-H42	Pic 4 Desc.	Downstream view of S-H42		
Insert image here			Insert image here		
GPS Location		GPS Location			
Field Station#		Field Station#			
Pic 5 Desc.		Pic 6 Desc.

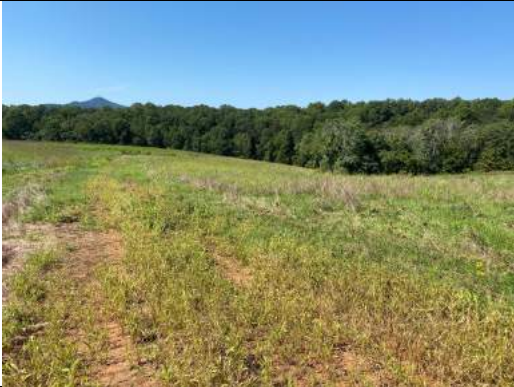
GPS Location	0	GPS Location	0		
Field Station#	14163+50	Field Station#	14157+55		
Pic 1 Desc.	Approximately 14163+50. Overview of ROW. ROW temporarily stabilized and has temporary vegetation growing.		Pic 2 Desc.	Approximately 14157+55. Overview of stream crossing, equipment bridge and ECDs at stream S-KL51.

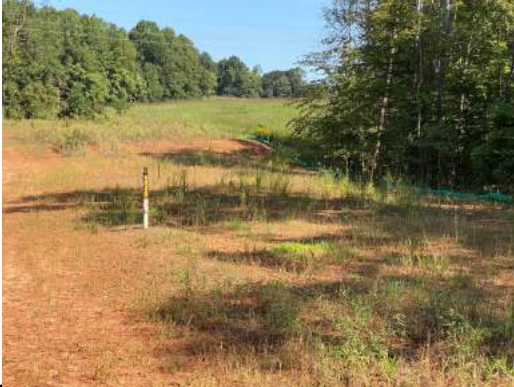
GPS Location	0	GPS Location	0		
Field Station#	14147+00	Field Station#	14131+50		
Pic 3 Desc.	Approximately 14147+00. Overview of ROW. ROW temporarily stabilized and has temporary vegetation growing.		Pic 4 Desc.	Approximately 14131+50. Overview of RCE. RCE appears to be installed and functioning correctly at time of inspection.

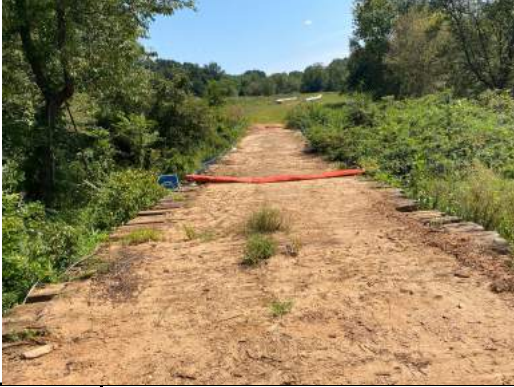
GPS Location	0	GPS Location	0		
Field Station#	13862+80	Field Station#	13877+50		
Pic 5 Desc.	Approximately 13862+80. Overview of stream crossing, equipment bridge and ECDs at stream S-C17.		Pic 6 Desc.	Approximately 13877+50. Overview of ROW. ROW temporarily stabilized and has temporary vegetation growing.

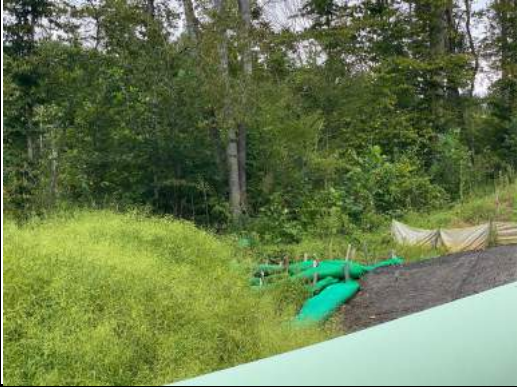
GPS Location	0	GPS Location	0		
Field Station#	13999+00	Field Station#	13904+00		
Pic 13 Desc.	Approximately 13999+00. Overview of ECDs and resource buffer downhill from adjacent pond overflow.		Pic 14 Desc.	Approximately 13904+00. Overview of ROW. ROW temporarily stabilized and has temporary vegetation growing.

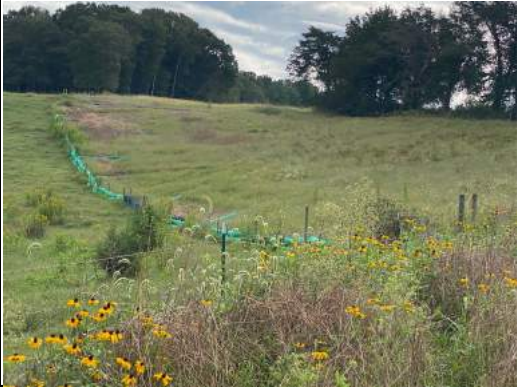
GPS Location	0	GPS Location	0		
Field Station#	13920+00	Field Station#	13934+00		
Pic 15 Desc.	Approximately 13920+00. Overview of ROW and ECDs. ROW temporarily stabilized and has temporary vegetation growing. ECDs installed and resource buffer formation in progress.		Pic 16 Desc.	Approximately 13934+00. Overview of ROW. ROW temporarily stabilized and has temporary vegetation growing.	
Insert image here			Insert image here		
GPS Location		GPS Location			
Field Station#		Field Station#			
Pic 17 Desc.			Pic 18 Desc.

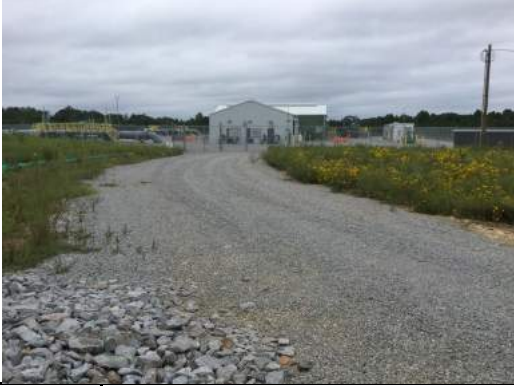
GPS Location	1	GPS Location	2		
Field Station#	0+00	Field Station#	0+00		
Pic 1 Desc.	Access road in good condition leading into Transco Interconnect Station		Pic 2 Desc.	All loose equipment and material is secured and surrounded by safety fence

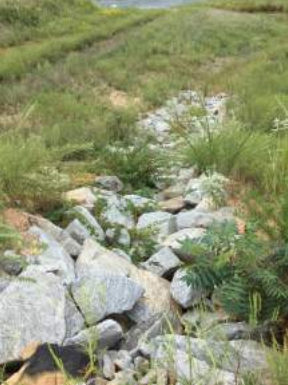
GPS Location	3	GPS Location	4		
Field Station#	0+00	Field Station#	0+00		
Pic 3 Desc.	Rock lined channel performing intended function.		Pic 4 Desc.	Spoil pile is stabilized with CFS surrounding it to prevent erosion.

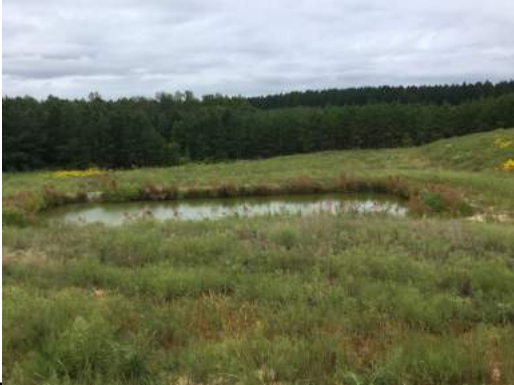
GPS Location	5	GPS Location	6		
Field Station#	0+00	Field Station#	0+00		
Pic 5 Desc.	Installed ECD's performing intended function. No issues observed.		Pic 6 Desc.	Extra workspace is rocked and no issues observed.
