# Visual Site Inspection Report

<b>Project Name</b>	H-600 Pipeline Spread I	<b>AFE</b>	124300139	<b>Spread</b>	H-600 Pipeline Spread I
<b>Contractor</b>	Precision			<b>Report #</b>	15213
<b>Inspector</b>	Justin Burch			<b>Date/Time</b>	10/5/2020 11:30 AM
<b>Permit #</b>	TBD	<b>Inspection Type</b>	VA SWPP	<b>Station Begin</b>	14694+77
<b>State</b>	VA	<b>Inspection Area</b>	Full	<b>Station End</b>	15142+66
<b>County</b>	Franklin/Pittsylvania	<b>Ground</b>	Damp	<b>Temperature (°F)</b>	68.00
<b>Municipality</b>	Chatham	<b>Weather</b>	Sunny	<b>Rain Gauge (in)</b>	1.20
				<b>Rain Accumulation Time (days)</b>	6.00

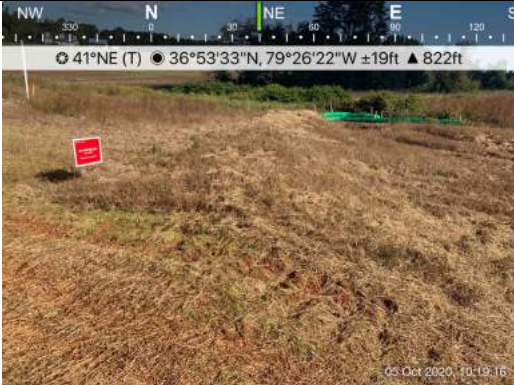
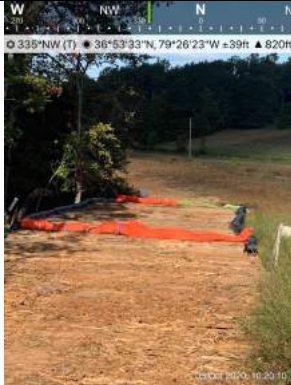
<b>GPS Location</b>	O	<b>GPS Location</b>	O		
<b>Field Station#</b>	15615+50	<b>Field Station#</b>	15614+94		
<b>Pic 1 Desc.</b>	Observing signage, breaker,end treatment and temporary stabilization.	<b>Pic 2 Desc.</b>	Observing equipment crossing and ECD's performing as they should.

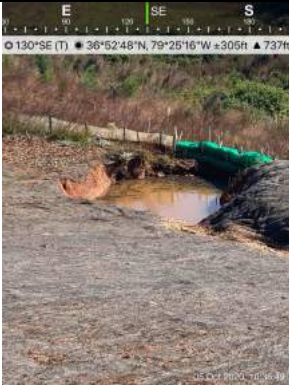
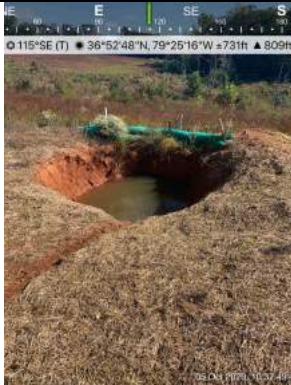
<b>GPS Location</b>	O	<b>GPS Location</b>	O		
<b>Field Station#</b>	15695+50	<b>Field Station#</b>	15618+00		
<b>Pic 3 Desc.</b>	Observing sump,end treatment and p1 performing as they should.	<b>Pic 4 Desc.</b>	Observing sump and end treatment performing as they should.

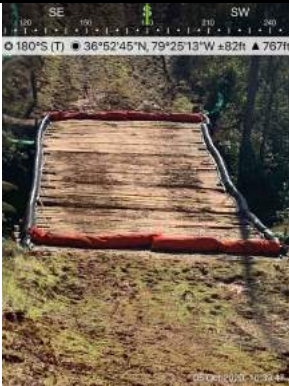
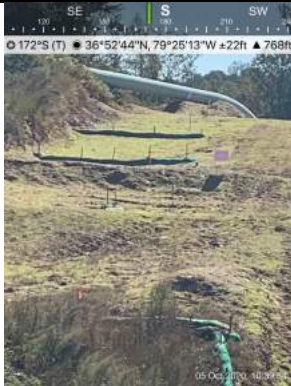
<b>GPS Location</b>	O	<b>GPS Location</b>	O		
<b>Field Station#</b>	15700+40	<b>Field Station#</b>	15702+00		
<b>Pic 5 Desc.</b>	Observing equipment crossing and ECD's performing as they should.	<b>Pic 6 Desc.</b>	Observing temporary vegetation and ECD's performing as they should.

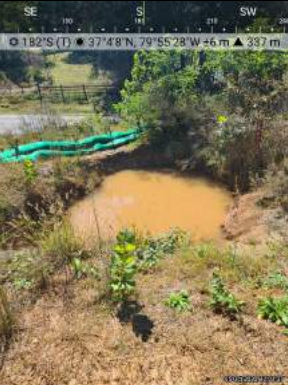
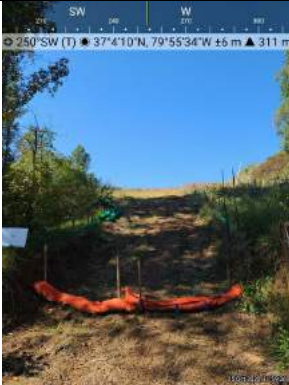
<b>GPS Location</b>	00000	<b>GPS Location</b>	00000		
<b>Field Station#</b>	13811+66	<b>Field Station#</b>	13805+66		
<b>Pic 1 Desc.</b>	Monitored sump pit and end treatment. No environmental issues observed at the time of inspection		<b>Pic 2 Desc.</b>	Row photo showing ECDs in place and functioning at the time of inspection

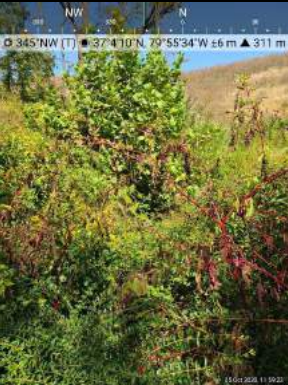
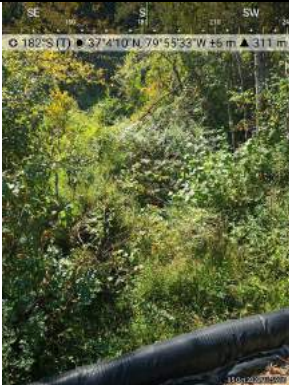
<b>GPS Location</b>	000000	<b>GPS Location</b>	000000		
<b>Field Station#</b>	13805+69	<b>Field Station#</b>	13805+69		
<b>Pic 3 Desc.</b>	Stream observation photo facing upstream. No environmental issues observed at the time of inspection		<b>Pic 4 Desc.</b>	Stream observation photo facing downstream	
Insert image here			Insert image here		
<b>GPS Location</b>		<b>GPS Location</b>			
<b>Field Station#</b>		<b>Field Station#</b>			
<b>Pic 5 Desc.</b>			<b>Pic 6 Desc.</b>

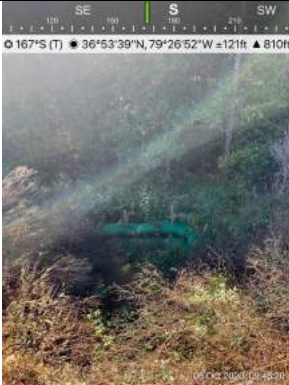
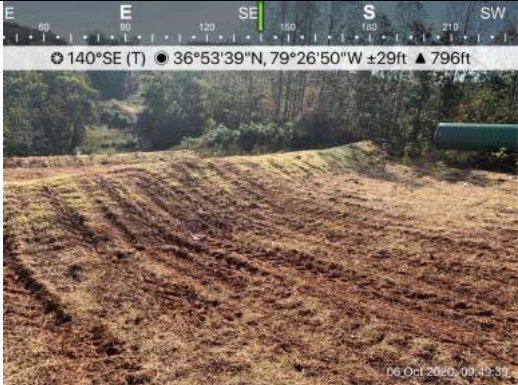
<b>GPS Location</b>	O	<b>GPS Location</b>	O		
<b>Field Station#</b>	15589+00	<b>Field Station#</b>	15593+00		
<b>Pic 1 Desc.</b>	Observing sump and end treatment.	<b>Pic 2 Desc.</b>	Observing water bar and new temporary vegetation.

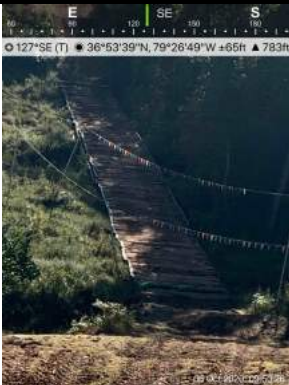
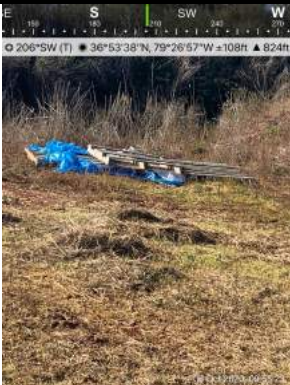
<b>GPS Location</b>	O	<b>GPS Location</b>	O		
<b>Field Station#</b>	15596+79	<b>Field Station#</b>	15585+00		
<b>Pic 3 Desc.</b>	Observing equipment crossing and ECD's performing as they should.	<b>Pic 4 Desc.</b>	Observing trash that needs to be removed from the ROW.

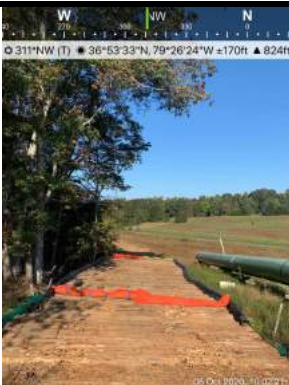
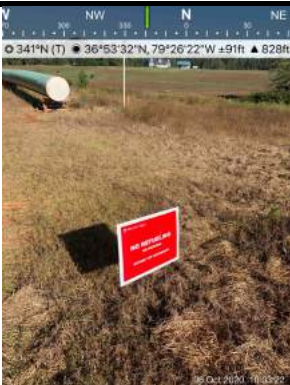
<b>GPS Location</b>	O	<b>GPS Location</b>	O		
<b>Field Station#</b>	15614+94	<b>Field Station#</b>	15616+00		
<b>Pic 5 Desc.</b>	Observing equipment crossing and ECD's performing as they should.	<b>Pic 6 Desc.</b>	Observing signage and temporary vegetation.

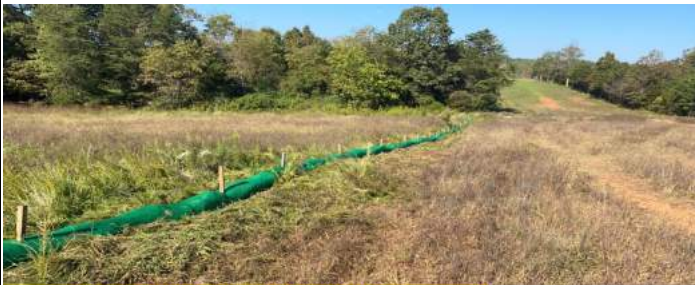
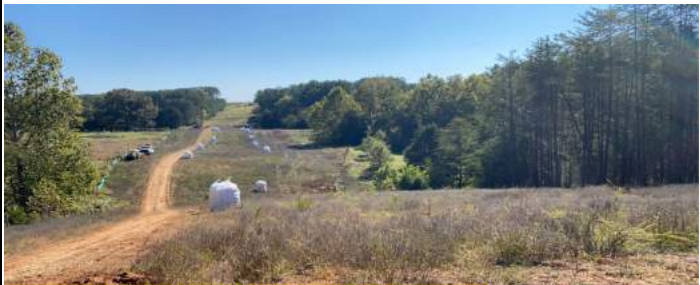
<b>GPS Location</b>	3	<b>GPS Location</b>	4		
<b>Field Station#</b>	15188+00	<b>Field Station#</b>	15194+00		
<b>Pic 3 Desc.</b>	Perimeter CFS replaced by contractor in final cleanup area.		<b>Pic 4 Desc.</b>	Materials being staged by contractor to replace perimeter CFS in final cleanup area.

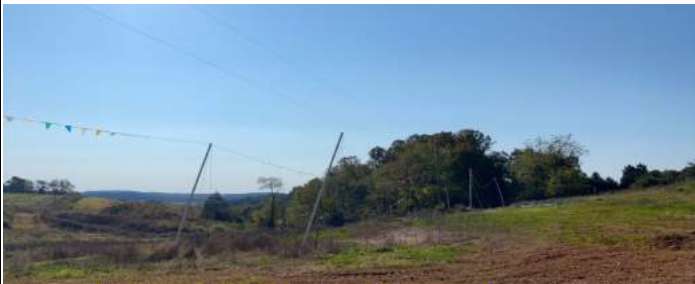
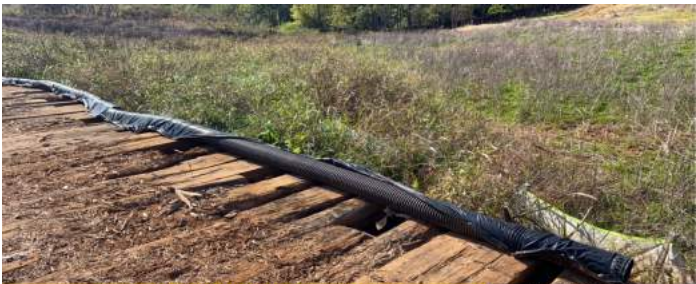
36°55'56" N 79°31'51" W 209°SW COURSE 171' GPS Chatham, VA 24531, United States 10.07.2020 10:18:48 Accur +/-20.0 Ft ALT 771 Ft			36°55'56" N 79°31'49" W 250°W COURSE 77' GPS Chatham, VA 24531, United States 10.07.2020 10:16:30 Accur +/-89.6 Ft ALT 750 Ft		
<b>GPS Location</b>	1	<b>GPS Location</b>	2		
<b>Field Station#</b>	15298+00	<b>Field Station#</b>	15299+50		
<b>Pic 1 Desc.</b>	Routine maintenance. Goalposts down across ROW. Needs repaired.		<b>Pic 2 Desc.</b>	Ineffective ESC measure. Geotextile fabric at equipment bridge needs nailed back down onto bridge mats.

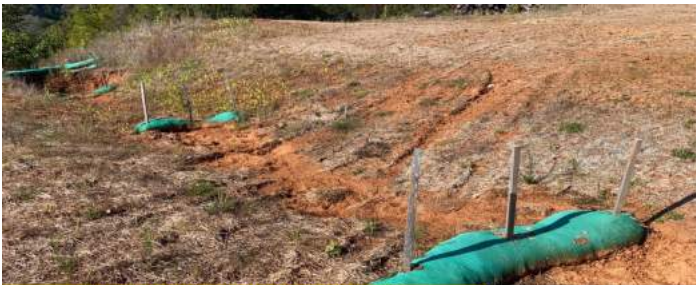
<b>GPS Location</b>	3	<b>GPS Location</b>	4		
<b>Field Station#</b>	15299+00	<b>Field Station#</b>	15322+00		
<b>Pic 3 Desc.</b>	Routine maintenance. Replace torn P1 silt fence from cattle damage.		<b>Pic 4 Desc.</b>	Ineffective ESC measure. CFS check dams torn and not filtering properly. Sediment/water flowing around checks creating erosion channel. Replace.

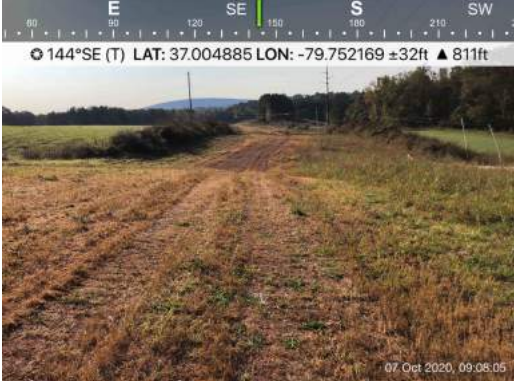
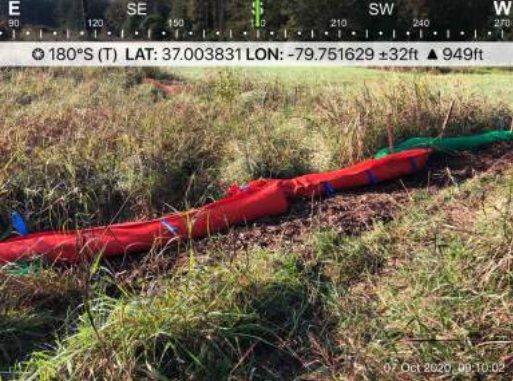
<b>GPS Location</b>	0	<b>GPS Location</b>	0		
<b>Field Station#</b>	14550+00	<b>Field Station#</b>	14553+00		
<b>Pic 1 Desc.</b>	Temporary stabilization on the GAS of Tobacco Road	<b>Pic 2 Desc.</b>	Perimeter CFS replaced that was damaged by land owner crossing

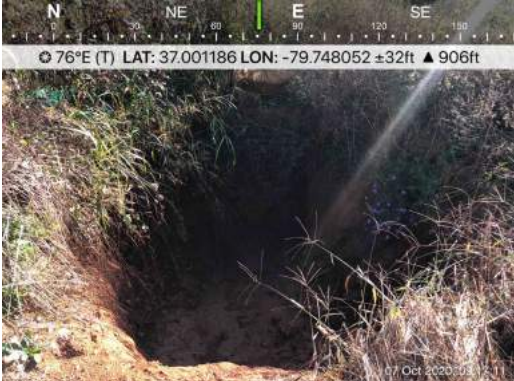
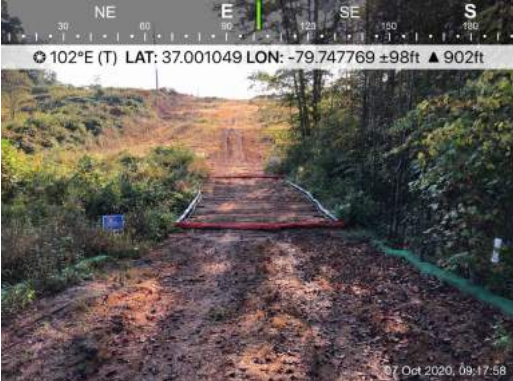
<b>GPS Location</b>	0	<b>GPS Location</b>	0		
<b>Field Station#</b>	14566+00	<b>Field Station#</b>	14568+10		
<b>Pic 3 Desc.</b>	Sump pit functioning as intended on the GAS of Tobacco Road	<b>Pic 4 Desc.</b>	Equipment bridge clean at stream S-E18

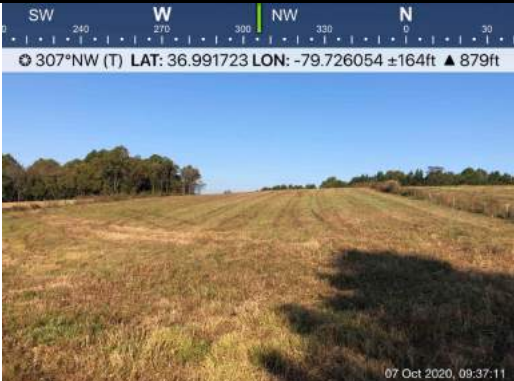
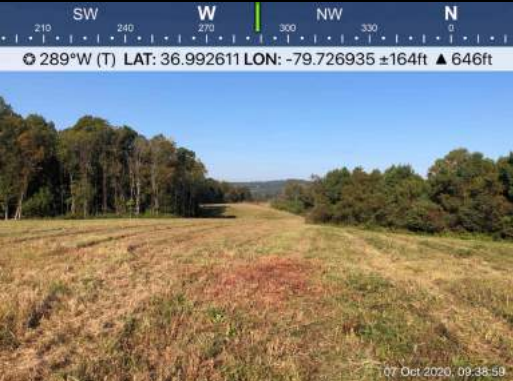
<b>GPS Location</b>	0	<b>GPS Location</b>	0		
<b>Field Station#</b>	14641+00	<b>Field Station#</b>	14637+00		
<b>Pic 5 Desc.</b>	Permanent stabiliziaon on the CIS of Brooks Mill Road	<b>Pic 6 Desc.</b>	Permanent Stabilization on the CIS of Brooks Mill Road

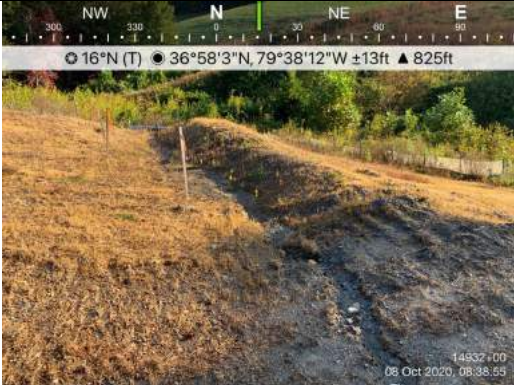
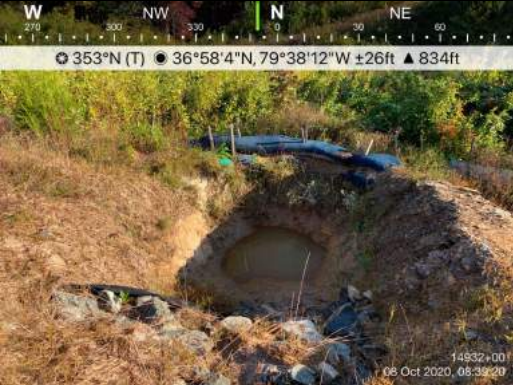
<b>GPS Location</b>	0	<b>GPS Location</b>	0		
<b>Field Station#</b>	14932+00	<b>Field Station#</b>	14932+00		
<b>Pic 1 Desc.</b>	Waterbar in acceptable condition		<b>Pic 2 Desc.</b>	Waterbar end treatment in acceptable condition

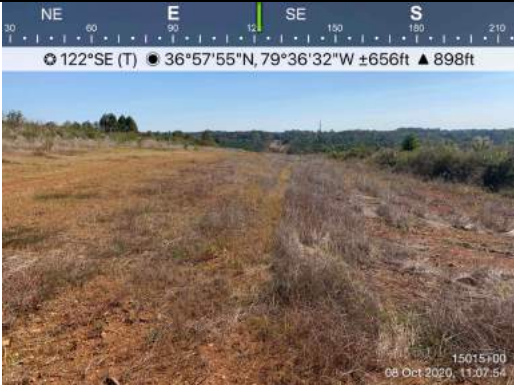
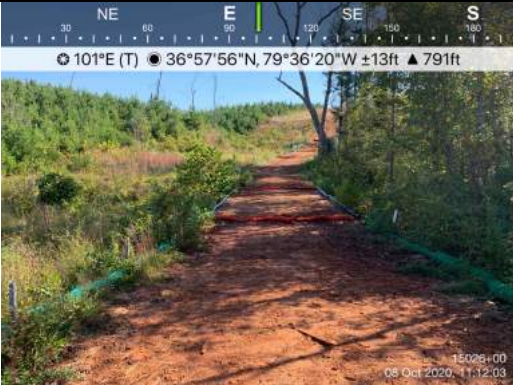
<b>GPS Location</b>	0	<b>GPS Location</b>	0		
<b>Field Station#</b>	15015+00	<b>Field Station#</b>	15026+00		
<b>Pic 3 Desc.</b>	Temporary vegetative stabilization in acceptable condition		<b>Pic 4 Desc.</b>	Equipment bridge in acceptable condition

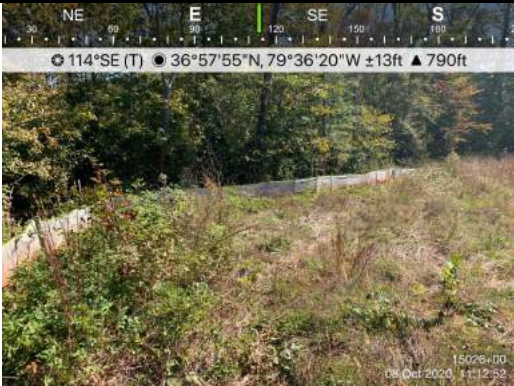
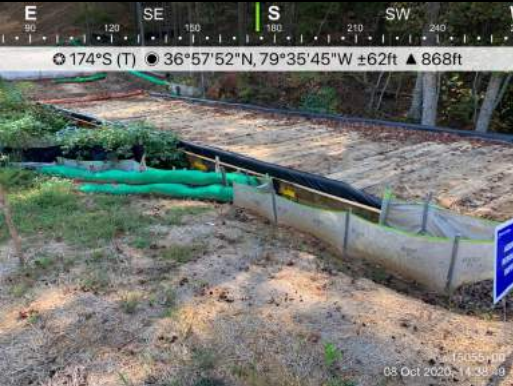
<b>GPS Location</b>	0	<b>GPS Location</b>	0		
<b>Field Station#</b>	15026+00	<b>Field Station#</b>	15055+00		
<b>Pic 5 Desc.</b>	P1 silt fence in acceptable condition		<b>Pic 6 Desc.</b>	CFS in acceptable condition

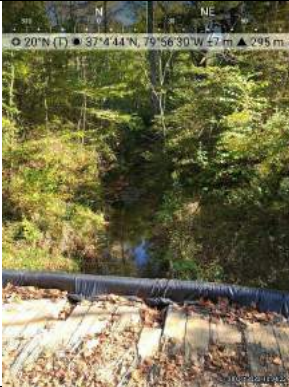
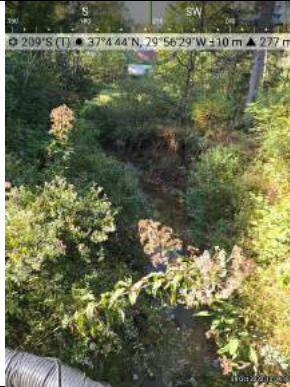
<b>GPS Location</b>	00000	<b>GPS Location</b>	0000		
<b>Field Station#</b>	13728+11	<b>Field Station#</b>	13728+11		
<b>Pic 1 Desc.</b>	Stream observation photo facing up stream during routine row inspection. The EI did not notice any environmental issues at the time of inspection.		<b>Pic 2 Desc.</b>	Stream observation photo facing downstream during routine row inspection. The EI did not notice any environmental issues at the time of inspection.

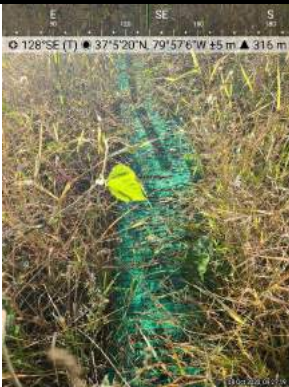
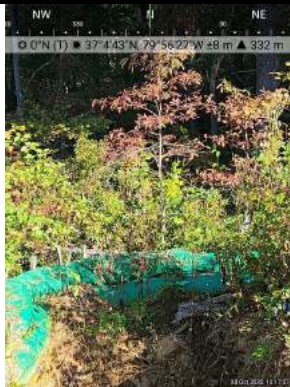
<b>GPS Location</b>	000000	<b>GPS Location</b>	000000		
<b>Field Station#</b>	13676+00	<b>Field Station#</b>	13731+00		
<b>Pic 3 Desc.</b>	The EI noticed during routine inspection that a section of CFS was in need of replacing, the EI Documented and sent in to be added to the punch list.		<b>Pic 4 Desc.</b>	The EI noticed CFS end treatment needed replaced, added to the punch list

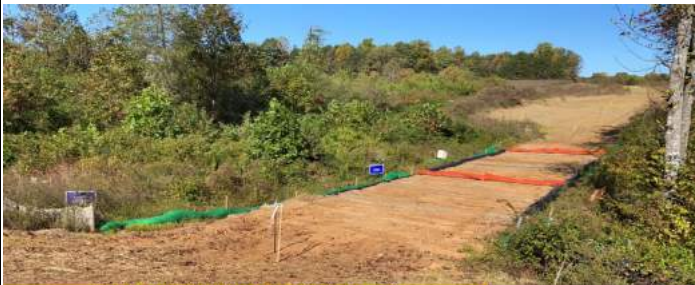
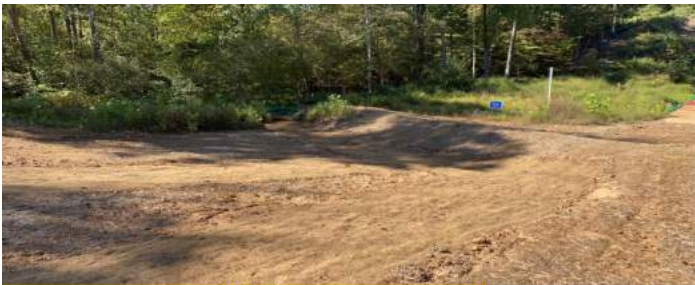
Pic 3 Desc.	Signage updated at stream crossing in covered area.		Pic 4 Desc.	Erosion control blanket installed on slopes where erosion was occurring per previous punch list identification. No erosion observed and will monitor for signs of new vegetation.

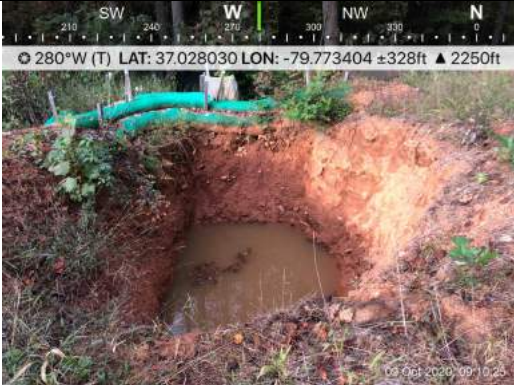
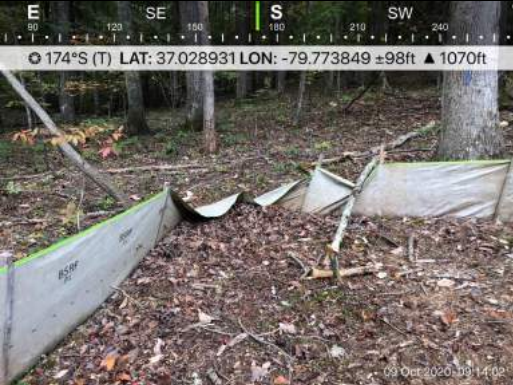
<b>GPS Location</b>	0	<b>GPS Location</b>	0		
<b>Field Station#</b>	14442+00	<b>Field Station#</b>	14437+00		
<b>Pic 1 Desc.</b>	Sump pit functioning as intended on the CIS of Webster Road	<b>Pic 2 Desc.</b>	P1 silt fence damaged and requires maintenance

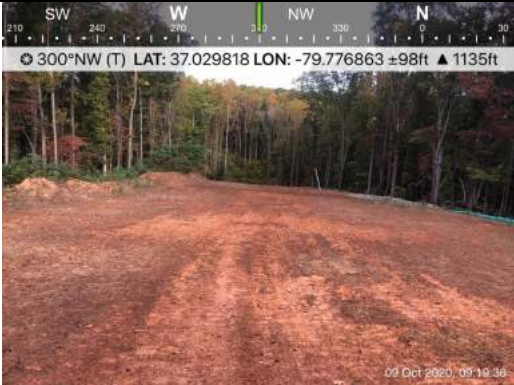
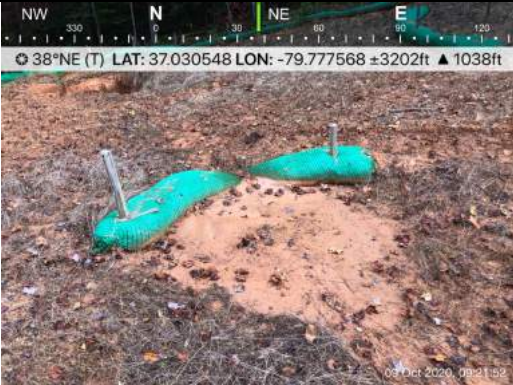
<b>GPS Location</b>	0	<b>GPS Location</b>	0		
<b>Field Station#</b>	14430+00	<b>Field Station#</b>	14423+00		
<b>Pic 3 Desc.</b>	Temporary stabilization on the CIS of Webster Road	<b>Pic 4 Desc.</b>	CFS check dam full and requires maintenance

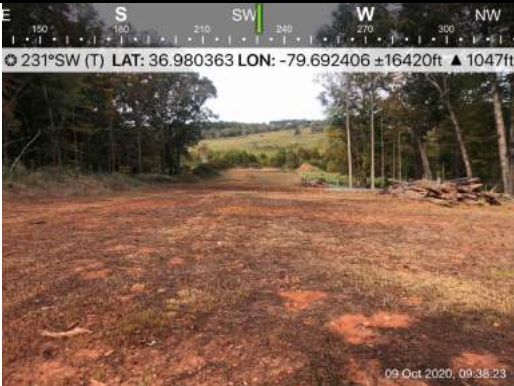
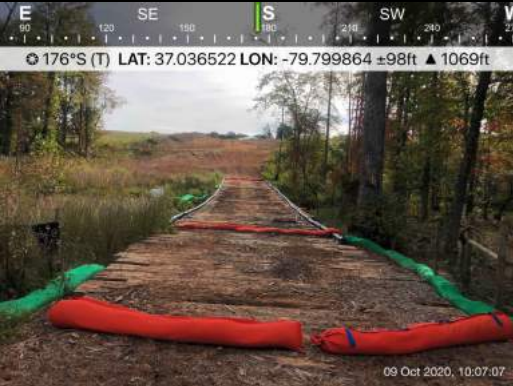
<b>GPS Location</b>	0	<b>GPS Location</b>	0		
<b>Field Station#</b>	14400+00	<b>Field Station#</b>	14353+53		
<b>Pic 5 Desc.</b>	Temporary stabilization on the CIS of Webster Road	<b>Pic 6 Desc.</b>	Equipment bridge clean at stream S-A38

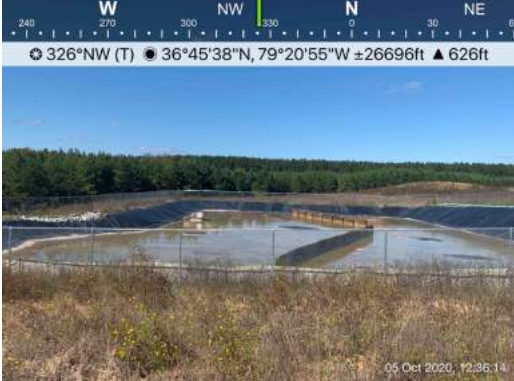
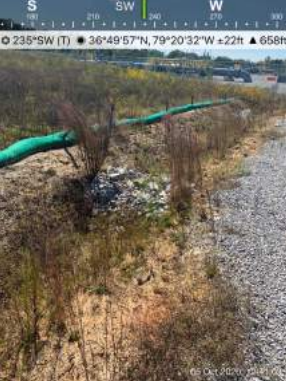
<b>GPS Location</b>	O	<b>GPS Location</b>	O		
<b>Field Station#</b>	00+00	<b>Field Station#</b>	00+00		
<b>Pic 1 Desc.</b>	Observing the storm water pond and ECD's performing as they should.		<b>Pic 2 Desc.</b>	Observing rock check dams and ECD's performing as they should.
