Visual Site Inspection Report

Project Name	H-600 Pipeline Spread G	AFE	124300137	Spread	H-600 Pipeline Spread G
Contractor	Precision			Report #	18704
Inspector	Len Kruizenga			Date/Time	1/4/2021 12:45 PM
Permit #	TBD	Inspection Type	VA SWPP	Station Begin	11254+99
State	VA	Inspection Area	Full	Station End	11158+27
County	Giles	Ground	Muddy	Temperature (°F)	32.00
Municipality	N/A	Weather	Cloudy	Rain Gauge (in)	0.05
				Rain Accumulation Time (days)	1.00

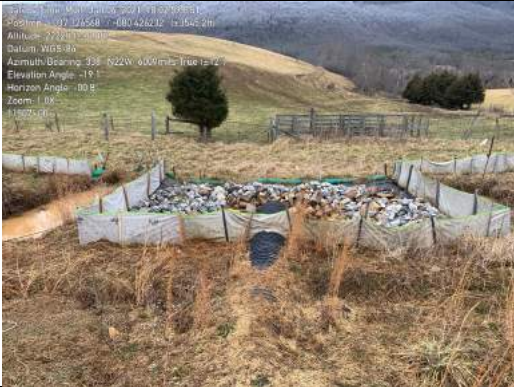
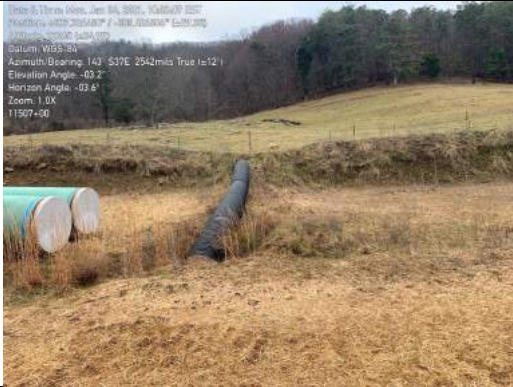
GPS Location	See photo for GPS location.		GPS Location	See photo for GPS location.	
Field Station#	11507+00		Field Station#	11507+00	
Pic 1 Desc.	Clean water diversion pipe and plunge pool in place.		Pic 2 Desc.	Clean water diversion pipe and clean water diversion berm in place.

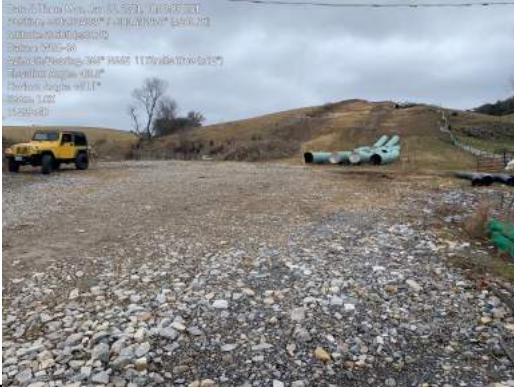
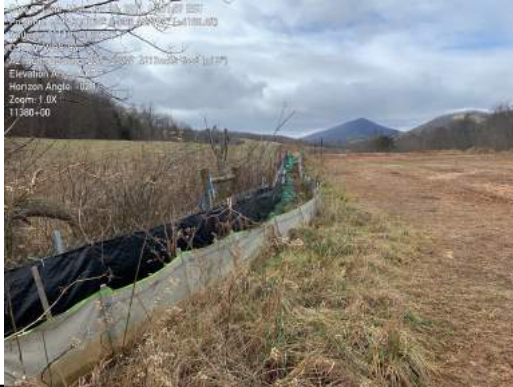
GPS Location	See photo for GPS location.		GPS Location	See photo for GPS location.	
Field Station#	11489+00		Field Station#	11380+00	
Pic 3 Desc.	RCE in place at Stevers Gap Road.		Pic 4 Desc.	Triple barrier ECDs in place at off ROW Karst feature.

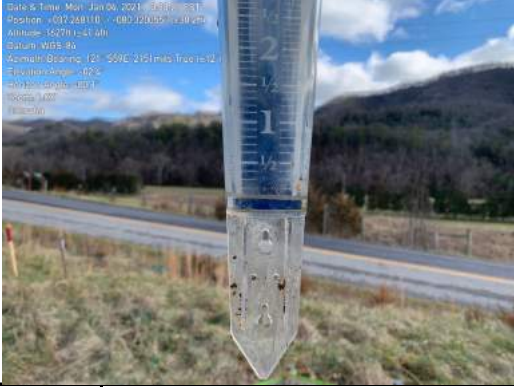
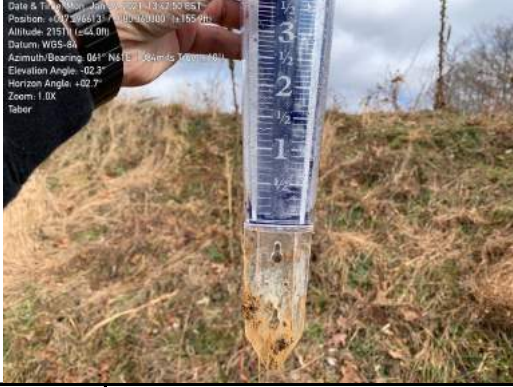
GPS Location	See photo for GPS location.		GPS Location	See photo for GPS location.	
Field Station#	11990+00		Field Station#	11767+00	
Pic 5 Desc.	Rain gauge at Catawba Road reads 0.1 inches.		Pic 6 Desc.	Rain gauge at Mount Tabor Road reads 0.05 inches.

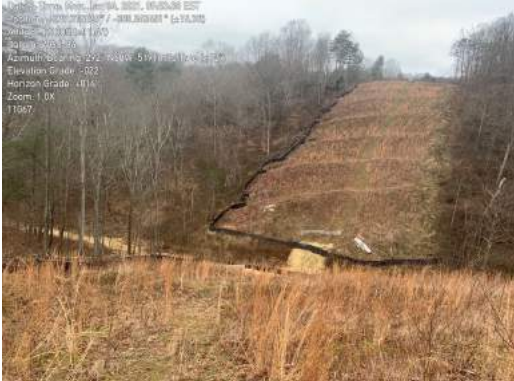
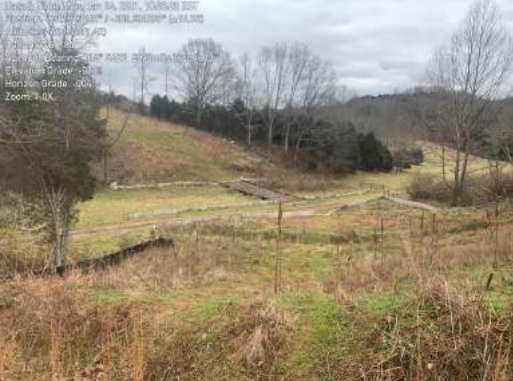
GPS Location	See picture above for GPS coordinates		GPS Location	See picture above for GPS coordinates	
Field Station#	11067+00		Field Station#	11098+00	
Pic 1 Desc.	ECD's and row conditions		Pic 2 Desc.	ECD's and row conditions

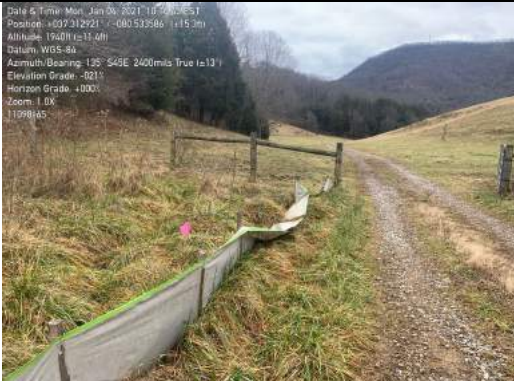
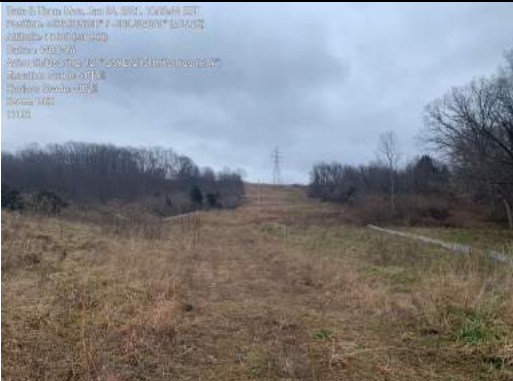
GPS Location	See picture above for GPS coordinates		GPS Location	See picture above for GPS coordinates	
Field Station#	11098+00		Field Station#	11131+00	
Pic 3 Desc.	Damaged P1		Pic 4 Desc.	ECD's and row conditions

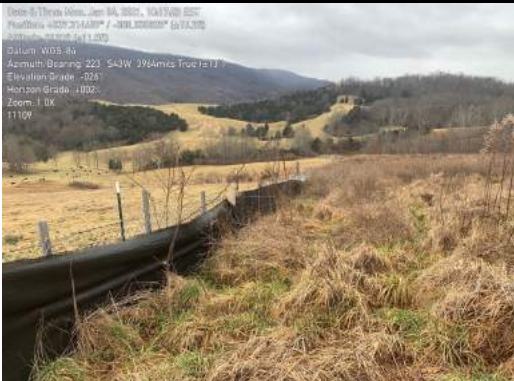
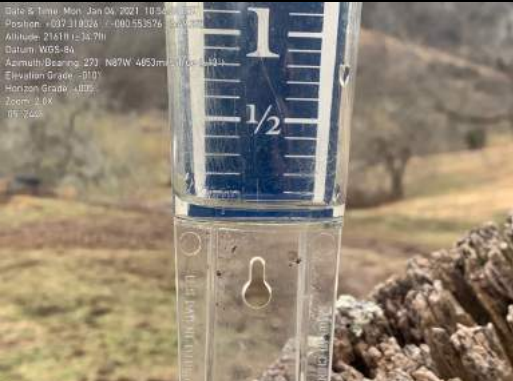
GPS Location	See picture above for GPS coordinates		GPS Location	See picture above for GPS coordinates	
Field Station#	11109+00		Field Station#	+1	
Pic 5 Desc.	Damaged SSF		Pic 6 Desc.	.05" of rain recorded

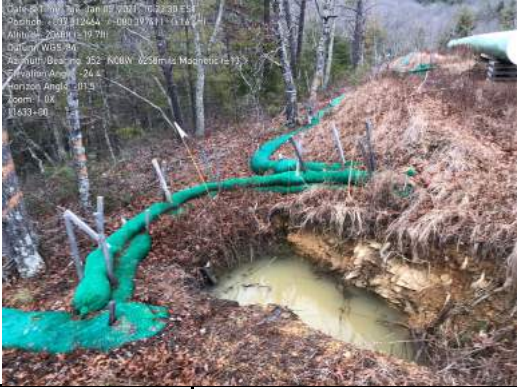
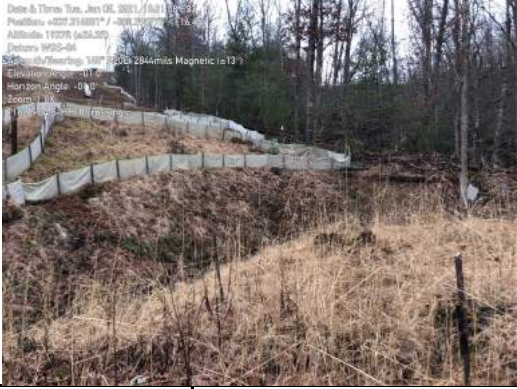
GPS Location	On photo	GPS Location	On photo		
Field Station#	11633+00	Field Station#	11626+04		
Pic 7 Desc.	End treatments and sumps are functional	Pic 8 Desc.	The S-HH18 crossing is currently stable.

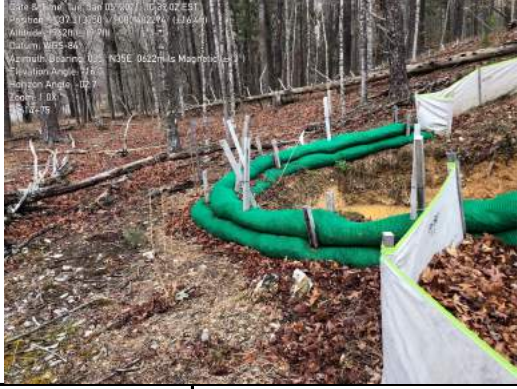
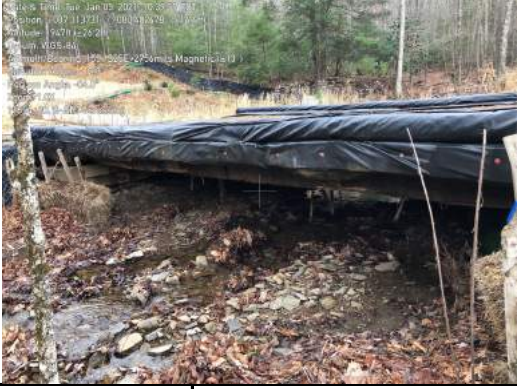
GPS Location	On photo	GPS Location	On photo		
Field Station#	11614+75	Field Station#	11614+20		
Pic 9 Desc.	The perimeter controls are in place and functioning.	Pic 10 Desc.	The S-RR14 crossing is currently stable with no visible impact.

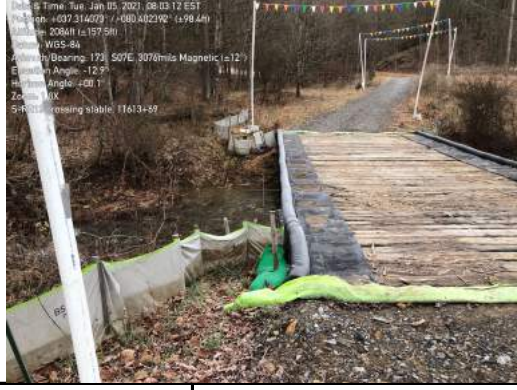
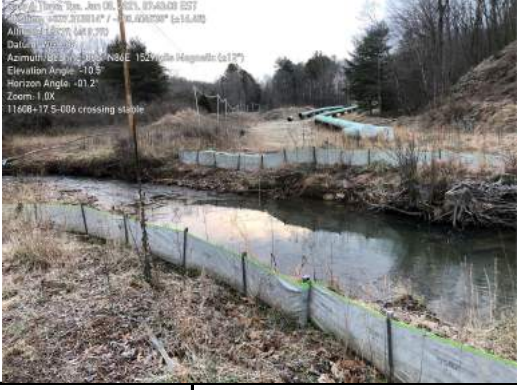
GPS Location	On photo	GPS Location	On photo		
Field Station#	11613+69	Field Station#	11608+17		
Pic 11 Desc.	The S-RR13 crossing at access road MN-258.04 is stable.	Pic 12 Desc.	The S-006 crossing is stable. ECDs in place.

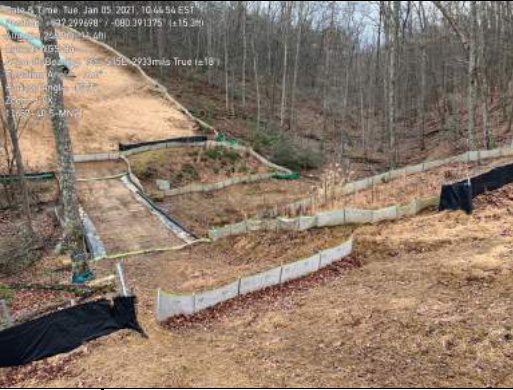
GPS Location	See photo for GPS location.		GPS Location	See photo for GPS location.	
Field Station#	11670+00		Field Station#	11687+00	
Pic 1 Desc.	Triple stack compost filter sock and priority one silt fence in place along LOD.		Pic 2 Desc.	Sensitive resource buffer in place at stream S-MN21.

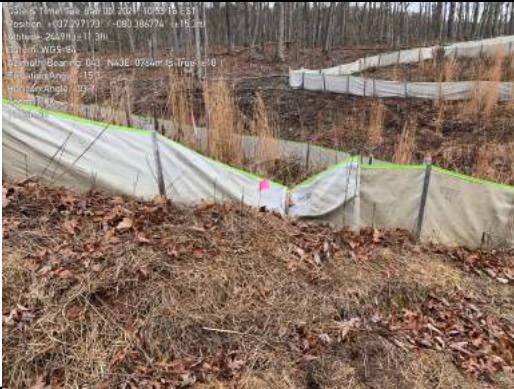
GPS Location	See photo for GPS location.		GPS Location	See photo for GPS location.	
Field Station#	11703+50		Field Station#	11728+00	
Pic 3 Desc.	Priority one silt fence stake broken.		Pic 4 Desc.	Priority one silt fence stake broken.

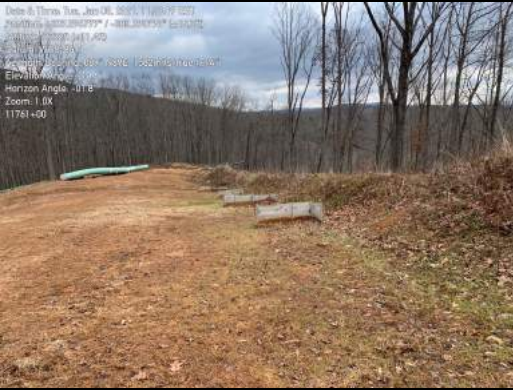
GPS Location	See photo for GPS location.		GPS Location	See photo for GPS location.	
Field Station#	11766+00		Field Station#	11761+00	
Pic 5 Desc.	RCE in place at MLV 26.		Pic 6 Desc.	Priority one silt fence checks in place.

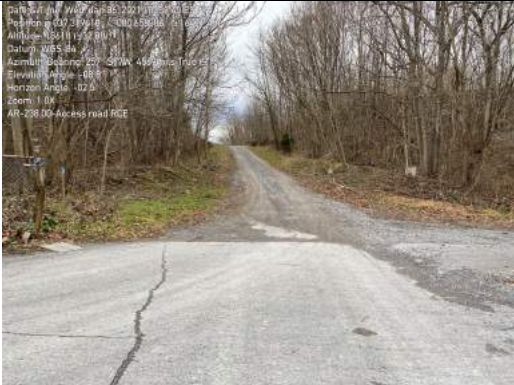
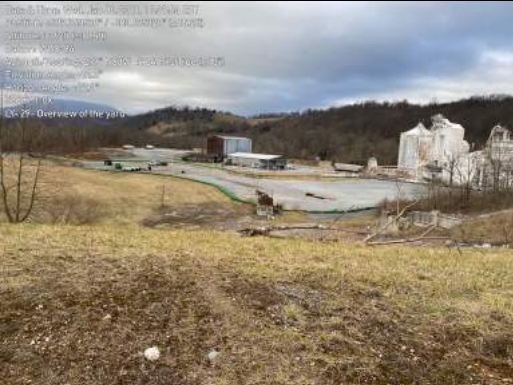
GPS Location	See photo GPS		GPS Location	See photo GPS	
Field Station#	12005+00		Field Station#	12005+00	
Pic 1 Desc.	AR-238.00- RCE is in acceptable condition		Pic 2 Desc.	LY29- Overview of the yard.

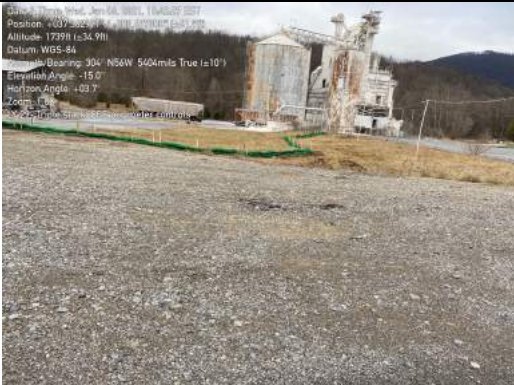
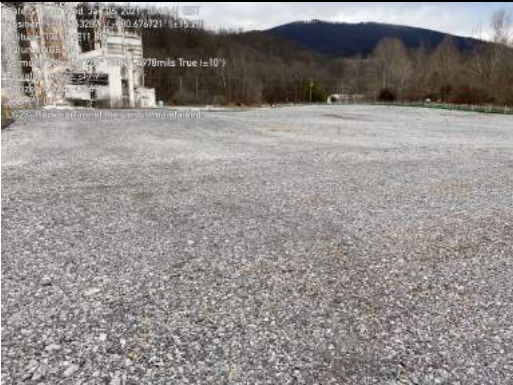
GPS Location	See photo GPS		GPS Location	See photo GPS	
Field Station#	12005+00		Field Station#	12005+00	
Pic 3 Desc.	CFS triple stack perimeter controls		Pic 4 Desc.	LY29- The rock surface of the yard is maintained in acceptable condition.

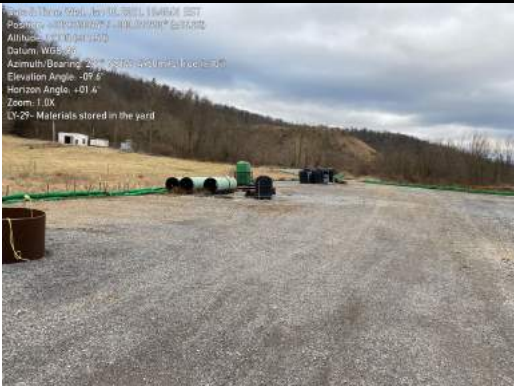
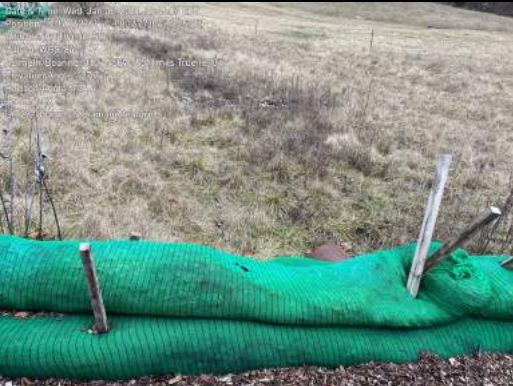
GPS Location	See photo GPS		GPS Location	See photo GPS	
Field Station#	12005+00		Field Station#	12005+00	
Pic 5 Desc.	LY- 29- Materials storage		Pic 6 Desc.	Culvert and drainage feature.

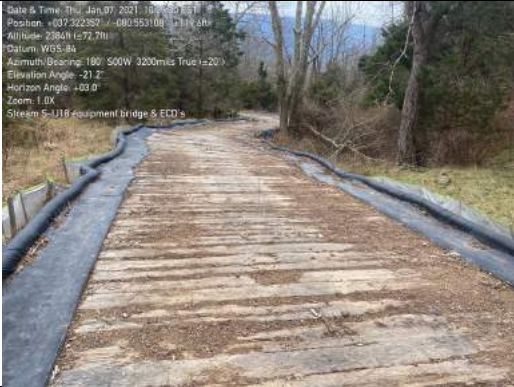
<p>Date & Time: Thu, Jan 07, 2021, 10:52:15 AM Position: +037 3222854° / -080 553108° (+111.8M) Altitude: 23618 (+57.8M) Datum: WGS-84 Azimuth/Bearing: 180° S00W 3200mils True (+20°) Elevation Angle: -21.2° Horizon Angle: +00.0° Zoom: 1.0X Stream: S-IJ18 equipment bridge & ECD's</p>

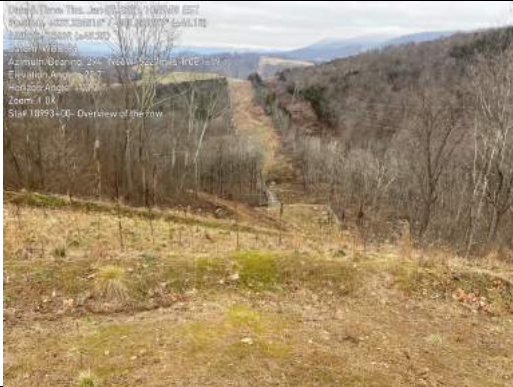
<p>Date & Time: Thu, Jan 07, 2021, 10:54:00 AM Position: +037 3222854° / -080 553108° (+111.8M) Altitude: 23618 (+57.8M) Datum: WGS-84 Azimuth/Bearing: 200° N00W 3200mils True (+20°) Elevation Angle: -21.2° Horizon Angle: +00.0° Zoom: 1.0X Stream: S-IJ18 equipment bridge & ECD's</p>			
GPS Location	See photo GPS		GPS Location	See photo GPS	
Field Station#	11023+88		Field Station#	10993+00	
Pic 1 Desc.	Stream S-IJ18 & bridge and ECD's.		Pic 2 Desc.	Overview of the row.

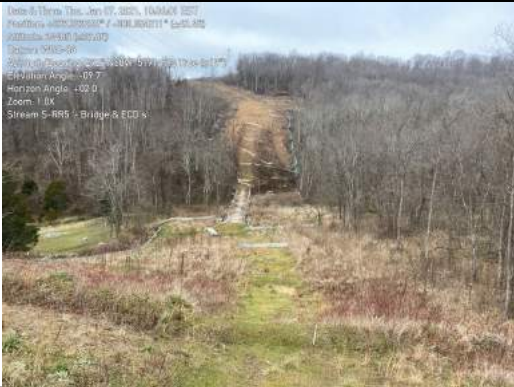
<p>Date & Time: Thu, Jan 07, 2021, 11:00:49 AM Position: +037 322544° / -080 56479° (+111.8M) Altitude: 23618 (+57.8M) Datum: WGS-84 Azimuth/Bearing: 103° S77E 1821mils True (+20°) Elevation Angle: -09.1° Horizon Angle: +01.1° Zoom: 1.0X Stream: S-RR5 Bridge & ECD's</p>

GPS Location	See photo GPS		GPS Location	See photo GPS	
Field Station#	11019+00		Field Station#	10986+00	
Pic 3 Desc.	Stream S- RR5, stream controls and row		Pic 4 Desc.	Stream S- E25, bridge and ECD's

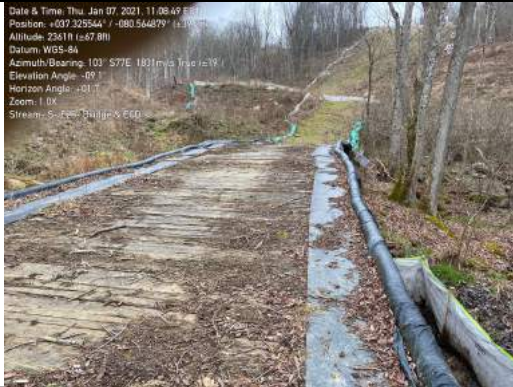
<p>Date & Time: Thu, Jan 07, 2021, 11:00:49 AM Position: +037 322544° / -080 56479° (+111.8M) Altitude: 23618 (+57.8M) Datum: WGS-84 Azimuth/Bearing: 103° S77E 1821mils True (+20°) Elevation Angle: -09.1° Horizon Angle: +01.1° Zoom: 1.0X Stream: S-E25 Bridge & ECD's</p>

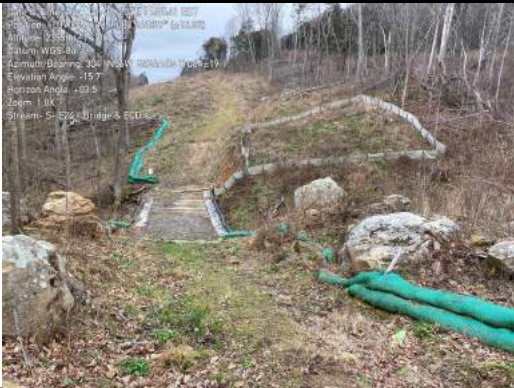
<p>Date & Time: Thu, Jan 07, 2021, 11:04:15 AM Position: +037 322544° / -080 56479° (+111.8M) Altitude: 23618 (+57.8M) Datum: WGS-84 Azimuth/Bearing: 304° N00W 3200mils True (+20°) Elevation Angle: -15.7° Horizon Angle: +02.5° Zoom: 1.0X Stream: S-E24 Bridge & ECD's</p>		  <p>Date & Time: Thu, Jan 07, 2021, 11:04:15 AM Position: +037 322544° / -080 56479° (+111.8M) Altitude: 23618 (+57.8M) Datum: WGS-84 Azimuth/Bearing: 304° N00W 3200mils True (+20°) Elevation Angle: -15.7° Horizon Angle: +02.5° Zoom: 1.0X Stream: S-E24 Bridge & ECD's</p>			
GPS Location	See photo GPS		GPS Location	See photo GPS	
Field Station#	10985+00		Field Station#	10964+00	
Pic 5 Desc.	Stream S- E 24 bridge and ECD's		Pic 6 Desc.	Drainage feature bridge & ECD's

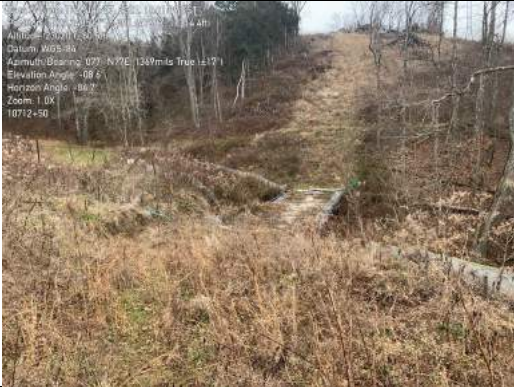
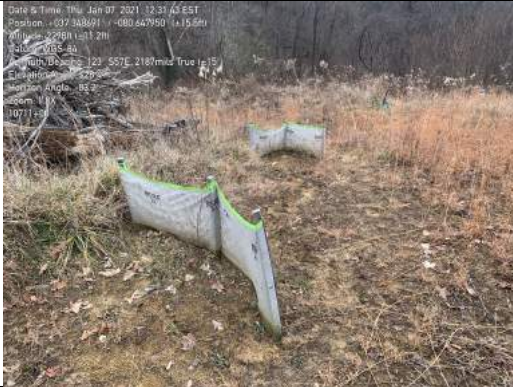
GPS Location	See photo for GPS location.		GPS Location	See photo for GPS location.	
Field Station#	10712+50		Field Station#	10711+00	
Pic 1 Desc.	Sensitive resource buffer in place at stream S-G33.		Pic 2 Desc.	Priority one silt fence checks in place.

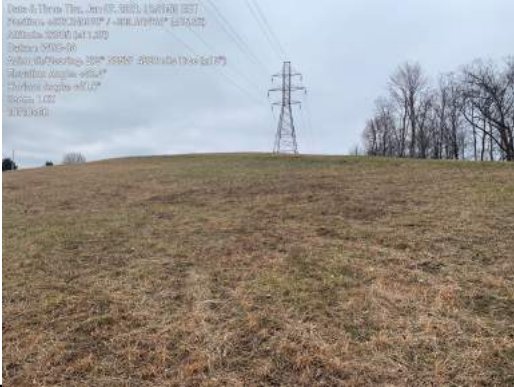
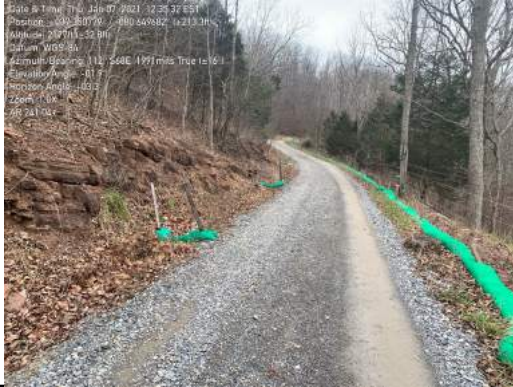
GPS Location	See photo for GPS location.		GPS Location	See photo for GPS location.	
Field Station#	10710+00		Field Station#	10710+00	
Pic 3 Desc.	ROW stabilized with natural vegetation growth.		Pic 4 Desc.	Compost filter sock checks in place along access road 241.04.

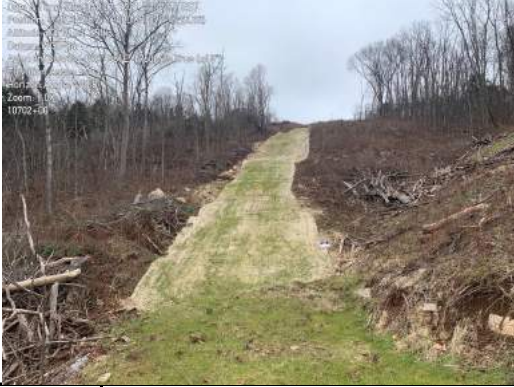
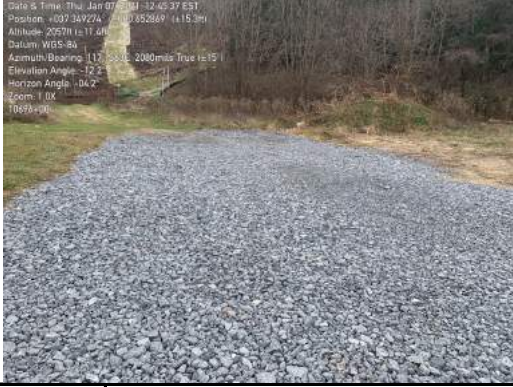
GPS Location	See photo for GPS location.		GPS Location	See photo for GPS location.	
Field Station#	10702+00		Field Station#	10696+00	
Pic 5 Desc.	Steep slope stabilized with ECB.		Pic 6 Desc.	RCE in place at Buffalo Anklets Road.

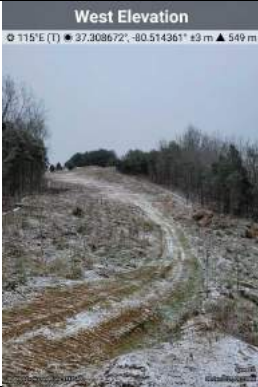
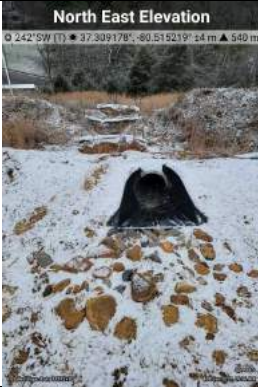
GPS Location	see photo		GPS Location	see photo	
Field Station#	11175+00		Field Station#	11172+70	
Pic 1 Desc.	stabilized ROW conditions		Pic 2 Desc.	installed slope drain

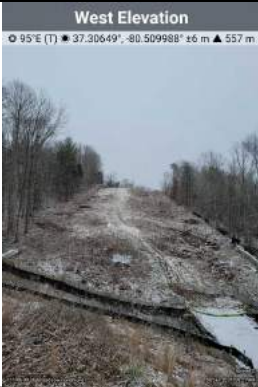
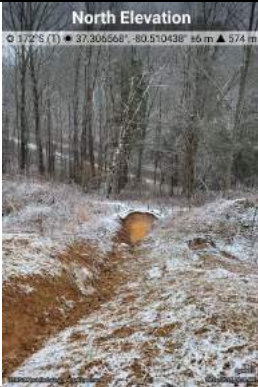
GPS Location	see photo		GPS Location	see photo	
Field Station#	11190+00		Field Station#	11187+00	
Pic 3 Desc.	stabilized row conditions		Pic 4 Desc.	installed waterbar/sump/end treatment

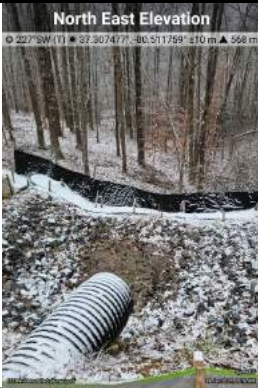
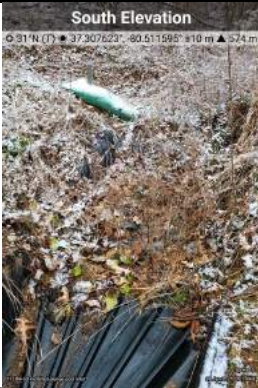
GPS Location	see photo		GPS Location	see photo	
Field Station#	11184+50		Field Station#	11184+50	
Pic 5 Desc.	installed plunge pool		Pic 6 Desc.	installed plunge pool inlet.
