Visual Site Inspection Report

Project Name	H-600 Pipeline Spread G	AFE	124300137	Spread	H-600 Pipeline Spread G
Contractor	Precision			Report #	18926
Inspector	Garrett Barclay			Date/Time	1/11/2021 12:29 PM
Permit #	TBD	Inspection Type	VA SWPP	Station Begin	11524+16
State	VA	Inspection Area	Partial	Station End	11600+01
County	Giles	Ground	Frozen	Temperature (°F)	26.00
Municipality	N/A	Weather	Snow/Sleet	Rain Gauge (in)	0.00
				Rain Accumulation Time (days)	1.00

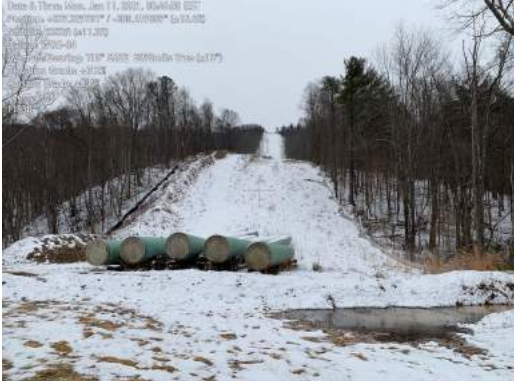
GPS Location	See picture above for GPS coordinates		GPS Location	See picture above for GPS coordinates	
Field Station#	11530+00		Field Station#	11549+00	
Pic 1 Desc.	ECD's and row conditions		Pic 2 Desc.	ECD's and row conditions

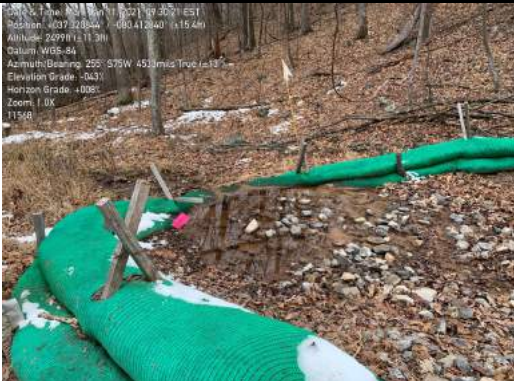
GPS Location	See picture above for GPS coordinates		GPS Location	See picture above for GPS coordinates	
Field Station#	11568+00		Field Station#	11585+00	
Pic 5 Desc.	Sediment build up on CFS		Pic 6 Desc.	ECD's and row conditions

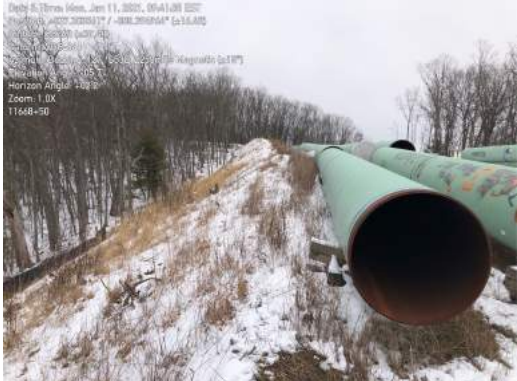
GPS Location	On photo		GPS Location	On photo	
Field Station#	11668+50		Field Station#	11663+00	
Pic 1 Desc.	ROW conditions at top of Brush Mountain are stable. Perimeter controls are in place.		Pic 2 Desc.	Perimeter controls are in place and effective.

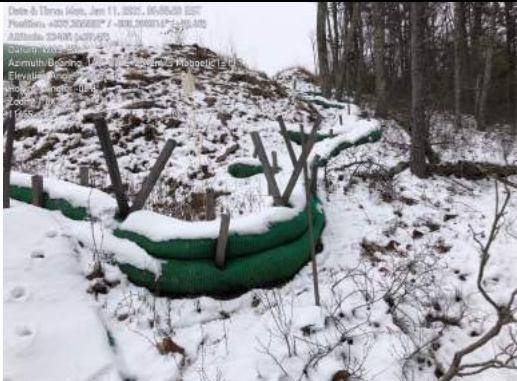
GPS Location	On photo		GPS Location	On photo	
Field Station#	11655+00		Field Station#	11653+00	
Pic 3 Desc.	End treatments are effectively controlling runoff.		Pic 4 Desc.	Slope breakers are functional. Perimeter controls are in place.

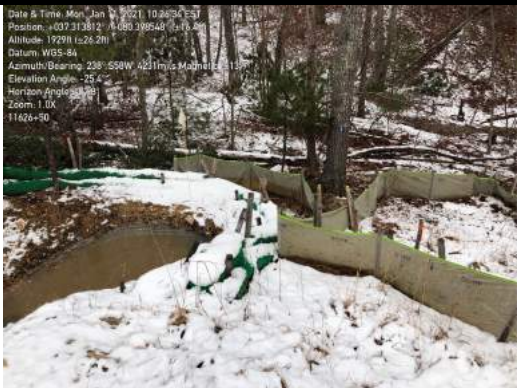
GPS Location	On photo		GPS Location	On photo	
Field Station#	11626+50		Field Station#	11626+04	
Pic 5 Desc.	Perimeter controls are effective.		Pic 6 Desc.	The S-HH18 crossing is stable with ECDs in place.

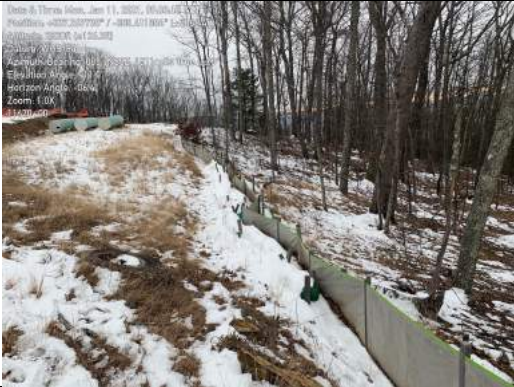
GPS Location	See photo for GPS location.		GPS Location	See photo for GPS location.	
Field Station#	11670+00		Field Station#	11672+00	
Pic 1 Desc.	CFS and priority one silt fence in place along LOD.		Pic 2 Desc.	Waterbar, sump pit, and end treatment in place.

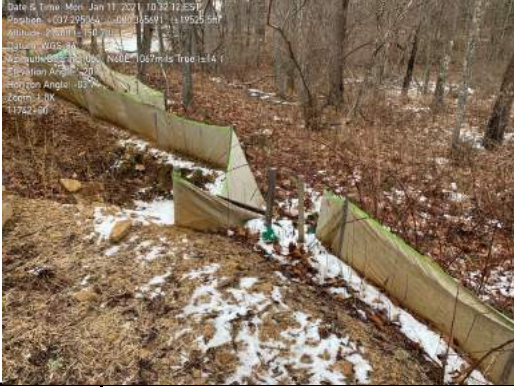
GPS Location	See photo for GPS location.		GPS Location	See photo for GPS location.	
Field Station#	11742+00		Field Station#	11767+00	
Pic 5 Desc.	Broken priority one silt fence stake.		Pic 6 Desc.	RCE in place at Main Line Valve 26.

E&S BMPs	Compliance Level	Corrective Action	Corrective Time Frame	Date Repaired
Cleanwater Diversion Berm	Acceptable			
Cleanwater Diversion Pipe	Acceptable			
Compost Filter Sock	Acceptable			
Equipment Bridge	Acceptable			
Housekeeping	Acceptable			
Erosion Control Blanket	Acceptable			
Plunge Pool	Acceptable			
Rock Construction Entrance	Acceptable			
Silt Fence (Filter Fabric Fence)	Communication	Broken priority one stake	Addressed	1/11/2021

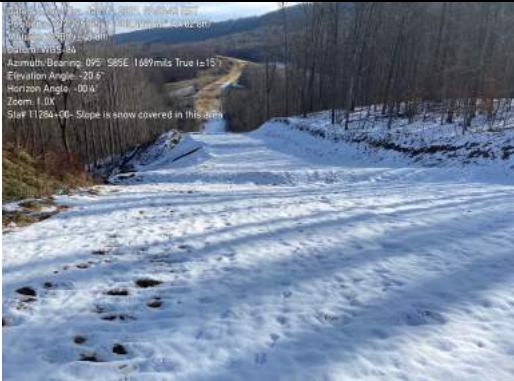
GPS Location	See photo GPS		GPS Location	See photo GPS	
Field Station#	11284+00		Field Station#	11293+00	
Pic 3 Desc.	Slope is covered in snow in this area.		Pic 4 Desc.	Stream crossing, equipment bridge, ECD's

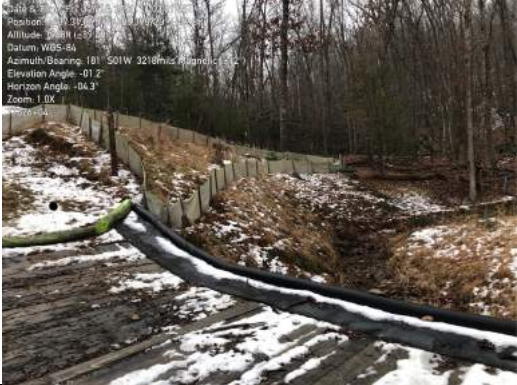
GPS Location	On photo	GPS Location	On photo		
Field Station#	11626+04	Field Station#	11614+20		
Pic 7 Desc.	The S-HH18 crossing is stable. No impact has occurred.	Pic 8 Desc.	The S-RR14 crossing is stable. Flow enters ground near centerline.

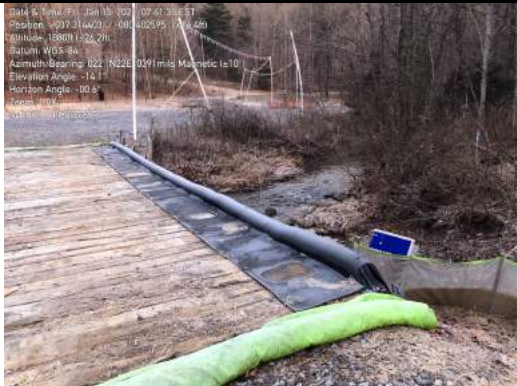
GPS Location	On photo	GPS Location	On photo		
Field Station#	11613+69	Field Station#	11608+17		
Pic 9 Desc.	The S-RR13 crossing on access road MN-258.04 is stable.	Pic 10 Desc.	The S-006 crossing is currently stable with ECDs in place.		
Insert image here		Insert image here			
GPS Location		GPS Location			
Field Station#		Field Station#			
Pic 11 Desc.		Pic 12 Desc.
