Visual Site Inspection Report

Project Name	H-600 Pipeline Spread G	AFE	124300137	Spread	H-600 Pipeline Spread G
Contractor	Precision			Report #	18031
Inspector	Len Kruizenga			Date/Time	12/14/2020 8:16 AM
Permit #	TBD	Inspection Type	VA SWPP	Station Begin	11023+88
State	VA	Inspection Area	Full	Station End	10930+00
County	Giles	Ground	Muddy	Temperature (°F)	41.00
Municipality	N/A	Weather	Heavy Rain	Rain Gauge (in)	1.10
				Rain Accumulation Time (days)	1.00

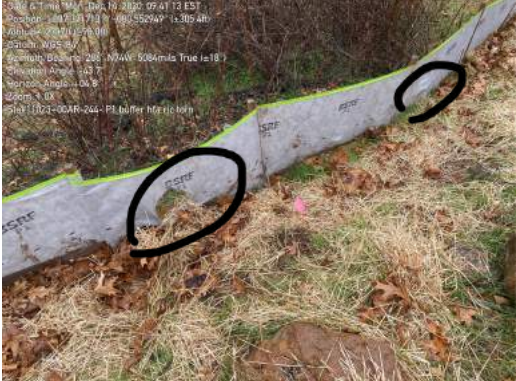
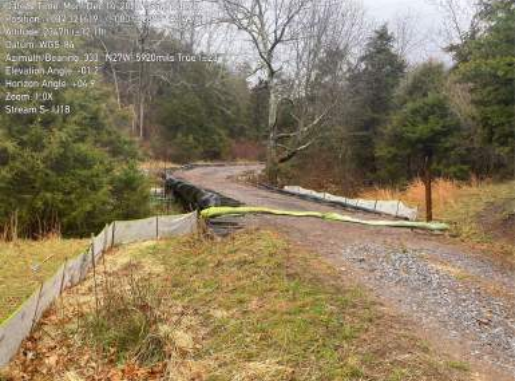
<p>GPS Location See photo GPS</p>	
<p>Field Station# 11023+88</p>		<p>Field Station# 11023+88</p>		<p>Field Station# 11023+88</p>	
<p>Pic 1 Desc. P1 buffer fabric damaged by cattle, contractor notified and items added to the punch list.</p>		<p>Pic 2 Desc. Stream S- IJ18</p>

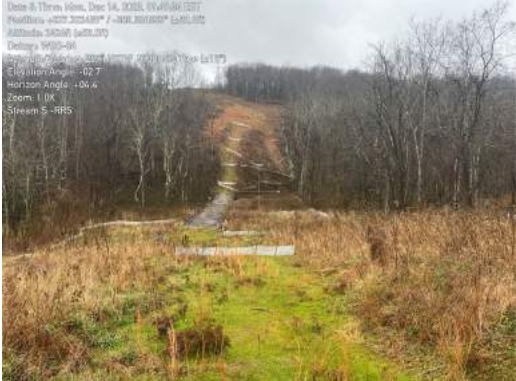
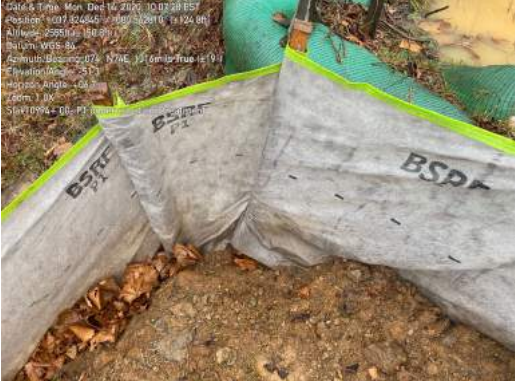
<p>GPS Location See photo GPS</p>	
<p>Field Station# 11018+00</p>		<p>Field Station# 10994+00</p>		<p>Field Station# 10994+00</p>	
<p>Pic 3 Desc. Stream S-RR5 & ECD's</p>		<p>Pic 4 Desc. P1 secondary controls under cut, contractor notified and items added to the punch list.</p>

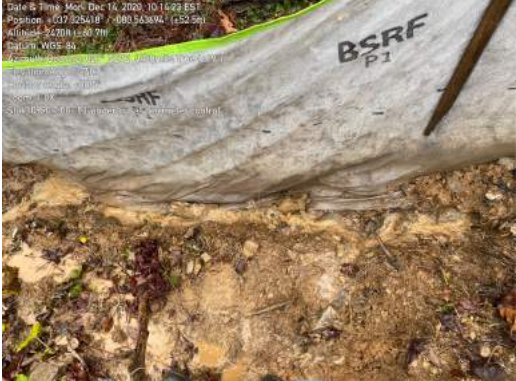
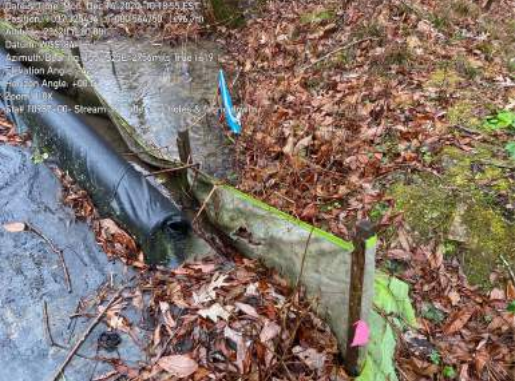
<p>GPS Location See photo GPS</p>	
<p>Field Station# 10990+00</p>		<p>Field Station# 10978+00</p>		<p>Field Station# 10978+00</p>	
<p>Pic 5 Desc. P1 perimeter controls under cut, contractor notified and items added to the punch list</p>		<p>Pic 6 Desc. P1 stream buffer damaged, contractor notified and items added to the punch list.</p>

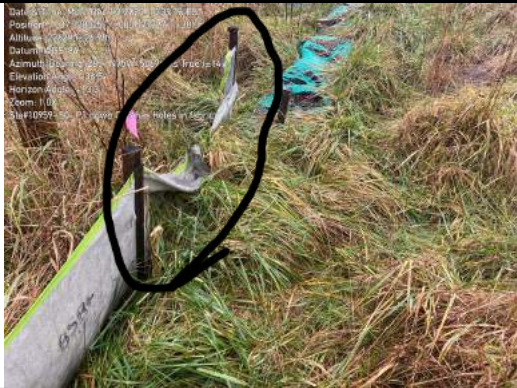
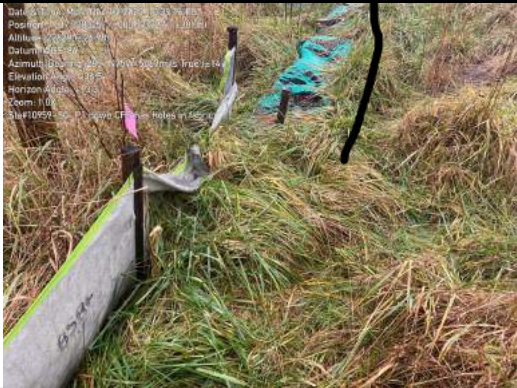
GPS Location	See photo GPS	GPS Location	See photo GPS		
Field Station#	10959+50	Field Station#	10959+50		
Pic 9 Desc.	P1 perimeter controls down, contractor notified and items added to the punch list	Pic 10 Desc.	CFS perimeter controls fabric torn up, contractor notified and items added to the punch list.		
Insert image here		Insert image here			
GPS Location		GPS Location			
Field Station#		Field Station#			
Pic 11 Desc.		Pic 12 Desc.

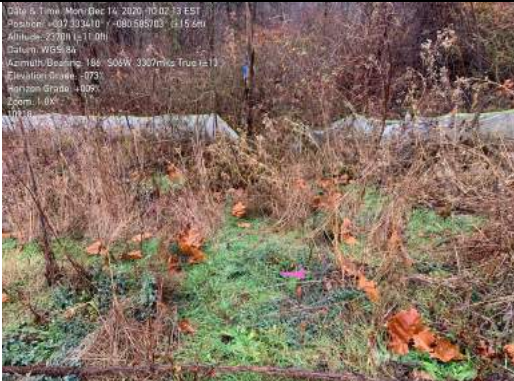
GPS Location	See picture above for GPS coordinates		GPS Location	See picture above for GPS coordinates	
Field Station#	10918+00		Field Station#	10894+00	
Pic 3 Desc.	Damaged P1		Pic 4 Desc.	SSF detached from wire backing
