Visual Site Inspection Report

Project Name	H-600 Pipeline Spread G	AFE	124300137	Spread	H-600 Pipeline Spread G
Contractor	Precision			Report #	18321
Inspector	Brian Shields			Date/Time	12/21/2020 11:30 AM
Permit #	TBD	Inspection Type	VA SWPP	Station Begin	11254+99
State	VA	Inspection Area	Full	Station End	11353+67
County	Giles	Ground	Damp	Temperature (°F)	47.00
Municipality	N/A	Weather	Sunny	Rain Gauge (in)	0.00
				Rain Accumulation Time (days)	1.00

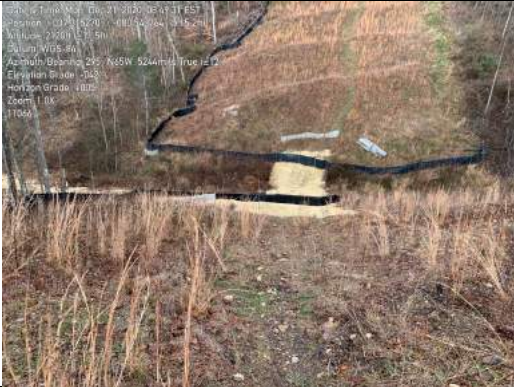
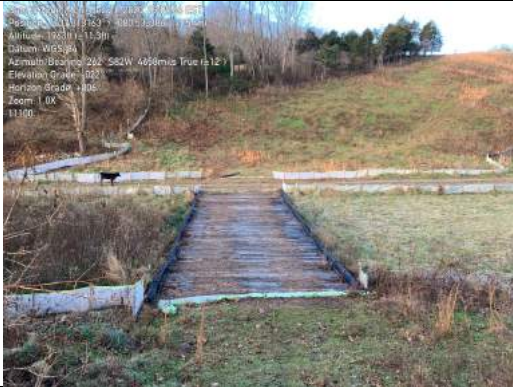
GPS Location	See picture above for GPS coordinates		GPS Location	See picture above for GPS coordinates	
Field Station#	11066+00		Field Station#	11100+00	
Pic 1 Desc.	ECD's and row conditions		Pic 2 Desc.	ECD's and row conditions

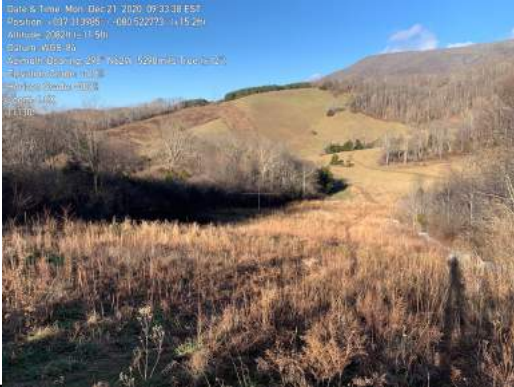
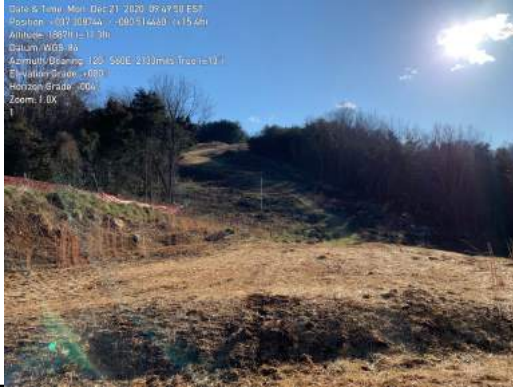
GPS Location	See picture above for GPS coordinates		GPS Location	See picture above for GPS coordinates	
Field Station#	11130+00		Field Station#	11180+00	
Pic 3 Desc.	ECD's and row conditions		Pic 4 Desc.	ECD's and row conditions

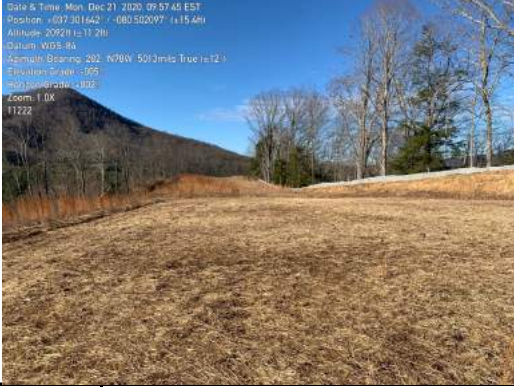
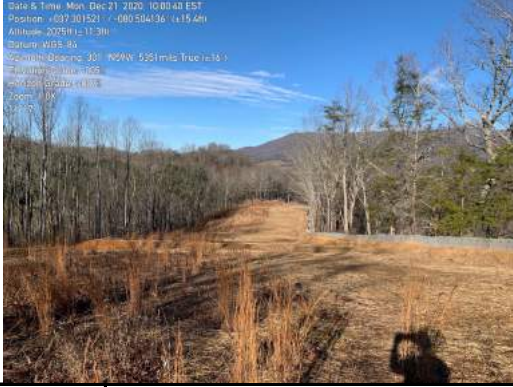
GPS Location	See picture above for GPS coordinates		GPS Location	See picture above for GPS coordinates	
Field Station#	11222+00		Field Station#	11217+00	
Pic 5 Desc.	ECD's and row conditions		Pic 6 Desc.	ECD's and row conditions

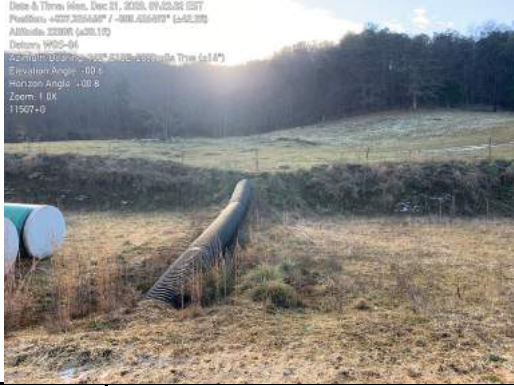
GPS Location	See photo for GPS location.		GPS Location	See photo for GPS location.	
Field Station#	11509+00		Field Station#	11507+00	
Pic 1 Desc.	Rock inlet and slope drain in place.		Pic 2 Desc.	Clean water diversion pipe and clean water diversion berm in place.

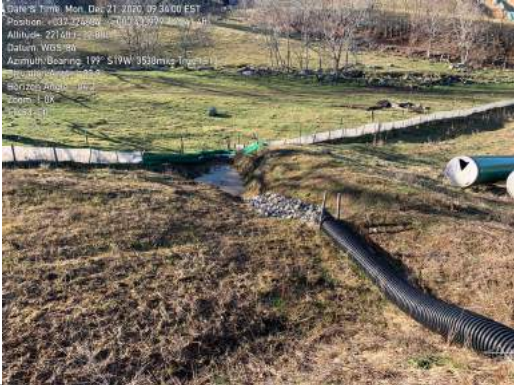
GPS Location	See photo for GPS location.		GPS Location	See photo for GPS location.	
Field Station#	11493+00		Field Station#	11489+00	
Pic 3 Desc.	Slope drain and rock outlet in place.		Pic 4 Desc.	RCE in place at Stevers Gap Road.

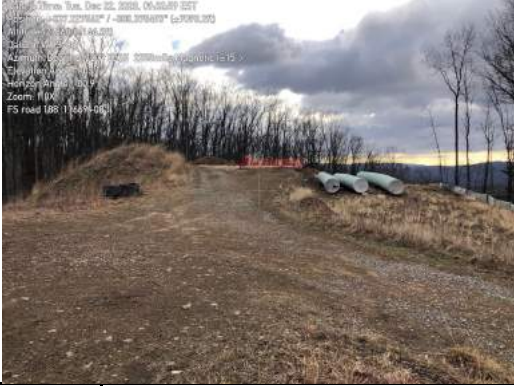
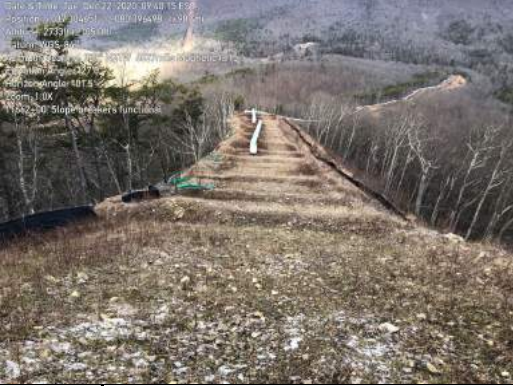
GPS Location	On photo	GPS Location	On photo		
Field Station#	11669+00	Field Station#	11662+00		
Pic 1 Desc.	ROW is stable at the FS188 road crossing	Pic 2 Desc.	Slope breakers in place. No stormwater runoff issues.

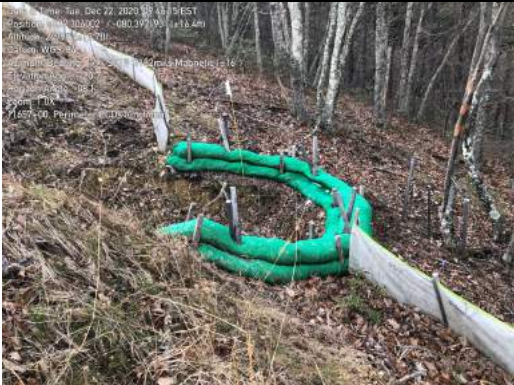
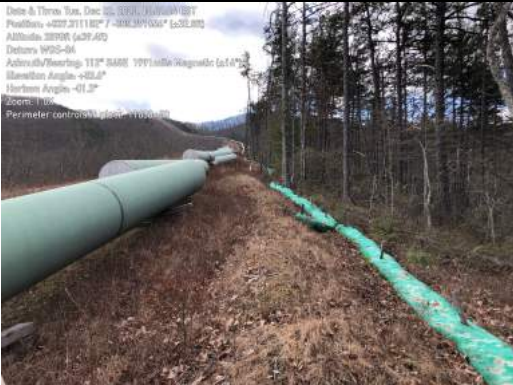
GPS Location	On photo	GPS Location	On photo		
Field Station#	11657+00	Field Station#	11638+00		
Pic 3 Desc.	End treatments in place and functioning	Pic 4 Desc.	Perimeter controls are in place

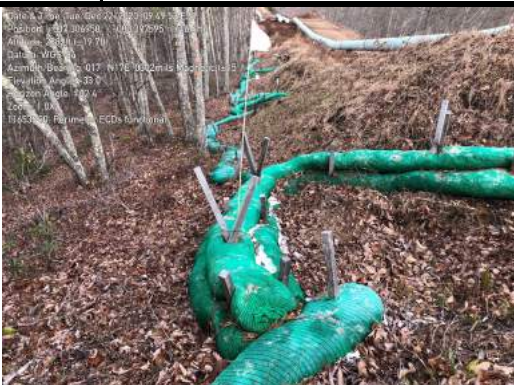
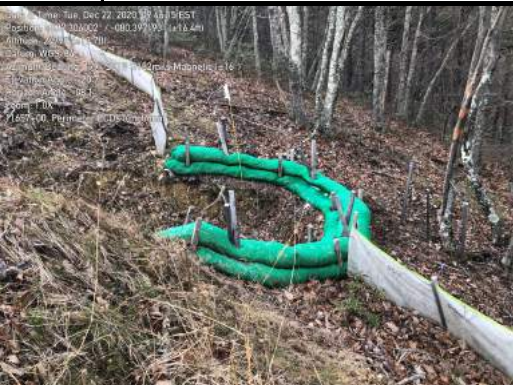
GPS Location	On photo	GPS Location	On photo		
Field Station#	11653+00	Field Station#	11657+00		
Pic 5 Desc.	End treatments in place and functional	Pic 6 Desc.	Perimeter controls, sumps and end treatments

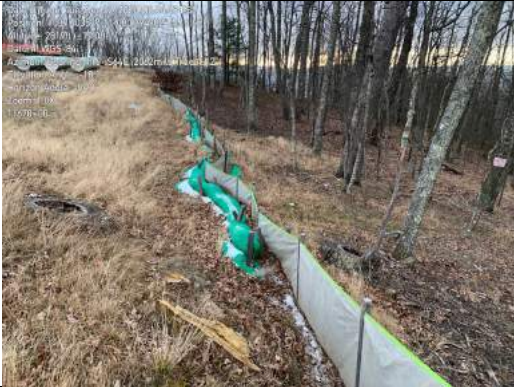
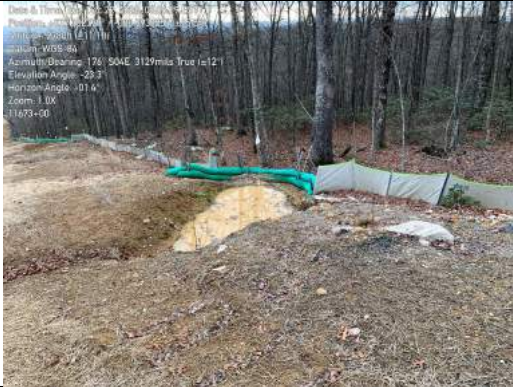
GPS Location	See photo for GPS location.		GPS Location	See photo for GPS location.	
Field Station#	11670+00		Field Station#	11673+00	
Pic 1 Desc.	Triple stack compost filter sock and priority one silt fence in place along LOD.		Pic 2 Desc.	ECDs in place.

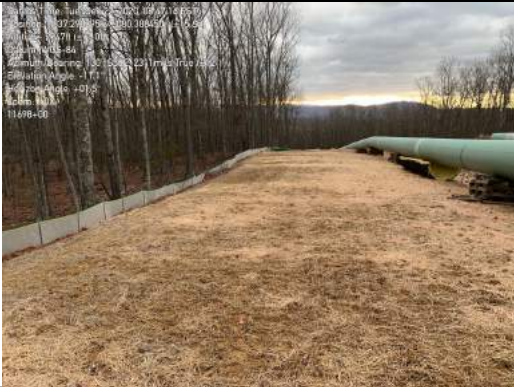
GPS Location	See photo for GPS location.		GPS Location	See photo for GPS location.	
Field Station#	11698+00		Field Station#	11704+10	
Pic 3 Desc.	ROW stabilized with seed and mulch.		Pic 4 Desc.	Sensitive resource buffer in place at stream S-MN22.

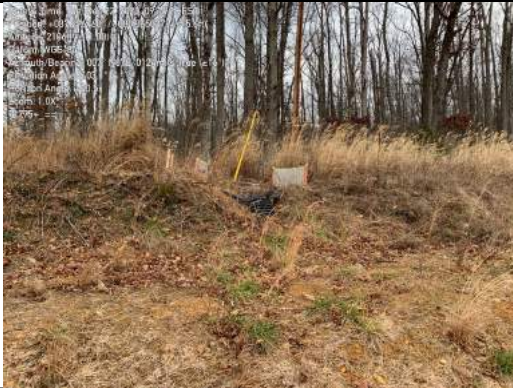
GPS Location	See photo for GPS location.		GPS Location	See photo for GPS location.	
Field Station#	11767+00		Field Station#	11775+00	
Pic 5 Desc.	RCE in place at Main Line Valve 26.		Pic 6 Desc.	Clean water diversion pipe inlet and clean water diversion berm in place.

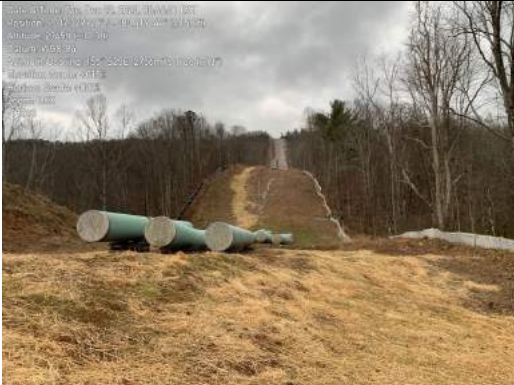
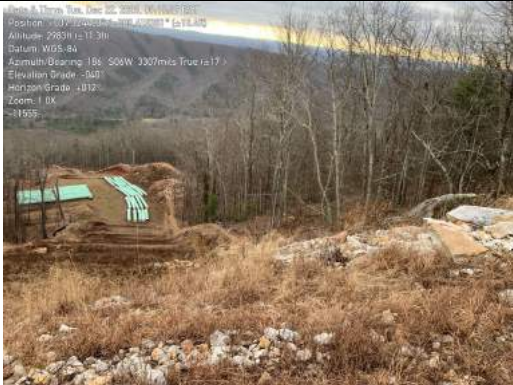
GPS Location	See picture above for GPS coordinates		GPS Location	See picture above for GPS coordinates	
Field Station#	11530+00		Field Station#	11555+00	
Pic 1 Desc.	ECD's and row conditions		Pic 2 Desc.	ECD's and row conditions

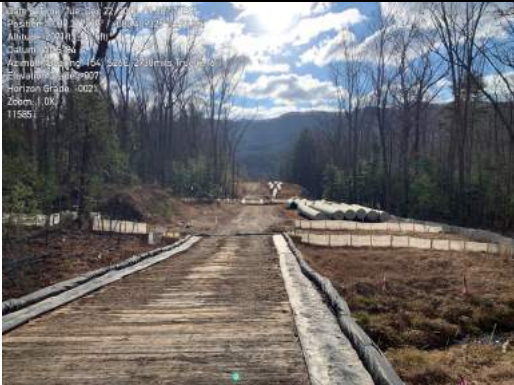
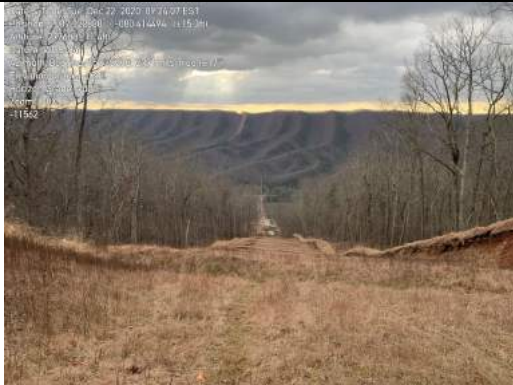
GPS Location	See picture above for GPS coordinates		GPS Location	See picture above for GPS coordinates	
Field Station#	11585+00		Field Station#	11562+00	
Pic 3 Desc.	ECD's and row conditions		Pic 4 Desc.	ECD's and row conditions

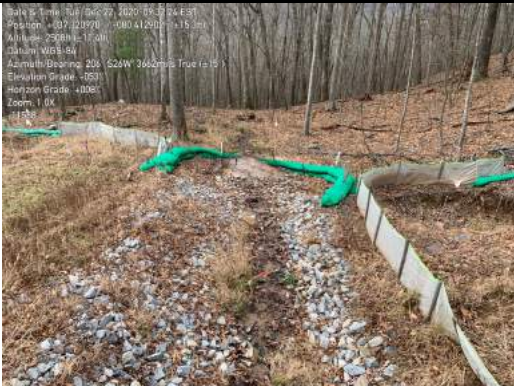
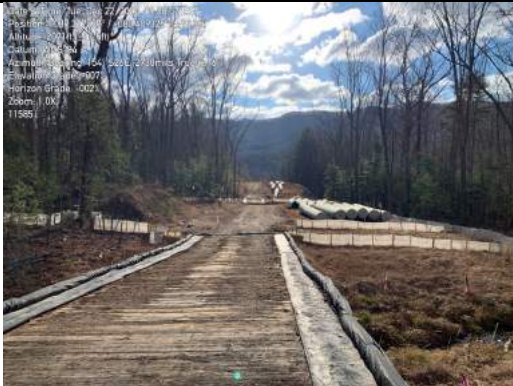
GPS Location	See picture above for GPS coordinates		GPS Location	See picture above for GPS coordinates	
Field Station#	11568+00		Field Station#	11585+00	
Pic 5 Desc.	ECD's and row conditions		Pic 6 Desc.	ECD's and row conditions

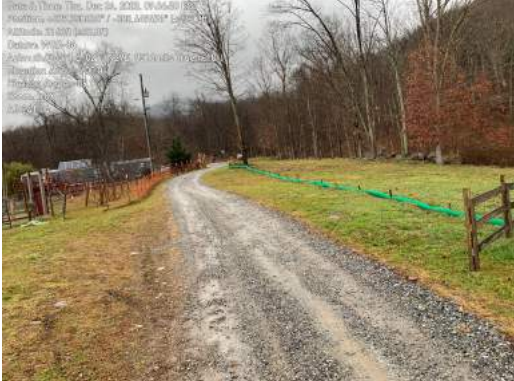
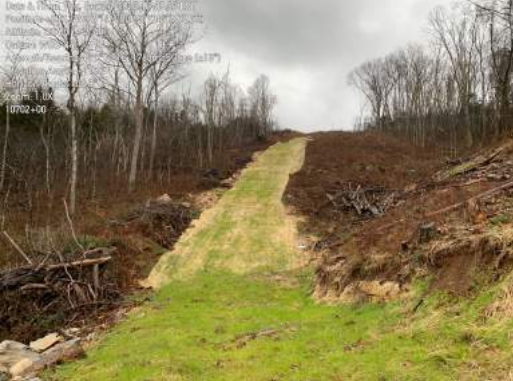
GPS Location	See photo for GPS location.		GPS Location	See photo for GPS location.	
Field Station#	10711+00		Field Station#	10702+00	
Pic 1 Desc.	CFS in place along AR 241.04.		Pic 2 Desc.	Steep slope stabilized with ECB.

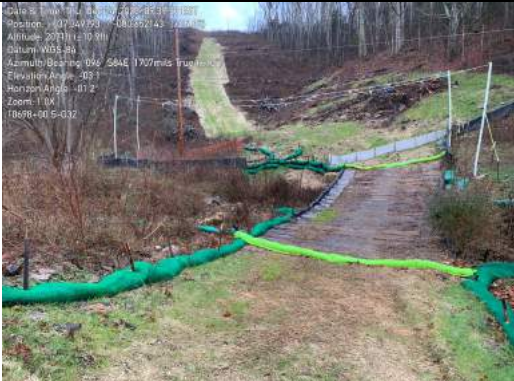
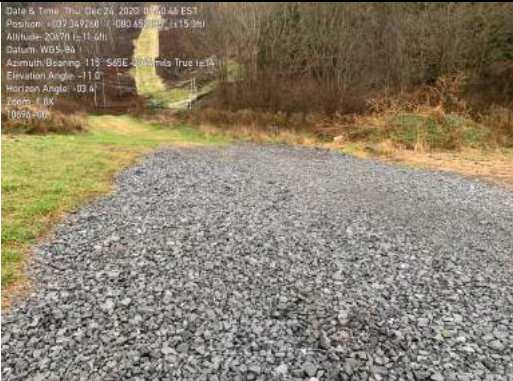
GPS Location	See photo for GPS location.		GPS Location	See photo for GPS location.	
Field Station#	10698+00		Field Station#	10696+00	
Pic 3 Desc.	Sensitive resource buffer in place at stream S-G32.		Pic 4 Desc.	RCE in place at Buffalo Anklets Road.

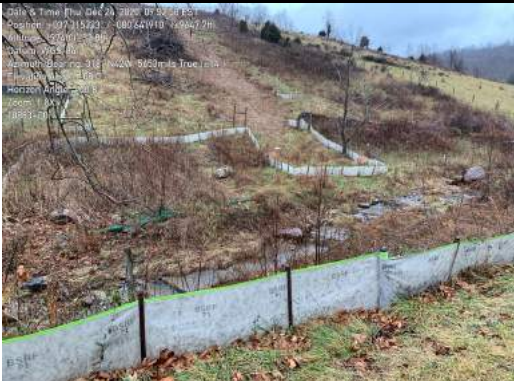
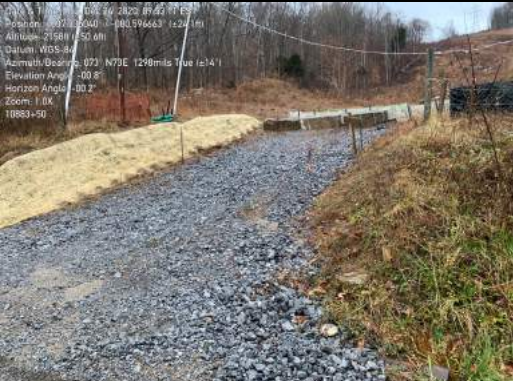
GPS Location	See photo for GPS location.		GPS Location	See photo for GPS location.	
Field Station#	10883+00		Field Station#	10883+50	
Pic 5 Desc.	Sensitive resource buffer in place at stream S-A32.		Pic 6 Desc.	RCE in place at Kow Camp Road.

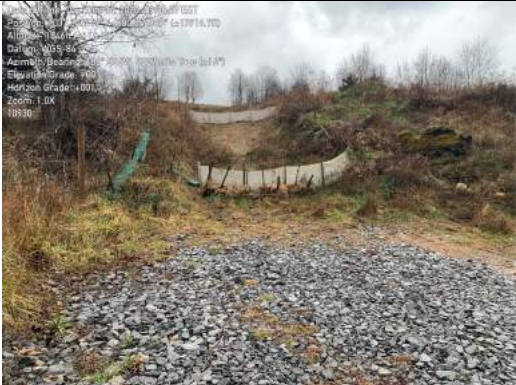
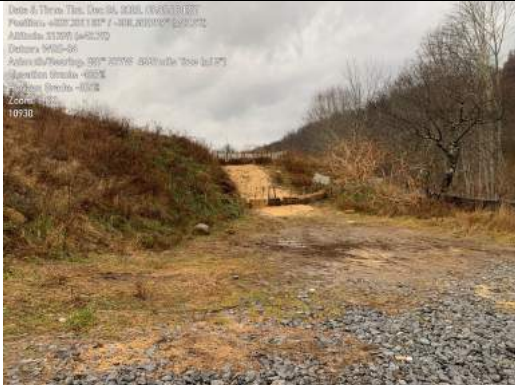
GPS Location	See picture above for GPS coordinates		GPS Location	See picture above for GPS coordinates	
Field Station#	10931+00		Field Station#	10930+00	
Pic 1 Desc.	ECD's and row conditions		Pic 2 Desc.	ECD's and row conditions

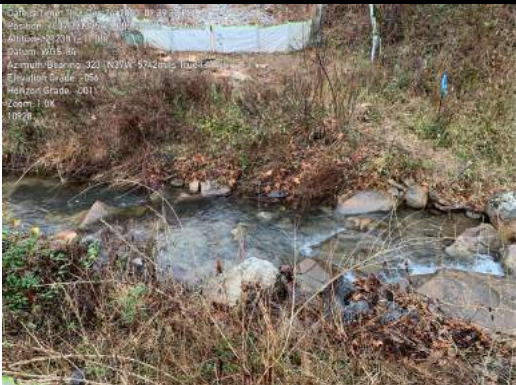
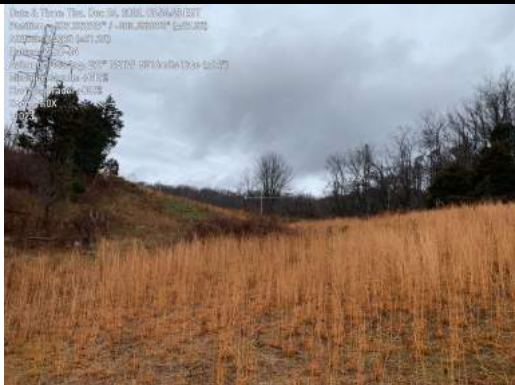
GPS Location	See picture above for GPS coordinates		GPS Location	See picture above for GPS coordinates	
Field Station#	10928+00		Field Station#	11023+00	
Pic 3 Desc.	ECD's and row conditions		Pic 4 Desc.	ECD's and row conditions

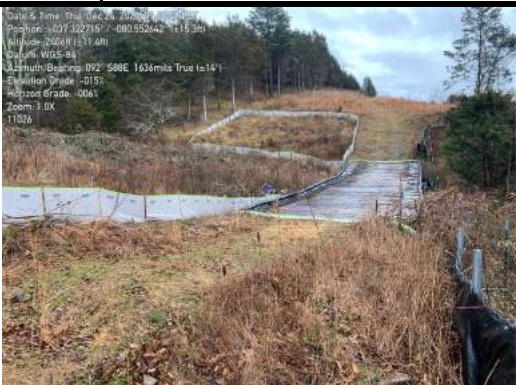
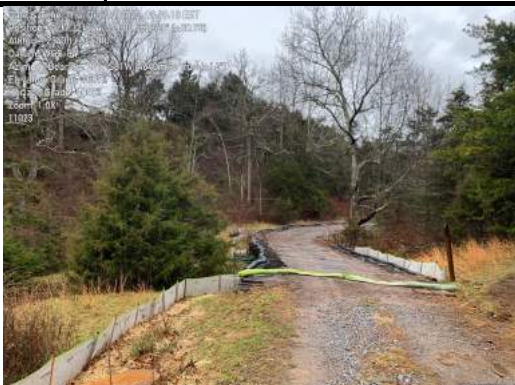
GPS Location	See picture above for GPS coordinates		GPS Location	See picture above for GPS coordinates	
Field Station#	11026+00		Field Station#	11023+00	
Pic 5 Desc.	ECD's and row conditions		Pic 6 Desc.	ECD's and row conditions
