## Visual Site Inspection Report

<b>Project Name</b>	H-600 Pipeline Spread G	<b>AFE</b>	124300137	<b>Spread</b>	H-600 Pipeline Spread G
<b>Contractor</b>	Precision			<b>Report #</b>	18505
<b>Inspector</b>	Jared Saunders			<b>Date/Time</b>	12/28/2020 3:01 PM
<b>Permit #</b>	TBD	<b>Inspection Type</b>	VA SWPP	<b>Station Begin</b>	11254+99
<b>State</b>	VA	<b>Inspection Area</b>	Partial	<b>Station End</b>	11524+16
<b>County</b>	Giles	<b>Ground</b>	Wet	<b>Temperature (°F)</b>	45.00
<b>Municipality</b>	N/A	<b>Weather</b>	Cloudy	<b>Rain Gauge (in)</b>	0.00
				<b>Rain Accumulation Time (days)</b>	1.00

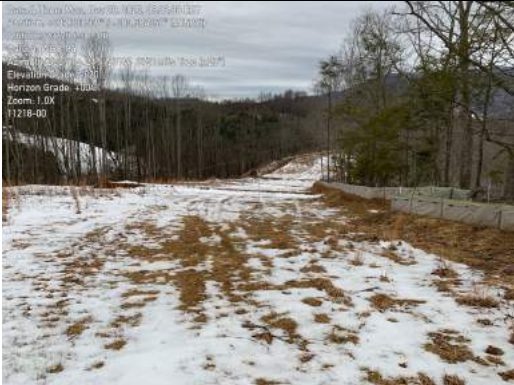
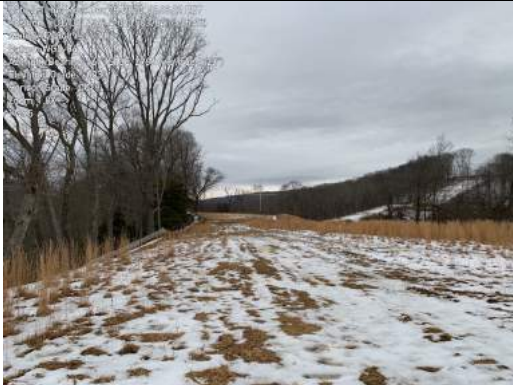
<b>GPS Location</b>	See picture above for GPS coordinates		<b>GPS Location</b>	See picture above for GPS coordinates	
<b>Field Station#</b>	11218+00		<b>Field Station#</b>	11225+00	
<b>Pic 1 Desc.</b>	ECD's and row conditions		<b>Pic 2 Desc.</b>	ECD's and row conditions

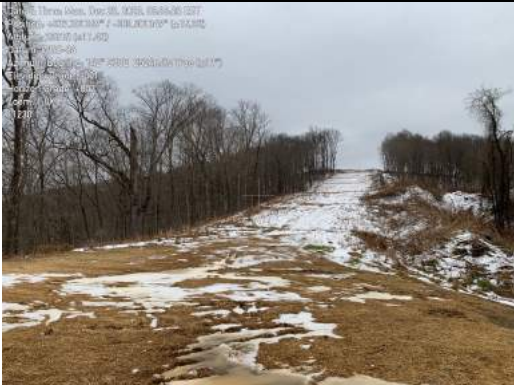
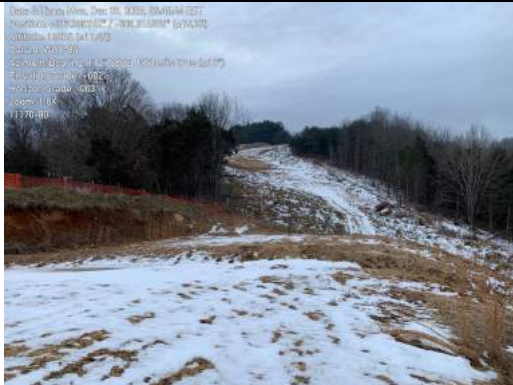
<b>GPS Location</b>	See picture above for GPS coordinates		<b>GPS Location</b>	See picture above for GPS coordinates	
<b>Field Station#</b>	11230+00		<b>Field Station#</b>	11170+00	
<b>Pic 3 Desc.</b>	ECD's and row conditions		<b>Pic 4 Desc.</b>	ECD's and row conditions

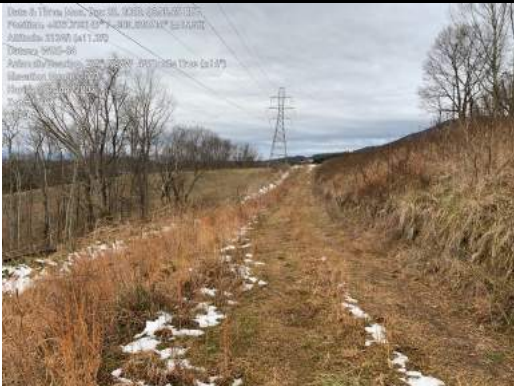
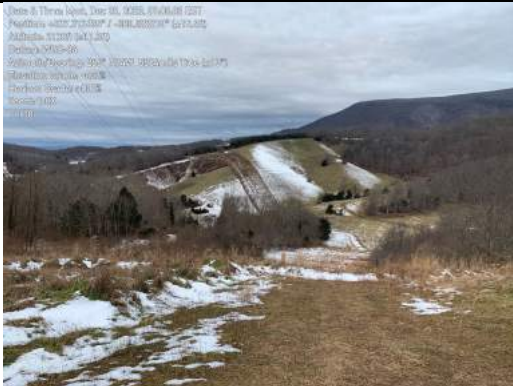
<b>GPS Location</b>	See picture above for GPS coordinates		<b>GPS Location</b>	See picture above for GPS coordinates	
<b>Field Station#</b>	11140+00		<b>Field Station#</b>	11130+00	
<b>Pic 5 Desc.</b>	ECD's and row conditions		<b>Pic 6 Desc.</b>	ECD's and row conditions

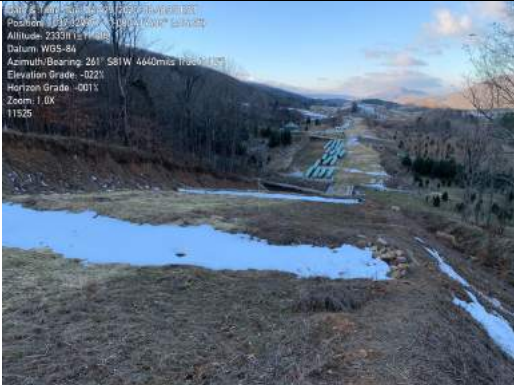
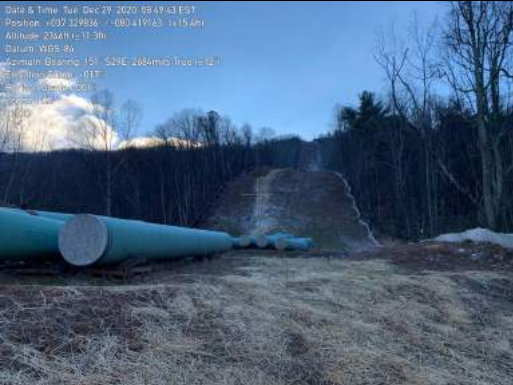
<b>GPS Location</b>	See picture above for GPS coordinates		<b>GPS Location</b>	See picture above for GPS coordinates	
<b>Field Station#</b>	11525+00		<b>Field Station#</b>	11530+00	
<b>Pic 1 Desc.</b>	ECD's and row conditions		<b>Pic 2 Desc.</b>	ECD's and row conditions

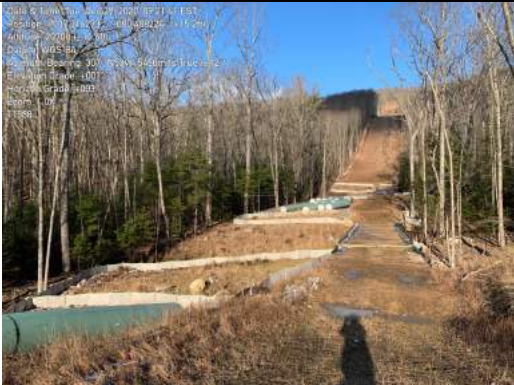
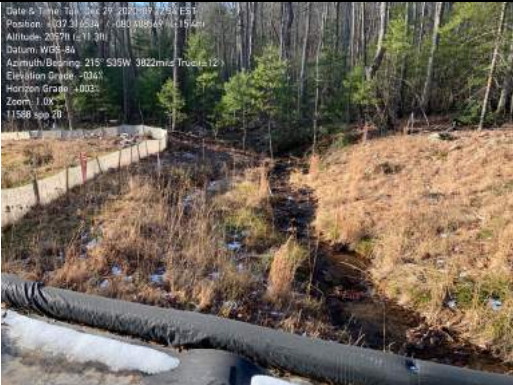
<b>GPS Location</b>	See picture above for GPS coordinates		<b>GPS Location</b>	See picture above for GPS coordinates	
<b>Field Station#</b>	11588+00		<b>Field Station#</b>	11588+00	
<b>Pic 3 Desc.</b>	ECD's and row conditions		<b>Pic 4 Desc.</b>	ECD's and row conditions

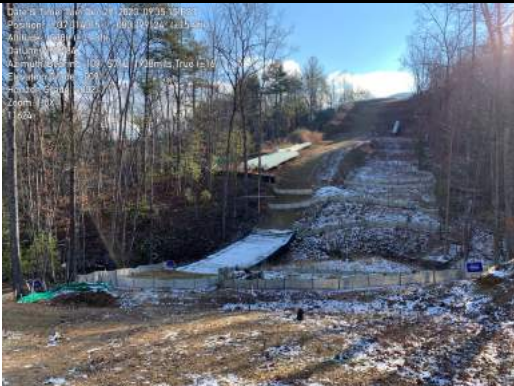
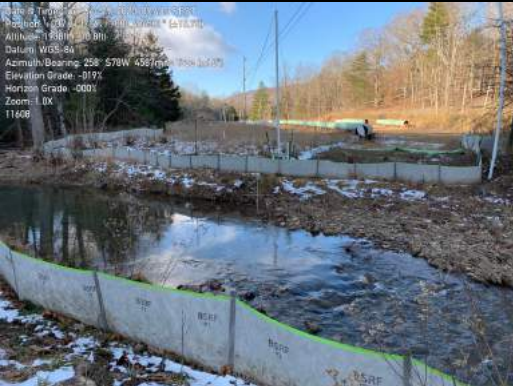
<b>GPS Location</b>	See picture above for GPS coordinates		<b>GPS Location</b>	See picture above for GPS coordinates	
<b>Field Station#</b>	11624+00		<b>Field Station#</b>	11608+00	
<b>Pic 5 Desc.</b>	ECD's and row conditions		<b>Pic 6 Desc.</b>	ECD's and row conditions

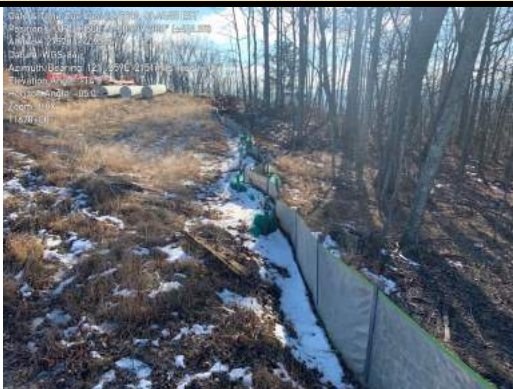
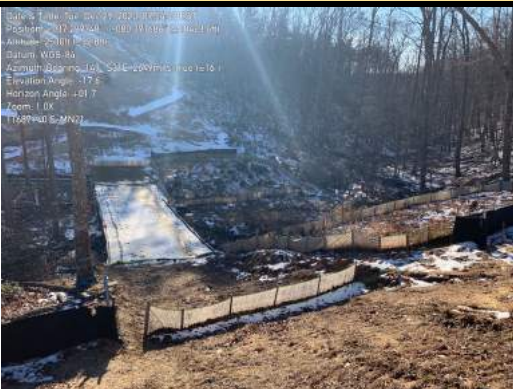
GPS Location	See photo for GPS location.		GPS Location	See photo for GPS location.	
Field Station#	11670+00		Field Station#	11687+40	
Pic 1 Desc.	Triple stack compost filter sock and priority one silt fence in place along LOD.		Pic 2 Desc.	Sensitive resource buffer in place at stream S-MN21.

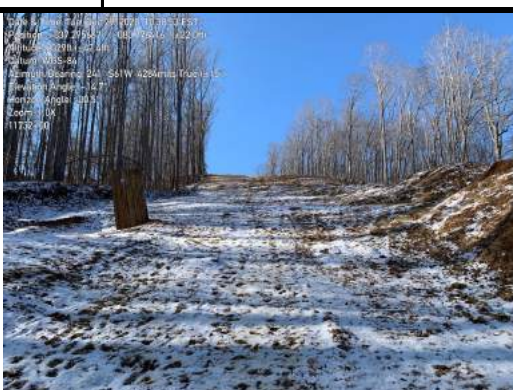
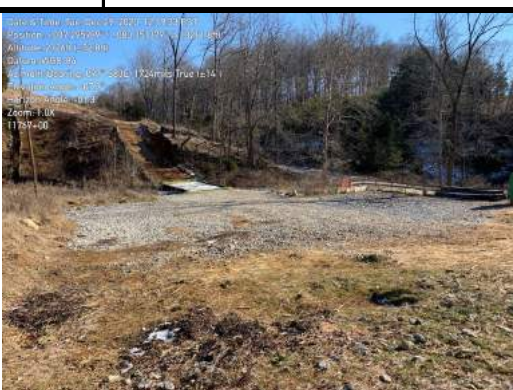
GPS Location	See photo for GPS location.		GPS Location	See photo for GPS location.	
Field Station#	11738+00		Field Station#	11767+00	
Pic 3 Desc.	ROW currently frozen and snow covered.		Pic 4 Desc.	RCE in place at MLV 26.

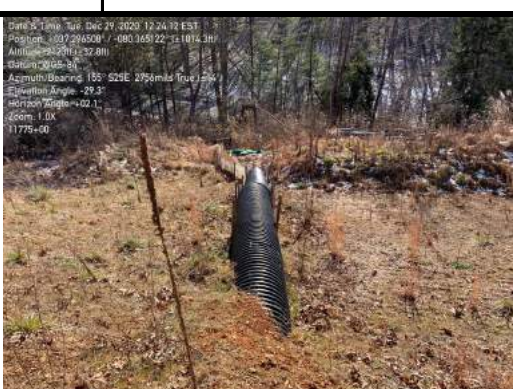
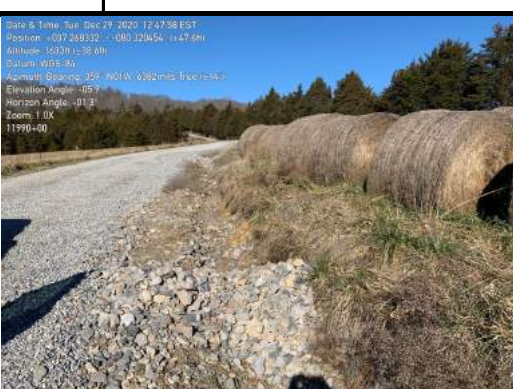
GPS Location	See photo for GPS location.		GPS Location	See photo for GPS location.	
Field Station#	11775+00		Field Station#	11990+00	
Pic 5 Desc.	Clean water diversion pipe and plunge pool in place.		Pic 6 Desc.	Rock checks in place along access road 266.

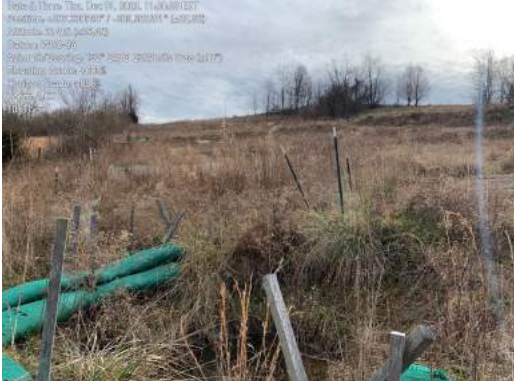
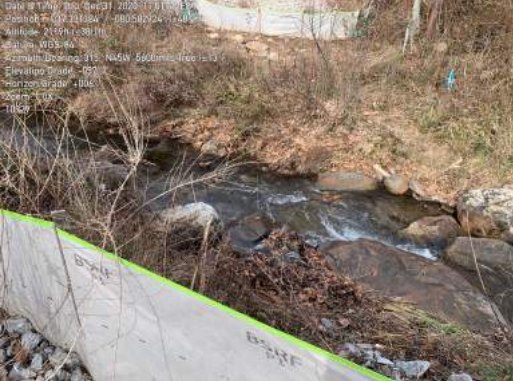
<b>GPS Location</b>	See picture above for GPS coordinates		<b>GPS Location</b>	See picture above for GPS coordinates	
<b>Field Station#</b>	10931+00		<b>Field Station#</b>	10929+00	
<b>Pic 1 Desc.</b>	ECD's and row conditions		<b>Pic 2 Desc.</b>	ECD's and row conditions

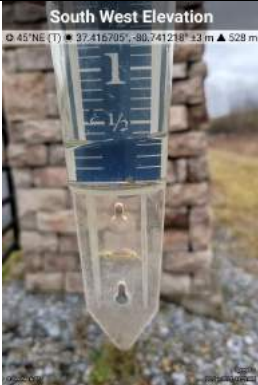
<b>GPS Location</b>	See photo for GPS location.		<b>GPS Location</b>	See photo for GPS location.	
<b>Field Station#</b>	12005+00		<b>Field Station#</b>	12005+00	
<b>Pic 1 Desc.</b>	Rain gauge at LDY reads 0.3 inches.		<b>Pic 2 Desc.</b>	ECDs in place along LOD.

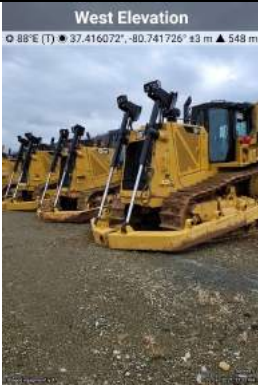
<b>GPS Location</b>	See photo for GPS location.		<b>GPS Location</b>	See photo for GPS location.	
<b>Field Station#</b>	12005+00		<b>Field Station#</b>	12005+00	
<b>Pic 3 Desc.</b>	Checked staged equipment for leaks.		<b>Pic 4 Desc.</b>	Priority one silt fence in place along LOD.
