Visual Site Inspection Report

Project Name	H-600 Pipeline Spread H	AFE	124300138	Spread	H-600 Pipeline Spread H
Contractor	Precision			Report #	19154
Inspector	John Brcic			Date/Time	1/18/2021 1:27 PM
Permit #	TBD	Inspection Type	VA SWPP	Station Begin	12284+75
State	VA	Inspection Area	Partial	Station End	12443+75
County	Montgomery	Ground	Damp	Temperature (°F)	0.00
Municipality	N/A	Weather	Cloudy	Rain Gauge (in)	34.00
				Rain Accumulation Time (days)	2.00

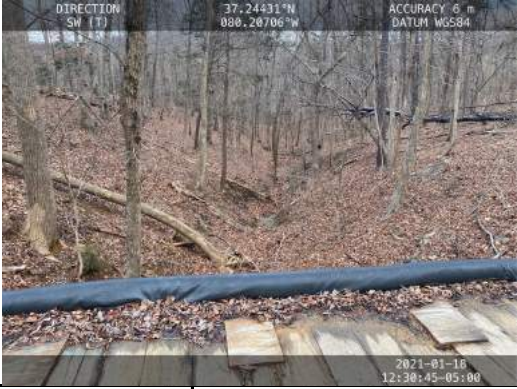
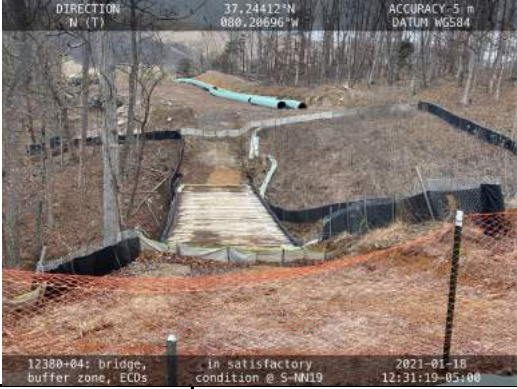
GPS Location	See photo		GPS Location	See photo	
Field Station#	12380+04		Field Station#	12380+04	
Pic 7 Desc.	Stream S-NN19, facing southwest, downstream		Pic 8 Desc.	Bridge, buffer zone and ECDs in satisfactory condition at stream S-NN19.

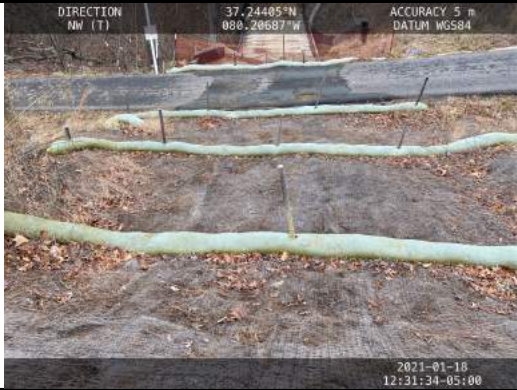
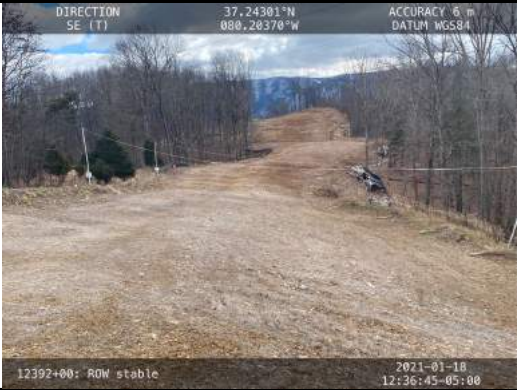
GPS Location	See photo		GPS Location	See photo	
Field Station#	12380+75		Field Station#	12392+00	
Pic 9 Desc.	Cannery Road crossing is in good condition and free of sediment.		Pic 10 Desc.	ROW stable

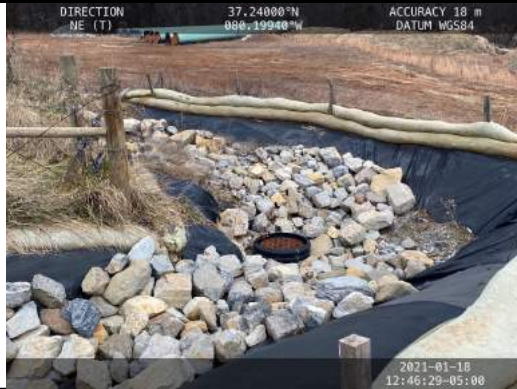
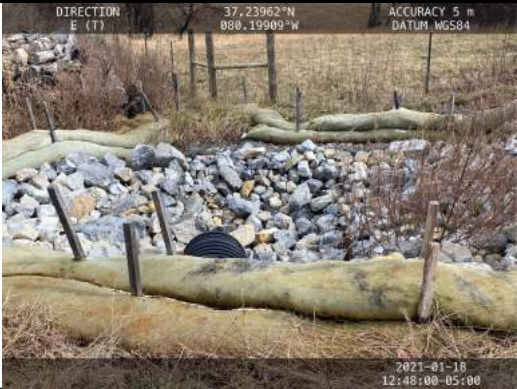
GPS Location	See photo		GPS Location	See photo	
Field Station#	12409+40		Field Station#	12410+50	
Pic 11 Desc.	Clean water diversion pipe inlet in good condition, free of sediment.		Pic 12 Desc.	Clean water diversion pipe outlet plunge pool is in satisfactory condition and free of sediment.

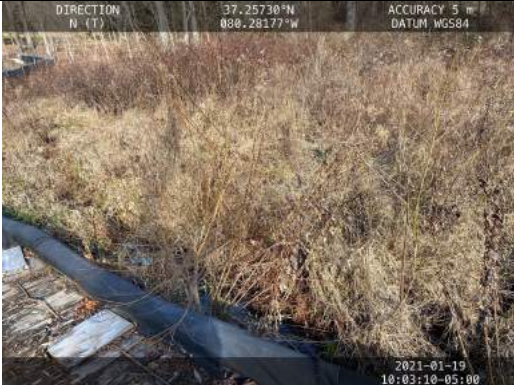
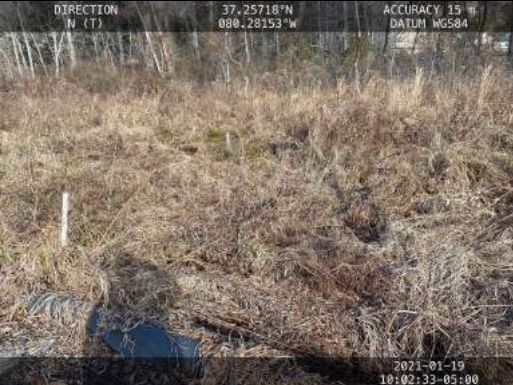
GPS Location	See photo		GPS Location	See photo	
Field Station#	12121+33		Field Station#	12121+83	
Pic 1 Desc.	Stream S-C33, facing north, upstream		Pic 2 Desc.	Stream S-C36, facing north, upstream

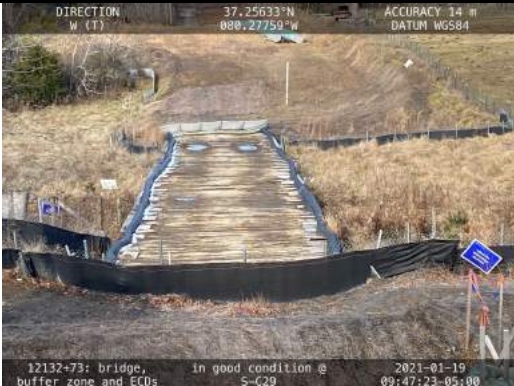
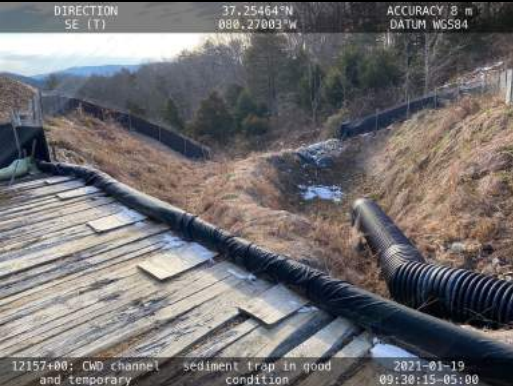
GPS Location	See photo		GPS Location	See photo	
Field Station#	12132+73		Field Station#	12157+00	
Pic 5 Desc.	Bridge, buffer zone and ECDs in satisfactory condition at stream S-C29.		Pic 6 Desc.	Clean water diversion channel and temporary sediment trap are in good condition and stable.

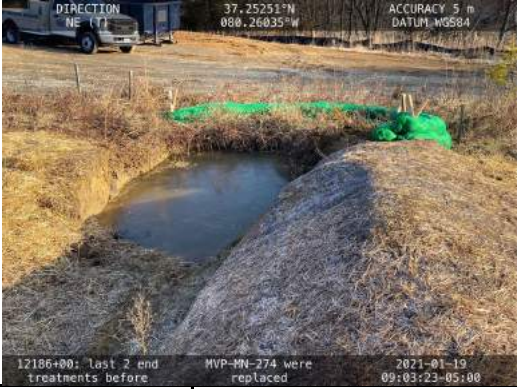
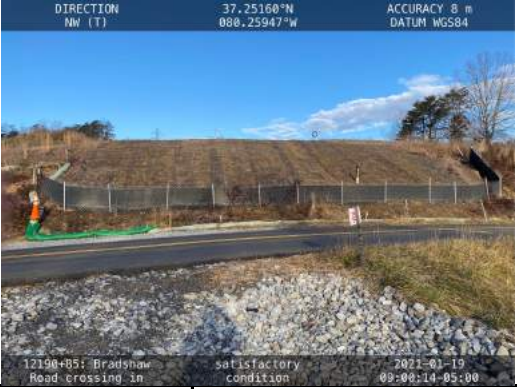
GPS Location	See photo		GPS Location	See photo	
Field Station#	12186+00		Field Station#	12190+85	
Pic 13 Desc.	The last two end treatments on the coming in side of access road MVP-MN-274 were replaced since the last SWPPP inspection.		Pic 14 Desc.	The Bradshaw Road crossing and associated ECDs are in satisfactory condition.

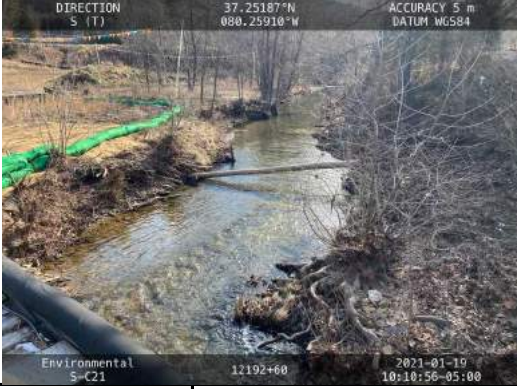
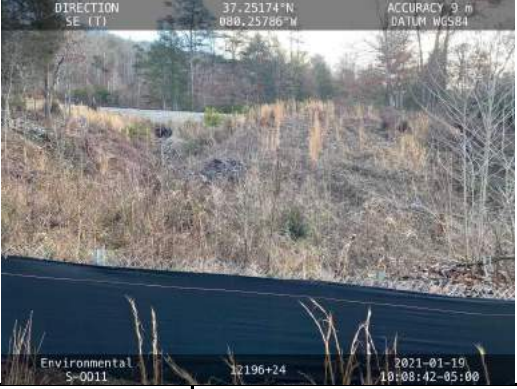
GPS Location	See photo		GPS Location	See photo	
Field Station#	12192+60		Field Station#	12196+24	
Pic 15 Desc.	Stream S-C21, Bradshaw Creek, facing south, downstream		Pic 16 Desc.	Stream S-0011, facing southeast, upstream

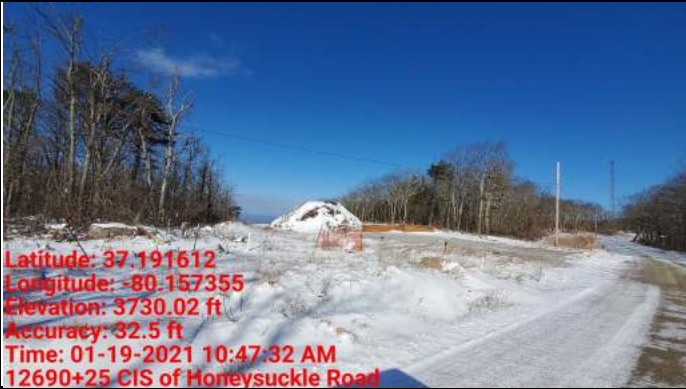
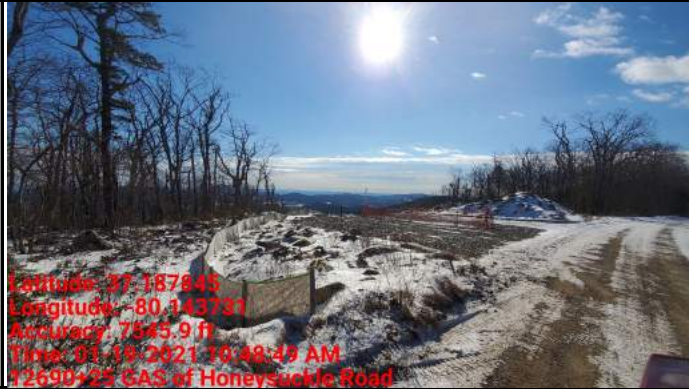
GPS Location	See pic for GPS location		GPS Location	See pic for GPS location	
Field Station#	12690+25		Field Station#	12690+25	
Pic 7 Desc.	No maintenance issues or impacts were observed on the CIS of Honeysuckle Road.		Pic 8 Desc.	No maintenance issues or impacts were observed on the GAS of Honeysuckle Road.

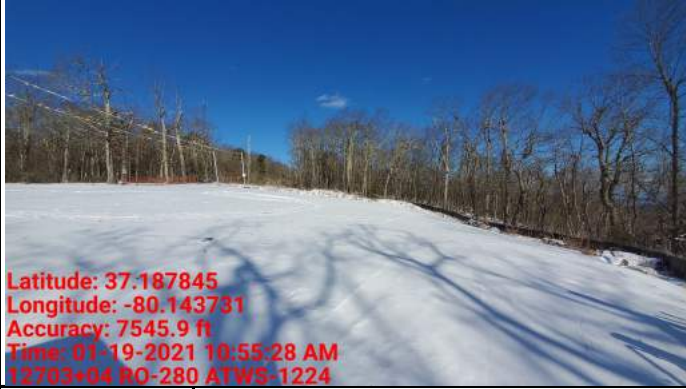
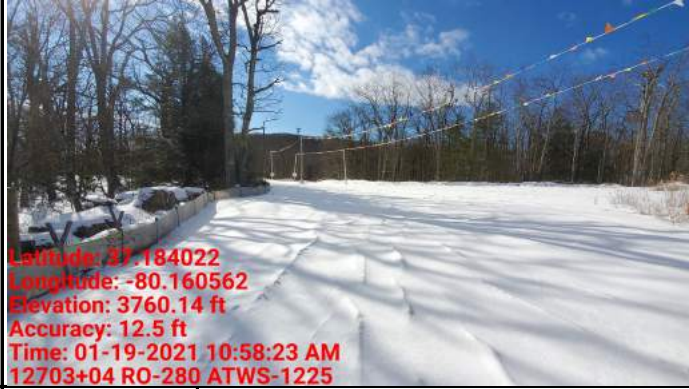
GPS Location	See pic for GPS location		GPS Location	See pic for GPS location	
Field Station#	12803+04		Field Station#	12703+04	
Pic 9 Desc.	No ECD or BMP deficiencies were observed at RO-280 and Honeysuckle.		Pic 10 Desc.	No environmental impacts observed in the area of RO-280.

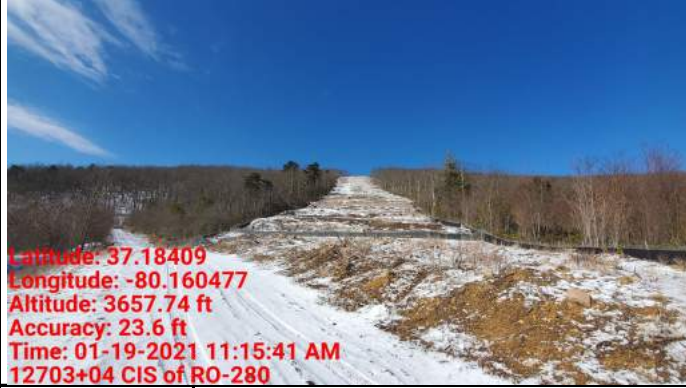
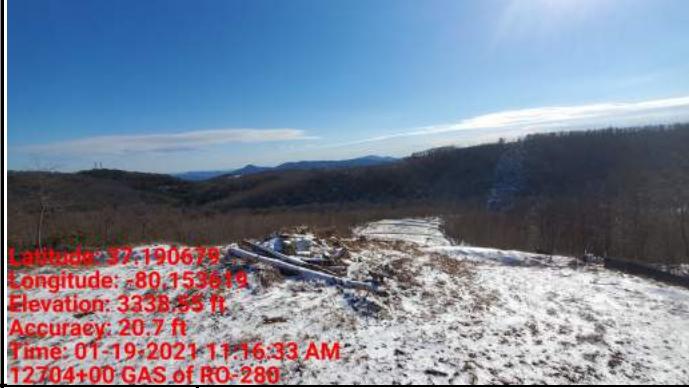
GPS Location	See pic for GPS location		GPS Location	See pic for GPS location	
Field Station#	12703+04		Field Station#	12704+00	
Pic 11 Desc.	CIS of RO-280 remains in compliance.		Pic 12 Desc.	No maintenance issues or impacts observed on the GAS of RO-288.

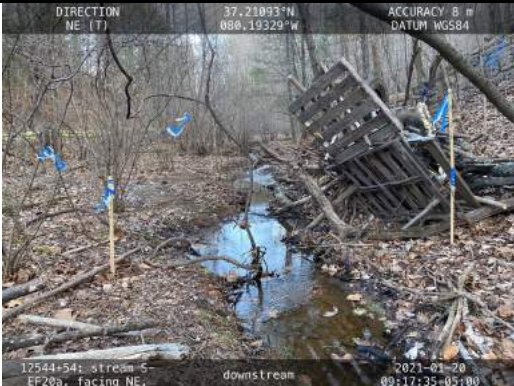
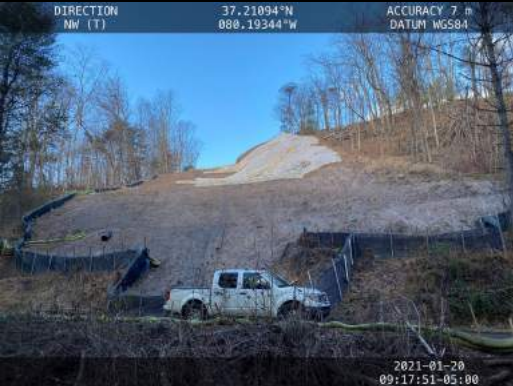
GPS Location	See photo		GPS Location	See photo	
Field Station#	12544+54		Field Station#	12544+06	
Pic 5 Desc.	Stream S-EF20a, facing northeast, downstream		Pic 6 Desc.	ECDs in satisfactory condition where MVP ROW crosses Yellow Finch Lane.

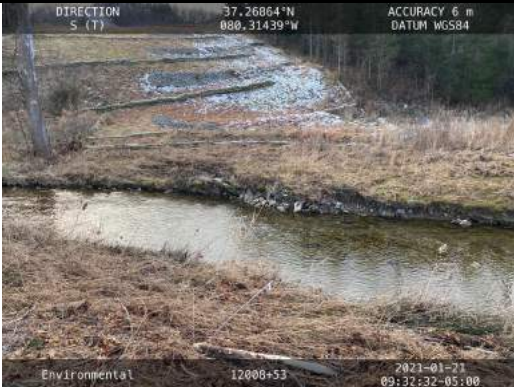
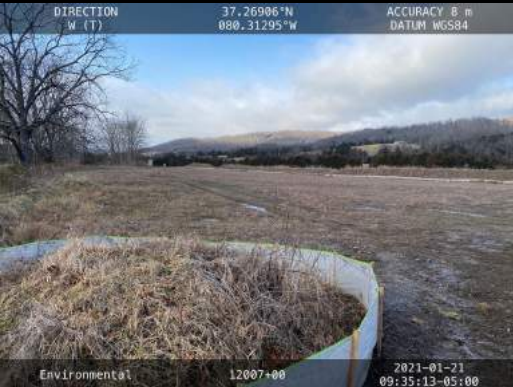
GPS Location	See photo for GPS coordinates		GPS Location	See photo for GPS coordinates	
Field Station#	12008+53		Field Station#	12007+00	
Pic 1 Desc.	S-G36 in acceptable condition with no sign of impact or disturbance		Pic 2 Desc.	Stabilized ROW with acceptable vegetation across LOD

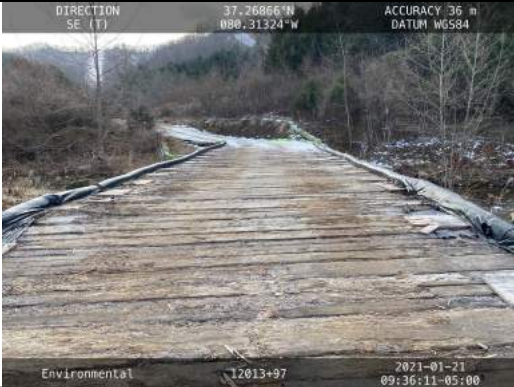
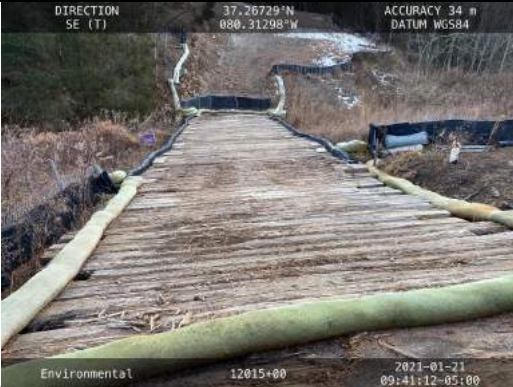
GPS Location	See photo for GPS coordinates		GPS Location	See photo for GPS coordinates	
Field Station#	12013+97		Field Station#	12015+00	
Pic 3 Desc.	Bridge and ECDs at S-G36 crossing on access road 268 is in acceptable condition		Pic 4 Desc.	Bridge and ECDs at S-G38 in acceptable condition

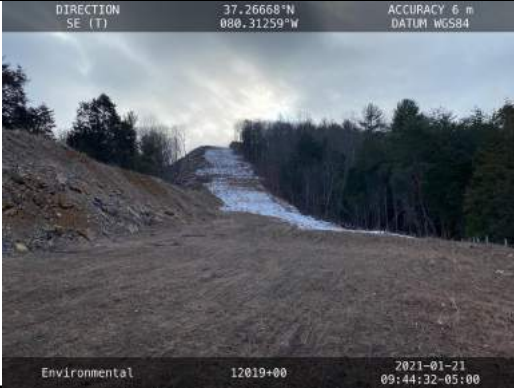
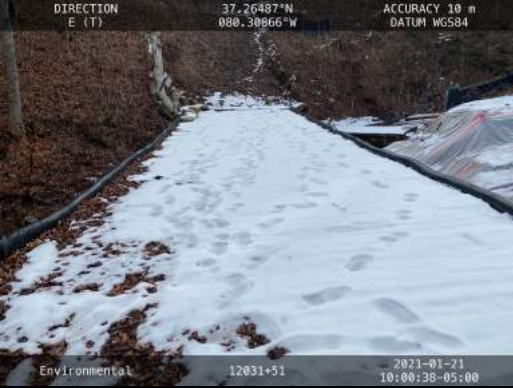
GPS Location	See photo for GPS coordinates		GPS Location	See photo for GPS coordinates	
Field Station#	12019+00		Field Station#	12031+51	
Pic 5 Desc.	Stabilized ROW with acceptable vegetation across LOD		Pic 6 Desc.	Bridge and ECDs at S-G39 in acceptable condition

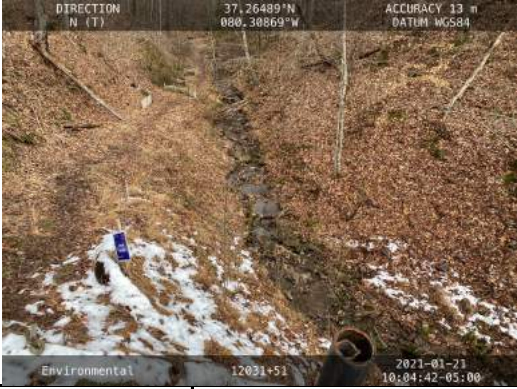
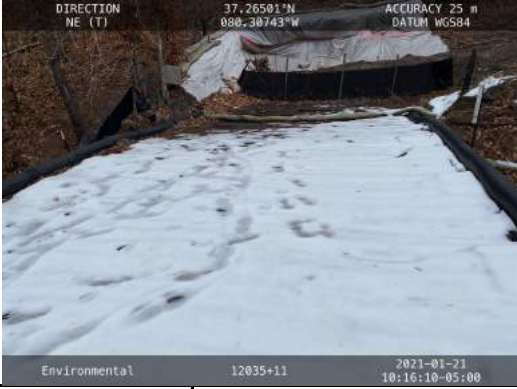
GPS Location	See photo for GPS coordinates		GPS Location	See photo for GPS coordinates	
Field Station#	12031+51		Field Station#	12035+11	
Pic 7 Desc.	Down stream view of S-G39 with no signs of impact or disturbance		Pic 8 Desc.	Bridge and ECDs at S-G40 in acceptable condition

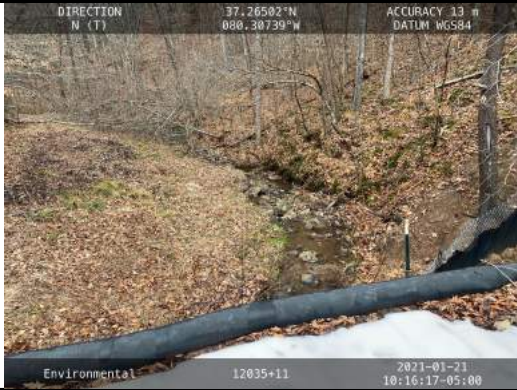
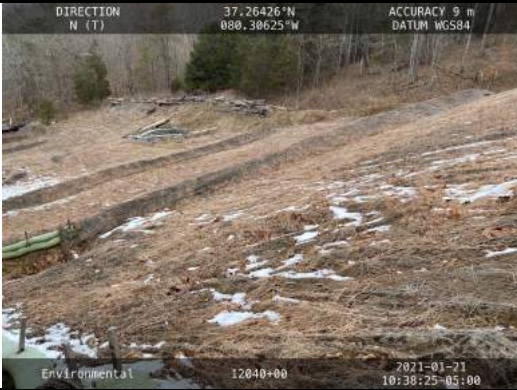
GPS Location	See photo for GPS coordinates		GPS Location	See photo for GPS coordinates	
Field Station#	12035+11		Field Station#	12040+00	
Pic 9 Desc.	Down stream view of S-G40 with no signs of impact or disturbance		Pic 10 Desc.	Stabilized ROW with acceptable vegetation across LOD

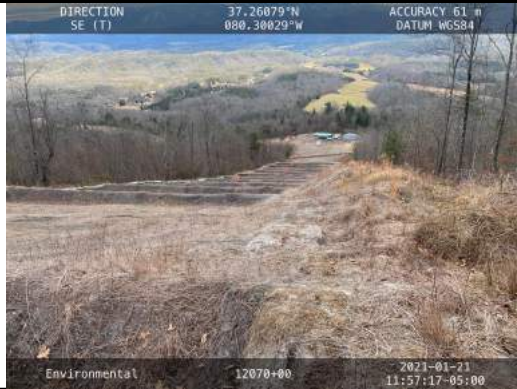
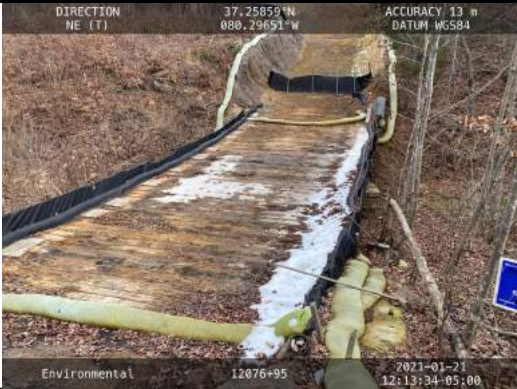
GPS Location	See photo for GPS coordinates		GPS Location	See photo for GPS coordinates	
Field Station#	12070+00		Field Station#	12076+95	
Pic 11 Desc.	Stabilized ROW with acceptable vegetation across LOD		Pic 12 Desc.	Bridge and ECDs at S-MM15 in acceptable condition

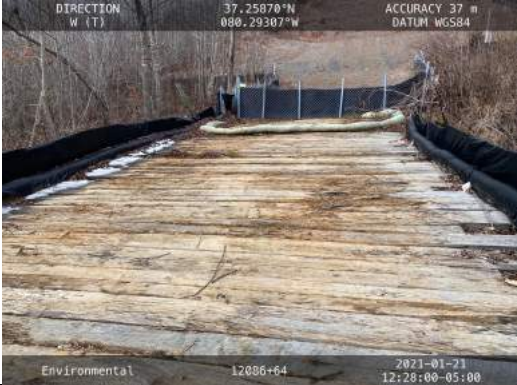
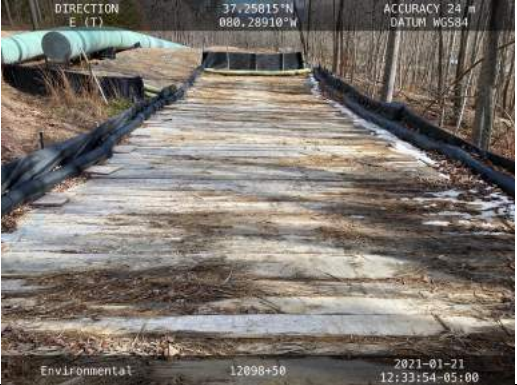
GPS Location	See photo for GPS coordinates		GPS Location	See photo for GPS coordinates	
Field Station#	12086+64		Field Station#	12098+50	
Pic 13 Desc.	Bridge and ECDs at S-MM14 in acceptable condition		Pic 14 Desc.	Bridge and ECDs at S-MM13 in acceptable condition

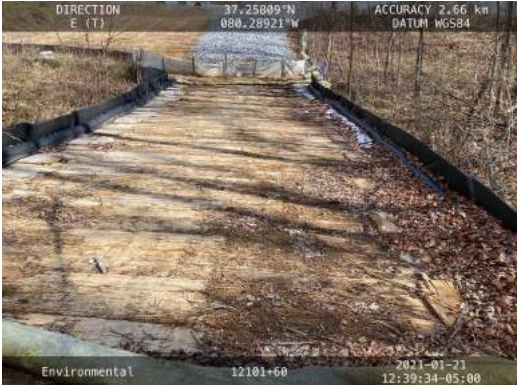
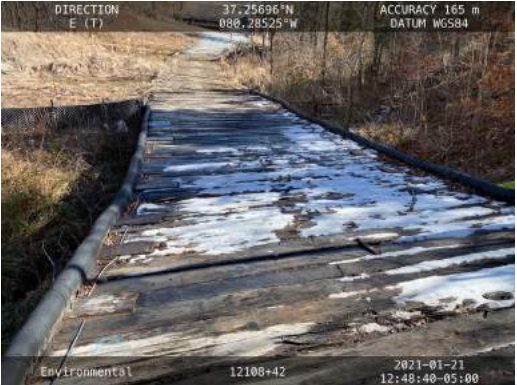
GPS Location	See photo for GPS coordinates		GPS Location	See photo for GPS w	
Field Station#	12101+60		Field Station#	12108+42	
Pic 15 Desc.	Bridge and ECDs at S-MM11 in acceptable condition		Pic 16 Desc.	Bridge and ECDs at S-F15 in acceptable condition

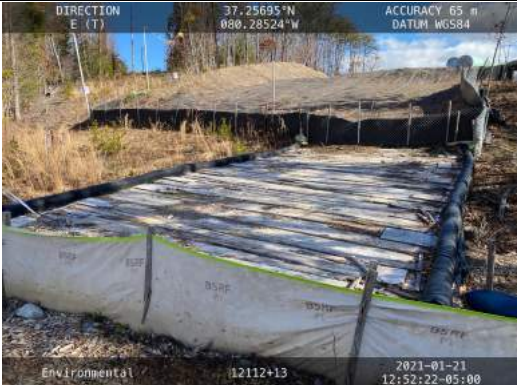
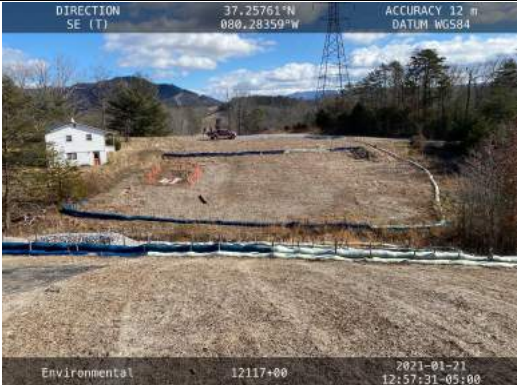
GPS Location	See photo for GPS coordinates		GPS Location	See photo for GPS coordinates	
Field Station#	12112+13		Field Station#	12117+00	
Pic 17 Desc.	Bridge and ECDs at S-F16A/B in acceptable condition		Pic 18 Desc.	Stabilized ROW

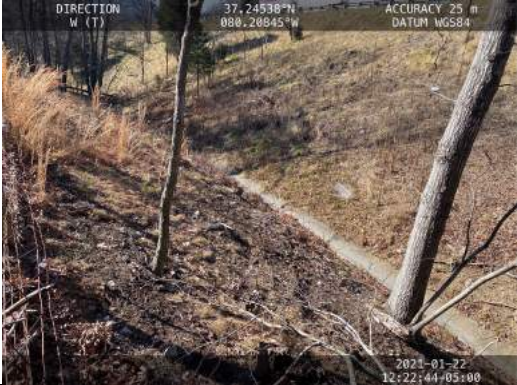
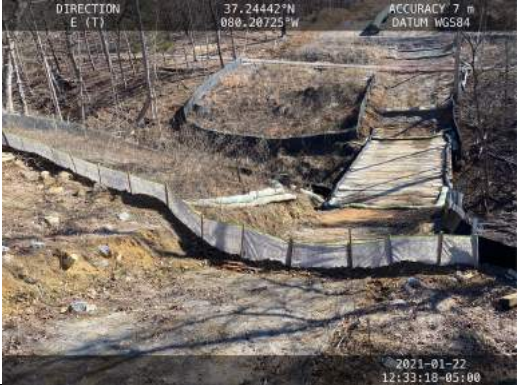
GPS Location	See photo		GPS Location	See photo	
Field Station#	12374+16		Field Station#	12380+04	
Pic 7 Desc.	Stream S-0016, facing west, upstream		Pic 8 Desc.	Bridge, buffer zone and ECDs in satisfactory condition at stream S-NN19.

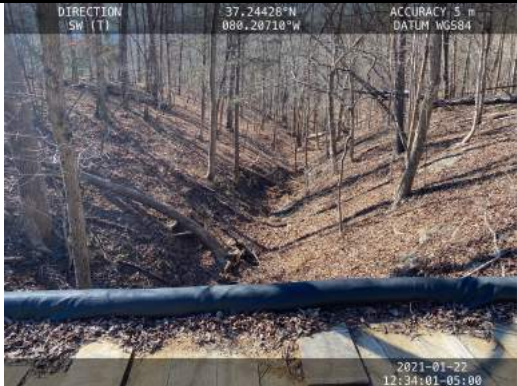
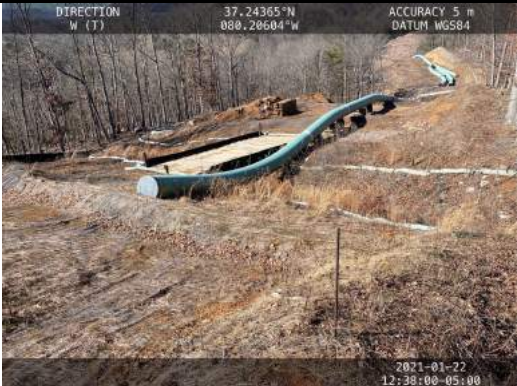
GPS Location	See photo		GPS Location	See photo	
Field Station#	12380+04		Field Station#	12383+00	
Pic 9 Desc.	Stream S-NN19, facing southwest, downstream		Pic 10 Desc.	Clean water diversion channel stable, ECDs intact.

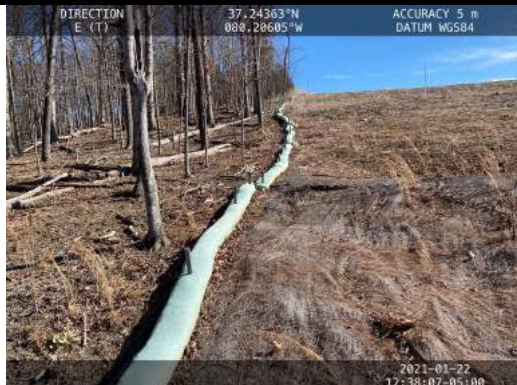
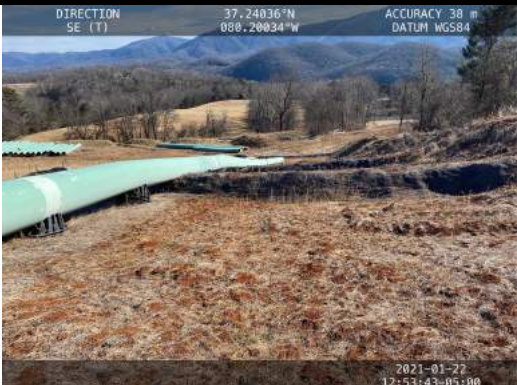
GPS Location	See photo		GPS Location	See photo	
Field Station#	12385+00		Field Station#	12405+00	
Pic 11 Desc.	Perimeter CFS is in satisfactory condition.		Pic 12 Desc.	ROW stable on slope leading down to MLV-27.

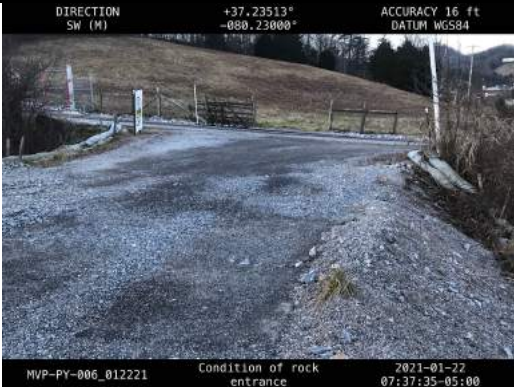
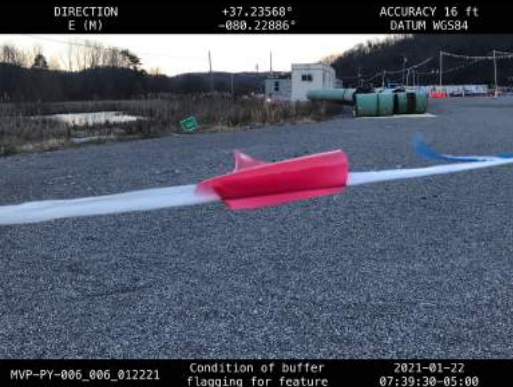
GPS Location	MVP-PY-006 See photo for gps data		GPS Location	MVP-PY-006 See photo for gps data	
Field Station#	+0		Field Station#	+0	
Pic 1 Desc.	Condition of west rock entrance. No sediment on stone. Looking SW.		Pic 2 Desc.	Condition of buffer and buffer flagging for feature W-008. Looking NE.

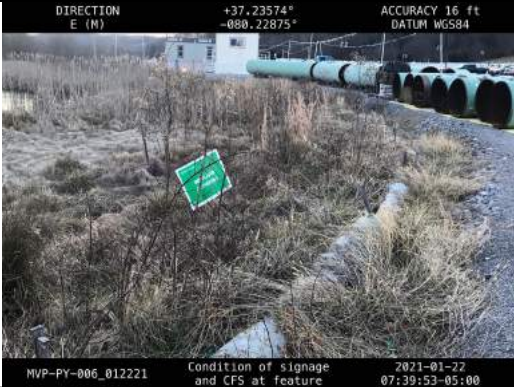
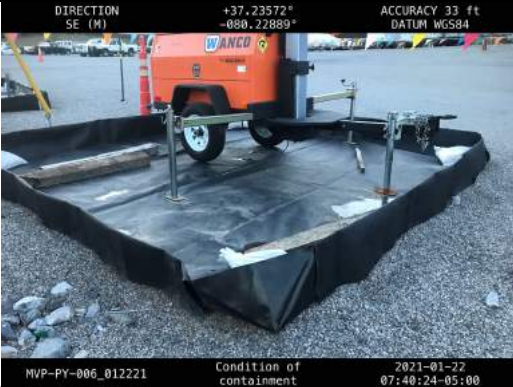
GPS Location	MVP-PY-006 See photo for gps data		GPS Location	MVP-PY-006 See photo for gps data	
Field Station#	+0		Field Station#	+0	
Pic 3 Desc.	Condition of signage and compost filter sock along south edge of feature W-CV21B. Looking E.		Pic 4 Desc.	Condition of containment under light plant. Free of stormwater. Looking SE.

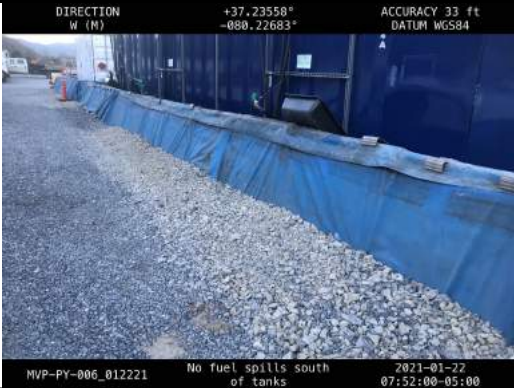
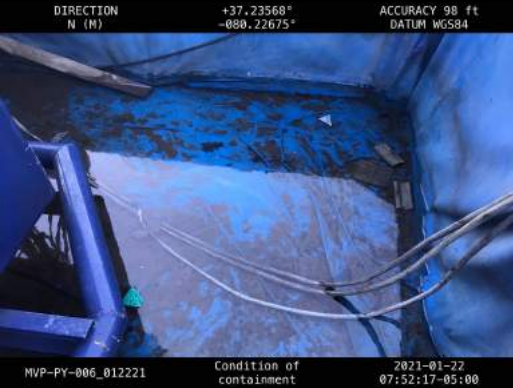
GPS Location	MVP-PY-006 See photo for gps data		GPS Location	MVP-PY-006 See photo for gps data	
Field Station#	+0		Field Station#	+0	
Pic 5 Desc.	No fuel spills south of the Blue Bulk fuel tanks. Looking W.		Pic 6 Desc.	Blue Bulk Fuel tanks containment holding stormwater. Sheen noted. Looking N.

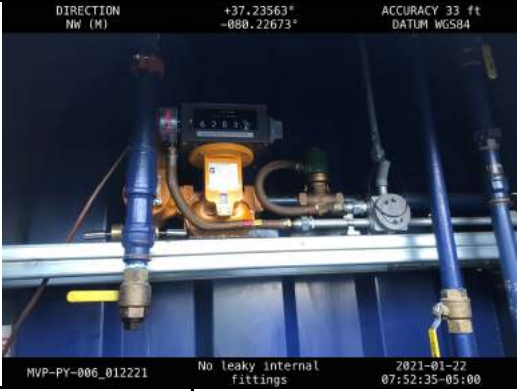
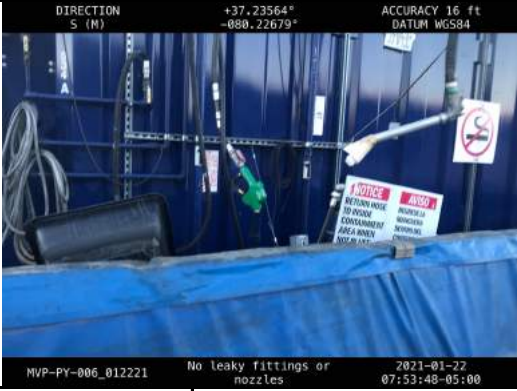
GPS Location	MVP-PY-006 See photo for gps data	GPS Location	MVP-PY-006 See photo for gps data		
Field Station#	+0	Field Station#	+0		
Pic 7 Desc.	Blue Bulk Fuel tanks no leaky internal fittings. Looking NW.	Pic 8 Desc.	Blue Bulk Fuel tanks no leaky fittings or nozzles. Drip pans in place. Looking S.
