Visual Site Inspection Report

| Project Name | H-600 Pipeline Spread H | AFE | 124300138 | Spread | H-600 Pipeline Spread H |
| Contractor | Precision | | | Report # | 18710 |
| Inspector | John Brcic | | | Date/Time | 1/4/2021 12:00 PM |

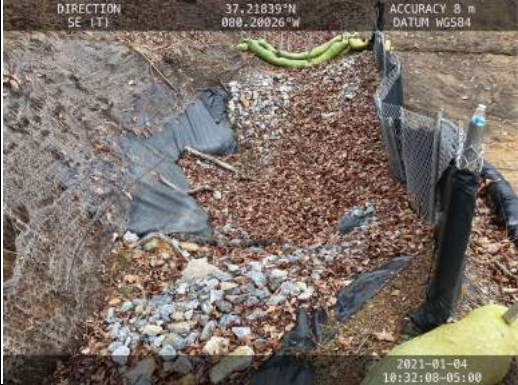
| Pic 13 Desc. | This clean water diversion pipe inlet is free of sediment and unobstructed. | | Pic 14 Desc. | ROW stable | |

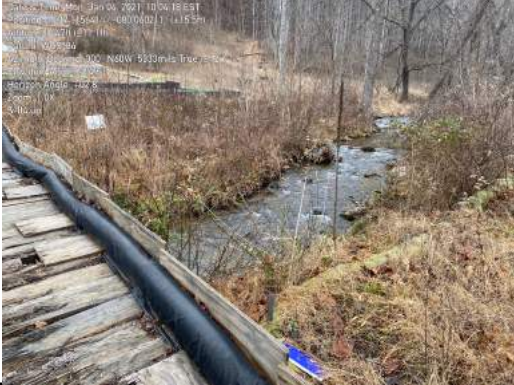
| Pic 3 Desc. | Waddle on bridge damaged. | | Pic 4 Desc. | Ridge over S-II4 in acceptable condition. | |

| E&S BMPs | Compliance Level | Corrective Action | Corrective Time Frame | Date Repaired |
|---|---|---|---|---|
| Compost Filter Sock | Communication | Repair waddle; 3 day maintenance | | |

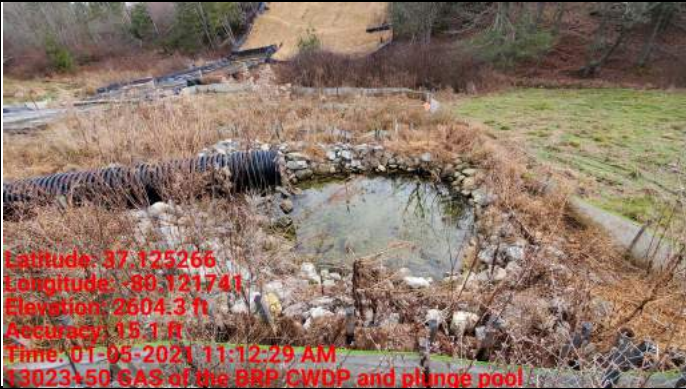
| <p>Latitude: 37.125266 Longitude: -80.121741 Elevation: 2604.3 ft Accuracy: 15.1 ft Time: 01-05-2021 11:12:29 AM 13023+50 GAS of the BRP CWDP and plunge pool</p> | | | <p>Latitude: 37.125449 Longitude: -80.122314 Elevation: 2648.81 ft Accuracy: 14.4 ft Time: 01-05-2021 11:19:31 AM 13021+77 GAS of the BRP NPS boundary</p> | | |

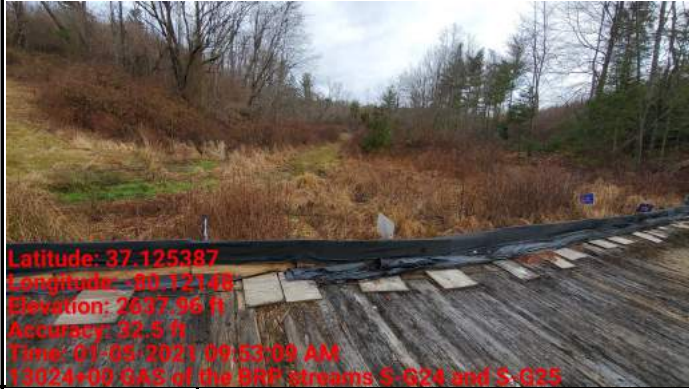
| <p>Latitude: 37.125377 Longitude: -80.12183 Elevation: 2628.32 ft Accuracy: 13.5 ft Time: 01-05-2021 10:54:37 AM 13023+00 GAS of the BRP CWDP</p> | | | <p>Latitude: 37.125387 Longitude: -80.12148 Elevation: 2637.96 ft Accuracy: 32.5 ft Time: 01-05-2021 09:53:09 AM 13024+00 GAS of the BRP streams S-G24 and S-G25</p> | | |

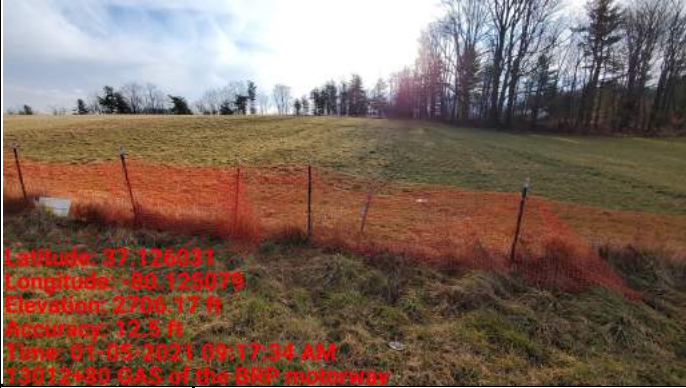
| <p>Latitude: 37.126031 Longitude: -80.125079 Elevation: 2706.17 ft Accuracy: 12.5 ft Time: 01-05-2021 09:17:34 AM 13012+80 GAS of the BRP motorway</p> | | | <p>Latitude: 37.126021 Longitude: -80.125016 Elevation: 2703.35 ft Accuracy: 12.5 ft Time: 01-05-2021 09:16:53 AM 13012+40 CIS of the BRP motorway</p> | | |

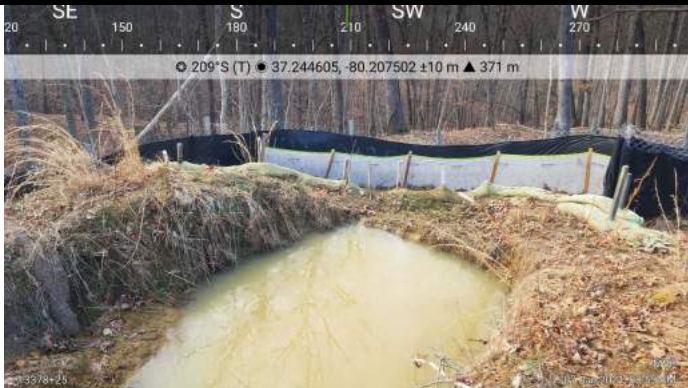
| Pic 7 Desc. | P1 silt fence needs repair. | | Pic 8 Desc. | Repairs needed to both small runs of P1 silt fence across the travel lane on the coming in side of the bridge at stream S-NN19. | |

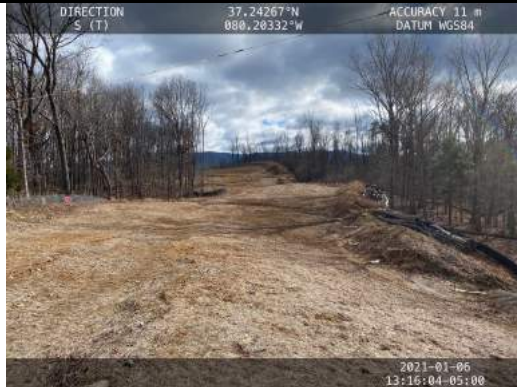
| Pic 9 Desc. | P1 silt fence was replaced. | | Pic 10 Desc. | P1 silt fence replaced on coming in side of bridge at S-NN18. | |

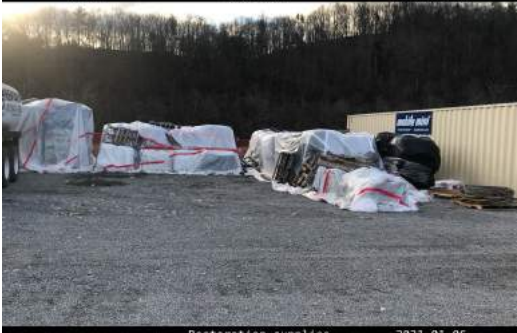
| DIRECTION SE (M) +37.27024° -080.12168° ACCURACY 33 ft DATUM WGS84 MVP-LY-049_010621 Restoration supplies covered 2021-01-06 08:35:59-05:00 | | DIRECTION NW (M) +37.26925° -080.12370° ACCURACY 16 ft DATUM WGS84 MVP-LY-049_010621 Condition of CFS around sand pile 2021-01-06 08:37:42-05:00 | | | |
| Pic 13 Desc. | Restoration supplies covered and protected from the elements. Looking SE. | | Pic 14 Desc. | Condition of compost filter sock around sand pile. Looking NW. | |

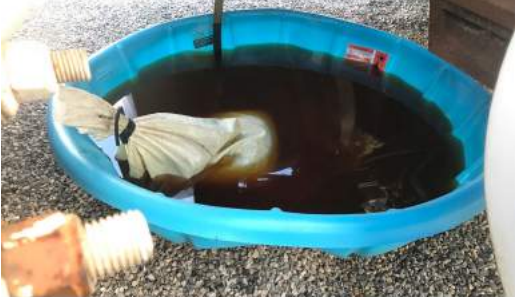
| DIRECTION S (M) +37.27018° -080.12286° ACCURACY 16 ft DATUM WGS84 MVP-LY-049_010621 Containment under stored vehicle 2021-01-06 08:54:59-05:00 | | DIRECTION N (M) +37.27013° -080.12269° ACCURACY 16 ft DATUM WGS84 MVP-LY-049_010621 Containment under stored vehicle 2021-01-06 08:55:30-05:00 | | | |

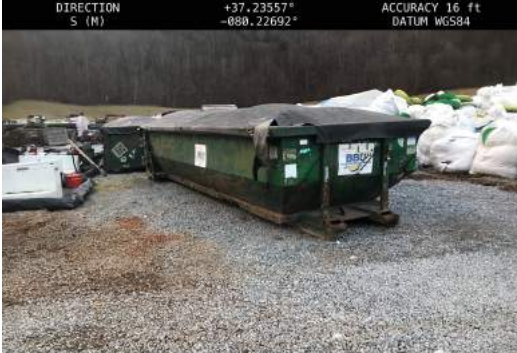
| <small>DIRECTION S (M) +37.23557° -080.22692° ACCURACY 16 ft DATUM WGS84</small> <small>MVP-PY-006_010621 No deposits around hazardous waste ... 2021-01-06 07:50:40-05:00</small> | | <small>DIRECTION SE (M) +37.23557° -080.22688° ACCURACY 16 ft DATUM WGS84</small> <small>MVP-PY-006_010621 No loose trash around dumpsters 2021-01-06 07:50:43-05:00</small> | | | |

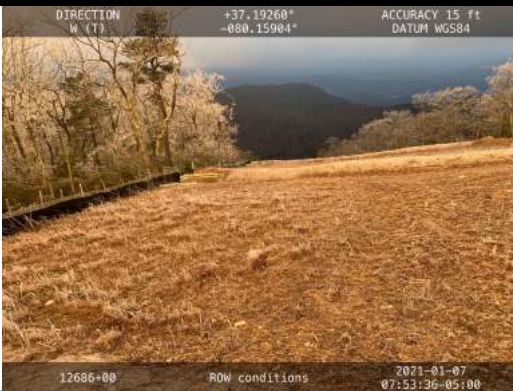
| <p>DIRECTION W (T) +37.19175° -880.15726° ACCURACY 15 ft DATUM WGS84 12690+00 RCE on the west side of Honeysuckle 2021-01-06 10:54:28-05:00</p> | | | <p>DIRECTION W (T) +37.19260° -880.15984° ACCURACY 15 ft DATUM WGS84 12686+00 ROW conditions 2021-01-07 07:53:36-05:00</p> | | |
