Visual Site Inspection Report

Project Name	H-600 Pipeline Spread H	AFE	124300138	Spread	H-600 Pipeline Spread H
Contractor	Precision			Report #	18940
Inspector	John Brcic			Date/Time	1/11/2021 9:57 AM
Permit #	TBD	Inspection Type	VA SWPP	Station Begin	12005+00
State	VA	Inspection Area	Partial	Station End	12119+17
County	Montgomery	Ground	Frozen	Temperature (°F)	32.00
Municipality	N/A	Weather	Snow/Sleet	Rain Gauge (in)	0.30
				Rain Accumulation Time (days)	3.00

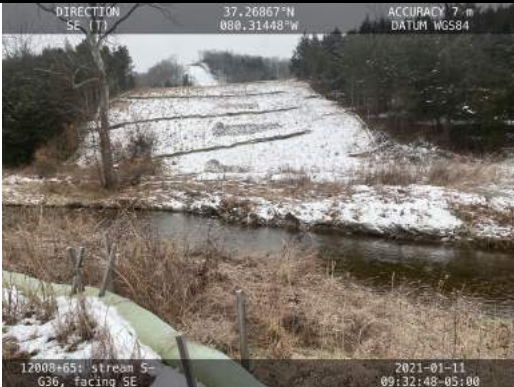
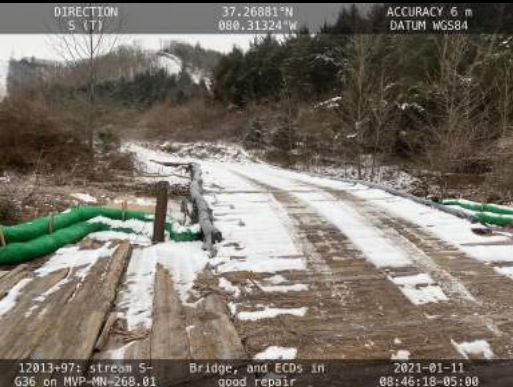
GPS Location	See photo		GPS Location	See photo	
Field Station#	12008+65		Field Station#	12013+97	
Pic 1 Desc.	Stream S-G36, facing southeast		Pic 2 Desc.	Stream S-G36 on access road MVP-MN-268.01. Bridge and ECDs in satisfactory condition.

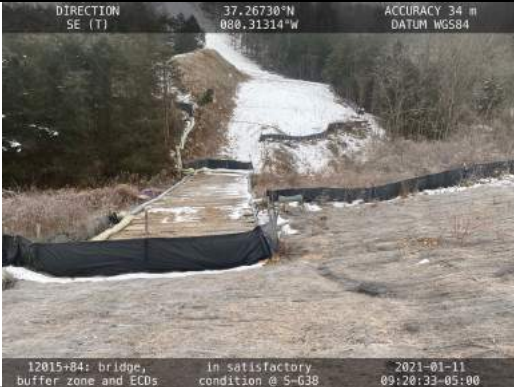
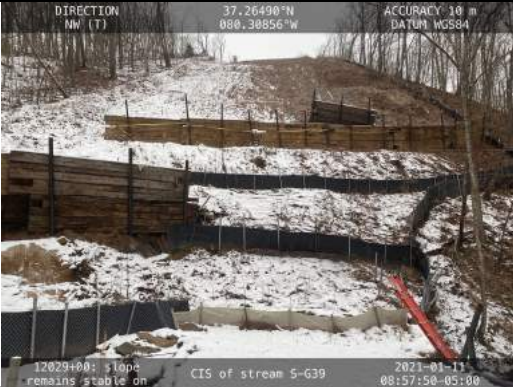
GPS Location	See photo		GPS Location	See photo	
Field Station#	12015+84		Field Station#	12029+00	
Pic 3 Desc.	Bridge, buffer zone and ECDs in satisfactory condition at stream S-G38.		Pic 4 Desc.	The slope on the coming in side of stream S-G38 remains stable.

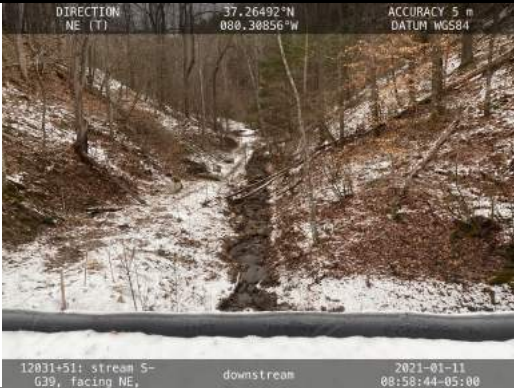
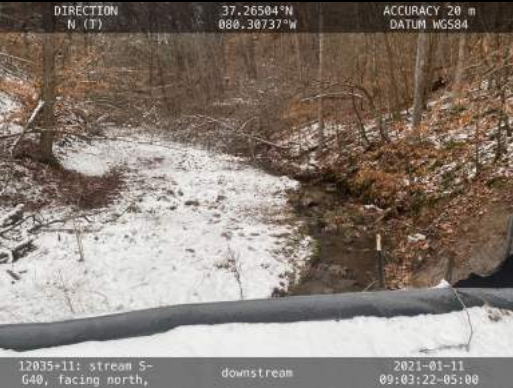
GPS Location	See photo		GPS Location	See photo	
Field Station#	12031+51		Field Station#	12035+11	
Pic 5 Desc.	Stream S-G39, facing northeast, downstream		Pic 6 Desc.	Stream S-G40, facing north, downstream

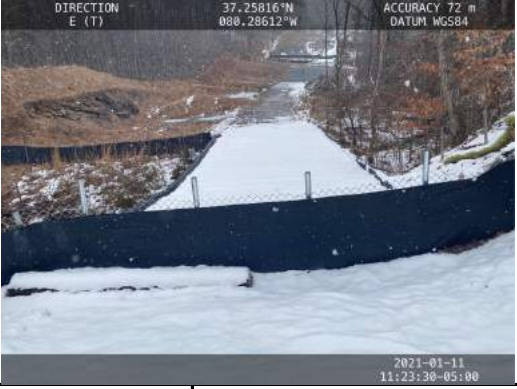
GPS Location	See photo		GPS Location	See photo	
Field Station#	12101+57		Field Station#	12108+41	
Pic 15 Desc.	Bridge, buffer zone and ECDs in satisfactory condition at stream S-MM11.		Pic 16 Desc.	Bridge, buffer zone and ECDs in satisfactory condition at stream S-F15.

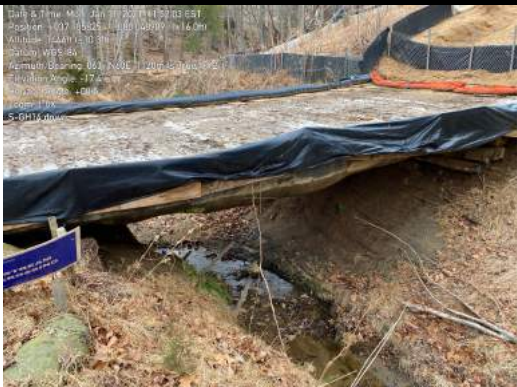
<p>Date & Time: 1/11/2021 11:40:48 EST Position: 42°51'10.00"N 76°50'00.00"W Altitude: 1241.00 ft Datum: WGS 84 Azimuth Bearing: 180.50°W Elevation Angle: 12.1° Horizon Angle: -10.2° Zoom: 1.0x S-GH14 down</p>			
GPS Location	See photo for coordinates.		GPS Location	See photo for coordinates.	
Field Station#	13323+00		Field Station#	13325+30	
Pic 11 Desc.	S-GH14, ROW stabilized, ECDs functioning acceptably.		Pic 12 Desc.	S-GH14, downstream, sagging of geotech observed under bridge, needs to be monitored, conditions likely frozen during inspection.

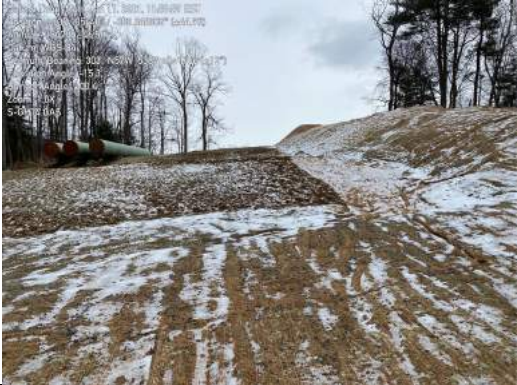
GPS Location	See photo for coordinates.		GPS Location	See photo for coordinates.	
Field Station#	13328+00		Field Station#	13332+00	
Pic 13 Desc.	ROW stabilized, the beginning of rilling observed upslope of waterbar.		Pic 14 Desc.	ROW stabilized, sparse vegetation noted in area.

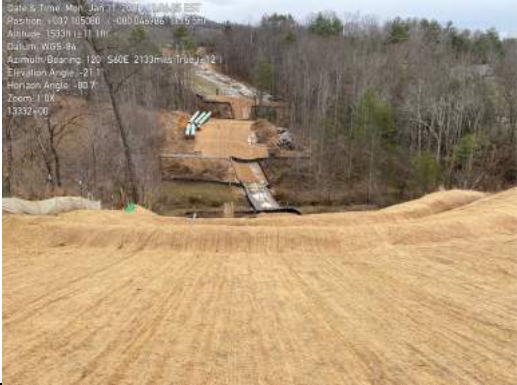
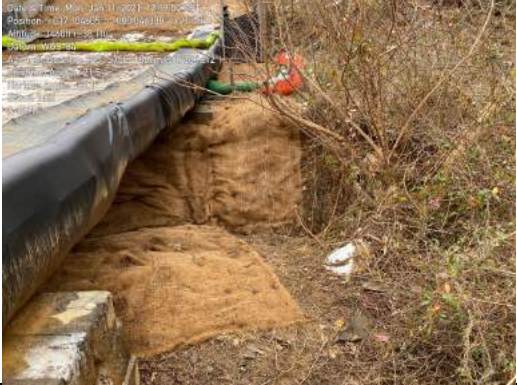
GPS Location	See photo for coordinates.		GPS Location	See photo for coordinates.	
Field Station#	13332+00		Field Station#	13334+17	
Pic 15 Desc.	ROW stabilized, sparse vegetation noted in area.		Pic 16 Desc.	S-GH11, downstream, stabilized banks appear to be holding, no ROW sediment in stream.

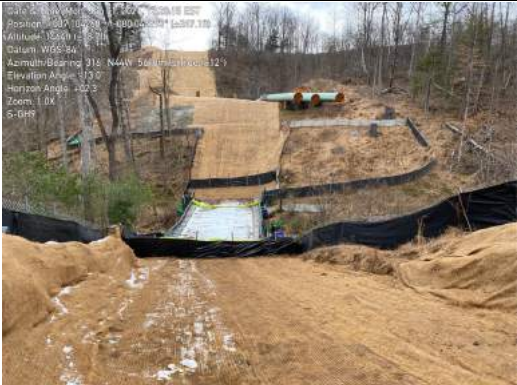
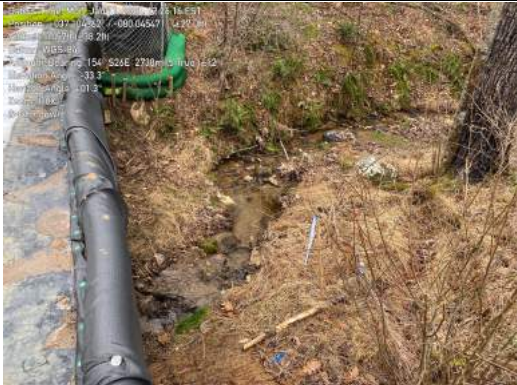
GPS Location	See photo for coordinates.		GPS Location	See photo for coordinates.	
Field Station#	13337+13		Field Station#	13337+13	
Pic 17 Desc.	S-GH9, ECDs at stream crossing in acceptable condition.		Pic 18 Desc.	S-GH9, downstream, steam banks appear stable, no turbidity observed.

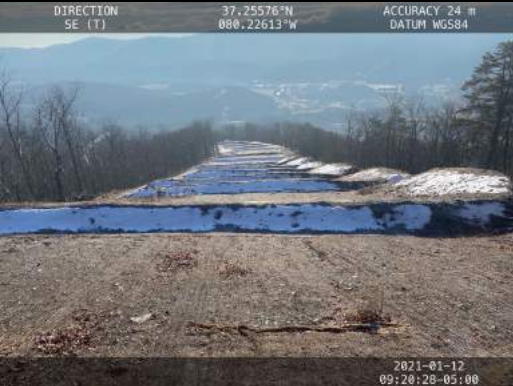
GPS Location	See photo		GPS Location	See photo	
Field Station#	12295+00		Field Station#	12300+00	
Pic 5 Desc.	Water bars are in good repair in the "Big V".		Pic 6 Desc.	ROW stable between Reese Mountain and I-81.

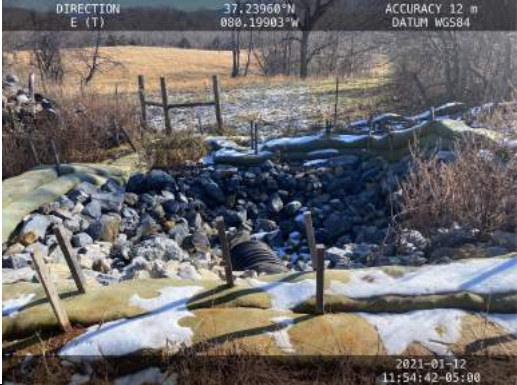
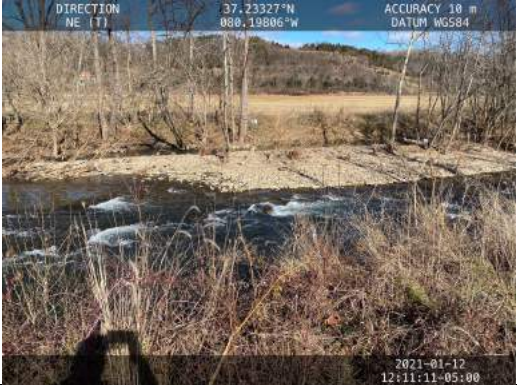
GPS Location	See photo		GPS Location	See photo	
Field Station#	12410+50		Field Station#	12435+50	
Pic 13 Desc.	Clean water diversion pipe outlet plunge pool in satisfactory condition.		Pic 14 Desc.	Stream S-NN16, Roanoke River, facing northeast from Lafayette Road

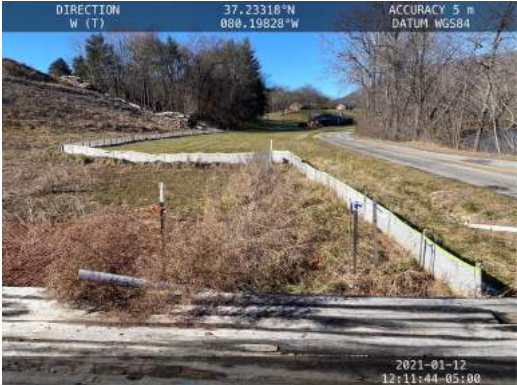
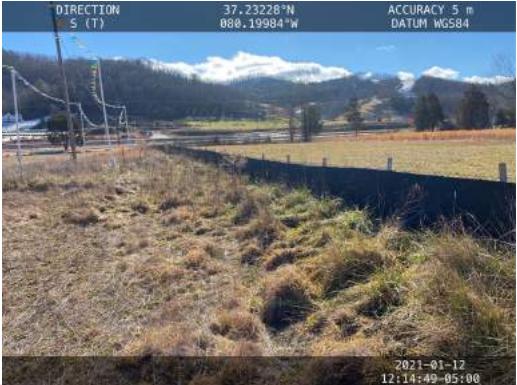
GPS Location	See photo		GPS Location	See photo	
Field Station#	12437+00		Field Station#	12442+00	
Pic 15 Desc.	P1 silt fence in good repair on going away side of Lafayette Road.		Pic 16 Desc.	Perimeter controls in satisfactory condition between Apgar Drive and Highway 11.

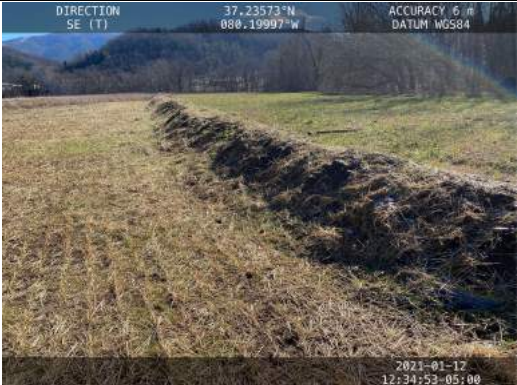
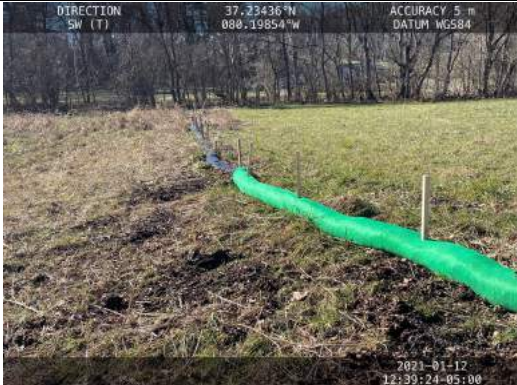
GPS Location	See photo		GPS Location	See photo	
Field Station#	12424+50		Field Station#	12431+00	
Pic 17 Desc.	The clean water diversion berm on the going away side of access road MVP-MN-279 is developing some vegetative cover.		Pic 18 Desc.	Perimeter CFS in satisfactory condition between access road MVP-MN-279 and the Roanoke River.

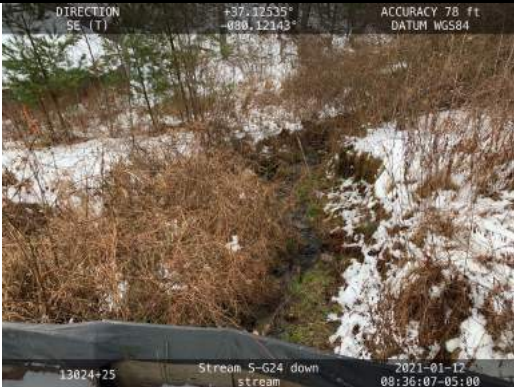
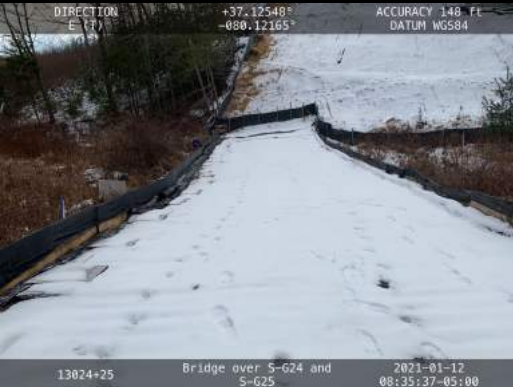
GPS Location	See pic for GPS location		GPS Location	See pic for GPS location	
Field Station#	13024+25		Field Station#	13024+25	
Pic 1 Desc.	Stream S-G24 downstream of the equipment bridge.		Pic 2 Desc.	Mat equipment bridge over streams S-G24 and S-G25.

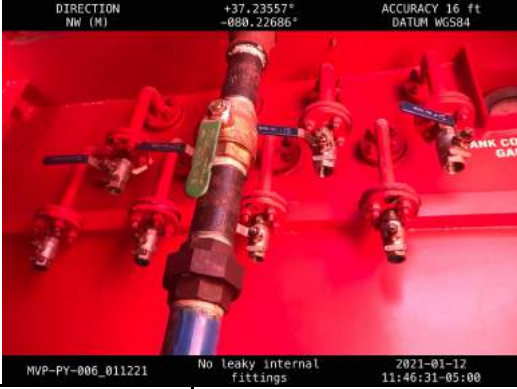
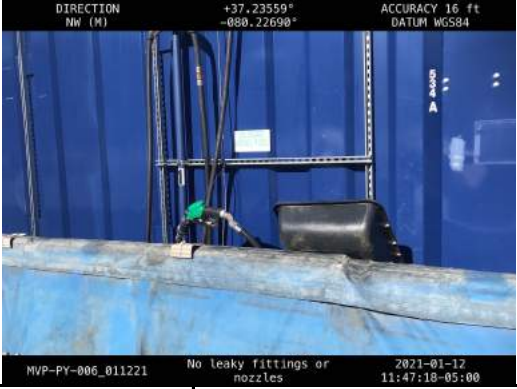
GPS Location	MVP-PY-006 See photo for gps data		GPS Location	MVP-PY-006 See photo for gps data	
Field Station#	+0		Field Station#	+0	
Pic 13 Desc.	Off Road Fuel unit no leaky internal fittings. Looking NW		Pic 14 Desc.	Blue Bulk Fuel tanks no leaky fittings or nozzles. Looking NW.

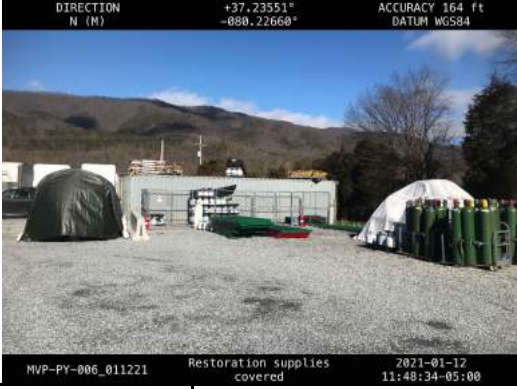
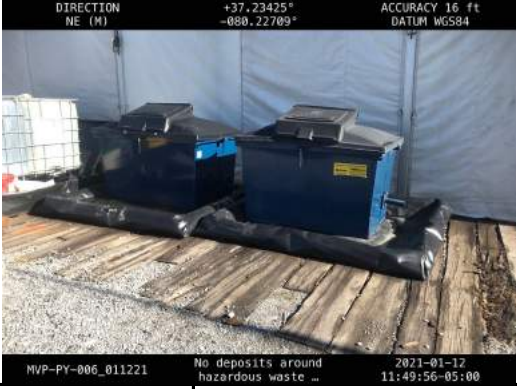
GPS Location	MVP-PY-006 See photo for gps data		GPS Location	MVP-PY-006 See photo for gps data	
Field Station#	+0		Field Station#	+0	
Pic 15 Desc.	Restoration supplies covered and protected from the elements. Looking N.		Pic 16 Desc.	No deposits or fluids around hazardous waste dumpsters west of mechanics building. Looking NE.

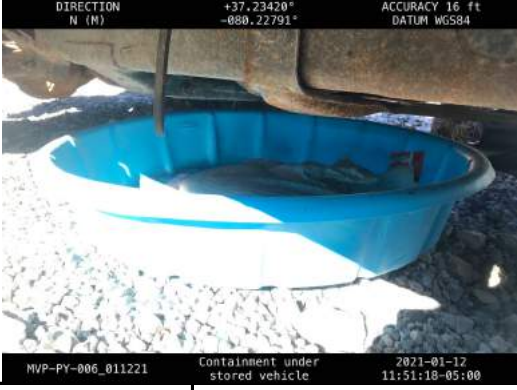
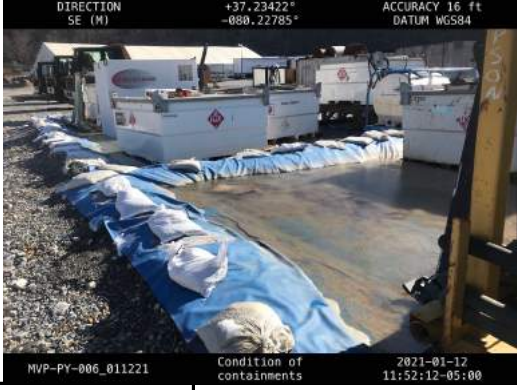
GPS Location	MVP-PY-006 See photo for gps data		GPS Location	MVP-PY-006 See photo for gps data	
Field Station#	+0		Field Station#	+0	
Pic 17 Desc.	Condition of containment under stored vehicle. Looking N.		Pic 18 Desc.	Condition of containments. Hold stormwater now frozen. Looking SE.

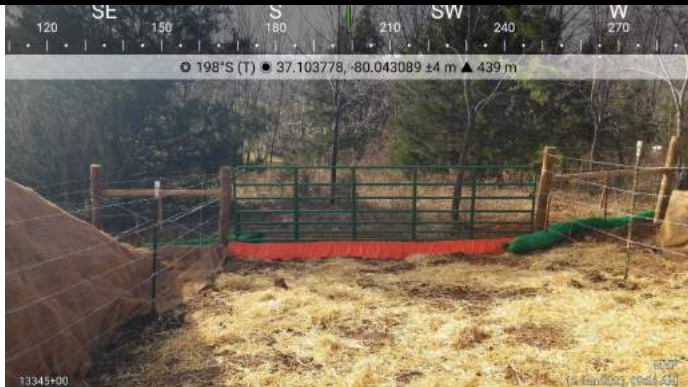
GPS Location	See Above		GPS Location	See Above	
Field Station#	13345+00		Field Station#	13345+10	
Pic 1 Desc.	Punchlist item completed: Compost filter sock added and base of livestock fencing to either side of gate.		Pic 2 Desc.	Punchlist item completed: Spoil pile stabilized.

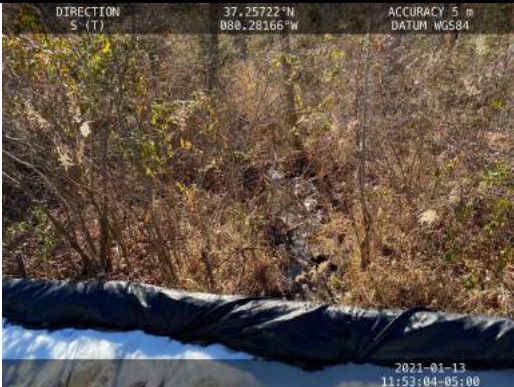
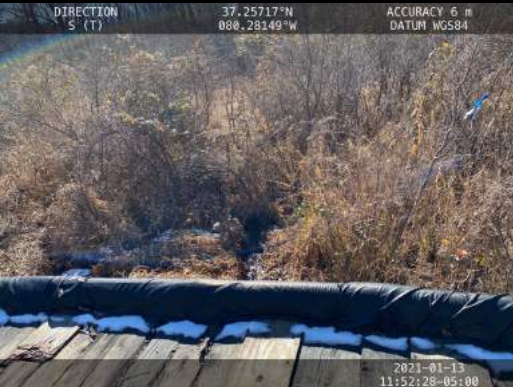
GPS Location	See photo		GPS Location	See photo	
Field Station#	12121+33		Field Station#	12121+83	
Pic 1 Desc.	Stream S-C33, facing south, downstream		Pic 2 Desc.	Stream S-C36, facing south, downstream

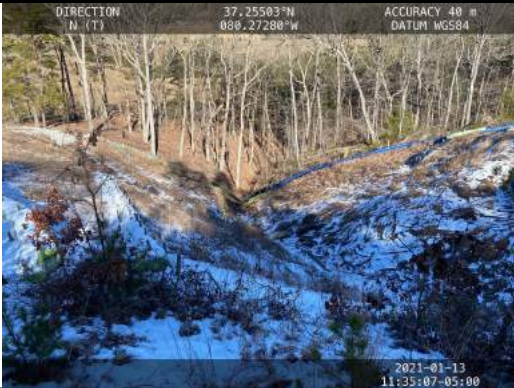
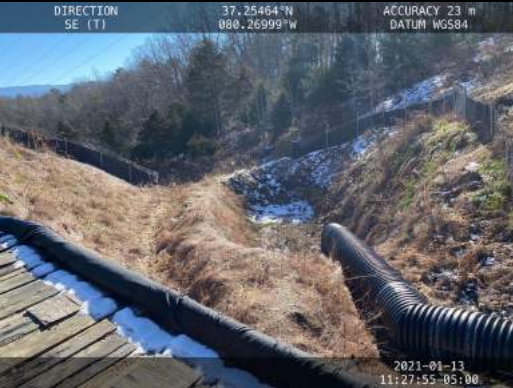
GPS Location	See photo		GPS Location	See photo	
Field Station#	12148+00		Field Station#	12157+00	
Pic 5 Desc.	The drainage feature between access roads MVP-MN-272 & 273 remains stable.		Pic 6 Desc.	Clean water diversion channel and temporary sediment trap are in satisfactory condition.

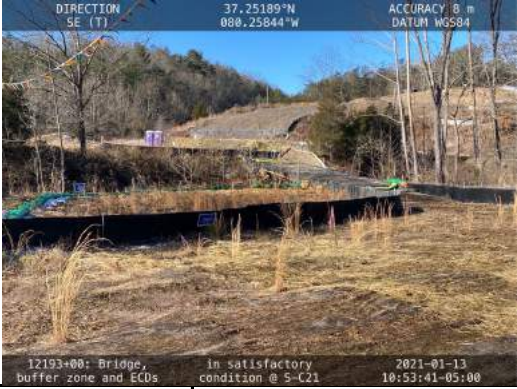
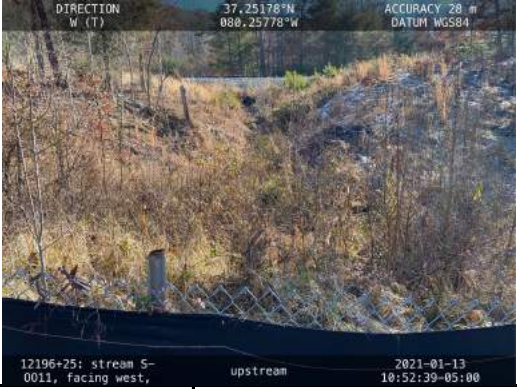
GPS Location	See photo		GPS Location	See photo	
Field Station#	12193+00		Field Station#	12196+25	
Pic 13 Desc.	Bridge, buffer zone and ECDs in satisfactory condition at stream S-C21.		Pic 14 Desc.	Stream S-0011, facing west, upstream

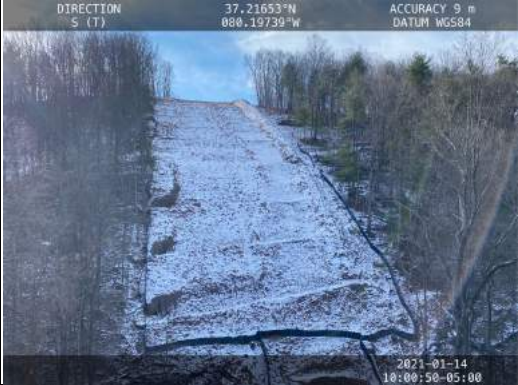
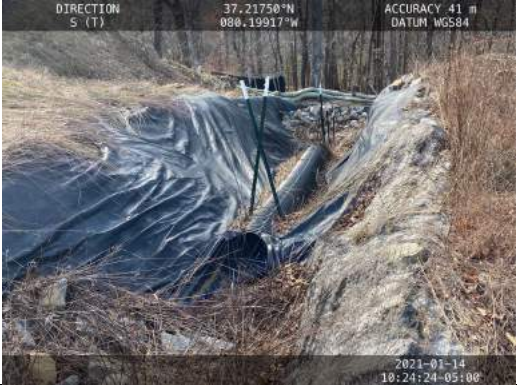
GPS Location	See photo		GPS Location	See photo	
Field Station#	12523+00		Field Station#	12508+00	
Pic 13 Desc.	The slope on the going away side of stream S-EF19 remains stable.		Pic 14 Desc.	Slope drain in good repair.

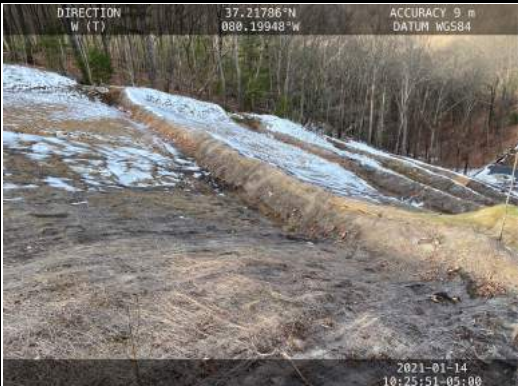
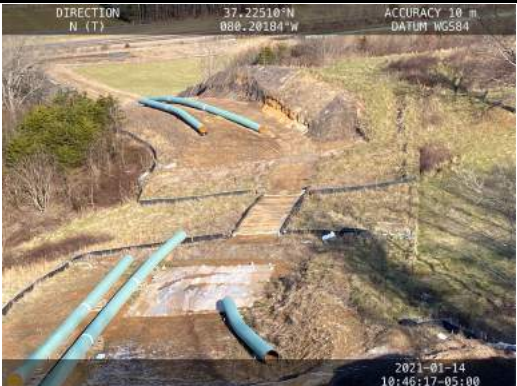
GPS Location	See photo		GPS Location	See photo	
Field Station#	12505+00		Field Station#	12482+00	
Pic 15 Desc.	Waterbars in satisfactory condition.		Pic 16 Desc.	View of "pig parts" excavation site and clean water diversion channel as seen from slope on going away side.

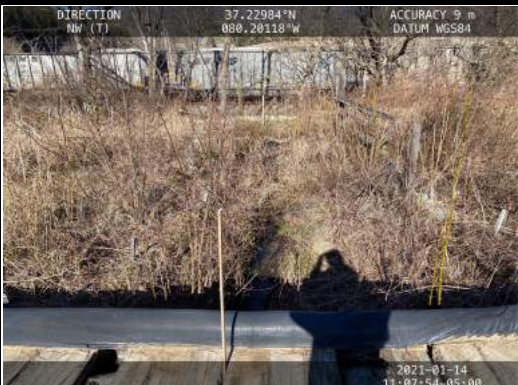
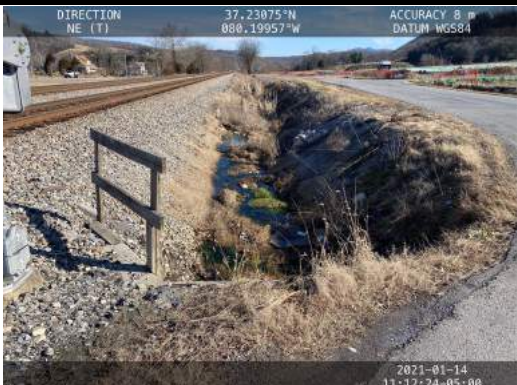
GPS Location	See photo		GPS Location	See photo	
Field Station#	12455+21		Field Station#	12444+94	
Pic 17 Desc.	Stream S-CD12, facing northwest, downstream		Pic 18 Desc.	Stream S-I1, facing northeast, downstream

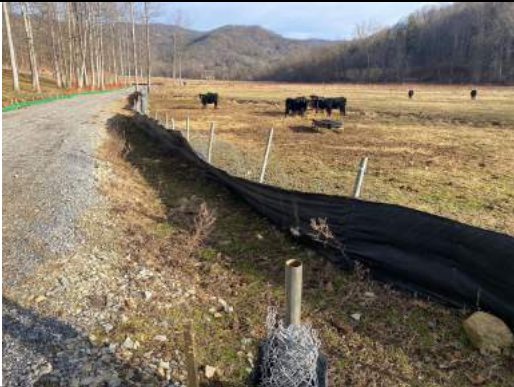
GPS Location	See photo for coordinates.		GPS Location	See photo for coordinates.	
Field Station#	13190+00		Field Station#	13262+00	
Pic 3 Desc.	MVP-AR-29, SSF down, hole in fabric noted.		Pic 4 Desc.	MVP-FR-293.01, Flanders Road, road crossing in acceptable condition.

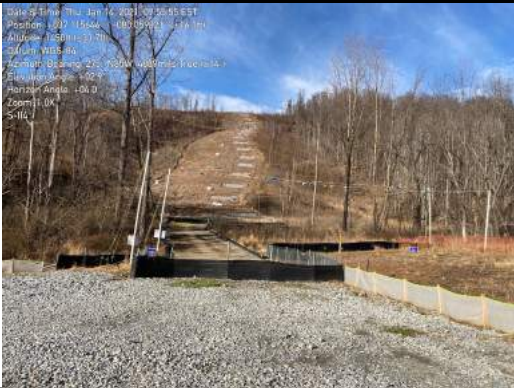
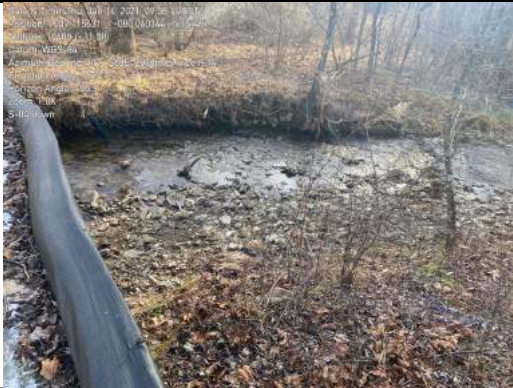
GPS Location	See photo for coordinates.		GPS Location	See photo for coordinates.	
Field Station#	13261+00		Field Station#	13260+60	
Pic 5 Desc.	S-II4, GAS, ECDs in acceptable condition, ROW stable.		Pic 6 Desc.	S-II4, downstream, no changes noted at stream crossing, no turbidity noted.

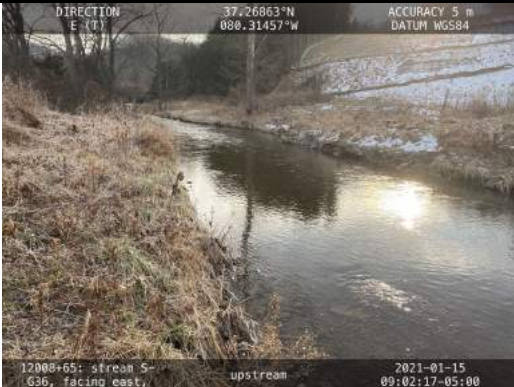
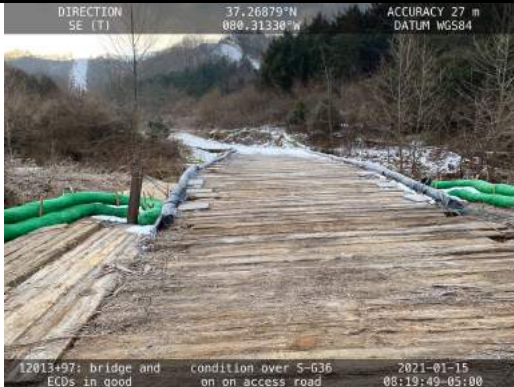
GPS Location	See photo		GPS Location	See photo	
Field Station#	12008+65		Field Station#	12013+97	
Pic 1 Desc.	Stream S-G36, facing east, upstream		Pic 2 Desc.	Bridge and ECDs in satisfactory condition at stream S-G36 on access road MVP-MN-268.01.

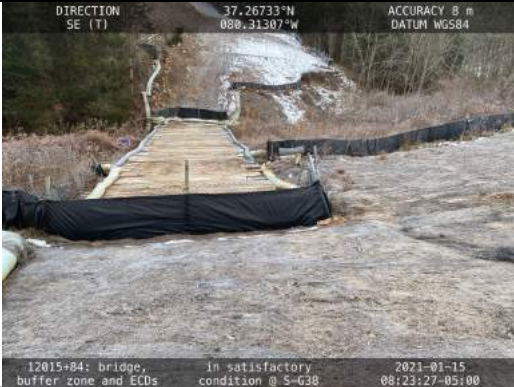
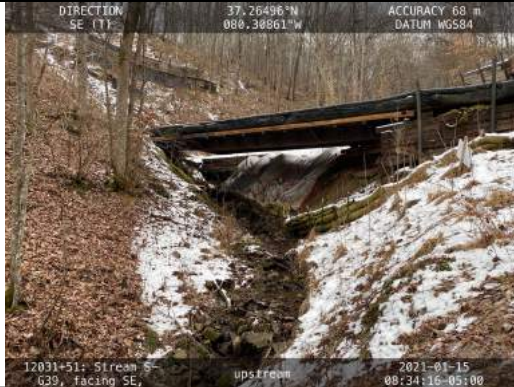
GPS Location	See photo		GPS Location	See photo	
Field Station#	12015+84		Field Station#	12031+51	
Pic 3 Desc.	Bridge, buffer zone and ECDs in satisfactory condition at stream S-G38.		Pic 4 Desc.	Stream S-G39, facing southeast, upstream

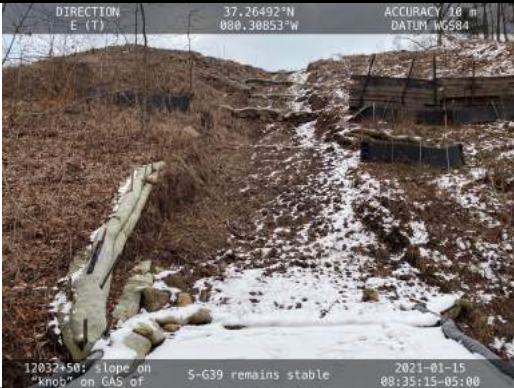
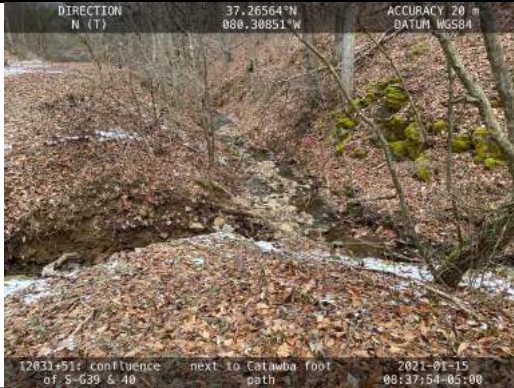
GPS Location	See photo		GPS Location	See photo	
Field Station#	12032+50		Field Station#	12031+51	
Pic 5 Desc.	The slope on the going away side of stream S-G39 remains stable.		Pic 6 Desc.	Convergence of streams S-G39 & 40 next to the Catawba foot path.

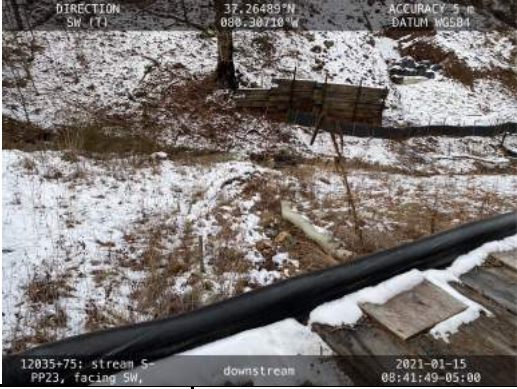
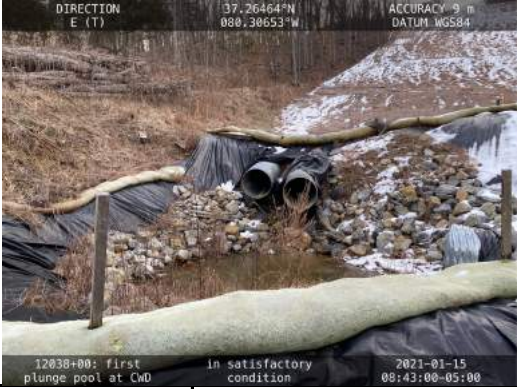
GPS Location	See photo		GPS Location	See photo	
Field Station#	12035+75		Field Station#	12038+00	
Pic 7 Desc.	Stream S-PP23, facing southwest, downstream to where it converges with S-G40.		Pic 8 Desc.	The clean water diversion pipe plunge pool outlets between Catawba and access road MVP-MN-270 are in satisfactory condition.

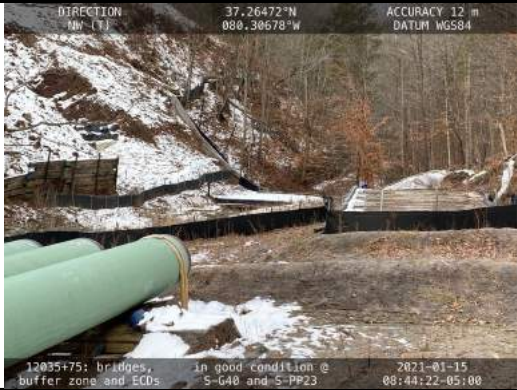
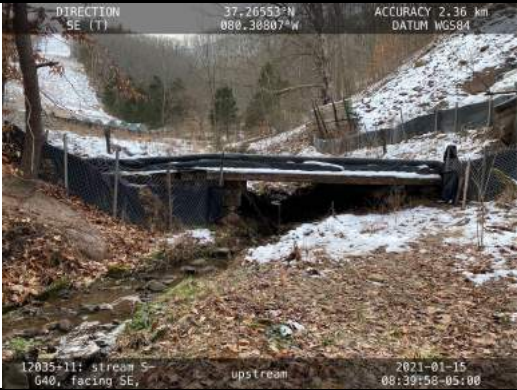
GPS Location	See photo		GPS Location	See photo	
Field Station#	12035+75		Field Station#	12035+11	
Pic 9 Desc.	Bridges, buffer zone and ECDs in satisfactory condition at streams S-G40 and S-PP23.		Pic 10 Desc.	Stream S-G40, facing southeast, upstream

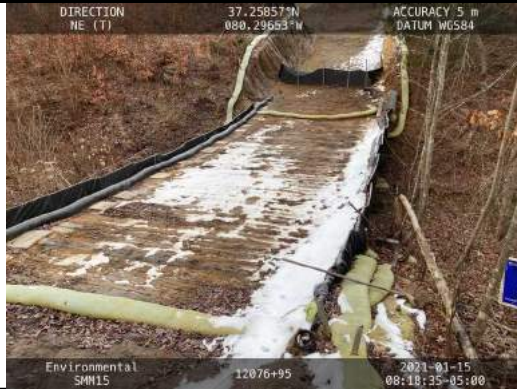
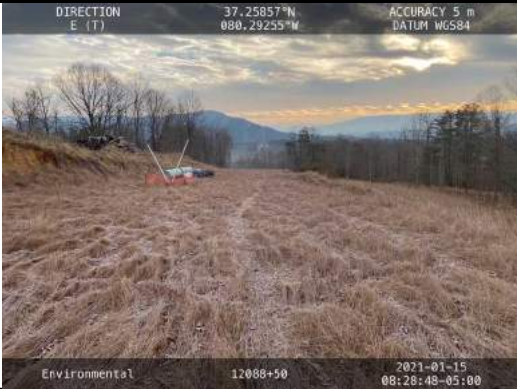
GPS Location	See photo		GPS Location	See photo	
Field Station#	12076+95		Field Station#	12088+50	
Pic 11 Desc.	Stream S-MM15, facing northeast		Pic 12 Desc.	ROW stable

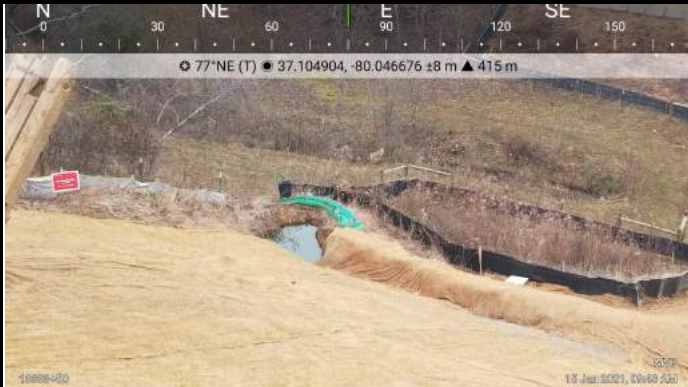
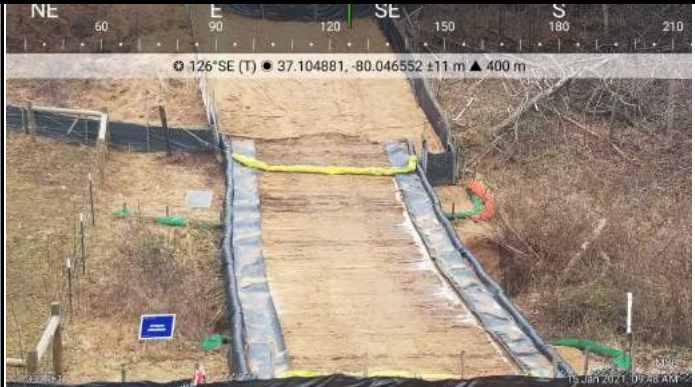
GPS Location	See Above		GPS Location	See Above	
Field Station#	13333+50		Field Station#	13334+17	
Pic 13 Desc.	ROW Overview (temporary stabilization). ECDs are functional and ROW is stable.		Pic 14 Desc.	Overview of Waterbody S-GH11. ECDs are functional and ROW is stable.

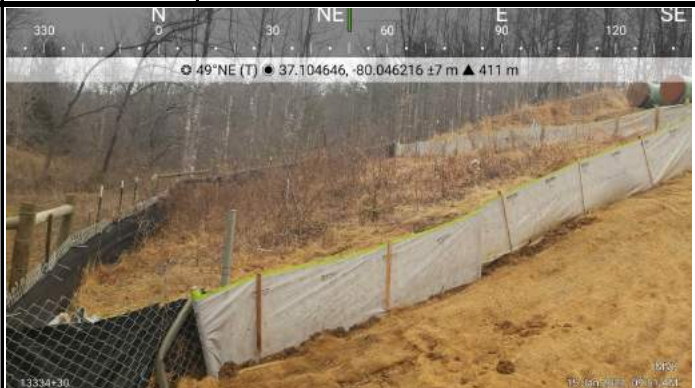
GPS Location	See Above		GPS Location	See Above	
Field Station#	13334+30		Field Station#	13334+30	
Pic 15 Desc.	DEQ punchlist item added 1/14/21. Repair P1 silt fence.		Pic 16 Desc.	DEQ punchlist item completed. P1 silt fence repaired.

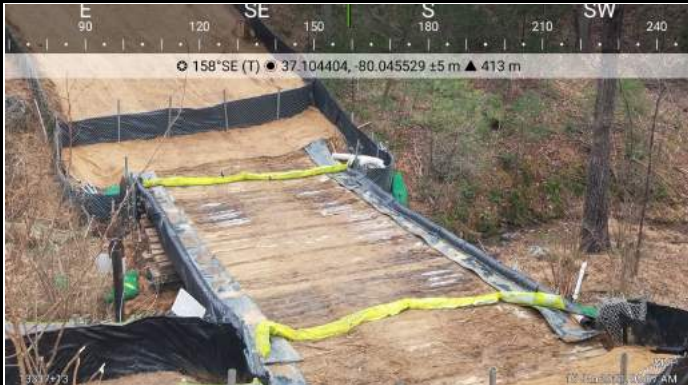
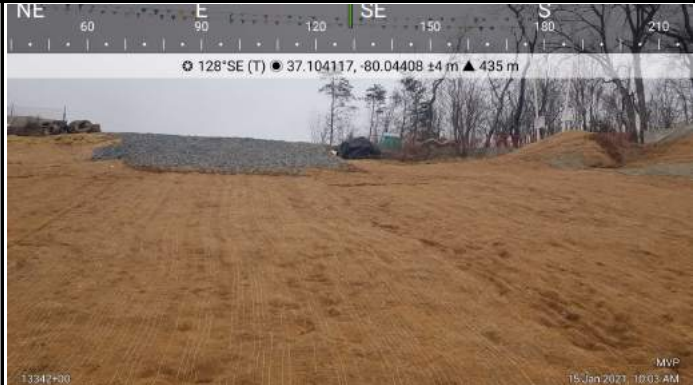
GPS Location	See Above		GPS Location	See Above	
Field Station#	13337+13		Field Station#	13342+00	
Pic 17 Desc.	Overview of Waterbody S-GH9. ECDs are functional and ROW is stable.		Pic 18 Desc.	ROW Overview (temporary stabilization). ECDs are functional and ROW is stable.
