Visual Site Inspection Report

Project Name	H-600 Pipeline Spread H	AFE	124300138	Spread	H-600 Pipeline Spread H
Contractor	Precision			Report #	18038
Inspector	Logan Box			Date/Time	12/14/2020 4:31 PM
Permit #	TBD	Inspection Type	VA SWPP	Station Begin	13415+51
State	VA	Inspection Area	Partial	Station End	13525+99
County	Franklin	Ground	Wet	Temperature (°F)	43.00
Municipality	N/A	Weather	Light Rain	Rain Gauge (in)	1.20
				Rain Accumulation Time (days)	1.00

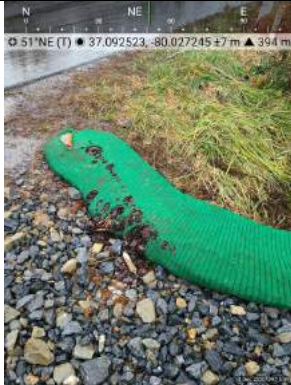
GPS Location	00000	GPS Location	00000		
Field Station#	13417+00	Field Station#	13455+00		
Pic 1 Desc.	During the EI's travel today the EI noticed a travel lane on a hill side needed to be stabilized after recent work has been done by the spread H contractor, documented and sent		Pic 2 Desc.	CFS needs replaced on RCE at CAHAS#1 rd crossing, documented that damage was done and needed repaired by the spread H contractor, discussed with lead EI

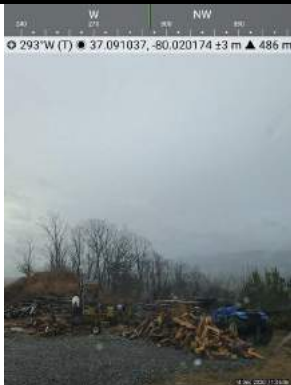
GPS Location	0000	GPS Location	00000		
Field Station#	13415+90	Field Station#	13437+75		
Pic 3 Desc.	The EI monitored ECDs and sump pit during inspection today. No environmental issues observed at the time of inspection		Pic 4 Desc.	EI noticed during routine row inspection today that the land owner has moved equipment back into the row cutting fire wood , no environmental issues observed

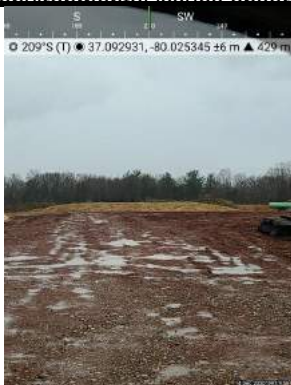
GPS Location	00000	GPS Location	000000		
Field Station#	13437+75	Field Station#	13420+00		
Pic 5 Desc.	Saturated row photo taken by the EI during 1.2" rain event today		Pic 6 Desc.	ATWS requires stabilization after recent work activities done by spread H, documented and sent in to the lead EI to be addressed by the spread H contractor

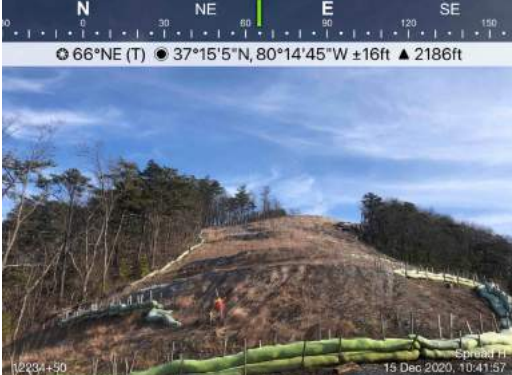
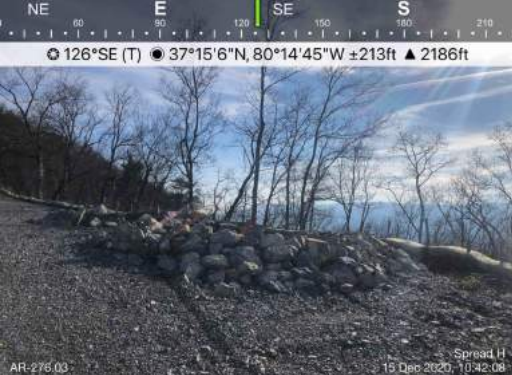
GPS Location	See photo		GPS Location	See photo	
Field Station#	12234+50		Field Station#	276+03	
Pic 1 Desc.	Start of inspection area. Perm. waterbars are stabilized and in good condition on this slope.		Pic 2 Desc.	Rock check dams are in good condition on AR-276.03

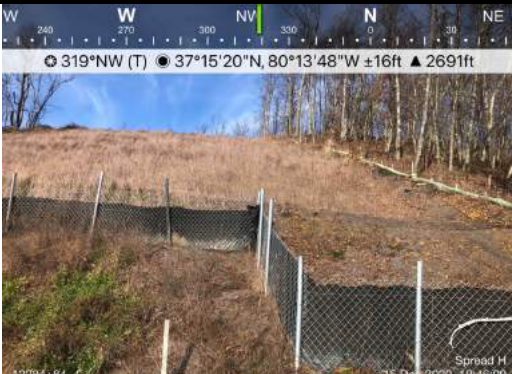
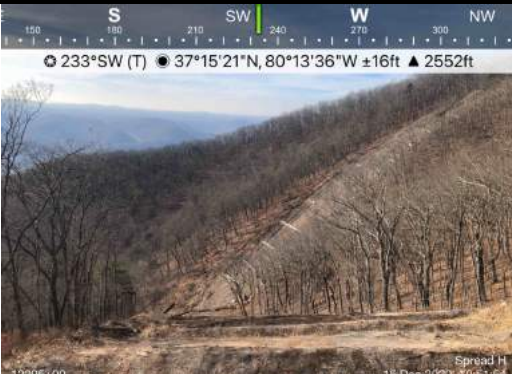
GPS Location	See photo		GPS Location	See photo	
Field Station#	12284+84		Field Station#	12295+00	
Pic 3 Desc.	SSF and CFS controls in good condition on this slope.		Pic 4 Desc.	Waterbars and end treatments are stabilized with ESC and in good condition in the Reese Mtn "V"

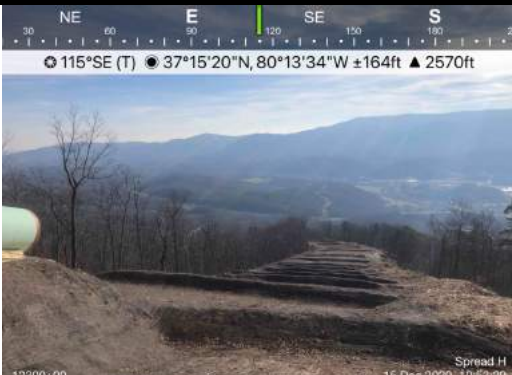
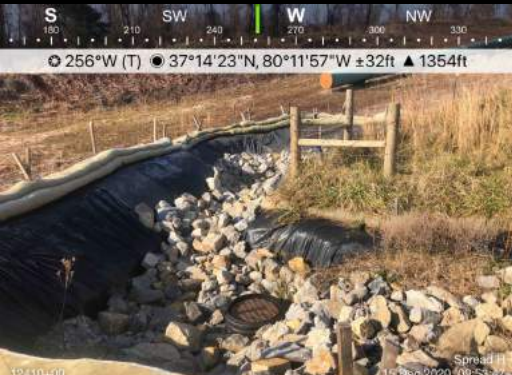
GPS Location	See photo		GPS Location	See photo	
Field Station#	12300+00		Field Station#	12410+00	
Pic 5 Desc.	Waterbars and end treatments are in good condition on this slope.		Pic 6 Desc.	CWD inlet in good condition.

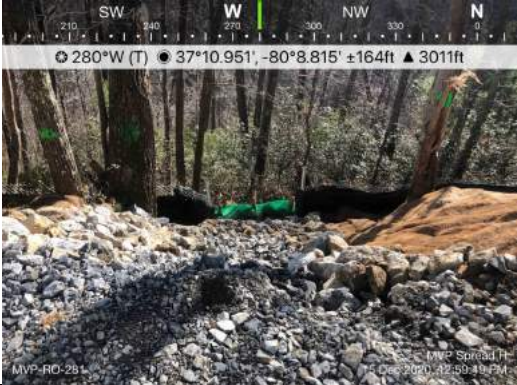
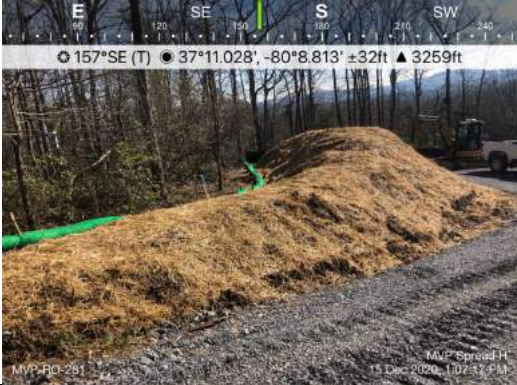
GPS Location	See Picture Watermark		GPS Location	See Picture Watermark	
Field Station#	12720+00		Field Station#	12720+00	
Pic 7 Desc.	Rock conveyance channels along MVP-RO-281 are in good condition with no maintenance needed.		Pic 8 Desc.	Stabilized stockpile within ATWS-1227. No maintenance is needed.

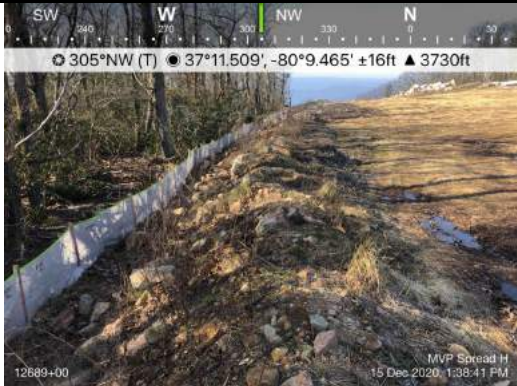
GPS Location	See Picture Watermark		GPS Location	See Picture Watermark	
Field Station#	12689+00		Field Station#	12638+75	
Pic 9 Desc.	Silt fence perimeter controls and previously stabilized areas on CIS Honeysuckle Road are in good condition.		Pic 10 Desc.	Sump pit and waterbar end treatment are in good condition with no maintenance is needed.

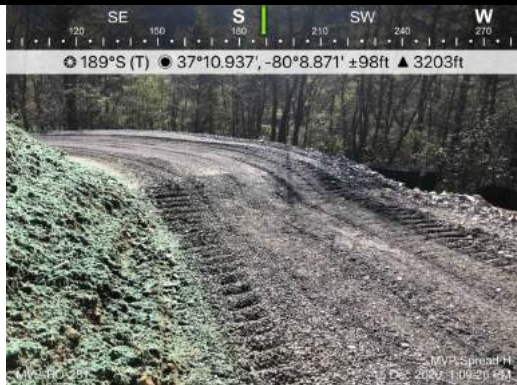
GPS Location	See Picture Watermark		GPS Location	See Picture Watermark	
Field Station#	12720+00		Field Station#	12640+25	
Pic 11 Desc.	Hydroseeded slopes, access road waterbars, and rock conveyance channels along MVP-RO-281 are in good condition.		Pic 12 Desc.	ROW remains well stabilized with temporary vegetation.

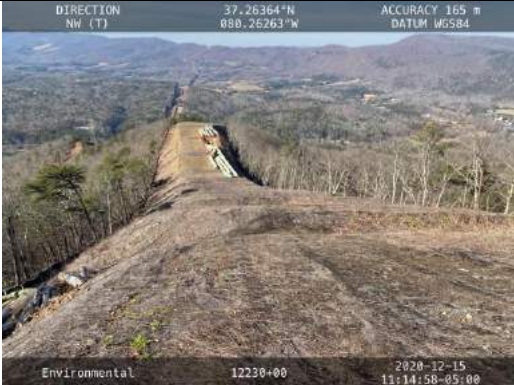
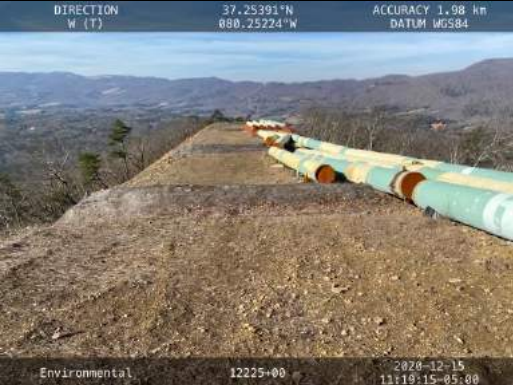
GPS Location	See photo for GPS coordinates		GPS Location	See photo for GPS coordinates	
Field Station#	12230+00		Field Station#	12225+00	
Pic 1 Desc.	Stabilized row with acceptable vegetative coverage across LOD		Pic 2 Desc.	Stabilized row with pipe stored for future use.

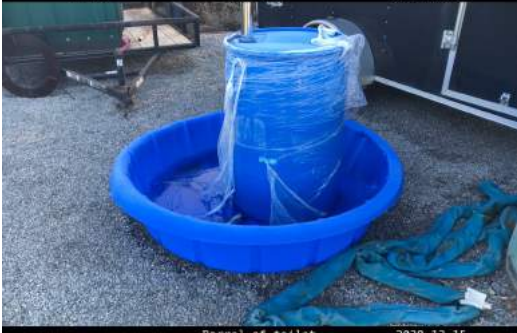
+37.27123° -080.12078° ACCURACY 164 ft DATUM WGS84 MVP-LY-049_121520 Barrel of toilet chemical in ... 2020-12-15 09:07:05-05:00		DIRECTION NW (M)

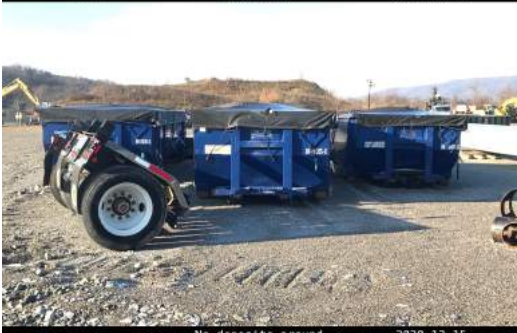
+37.27050° -080.12262° ACCURACY 16 ft DATUM WGS84 MVP-LY-049_121520 No deposits around hazardous waste ... 2020-12-15 09:09:53-05:00			
GPS Location	MVP-LY-049 See photo for gps data		GPS Location	MVP-LY-049 See photo for gps data	
Field Station#	+0		Field Station#	+0	
Pic 7 Desc.	Barrel of toilet chemical in containment, Holding stormwater and layer of ice. Looking E.		Pic 8 Desc.	No fluids or deposits around hazardous waste dumpsters. Looking NW.	
DIRECTION W (M)

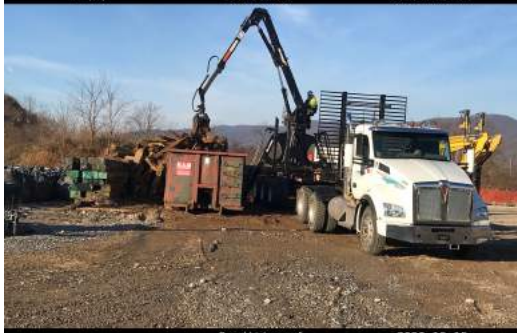
+37.27070° -080.12326° ACCURACY 33 ft DATUM WGS84 MVP-LY-049_121520 Condition of temporary trash ... 2020-12-15 09:10:44-05:00		DIRECTION NE (M)

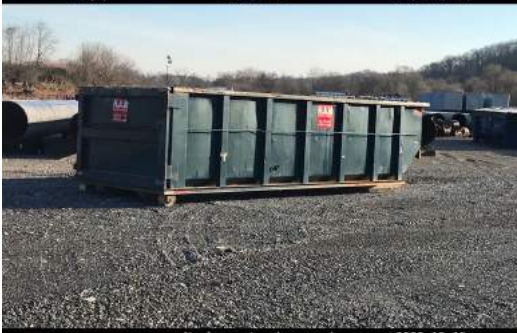
+37.27045° -080.12312° ACCURACY 16 ft DATUM WGS84 MVP-LY-049_121520 No loose trash around dumpsters 2020-12-15 09:14:19-05:00

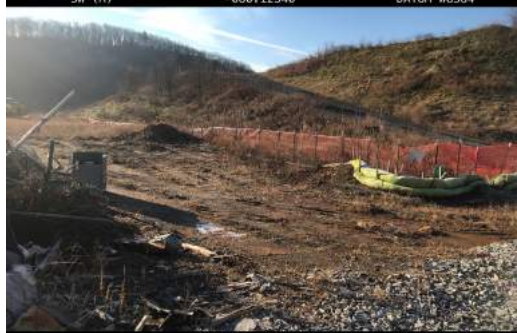
+37.27060° -080.12340° ACCURACY 16 ft DATUM WGS84 MVP-LY-049_121520 Landowner disturbance along CFS & feature 2020-12-15 09:12:05-05:00		DIRECTION W (M)

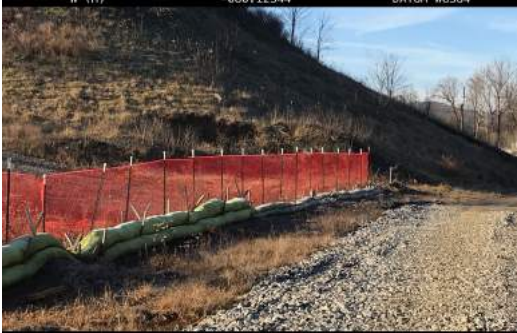
+37.27056° -080.12344° ACCURACY 16 ft DATUM WGS84 MVP-LY-049_121520 Landowner disturbance within 66' of feature 2020-12-15 09:12:12-05:00			
GPS Location	MVP-LY-049 See photo for gps data		GPS Location	MVP-LY-049 See photo for gps data	
Field Station#	+0		Field Station#	+0	
Pic 11 Desc.	Landowner soil disturbance along compost filter sock and feature W-CV21B. Area not stabilized. No impacts. Looking SW.		Pic 12 Desc.	Landowner soil disturbance within 66' and 120' west of feature W-CV21B. Area not stabilized. No impacts. Looking SW.

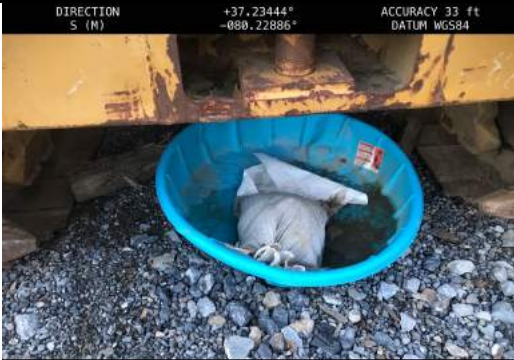
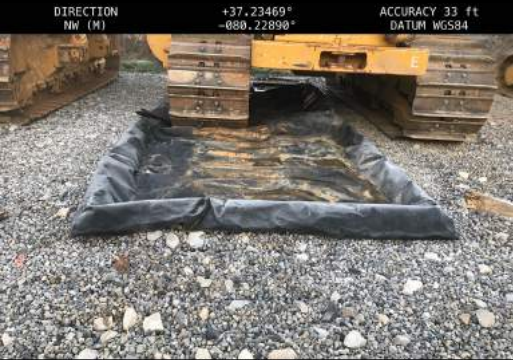
GPS Location	MVP-PY-006 See photo for gps data		GPS Location	MVP-PY-006 See photo for gps data	
Field Station#	+0		Field Station#	+0	
Pic 1 Desc.	Condition of containment under stored equipment. Looking S.		Pic 2 Desc.	Condition of containment under stored equipment. Looking NW.

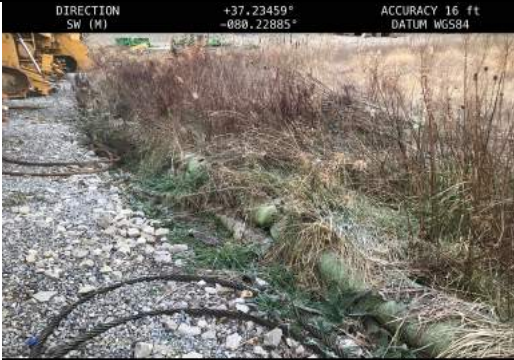
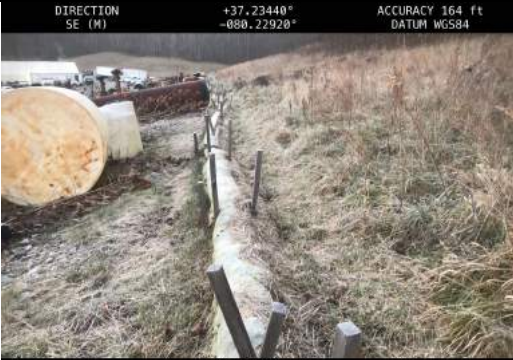
GPS Location	MVP-PY-006 See photo for gps data		GPS Location	MVP-PY-006 See photo for gps data	
Field Station#	+0		Field Station#	+0	
Pic 3 Desc.	Condition of compost filter sock along west LOD. Looking SW.		Pic 4 Desc.	Condition of compost filter sock along south LOD. Looking SE.

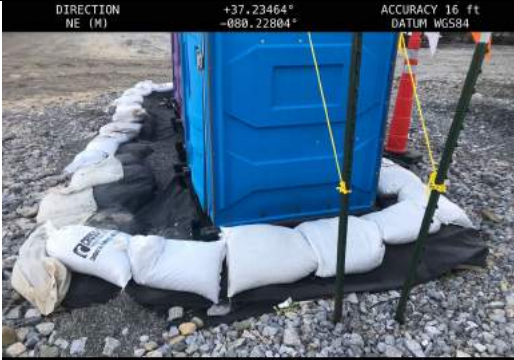
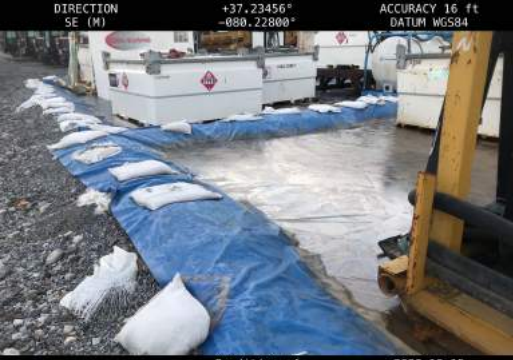
GPS Location	MVP-PY-006 See photo for gps data		GPS Location	MVP-PY-006 See photo for gps data	
Field Station#	+0		Field Station#	+0	
Pic 5 Desc.	Condition of trays and containment under toilets. Looking NE.		Pic 6 Desc.	Condition of containments. Holding stormwater with layer of ice. Looking SE.

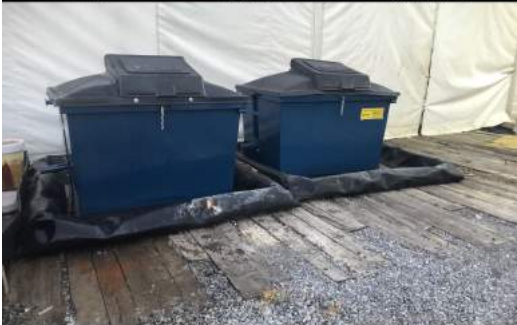
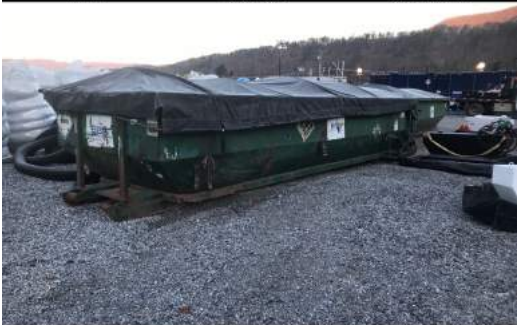
MVP-PY-006_121520 No deposits around hazardous waste ... 2020-12-15 07:43:46-05:00		MVP-PY-006_121520 No deposits around hazardous waste ... 2020-12-15 07:47:15-05:00			
GPS Location	MVP-PY-006 See photo for gps data		GPS Location	MVP-PY-006 See photo for gps data	
Field Station#	+0		Field Station#	+0	
Pic 7 Desc.	No fluids and or deposits around hazardous waste dumpsters west of the mechanics building. Looking E.		Pic 8 Desc.	No deposits or fluids around hazardous waste dumpsters. Looking NW.	
DIRECTION SE (M) +37.23554° -080.22667° ACCURACY 16 ft DATUM WGS84		DIRECTION NW (M) +37.23559° -080.22670° ACCURACY 16 ft DATUM WGS84

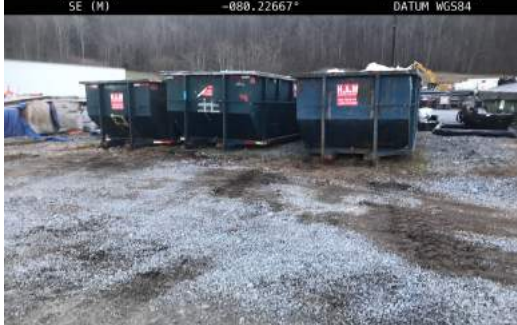
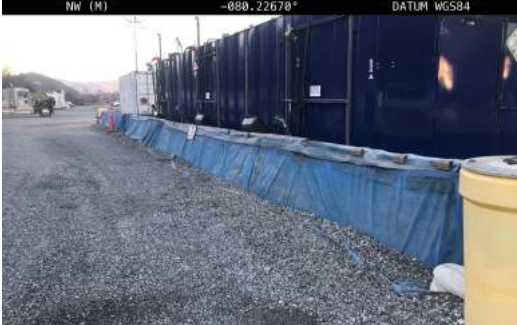
MVP-PY-006_121520 No loose trash around dumpsters 2020-12-15 07:49:31-05:00		MVP-PY-006_121520 No fuel spills south of tanks 2020-12-15 07:49:43-05:00

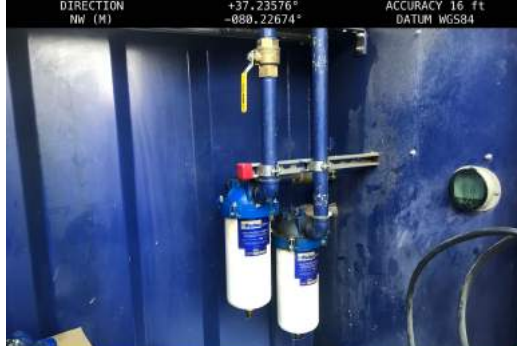
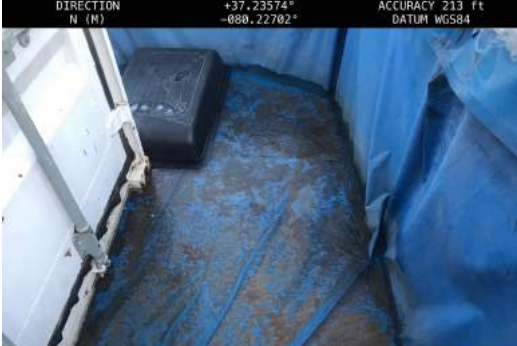
MVP-PY-006_121520 No leaky internal fittings 2020-12-15 07:50:28-05:00		MVP-PY-006_121520 Condition of containment 2020-12-15 07:51:37-05:00			
GPS Location	MVP-PY-006 See photo for gps data		GPS Location	MVP-PY-006 See photo for gps data	
Field Station#	+0		Field Station#	+0	
Pic 11 Desc.	Blue Bulk Fuel tanks no leaky internal fittings. Looking NW.		Pic 12 Desc.	Off Road Fuel unit containment of containment. holding stormwater with layer of ice. Looking N.

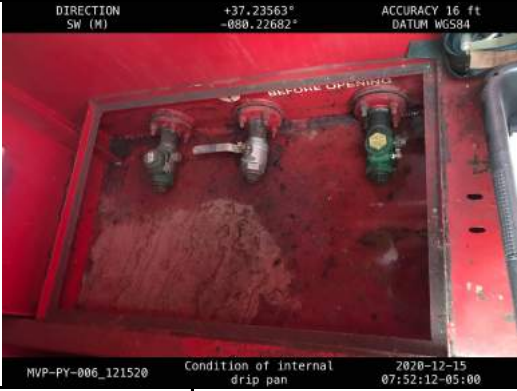
<p>DIRECTION SW (M) +37.23563° -080.22682° ACCURACY 16 ft DATUM WGS84</p> <p>MVP-PY-006_121520 Condition of internal drip pan 2020-12-15 07:52:12-05:00</p>

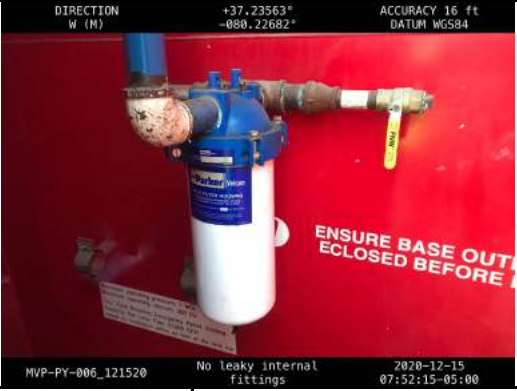
<p>DIRECTION W (M) +37.23563° -080.22682° ACCURACY 16 ft DATUM WGS84</p> <p>MVP-PY-006_121520 No leaky internal fittings 2020-12-15 07:52:15-05:00</p>			
GPS Location	MVP-PY-006 See photo for gps data		GPS Location	MVP-PY-006 See photo for gps data	
Field Station#	+0		Field Station#	+0	
Pic 13 Desc.	Off Road Fuel unit containment of internal drip pan. Looking SW.		Pic 14 Desc.	Off Road Fuel unit no leaky internal fittings. Looking W.

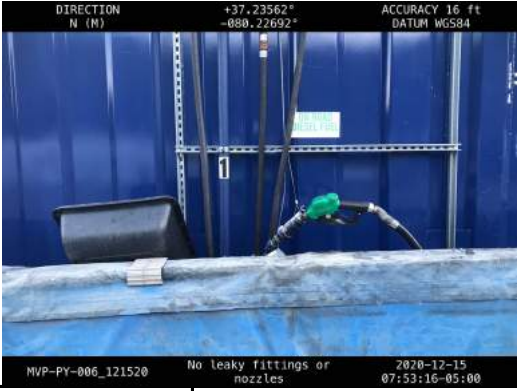
<p>DIRECTION N (M) +37.23562° -080.22692° ACCURACY 16 ft DATUM WGS84</p> <p>MVP-PY-006_121520 No leaky fittings or nozzles 2020-12-15 07:53:16-05:00</p>

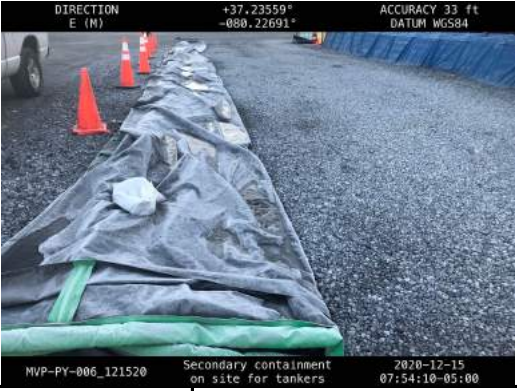
<p>DIRECTION E (M) +37.23559° -080.22691° ACCURACY 33 ft DATUM WGS84</p> <p>MVP-PY-006_121520 Secondary containment on site for tankers 2020-12-15 07:54:10-05:00</p>

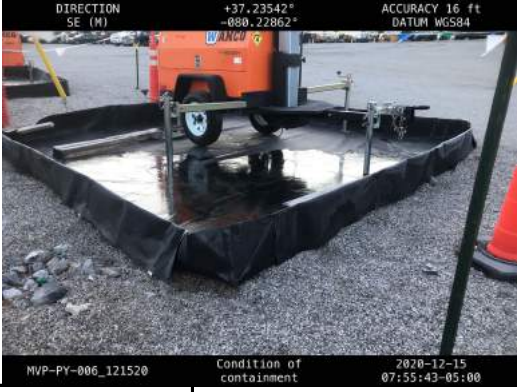
<p>DIRECTION SE (M) +37.23542° -080.22862° ACCURACY 16 ft DATUM WGS84</p> <p>MVP-PY-006_121520 Condition of containment 2020-12-15 07:55:43-05:00</p>

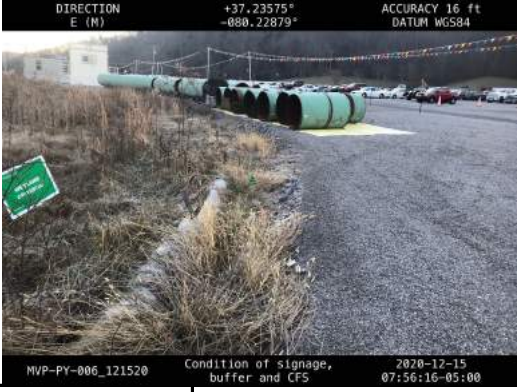
<p>DIRECTION E (M) +37.23575° -080.22879° ACCURACY 16 ft DATUM WGS84</p> <p>MVP-PY-006_121520 Condition of signage, buffer and CFS 2020-12-15 07:56:16-05:00</p>			
GPS Location	MVP-PY-006 See photo for gps data		GPS Location	MVP-PY-006 See photo for gps data	
Field Station#	+0		Field Station#	+0	
Pic 17 Desc.	Condition of containment under light plant. Holding stormwater with layer of ice. Looking SE.		Pic 18 Desc.	Condition of signage, compost filter sock and buffer for feature W-008. Looking E.

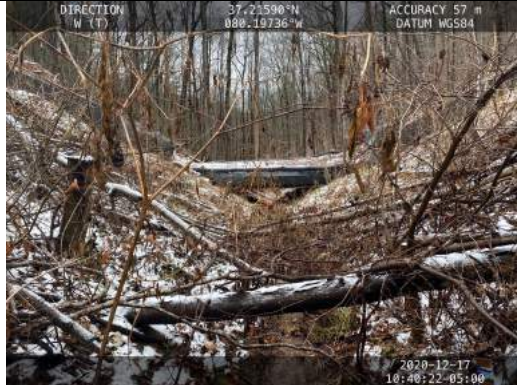
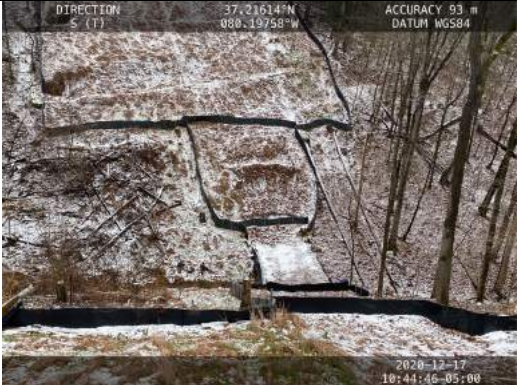
GPS Location	See		GPS Location	See photo	
Field Station#	12519+41		Field Station#	12519+41	
Pic 11 Desc.	Stream S-EF19, facing west, downstream		Pic 12 Desc.	The buffer zone, bridge and ECDs at stream S-EF19 are in satisfactory condition.

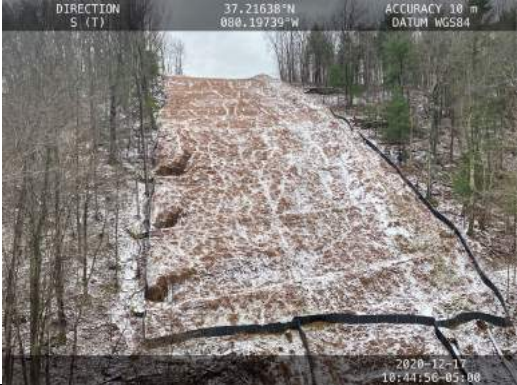
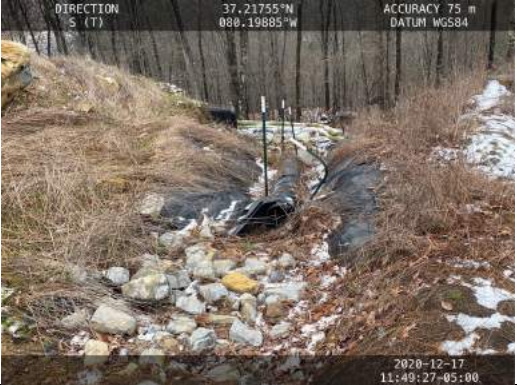
GPS Location	See photo		GPS Location	See photo	
Field Station#	12523+00		Field Station#	12509+00	
Pic 13 Desc.	The slope on the going away side of stream S-EF19 is stable.		Pic 14 Desc.	Fill slope drain in satisfactory condition.

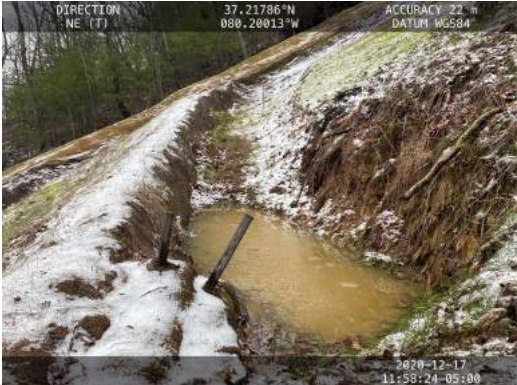
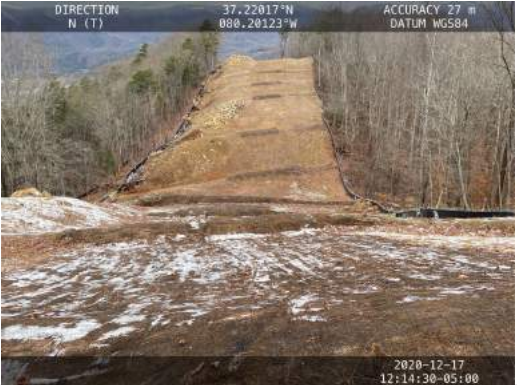
GPS Location	See photo		GPS Location	See photo	
Field Station#	12506+00		Field Station#	12496+00	
Pic 15 Desc.	Waterbars and sumps in satisfactory condition.		Pic 16 Desc.	ROW stable

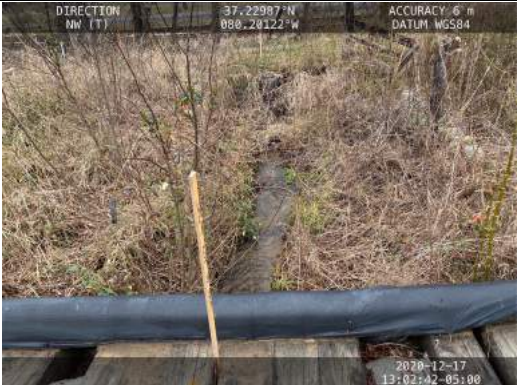
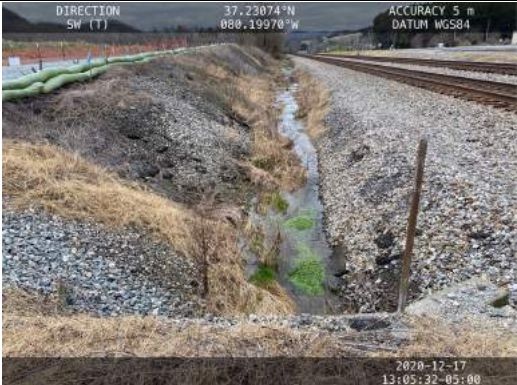
GPS Location	See photo		GPS Location	See photo	
Field Station#	12455+21		Field Station#	12444+94	
Pic 17 Desc.	Stream S-CD12, facing northwest, downstream		Pic 18 Desc.	Stream S-I1, facing southwest, upstream

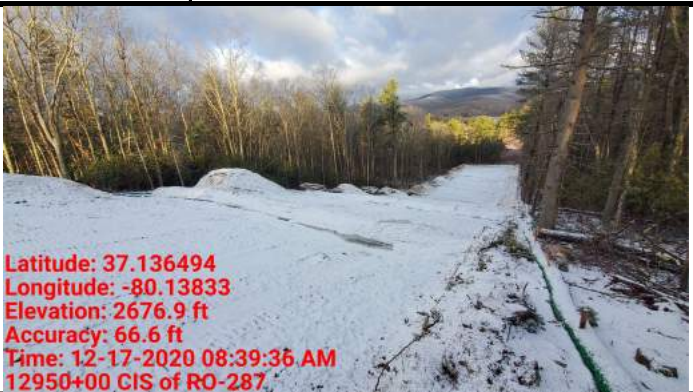
<p>Latitude: 37.136494 Longitude: -80.13833 Elevation: 2676.9 ft Accuracy: 66.6 ft Time: 12-17-2020 08:39:36 AM 12950+00 CIS of RO-287</p>			
GPS Location	See pic for GPS location		GPS Location	See pic for GPS location	
Field Station#	12952+00		Field Station#	12950+00	
Pic 5 Desc.	ROW on CIS of RO-287 stabilized with EarthGuard, straw mulch, and curlex.		Pic 6 Desc.	No maintenance issues or impacts observed on the CIS of RO-287.

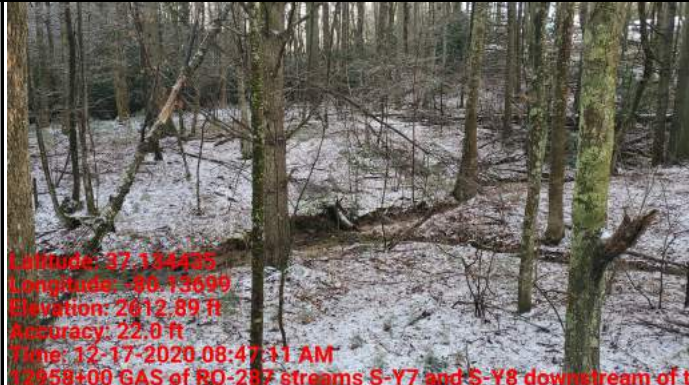
<p>Latitude: 37.134435 Longitude: -80.13699 Elevation: 2612.89 ft Accuracy: 22.8 ft Time: 12-17-2020 08:47:41 AM 12958+00 GAS of RO-287 streams S-Y7 and S-Y8 downstream of t</p>		
GPS Location	See pic for GPS location		GPS Location	See pic for GPS location	
Field Station#	12956+00		Field Station#	12958+00	
Pic 7 Desc.	Sediment trap on the CIS of RO-287.		Pic 8 Desc.	Streams S-Y7 and S-Y8 on the downstream side of the project.	
  <p>Latitude: 37.134678 Longitude: -80.137485 Elevation: 2670.31 ft Accuracy: 50.9 ft Time: 12-17-2020 08:50:44 AM 12957+00 RO-287 landowner's spring box</p>			  <p>Latitude: 37.130745 Longitude: -80.13714 Elevation: 2729.89 ft Accuracy: 13.1 ft Time: 12-17-2020 09:08:10 AM 12972+20 RO-288</p>

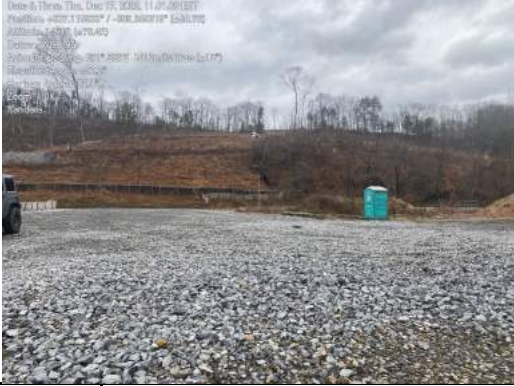
GPS Location	See photo for coordinates.		GPS Location	See photo for coordinates.	
Field Station#	13262+00		Field Station#	13260+60	
Pic 1 Desc.	MVP-FR-291.01, Flanders Road and ATWS - 1055, ECDs functioning acceptably.		Pic 2 Desc.	S-II4, upstream, no turbidity noted, no ROW impacts observed.

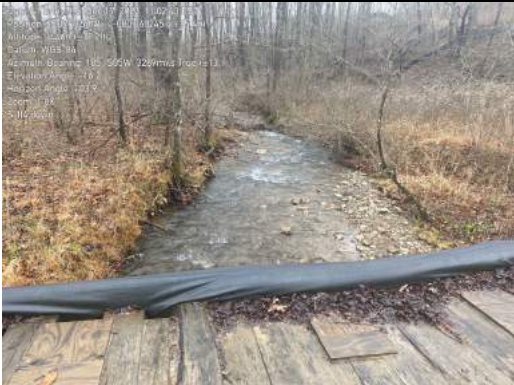
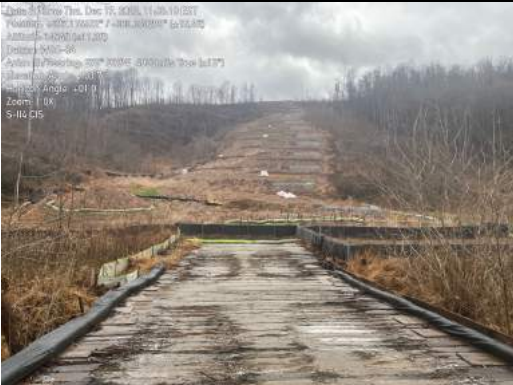
GPS Location	See photo for coordinates.		GPS Location	See photo for coordinates.	
Field Station#	13260+60		Field Station#	13260+60	
Pic 3 Desc.	S-II4, downstream, no ROW impacts, stream bed and banks stable.		Pic 4 Desc.	CIS S-II4, ROW stable with vegetative cover noted across LOD.

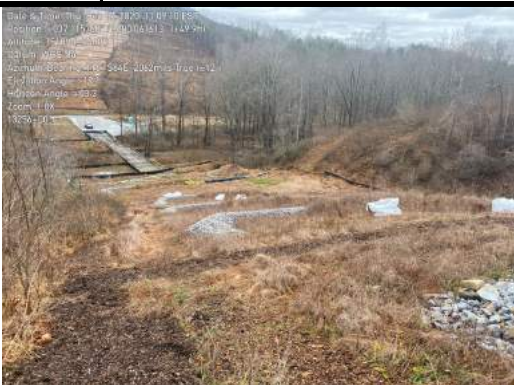
GPS Location	See photo for coordinates.		GPS Location	See photo for coordinates.	
Field Station#	13256+00		Field Station#	13253+00	
Pic 5 Desc.	CIS S-II4, ROW stable with vegetative cover noted across LOD.		Pic 6 Desc.	Previously documented slip stabilized, no additional movement noted.

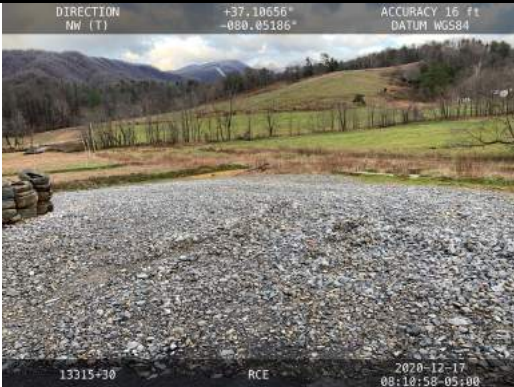
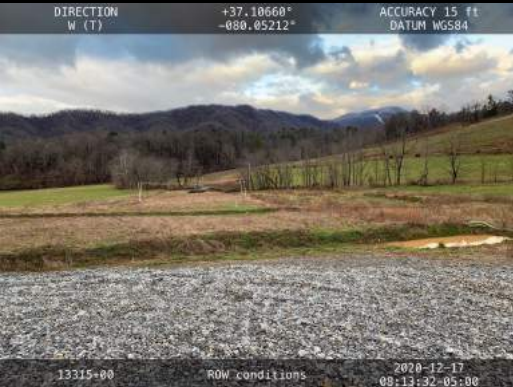
GPS Location	See photo for gps location data.		GPS Location	See photo for gps location data.	
Field Station#	13315+30		Field Station#	13315+00	
Pic 1 Desc.	Photo shows the RCE on the west side of Wades Gap Road.		Pic 2 Desc.	Photo shows the ROW condition from about 13311+00 to 13315+00.

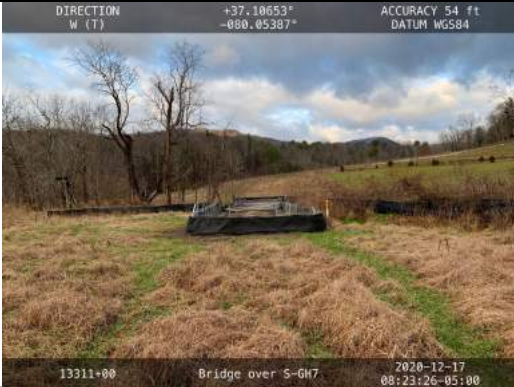
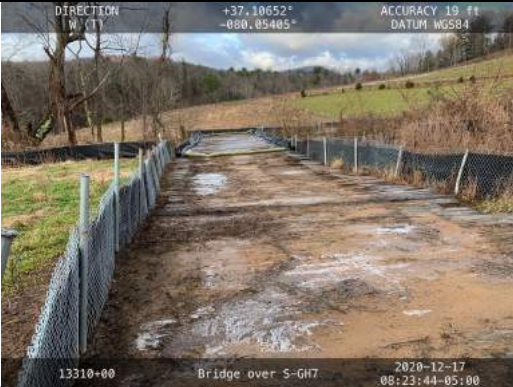
GPS Location	See photo for gps location data.		GPS Location	See photo for gps location data.	
Field Station#	13311+00		Field Station#	13310+00	
Pic 3 Desc.	Photo shows the bridge over stream S-GH7 and adjacent ECDs.		Pic 4 Desc.	Photo shows the bridge over stream S-GH7.

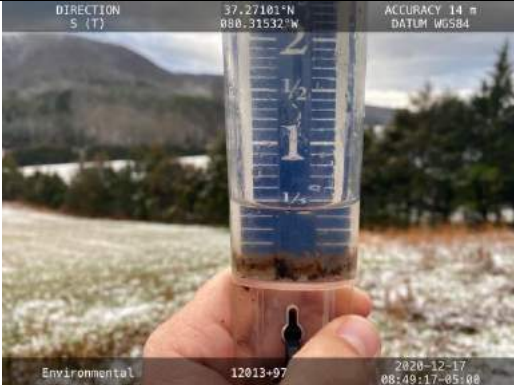
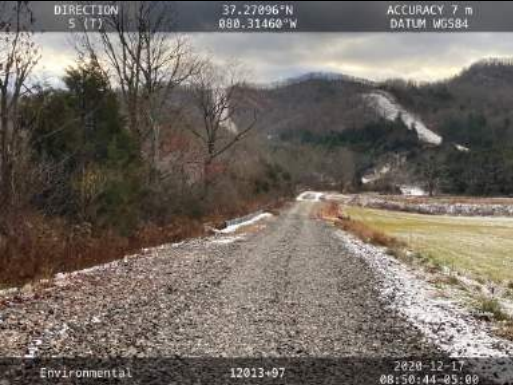
GPS Location	See photo for GPS coordinates		GPS Location	See photo for GPS coordinates	
Field Station#	12013+97		Field Station#	12013+97	
Pic 1 Desc.	Rain gauge totals for Catawba rain gauge (.5").		Pic 2 Desc.	Access road MVP-MN-268.01 in acceptable condition.

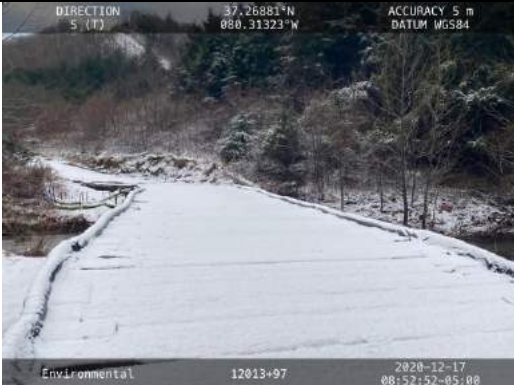
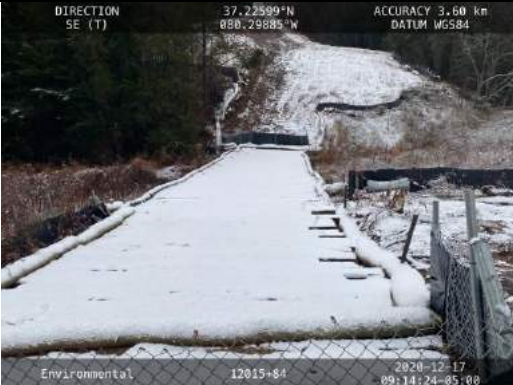
GPS Location	See photo for GPS coordinates		GPS Location	See photo for GPS coordinates	
Field Station#	12013+97		Field Station#	12015+84	
Pic 3 Desc.	Bridge and ECDs at S-G36 access road crossing in acceptable condition.		Pic 4 Desc.	Bridge and ECDs at S-G38 in acceptable condition.

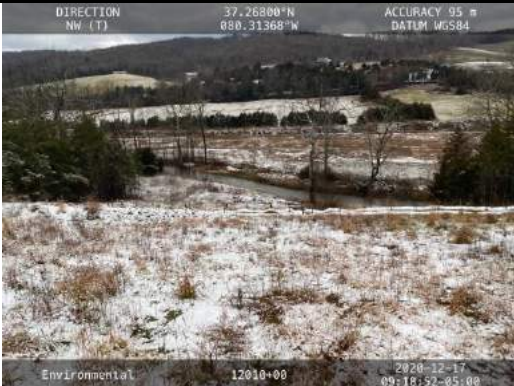
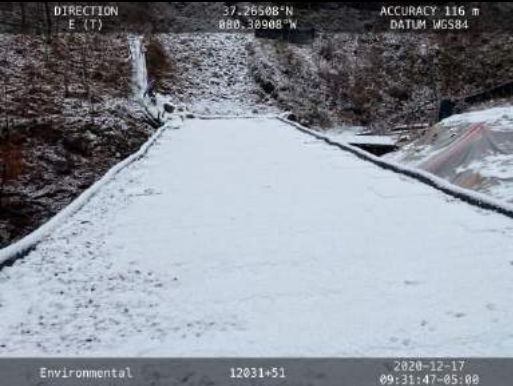
GPS Location	See photo for GPS coordinates		GPS Location	See photo for GPS coordinates	
Field Station#	12010+00		Field Station#	12031+51	
Pic 5 Desc.	Stabilized ROW with acceptable vegetative coverage across LOD		Pic 6 Desc.	Bridge and ECDs at S-G39 in acceptable condition

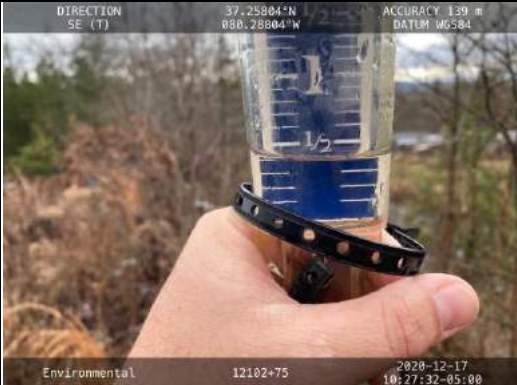
GPS Location	See photo for GPS coordinates		GPS Location	See photo for GPS coordinates	
Field Station#	12102+75		Field Station#	12101+57	
Pic 13 Desc.	Rain gauge totals at Half Acre of Rock road (0.4").		Pic 14 Desc.	Bridge and ECDs at S-MM11 in acceptable condition

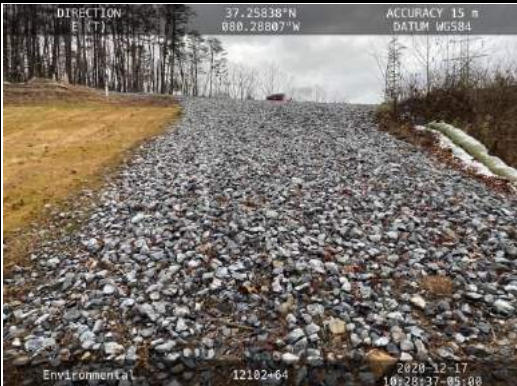
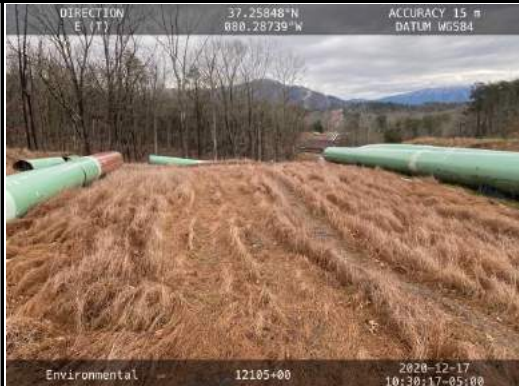
GPS Location	See photo for GPS coordinates		GPS Location	See photo for GPS coordinates	
Field Station#	12102+64		Field Station#	12105+00	
Pic 15 Desc.	RCE on the CIS of Half Acre of Rock Rd in acceptable condition.		Pic 16 Desc.	Stabilized ROW with acceptable vegetative coverage across LOD

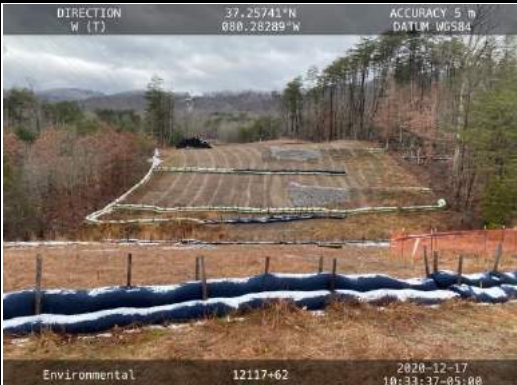
Insert image here			
GPS Location	See photo for GPS coordinates		GPS Location		
Field Station#	12117+62		Field Station#		
Pic 17 Desc.	Stabilized ROW with acceptable vegetative coverage across LOD		Pic 18 Desc.

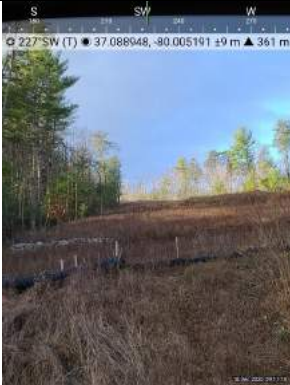
GPS Location	00000	GPS Location	00000		
Field Station#	13437+75	Field Station#	13496+32		
Pic 1 Desc.	Observed area where land owner continues to cut fire wood on row , no issues observed at the time of inspection		Pic 2 Desc.	Row photo taken by the EI showing vegetation and ECDs in place and functioning

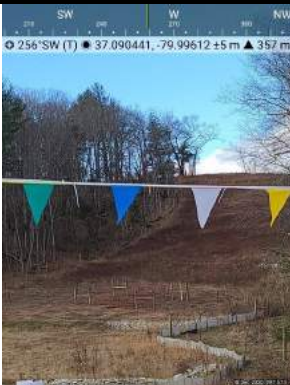
GPS Location	0000	GPS Location	00000		
Field Station#	13496+32	Field Station#	13525+25		
Pic 3 Desc.	Observed rock lined channel at road crossing. No issues observed at the time of inspection		Pic 4 Desc.	The EI monitored vegetation growth and ECDs throughout, no environmental issues observed at time of inspection
