# Visual Site Inspection Report

<b>Project Name</b>	H-600 Pipeline Spread H	<b>AFE</b>	124300138	<b>Spread</b>	H-600 Pipeline Spread H
<b>Contractor</b>	Precision			<b>Report #</b>	18327
<b>Inspector</b>	Stephen Bendele			<b>Date/Time</b>	12/21/2020 12:36 PM
<b>Permit #</b>	TBD	<b>Inspection Type</b>	VA SWPP	<b>Station Begin</b>	12638+24
<b>State</b>	VA	<b>Inspection Area</b>	Partial	<b>Station End</b>	12865+00
<b>County</b>	Roanoke	<b>Ground</b>	Frozen	<b>Temperature (°F)</b>	36.00
<b>Municipality</b>	N/A	<b>Weather</b>	Sunny	<b>Rain Gauge (in)</b>	0.00
				<b>Rain Accumulation Time (days)</b>	0.00

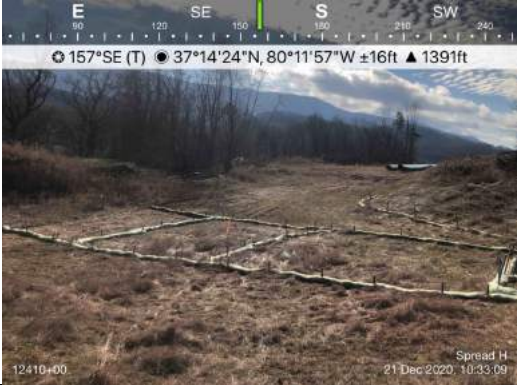
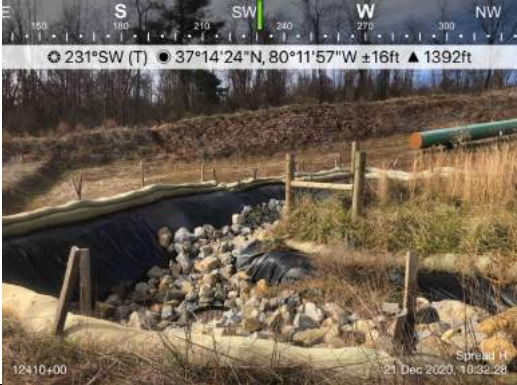
<b>GPS Location</b>	See photo		<b>GPS Location</b>	See photo	
<b>Field Station#</b>	12410+00		<b>Field Station#</b>	12410+00	
<b>Pic 7 Desc.</b>	CFS controls are keyed in and in good condition.		<b>Pic 8 Desc.</b>	CWD inlet in good condition.

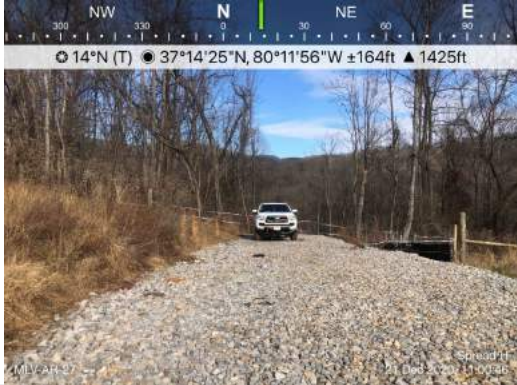
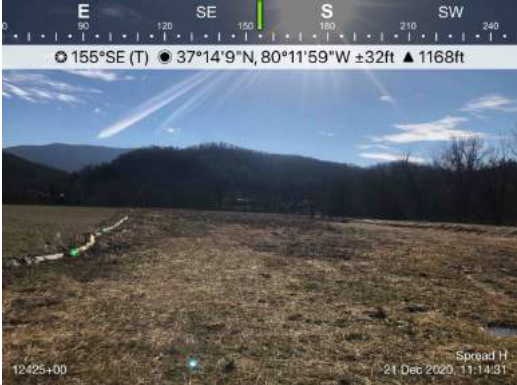
<b>GPS Location</b>	See photo		<b>GPS Location</b>	See photo	
<b>Field Station#</b>	+27		<b>Field Station#</b>	12425+00	
<b>Pic 9 Desc.</b>	Rock CE at MLV-AR-27 in good condition.		<b>Pic 10 Desc.</b>	Roanoke River floodplain area is stabilized and in acceptable condition.

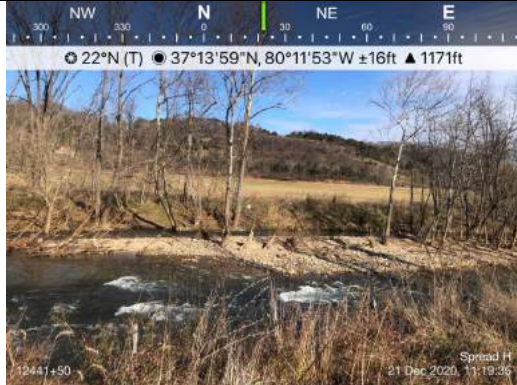
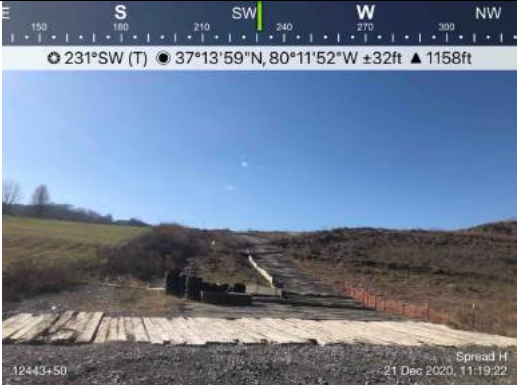
<b>GPS Location</b>	See photo		<b>GPS Location</b>	See photo	
<b>Field Station#</b>	12441+50		<b>Field Station#</b>	12443+50	
<b>Pic 11 Desc.</b>	Roanoke River future bore crossing area in good condition. Resource remains unimpacted.		<b>Pic 12 Desc.</b>	Timbermatting and SF controls in good condition. End of inspection area.

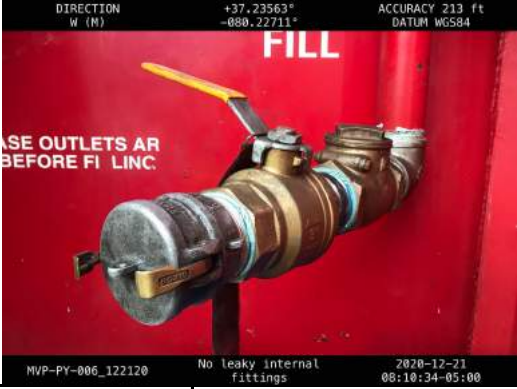
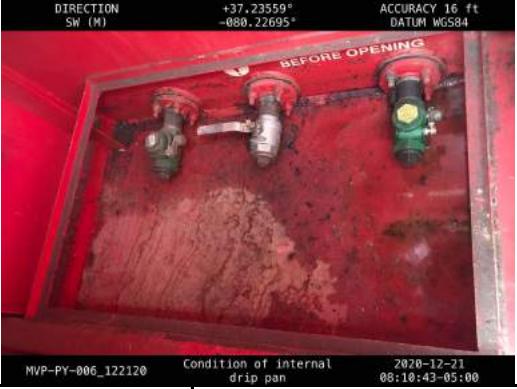
<b>GPS Location</b>	MVP-PY-006 See photo for gps data		<b>GPS Location</b>	MVP-PY-006 See photo for gps data	
<b>Field Station#</b>	+0		<b>Field Station#</b>	+0	
<b>Pic 13 Desc.</b>	Off Road Fuel unit no leaky internal fittings. Looking W.		<b>Pic 14 Desc.</b>	Off Road Fuel unit condition of internal drip pan. Looking SW.

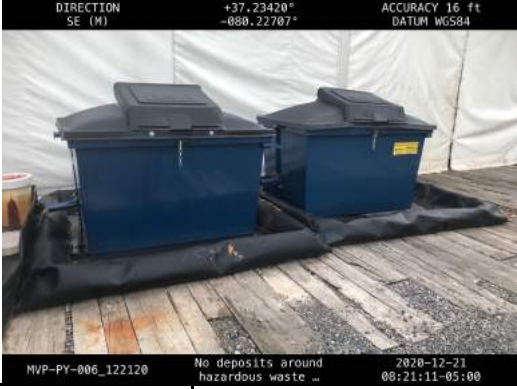
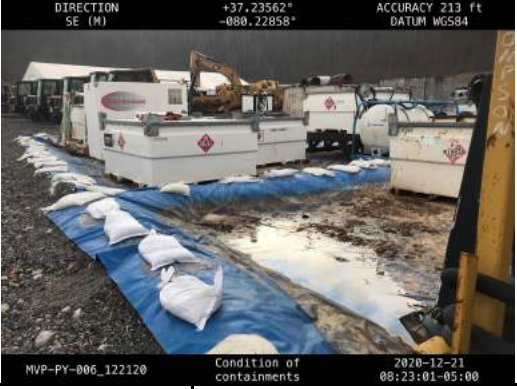
<b>GPS Location</b>	MVP-PY-006 See photo for gps data		<b>GPS Location</b>	MVP-PY-006 See photo for gps data	
<b>Field Station#</b>	+0		<b>Field Station#</b>	+0	
<b>Pic 15 Desc.</b>	No fluids or deposits around hazardous waste dumpsters west of mechanics building. Looking SE.		<b>Pic 16 Desc.</b>	Condition of containments. Free of stormwater. Looking SE.

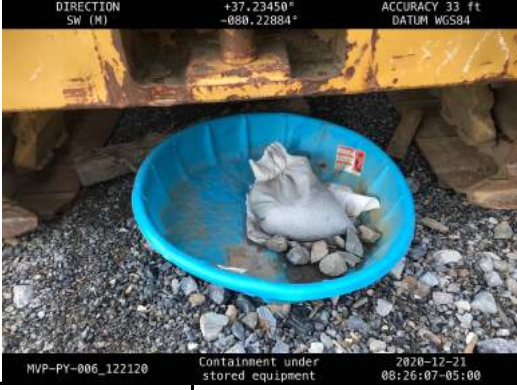
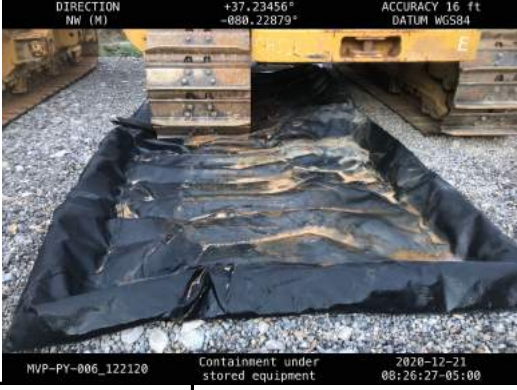
<b>Field Station#</b>	+0		<b>Field Station#</b>	+0	
<b>Pic 17 Desc.</b>	Condition of containment under stored equipment. Looking SW.		<b>Pic 18 Desc.</b>	Condition of containment under stored equipment. Looking NW.

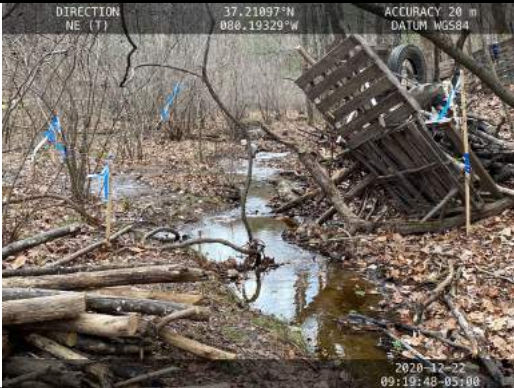
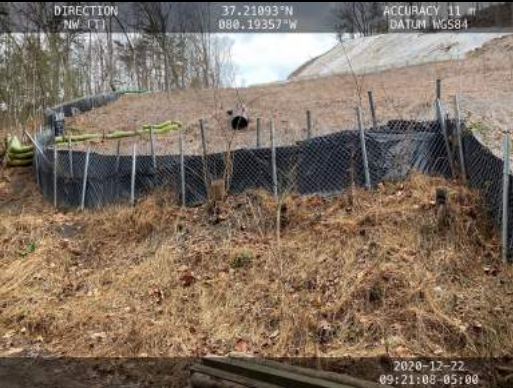
<b>GPS Location</b>	See photo		<b>GPS Location</b>	See photo	
<b>Field Station#</b>	12544+54		<b>Field Station#</b>	12543+75	
<b>Pic 5 Desc.</b>	Stream S-EF20a, facing northeast, downstream		<b>Pic 6 Desc.</b>	ECDs in satisfactory condition on coming in side of Yellow Finch Road.

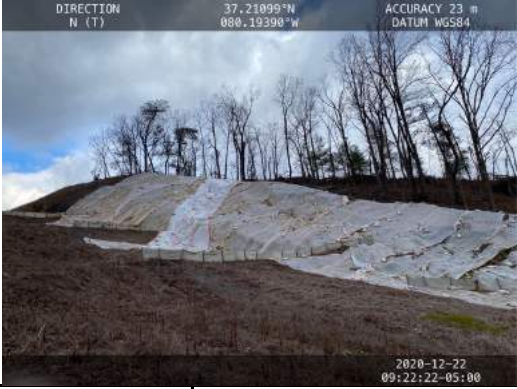
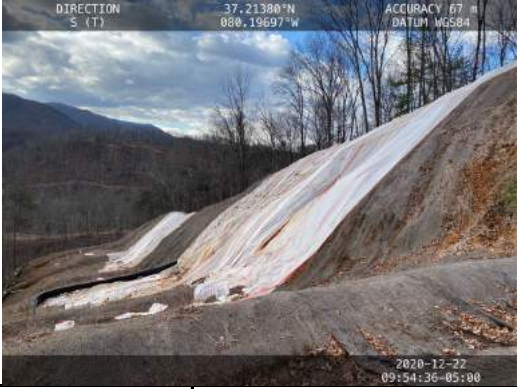
<b>GPS Location</b>	See photo		<b>GPS Location</b>	See photo	
<b>Field Station#</b>	12543+00		<b>Field Station#</b>	12529+00	
<b>Pic 7 Desc.</b>	Plastic sheeting intact and secure on stockpiles nearest to Yellow Finch Road.		<b>Pic 8 Desc.</b>	Plastic sheeting approximately 1500 feet from Yellow Finch Road is intact and secure.

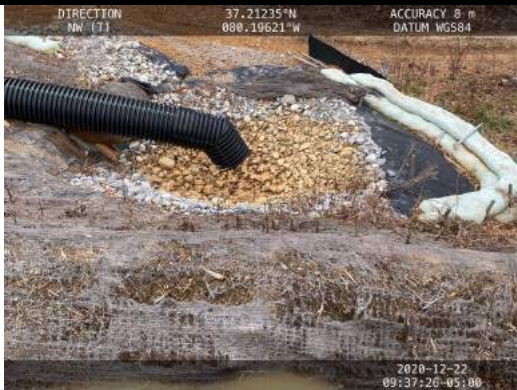
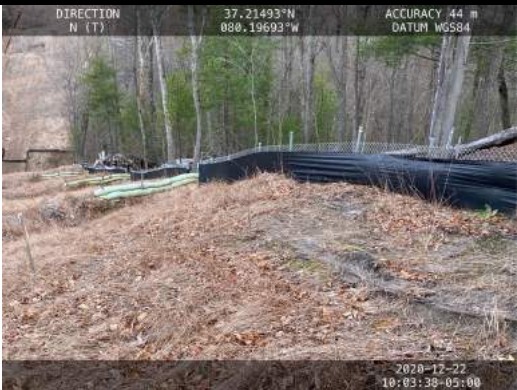
<b>GPS Location</b>	See photo		<b>GPS Location</b>	See photo	
<b>Field Station#</b>	12534+00		<b>Field Station#</b>	12524+00	
<b>Pic 9 Desc.</b>	Although rock is discolored, there is no sediment deposits in the clean water diversion pipe outlet next to the landowner's crossing.		<b>Pic 10 Desc.</b>	Super silt fence in satisfactory condition on slope on going away side of stream S-EF19.

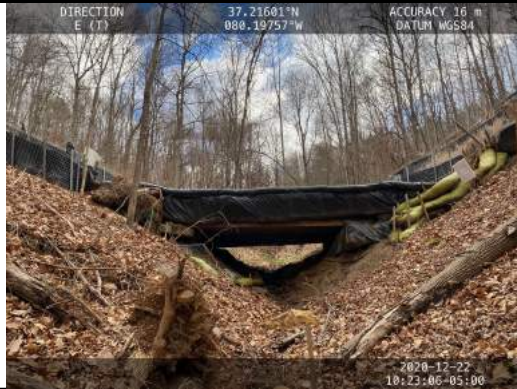
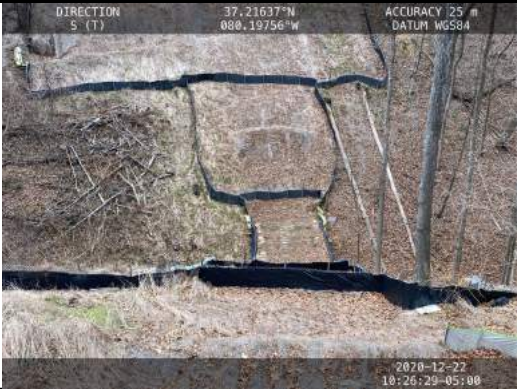
<b>Field Station#</b>	12519+41		<b>Field Station#</b>	12519+41	
<b>Pic 11 Desc.</b>	Stream S-EF18, facing east, upstream		<b>Pic 12 Desc.</b>	Bridge, buffer zone and ECDs in satisfactory at stream S-EF19.

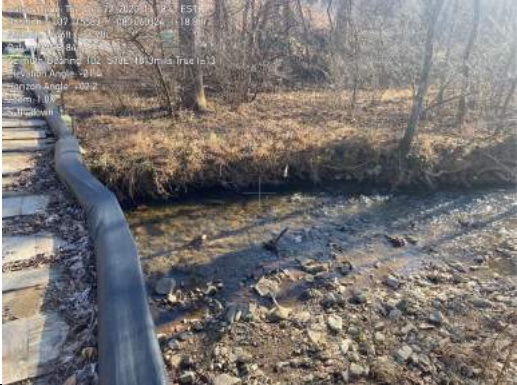
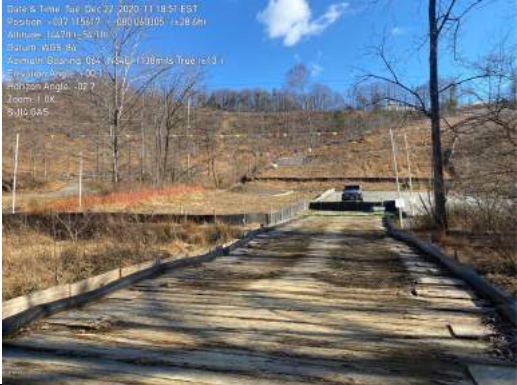
<b>GPS Location</b>	See photo for coordinates.		<b>GPS Location</b>	See photo for coordinates.	
<b>Field Station#</b>	13260+60		<b>Field Station#</b>	132560+50	
<b>Pic 7 Desc.</b>	S-II4, downstream, no environmental concerns noted.		<b>Pic 8 Desc.</b>	S-II4, GAS, ECDs at stream crossing in acceptable condition.

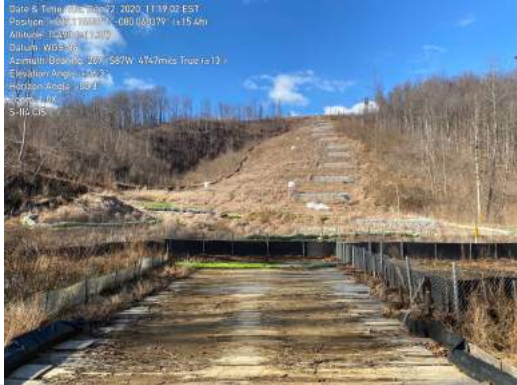
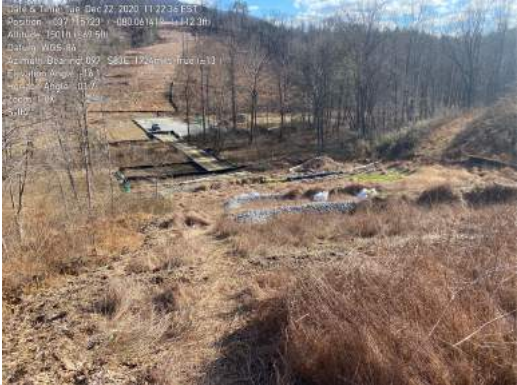
<b>GPS Location</b>	See photo for coordinates.		<b>GPS Location</b>	See photo for coordinates.	
<b>Field Station#</b>	13260+60		<b>Field Station#</b>	13255+00	
<b>Pic 9 Desc.</b>	S-II4, CIS, ECDs at stream crossing in acceptable condition.		<b>Pic 10 Desc.</b>	ROW stable with good vegetative cover across LOD.

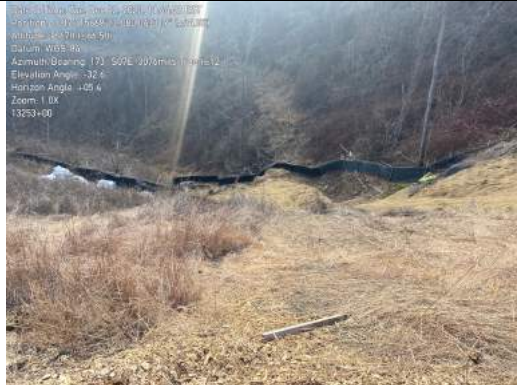
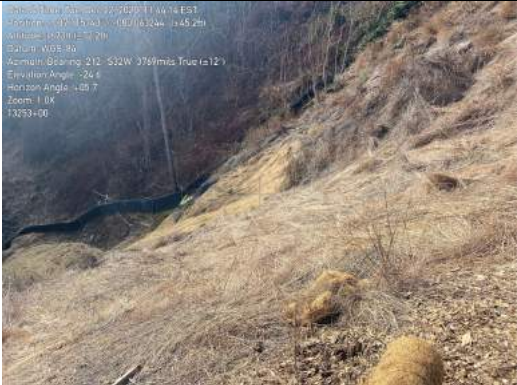
<b>Pic 11 Desc.</b>	No changes noted at previously documented and stabilized slip.		<b>Pic 12 Desc.</b>	No changes noted at previously documented and stabilized slip.

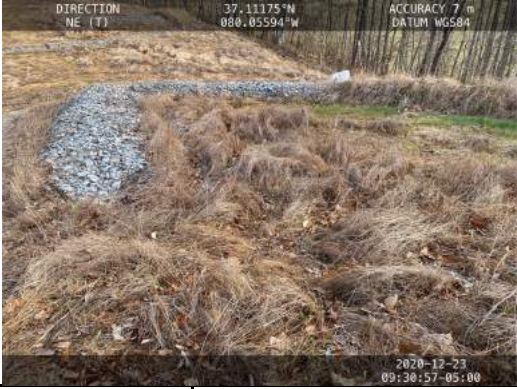
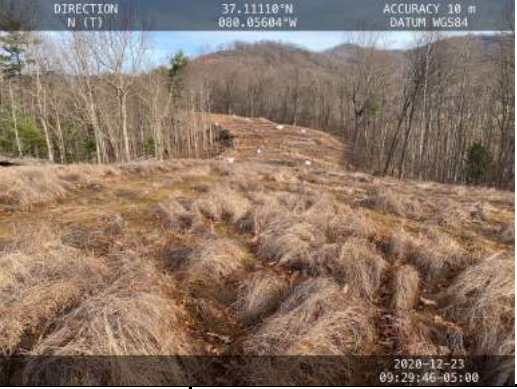
<b>GPS Location</b>	See photo		<b>GPS Location</b>	See photo	
<b>Field Station#</b>	13286+00		<b>Field Station#</b>	13290+00	
<b>Pic 7 Desc.</b>	Permanent waterbars in satisfactory condition.		<b>Pic 8 Desc.</b>	ROW stable

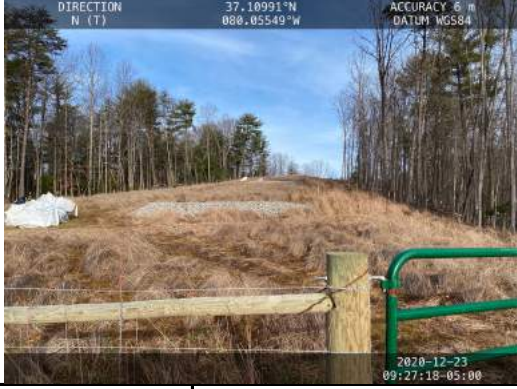
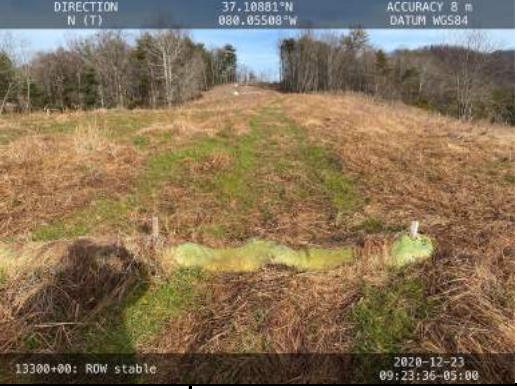
<b>GPS Location</b>	See photo		<b>GPS Location</b>	See photo	
<b>Field Station#</b>	13295+00		<b>Field Station#</b>	13300+00	
<b>Pic 9 Desc.</b>	ROW stable		<b>Pic 10 Desc.</b>	ROW stable

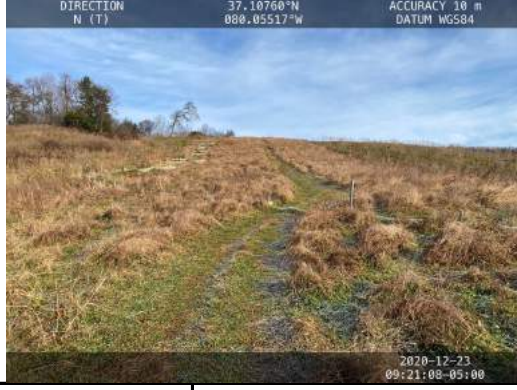
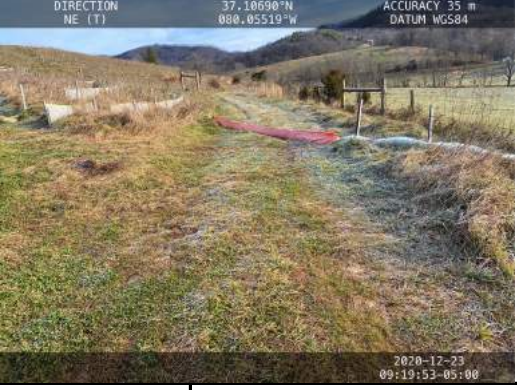
<b>GPS Location</b>	See photo		<b>GPS Location</b>	See photo	
<b>Field Station#</b>	13303+00		<b>Field Station#</b>	13305+71	
<b>Pic 11 Desc.</b>	ROW stable		<b>Pic 12 Desc.</b>	Foam silt dyke in good condition on landowner crossing.

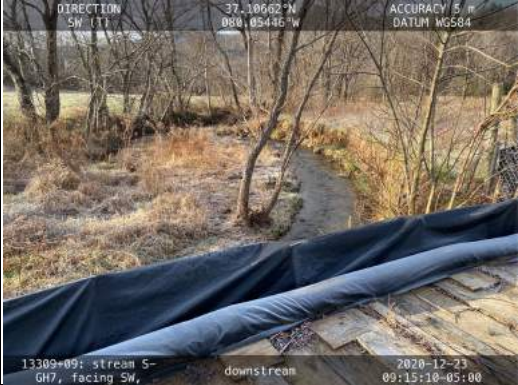
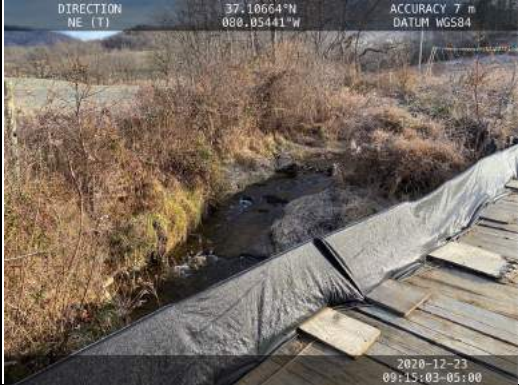
<b>GPS Location</b>	See photo		<b>GPS Location</b>	See photo	
<b>Field Station#</b>	13309+09		<b>Field Station#</b>	13309+09	
<b>Pic 13 Desc.</b>	Stream S-GH7, facing southwest, downstream		<b>Pic 14 Desc.</b>	Stream S-GH7, facing northeast, upstream

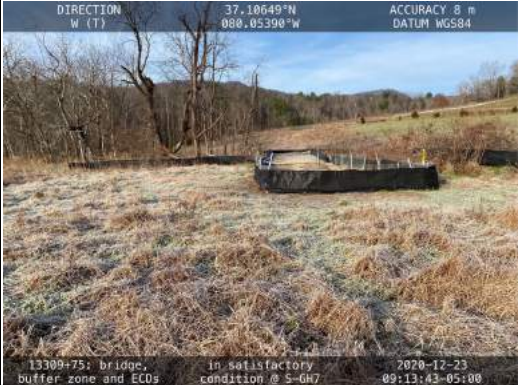
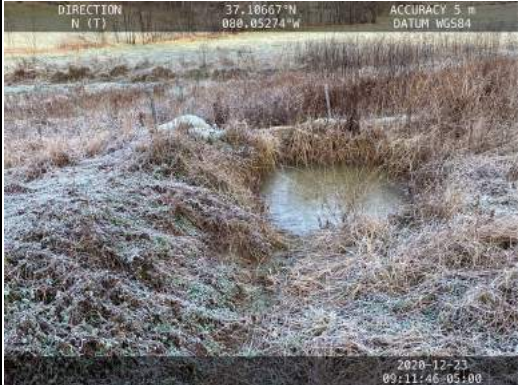
<b>GPS Location</b>	See photo		<b>GPS Location</b>	See photo	
<b>Field Station#</b>	13309+75		<b>Field Station#</b>	13313+00	
<b>Pic 15 Desc.</b>	Bridge, buffer zone and ECDs in satisfactory condition at stream S-GH7.		<b>Pic 16 Desc.</b>	Sumps and end treatments in satisfactory condition between stream S-GH7 and Wades Gap Road.

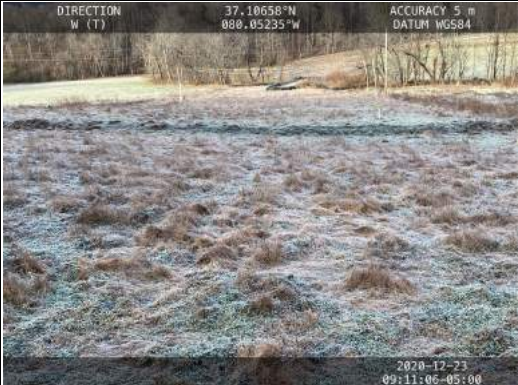
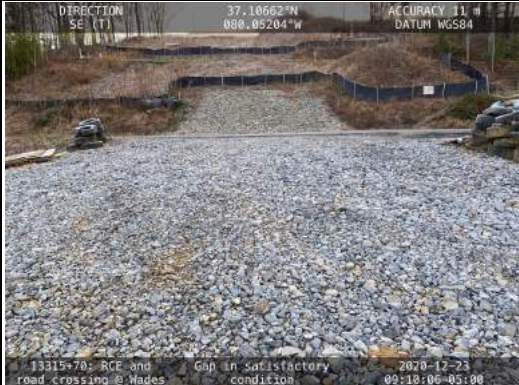
<b>GPS Location</b>	See photo		<b>GPS Location</b>	See photo	
<b>Field Station#</b>	13312+00		<b>Field Station#</b>	13315+70	
<b>Pic 17 Desc.</b>	Temporary stabilization is well vegetated and stable between stream S-GH7 and Wades Gap Road.		<b>Pic 18 Desc.</b>	Rock construction entrance and road crossing in satisfactory condition at Wades Gap Road.

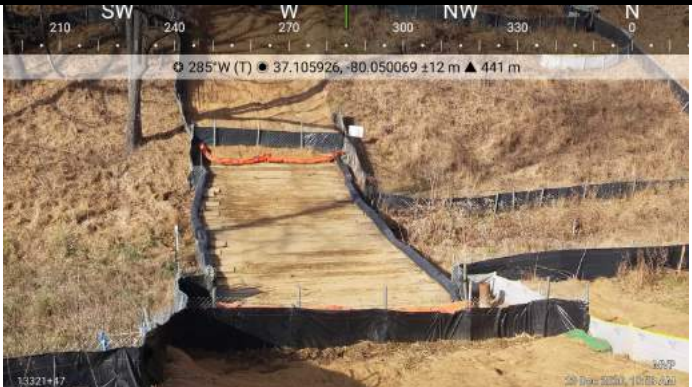
GPS Location	See Above		GPS Location	See Above	
Field Station#	13317+02		Field Station#	13321+47	
Pic 1 Desc.	Overview of private road crossing ROW. ECDs are functional and ROW is stable.		Pic 2 Desc.	Overview of Waterbody S-GH15. ECDs are functional and ROW is stable.

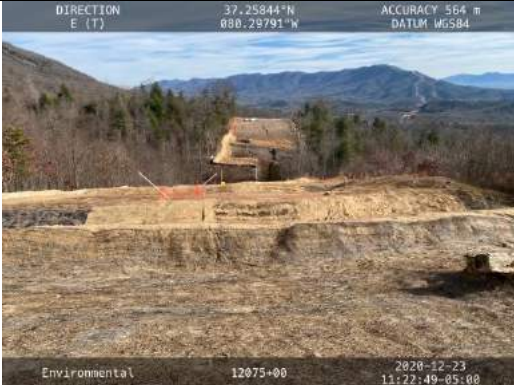
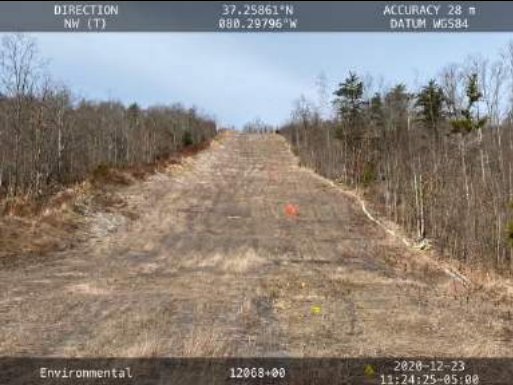
<b>GPS Location</b>	See photo for GPS coordinates		<b>GPS Location</b>	See photo for GPS coordinates	
<b>Field Station#</b>	12075+00		<b>Field Station#</b>	12068+00	
<b>Pic 1 Desc.</b>	Stabilized ROW with acceptable vegetative coverage across LOD		<b>Pic 2 Desc.</b>	Stabilized ROW with acceptable vegetative coverage across LOD

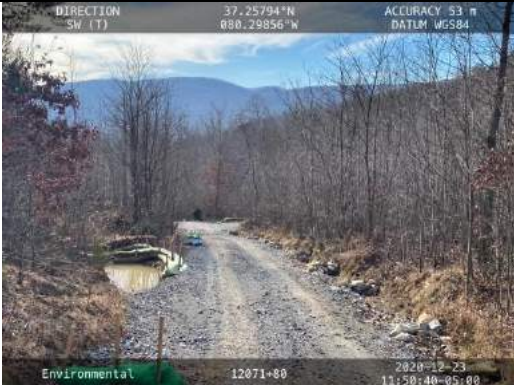
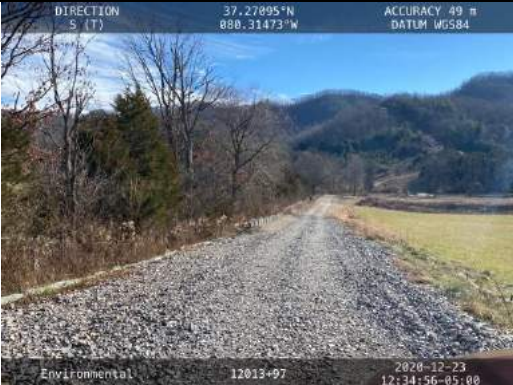
<b>GPS Location</b>	See photo for GPS coordinates		<b>GPS Location</b>	See photo for GPS coordinates	
<b>Field Station#</b>	12071+80		<b>Field Station#</b>	12013+97	
<b>Pic 3 Desc.</b>	Access Road MVP-MN-270 is in acceptable condition		<b>Pic 4 Desc.</b>	Access Road MVP-MN-268.01 in acceptable condition.

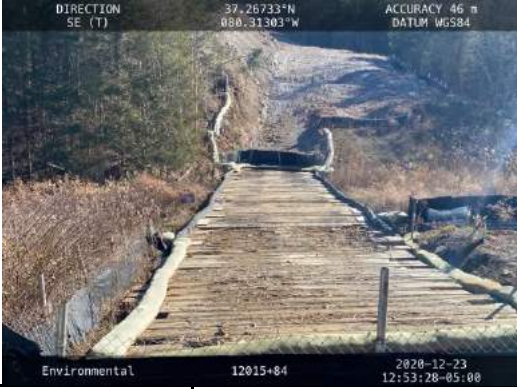
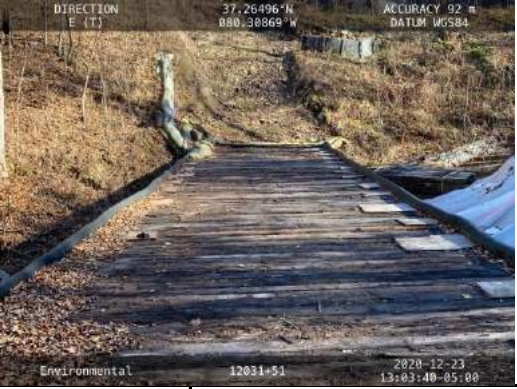
<b>GPS Location</b>	See photo for GPS coordinates		<b>GPS Location</b>	See photo for GPS coordinates	
<b>Field Station#</b>	12015+84		<b>Field Station#</b>	12031+51	
<b>Pic 7 Desc.</b>	Bridge and ECDs at S-G38 are in acceptable condition		<b>Pic 8 Desc.</b>	Bridge and ECDs at S-G39 are in acceptable condition

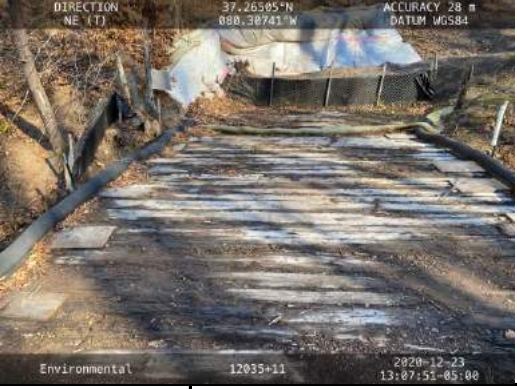
<b>GPS Location</b>	See photo for GPS coordinates		<b>GPS Location</b>	See photo for GPS coordinates	
<b>Field Station#</b>	12029+00		<b>Field Station#</b>	12035+11	
<b>Pic 9 Desc.</b>	Stabilized ROW with acceptable vegetative coverage across LOD		<b>Pic 10 Desc.</b>	Bridge and ECDs at S-G40 are in acceptable condition.

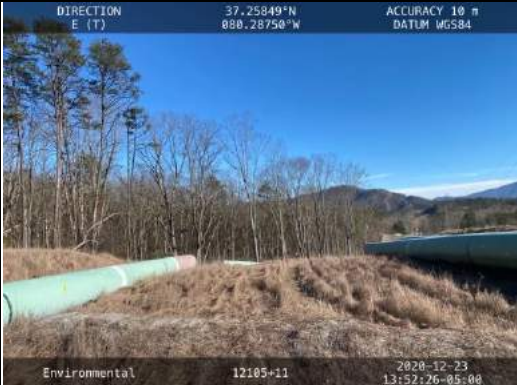
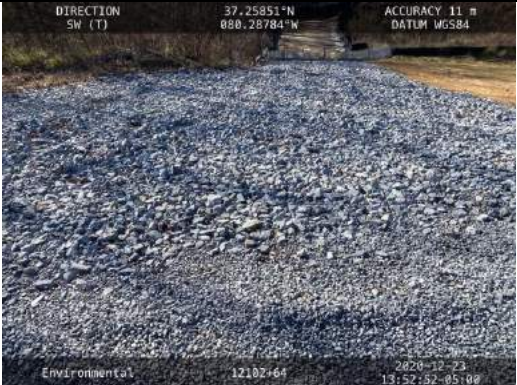
GPS Location	See photo for GPS coordinates		GPS Location	See photo for GPS coordinates	
Field Station#	12105+11		Field Station#	12102+64	
Pic 13 Desc.	Stabilized ROW with acceptable vegetative coverage across LOD		Pic 14 Desc.	RCE on the CIS of access road MVP-MN-270.01

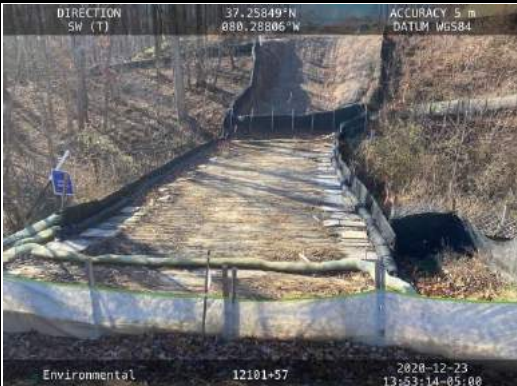
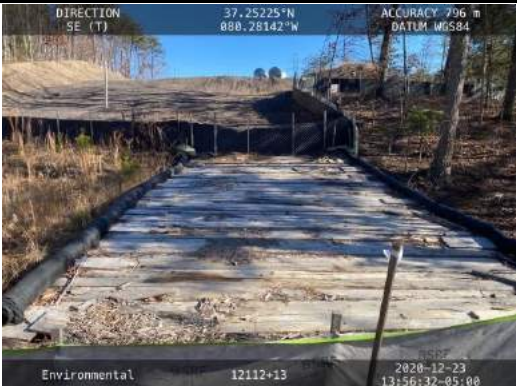
GPS Location	See photo for GPS coordinates		GPS Location	See photo for GPS coordinates	
Field Station#	12101+57		Field Station#	12112+13	
Pic 15 Desc.	Bridge and ECDs at S-MM11 are in acceptable condition		Pic 16 Desc.	Bridge and ECDs at S-F16A/B in acceptable condition

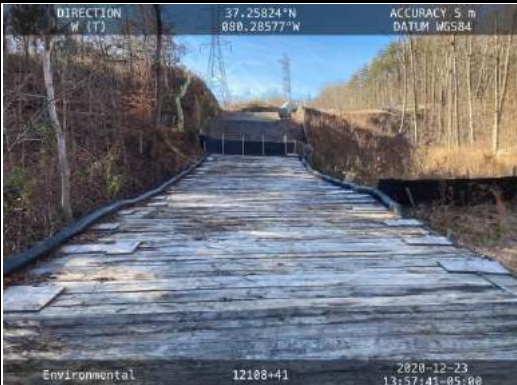
Insert image here			
GPS Location	See photo for GPS coordinates		GPS Location		
Field Station#	12108+41		Field Station#		
Pic 17 Desc.	Bridge and ECDs at S-F15 in acceptable condition		Pic 18 Desc.

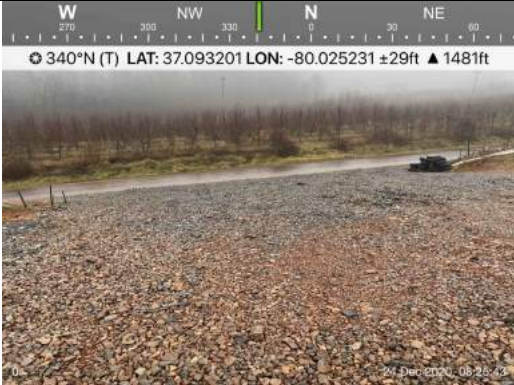
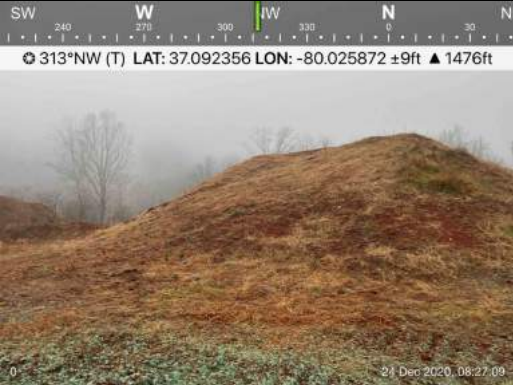
<b>GPS Location</b>	See Photo		<b>GPS Location</b>	See Photo	
<b>Field Station#</b>	13415+51		<b>Field Station#</b>	13418+00	
<b>Pic 1 Desc.</b>	RCEs in good condition and functioning.		<b>Pic 2 Desc.</b>	Stockpiles remain stabilized.

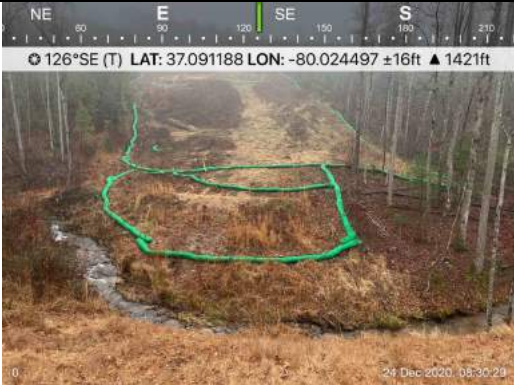
<b>GPS Location</b>	See Photo		<b>GPS Location</b>	See Photo	
<b>Field Station#</b>	13425+01		<b>Field Station#</b>	13436+00	
<b>Pic 3 Desc.</b>	CFS in good condition and functioning throughout this section of ROW.		<b>Pic 4 Desc.</b>	Permanent waterbars and end treatments are functioning.

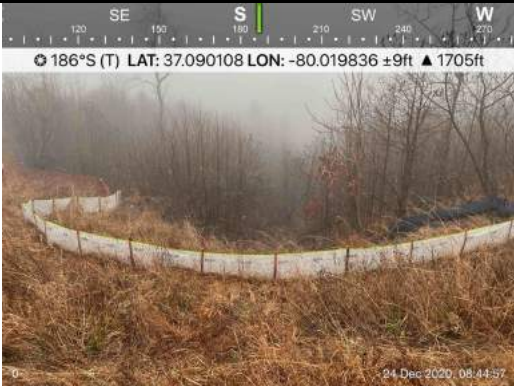
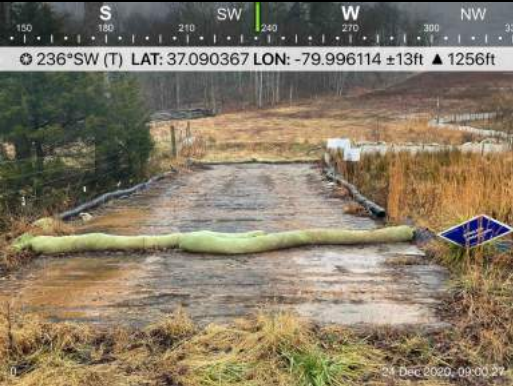
<b>GPS Location</b>	See Photo		<b>GPS Location</b>	See Photo	
<b>Field Station#</b>	13438+41		<b>Field Station#</b>	13525+08	
<b>Pic 5 Desc.</b>	P1 in good condition throughout this section of ROW.		<b>Pic 6 Desc.</b>	Equipment bridge ECDs are in place and functioning.

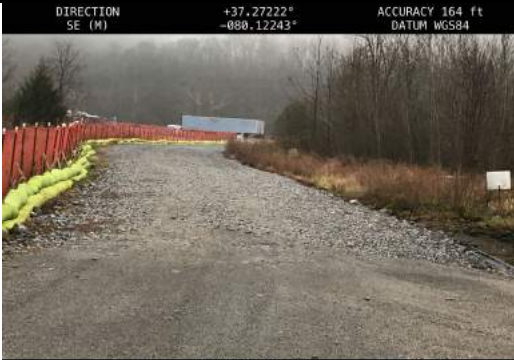
<b>GPS Location</b>	MVP-LY-049 See photo for gps data	<b>GPS Location</b>	MVP-LY-049 See photo for gps data		
<b>Field Station#</b>	+0	<b>Field Station#</b>	+0		
<b>Pic 1 Desc.</b>	Condition of rock entrance on center drive. No sediment on stone. Looking SE.	<b>Pic 2 Desc.</b>	Condition of containment under light plant. Free of stormwater. Looking S.

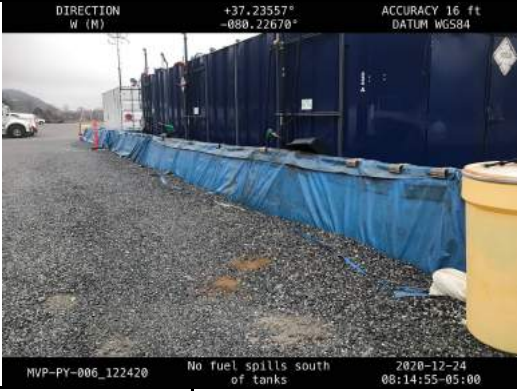
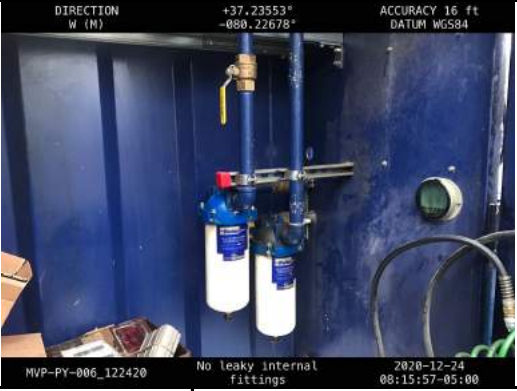
<b>GPS Location</b>	MVP-PY-006 See photo for gps data		<b>GPS Location</b>	MVP-PY-006 See photo for gps data	
<b>Field Station#</b>	+0		<b>Field Station#</b>	+0	
<b>Pic 13 Desc.</b>	No fuel spills south of the Blue Bulk fuel tanks. Looking W.		<b>Pic 14 Desc.</b>	Blue Bulk Fuel tanks no leaky internal fittings. Looking W.

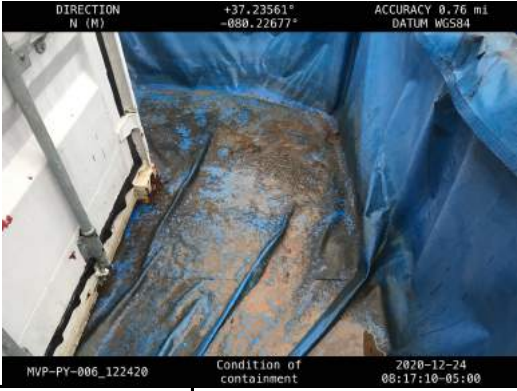
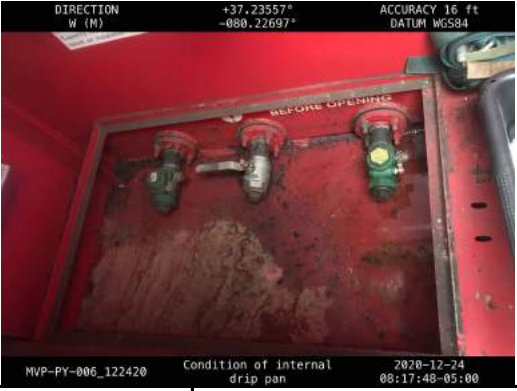
<b>GPS Location</b>	MVP-PY-006 See photo for gps data		<b>GPS Location</b>	MVP-PY-006 See photo for gps data	
<b>Field Station#</b>	+0		<b>Field Station#</b>	+0	
<b>Pic 15 Desc.</b>	Off Road Fuel unit containment free of stormwater. Looking N.		<b>Pic 16 Desc.</b>	Off Road Fuel unit condition of internal drip pan. Looking W.

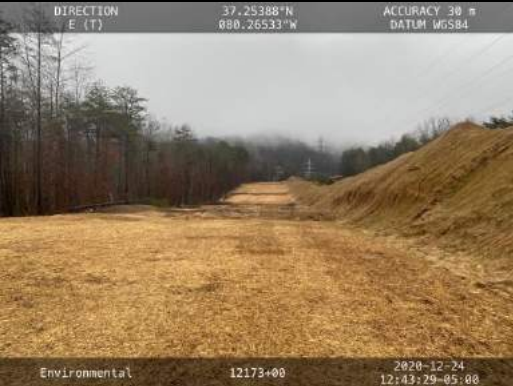
<b>GPS Location</b>	See photo for GPS coordinates		<b>GPS Location</b>	See photo for GPS coordinates	
<b>Field Station#</b>	12166+47		<b>Field Station#</b>	12173+00	
<b>Pic 5 Desc.</b>	Bridge and ECDs at S-C25 in acceptable condition		<b>Pic 6 Desc.</b>	Stabilized ROW with acceptable vegetative coverage across LOD
