Visual Site Inspection Report

Project Name	H-600 Pipeline Spread H	AFE	124300138	Spread	H-600 Pipeline Spread H
Contractor	Precision			Report #	18508
Inspector	John Brcic			Date/Time	12/28/2020 12:01 PM
Permit #	TBD	Inspection Type	VA SWPP	Station Begin	12443+75
State	VA	Inspection Area	Partial	Station End	12544+06
County	Montgomery	Ground	Damp	Temperature (°F)	31.00
Municipality	N/A	Weather	Cloudy	Rain Gauge (in)	0.00
				Rain Accumulation Time (days)	2.00

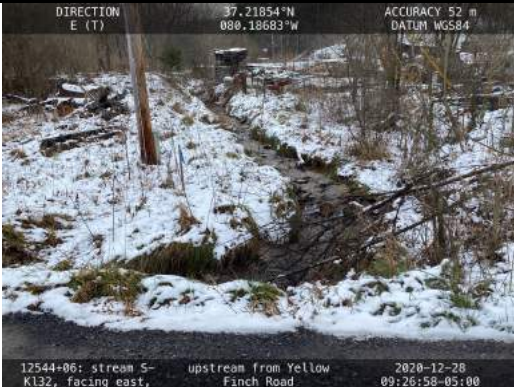
GPS Location	See photo		GPS Location	See photo	
Field Station#	12544+06		Field Station#	12544+06	
Pic 1 Desc.	Stream S-KL32, facing east, upstream from Yellow		Pic 2 Desc.	Stream S-EF20b, facing north, downstream from Yellow Finch Road

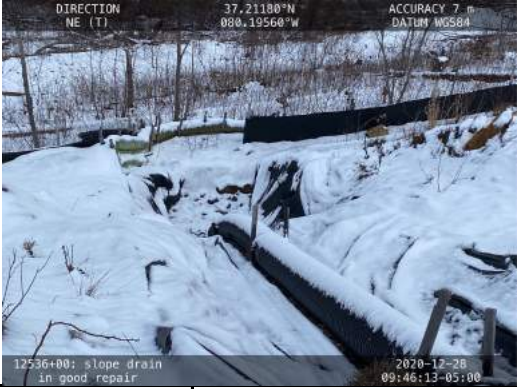
GPS Location	See photo		GPS Location	See photo	
Field Station#	12536+00		Field Station#	12534+00	
Pic 7 Desc.	Slope drain in satisfactory condition.		Pic 8 Desc.	Clean water diversion pipe outlet plunge pool in satisfactory condition.

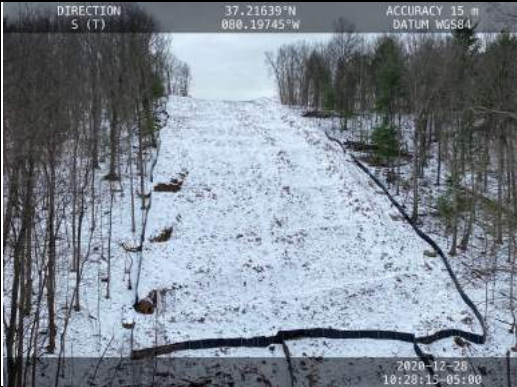
GPS Location	See photo		GPS Location	See photo	
Field Station#	12523+00		Field Station#	12503+70	
Pic 13 Desc.	Slope on going away side of stream S-EF19 is stable.		Pic 14 Desc.	Clean water diversion pipe outlet plunge pool in good repair, free of sediment.

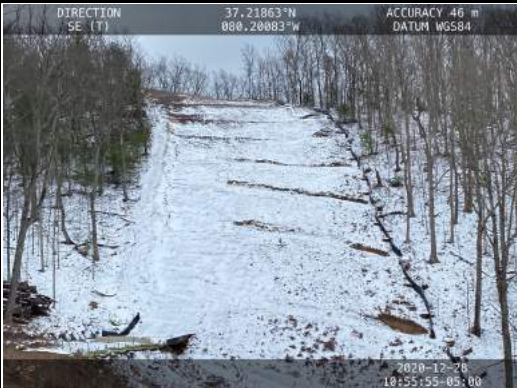
GPS Location	See photo		GPS Location	See photo	
Field Station#	12506+00		Field Station#	12460+75	
Pic 15 Desc.	Slope on going away side of clean water diversion pipe remains stable.		Pic 16 Desc.	Wetland W-KL58, facing west

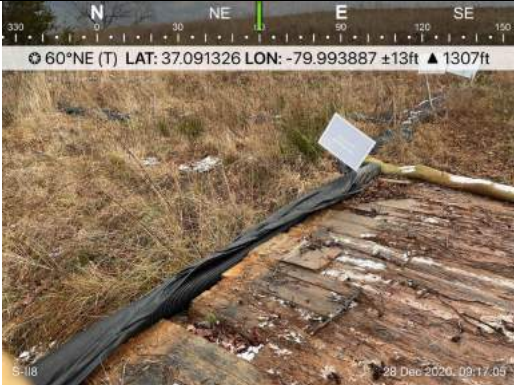
E&S BMPs	Compliance Level	Corrective Action	Corrective Time Frame	Date Repaired
Equipment Bridge	Communication	Equipment bridge sideboard needs t		
Silt Fence (Filter Fabric Fence)	Communication	Multiple area of P1 have been dama		
Other - Explain in Comments	Communication	Tree has fallen at the intersection of

GPS Location	See photo		GPS Location	See photo	
Field Station#	13533+52		Field Station#	13560+00	
Pic 1 Desc.	Equipment bridge sideboard needs to be repaired.		Pic 2 Desc.	P1 has been damaged and needs to be replaced.

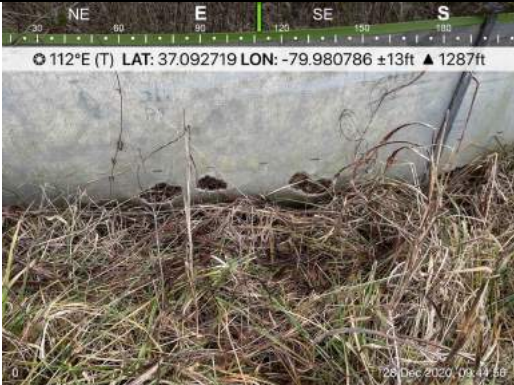
GPS Location	See photo		GPS Location	See photo	
Field Station#	13573+00		Field Station#	13600+00	
Pic 3 Desc.	P1 has been damaged and needs to be replaced.		Pic 4 Desc.	P1 has been damaged and needs to be replaced.

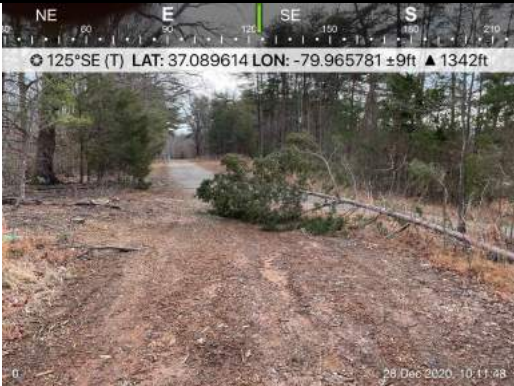
GPS Location	See photo		GPS Location	See photo	
Field Station#	13618+26		Field Station#	13634+00	
Pic 5 Desc.	Tree has fallen across access road at this location.		Pic 6 Desc.	P1 has been damaged and needs to be replaced.

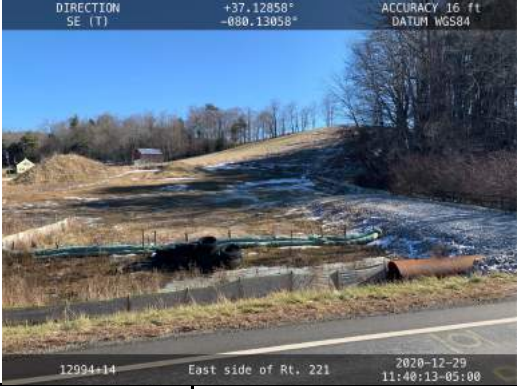
<p>DIRECTION SE (T) +37.12858° -080.13058° ACCURACY 16 ft DATUM WGS84</p> <p>12994+14 East side of Rt. 221 2020-12-29 11:40:13-05:00</p>

Field Station#	12994+14		Field Station#	12993+98	
Pic 15 Desc.	No maintenance issues or impacts observed on the GAS of the US-221 road crossing.		Pic 16 Desc.	No maintenance issues or impacts observed on the CIS of the US-221 road crossing.

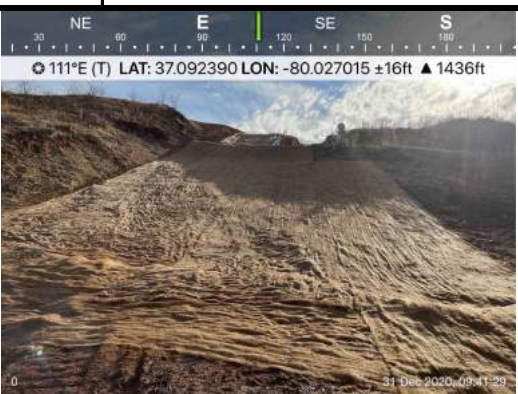
GPS Location	See photo		GPS Location	See photo	
Field Station#	13415+51		Field Station#	13416+00	
Pic 3 Desc.	RCEs remain in good condition.		Pic 4 Desc.	Erosion control fabric in good condition on this slope.
