Visual Site Inspection Report

Project Name	H-600 Pipeline Spread H	AFE	124300138	Spread	H-600 Pipeline Spread H
Contractor	Precision			Report #	16922
Inspector	John Brcic			Date/Time	11/16/2020 9:17 AM
Permit #	TBD	Inspection Type	VA SWPP	Station Begin	12865+00
State	VA	Inspection Area	Partial	Station End	13116+00
County	Franklin	Ground	Damp	Temperature (°F)	55.00
Municipality	N/A	Weather	Sunny	Rain Gauge (in)	0.00
				Rain Accumulation Time (days)	2.00

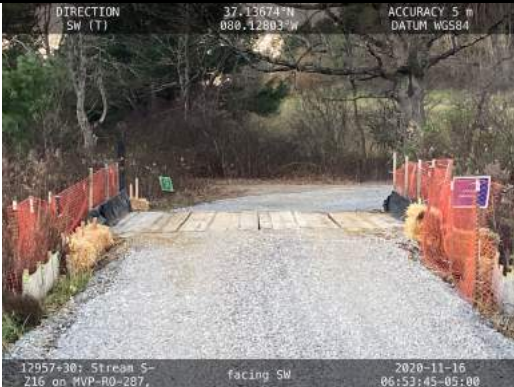
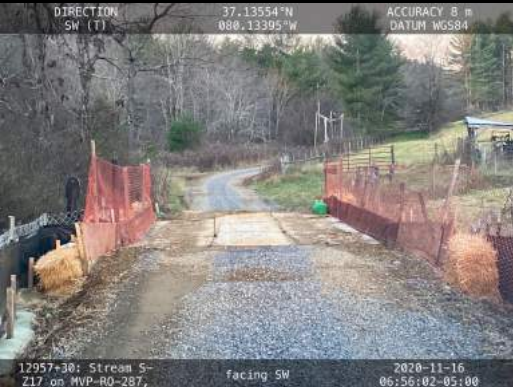
GPS Location	See photo		GPS Location	See photo	
Field Station#	12957+30		Field Station#	12957+30	
Pic 1 Desc.	Stream Z16 on MVP-ROW-287, facing southwest		Pic 2 Desc.	Stream S-Z17 on MVP-RO-287, facing southwest

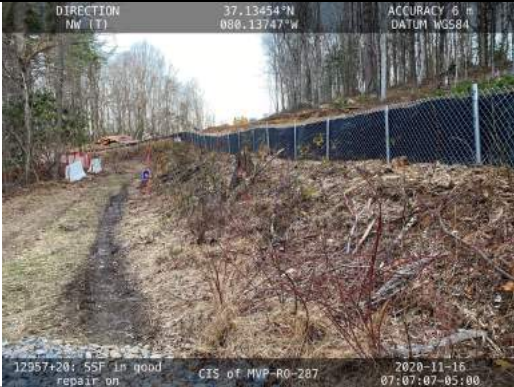
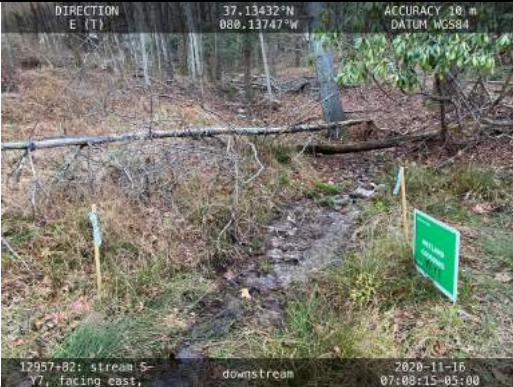
GPS Location	See photo		GPS Location	See photo	
Field Station#	12957+20		Field Station#	12957+82	
Pic 3 Desc.	SSF in good repair on coming in side of access road MVP-RO-287.		Pic 4 Desc.	Stream S-Y7, facing east, downstream

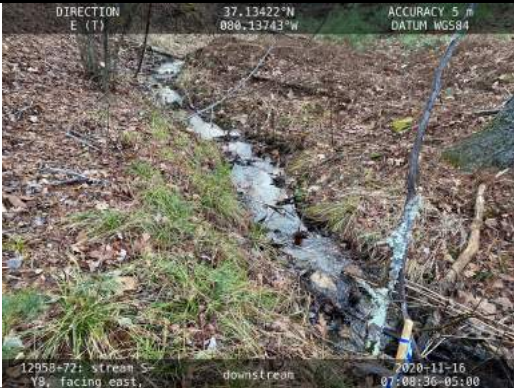
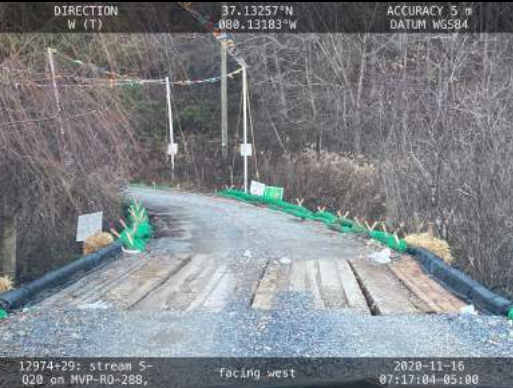
GPS Location	See photo		GPS Location	See photo	
Field Station#	12958+72		Field Station#	12974+29	
Pic 5 Desc.	Stream S-Y8, facing east, downstream		Pic 6 Desc.	Stream S-Q20 on access road MVP-RO-288, facing west

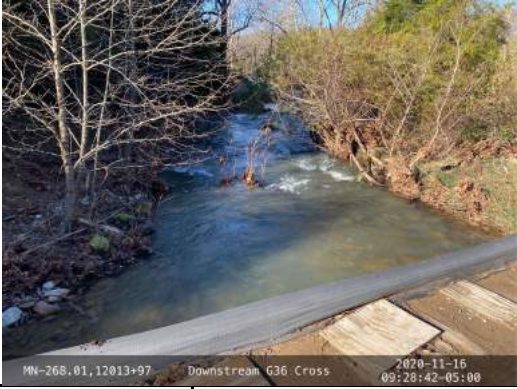
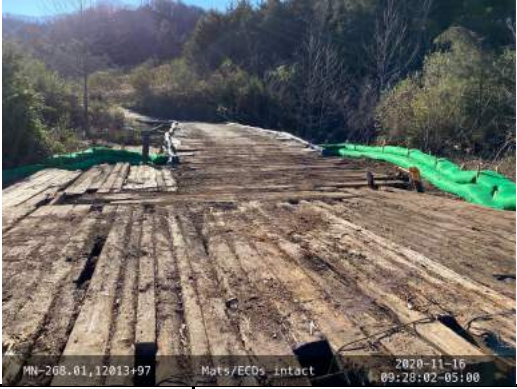
GPS Location	See photo GPS for location		GPS Location	See photo GPS for location	
Field Station#	12013+97		Field Station#	12013+97	
Pic 13 Desc.	S-G36 bridge crossing on MVP-MN-268.01 shows no turbidity upstream and surrounding ECDs are in acceptable condition.		Pic 14 Desc.	Mat approach and new CFS at S-G36 bridge crossing on MVP-MN-268.01 has been replaced satisfactorily.

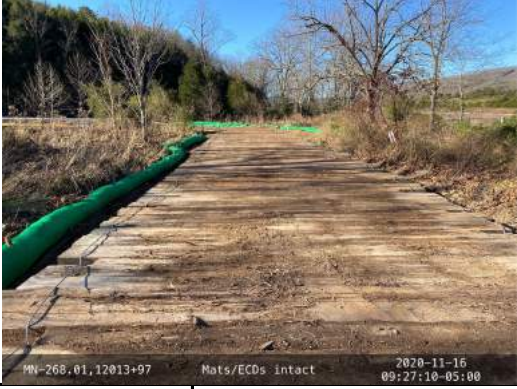
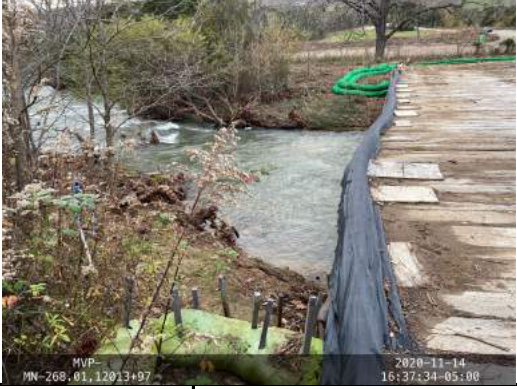
GPS Location	See photo GPS for location		GPS Location	See photo GPS for location	
Field Station#	12013+97		Field Station#	12013+97	
Pic 15 Desc.	Mat approach and new CFS at S-G36 bridge crossing on MVP-MN-268.01 has been replaced satisfactorily.		Pic 16 Desc.	S-G36 bridge crossing on MVP-MN-268.01 shows no turbidity downstream and surrounding ECDs are in acceptable condition.

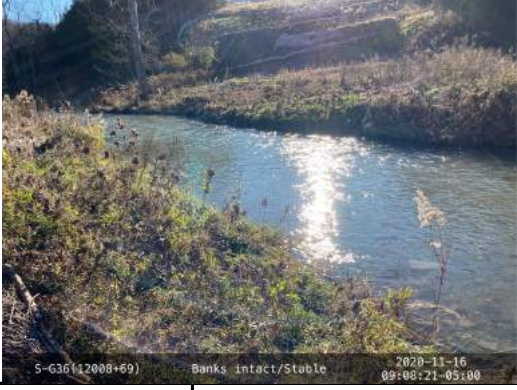
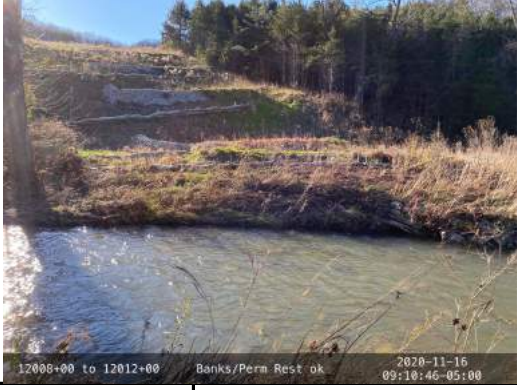
Field Station#	12008+69		Field Station#	12010+00	
Pic 17 Desc.	Water from flooding has receded. Banks and CFS are intact.		Pic 18 Desc.	Permanent restoration is in stable and acceptable condition.

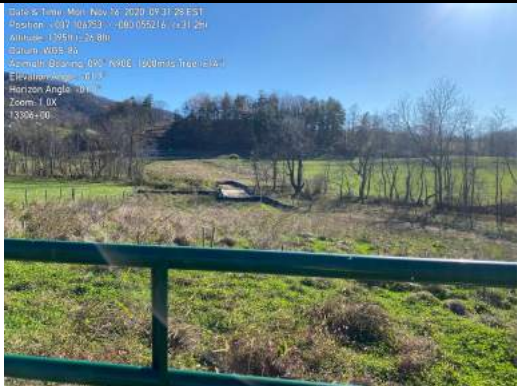
GPS Location	See photo for coordinates.		GPS Location	See photo for coordinates.	
Field Station#	13306+00		Field Station#	13306+00	
Pic 9 Desc.	ROW stable with acceptable vegetative cover.		Pic 10 Desc.	Small holes in CFS where vehicle has driven over multiple times.

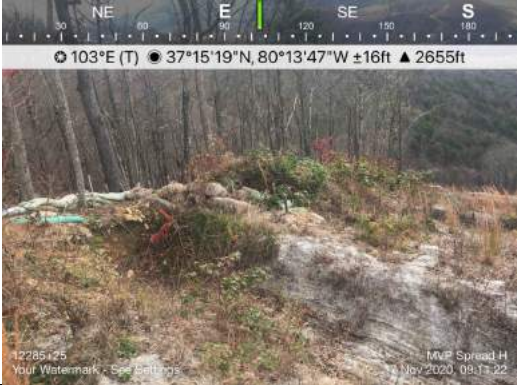
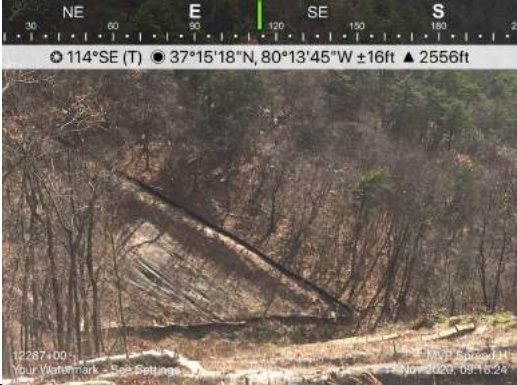
GPS Location	See Watermark		GPS Location	See Watermark	
Field Station#	12285+25		Field Station#	12287+00	
Pic 7 Desc.	Waterbar sump pit and CFS end treatment do not require maintenance.		Pic 8 Desc.	GAS of the "V", silt fence is undamaged and stable.

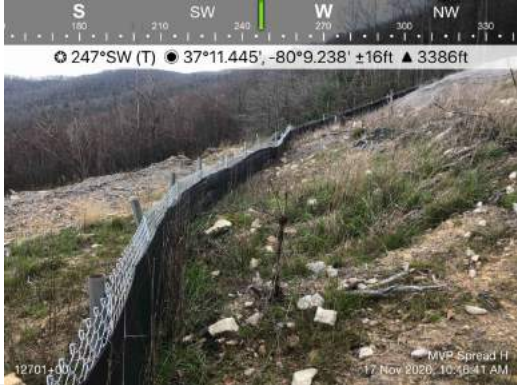
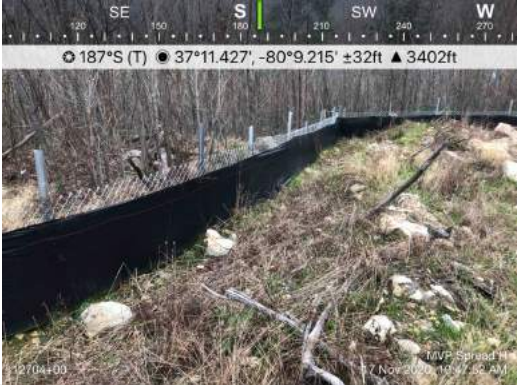
GPS Location	See Picture Watermark		GPS Location	See Picture Watermark	
Field Station#	12701+00		Field Station#	12704+00	
Pic 9 Desc.	Previously noted SSF fabric has been reattached and in good condition.		Pic 10 Desc.	Previously noted SSF has been reattached and is in good condition.

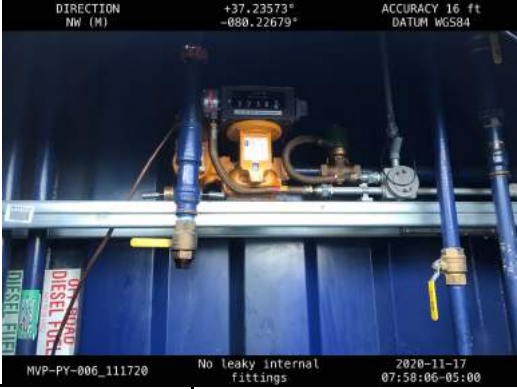
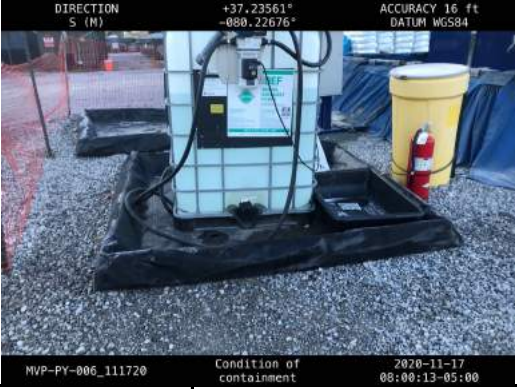
GPS Location	MVP-PY-006 See photo for gps data		GPS Location	MVP-PY-006 See photo for gps data	
Field Station#	+0		Field Station#	+0	
Pic 13 Desc.	Blue Bulk Fuel tanks no leaky internal fittings. Looking NW.		Pic 14 Desc.	Condition of containment under DEF tank. Looking S.

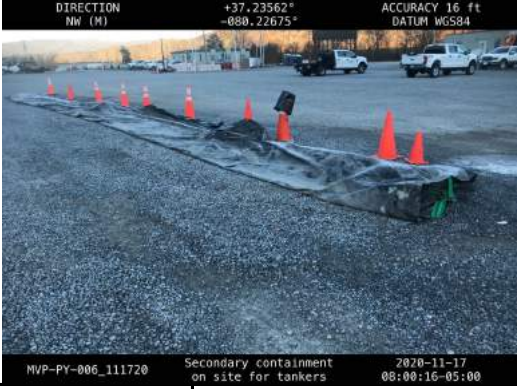
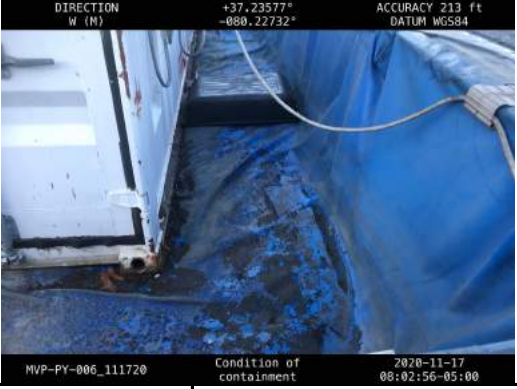
GPS Location	MVP-PY-006 See photo for gps data		GPS Location	MVP-PY-006 See photo for gps data	
Field Station#	+0		Field Station#	+0	
Pic 15 Desc.	Secondary containment on site for tankers offloading fuel into Blue Bulk fuel tanks. Looking NW.		Pic 16 Desc.	Off Road Fuel unit containment, free of stormwater. Looking W.

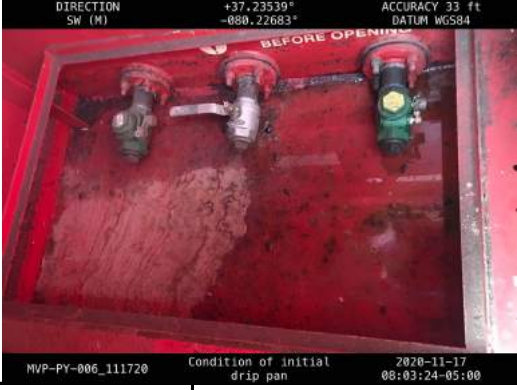
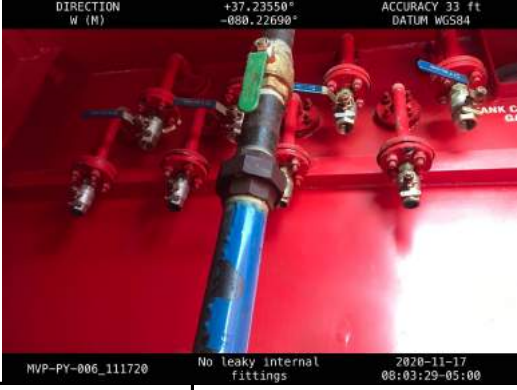
GPS Location	MVP-PY-006 See photo for gps data		GPS Location	MVP-PY-006 See photo for gps data	
Field Station#	+0		Field Station#	+0	
Pic 17 Desc.	Off Road Fuel unit condition of internal drip pan. Looking SW.		Pic 18 Desc.	Off Road Fuel unit no leaky internal fittings. Looking W.

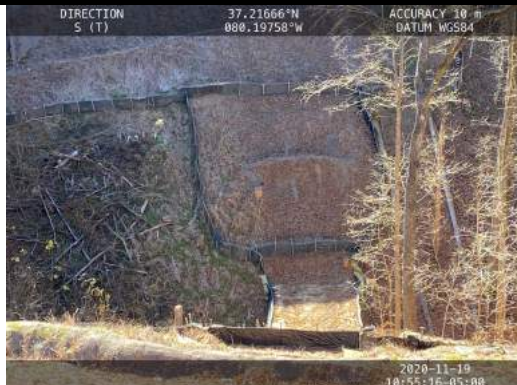
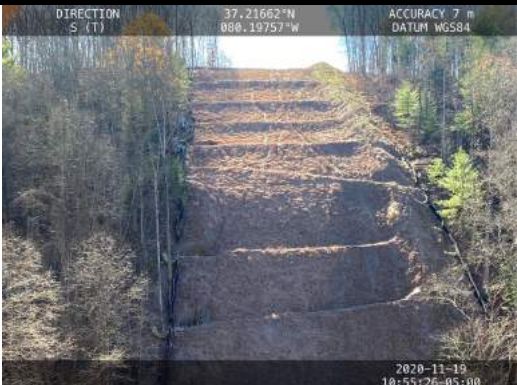
GPS Location	See photo		GPS Location	See photo	
Field Station#	12519+41		Field Station#	12523+00	
Pic 11 Desc.	Bridge, buffer zone, and ECDs in satisfactory condition at stream S-EF19.		Pic 12 Desc.	Slope on going away side of stream S-EF19 remains stable.
