Visual Site Inspection Report

Project Name	H-600 Pipeline Spread H	AFE	124300138	Spread	H-600 Pipeline Spread H
Contractor	Precision			Report #	17213
Inspector	Kaitlyn Ball			Date/Time	11/23/2020 1:40 PM
Permit #	TBD	Inspection Type	VA SWPP	Station Begin	12234+50
State	VA	Inspection Area	Partial	Station End	12443+75
County	Montgomery	Ground	Dry	Temperature (°F)	47.00
Municipality	N/A	Weather	Sunny	Rain Gauge (in)	0.10
				Rain Accumulation Time (days)	1.00

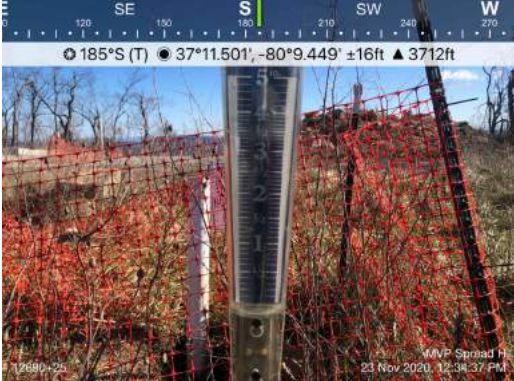
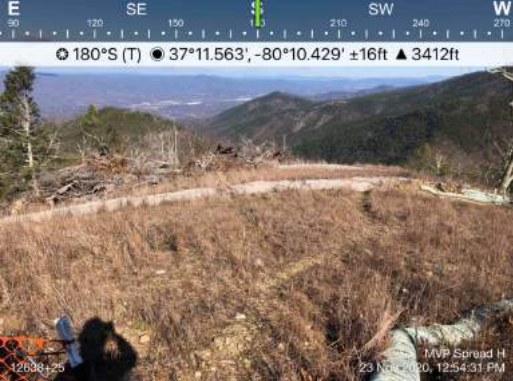
GPS Location	See Picture Watermark		GPS Location	See Picture Watermark	
Field Station#	12690+25		Field Station#	12638+25	
Pic 1 Desc.	Honeysuckle rain gauge showing 0.00" of rain.		Pic 2 Desc.	Beginning of inspection area. ROW remains well vegetated, and no maintenance is needed.

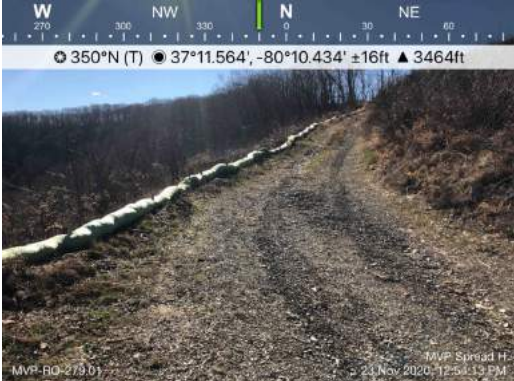
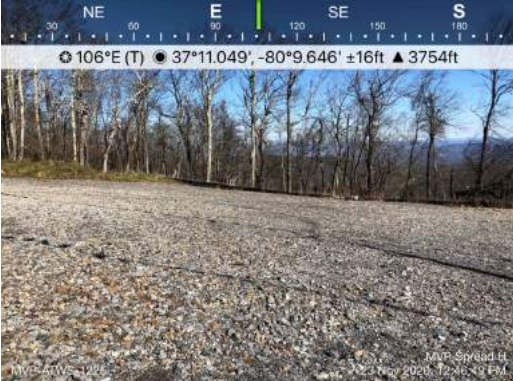
GPS Location	See Picture Watermark		GPS Location	See Picture Watermark	
Field Station#	12638+24		Field Station#	12701+00	
Pic 3 Desc.	MVP-RO-279.0.1 is in good condition and no maintenance is needed.		Pic 4 Desc.	MVP-ATWS-1225 is in good condition, and no materials are stored here currently.

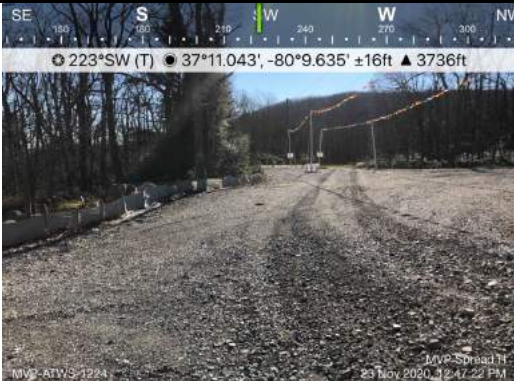
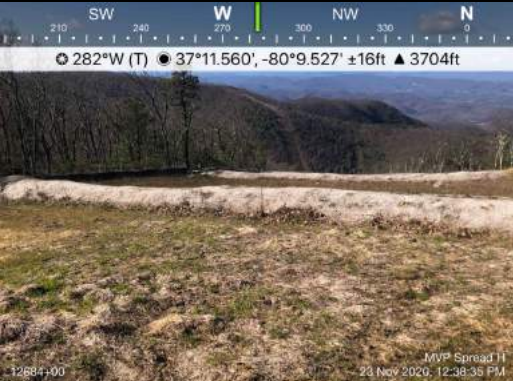
GPS Location	See Picture Watermark		GPS Location	See Picture Watermark	
Field Station#	12701+00		Field Station#	12684+00	
Pic 5 Desc.	MVP-ATWS-1224 is in good condition and no material is stored here.		Pic 6 Desc.	Waterbars remain well stabilized with erosion blankets and ROW remains vegetated.

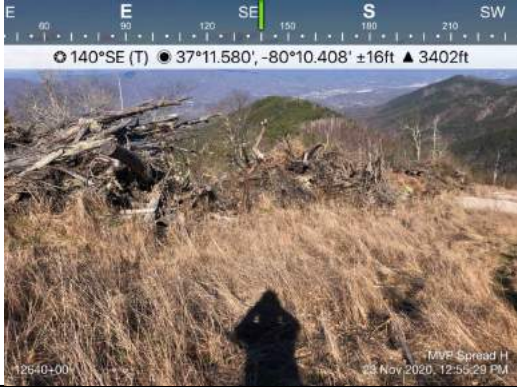
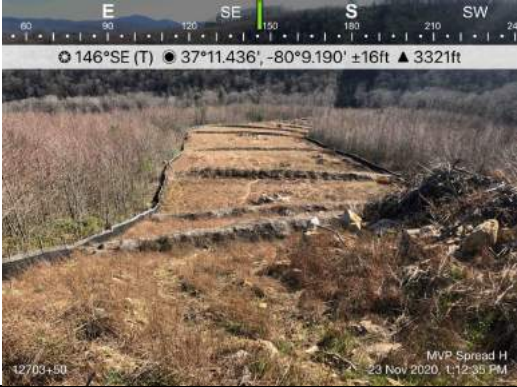
GPS Location	See Picture Watermark		GPS Location	See Picture Watermark	
Field Station#	12640+00		Field Station#	12703+50	
Pic 9 Desc.	Wood debris stockpiled within ROW. No maintenance is needed.		Pic 10 Desc.	ROW on GAS AR-280 is in good condition and remains well vegetated.

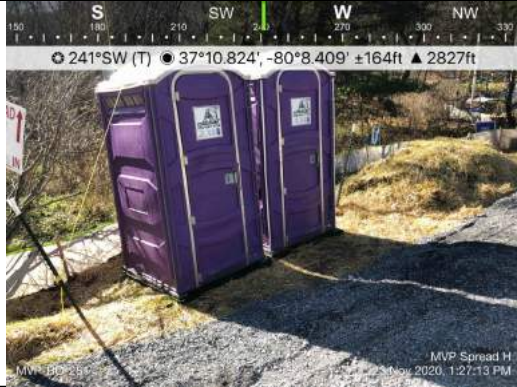
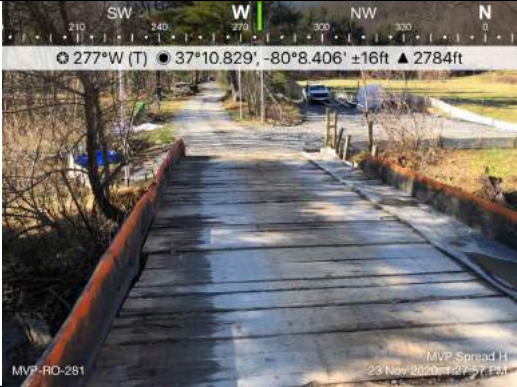
GPS Location	See Picture Watermark		GPS Location	See Picture Watermark	
Field Station#	12743+82		Field Station#	12743+82	
Pic 11 Desc.	Portable toilets within secondary containment along access road MVP-RO-81.		Pic 12 Desc.	Equipment/access bridge for MVP-RO-281 is in good condition and no maintenance is needed.

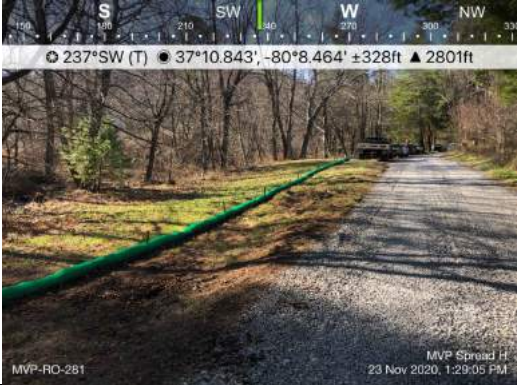
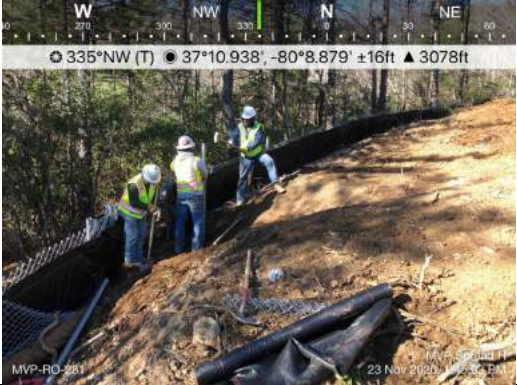
GPS Location	See Picture Watermark		GPS Location	See Picture Watermark	
Field Station#	12743+82		Field Station#	12743+82	
Pic 13 Desc.	Completed areas of access road MVP-RO-281 are stabilized and in good condition.		Pic 14 Desc.	Environmental crews along MVP-RO-281 installing rock conveyance channels along steep slopes.

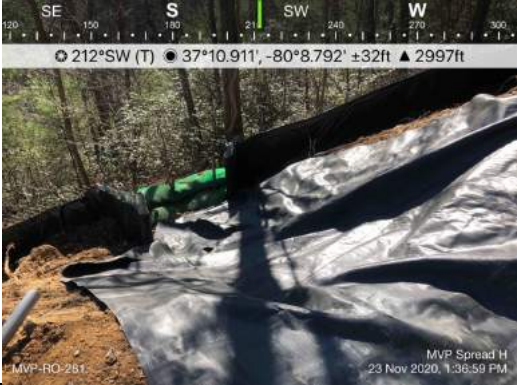
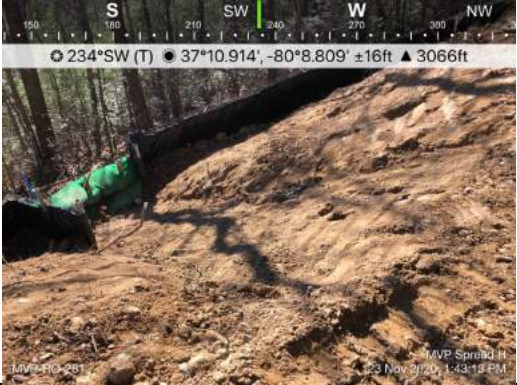
GPS Location	See Picture Watermark		GPS Location	See Picture Watermark	
Field Station#	12743+82		Field Station#	12743+82	
Pic 15 Desc.	Fabric underlayment for rock conveyance channels is being installed for channels along MVP-RO-281.		Pic 16 Desc.	Grading for rock conveyance channels along MVP-RO-281.

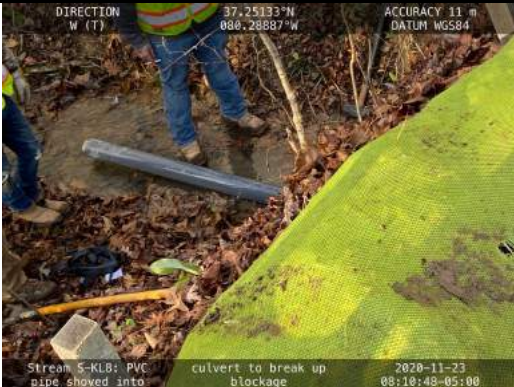
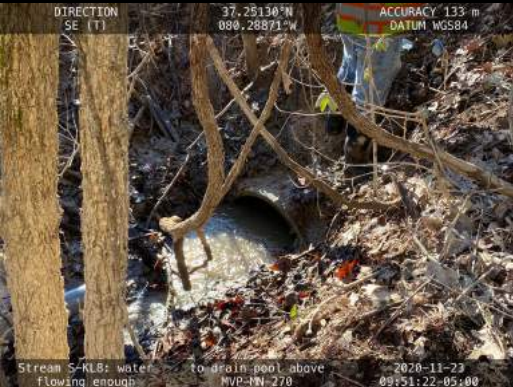
GPS Location	See photo		GPS Location	See photo	
Field Station#	12071+80		Field Station#	12071+80	
Pic 1 Desc.	PVC pipe was used to break up a clogged culvert under access road MVP-MN-270.		Pic 2 Desc.	Water is now flowing enough that it is no longer pooling on the upstream side of the culvert under access road MVP-MN-270.

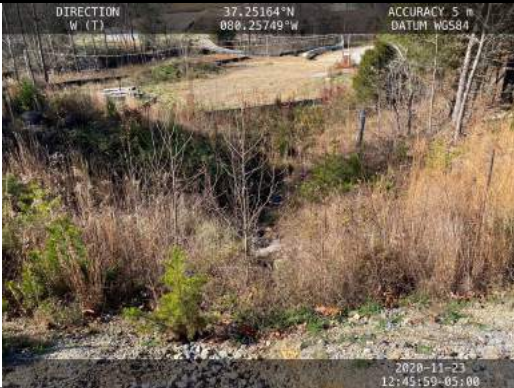
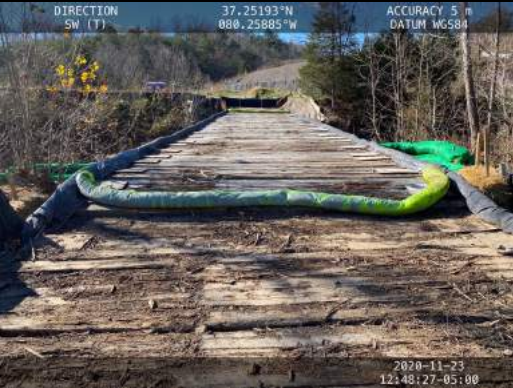
GPS Location	See photo		GPS Location	See photo	
Field Station#	12197+37		Field Station#	12192+50	
Pic 5 Desc.	Stream S-0011, facing west, downstream from railroad tracks		Pic 6 Desc.	Bridge and ECDs over stream S-C21, Bradshaw Creek, remain in satisfactory condition.

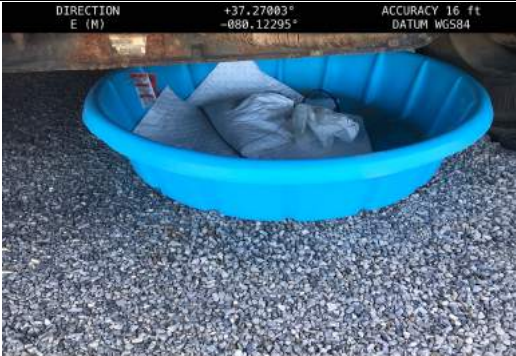
<p>DIRECTION E (M) +37.27003° -080.12295° ACCURACY 16 ft DATUM WGS84</p> <p>MVP-LY-049_112320 Containment under stored vehicle 2020-11-23 08:56:16-05:00</p>			
GPS Location	MVP-LY-049 See photo for gps data		GPS Location	MVP-LY-049 See photo for gps data	
Field Station#	+0		Field Station#	+0	
Pic 17 Desc.	Condition of containment under stored vehicle. Looking SE.		Pic 18 Desc.	Condition of containment under stored vehicle. Looking E.

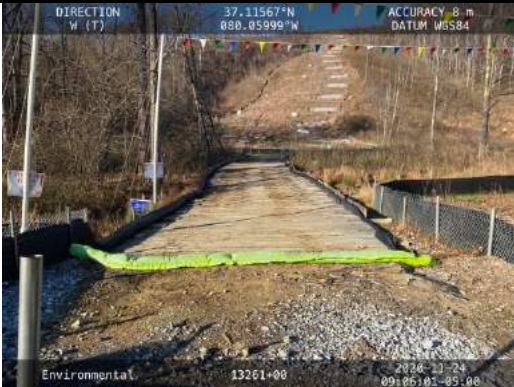
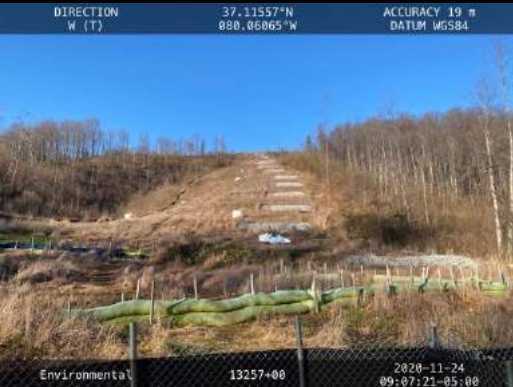
GPS Location	See Photo for GPS coordinates		GPS Location	See photo for GPS coordinates	
Field Station#	13261+00		Field Station#	13257+00	
Pic 1 Desc.	Bridge crossing feature S-II4 in good condition.		Pic 2 Desc.	Well vegetative cover across the LOD.

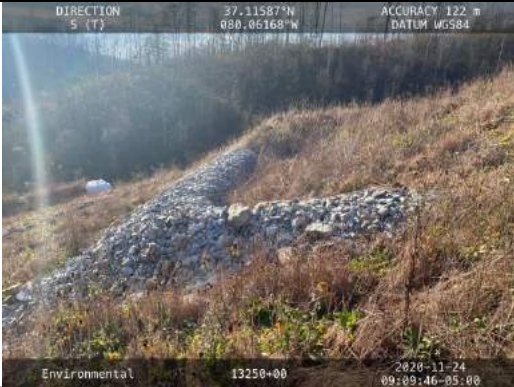
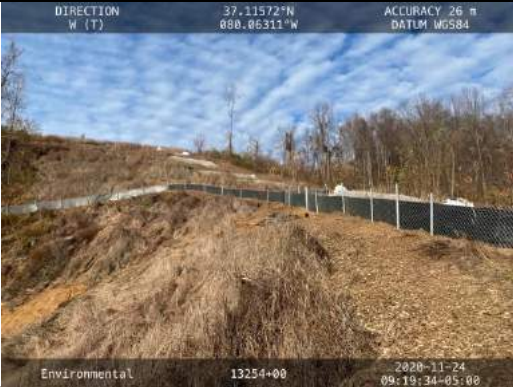
GPS Location	See photo for GPS coordinates		GPS Location	See photo for GPS coordinates	
Field Station#	13250+00		Field Station#	13254+00	
Pic 3 Desc.	Rock Weir within a well vegetated ROW.		Pic 4 Desc.	Silt fence installed above slip to direct water away from the disturbed area.

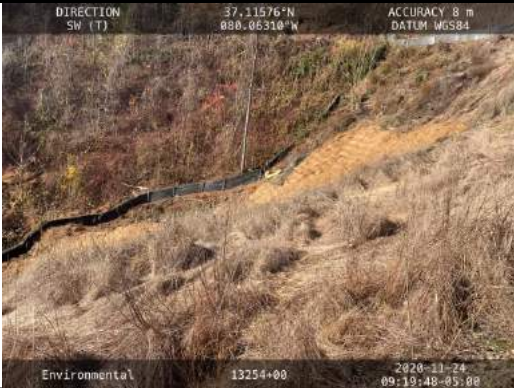
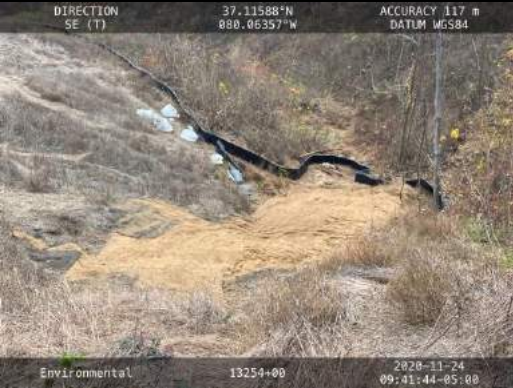
GPS Location	See photo for GPS coordinates		GPS Location	See photo for GPS coordinates	
Field Station#	13254+00		Field Station#	13254+00	
Pic 5 Desc.	Silt fence installed along the perimeter of the LOD to prevent the slip from exiting the LOD.		Pic 6 Desc.	Erosion control blanket covering the disturbed ground cause by the slip.

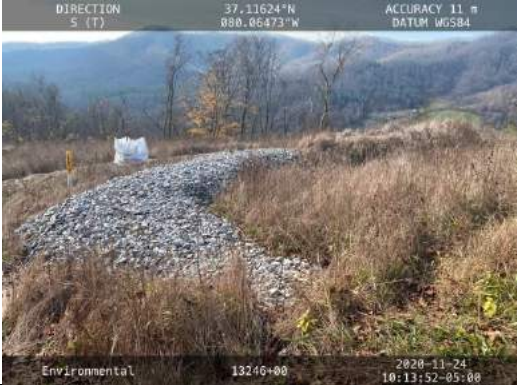
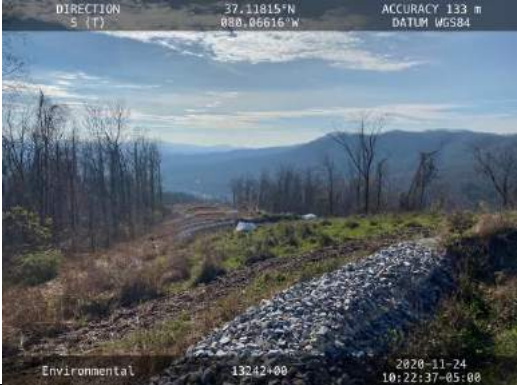
GPS Location	See photo for GPS coordinates		GPS Location	See photo for GPS coordinates	
Field Station#	13246+00		Field Station#	13242+00	
Pic 7 Desc.	Well vegetative cover across LOD.		Pic 8 Desc.	Well vegetative cover across LOD.

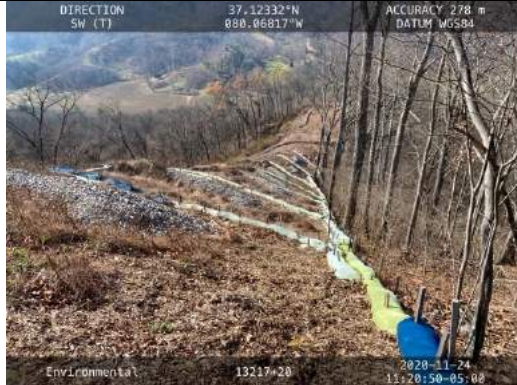
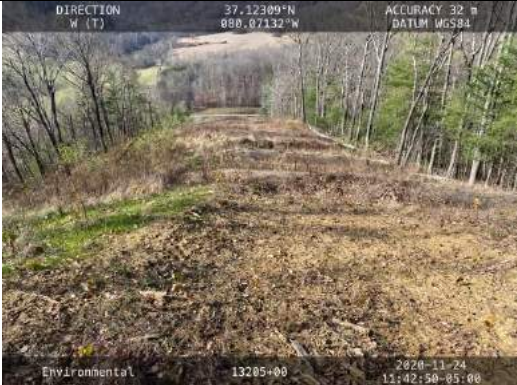
GPS Location	See photo for GPS coordinates		GPS Location	See photo for GPS coordinates	
Field Station#	13217+20		Field Station#	13205+00	
Pic 11 Desc.	CFS perimeter controls in place and in good working conditions.		Pic 12 Desc.	Well vegetative cover across LOD.

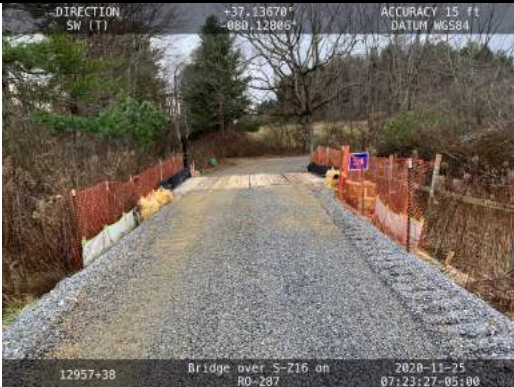
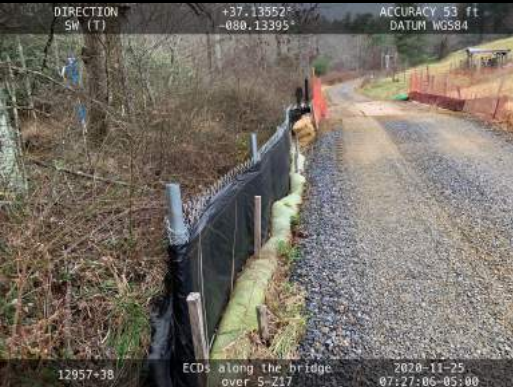
GPS Location	See photo for gps location data.		GPS Location	See photo for gps location data.	
Field Station#	12957+38		Field Station#	12957+38	
Pic 1 Desc.	Photo shows the bridge over stream S-Z16 RO-287.		Pic 2 Desc.	Photo shows the ECDs along access road RO-287 at S-Z17.

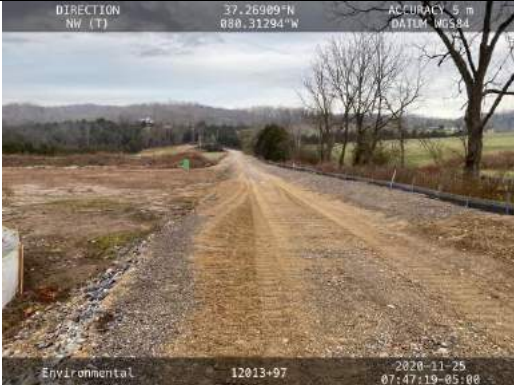
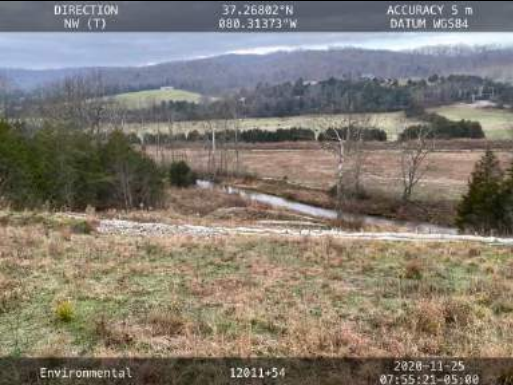
GPS Location	See photo for GPS coordinates		GPS Location	See photo for GPS coordinates	
Field Station#	12013+97		Field Station#	12011+54	
Pic 1 Desc.	Access Road 268.01 in acceptable condition.		Pic 2 Desc.	Well vegetated permanent ROW on the GAS of S-G36 ROW crossing.

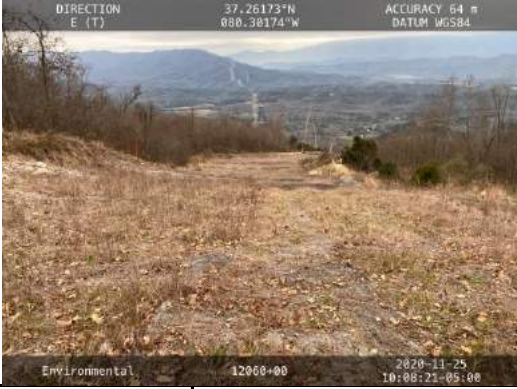
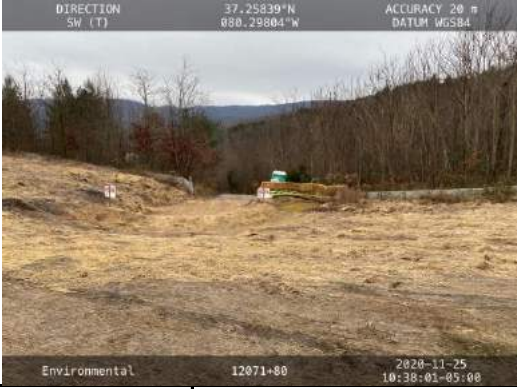
GPS Location	See photo for GPS coordinates		GPS Location	See photo for GPS coordinates	
Field Station#	12060+00		Field Station#	12071+80	
Pic 7 Desc.	Well vegetated coverage across LOD.		Pic 8 Desc.	Access Road 270 ROW entrance stabilized and in good condition.

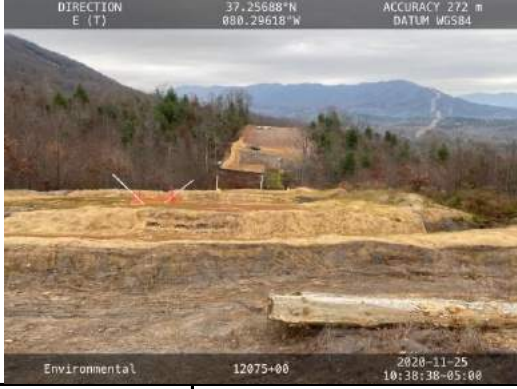
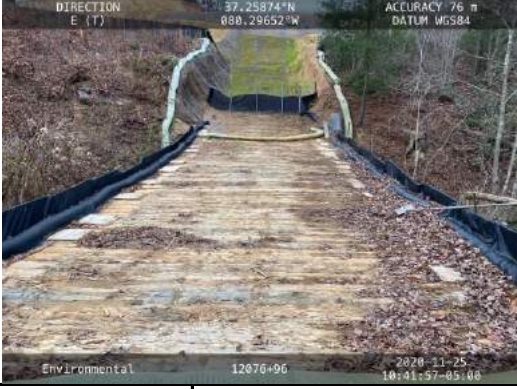
GPS Location	See photo for GPS coordinates		GPS Location	See photo for GPS coordinates	
Field Station#	12075+00		Field Station#	12076+96	
Pic 9 Desc.	Well covered and stabilized LOD.		Pic 10 Desc.	Bridge and ECDs at S-MM15 are in good condition.

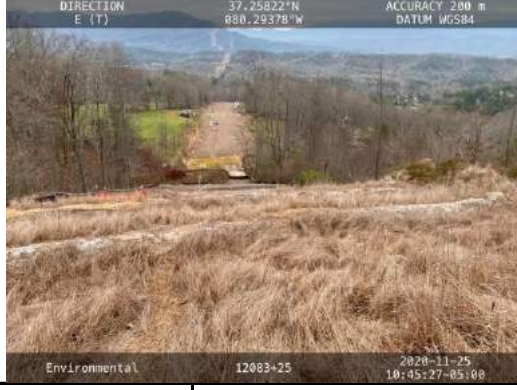
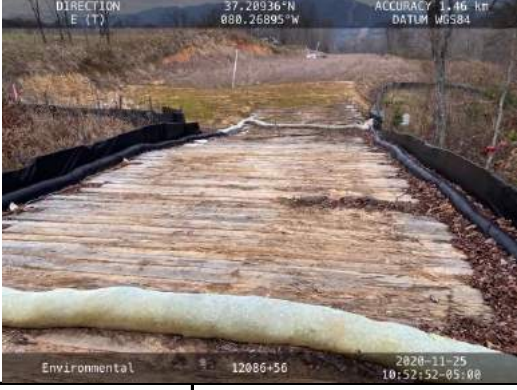
GPS Location	See photo for GPS coordinates		GPS Location	See photo for GPS coordinates	
Field Station#	12083+25		Field Station#	12086+56	
Pic 11 Desc.	Well vegetated coverage across LOD		Pic 12 Desc.	Bridge and ECDs at S-MM14 are in acceptable condition

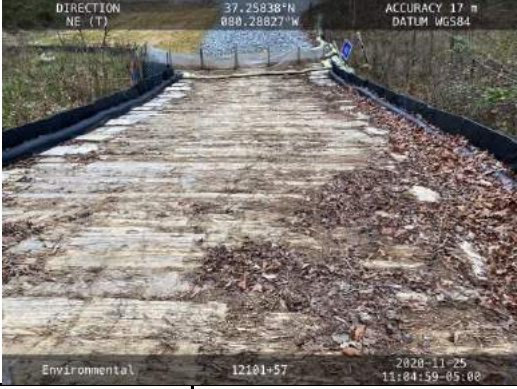
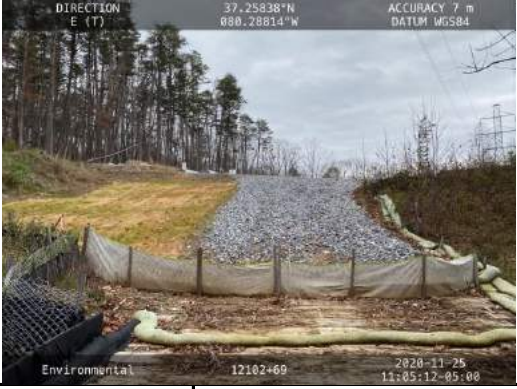
GPS Location	See photo for GPS coordinates	GPS Location	See photo for GPS coordinates		
Field Station#	12101+57	Field Station#	12102+69		
Pic 15 Desc.	Bridge and ECDs at S-MM11 are in acceptable condition	Pic 16 Desc.	RCE in acceptable condition and functional		
Insert image here		Insert image here			
GPS Location		GPS Location			
Field Station#		Field Station#			
Pic 17 Desc.		Pic 18 Desc.

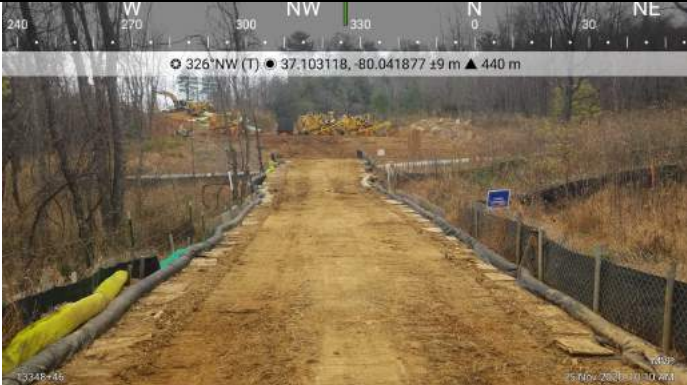
GPS Location	See Above		GPS Location	See Above	
Field Station#	13340+00		Field Station#	13348+46	
Pic 7 Desc.	Tie-in work. ECDs are functional. Crew will repair any nearby temp. waterbars and replace ECDs at end of day.		Pic 8 Desc.	Waterbody S-RR08. ECDs are functional. Crew will repair any nearby temp. waterbars and replace compost sock at end of day.

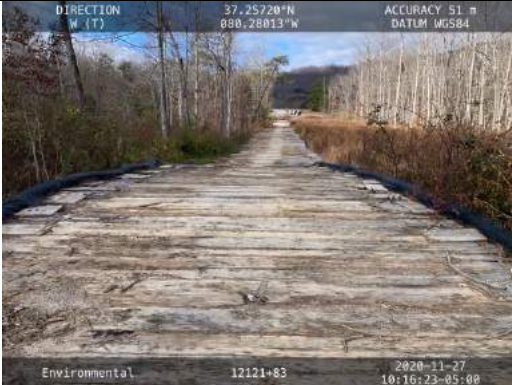
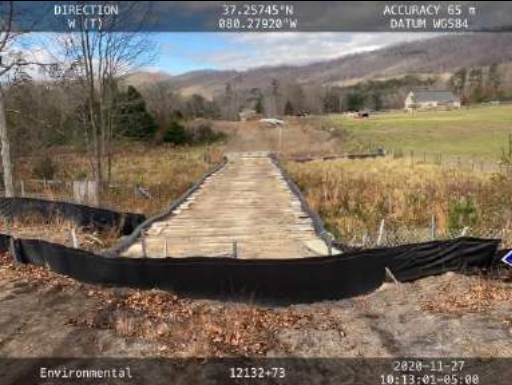
GPS Location	See photo for GPS coordinates		GPS Location	See photo for GPS coordinates	
Field Station#	12121+83		Field Station#	12132+73	
Pic 1 Desc.	Equipment bridge that crosses multiple wetland and stream crossings in good condition.		Pic 2 Desc.	S-C29 bridge and ECDs in good condition.

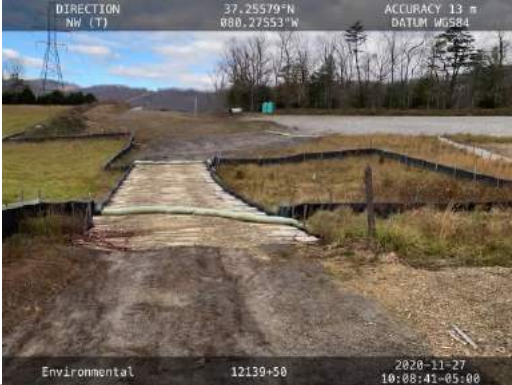
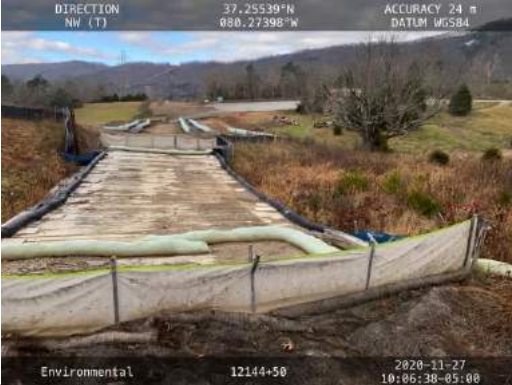
GPS Location	See photo for GPS coordinates		GPS Location	See photo for GPS coordinates	
Field Station#	12139+50		Field Station#	12144+50	
Pic 3 Desc.	W-C6 ECDs are in good working condition.		Pic 4 Desc.	Bridge and ECDs at wetland W-C5 in good condition.

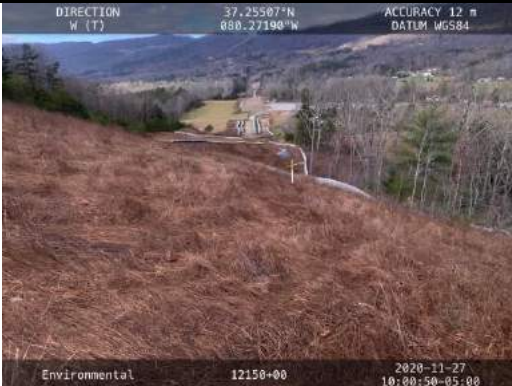
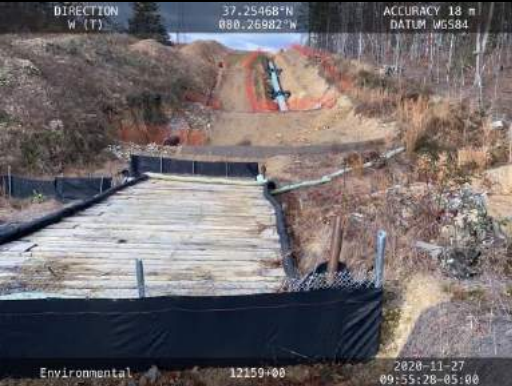
GPS Location	See photo for GPS coordinates		GPS Location	See photo for GPS coordinates	
Field Station#	12150+00		Field Station#	12159+00	
Pic 5 Desc.	Well vegetated cover across LOD.		Pic 6 Desc.	Well stabilized ROW and clear water crossing with ECDs in place and in good condition.
