Visual Site Inspection Report

Project Name	H-600 Pipeline Spread H	AFE	124300138	Spread	H-600 Pipeline Spread H
Contractor	Precision			Report #	17462
Inspector	John Brcic			Date/Time	11/30/2020 2:45 PM
Permit #	TBD	Inspection Type	VA SWPP	Station Begin	12443+75
State	VA	Inspection Area	Partial	Station End	12544+06
County	Montgomery	Ground	Wet	Temperature (°F)	46.00
Municipality	N/A	Weather	Light Rain	Rain Gauge (in)	0.90
				Rain Accumulation Time (days)	2.00

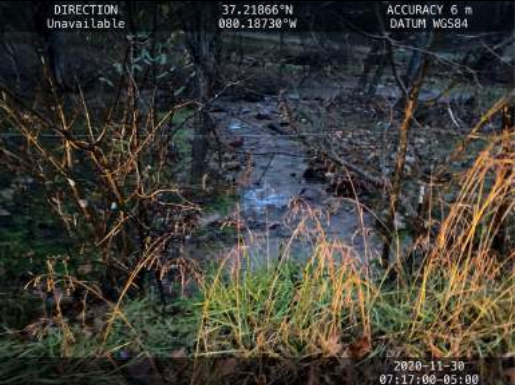
GPS Location	See photo		GPS Location	See photo	
Field Station#	12544+06		Field Station#	12544+06	
Pic 1 Desc.	0.9 inches of precipitation at Yellow Finch Road produced by an overnight rain event.		Pic 2 Desc.	Stream S-KL32, facing northwest, downstream from Yellow Finch Road

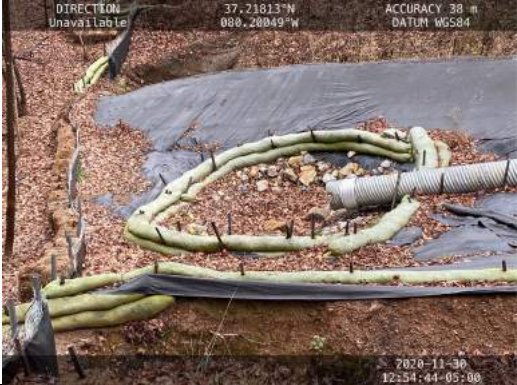
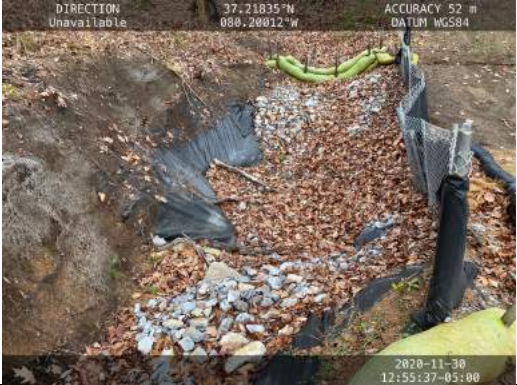
GPS Location	See photo		GPS Location	See photo	
Field Station#	12503+70		Field Station#	12503+70	
Pic 13 Desc.	Clean water diversion pipe outlet plunge pool in satisfactory condition.		Pic 14 Desc.	Clean water diversion pipe inlet is in good condition, free of sediment.

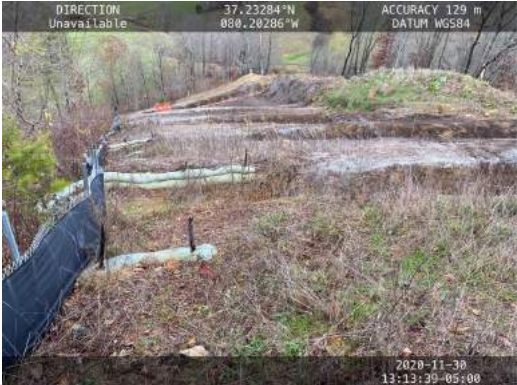
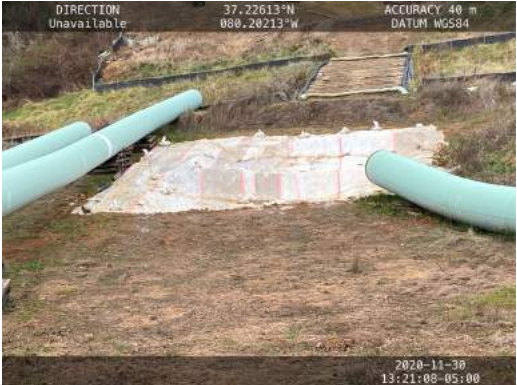
GPS Location	See photo		GPS Location	See photo	
Field Station#	12486+00		Field Station#	12482+00	
Pic 15 Desc.	Slope between "pig parts" excavation site and MLV-28 remains stable.		Pic 16 Desc.	Plastic sheeting over the site of the "pig parts" excavation is intact and secure.

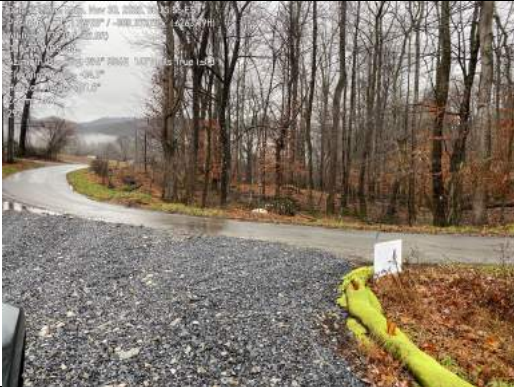
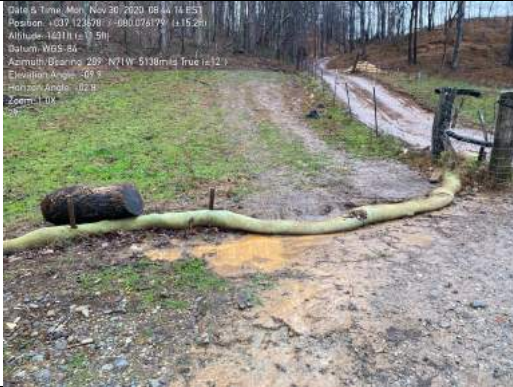
GPS Location	See photo for coordinates.		GPS Location	See photo for coordinates.	
Field Station#	13148+00		Field Station#	13190+00	
Pic 1 Desc.	MVP-FR-292, RCE in acceptable condition, no sediment on road.		Pic 2 Desc.	Damaged CFS MVL-AR-29, added as punch list item.

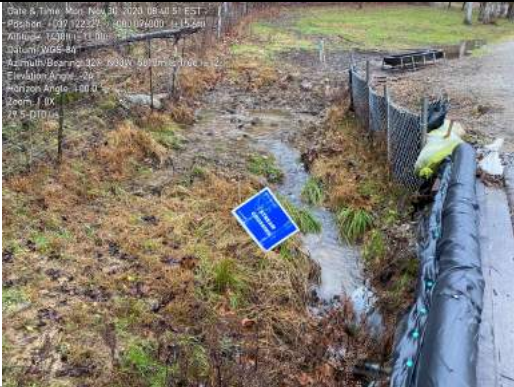
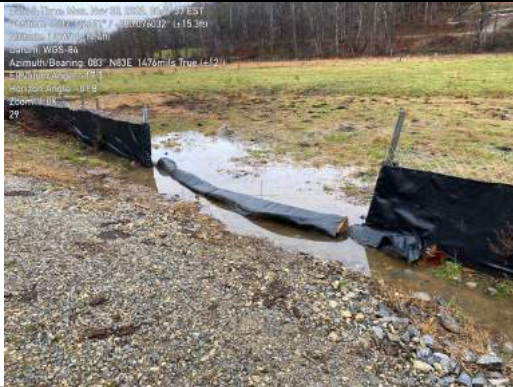
GPS Location	See photo for coordinates.		GPS Location	See photo for coordinates.	
Field Station#	13190+00		Field Station#	13190+00	
Pic 3 Desc.	S-D10, upstream, typical cattle disturbance to stream banks.		Pic 4 Desc.	Damaged triangular diversion dike, added as punch list item for repair.

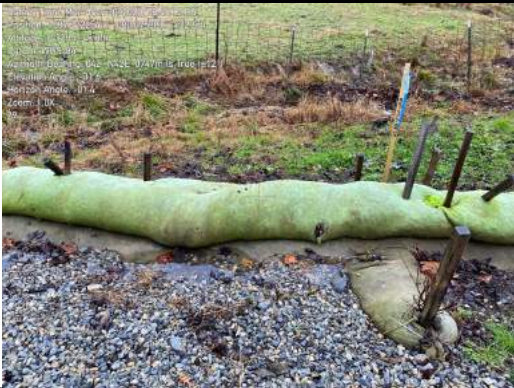
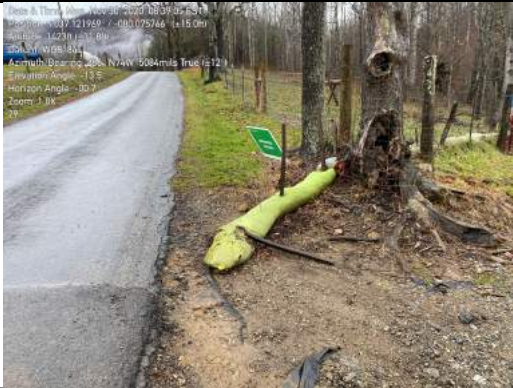
GPS Location	See photo for coordinates.		GPS Location	See photo for coordinates.	
Field Station#	13190+00		Field Station#	13190+00	
Pic 5 Desc.	Damaged CFS MVL-AR-29, added as punch list item.		Pic 6 Desc.	Damaged CFS MVL-AR-29, added as punch list item.

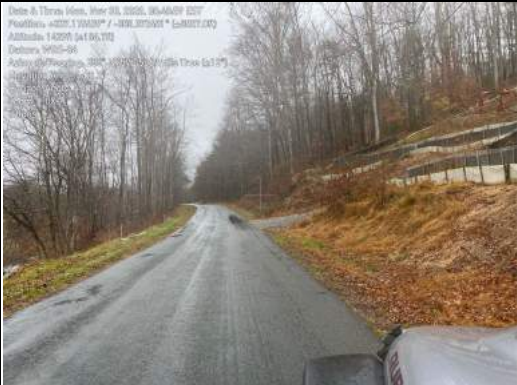
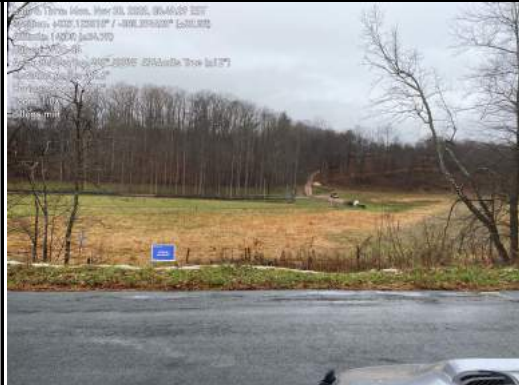
GPS Location	See photo for coordinates.		GPS Location	See photo for coordinates.	
Field Station#	13197+50		Field Station#	13197+50	
Pic 7 Desc.	Dillons Mill, road clean of sediment.		Pic 8 Desc.	Dillons Mill, CIS, no ground disturbance on ROW.

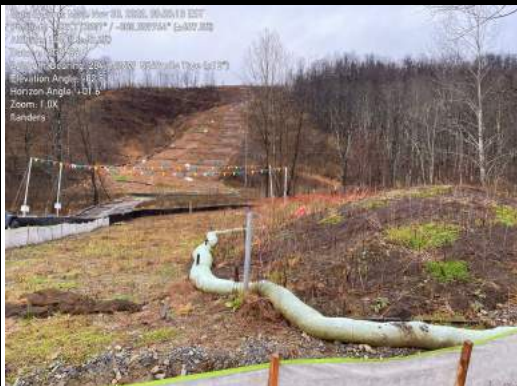
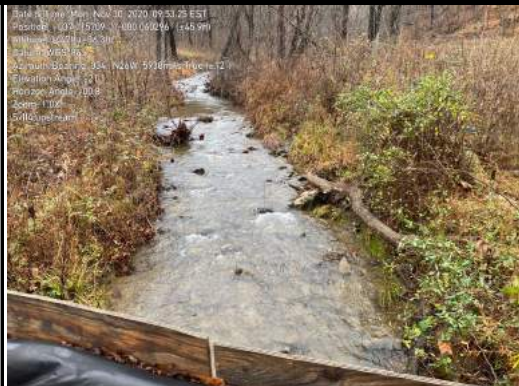
GPS Location	See photo for coordinates.		GPS Location	See photo for coordinates.	
Field Station#	1262+50		Field Station#	13260+60	
Pic 9 Desc.	ROW stable, perimeter ECDs functioning acceptably.		Pic 10 Desc.	S-II4, upstream, no changes noted, slight turbidity noted.

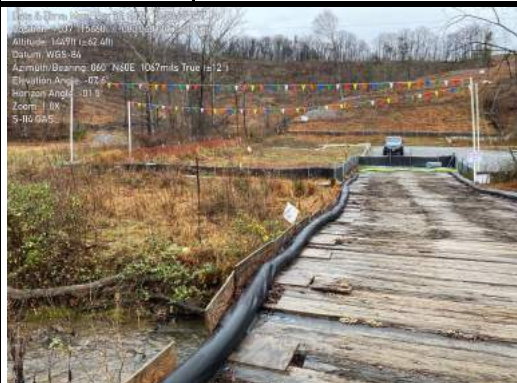
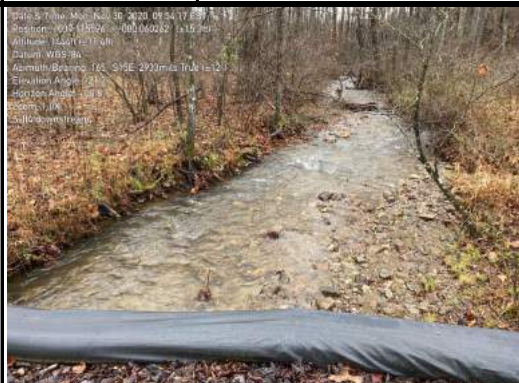
GPS Location	See photo for coordinates.		GPS Location	See photo for coordinates.	
Field Station#	13160+60		Field Station#	13260+60	
Pic 11 Desc.	GAS S-II4, bridge on acceptable condition.		Pic 12 Desc.	S-II4, downstream, no environmental issues noted.

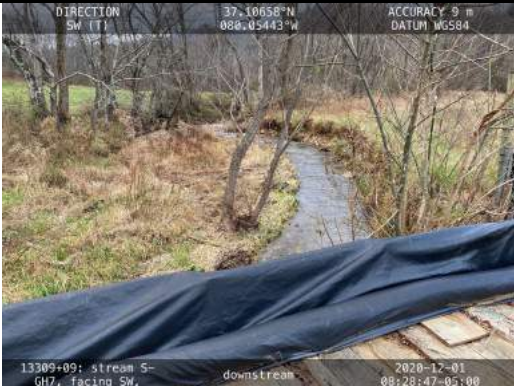
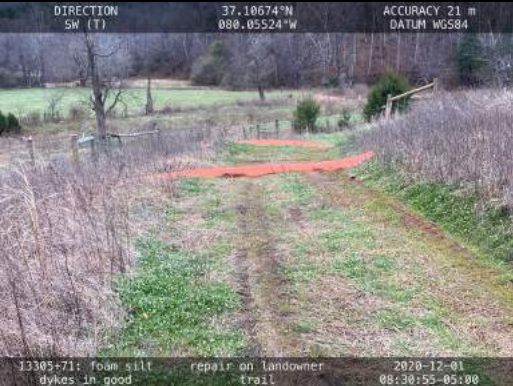
GPS Location	See photo		GPS Location	See photo	
Field Station#	13109+09		Field Station#	13305+71	
Pic 5 Desc.	Stream S-GH7, facing southwest, downstream		Pic 6 Desc.	Foam silt dykes on the landowner road are in good repair.

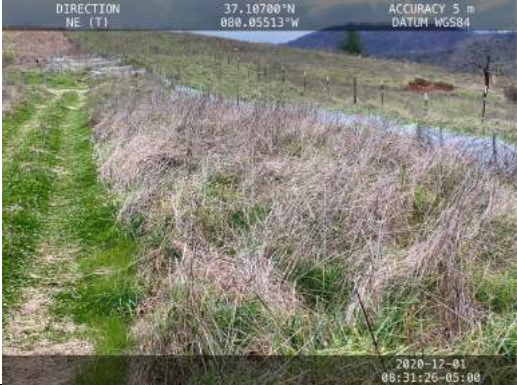
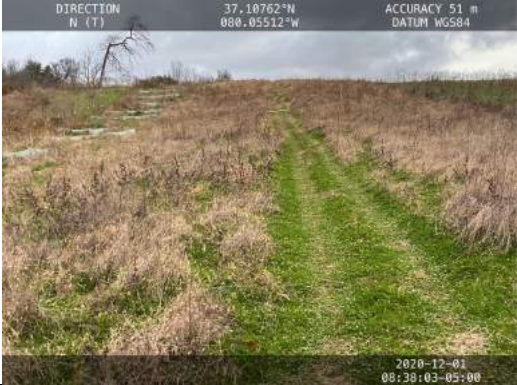
GPS Location	See photo		GPS Location	See photo	
Field Station#	13103+00		Field Station#	13101+00	
Pic 7 Desc.	P1 silt fence is in satisfactory condition.		Pic 8 Desc.	ROW stable

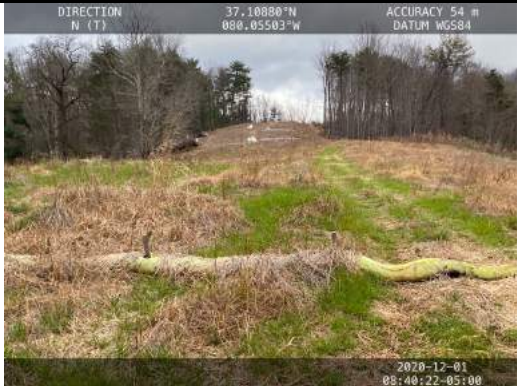
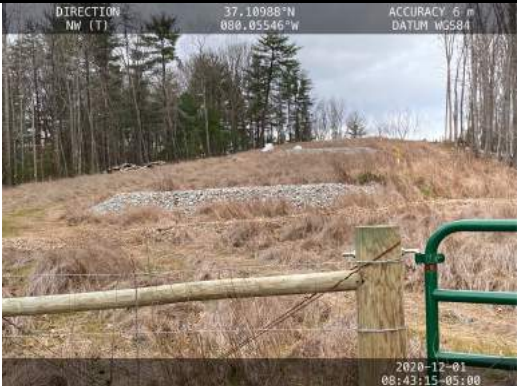
GPS Location	See photo		GPS Location	See photo	
Field Station#	13099+00		Field Station#	13095+00	
Pic 9 Desc.	ROW stable		Pic 10 Desc.	ROW stable

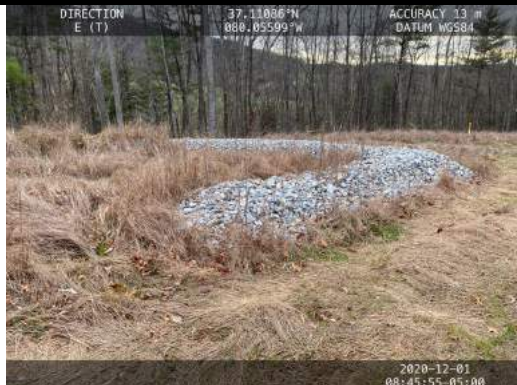
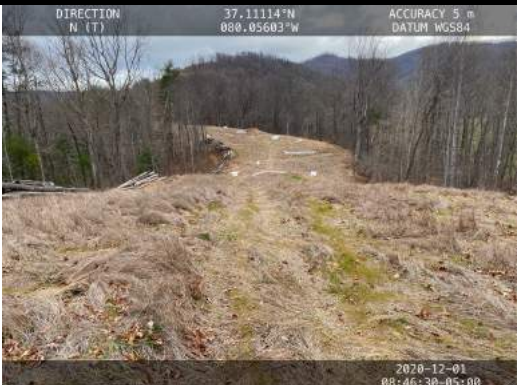
GPS Location	See photo		GPS Location	See photo	
Field Station#	13091+00		Field Station#	13090+00	
Pic 11 Desc.	Rocks weirs in good condition		Pic 12 Desc.	ROW stable

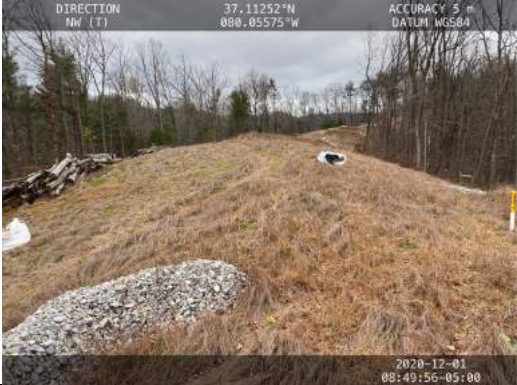
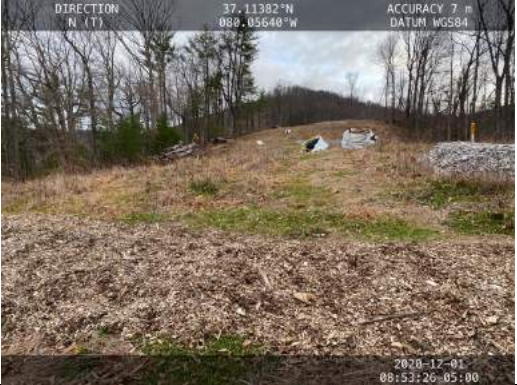
GPS Location	See photo		GPS Location	See photo	
Field Station#	13085+00		Field Station#	13080+00	
Pic 13 Desc.	ROW stable		Pic 14 Desc.	ROW stable

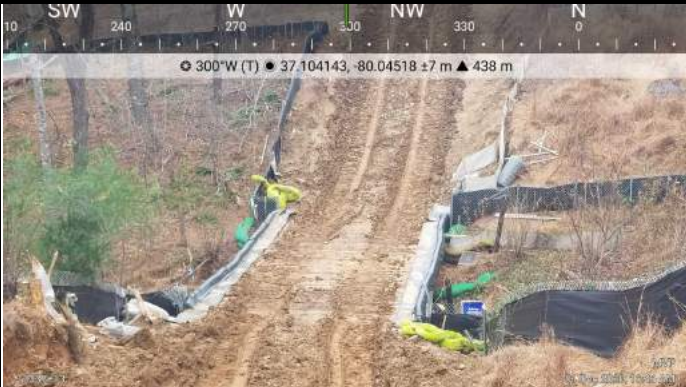
GPS Location	See Above		GPS Location	See Above	
Field Station#	13337+13		Field Station#	13341+50	
Pic 7 Desc.	Waterbody S-GH9. ECDs are functional. Crew will repair any nearby temp. waterbars and replace ECDs at end of day.		Pic 8 Desc.	Punclist item from 11/30 completed. Compost Filter sock has been cleaned out.

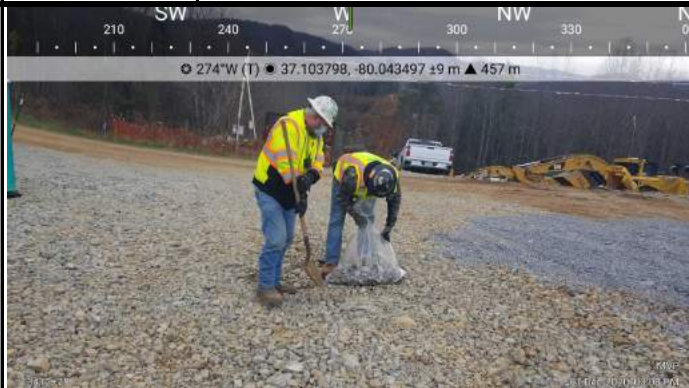
GPS Location	See Above		GPS Location	See Above	
Field Station#	13342+75		Field Station#	13342+75	
Pic 9 Desc.	Punclist item from 11/30 completed. Rocked Construction Entrance has been repaired.		Pic 10 Desc.	A small spill (1 cup motor oil) has been cleaned up near station 13342+75.

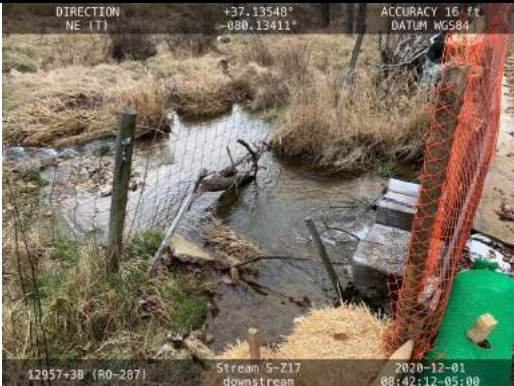
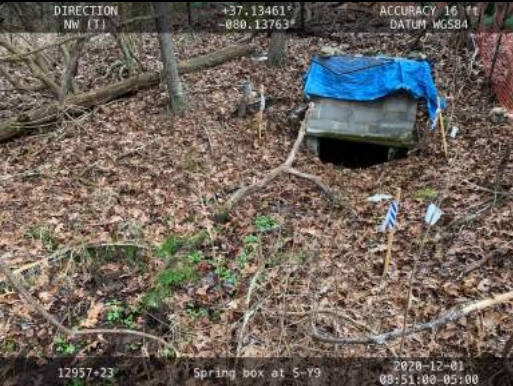
GPS Location	See photo for gps location data.		GPS Location	See photo for gps location data.	
Field Station#	12957+38		Field Station#	12957+23	
Pic 5 Desc.	Photo shows stream S-Z17 downstream from the bridge.		Pic 6 Desc.	Photo shows the the spring box on stream S-Y9. No impacts were observed.

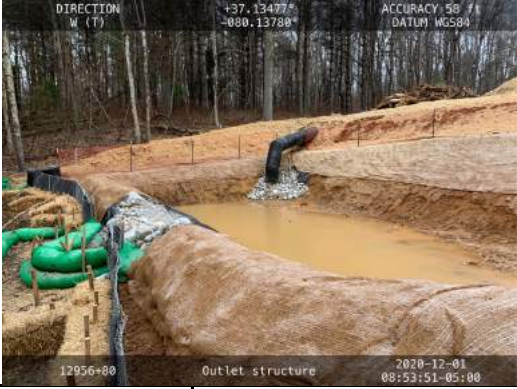
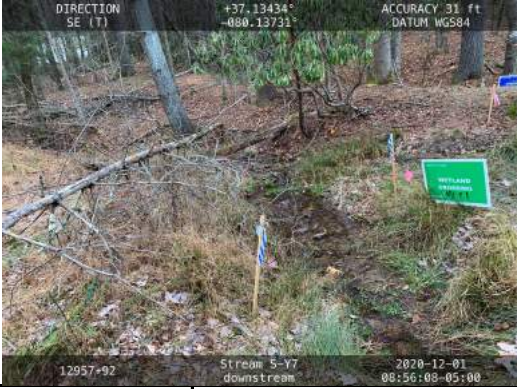
GPS Location	See photo for gps location data.		GPS Location	See photo for gps location data.	
Field Station#	12956+80		Field Station#	12957+92	
Pic 7 Desc.	Photo shows the sump pit outlet structure.		Pic 8 Desc.	Photo shows stream S-Y7 downstream from the ROW. No impacts were observed.

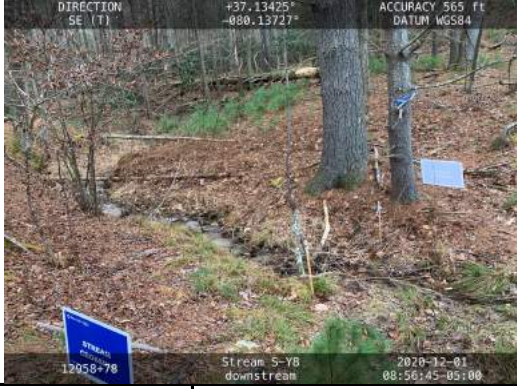
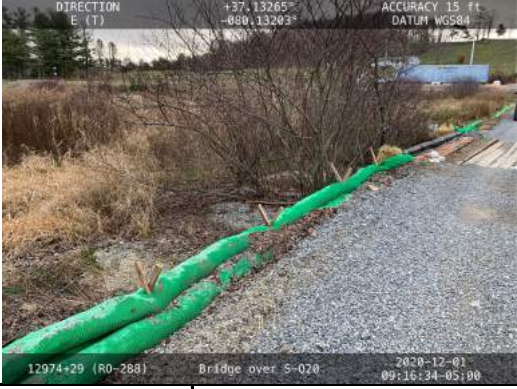
GPS Location	See photo for gps location data.		GPS Location	See photo for gps location data.	
Field Station#	12958+78		Field Station#	12974+29	
Pic 9 Desc.	Photo shows stream S-Y8 downstream from the ROW. No impacts were observed.		Pic 10 Desc.	Photo shows the bridge over stream S-Q20. Note the off-ROW crushed stone. Awaiting landowner permission to retrieve stone.

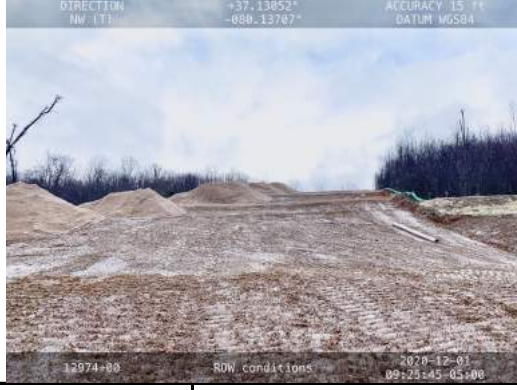
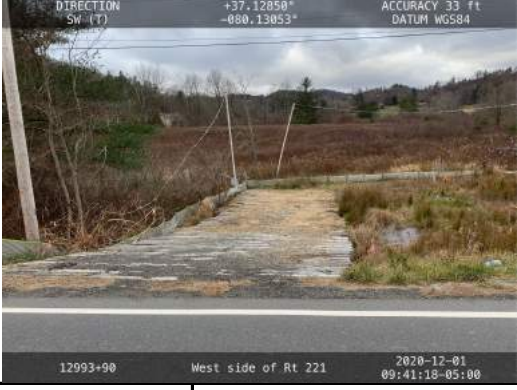
GPS Location	See photo for gps location data.		GPS Location	See photo for gps location data.	
Field Station#	12974+00		Field Station#	12993+90	
Pic 11 Desc.	Photo shows the ROW condition from about 12971+00 to 12974+00. No issues were observed.		Pic 12 Desc.	Photo shows the ROW condition n the west side of Rt 221.

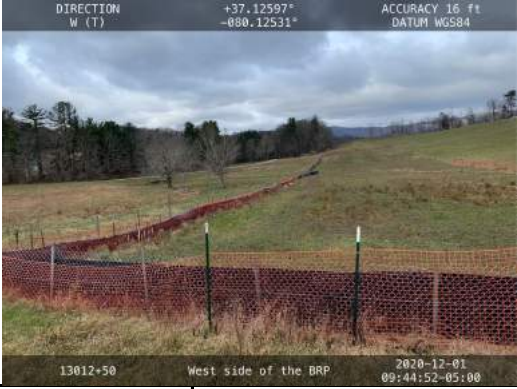
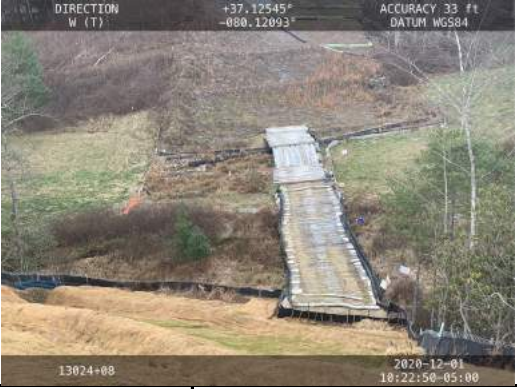
GPS Location	See photo for gps location data.		GPS Location	See photo for gps location data.	
Field Station#	13012+50		Field Station#	13024+08	
Pic 13 Desc.	Photo shows the ROW condition from on the west side of the Blue Ridge Parkway.		Pic 14 Desc.	Photo shows the bridge over stream streams S-G24 and S-G25. No issues were observed.

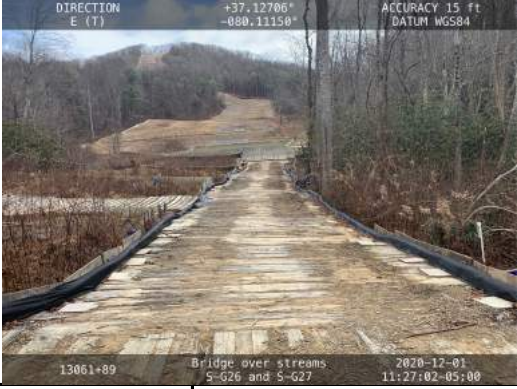
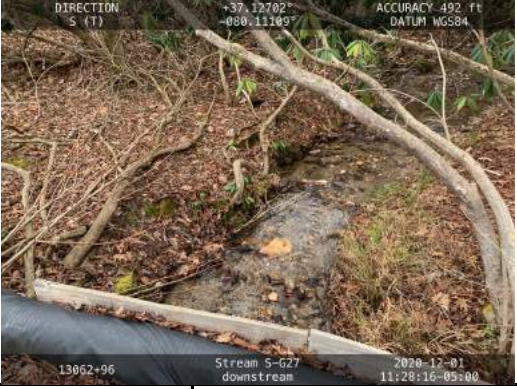
GPS Location	See photo for gps location data.		GPS Location	See photo for gps location data.	
Field Station#	13061+89		Field Station#	13062+96	
Pic 15 Desc.	Photo shows the bridge over streams S-G26 and S-G27. No issues were observed.		Pic 16 Desc.	Photo shows stream S-G27 downstream from the bridge.

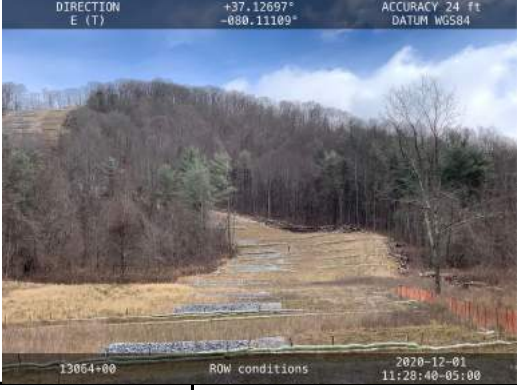
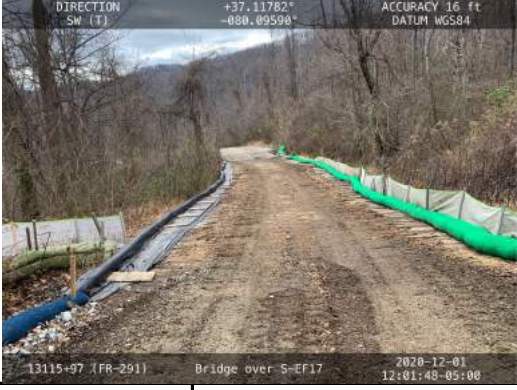
GPS Location	See photo for gps location data.		GPS Location	See photo for gps location data.	
Field Station#	13064+00		Field Station#	13115+97	
Pic 17 Desc.	Photo shows the ROW condition from about 13064+00 to 13070+00.		Pic 18 Desc.	Photo shows the bridge bridge S-EF17 on access road FR-291. No environmental issues were observed.

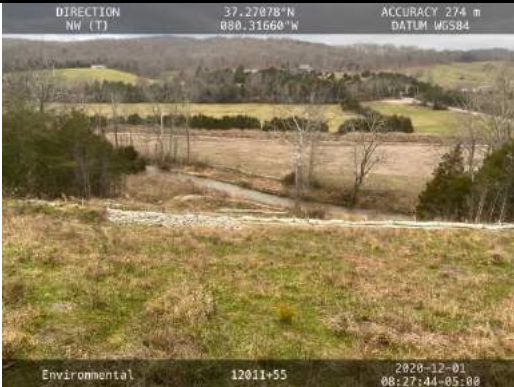
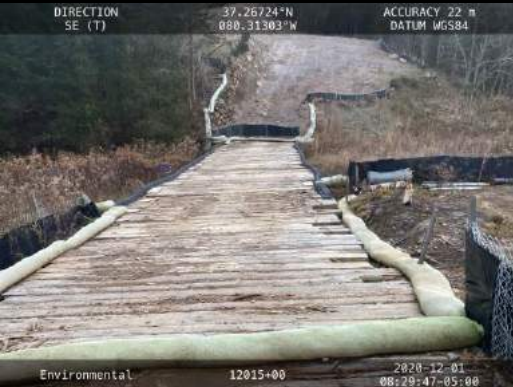
GPS Location	See photo for GPS coordinates		GPS Location	See photo for GPS coordinates	
Field Station#	12011+55		Field Station#	12015+00	
Pic 1 Desc.	Stabilized ROW on the GAS of S-G36.		Pic 2 Desc.	Bridge and ECDs at S-G38 in acceptable condition

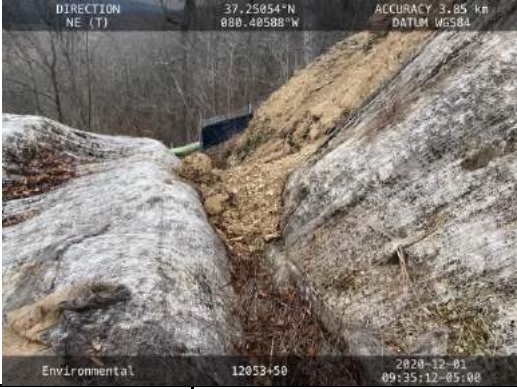
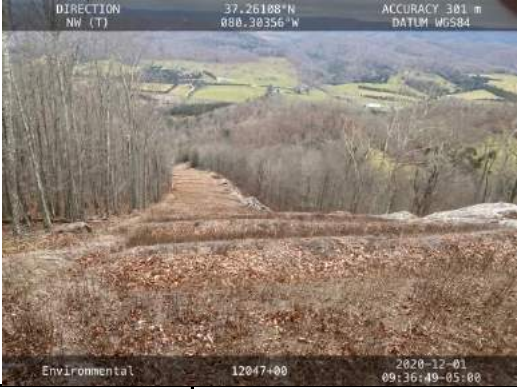
GPS Location	See photo for GPS coordinates		GPS Location	See photo for GPS coordinates	
Field Station#	12053+50		Field Station#	12047+00	
Pic 7 Desc.	The spoil pile has sloughed off and is blocking the flow path of the waterbar.		Pic 8 Desc.	Well vegetative cover across LOD.

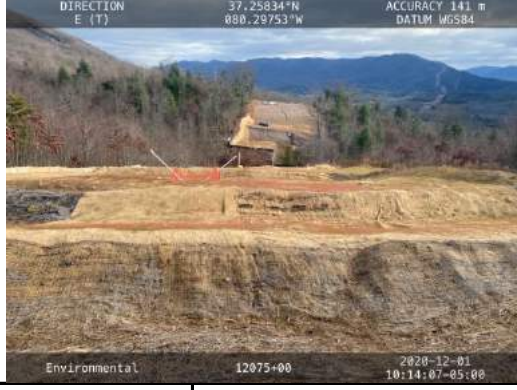
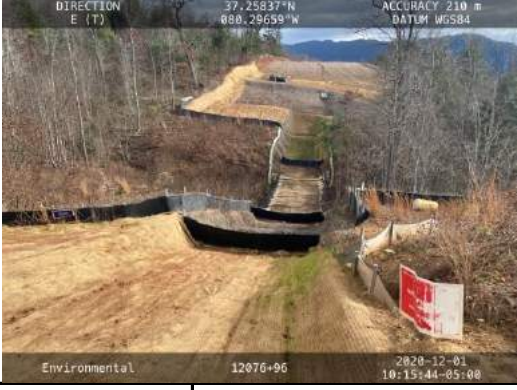
GPS Location	See photo for GPS coordinates		GPS Location	See photo for GPS coordinates	
Field Station#	12075+00		Field Station#	12076+96	
Pic 11 Desc.	Well vegetative cover across LOD		Pic 12 Desc.	Bridge and ECDs at S-MM15 ins acceptable conditions.

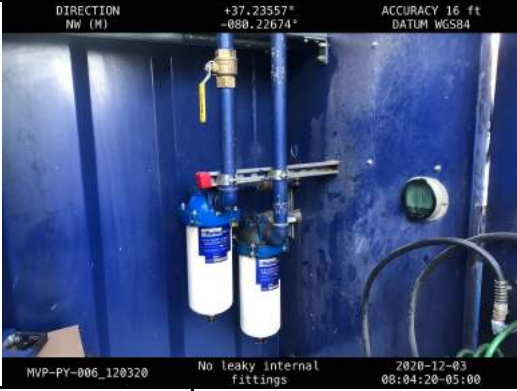
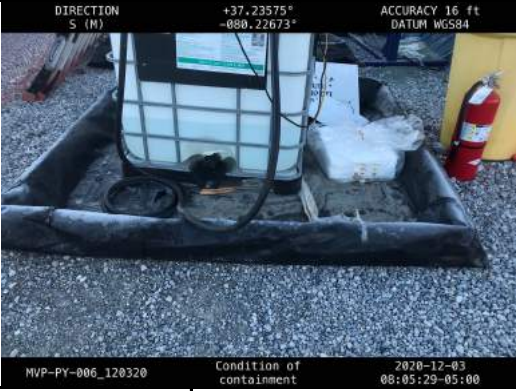
GPS Location	MVP-PY-006 See photo for gps data	GPS Location	MVP-PY-006 See photo for gps data		
Field Station#	+0	Field Station#	+0		
Pic 7 Desc.	Blue Bulk Fuel tanks no leaky internal fittings. Looking NW.	Pic 8 Desc.	Condition of containment under DEF tank. Looking S.

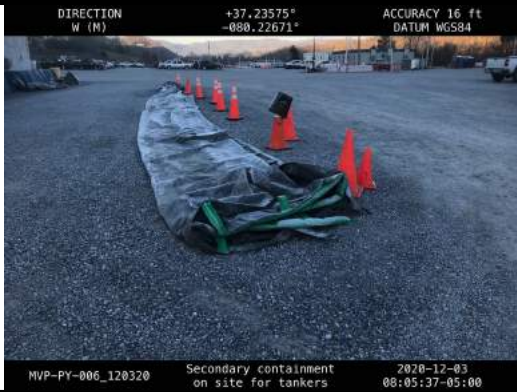
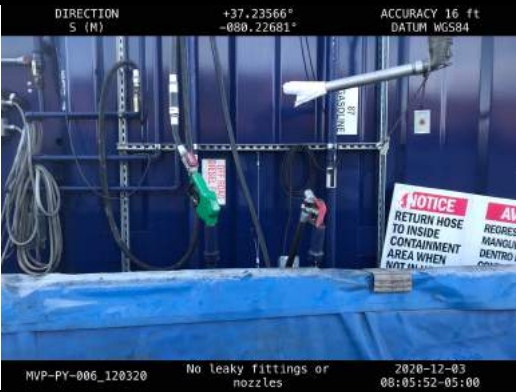
GPS Location	MVP-PY-006 See photo for gps data	GPS Location	MVP-PY-006 See photo for gps data		
Field Station#	+0	Field Station#	+0		
Pic 9 Desc.	Secondary containment on site for tankers offloading fuel into Blue Bulk fuel tanks. Looking W.	Pic 10 Desc.	Blue Bulk Fuel tanks no leaky fittings or nozzles. Looking S.

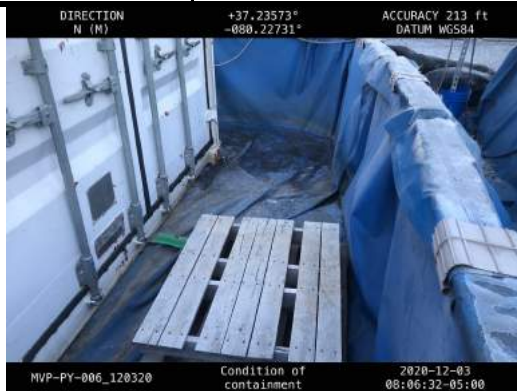
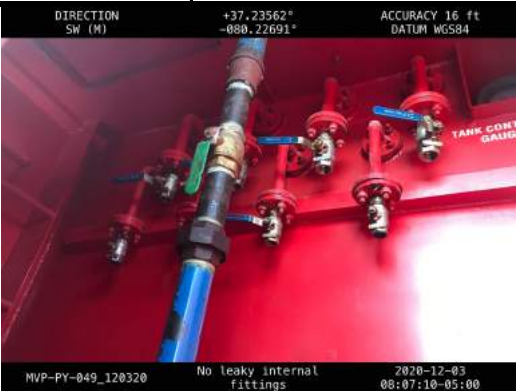
GPS Location	MVP-PY-006 See photo for gps data	GPS Location	MVP-PY-006 See photo for gps data		
Field Station#	+0	Field Station#	+0		
Pic 11 Desc.	Off Road Fuel unit condition of containment. Free of stormwater. Looking N.	Pic 12 Desc.	Off Road Fuel unit no leaky internal fittings. Looking SW.

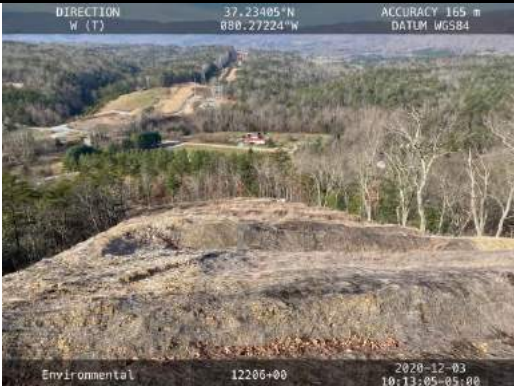
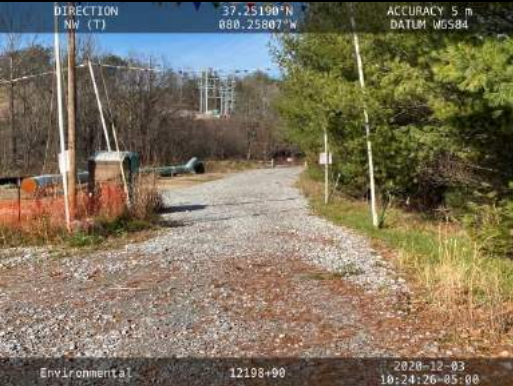
GPS Location	See photo for GPS coordinates		GPS Location	See photo for GPS coordinates	
Field Station#	12206+00		Field Station#	12198+90	
Pic 5 Desc.	Stabilized ROW with an acceptable vegetative coverage.		Pic 6 Desc.	Access road MVP-MN-275 in acceptable condition.

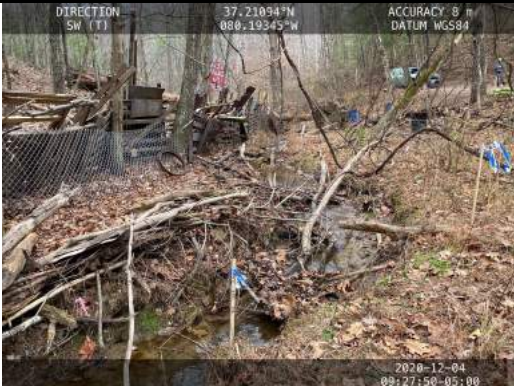
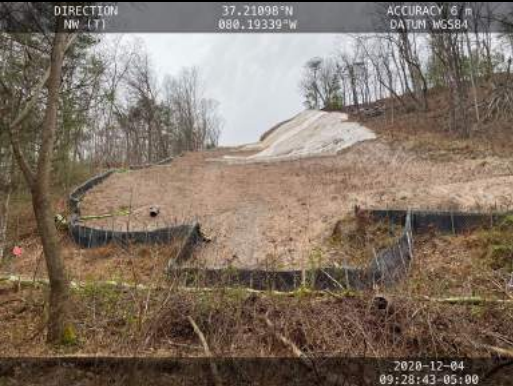
GPS Location	See photo		GPS Location	See photo	
Field Station#	12544+54		Field Station#	12544+06	
Pic 5 Desc.	Stream S-EF20a, facing southwest, upstream		Pic 6 Desc.	ECDs on coming in side of Yellow Finch Road in good repair.

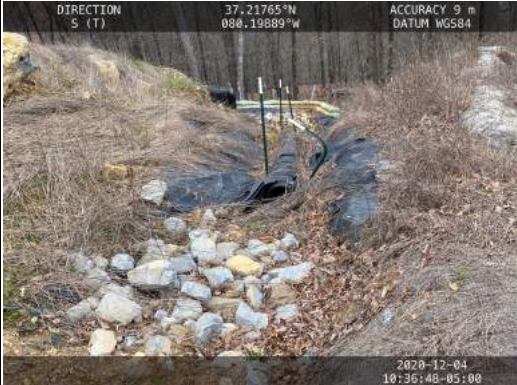
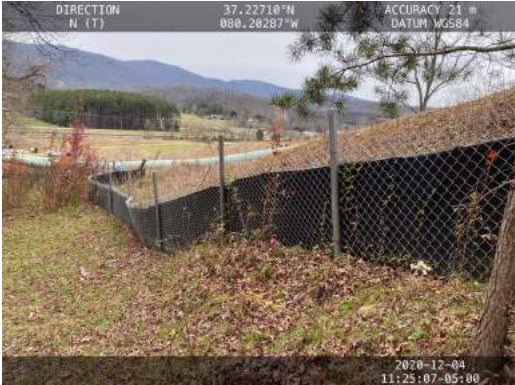
GPS Location	See photo		GPS Location	See photo	
Field Station#	12508+00		Field Station#	12474+00	
Pic 15 Desc.	Fill slope drains are in in satisfactory condition and functioning properly.		Pic 16 Desc.	Perimeter silt fence in satisfactory condition where it parallels access road MVP-MLV-AR-28.

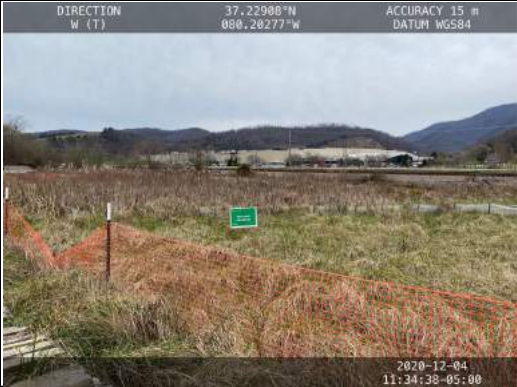
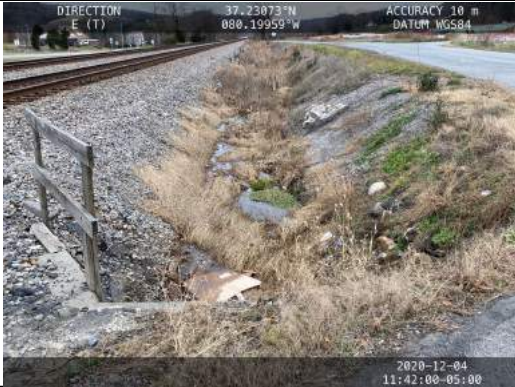
GPS Location	See photo		GPS Location	See photo	
Field Station#	12460+75		Field Station#	12444+94	
Pic 17 Desc.	Wetland W-KL58, facing west		Pic 18 Desc.	Stream S-I1, facing east, upstream from Cove Hollow Road.
