<b>Project Name</b>		H-600 Pipeline Spread I		<b>AFE</b>	124300139	<b>Spread</b>	H-600 Pipeline Spread I	
<b>Contractor</b>		Precision				<b>Report #</b>	18921	
<b>Inspector</b>		Ben Farmer				<b>Date/Time</b>	1/11/2021 10:49 AM	
<b>Permit #</b>	TBD	<b>Inspection Type</b>	VA SWPP		<b>Station Begin</b>	15370+62		
<b>State</b>	VA	<b>Inspection Area</b>	Partial		<b>Station End</b>	15480+67		
<b>County</b>	Pittsylvania	<b>Ground</b>	Frozen		<b>Temperature (°F)</b>	36.00		
<b>Municipality</b>	Chatham	<b>Weather</b>	Cloudy		<b>Rain Gauge (in)</b>	0.00		
					<b>Rain Accumulation Time (days)</b>	0.00

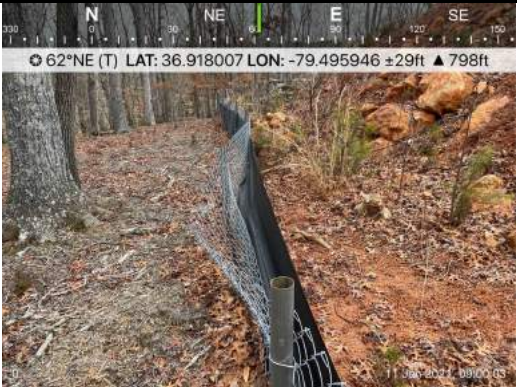
GPS Location	See photo				
Field Station#	15415+00				
Pic 1 Desc.	SSF fabric needs to be reattached.

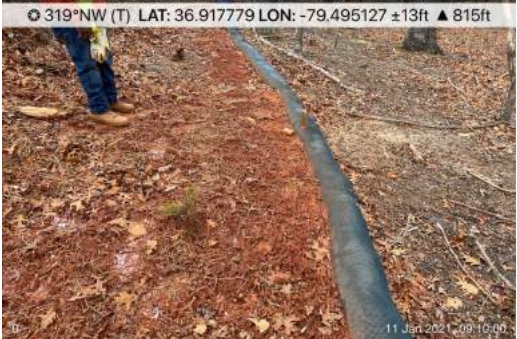
GPS Location	See photo				
Field Station#	15417+00				
Pic 3 Desc.	Sediment needs to be removed from CFS.

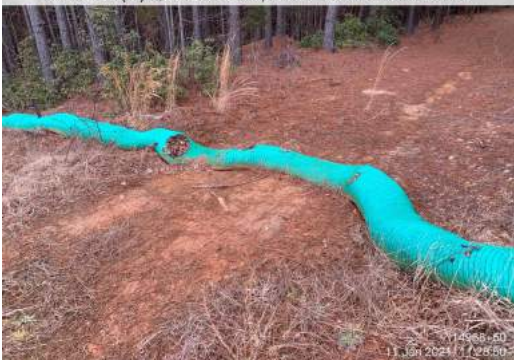
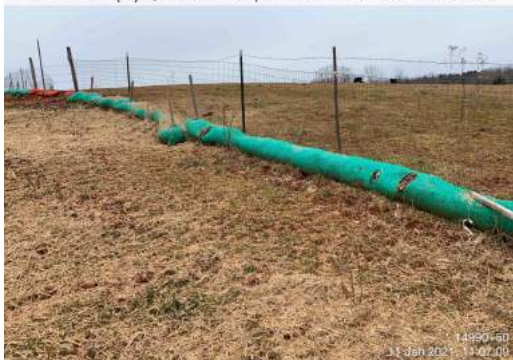
<b>GPS Location</b>	0	<b>GPS Location</b>	0		
<b>Field Station#</b>	14968+50	<b>Field Station#</b>	14990+50		
<b>Pic 3 Desc.</b>	Perimeter CFS damaged by traffic on logging trail		<b>Pic 4 Desc.</b>	Perimeter CFS at 14990+50 to 14991+00 damaged by livestock

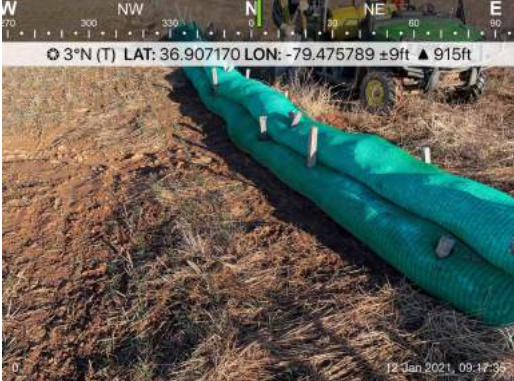
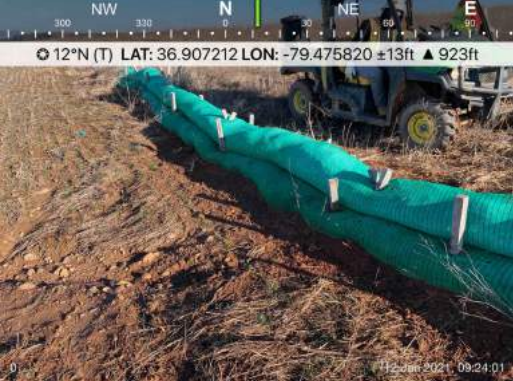
<b>GPS Location</b>	See photo	<b>GPS Location</b>	See photo		
<b>Field Station#</b>	15495+00	<b>Field Station#</b>	15495+00		
<b>Pic 1 Desc.</b>	CFS has been undermined and needs to be keyed in.	<b>Pic 2 Desc.</b>	Environmental crew has corrected this issue.

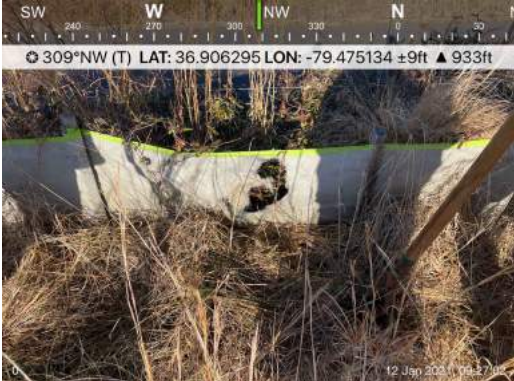
<b>GPS Location</b>	See photo	<b>GPS Location</b>	See photo		
<b>Field Station#</b>	15497+00	<b>Field Station#</b>	15497+00		
<b>Pic 3 Desc.</b>	P1 has been damaged and needs to be replaced	<b>Pic 4 Desc.</b>	Environmental crew has corrected this issue.

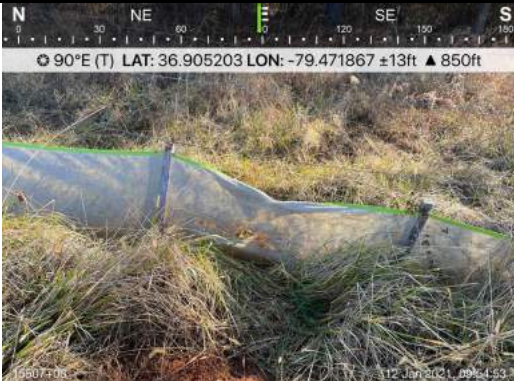
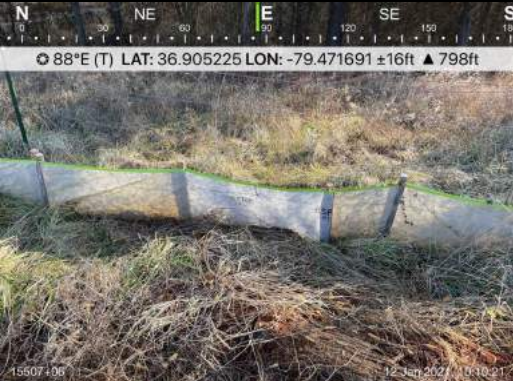
<b>GPS Location</b>	See photo	<b>GPS Location</b>	See photo		
<b>Field Station#</b>	15507+06	<b>Field Station#</b>	15507+06		
<b>Pic 5 Desc.</b>	P1 has been damaged and needs to be replaced	<b>Pic 6 Desc.</b>	Environmental crew has corrected this issue.

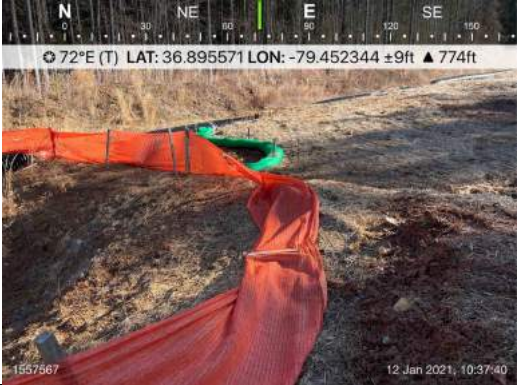
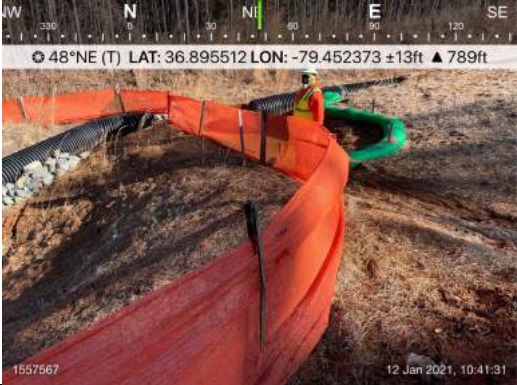
<b>GPS Location</b>	See photo	<b>GPS Location</b>	See photo		
<b>Field Station#</b>	15575+67	<b>Field Station#</b>	15575+67		
<b>Pic 7 Desc.</b>	Safety fence is down and needs to be restaked.	<b>Pic 8 Desc.</b>	Environmental crew has corrected this issue.

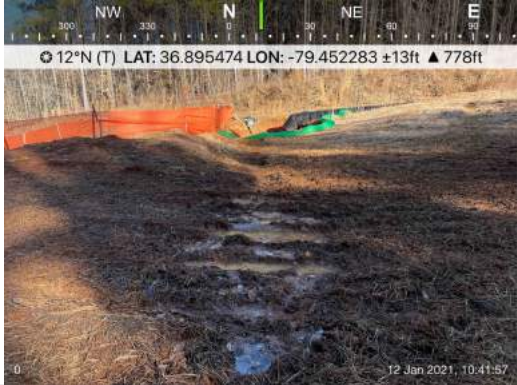
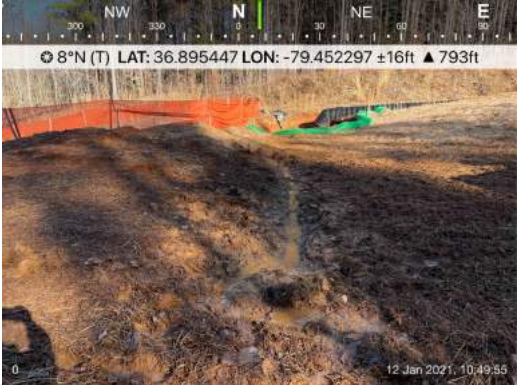
<b>GPS Location</b>	See photo	<b>GPS Location</b>	See photo		
<b>Field Station#</b>	15576+00	<b>Field Station#</b>	15576+00		
<b>Pic 9 Desc.</b>	Waterbar channel is obstructed and needs to be regraded.	<b>Pic 10 Desc.</b>	Environmental crew has corrected this issue.		
Insert image here			Insert image here		
<b>GPS Location</b>		<b>GPS Location</b>			
<b>Field Station#</b>		<b>Field Station#</b>			
<b>Pic 11 Desc.</b>		<b>Pic 12 Desc.</b>

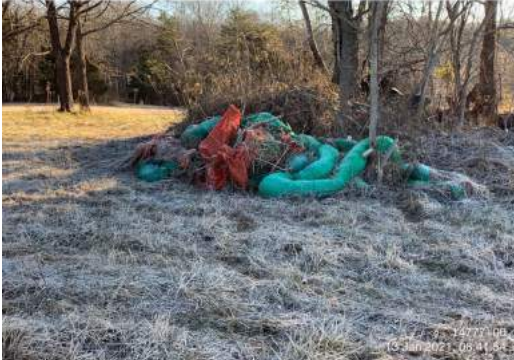
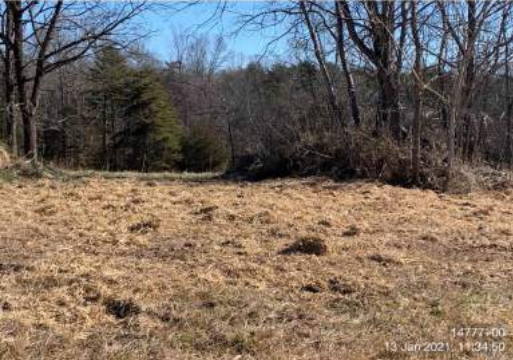
<b>GPS Location</b>	0	<b>GPS Location</b>	0		
<b>Field Station#</b>	14777+00	<b>Field Station#</b>	14777+00		
<b>Pic 1 Desc.</b>	Trash needs cleaned up in MVP-ATWS-715A		<b>Pic 2 Desc.</b>	Trash was cleaned up immediately in MVP-ATWS-715A

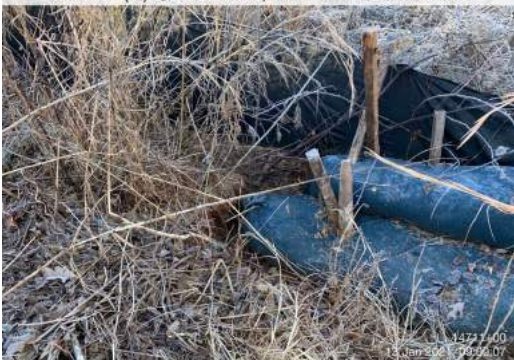
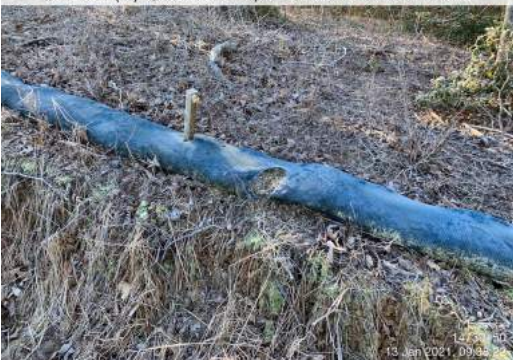
<b>GPS Location</b>	0	<b>GPS Location</b>	0		
<b>Field Station#</b>	14711+00	<b>Field Station#</b>	14730+50		
<b>Pic 3 Desc.</b>	Water is running around CFS		<b>Pic 4 Desc.</b>	Hole in CFS

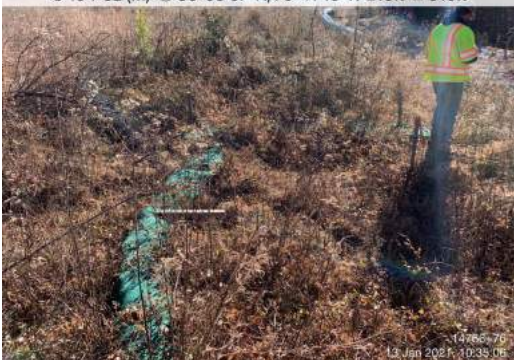
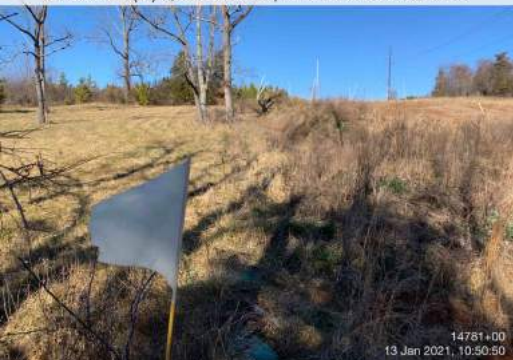
<b>GPS Location</b>	0	<b>GPS Location</b>	0		
<b>Field Station#</b>	14766+76	<b>Field Station#</b>	14781+00		
<b>Pic 5 Desc.</b>	CFS requires maintenance		<b>Pic 6 Desc.</b>	CFS needs stakes installed from 14779+00 to 14781+00

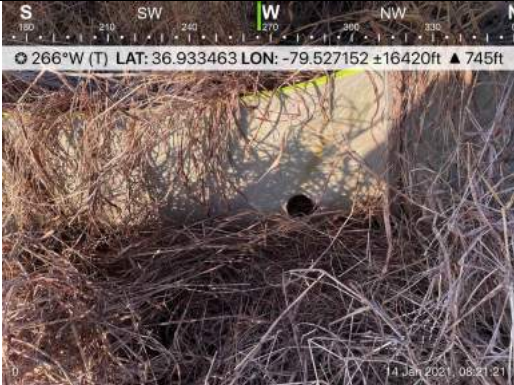
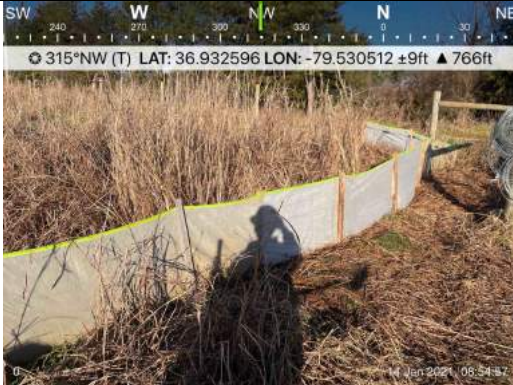
<b>GPS Location</b>	See photo		<b>GPS Location</b>	See photo	
<b>Field Station#</b>	15300+00		<b>Field Station#</b>	15300+00	
<b>Pic 1 Desc.</b>	P1 has been damaged and needs to be replaced.		<b>Pic 2 Desc.</b>	Environmental crew has corrected this issue.

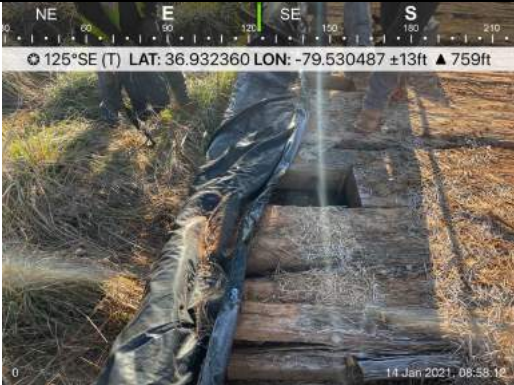
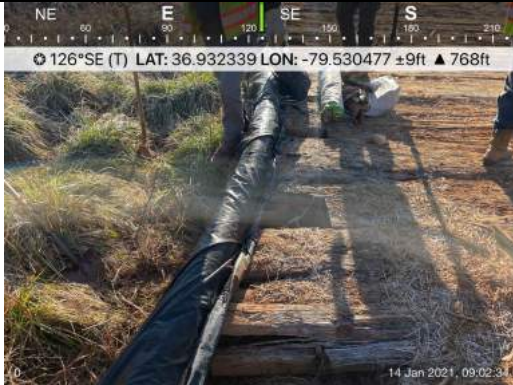
<b>GPS Location</b>	See photo		<b>GPS Location</b>	See photo	
<b>Field Station#</b>	15300+50		<b>Field Station#</b>	15300+50	
<b>Pic 3 Desc.</b>	Equipment bridge sideboard needs to be reattached.		<b>Pic 4 Desc.</b>	Environmental crew has corrected this issue.

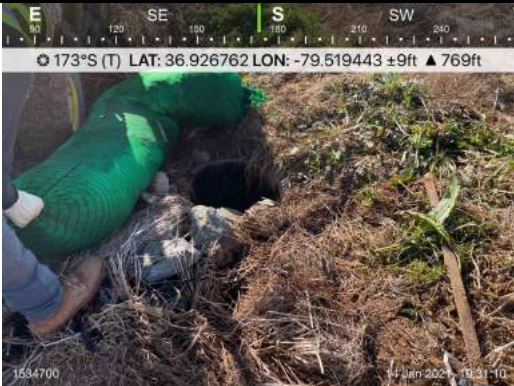
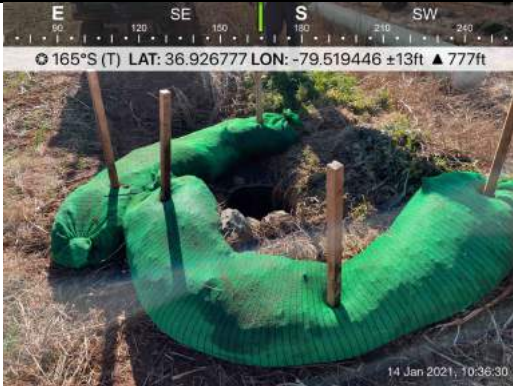
<b>GPS Location</b>	See photo		<b>GPS Location</b>	See photo	
<b>Field Station#</b>	15338+00		<b>Field Station#</b>	15338+00	
<b>Pic 5 Desc.</b>	CWD needs additional inlet protection.		<b>Pic 6 Desc.</b>	Environmental crew has corrected this issue.

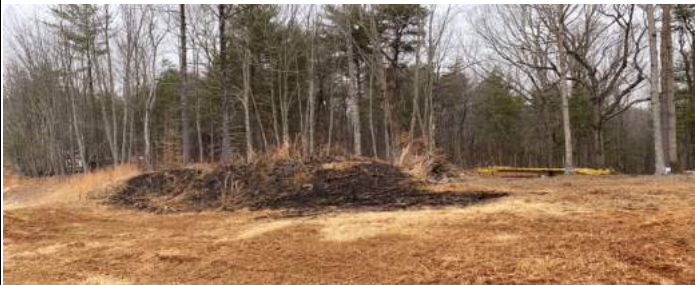
Pic 3 Desc.	Landowner was burning brush off ROW and caught spoil pile on fire. Area will need to be reseeded and stabilized.		Pic 4 Desc.	View of temporary stabilization along ROW. Little vegetative growth observed.

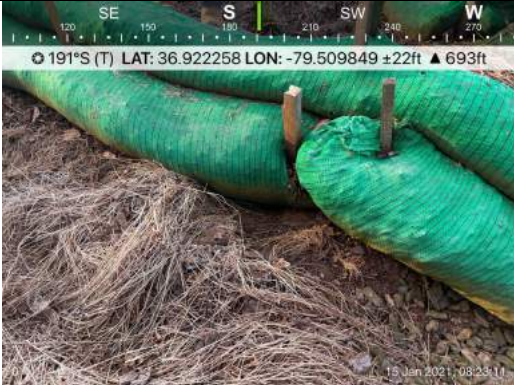
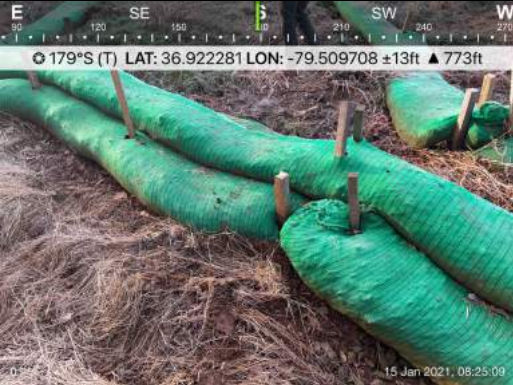
<b>GPS Location</b>	See photo	<b>GPS Location</b>	See photo		
<b>Field Station#</b>	15373+00	<b>Field Station#</b>	15373+00		
<b>Pic 1 Desc.</b>	CFS has been undermined and needs to be keyed.	<b>Pic 2 Desc.</b>	Environmental crew has corrected this issue.

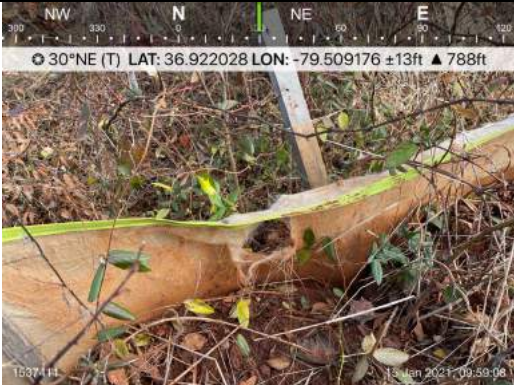
<b>GPS Location</b>	See photo	<b>GPS Location</b>	See photo		
<b>Field Station#</b>	15374+11	<b>Field Station#</b>	15383+00		
<b>Pic 3 Desc.</b>	P1 has been damaged and needs to be replaced.	<b>Pic 4 Desc.</b>	Waterbars are in good condition and functioning.
