Visual Site Inspection Report

Project Name	H-600 Pipeline Spread I	AFE	124300139	Spread	H-600 Pipeline Spread I
Contractor	Precision	Report #	18042		
Inspector	Ben Farmer	Date/Time	12/14/2020 2:00 PM		
Permit #	TBD	Inspection Type	VA SWPP	Station Begin	15142+66
State	VA	Inspection Area	Partial	Station End	15260+00
County	Pittsylvania	Ground	Wet	Temperature (°F)	46.00
Municipality	Chatham	Weather	Heavy Rain	Rain Gauge (in)	1.40
				Rain Accumulation Time (days)	0.00

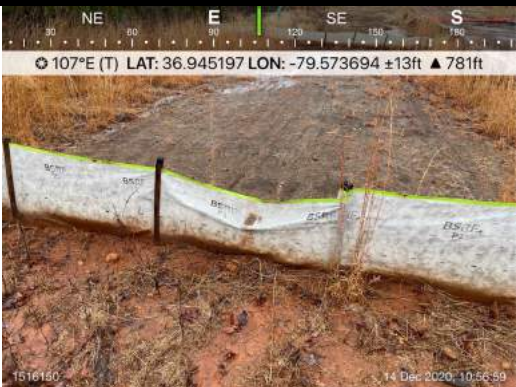
GPS Location	See photo		GPS Location	See photo	
Field Station#	15161+50		Field Station#	15161+75	
Pic 3 Desc.	P1 has been damaged and needs to be replaced.		Pic 4 Desc.	P1 has been undermined and needs to be keyed in.

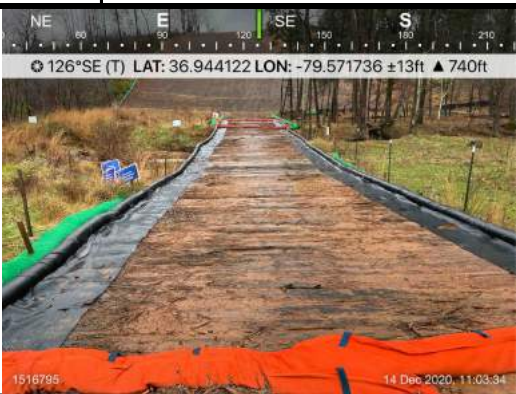
GPS Location	See photo		GPS Location	See photo	
Field Station#	15167+95		Field Station#	15170+00	
Pic 5 Desc.	Equipment bridge ECDS are in place and functioning.		Pic 6 Desc.	Waterbars are in good condition and functioning.

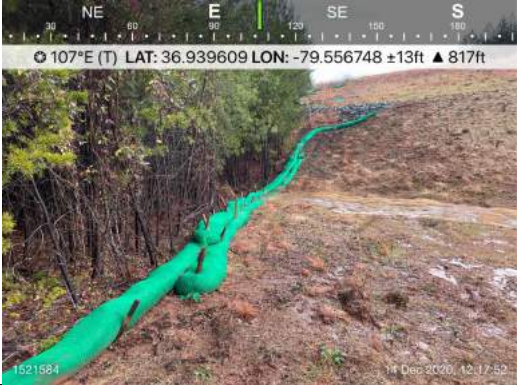
Insert image here			
GPS Location	See photo	GPS Location			
Field Station#	15215+84	Field Station#			
Pic 7 Desc.	CFS is in good condition throughout this section of ROW.	Pic 8 Desc.			
Insert image here		Insert image here			
GPS Location		GPS Location			
Field Station#		Field Station#			
Pic 9 Desc.		Pic 10 Desc.			
Insert image here		Insert image here			
GPS Location		GPS Location			
Field Station#		Field Station#			
Pic 11 Desc.		Pic 12 Desc.

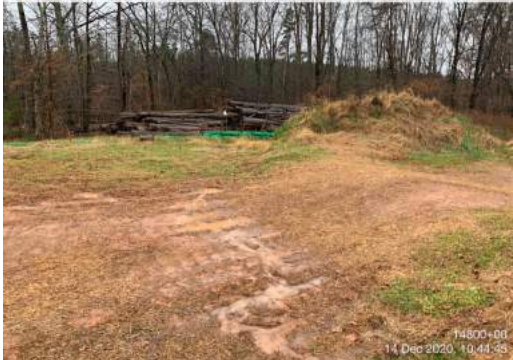
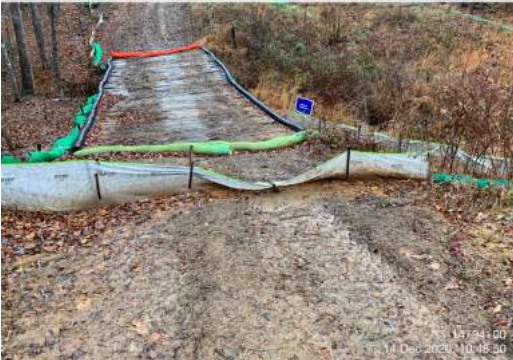
GPS Location			0	GPS Location		0
Field Station#			14800+00	Field Station#		14794+00
Pic 1 Desc.			Waterbar in acceptable condition	Pic 2 Desc.		P1 silt fence requiring maintenance

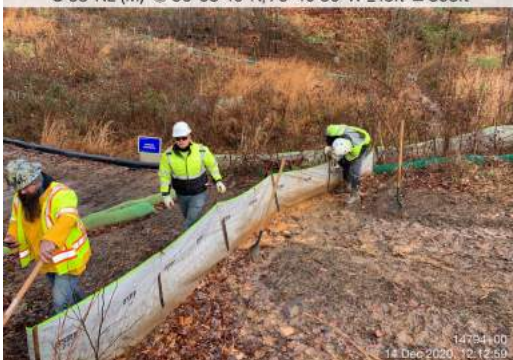
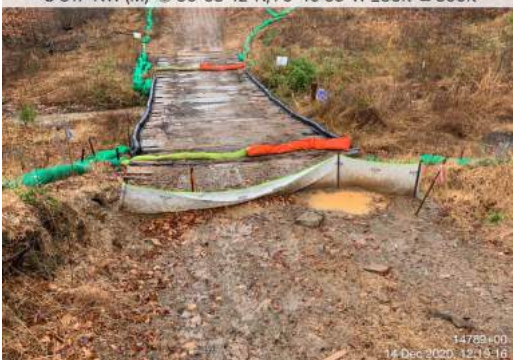
GPS Location			0	GPS Location		0
Field Station#			14794+00	Field Station#		14789+00
Pic 3 Desc.			Repaired P1 silt fence	Pic 4 Desc.		P1 silt fence requiring maintenance

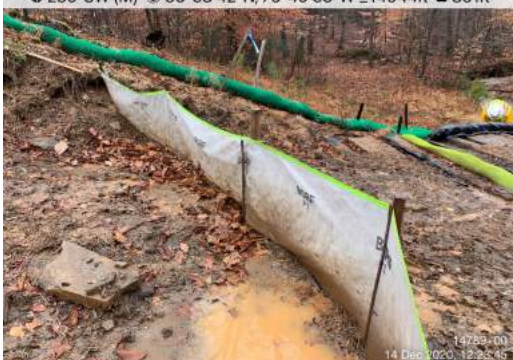
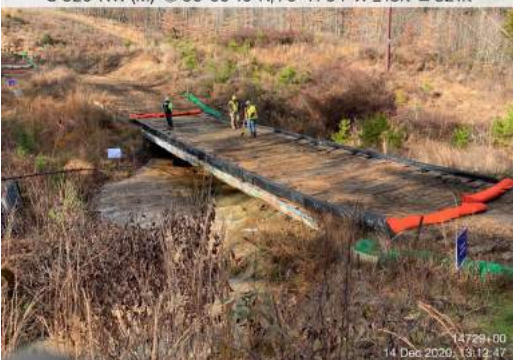
GPS Location			0	GPS Location		0
Field Station#			14789+00	Field Station#		14729+00
Pic 5 Desc.			Repaired P1 silt fence	Pic 6 Desc.		Equipment bridge in acceptable condition

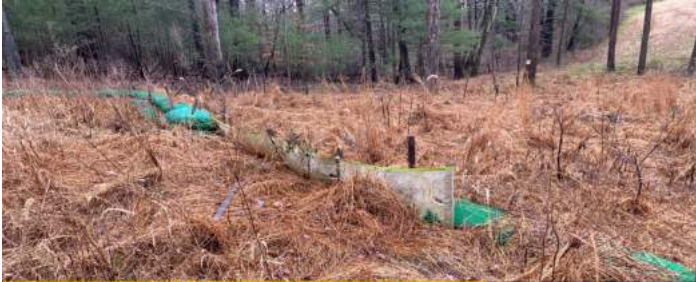
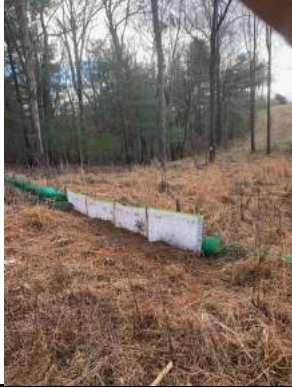
GPS Location	1	GPS Location	2		
Field Station#	13951+25	Field Station#	13951+25		
Pic 1 Desc.	Routine maintenance. Replace damaged panels of P1 silt fence with holes in fabric.	Pic 2 Desc.	Contractor replaced P1 silt fence per punch list item.

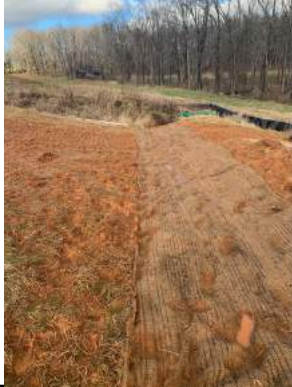
GPS Location	3	GPS Location	4		
Field Station#	13947+00	Field Station#	13947+00		
Pic 3 Desc.	Reinstall/re-pin Curlex in throat of water bars across travel lane.	Pic 4 Desc.	Contractor reinstalled Curlex per punch list item.

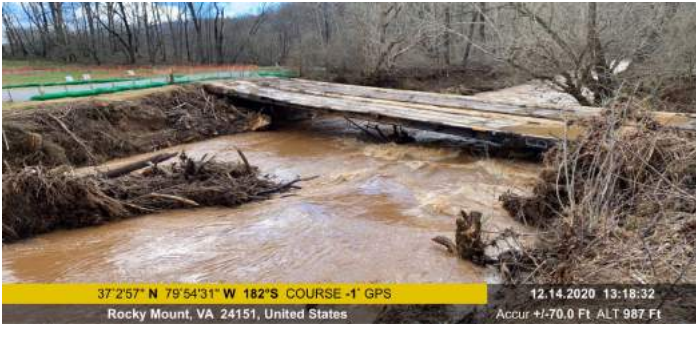
GPS Location	5	GPS Location	6		
Field Station#	13915+51	Field Station#	13875+16		
Pic 5 Desc.	View of equipment bridge at S-II2. Debris still dammed in crossing. No additional issues identified.	Pic 6 Desc.	Ditch subsidence CIS S-CD6 has worsened from previous inspection and is beginning to erode bank.

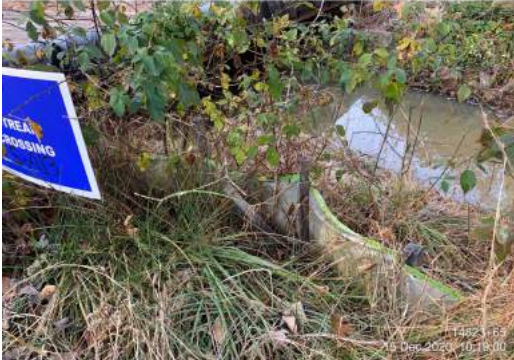
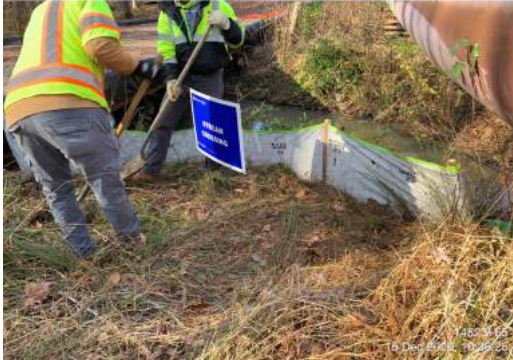
GPS Location	0	GPS Location	0		
Field Station#	14823+65	Field Station#	14823+65		
Pic 1 Desc.	Holes in P1 silt fence	Pic 2 Desc.	P1 silt fence maintained

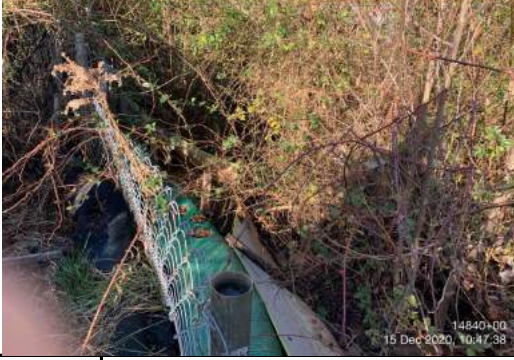
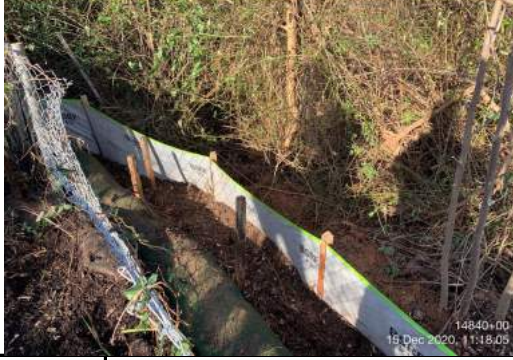
GPS Location	0	GPS Location	0		
Field Station#	14840+00	Field Station#	14840+00		
Pic 3 Desc.	P1 silt fence requires maintenance	Pic 4 Desc.	P1 silt fence maintained

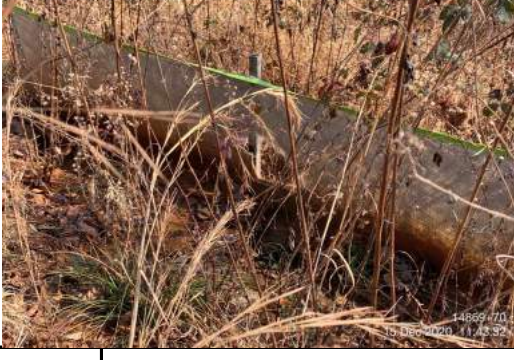
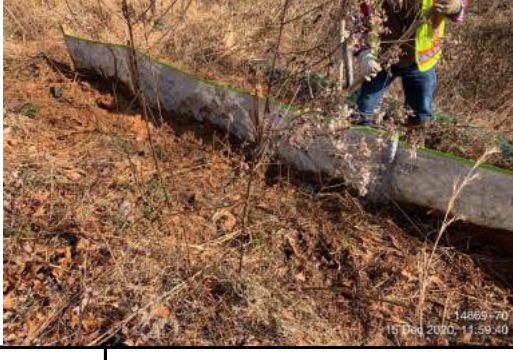
GPS Location	0	GPS Location	0		
Field Station#	14869+70	Field Station#	14869+70		
Pic 5 Desc.	Holes in P1 silt fence	Pic 6 Desc.	P1 silt fence maintained

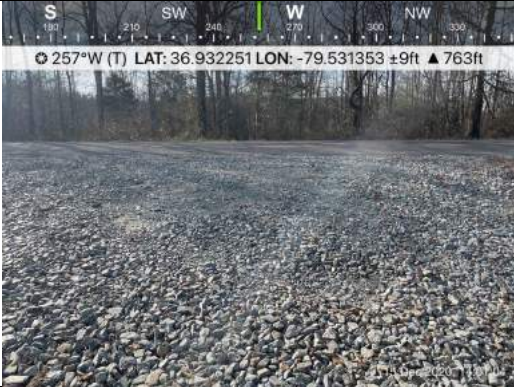
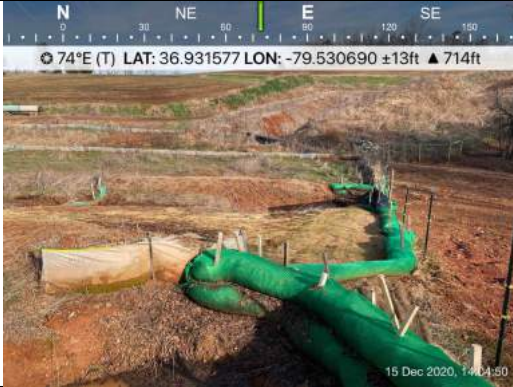
GPS Location	See photo	GPS Location	See photo		
Field Station#	15296+00	Field Station#	15298+00		
Pic 1 Desc.	RCEs in good condition throughout this section.	Pic 2 Desc.	End treatments in good condition and functioning.

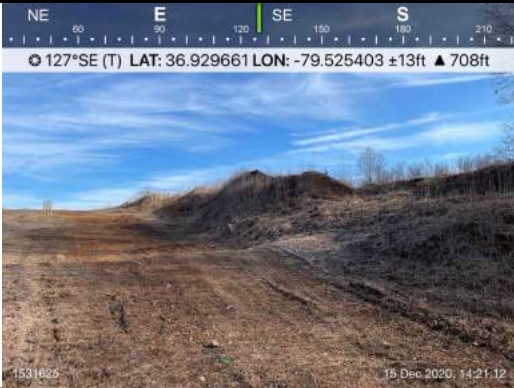
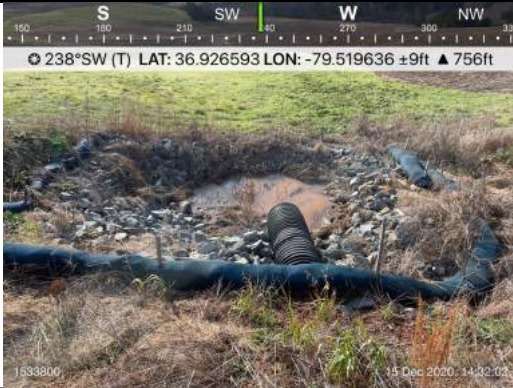
GPS Location	See photo	GPS Location	See photo		
Field Station#	15316+25	Field Station#	15338+00		
Pic 5 Desc.	Stockpiles remain stabilized.	Pic 6 Desc.	CWDs throughout this section are in good condition and functioning.

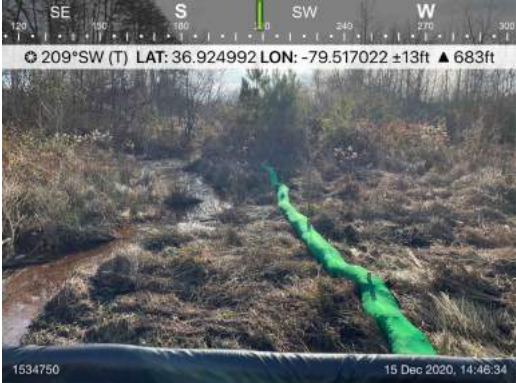
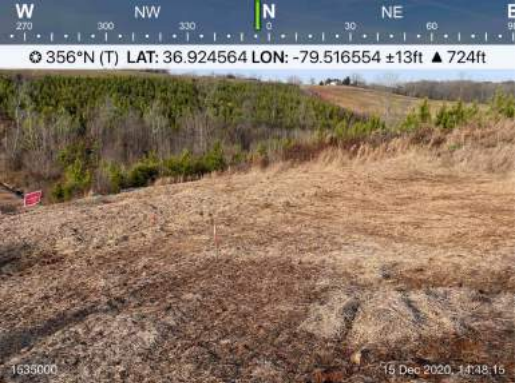
GPS Location	See photo		GPS Location	See photo	
Field Station#	15347+50		Field Station#	15350+00	
Pic 7 Desc.	CFS in good condition at all stream and wetland crossings.		Pic 8 Desc.	Waterbars in good condition and functioning.	
Insert image here			Insert image here		
GPS Location			GPS Location		
Field Station#			Field Station#		
Pic 9 Desc.			Pic 10 Desc.		
Insert image here			Insert image here		
GPS Location			GPS Location		
Field Station#			Field Station#		
Pic 11 Desc.			Pic 12 Desc.

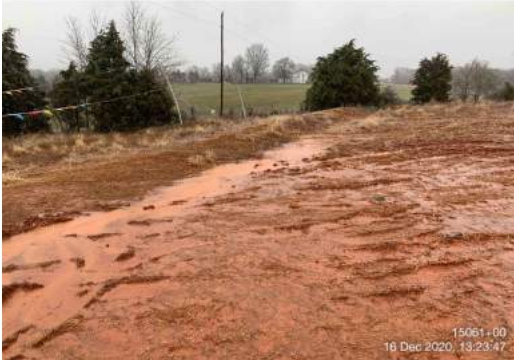
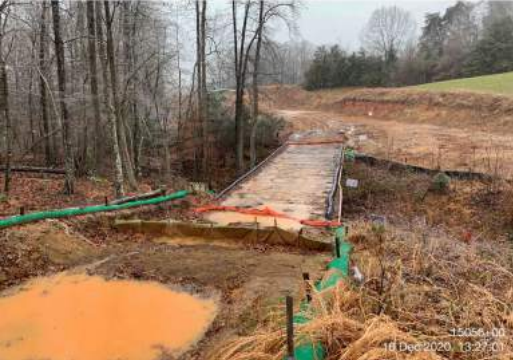
GPS Location	0	GPS Location	0		
Field Station#	15061+00	Field Station#	15056+00		
Pic 1 Desc.	Waterbar in acceptable condition	Pic 2 Desc.	Equipment bridge in acceptable condition

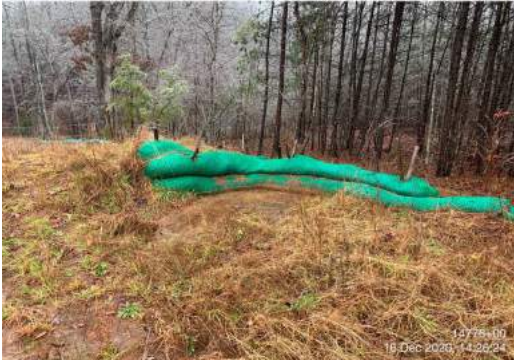
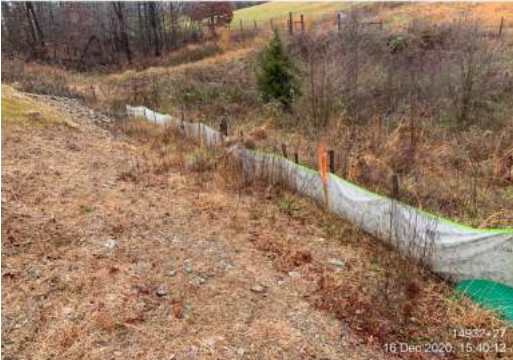
GPS Location	0	GPS Location	0		
Field Station#	14778+00	Field Station#	14932+27		
Pic 3 Desc.	Waterbar end treatment in acceptable condition	Pic 4 Desc.	P1 silt fence in acceptable condition

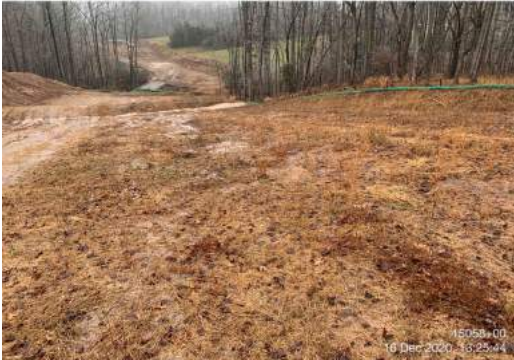
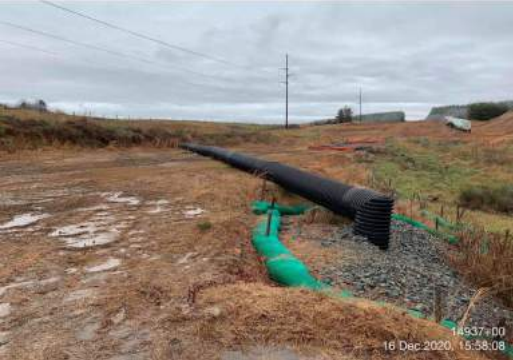
GPS Location	0	GPS Location	0		
Field Station#	15058+00	Field Station#	14937+00		
Pic 5 Desc.	Temporary vegetative stabilization in acceptable condition	Pic 6 Desc.	Clean water diversion pipe in acceptable condition

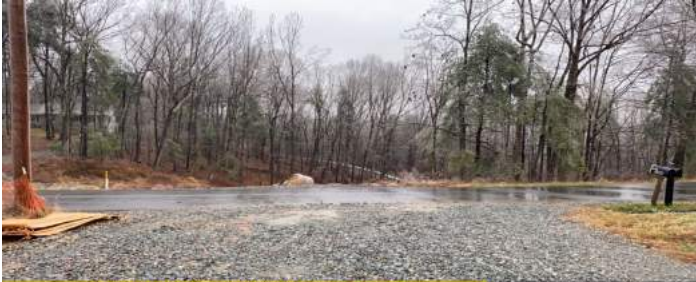
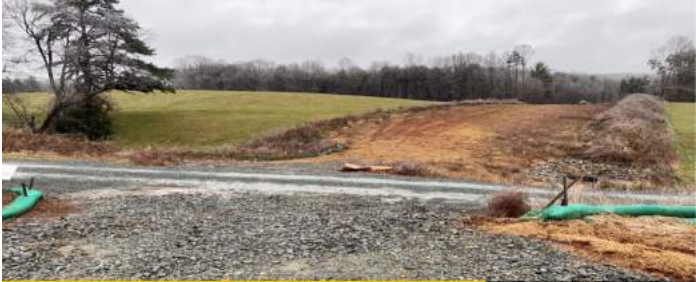
<small>37°3'55" N 79°52'31" W 234°SW COURSE 0° GPS 1315 Bonbrook Mill Rd, Rocky Mount, VA 24151, United States 12.16.2020 14:08:40 Accur +/-37.0 Ft ALT 0 Ft</small>			<small>37°3'41" N 79°51'17" W 148°SE COURSE -1° GPS 180 Jonesmill Ln, Rocky Mount, VA 24151, United States 12.16.2020 14:13:49 Accur +/-103.9 Ft ALT 1203 Ft</small>		
GPS Location	1		GPS Location	2	
Field Station#	14062+17		Field Station#	14131+28	
Pic 1 Desc.	RCE at Bonbrook Mill RC2 in good condition		Pic 2 Desc.	RCE at Jones Mill Rd in good condition

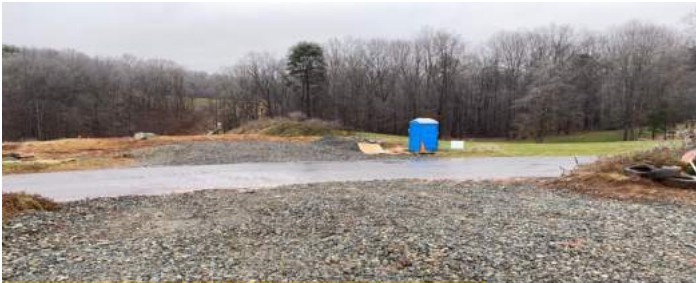
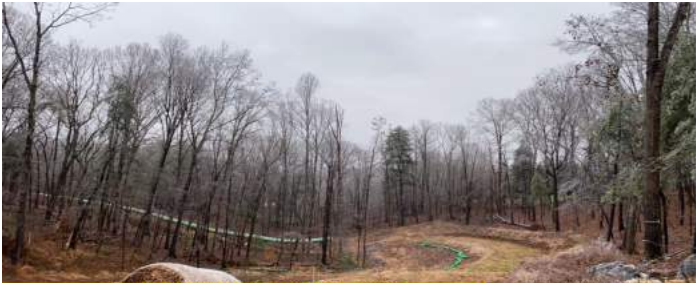
GPS Location	3		GPS Location	4	
Field Station#	14171+36		Field Station#	14064+00	
Pic 3 Desc.	RCE at Angle Plantation Rd in good condition		Pic 4 Desc.	Travel lane stabilized GAS Bonbrook Mill RC2 and all ECDs in place and functional.	
Insert image here			Insert image here		
GPS Location			GPS Location		
Field Station#			Field Station#		
Pic 5 Desc.			Pic 6 Desc.

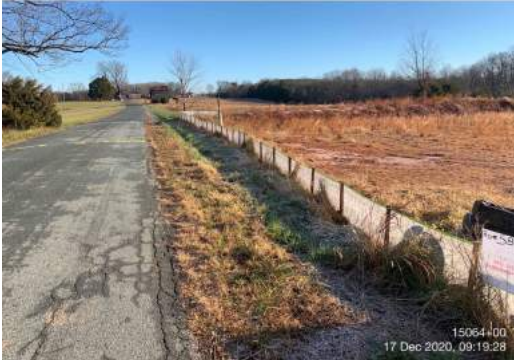
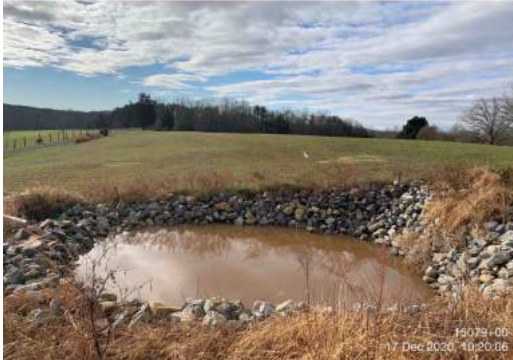
GPS Location	0	GPS Location	0		
Field Station#	15064+00	Field Station#	15079+00		
Pic 1 Desc.	P1 silt fence in acceptable condition	Pic 2 Desc.	Clean water diversion plunge pool in acceptable condition

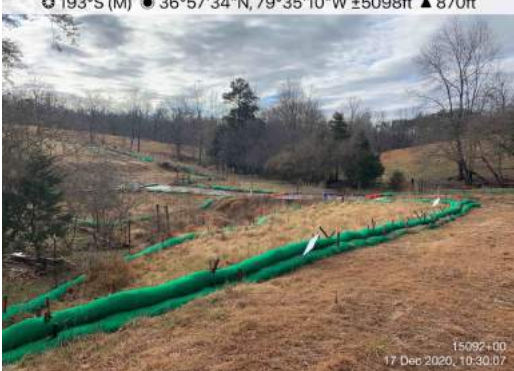
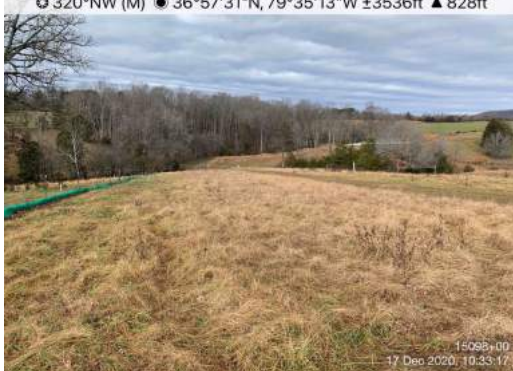
GPS Location	0	GPS Location	0		
Field Station#	15092+00	Field Station#	15098+00		
Pic 3 Desc.	Triple stack CFS in acceptable condition	Pic 4 Desc.	Permanent vegetative stabilization in acceptable condition

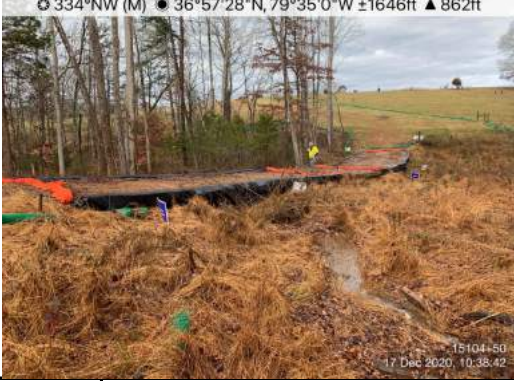
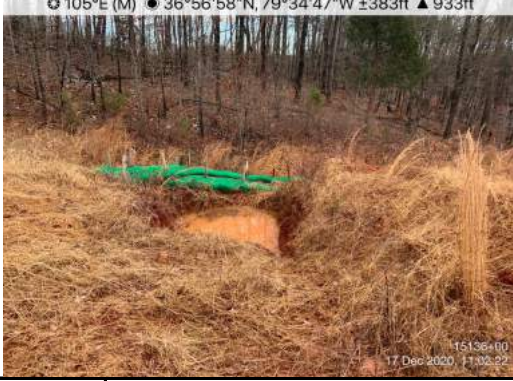
GPS Location	0	GPS Location	0		
Field Station#	15104+00	Field Station#	15136+00		
Pic 5 Desc.	Equipment bridge in acceptable condition	Pic 6 Desc.	Waterbar end treatment in acceptable condition

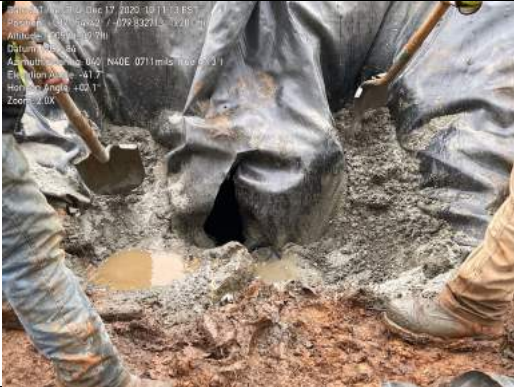
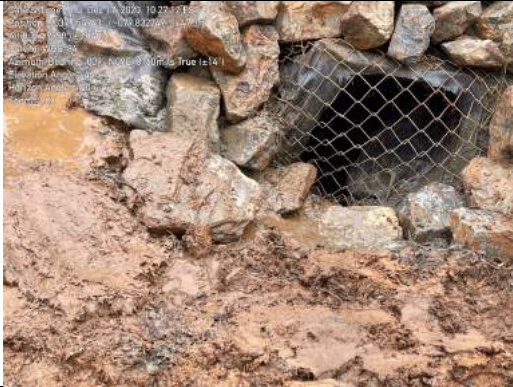
GPS Location	1	GPS Location	2		
Field Station#	14225+72	Field Station#	14225+72		
Pic 1 Desc.	Contractor reinforced CWD berm and pipe with additional ECD measures.		Pic 2 Desc.	Contractor reinforced CWD berm and pipe with additional ECD measures.

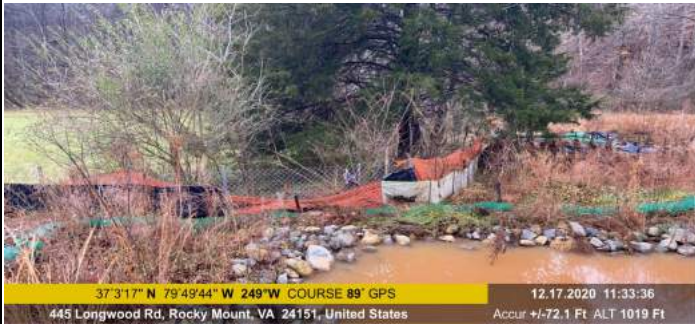
GPS Location	5	GPS Location	6		
Field Station#	14225+00	Field Station#	14236+00		
Pic 5 Desc.	Routine maintenance. CFS end treatment undermining. Repair and stabilize.		Pic 6 Desc.	Routine maintenance. Replace worn P1 silt fence and replace stakes for safety fence along perimeter of ROW.

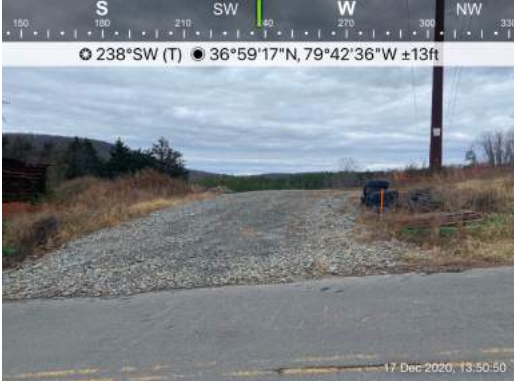
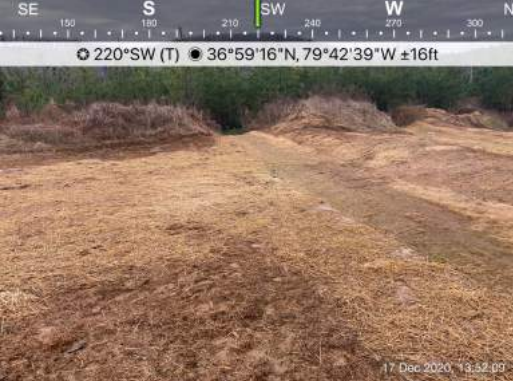
GPS Location	0	GPS Location	0		
Field Station#	14694+75	Field Station#	14690+50		
Pic 1 Desc.	Approximately 14694+75. Overview of road crossing and RCE. RCE installed and appears to be functioning correctly at time of inspection.		Pic 2 Desc.	Approximately 14690+50. Overview of ROW. ROW temporarily stabilized and has temporary vegetation growing. Water bar and sump installed and appears to be functioning correctly.

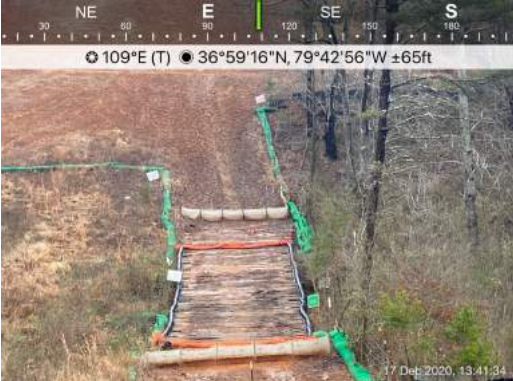
GPS Location	0	GPS Location	0		
Field Station#	14653+00	Field Station#	14680+30		
Pic 3 Desc.	Approximately 14653+00. Overview of ROW. ROW temporarily stabilized and has temporary vegetation growing.		Pic 4 Desc.	Approximately 14680+30. Overview of stream crossing, equipment bridge and ECDs at stream S-H36.

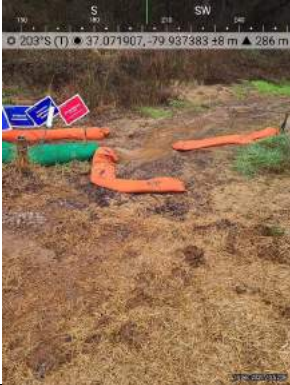
Insert image here		Insert image here	
GPS Location	00000	GPS Location			
Field Station#	13770+67	Field Station#			
Pic 7 Desc.	El noticed where a land owner continues to drive over orange wattles to cross the row, will continue to monitor the area .		Pic 8 Desc.		
Insert image here		Insert image here			
GPS Location		GPS Location			
Field Station#		Field Station#			
Pic 9 Desc.		Pic 10 Desc.			
Insert image here		Insert image here			
GPS Location		GPS Location			
Field Station#		Field Station#			
Pic 11 Desc.		Pic 12 Desc.

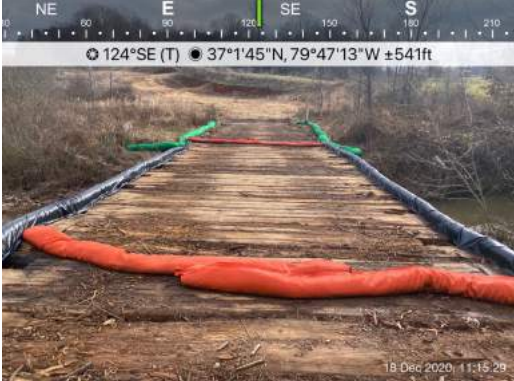
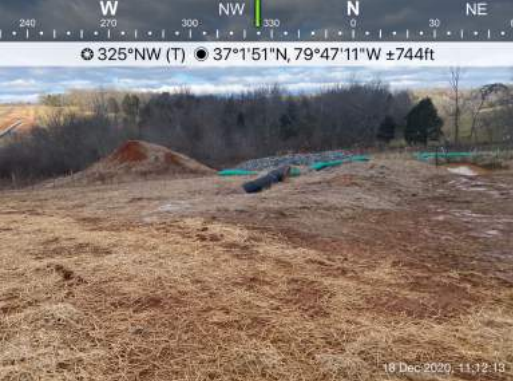
GPS Location	0	GPS Location	0		
Field Station#	14391+53	Field Station#	14400+00		
Pic 1 Desc.	Approximately 14391+53. Overview of stream crossing, equipment bridge and ECDs at stream S-A41.		Pic 2 Desc.	Approximately 14400+00. Overview of ROW. ROW temporarily stabilized and has temporary vegetation growing. CWD piping and level spreader installed and appears to be

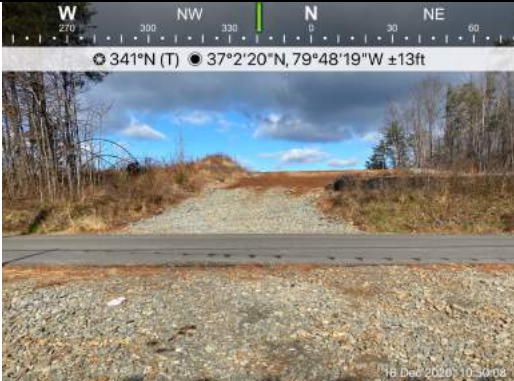
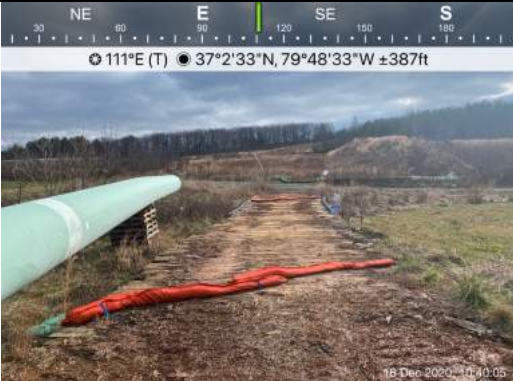
GPS Location	0	GPS Location	0		
Field Station#	14333+00	Field Station#	14314+79		
Pic 3 Desc.	Approximately 14333+00. Overview of road crossing and RCE. RCE installed and appears to be functioning correctly at time of inspection.		Pic 4 Desc.	Approximately 14314+79. Overview of stream crossing, equipment bridge and ECDs at stream S-GG4.

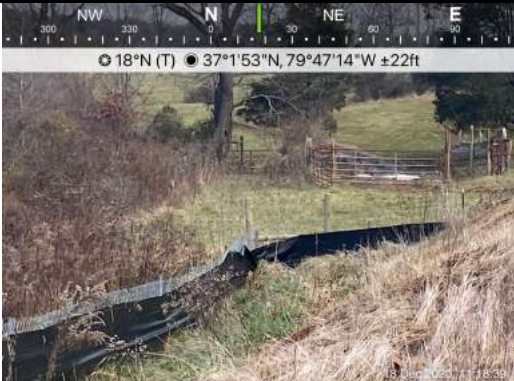
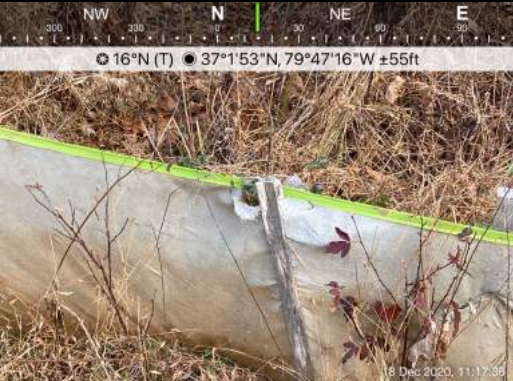
GPS Location	0	GPS Location	0		
Field Station#	14394+41	Field Station#	14392+75		
Pic 5 Desc.	Approximately 14394+41. SSF requires maintenance. Reattach fabric to fence.		Pic 6 Desc.	Approximately 14392+75. P-1 requires maintenance. Fabric and stakes are deteriorating.

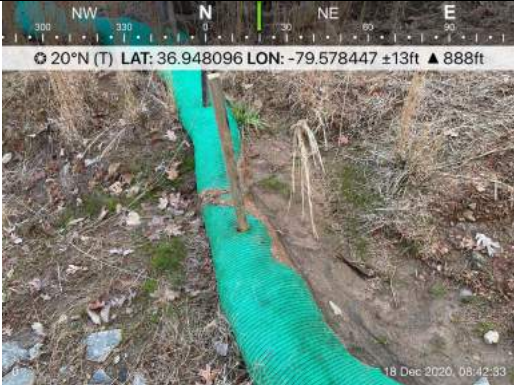
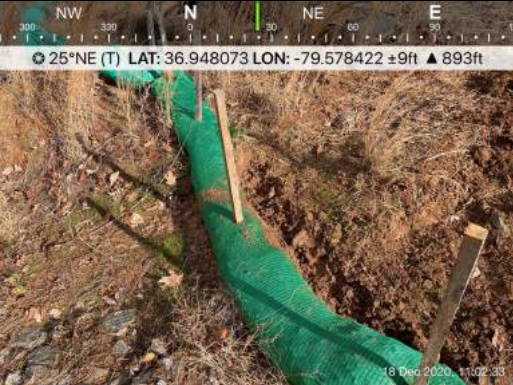
GPS Location	See photo		GPS Location	See photo	
Field Station#	15143+00		Field Station#	15143+00	
Pic 1 Desc.	Sediment needs to be removed from CFS.		Pic 2 Desc.	Environmental crew has corrected this issue.

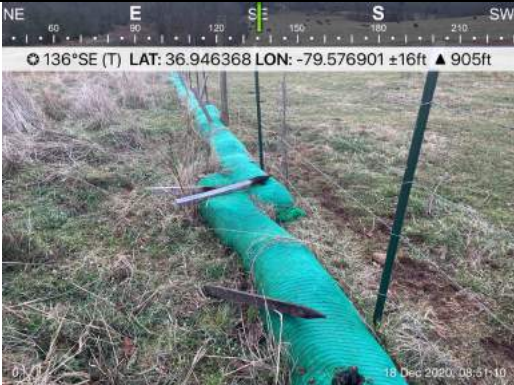
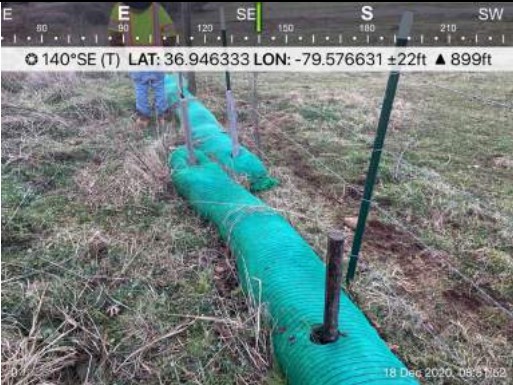
GPS Location	See photo		GPS Location	See photo	
Field Station#	15150+00		Field Station#	15150+00	
Pic 3 Desc.	CFS needs to be restaked.		Pic 4 Desc.	Environmental crew has corrected this issue.

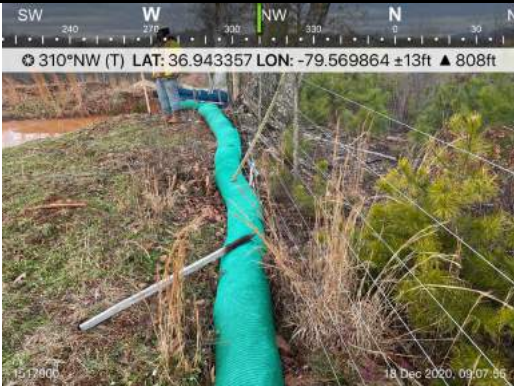
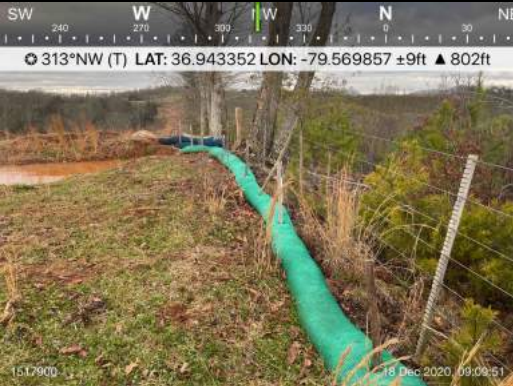
GPS Location	See photo		GPS Location	See photo	
Field Station#	15179+00		Field Station#	15179+00	
Pic 5 Desc.	CFS needs to be restaked.		Pic 6 Desc.	Environmental crew has corrected this issue.

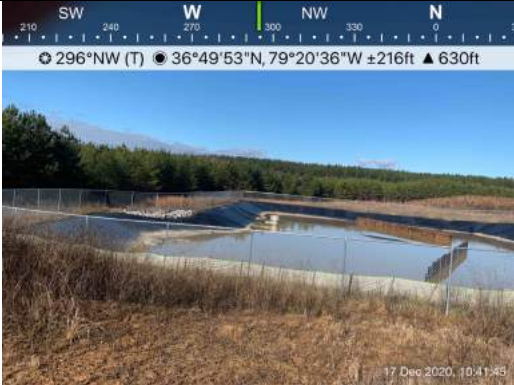
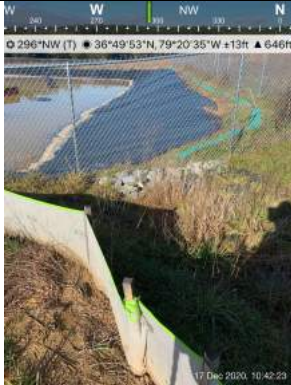
GPS Location	O	GPS Location	O		
Field Station#	00+00	Field Station#	00+00		
Pic 1 Desc.	Observing storm water pond and ECD's	Pic 2 Desc.	Observing rock check dam and ECD's

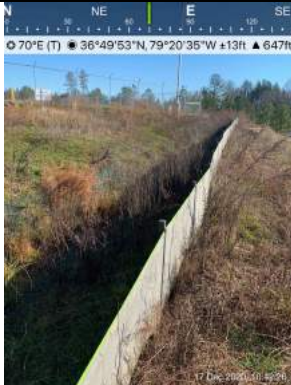
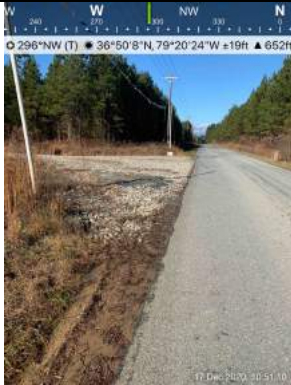
GPS Location	O	GPS Location	O		
Field Station#	00+00	Field Station#	00+00		
Pic 3 Desc.	Observing drainage channel and ECD's	Pic 4 Desc.	Observing RCE.		
Insert image here			Insert image here		
GPS Location		GPS Location			
Field Station#		Field Station#			
Pic 5 Desc.		Pic 6 Desc.
