Visual Site Inspection Report

Project Name	H-600 Pipeline Spread I	AFE	124300139	Spread	H-600 Pipeline Spread I
Contractor	Precision			Report #	18490
Inspector	John White			Date/Time	12/28/2020 8:00 AM
Permit #	TBD	Inspection Type	VA SWPP	Station Begin	15647+03
State	VA	Inspection Area	Full	Station End	15772+27
County	Pittsylvania	Ground	Frozen	Temperature (°F)	36.00
Municipality	Chatham	Weather	Cloudy	Rain Gauge (in)	1.40
				Rain Accumulation Time (days)	6.00

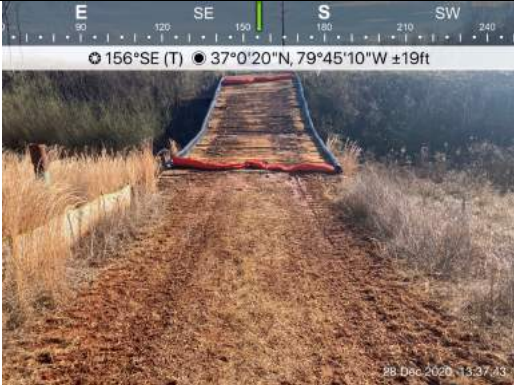
GPS Location	0	GPS Location	0		
Field Station#	14546+75	Field Station#	14515+00		
Pic 1 Desc.	Approximately 14546+75. Overview of stream crossing, equipment bridge and ECDs at stream S-G17.		Pic 2 Desc.	Approximately 14515+00. Overview of ROW. ROW temporarily stabilized and has temporary vegetation growing.

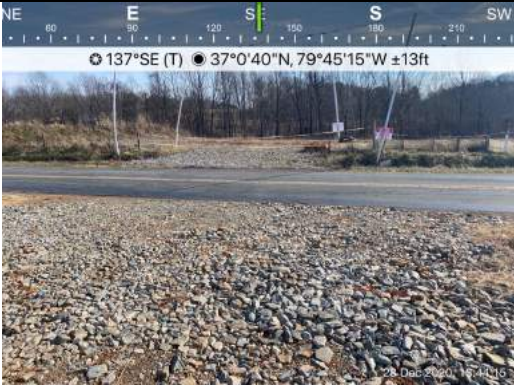
GPS Location	0	GPS Location	0		
Field Station#	14524+76	Field Station#	14530+00		
Pic 3 Desc.	Approximately 14524+76. Overview of road crossing and RCEs. RCEs installed and appears to be functioning correctly at time of inspection.		Pic 4 Desc.	Approximately 14530+00. Overview of ROW. ROW temporarily stabilized and has temporary vegetation growing.

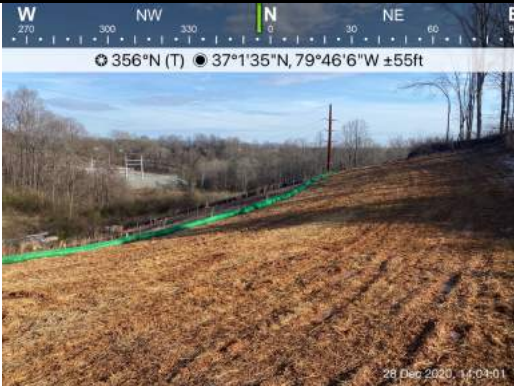
GPS Location	0	GPS Location	0		
Field Station#	14456+50	Field Station#	14471+00		
Pic 5 Desc.	Approximately 14456+50. Overview of ROW. ROW temporarily stabilized and has temporary vegetation growing.		Pic 6 Desc.	Approximately 14471+00. Overview of ROW. ROW temporarily stabilized and has temporary vegetation growing.

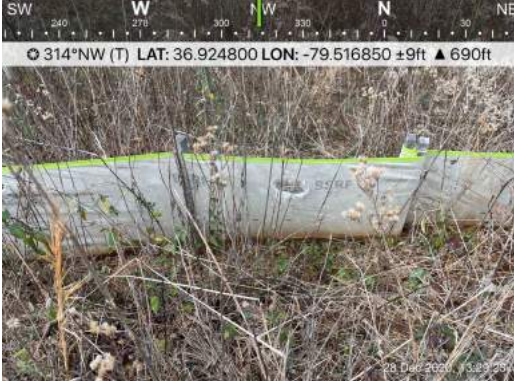
GPS Location	See photo		GPS Location	See photo	
Field Station#	15348+80		Field Station#	15348+80	
Pic 1 Desc.	P1 has been damaged and needs to be replaced.		Pic 2 Desc.	Environmental crew has corrected this issue.

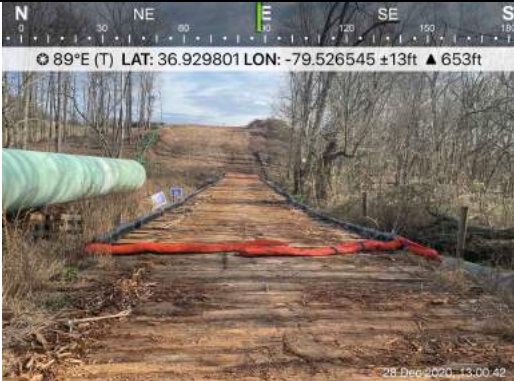
GPS Location	See photo		GPS Location	See photo	
Field Station#	15314+19		Field Station#	15316+35	
Pic 3 Desc.	Equipment bridge ECDs in place and functioning.		Pic 4 Desc.	Stockpiles remain stabilized.

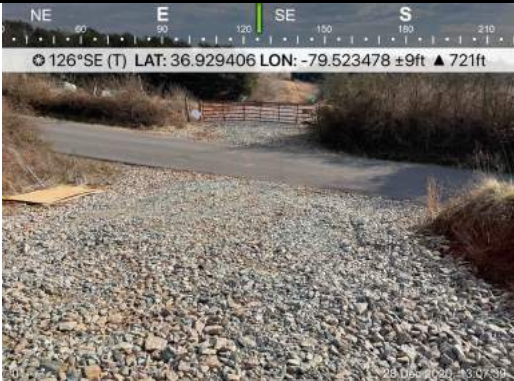
GPS Location	See photo		GPS Location	See photo	
Field Station#	15323+24		Field Station#	15338+00	
Pic 5 Desc.	RCEs are in good condition at all road crossings.		Pic 6 Desc.	CWDs throughout this section are functioning.

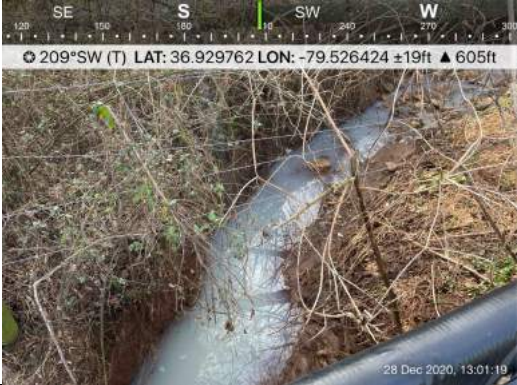
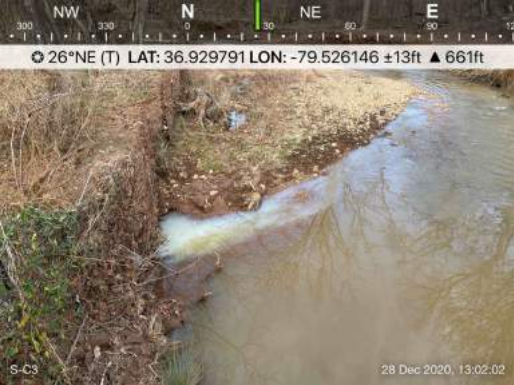
7. Identify all remedial measures that have been taken since the previous inspection was conducted.					
Comments (Reference above questions as appropriate.)					
SWPPP Inspection (Sunny, 50 F) Rain Gauge= 0.0" 15260+00-15370+62 -EI began inspection at Oxford Rd. -EI was accompanied by 2 laborers to address issues as they were discovered. -RCEs at all road crossings are in good condition with controls in place. -Perimeter CFS is in good condition throughout this section. -Equipment bridge ECDs in place and functioning at all stream/wetland crossings. -Temporary/permanent waterbars and end treatments are in good condition and functioning. -Stockpiles remain temporarily stabilized. -P1 damaged at 15348+80. Environmental crew has corrected this issue. *During inspection stream S-C4 appeared to contain an odorous white substance (potentially milk from dairy farm upstream). This substance is entering this stream from an offsite source not related to pipeline activity. See photos.

GPS Location	See photo	GPS Location	See photo		
Field Station#	15314+18	Field Station#	15314+18		
Pic 7 Desc.	S-C4 entering ROW containing odorous white substance.	Pic 8 Desc.	S-C4/S-C3 confluence.		
Insert image here		Insert image here			
GPS Location		GPS Location			
Field Station#		Field Station#			
Pic 9 Desc.		Pic 10 Desc.			
Insert image here		Insert image here			
GPS Location		GPS Location			
Field Station#		Field Station#			
Pic 11 Desc.		Pic 12 Desc.

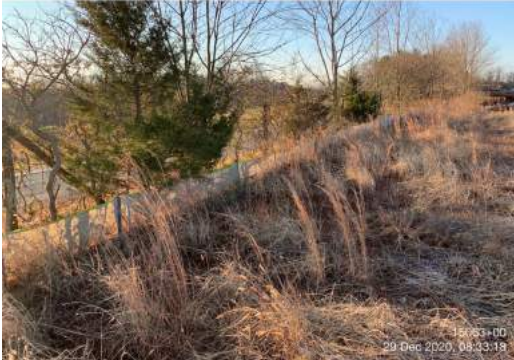
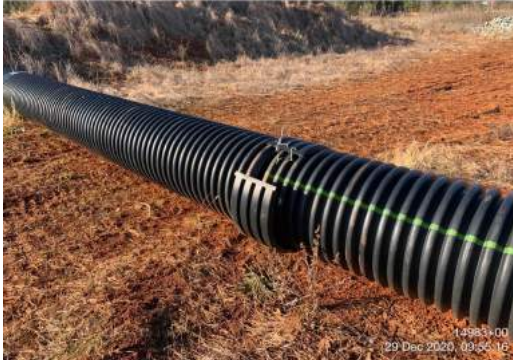
GPS Location	0	GPS Location	0		
Field Station#	15063+00	Field Station#	14983+00		
Pic 1 Desc.	P1 silt fence in acceptable condition	Pic 2 Desc.	Clean water diversion pipe requiring maintenance

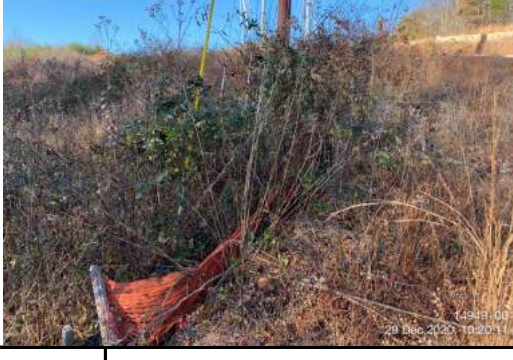
GPS Location	0	GPS Location	0		
Field Station#	14949+00	Field Station#	14949+00		
Pic 5 Desc.	Goal post requiring maintenance	Pic 6 Desc.	Safety fence requiring maintenance

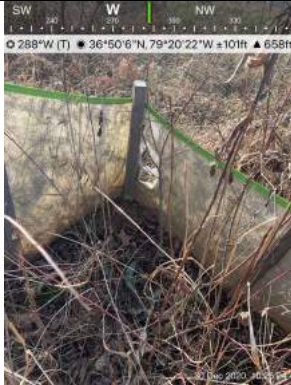
GPS Location	O	GPS Location	O		
Field Station#	21+00	Field Station#	15+70		
Pic 1 Desc.	Observing CFS that requires maintenance	Pic 2 Desc.	Observing p1 that requires

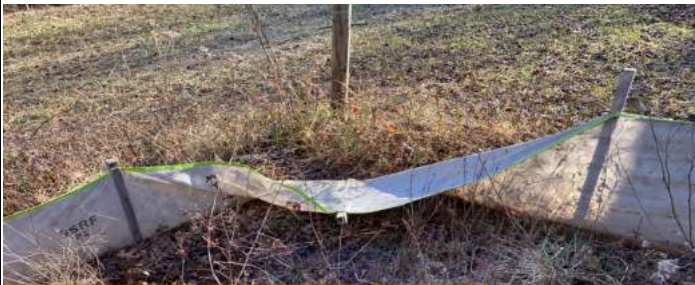
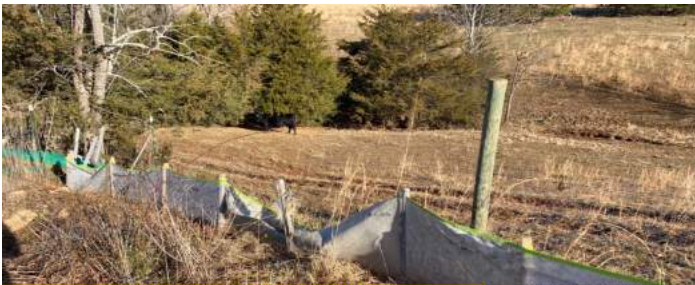
GPS Location	3		GPS Location	4	
Field Station#	14278+50		Field Station#	14297+00	
Pic 3 Desc.	Routine maintenance. Replace damaged P1 silt fence from cattle damage.		Pic 4 Desc.	Routine maintenance. Replace damaged P1 silt fence from cattle damage.

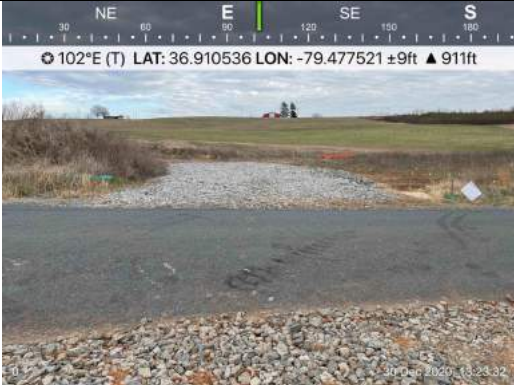
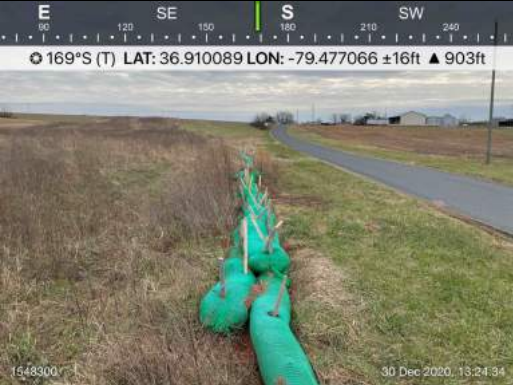
GPS Location	See photo		GPS Location	See photo	
Field Station#	15480+67		Field Station#	15483+00	
Pic 1 Desc.	RCEs in good condition at all road crossings.		Pic 2 Desc.	CFS in good condition throughout this section.

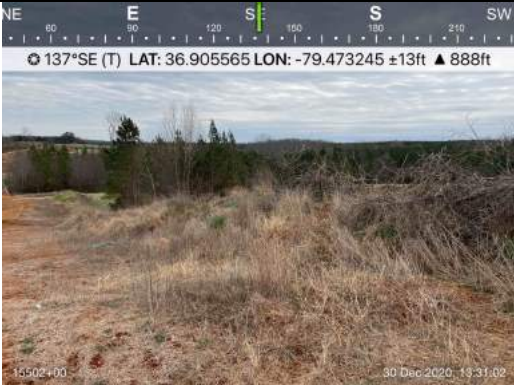
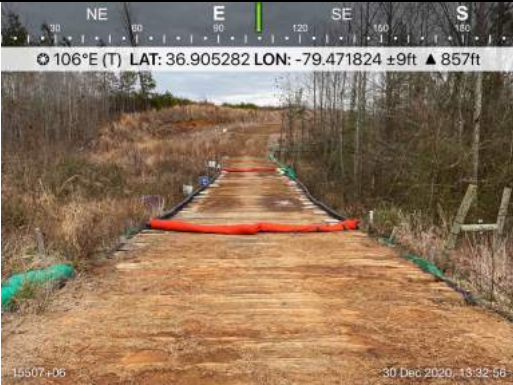
GPS Location	See photo		GPS Location	See photo	
Field Station#	15502+00		Field Station#	15507+06	
Pic 3 Desc.	Stockpiles remain stabilized.		Pic 4 Desc.	Equipment bridge ECDs in place at all stream and wetland crossings.

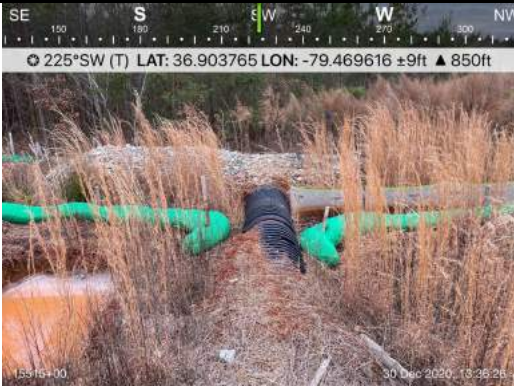
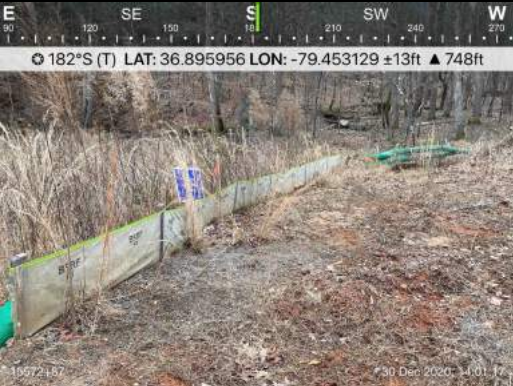
GPS Location	See photo		GPS Location	See photo	
Field Station#	15515+00		Field Station#	15572+87	
Pic 5 Desc.	CWDs functioning as intended.		Pic 6 Desc.	P1 in place at all stream and wetland buffers.

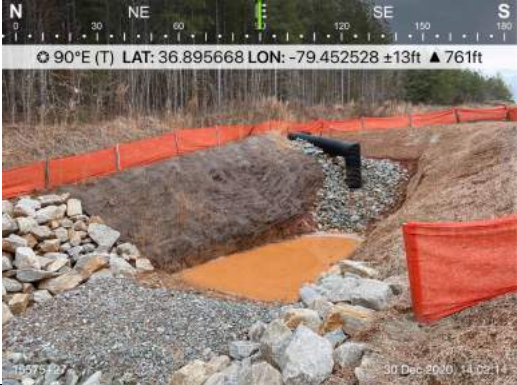
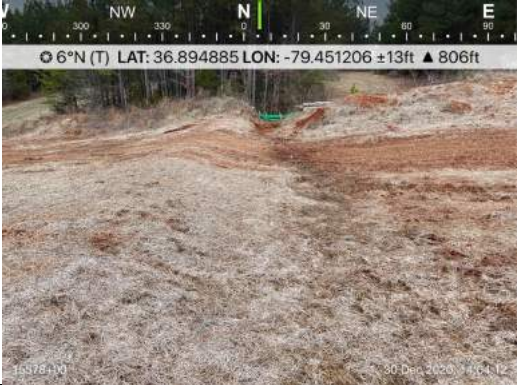
GPS Location	See photo		GPS Location	See photo	
Field Station#	15575+27		Field Station#	15578+00	
Pic 7 Desc.	Slope drain at this location in good condition and functioning.		Pic 8 Desc.	Temporary waterbars in good condition.	
Insert image here			Insert image here		
GPS Location			GPS Location		
Field Station#			Field Station#		
Pic 9 Desc.			Pic 10 Desc.		
Insert image here			Insert image here		
GPS Location			GPS Location		
Field Station#			Field Station#		
Pic 11 Desc.			Pic 12 Desc.

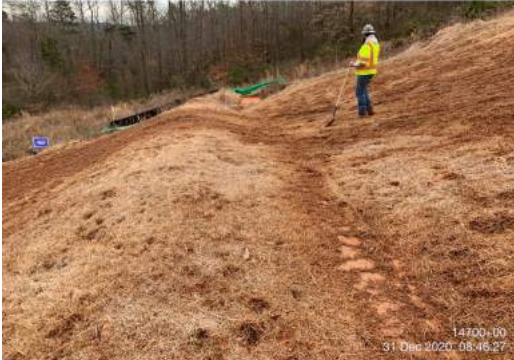
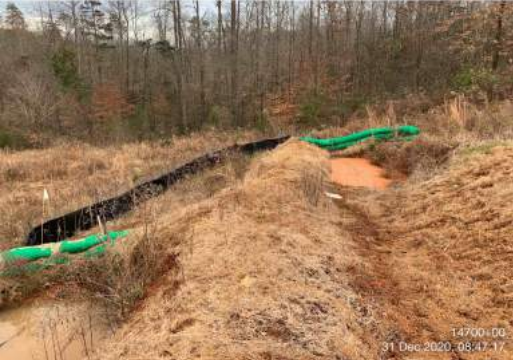
GPS Location	0	GPS Location	0		
Field Station#	14700+00	Field Station#	14700+00		
Pic 1 Desc.	Waterbar in acceptable condition	Pic 2 Desc.	Waterbar end treatment in acceptable condition

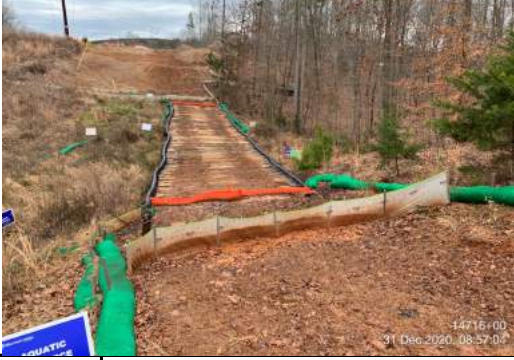
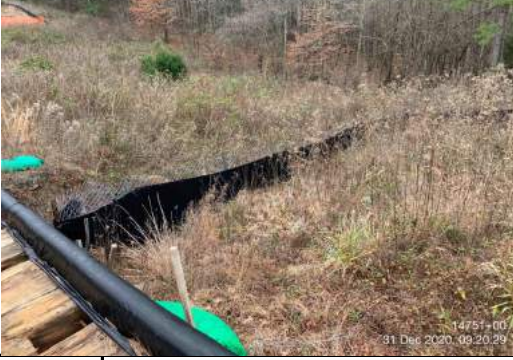
GPS Location	0	GPS Location	0		
Field Station#	14716+00	Field Station#	14751+00		
Pic 3 Desc.	P1 silt fence in acceptable condition	Pic 4 Desc.	Super silt fence in acceptable condition

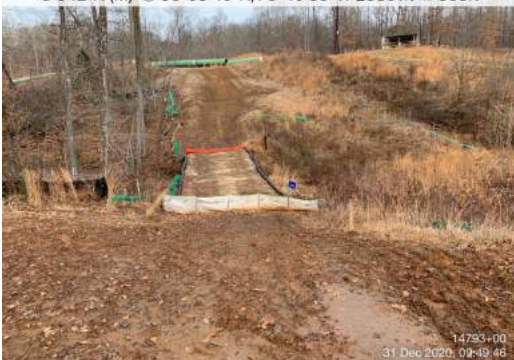
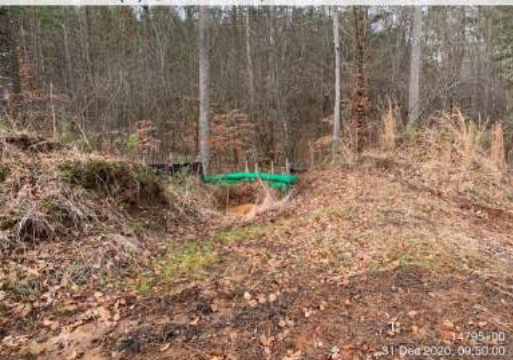
GPS Location	0	GPS Location	0		
Field Station#	14793+00	Field Station#	14795+00		
Pic 5 Desc.	Equipment bridge in acceptable condition	Pic 6 Desc.	Waterbar end treatment in acceptable condition

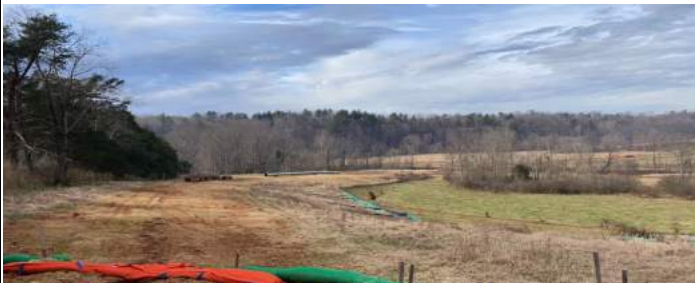
Pic 3 Desc.	ROW stabilized GAS Iron Ridge Rd. Perimeter controls in place and functional.		Pic 4 Desc.	Picture of debris in stream at ROW crossing of S-II2.

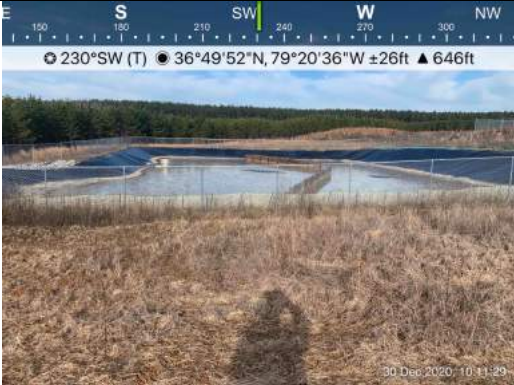
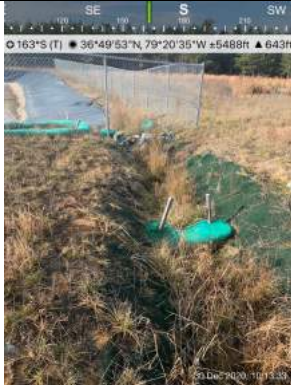
GPS Location	O	GPS Location	O		
Field Station#	00+00	Field Station#	00+00		
Pic 1 Desc.	Observing storm water pond and ECD's	Pic 2 Desc.	Observing drain and ECD's

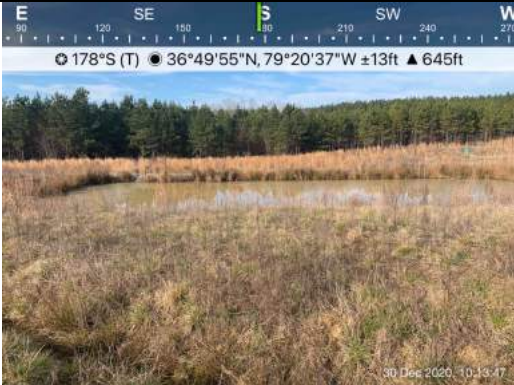
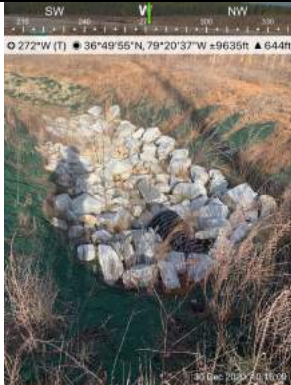
GPS Location	O	GPS Location	O		
Field Station#	00+00	Field Station#	00+00		
Pic 3 Desc.	Observing vegetation and sediment basin	Pic 4 Desc.	Observing outlet and outlet protection		
Insert image here			Insert image here		
GPS Location		GPS Location			
Field Station#		Field Station#			
Pic 5 Desc.		Pic 6 Desc.
