Visual Site Inspection Report

Project Name	H-600 Pipeline Spread I	AFE	124300139	Spread	H-600 Pipeline Spread I
Contractor	Precision			Report #	16917
Inspector	Justin Burch			Date/Time	11/16/2020 8:23 AM
Permit #	TBD	Inspection Type	VA SWPP	Station Begin	14802+19
State	VA	Inspection Area	Full	Station End	14928+52
County	Franklin	Ground	Wet	Temperature (°F)	59.00
Municipality	N/A	Weather	Sunny	Rain Gauge (in)	5.00
				Rain Accumulation Time (days)	8.00

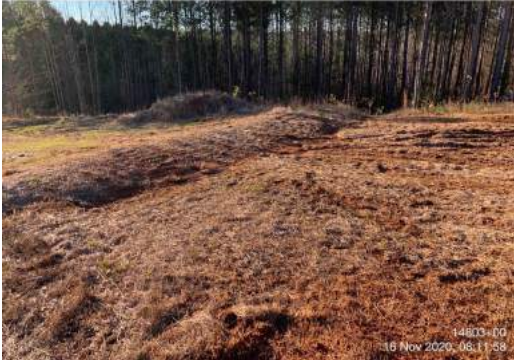
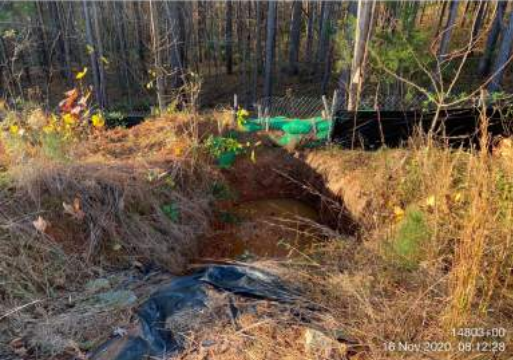
GPS Location	0	GPS Location	0		
Field Station#	14803+00	Field Station#	14803+00		
Pic 1 Desc.	Waterbar in acceptable condition		Pic 2 Desc.	Waterbar end treatment in acceptable condition

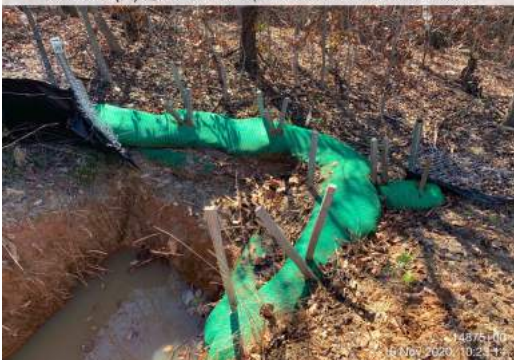
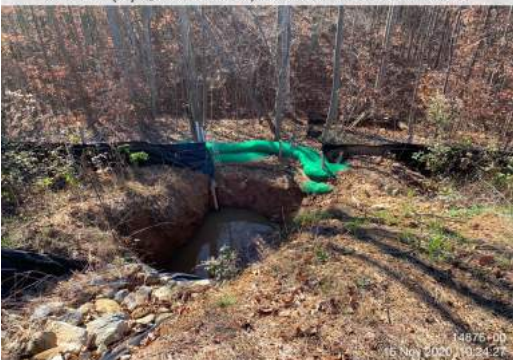
GPS Location	0	GPS Location	0		
Field Station#	14875+00	Field Station#	14876+00		
Pic 3 Desc.	Accumulated sediment on CFS at waterbar end treatment		Pic 4 Desc.	Accumulated sediment on CFS at waterbar end treatment

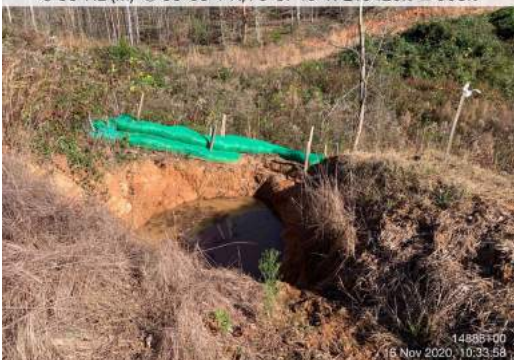
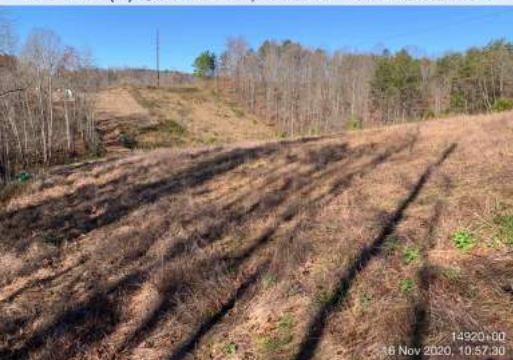
GPS Location	0	GPS Location	0		
Field Station#	14888+00	Field Station#	14920+00		
Pic 5 Desc.	Accumulated sediment on CFS at waterbar end treatment		Pic 6 Desc.	Permanent vegetative stabilization in acceptable condition

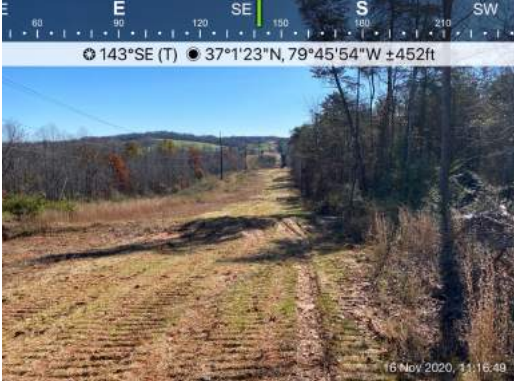
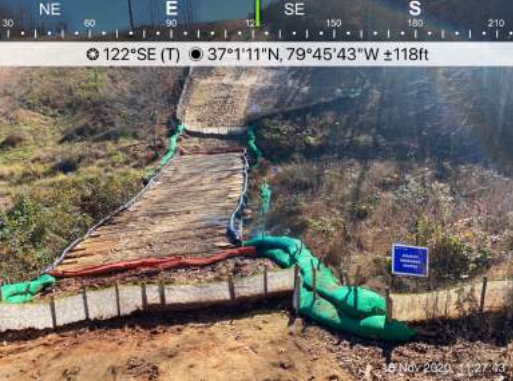
GPS Location	0	GPS Location	0		
Field Station#	14475+00	Field Station#	14486+62		
Pic 1 Desc.	Approximately 14475+00. Overview of ROW. ROW temporarily stabilized and has temporary vegetation growing.		Pic 2 Desc.	Approximately 14486+62. Overview of stream crossing, equipment bridge and ECDs at stream S-G22.

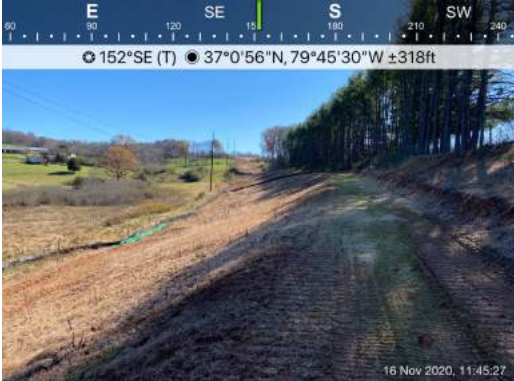
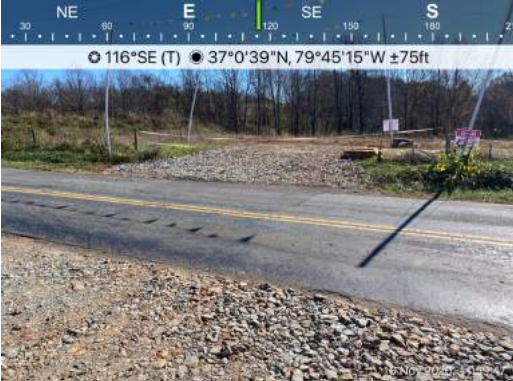
GPS Location	0	GPS Location	0		
Field Station#	14505+00	Field Station#	14525+00		
Pic 3 Desc.	Approximately 14505+00. Overview of ROW. ROW temporarily stabilized and has temporary vegetation growing.		Pic 4 Desc.	Approximately 14525+00. Overview of road crossing and RCEs. RCEs installed and appears to be functioning correctly at time of inspection.

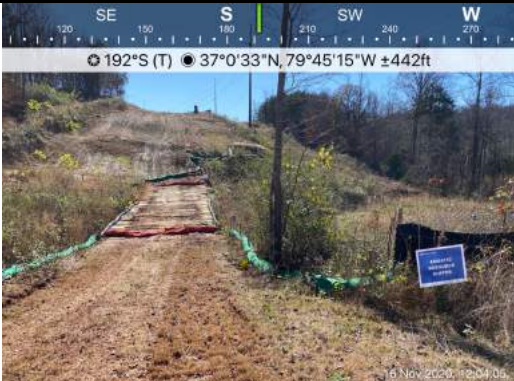
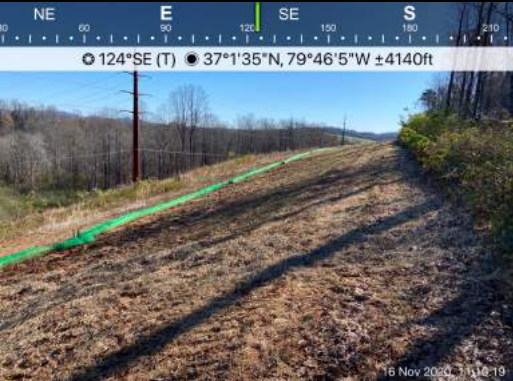
GPS Location	0	GPS Location	0		
Field Station#	14531+58	Field Station#	14457+00		
Pic 5 Desc.	Approximately 14531+58. Overview of stream crossing, equipment bridge and ECDs at stream S-G18.		Pic 6 Desc.	Approximately 14457+00. Overview of ROW. ROW temporarily stabilized and has temporary vegetation growing.

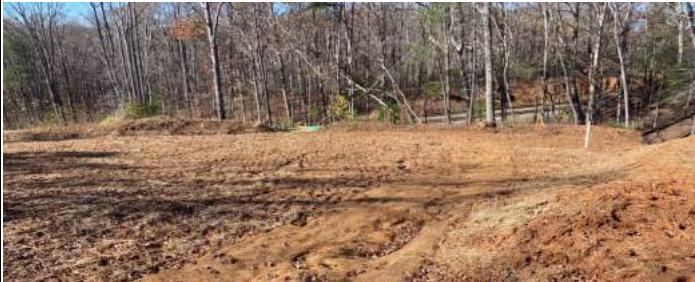
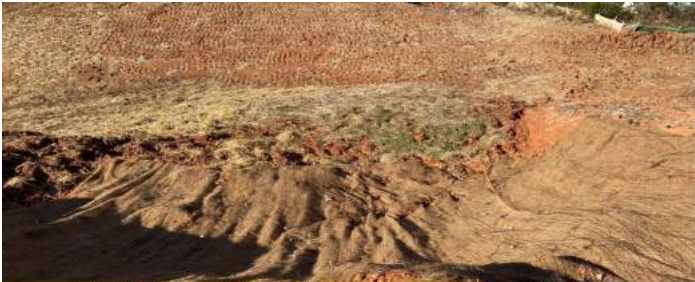
37°3'46" N 79°52'41" W 290°W COURSE 180° GPS Rocky Mount, VA 24151, United States 11.16.2020 11:54:17 Accur +/-134.5 Ft ALT 1153 Ft			37°3'48" N 79°52'37" W 329°NW COURSE 180° GPS Rocky Mount, VA 24151, United States 11.16.2020 11:55:03 Accur +/-229.4 Ft ALT 1153 Ft		
GPS Location	1	GPS Location	2		
Field Station#	14044+00	Field Station#	14044+00		
Pic 1 Desc.	Contractor repaired and stabilized erosion rills across ROW per punch list item		Pic 2 Desc.	Contractor repaired and stabilized erosion rills across ROW per punch list item

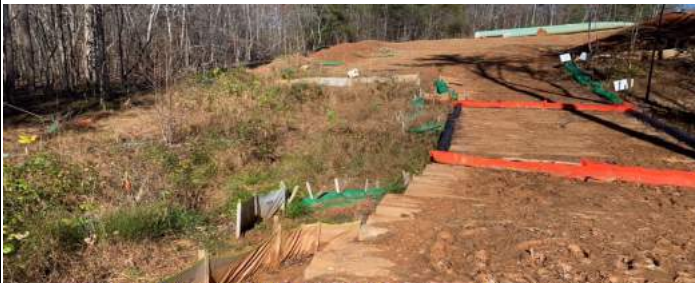
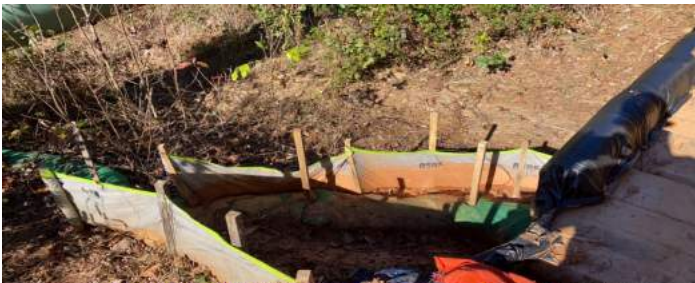
GPS Location	3	GPS Location	4		
Field Station#	14050+00	Field Station#	14045+50		
Pic 3 Desc.	Contractor repaired damaged P1 silt fence per punch list item		Pic 4 Desc.	Contractor cleaned out ECDs at bridge crossing per punch list item

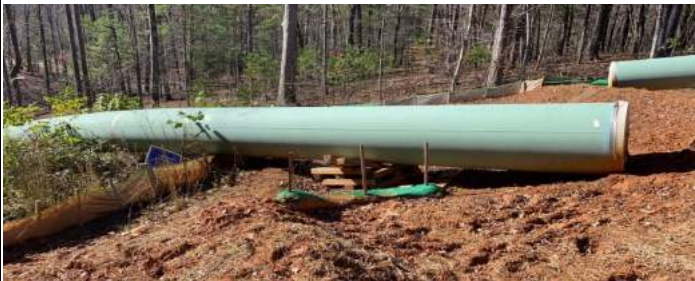
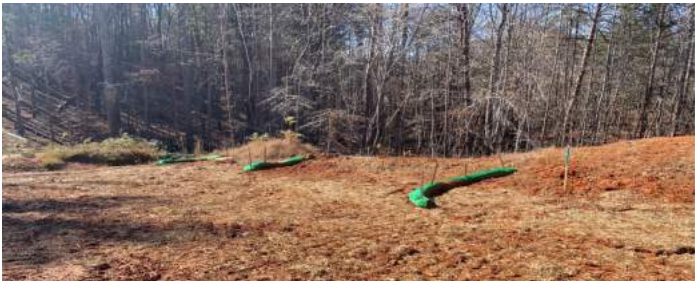
37°3'53" N 79°52'40" W 269°W COURSE 2° GPS 1345 Bonbrook Mill Rd, Rocky Mount, VA 24151, United States 11.16.2020 11:51:25 Accur +/-167.2 Ft ALT 1154 Ft			37°3'54" N 79°52'41" W 229°SW COURSE 0° GPS 1345 Bonbrook Mill Rd, Rocky Mount, VA 24151, United States 11.16.2020 11:47:18 Accur +/-70.0 Ft ALT 0 Ft		
GPS Location	5	GPS Location	6		
Field Station#	14046+00	Field Station#	14051+00		
Pic 5 Desc.	Contractor cleaned out overtopped CFS J Hook per punch list item		Pic 6 Desc.	Contractor cleaned out CFS check dams per punch list item

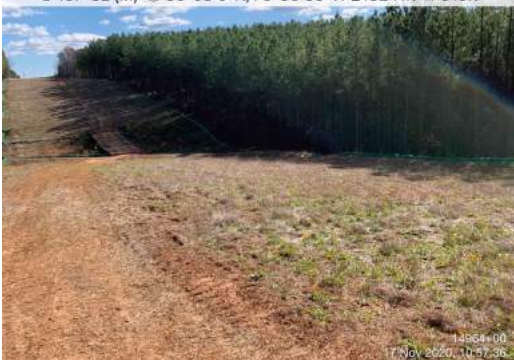
GPS Location	0	GPS Location	0		
Field Station#	14964+00	Field Station#	14932+00		
Pic 5 Desc.	Permanent vegetative stabilization in acceptable condition		Pic 6 Desc.	Waterbar in acceptable condition

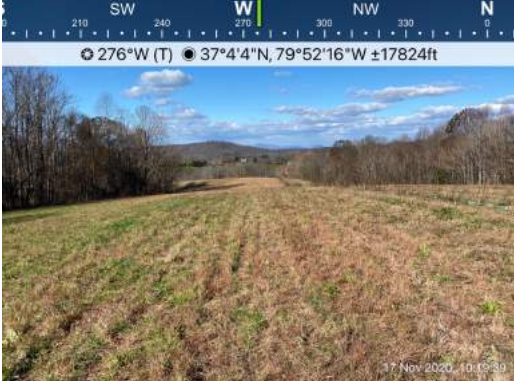
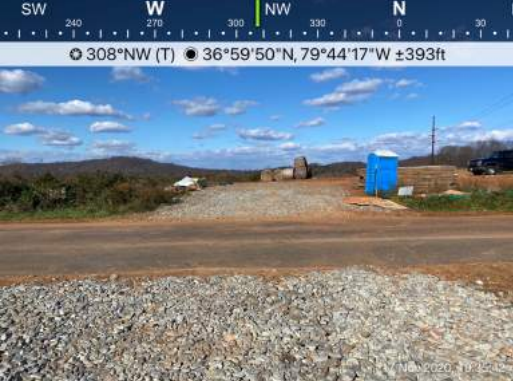
GPS Location	0	GPS Location	0		
Field Station#	14625+00	Field Station#	14599+00		
Pic 1 Desc.	Approximately 14625+00. Overview of ROW. ROW temporarily stabilized and has temporary vegetation growing.		Pic 2 Desc.	Approximately 14599+00. Overview of road crossing and RCEs. RCEs installed and appears to be functioning correctly at time of inspection.

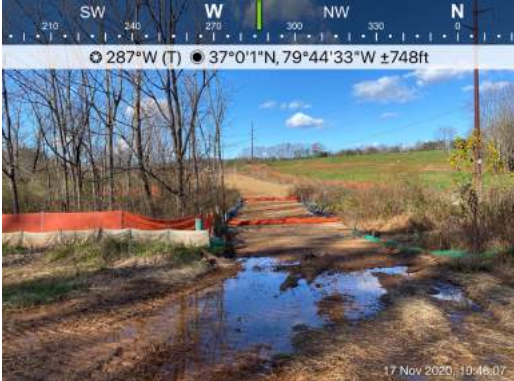
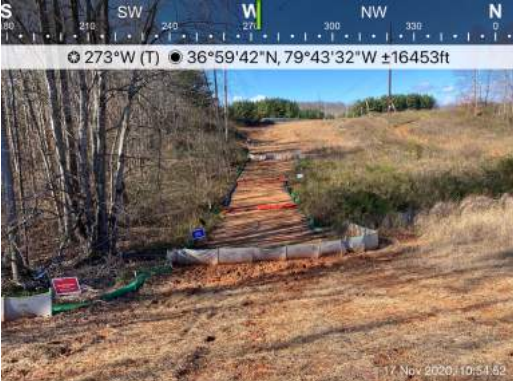
GPS Location	0	GPS Location	0		
Field Station#	14582+85	Field Station#	14568+10		
Pic 3 Desc.	Approximately 14582+45. Overview of stream crossing, equipment bridge and ECDs at stream S-E17.		Pic 4 Desc.	Approximately 14568+10. Overview of stream crossing, equipment bridge and ECDs at stream S-E18.

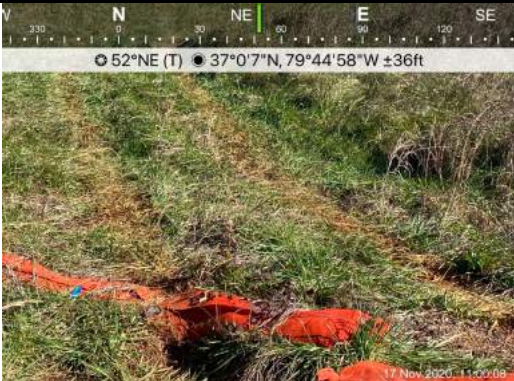
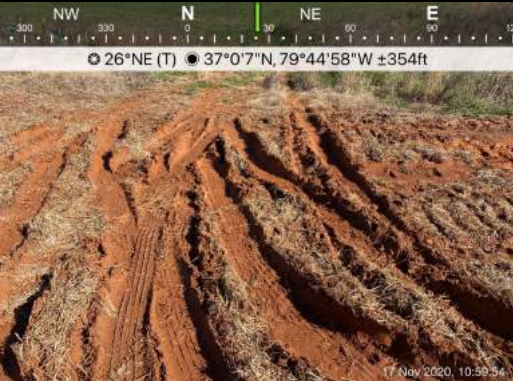
GPS Location	0	GPS Location	0		
Field Station#	14562+50	Field Station#	14562+50		
Pic 5 Desc.	Approximately 14562+50. Observed ruts across ROW and muddy tracks beyond the LOD. Ruts and tracks appear to have been made by a third party.		Pic 6 Desc.	Approximately 14562+50. Observed ruts across ROW and muddy tracks beyond the LOD. Ruts and tracks appear to have been made by a third party.

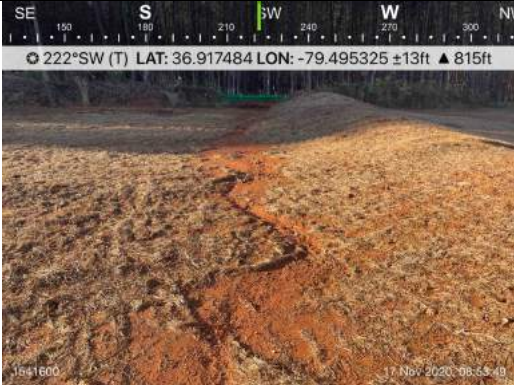
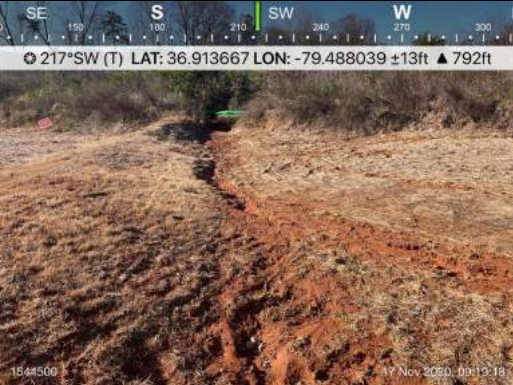
GPS Location	1	GPS Location	2		
Field Station#	15416+00	Field Station#	15445+00		
Pic 1 Desc.	Erosion in waterbar channel. Channel needs to be regraded and stabilized.		Pic 2 Desc.	Erosion in waterbar channel. Channel needs to be regraded and stabilized.

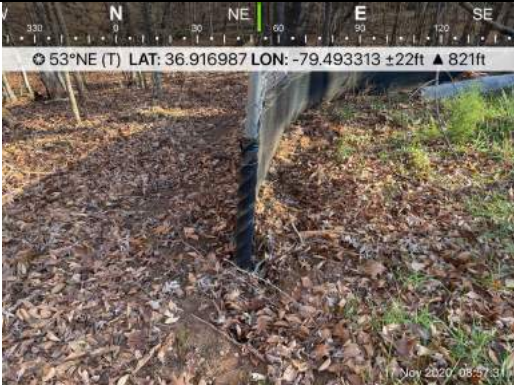
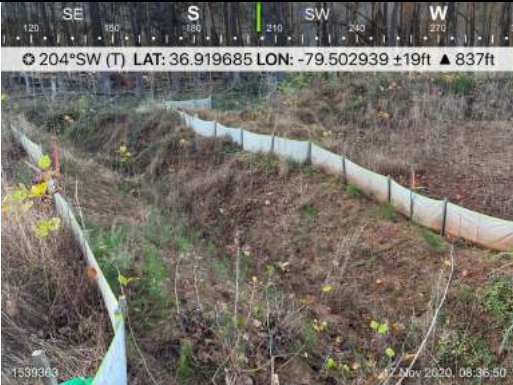
GPS Location	3	GPS Location	4		
Field Station#	15424+00	Field Station#	15393+63		
Pic 3 Desc.	SSF undermined and needs to be back filled.		Pic 4 Desc.	P1 in good condition throughout this section.

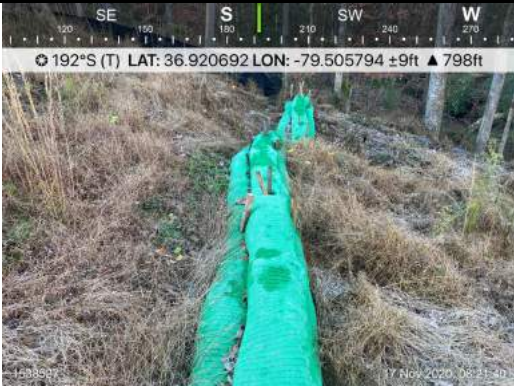
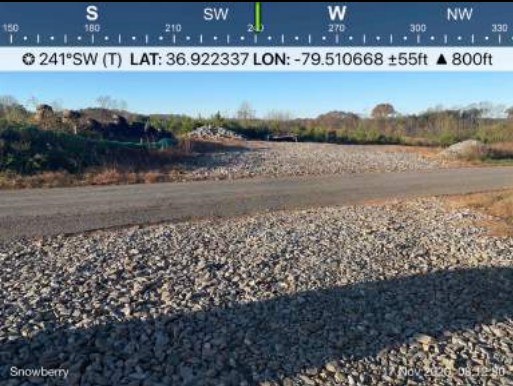
GPS Location	5	GPS Location	6		
Field Station#	15385+27	Field Station#	15370+62		
Pic 5 Desc.	CFS in good condition throughout this section.		Pic 6 Desc.	CE's in good condition.

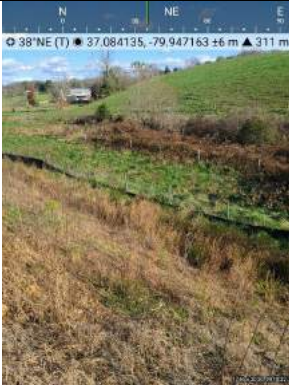
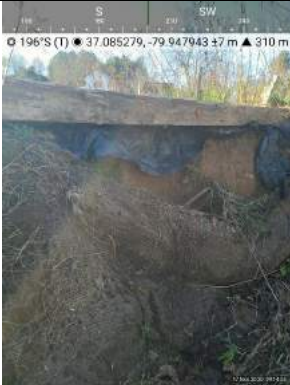
GPS Location	00000	GPS Location	00000		
Field Station#	13700+00	Field Station#	13692+77		
Pic 1 Desc.	Wire back silt fence requires maintenance, documented by the EI and sent in to be added to the punch list		Pic 2 Desc.	Erosion control blanket needs repair on S-E28 where equipment mats were removed during equipment bridge repairs previously

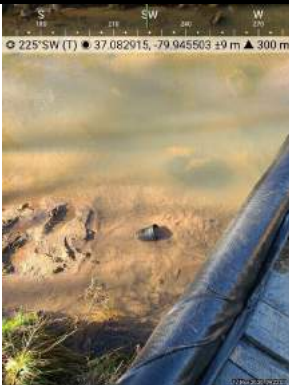
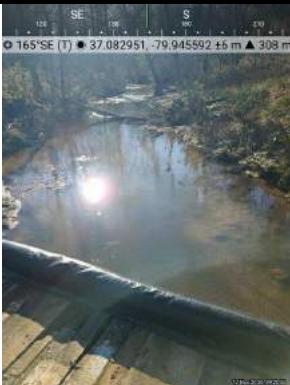
GPS Location	0000	GPS Location	0000		
Field Station#	13705+05	Field Station#	13705+07		
Pic 3 Desc.	Splash protection needs removed from stream S-E28, documented by the EI and sent in to be added to the punch list		Pic 4 Desc.	Stream observation photo facing downstream by the EI during routine inspection today

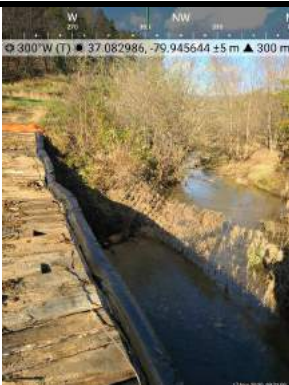
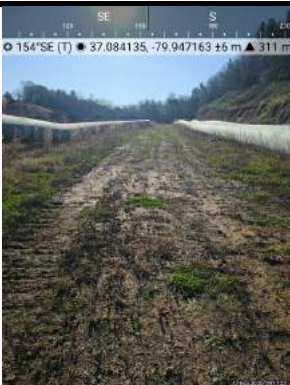
GPS Location	0000	GPS Location	0000		
Field Station#	13705+07	Field Station#	13698+50		
Pic 5 Desc.	Stream observation photo facing upstream by the EI, no environmental issues observed at the time of inspection.		Pic 6 Desc.	Row photo showing vegetation during routine inspection today.

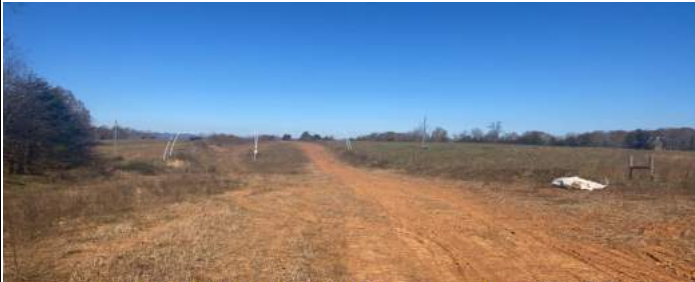
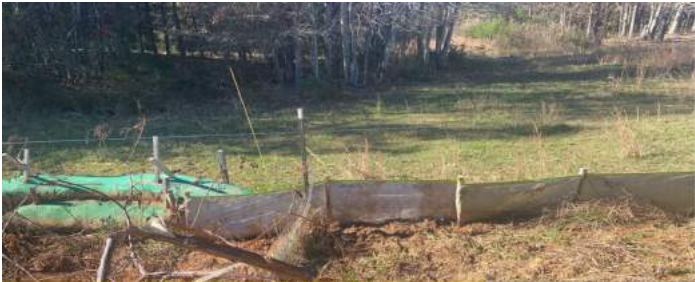
37°2'36" N 79°48'37" W 351°N COURSE 159° GPS 955 Greenway Rd, Glade Hill, VA 24092, United States 11.18.2020 10:40:33 Accur +/-159.4 Ft ALT 1068 Ft			37°2'37" N 79°48'39" W 246°SW COURSE 0° GPS 955 Greenway Rd, Glade Hill, VA 24092, United States 11.18.2020 10:35:14 Accur +/-63.3 Ft ALT 0 Ft		
GPS Location	1	GPS Location	2		
Field Station#	14308+00	Field Station#	14306+00		
Pic 1 Desc.	ROW travel lane will need to be seeded and stabilized within appropriate timeframe		Pic 2 Desc.	Contractor replaced damaged row of P1 silt fence per punch list item

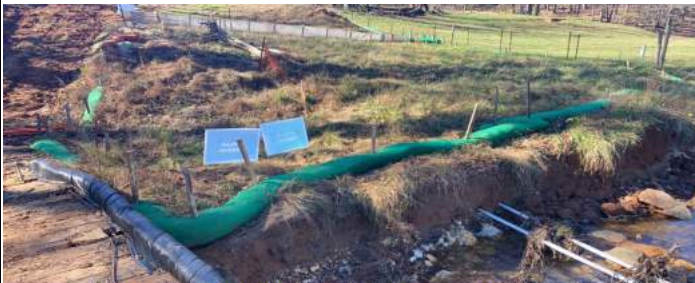
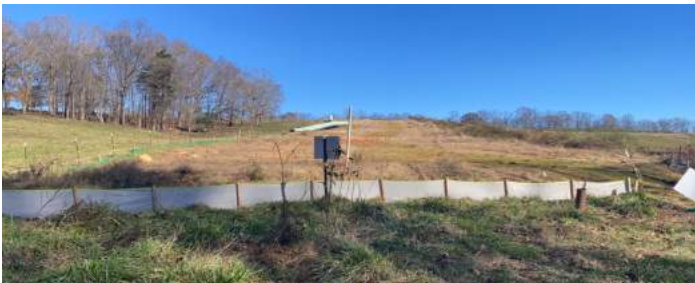
GPS Location	3	GPS Location	4		
Field Station#	14190+14	Field Station#	14190+75		
Pic 3 Desc.	Contractor repaired perimeter CFS that had fallen into stream per punch list item		Pic 4 Desc.	Contractor replaced damaged row of P1 silt fence per punch list item

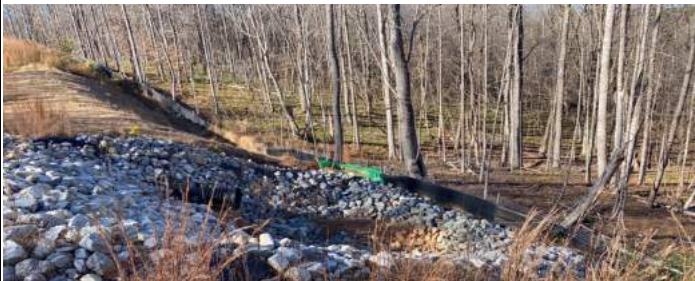
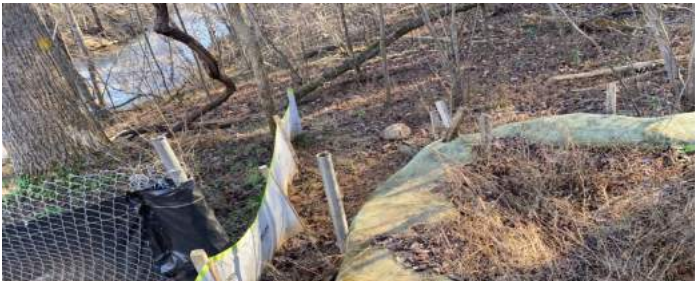
37°3'19" N 79°49'56" W 329°NW COURSE 150° GPS Rocky Mount, VA 24151, United States 11.18.2020 13:38:03 Accur +/-97.5 Ft ALT 0 Ft			37°3'17" N 79°49'49" W 162°S COURSE 342° GPS Rocky Mount, VA 24151, United States 11.18.2020 13:45:32 Accur +/-108.8 Ft ALT 972 Ft		
GPS Location	5	GPS Location	6		
Field Station#	14226+00	Field Station#	14232+50		
Pic 5 Desc.	Plunge pool performing intended function along edge of ROW		Pic 6 Desc.	Contractor repaired damaged row of P1 silt fence per punch list item

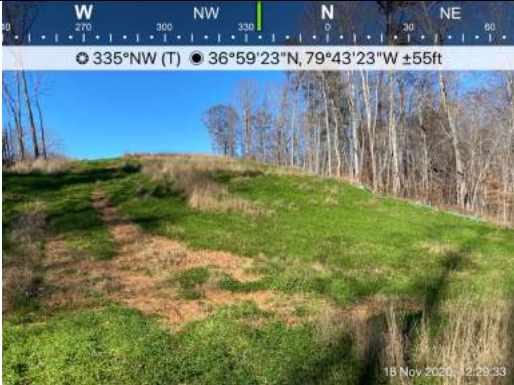
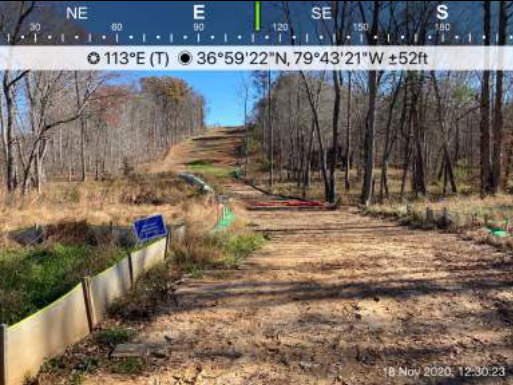
GPS Location	0	GPS Location	0		
Field Station#	14653+00	Field Station#	14656+94		
Pic 1 Desc.	Approximately 14653+00. Overview of ROW. ROW temporarily stabilized and has temporary vegetation growing.		Pic 2 Desc.	Approximately 14656+94. Overview of stream crossing, equipment bridge and ECDs at stream S-H38.

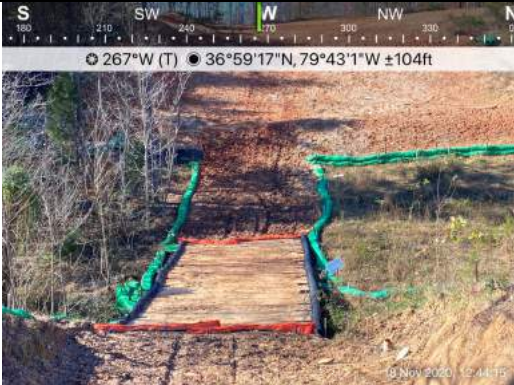
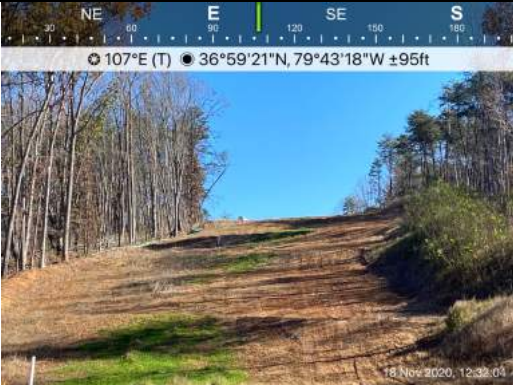
GPS Location	0	GPS Location	0		
Field Station#	14673+10	Field Station#	14660+00		
Pic 3 Desc.	Approximately 14673+10. Overview of stream crossing, equipment bridge and ECDs at stream S-H37.		Pic 4 Desc.	Approximately 14660+00. Overview of ROW. ROW temporarily stabilized and has temporary vegetation growing.

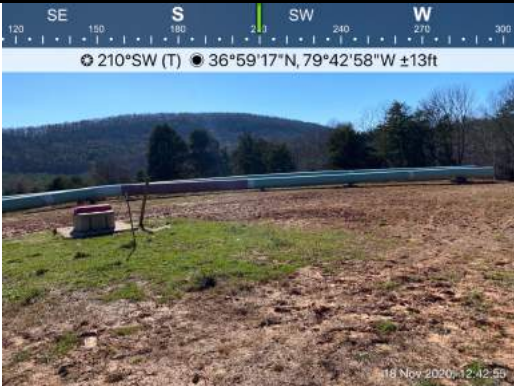
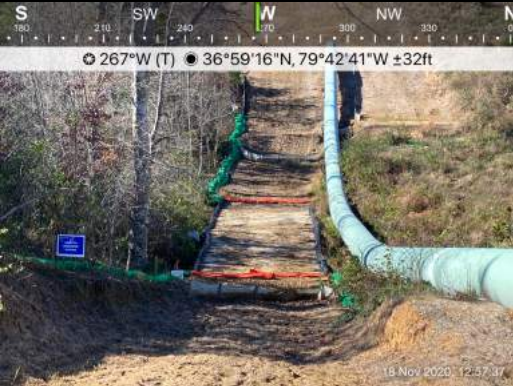
GPS Location	0	GPS Location	0		
Field Station#	14676+50	Field Station#	14689+36		
Pic 5 Desc.	Approximately 14676+50. Overview of ROW. ROW temporarily stabilized and has temporary vegetation growing.		Pic 6 Desc.	Approximately 14689+36. Overview of stream crossing, equipment bridge and ECDs at stream S-H34.

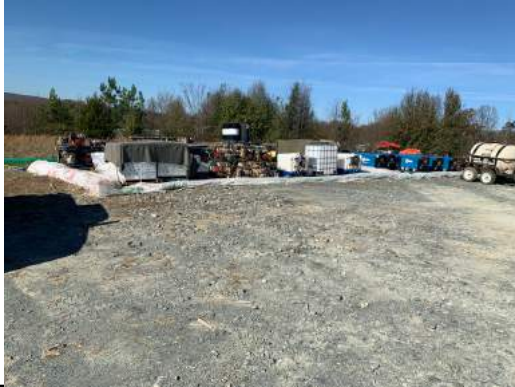
GPS Location	000000000000	GPS Location	000000000000		
Field Station#	0000+00	Field Station#	0000+00		
Pic 3 Desc.	Secondary containment structure for fuel cell in good condition.		Pic 4 Desc.	Secondary containment structure on north end of gravel yard in good condition.	
 		Insert image here			
GPS Location	000000000000	GPS Location			
Field Station#	0000+00	Field Station#			
Pic 5 Desc.	Perimeter ECD's on northwest corner of gravel yard over 50% full requires maintenance.		Pic 6 Desc.

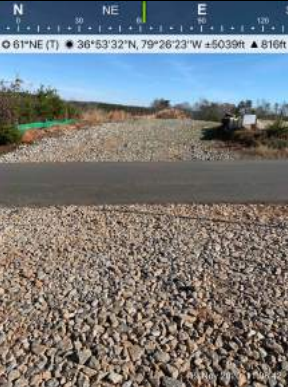
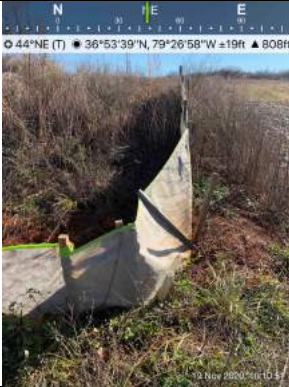
GPS Location	O	GPS Location	O		
Field Station#	15619+48	Field Station#	15584+50		
Pic 1 Desc.	Observing RCE	Pic 2 Desc.	Observing p1 that requires maintenance.

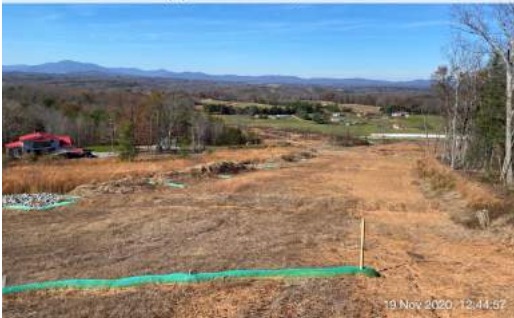
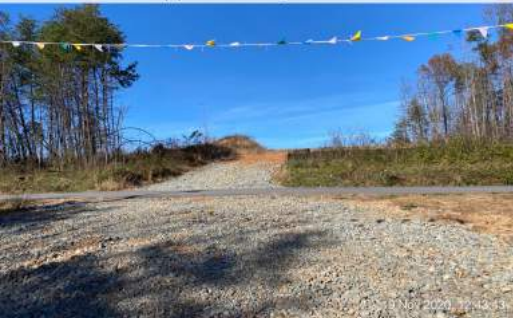
GPS Location	0	GPS Location	0		
Field Station#	14327+00	Field Station#	14333+50		
Pic 1 Desc.	Approximately 14327+00. Overview of ROW. ROW temporarily stabilized and has temporary vegetation growing.		Pic 2 Desc.	Approximately 14333+50. Overview of road crossing and RCEs. RCEs installed and appears to be functioning correctly at time of inspection.

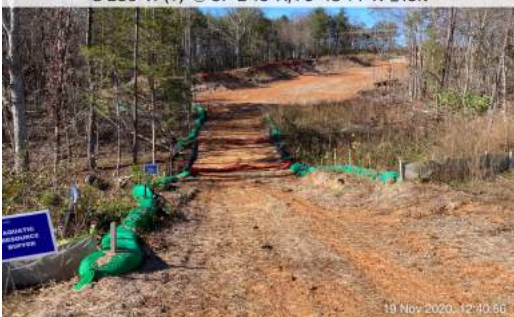
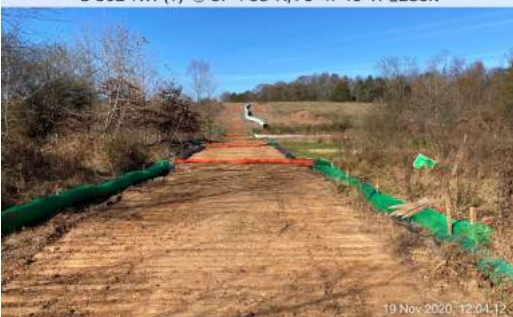
GPS Location	0	GPS Location	0		
Field Station#	14338+56	Field Station#	14391+53		
Pic 3 Desc.	Approximately 14338+56. Overview of stream crossing, equipment bridge and ECDs at stream S-A36.		Pic 4 Desc.	Approximately 14391+53. Overview of stream crossing, equipment bridge and ECDs at stream S-A41.

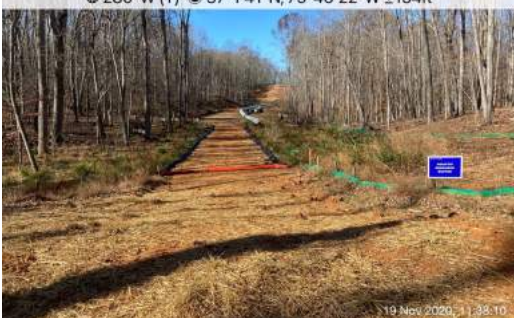
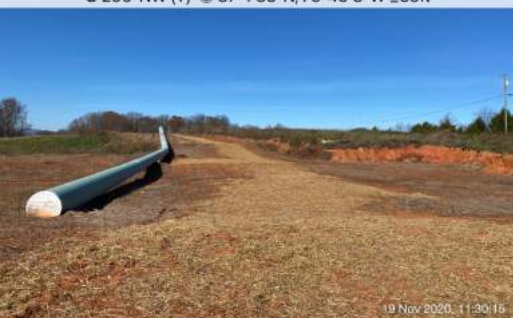
GPS Location	0	GPS Location	0		
Field Station#	14438+49	Field Station#	14450+00		
Pic 5 Desc.	Approximately 14438+49. Overview of stream crossing, equipment bridge and ECDs at stream S-IJ47.		Pic 6 Desc.	Approximately 14450+00. Overview of ROW. ROW temporarily stabilized and has temporary vegetation growing. Travel lane appears to be needed and stabilized.

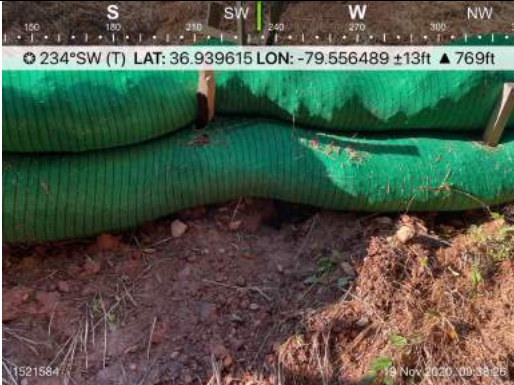
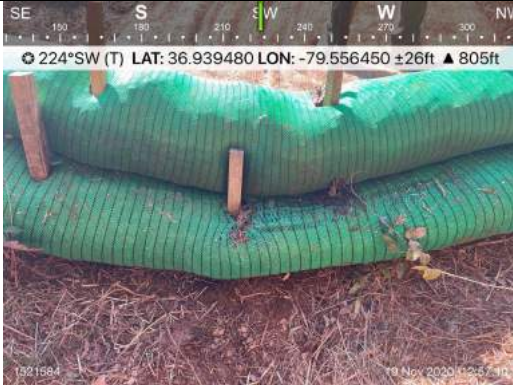
GPS Location	1	GPS Location	2		
Field Station#	15215+84	Field Station#	15215+84		
Pic 1 Desc.	Undermined CFS at this location.	Pic 2 Desc.	Environmental crew has corrected this issue.

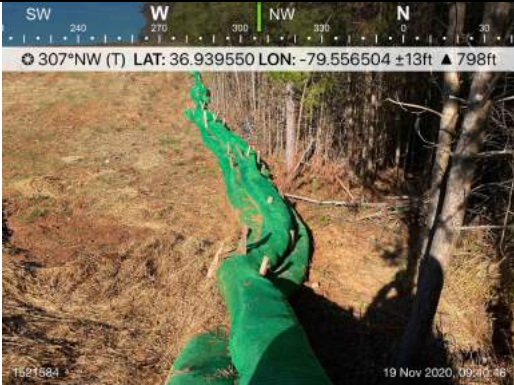
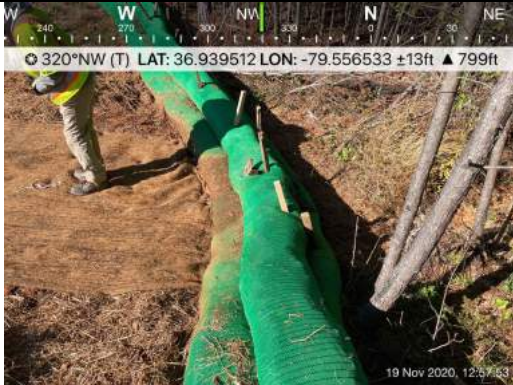
GPS Location	3	GPS Location	4		
Field Station#	15215+84	Field Station#	15215+84		
Pic 3 Desc.	CFS displaced and requires maintenance.	Pic 4 Desc.	Environmental crew has corrected this issue.

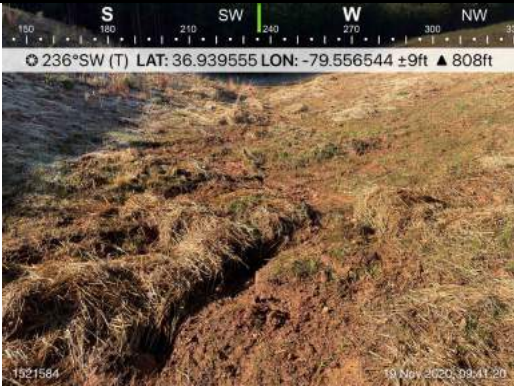
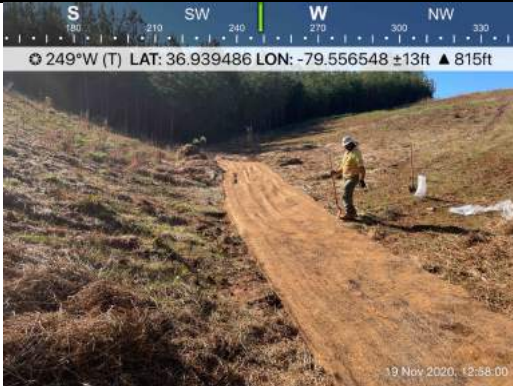
GPS Location	5	GPS Location	6		
Field Station#	15215+84	Field Station#	15215+84		
Pic 5 Desc.	Erosion within drainage channel needs to be regraded and stabilized.	Pic 6 Desc.	Environmental crew has corrected this issue.

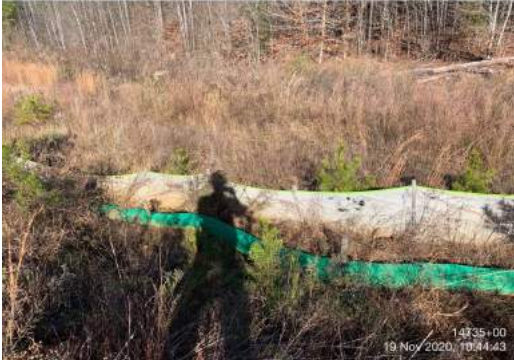
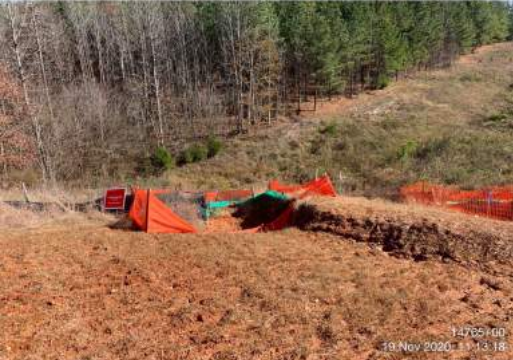
GPS Location	0	GPS Location	0		
Field Station#	14735+00	Field Station#	14765+00		
Pic 1 Desc.	P1 silt fence with holes and broken stakes	Pic 2 Desc.	Safety fence around waterbar sump requires maintenance

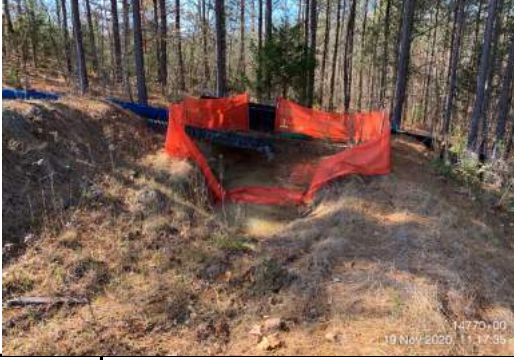
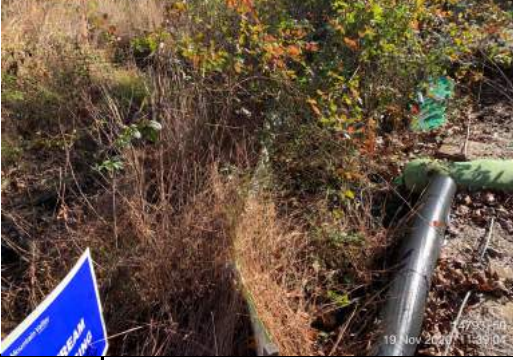
GPS Location	0	GPS Location	0		
Field Station#	14770+00	Field Station#	14793+50		
Pic 3 Desc.	Safety fence around waterbar sump requires maintenance	Pic 4 Desc.	P1 silt fence with several broken stakes adjacent to stream S-H24

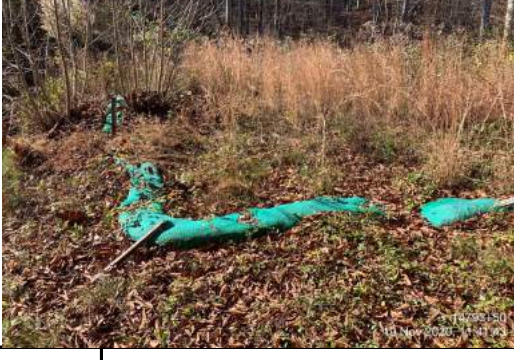
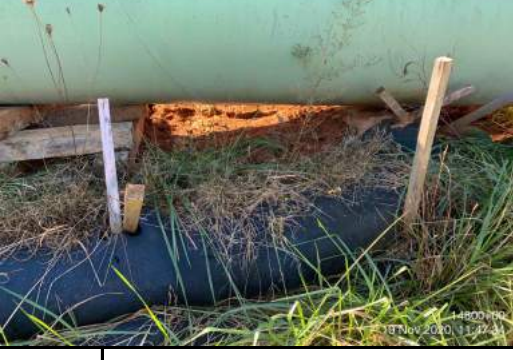
GPS Location	0	GPS Location	0		
Field Station#	14793+50	Field Station#	14800+00		
Pic 5 Desc.	CFS with holes and missing stakes adjacent to stream S-H24	Pic 6 Desc.	CFS is full of sediment
