Visual Site Inspection Report

Project Name	H-600 Pipeline Spread I	AFE	124300139	Spread	H-600 Pipeline Spread I
Contractor	Precision			Report #	17208
Inspector	John White			Date/Time	11/23/2020 11:56 AM
Permit #	TBD	Inspection Type	VA SWPP	Station Begin	15772+27
State	VA	Inspection Area	Full	Station End	15947+64
County	Pittsylvania	Ground	Dry	Temperature (°F)	53.00
Municipality	Chatham	Weather	Sunny	Rain Gauge (in)	0.00
				Rain Accumulation Time (days)	6.00

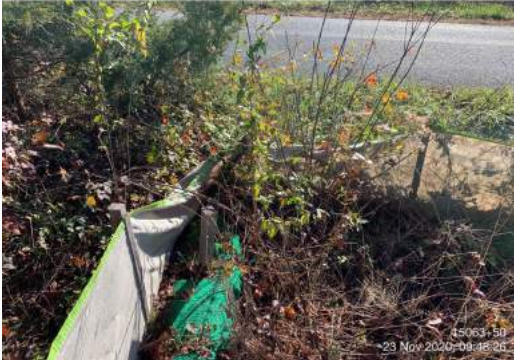
GPS Location	0	GPS Location	0		
Field Station#	15063+50	Field Station#	15063+50		
Pic 1 Desc.	P1 silt fence requires maintenance	Pic 2 Desc.	P1 silt fence was repaired

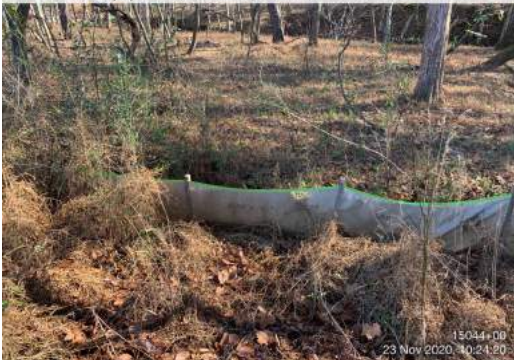
GPS Location	0	GPS Location	0		
Field Station#	15044+00	Field Station#	15042+00		
Pic 3 Desc.	P1 silt fence has multiple locations with holes and broken stakes	Pic 4 Desc.	Waterbar end treatment in acceptable condition

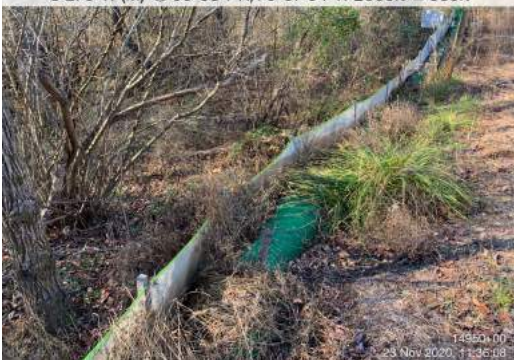
GPS Location	0	GPS Location	0		
Field Station#	14950+00	Field Station#	14929+00		
Pic 5 Desc.	P1 silt fence has several broken stakes	Pic 6 Desc.	Waterbar in acceptable condition

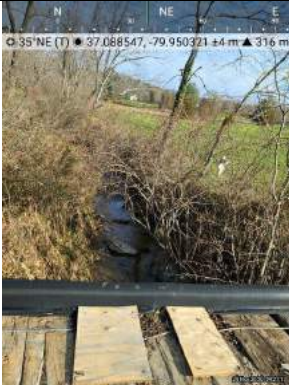
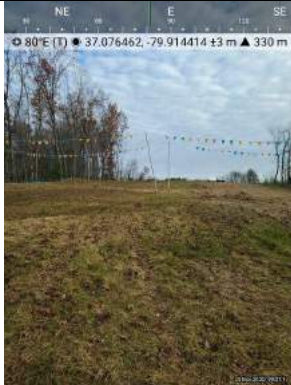
GPS Location	00000	GPS Location	00000		
Field Station#	13678+71	Field Station#	13742+39		
Pic 1 Desc.	Stream observation photo facing upstream during routine inspection today, no issues observed at the time of inspection.		Pic 2 Desc.	EI noticed new vegetation growing after recent work activities completed in the area.

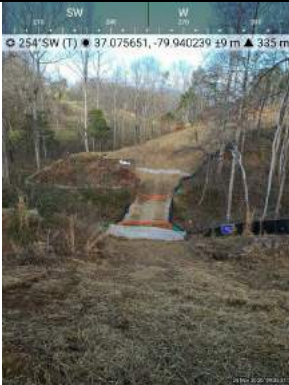
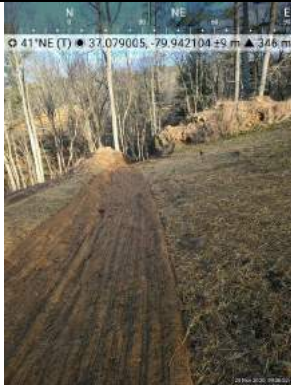
GPS Location	00000	GPS Location	00000		
Field Station#	13728+99	Field Station#	13731+00		
Pic 3 Desc.	Row photo showing equipment bridge and ECDs in place and functioning, EI monitored row conditions being stabilized		Pic 4 Desc.	Monitored erosion blanket installed after work activities completed

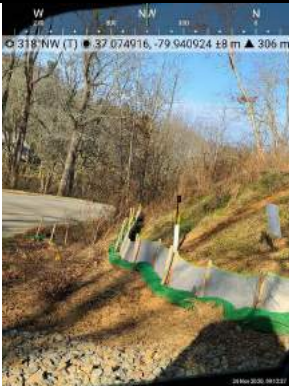
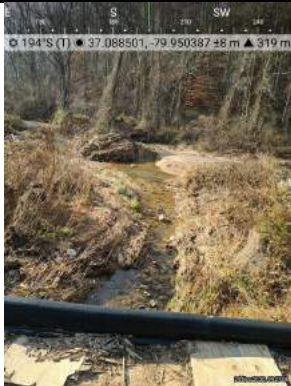
GPS Location	000000	GPS Location	0000		
Field Station#	13748+05	Field Station#	13678+71		
Pic 5 Desc.	Monitored ECDs throughout inspection today, no issue observed at the time of inspection		Pic 6 Desc.	Stream observation photo facing downstream during routine inspection of the row, no issue observed at the time of inspection

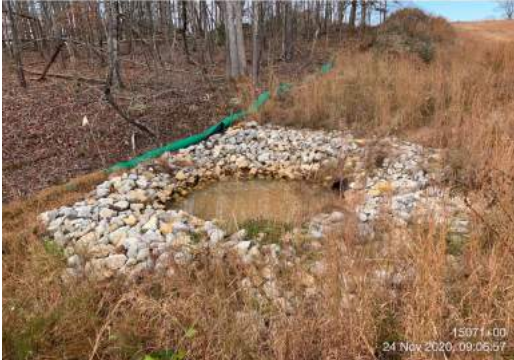
GPS Location	0	GPS Location	0		
Field Station#	15071+00	Field Station#	15072+65		
Pic 1 Desc.	Clean water diversion plunge pool in acceptable condition	Pic 2 Desc.	P1 silt fence has a hole in it

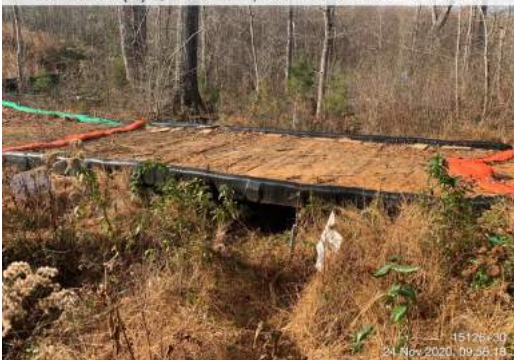
GPS Location	0	GPS Location	0		
Field Station#	15126+30	Field Station#	15096+00		
Pic 3 Desc.	Equipment bridge in acceptable condition	Pic 4 Desc.	Permanent vegetative stabilization in acceptable condition

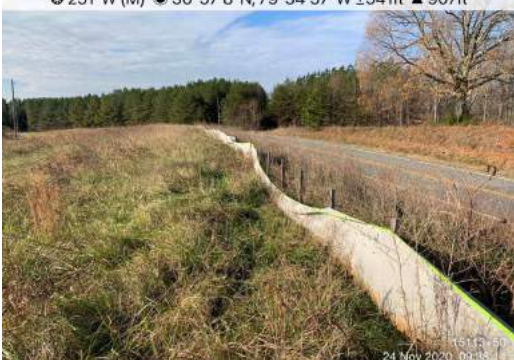
GPS Location	0	GPS Location	0		
Field Station#	15113+50	Field Station#	15141+50		
Pic 5 Desc.	P1 silt fence requires maintenance in several locations at anode bed	Pic 6 Desc.	Super silt fence in acceptable condition

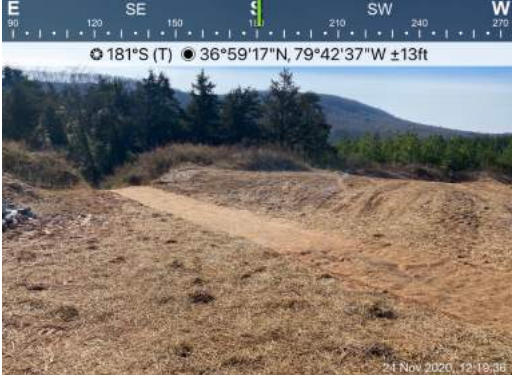
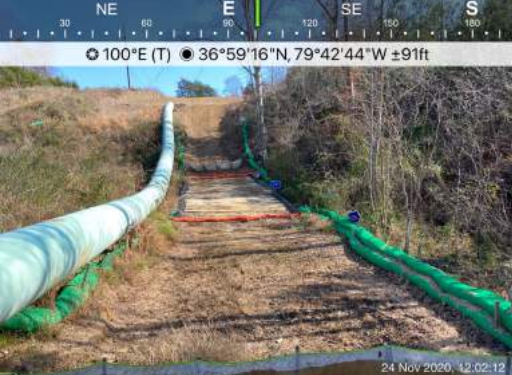
GPS Location	0	GPS Location	0	Field Station#	14692+00
Pic 1 Desc.	Approximately 14692+00. Overview of ROW. ROW temporarily stabilized and has temporary vegetation growing. Water bar and sump installed and appear to be functioning correctly.

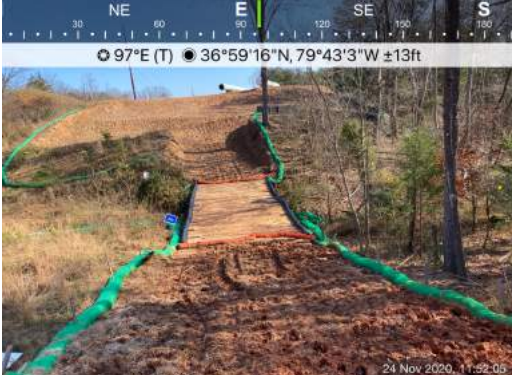
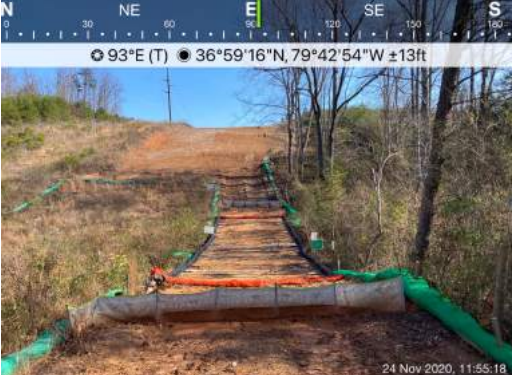
GPS Location	0	GPS Location	0	Field Station#	14673+10
Pic 3 Desc.	Approximately 14673+10. Overview of stream crossing, equipment bridge and ECDs at stream S-H37.

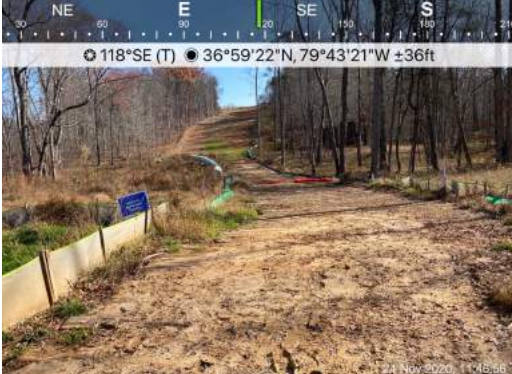
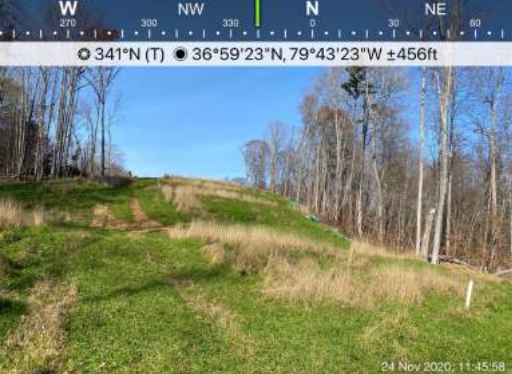
GPS Location	0	GPS Location	0	Field Station#	14656+94
Pic 5 Desc.	Approximately 14656+94. Overview of stream crossing, equipment bridge and ECDs at stream S-H38.				
Field Station#	14653+00	Pic 6 Desc.	Approximately 14653+00. Overview of ROW. ROW temporarily stabilized and has temporary vegetation growing.

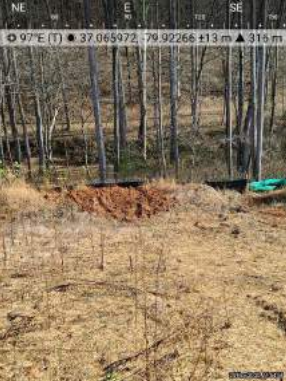
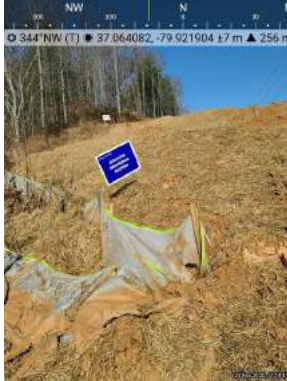
GPS Location	00000		GPS Location	0000	
Field Station#	13845+20		Field Station#	13833+77	
Pic 1 Desc.	Spoil pile observed and needs stabilized, the EI added to the punch list to be addressed by the contractor		Pic 2 Desc.	P1 requires maintenance, the EI added to the punch list for repairs.

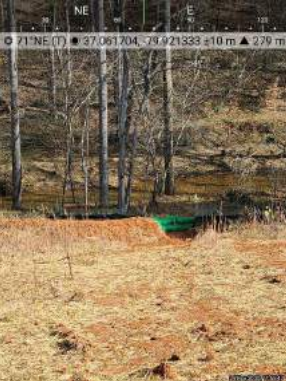
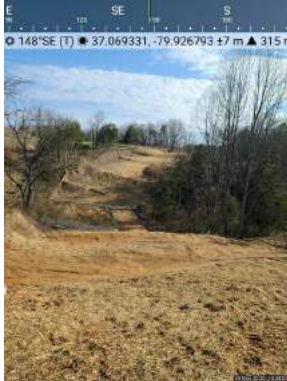
GPS Location	00000		GPS Location	0000	
Field Station#	13842+55		Field Station#	13800+00	
Pic 3 Desc.	Slope breaker needs stabilized after sump pit was cleaned out. Added to the punch list		Pic 4 Desc.	Row photo showing stabilization after recent work activities

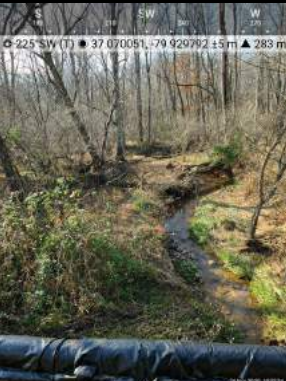
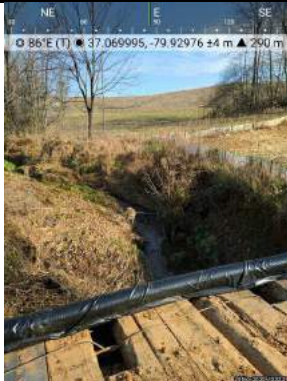
GPS Location	00000		GPS Location	0000	
Field Station#	13797+47		Field Station#	13797+47	
Pic 5 Desc.	Stream observation photo facing upstream during routine inspection today. No issue observed at the time of inspection		Pic 6 Desc.	Stream observation photo facing downstream by the EI , no issue observed at the time of inspection.

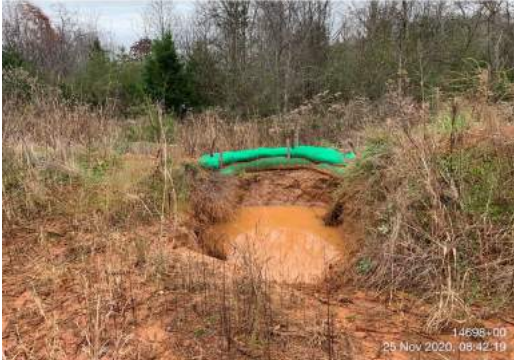
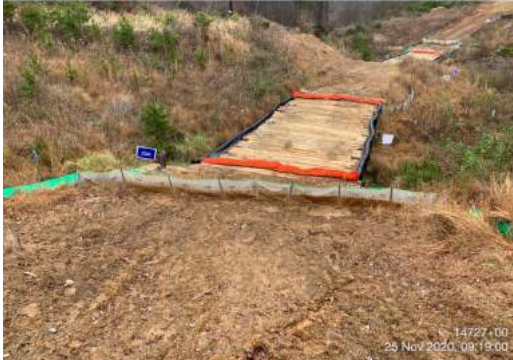
<p>97°E (M) 36°59'15"N, 79°41'56"W ±590ft ▲860ft 14727+00 25 Nov 2020, 09:19:00</p>			
GPS Location	0	GPS Location	0		
Field Station#	14698+00	Field Station#	14727+00		
Pic 1 Desc.	Sump pit in acceptable condition	Pic 2 Desc.	Equipment bridge in acceptable condition

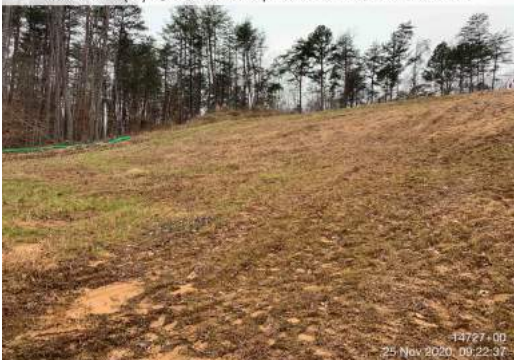
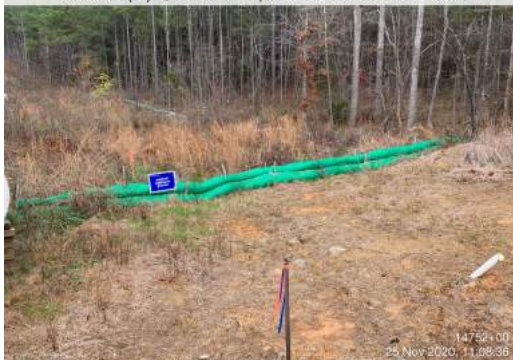
<p>355°N (M) 36°59'5"N, 79°41'30"W ±78ft ▲892ft 14752+00 25 Nov 2020, 11:08:36</p>			
GPS Location	0	GPS Location	0		
Field Station#	14727+00	Field Station#	14752+00		
Pic 3 Desc.	Temporary vegetative stabilization in acceptable condition	Pic 4 Desc.	Triple stack CFS in acceptable condition

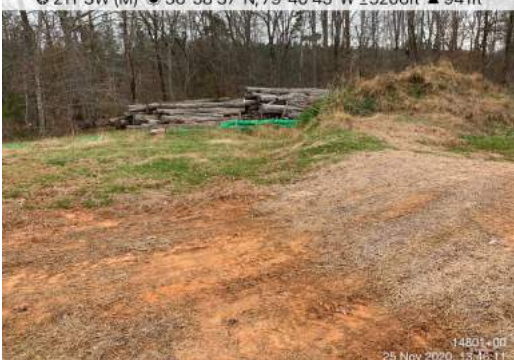
<p>211°SW (M) 36°58'37"N, 79°40'43"W ±5206ft ▲941ft 14801+00 25 Nov 2020, 13:46:11</p>

GPS Location	0	GPS Location	0		
Field Station#	14801+00	Field Station#	14801+00		
Pic 5 Desc.	Waterbar in acceptable condition	Pic 6 Desc.	Waterbar end treatment in acceptable condition

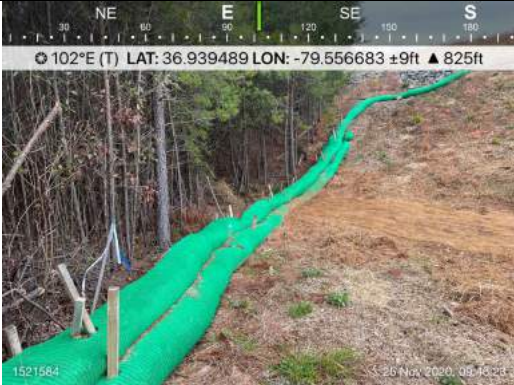
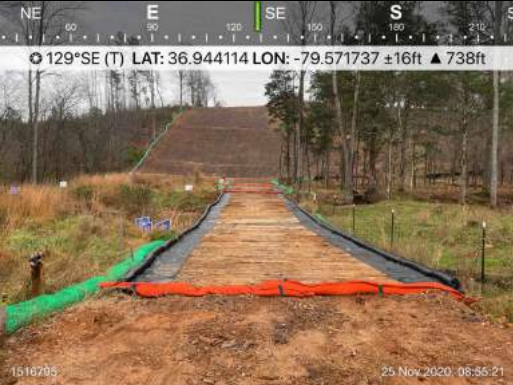
GPS Location	See photo		GPS Location	See photo	
Field Station#	15215+84		Field Station#	15167+95	
Pic 1 Desc.	CFS in good condition.		Pic 2 Desc.	Equipment bridge ECDs present and functioning.

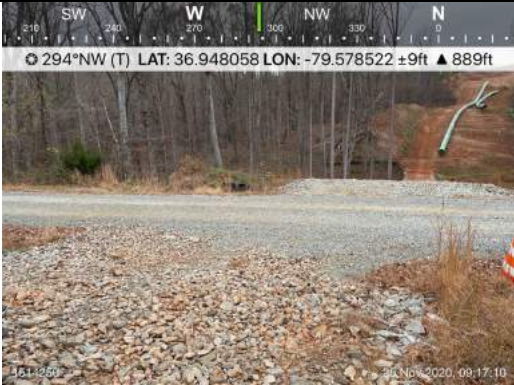
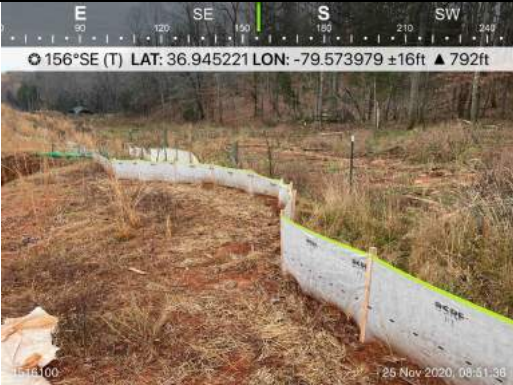
GPS Location	See photo		GPS Location	See photo	
Field Station#	15142+50		Field Station#	15161+00	
Pic 3 Desc.	CE at Rockcreek Road in good condition.		Pic 4 Desc.	P1 in good condition throughout this section.

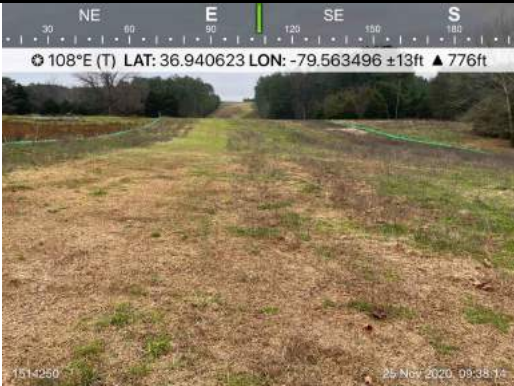
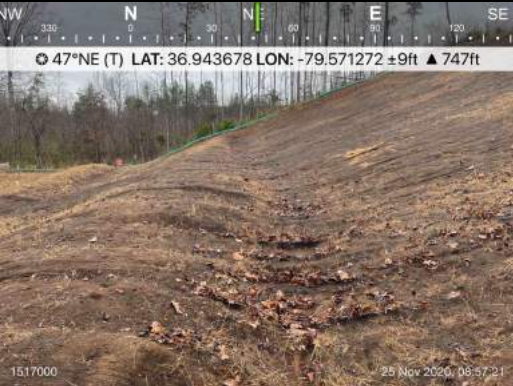
GPS Location	See photo		GPS Location	See photo	
Field Station#	15195+00		Field Station#	15170+00	
Pic 5 Desc.	Permanent vegetation is in good condition and inhibiting erosion m		Pic 6 Desc.	Waterbars are in good condition and functioning as intended.

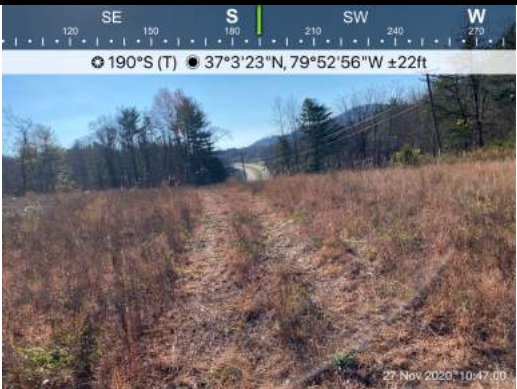
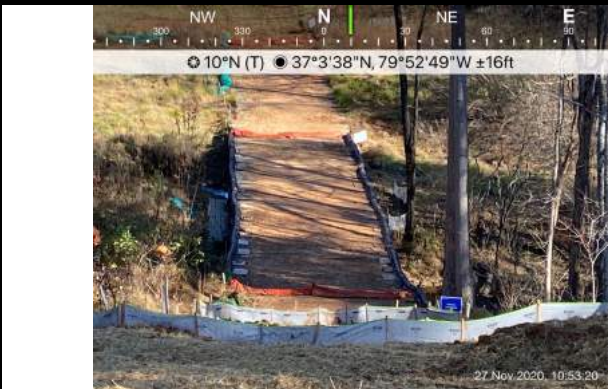
GPS Location	0		GPS Location	0	
Field Station#	14012+60		Field Station#	14035+28	
Pic 1 Desc.	Approximately 14012+60. Overview of ROW. ROW temporarily stabilized and has temporary vegetation growing.		Pic 2 Desc.	Approximately 14035+28. Overview of stream crossing, equipment bridge and ECDs at stream S-KL39.

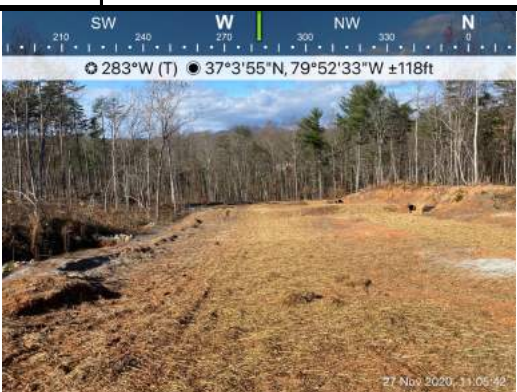
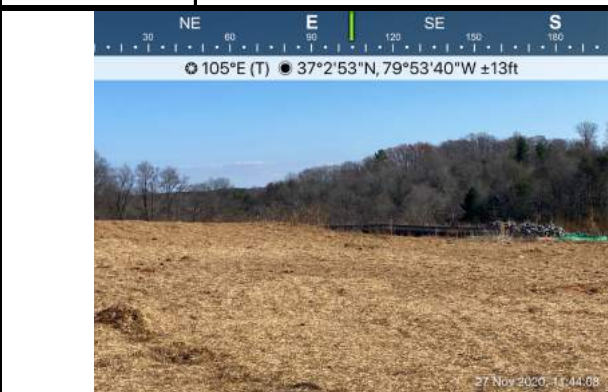
GPS Location	0		GPS Location	0	
Field Station#	14058+00		Field Station#	13960+00	
Pic 3 Desc.	Approximately 14058+00. Overview of ROW. ROW temporarily stabilized and seeded.		Pic 4 Desc.	Approximately 13960+00. Overview of ROW. ROW temporarily stabilized and has temporary vegetation growing. CWD piping installed and appears to be functioning correctly at time of inspection.

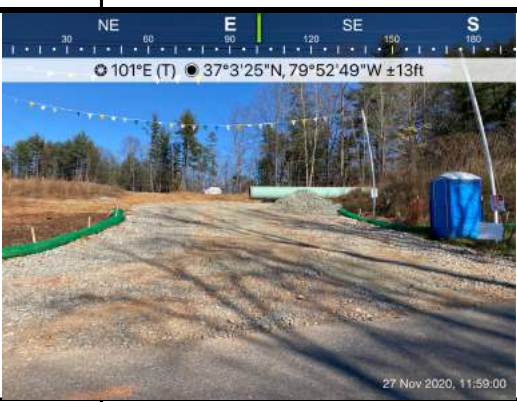
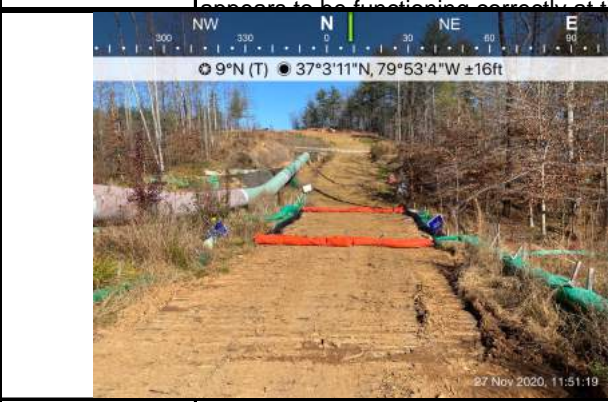
GPS Location	0		GPS Location	0	
Field Station#	14018+75		Field Station#	13998+15	
Pic 5 Desc.	Approximately 14018+75. Overview of road crossing and RCE. RCE installed and appears to be functioning correctly at time of inspection.		Pic 6 Desc.	Approximately 13998+15. Overview of stream crossing, equipment bridge and ECDs at stream S-KL36.

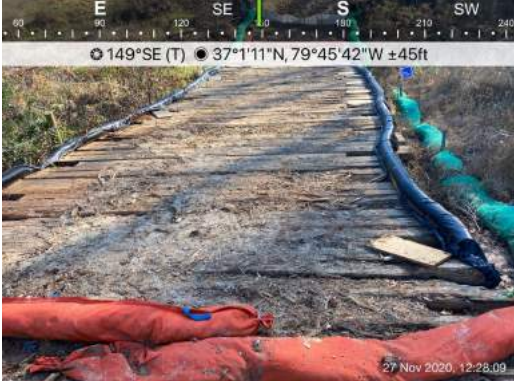
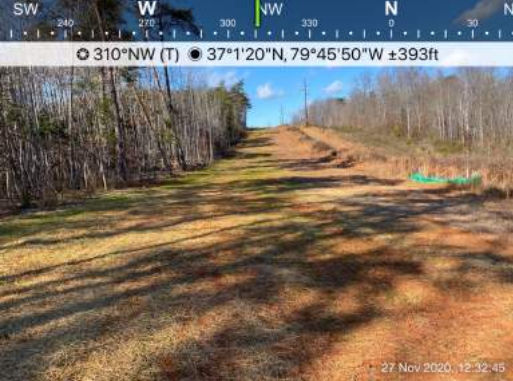
GPS Location	0	GPS Location	0		
Field Station#	14486+62	Field Station#	14475+00		
Pic 1 Desc.	Approximately 14486+62. Overview of stream crossing, equipment bridge and ECDs at stream S-G22.		Pic 2 Desc.	Approximately 14475+00. Overview of ROW. ROW temporarily stabilized and has temporary vegetation.

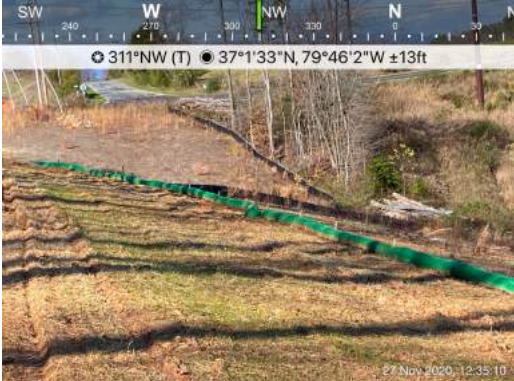
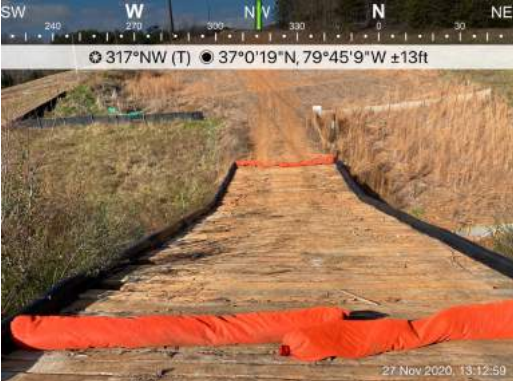
GPS Location	0	GPS Location	0		
Field Station#	14457+00	Field Station#	14546+33		
Pic 3 Desc.	Approximately 14457+00. Overview of ROW. ROW temporarily stabilized and has temporary vegetation growing. CWD piping installed and appears to be functioning correctly at time of		Pic 4 Desc.	Approximately 14546+33. Overview of stream crossing, equipment bridge and ECDs at stream S-G17.

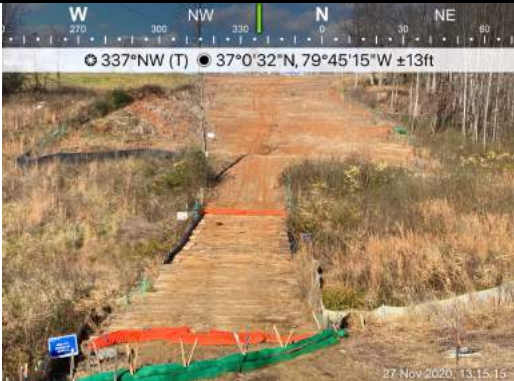
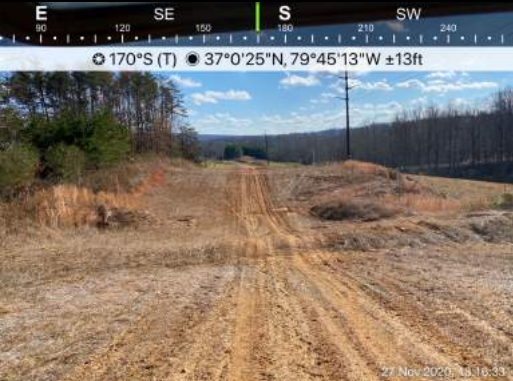
GPS Location	0	GPS Location	0		
Field Station#	14531+58	Field Station#	14537+00		
Pic 5 Desc.	Approximately 14531+58. Overview of stream crossing, equipment bridge and ECDs at stream S-G18.		Pic 6 Desc.	Approximately 14537+00. Overview of ROW. ROW temporarily stabilized and has temporary vegetation growing.

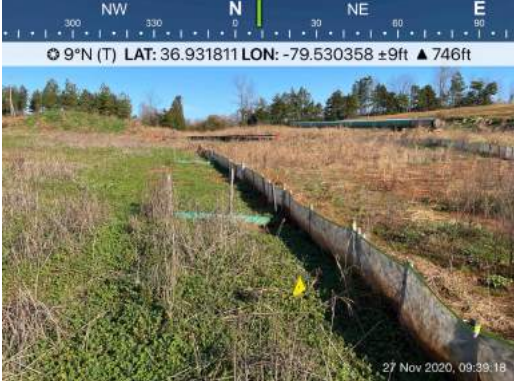
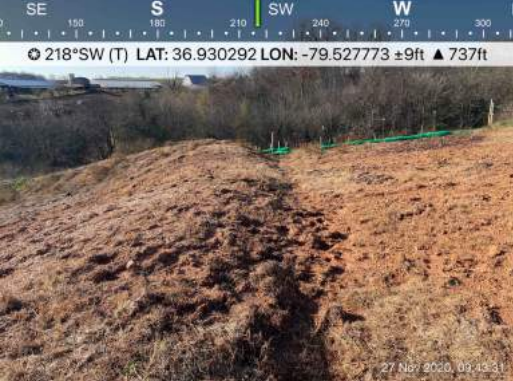
GPS Location	See photo		GPS Location	See photo	
Field Station#	15298+00		Field Station#	15309+00	
Pic 1 Desc.	P1 in good condition throughout this section of ROW.		Pic 2 Desc.	Waterbars are in good condition and functioning.

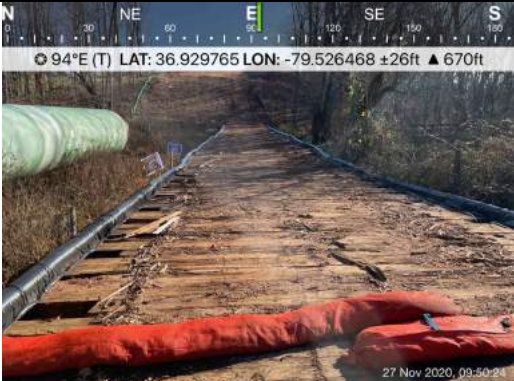
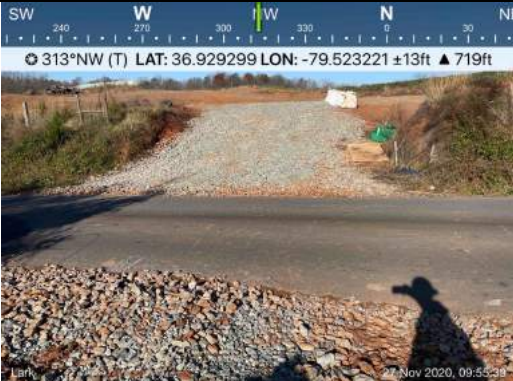
GPS Location	See photo		GPS Location	See photo	
Field Station#	15312+48		Field Station#	15323+24	
Pic 3 Desc.	Equipment bridge ECDs are in place and in good condition.		Pic 4 Desc.	CE's are in place and functioning at all road crossings.

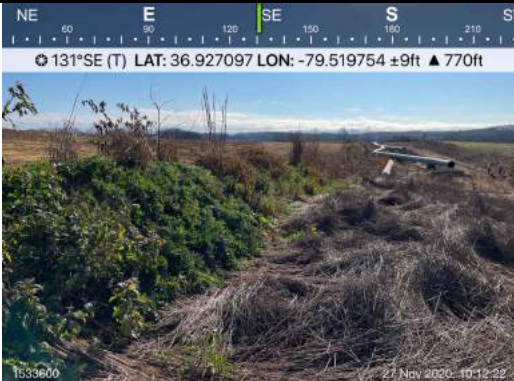
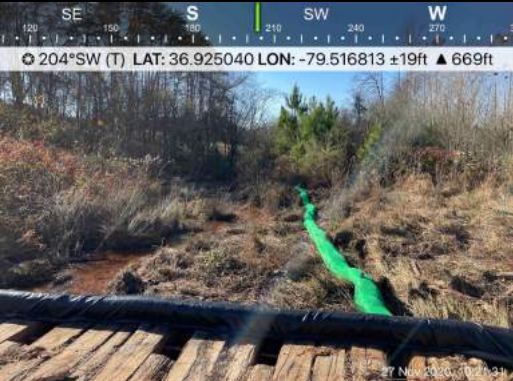
GPS Location	See photo		GPS Location	See photo	
Field Station#	15336+00		Field Station#	15347+00	
Pic 5 Desc.	Topsoil berms and stockpiles are adequately stabilized.		Pic 6 Desc.	Perimeter controls are in place at all aquatic resource buffers.

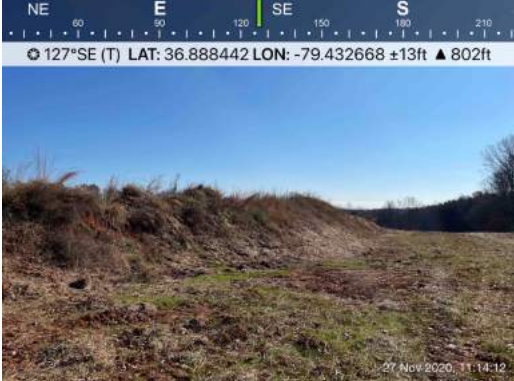
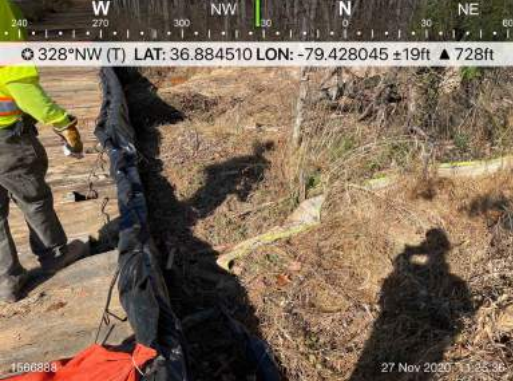
GPS Location	See photo		GPS Location	See photo	
Field Station#	15647+03		Field Station#	15668+88	
Pic 1 Desc.	Stockpiles are adequately stabilized.		Pic 2 Desc.	Buffer zone P1 is down at this location.

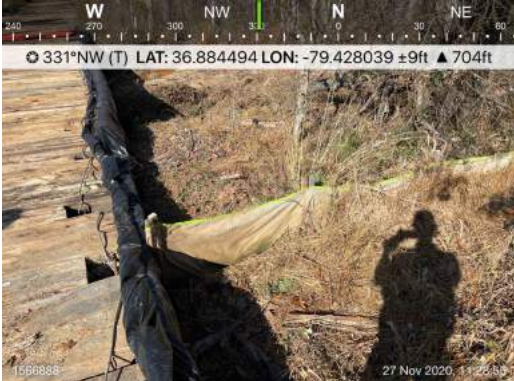
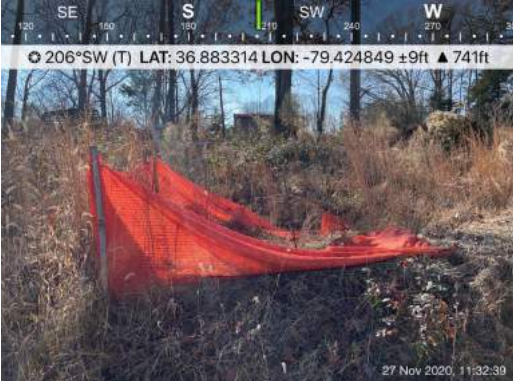
GPS Location	See photo		GPS Location	See photo	
Field Station#	15668+88		Field Station#	15680+00	
Pic 3 Desc.	Environmental crew has corrected this issue.		Pic 4 Desc.	Orange safety fence needs to be restaked at this location.

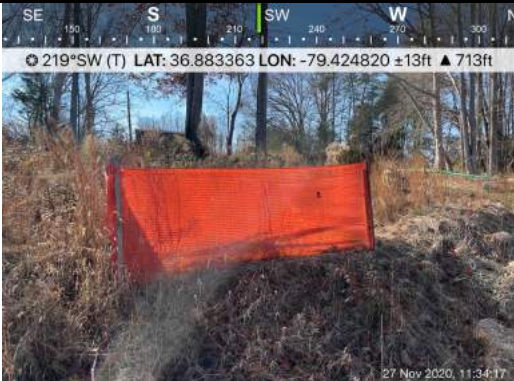
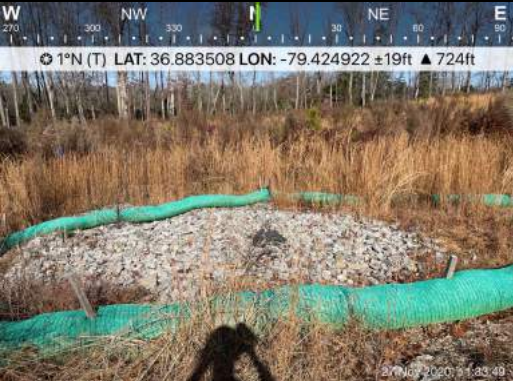
GPS Location	See photo		GPS Location	See photo	
Field Station#	15680+00		Field Station#	15680+00	
Pic 5 Desc.	Environmental crew has corrected this issue.		Pic 6 Desc.	CWD is in good condition and functioning.

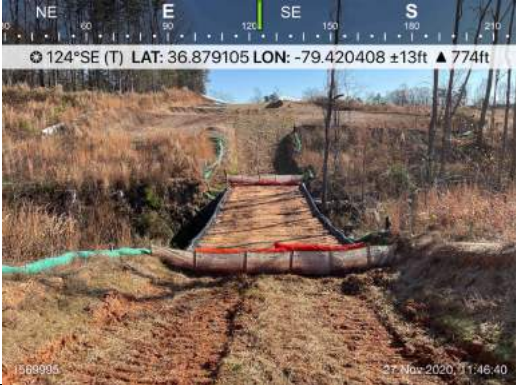
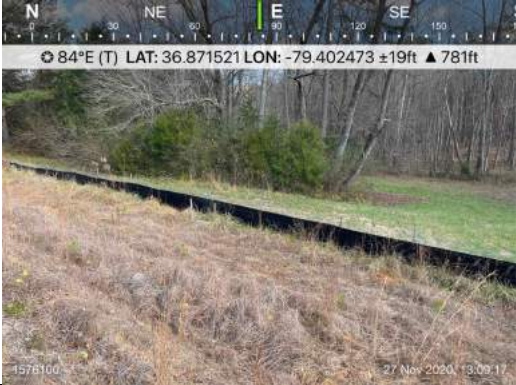
GPS Location	See photo		GPS Location	See photo	
Field Station#	15699+95		Field Station#	15761+00	
Pic 7 Desc.	Equipment bridge ECDs are in place and functioning.		Pic 8 Desc.	SSF throughout this section is in good condition.	
Insert image here			Insert image here		
GPS Location			GPS Location		
Field Station#			Field Station#		
Pic 9 Desc.			Pic 10 Desc.		
Insert image here			Insert image here		
GPS Location			GPS Location		
Field Station#			Field Station#		
Pic 11 Desc.			Pic 12 Desc.
